Evaluation of Stainless Steel Reinforcement in Bridge Decks

Follow up and Final Report

RI00-027

By
John D. Wenzlick, P.E.
Missouri Department of Transportation

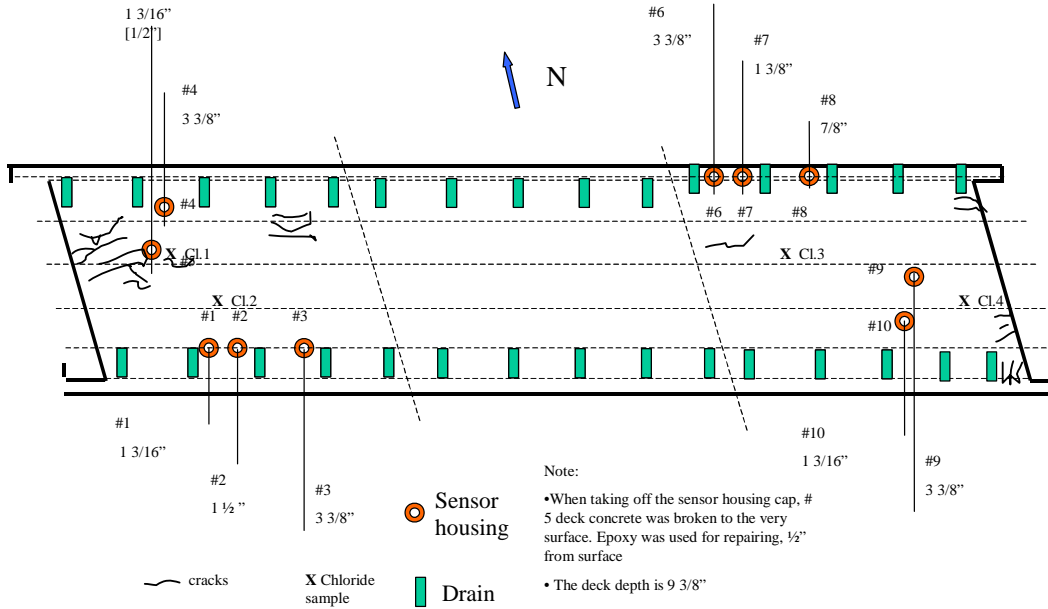
1. There was no delamination or spalling found on the surface of either bridge deck.
2. On Bridge A6059, the stainless steel reinforced concrete deck, there was 57 linear feet of cracking at five years old. The bridge is built with a 30° skew and most of the cracking was found at the skewed ends of the bridge deck, there were a couple of cracks also found over the interior bents. The rate of cracking for A6060 was 10.34 LF/ 1,000 SF (0.038M/M²).
Bridge A6050, the epoxy coated reinforced steel concrete deck, which doesn’t have a skew, had no cracking found at five years old.
3. Concrete samples taken from the deck for chloride content are shown in Table 2 and the locations samples were taken at in the deck surface profiles in Figure 3.

Figure 3: Surface Profile of Bridge A6059 in year 2006

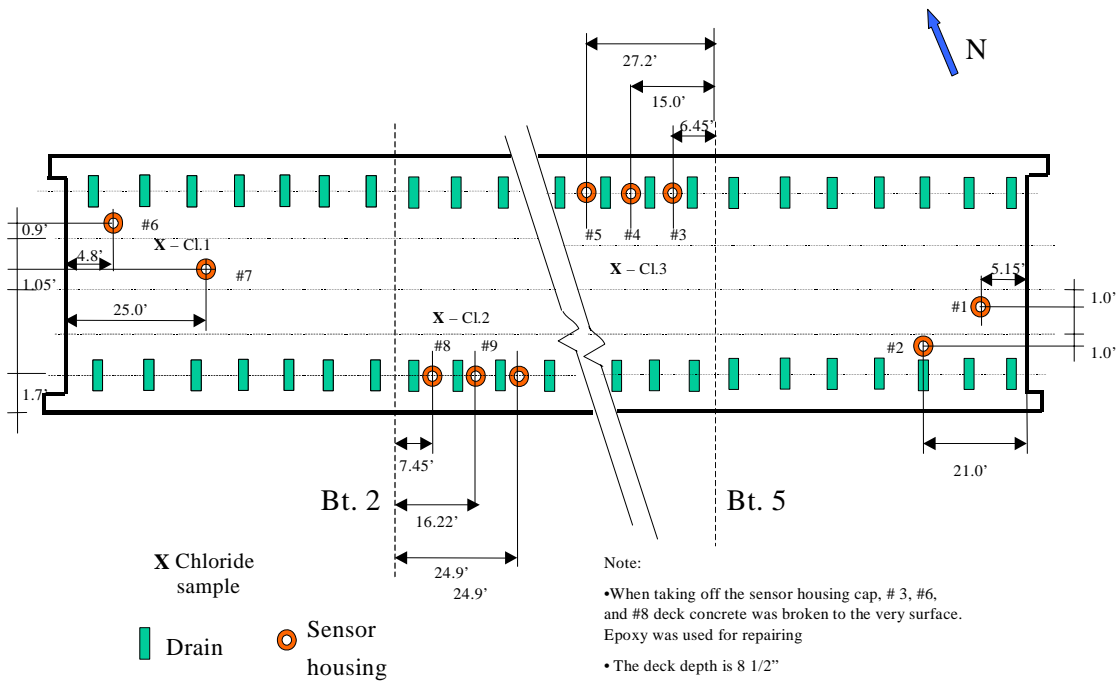
Figure 3 (continued): Surface Profile of Bridge A6060 in year 2006
