INVESTIGATION OF ROADWAY DESIGN VARIABLES TO REDUCE D-CRACKING

15-YEAR STATUS REPORT

MISSOURI HIGHWAY AND TRANSPORTATION DEPARTMENT

STUDY NO. 78-1

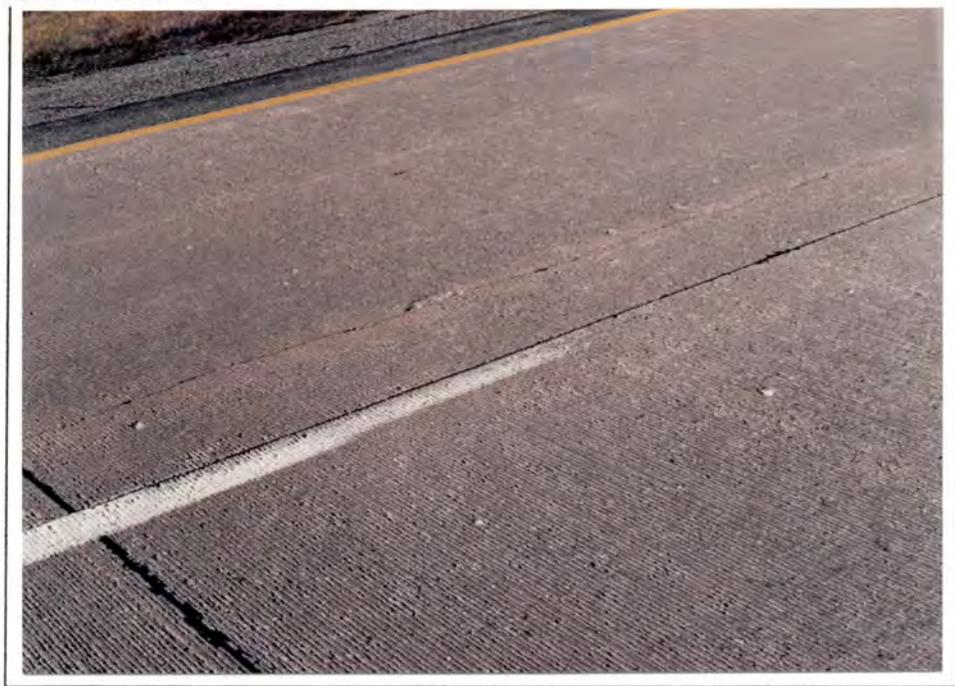
Photo No. 1

This section did not have any D-cracking or D-crack type staining, nor did it have any transverse cracks. There were two longitudinal cracks, both were rated moderate severity due to spalling and both run close to the centerline joint, see Photo 1. Most noticeable about this section were the numerous popouts as shown in Photo 2.

TS #1. Longitudinal crack at slab 14.

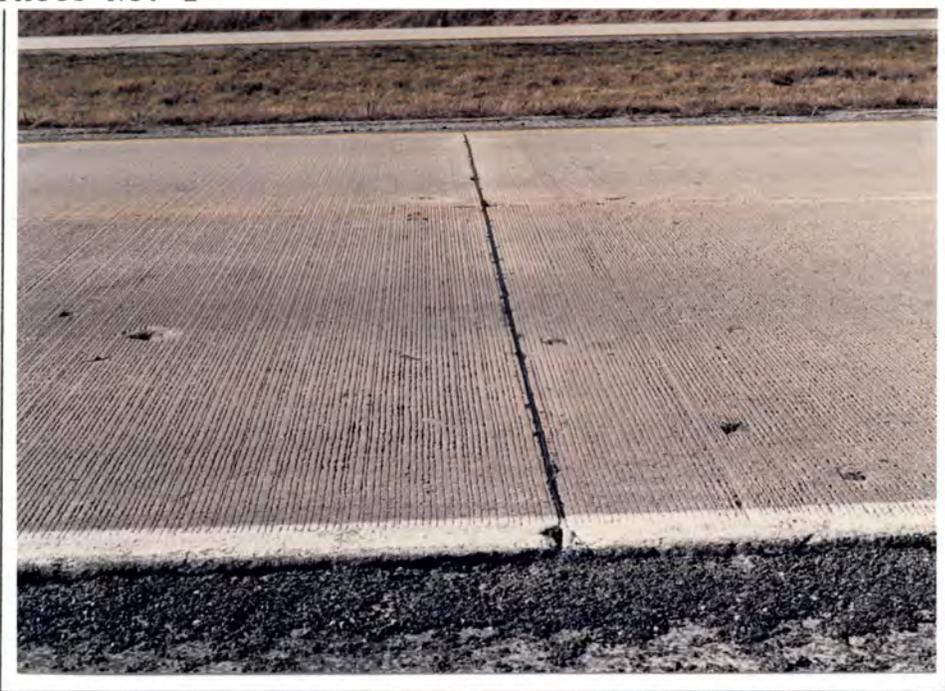
Photo No. 2

TS #1. Popouts near joint 4.

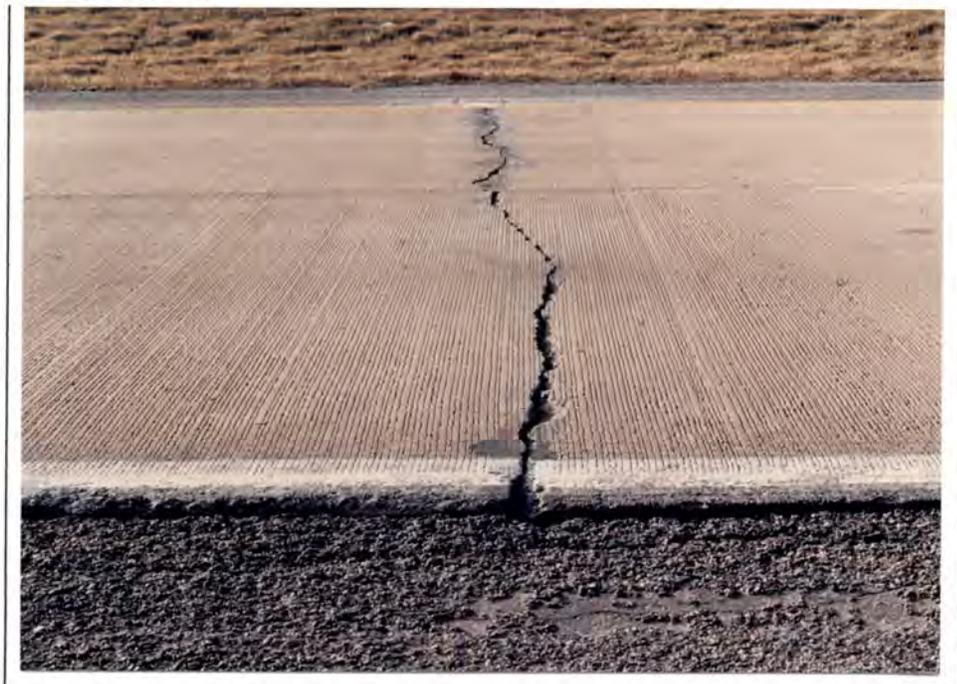
Photo No. 3

This section did not have any D-cracking although transverse joint number 1 had some staining at the centerline. There was 1 moderate-severity longitudinal crack and 19 transverse cracks: 12 rated low severity (hairline cracks without spalling or faulting); 6 rated moderate severity (due to spalling less than 3 inches wide); and 1 rated high severity (due to spalling of 3 inches wide or more) shown in Photo 3. One transverse joint in the driving lane has been replaced as shown in Photo 4, probably due to spalling since over 6 feet of the joint was spalled in 1990.

TS #2. High-severity transverse crack at slab 8.

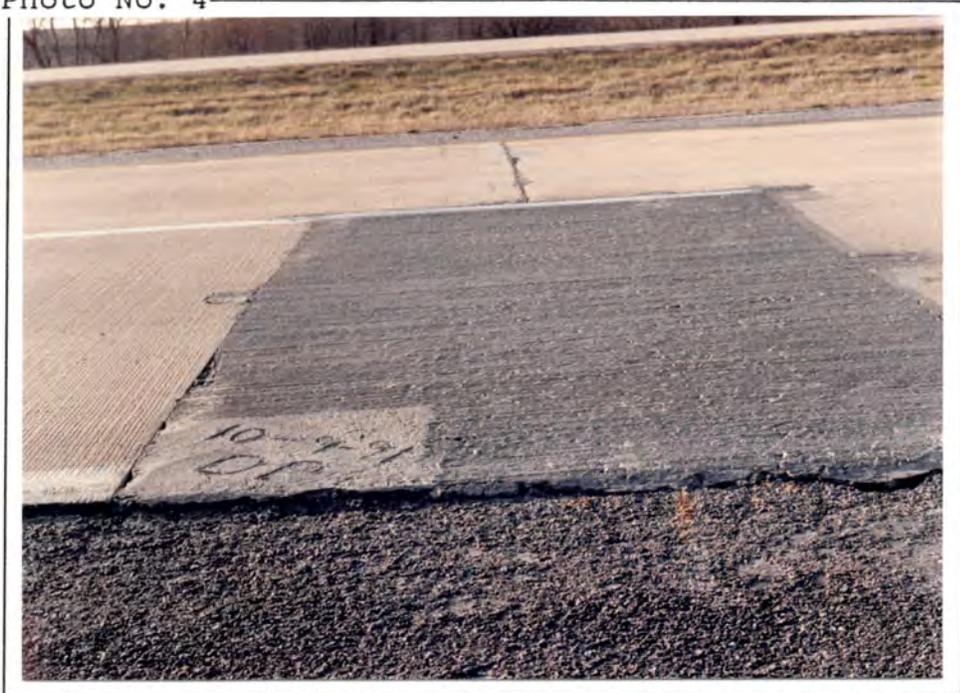
Photo No. 4

TS #2. Transverse joint repair at joint 6.

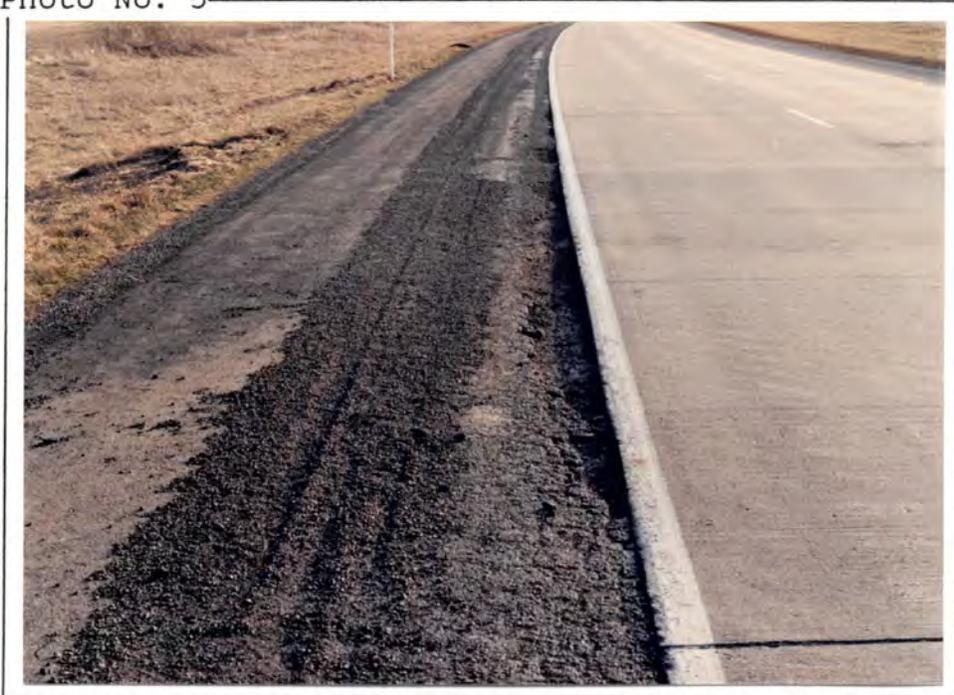
Photo No. 5

The asphalt shoulder was broken up at several locations along the outside edge of the pavement as shown in Photo 5.

TS #2. Asphalt shoulder broken up at outside edge of pavement resulting in lane-to-shoulder dropoff at slab 13.

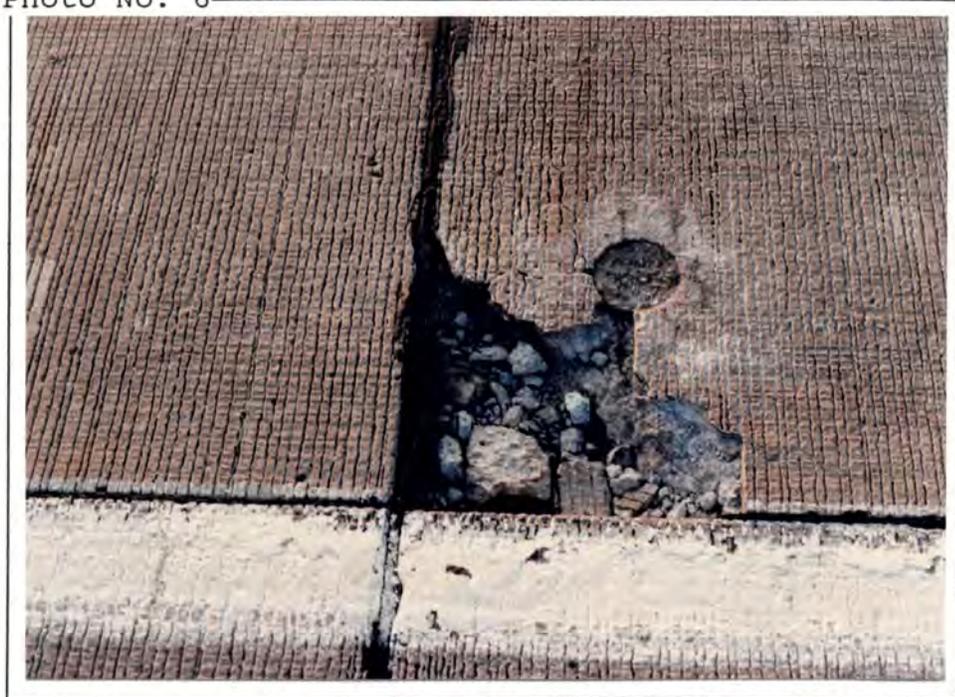
Photo No. 6

This section did not have any D-cracking. Concrete was spalled out of a corner break at the centerline in the passing lane of joint number 8 and the area had some D-crack type staining, photo 6. This test section had 27 transverse cracks, having slightly more cracks of each severity level compared to the adjacent test section 2 which had the polyethylene sheeting moisture barrier.

TS #3. Concrete spalling and staining at joint number 8 where only a corner break was noted prior to 1992 survey. Core was drilled in March 1990.

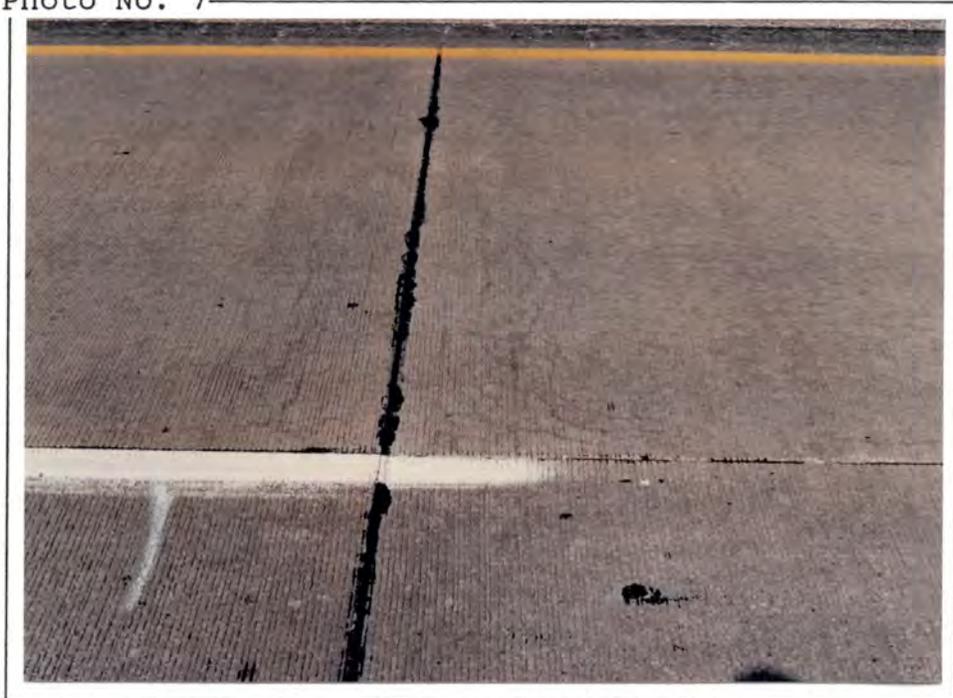
Photo No. 7

This section had low-severity D-cracking at joints 1, 3, 6, and 7. See Photos 7 and 8. Most of the observed D-cracking (approximately 25 out of 30 square feet of affected area) was in the passing lane. Another joint had some D-crack type staining and six feet of high-severity spalling, as shown in Photo 9.

TS #4. Low severity D-cracking at interior corners in passing lane of joint number 6.

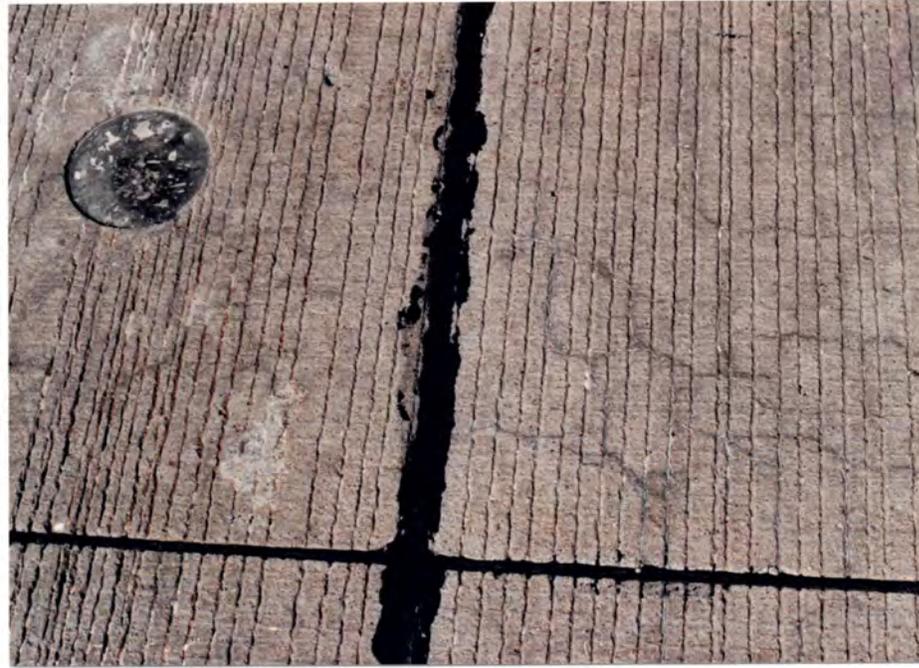
Photo No. 8

TS #4. Close-up of D-cracking in passing lane at joint number 7. Core was drilled in 1990.

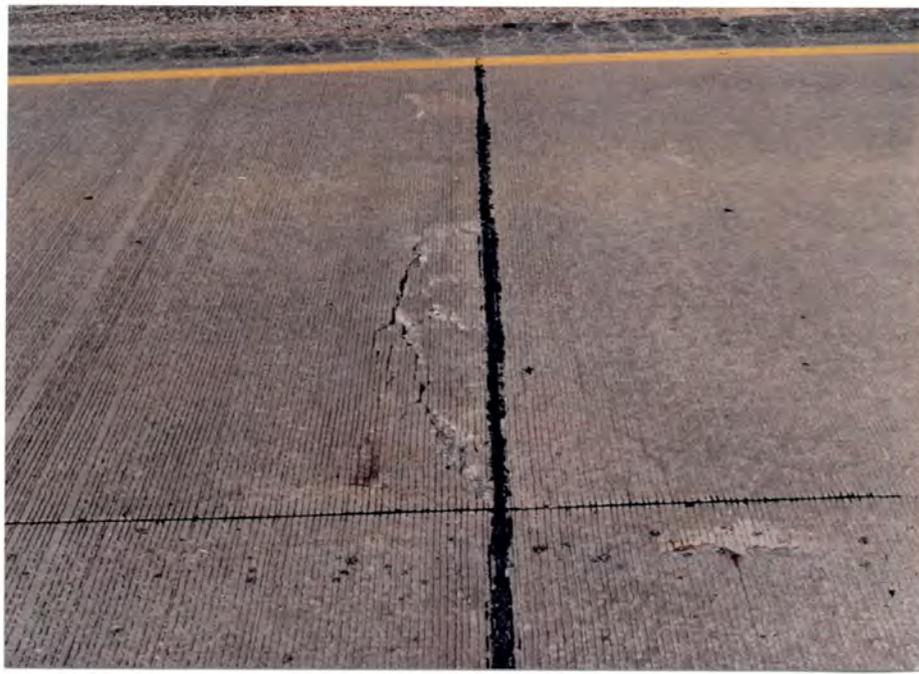
Photo No. 9

TS #4. Transverse spalling and some D-crack type staining in passing lane at joint number 14.

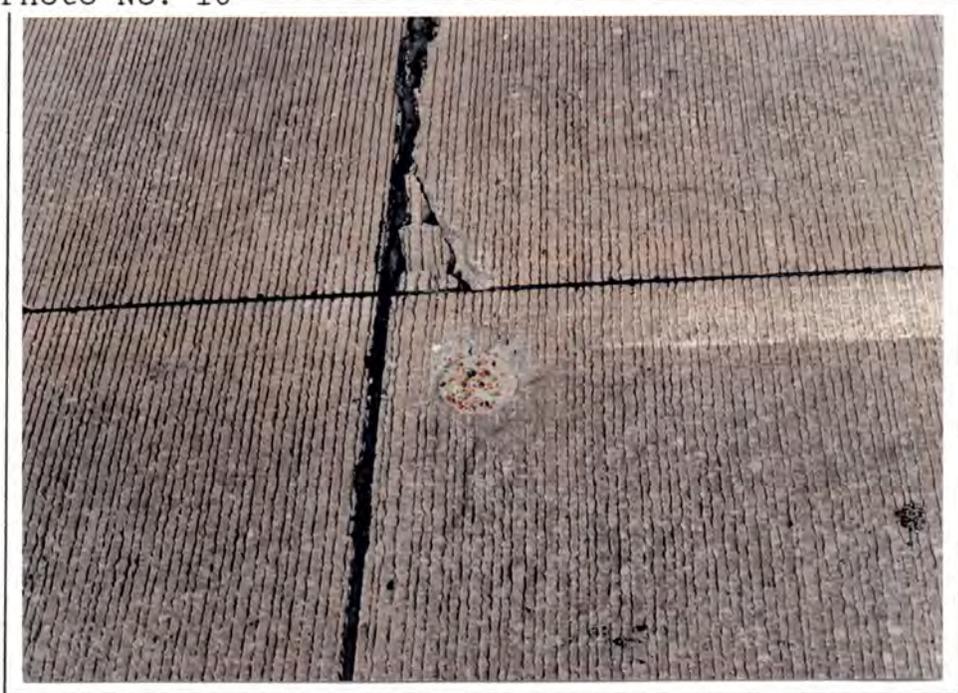
Photo No. 10

This section had a small area of low-severity D-cracking at the interior area along joint number 15, see Photos 10 and 11. The other joints in this section did not have any D-cracking or D-crack type staining.

TS #5. Low-severity D-cracking at joint number 15.

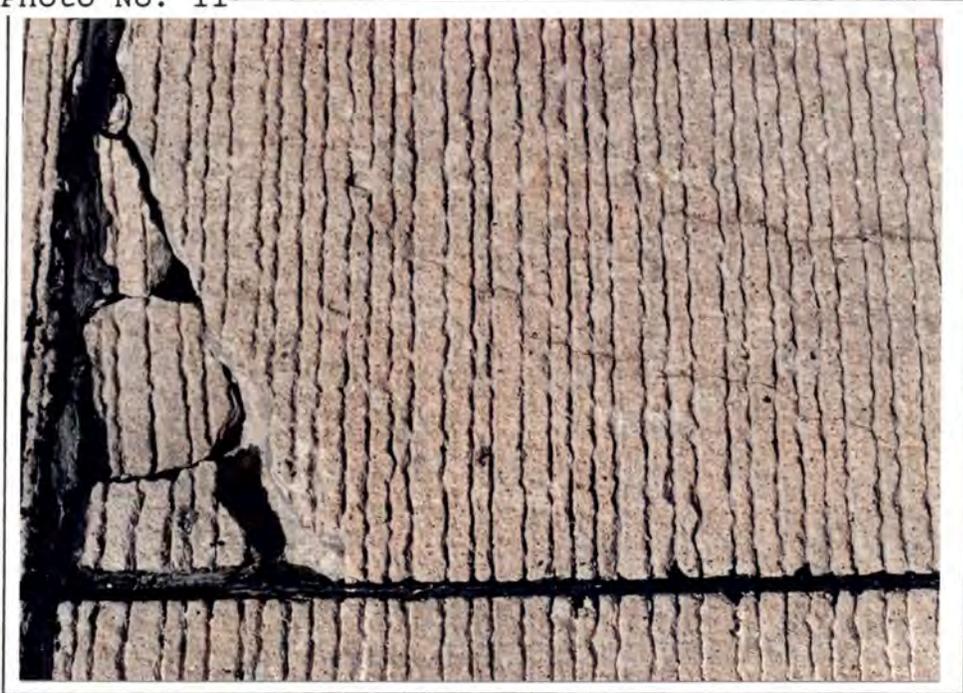
Photo No. 11

TS #5. Close-up showing spalling of the transverse joint (on left) and low-severity D-cracking (2 fine closely-spaced curved cracks) at northwest corner at joint number 15.

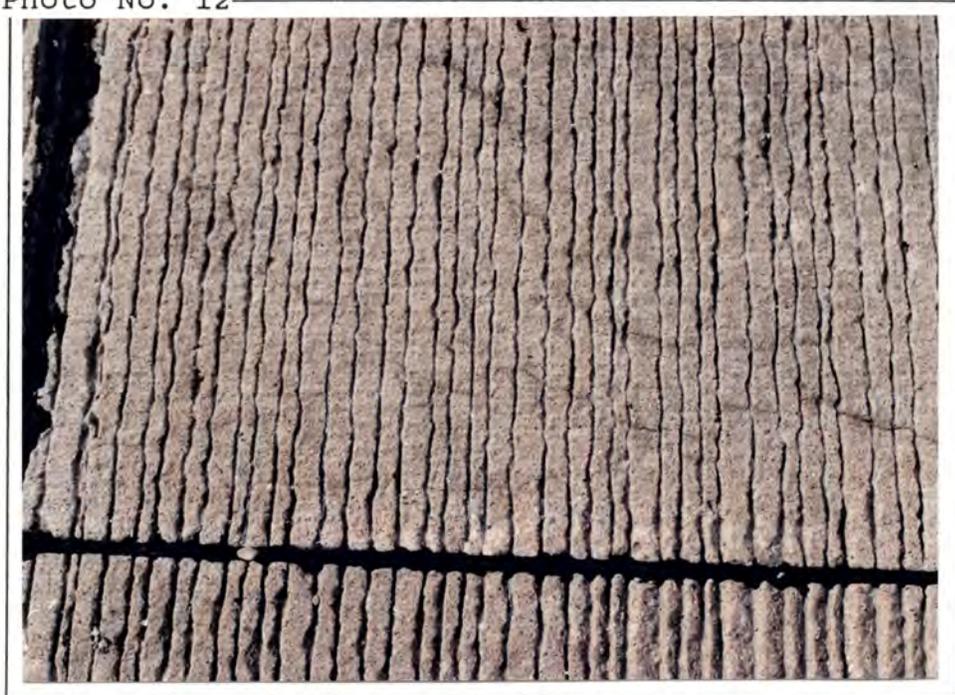
Photo No. 12

This section had a small area of low-severity D-cracking at the interior corners at joint number 15, see Photo 12, and some D-crack type staining at joint number 13.

TS #7. Close-up of low-severity D-cracking at northwest interior corner at joint number 15.

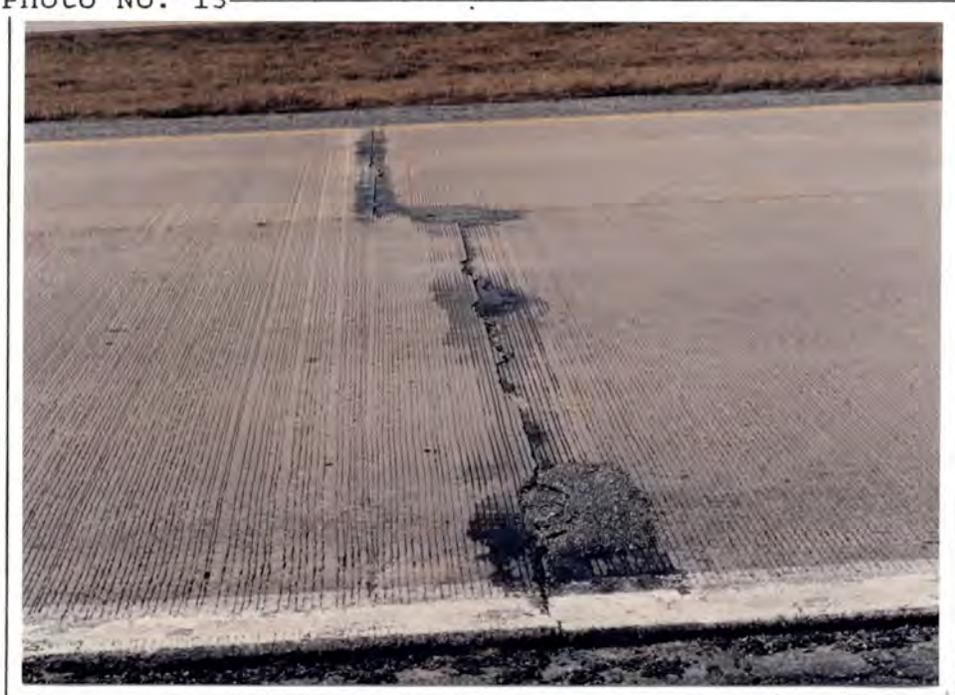
Photo No. 13

This section did not have any D-cracking or D-crack type staining. This section had 32 transverse cracks with a total length of 356 feet, more than any other section except test section 4. Twenty of the transverse cracks were rated either moderate or high severity. Photo 13 shows a typical high-severity and moderate-severity transverse cracks.

TS #8. Transverse cracks at slab number 6. Transverse crack in the driving lane (foreground) was rated high severity due to spalling greater than 3 inches wide and faulting of 1/4 inch. Transverse crack in the passing lane was rated moderate severity.

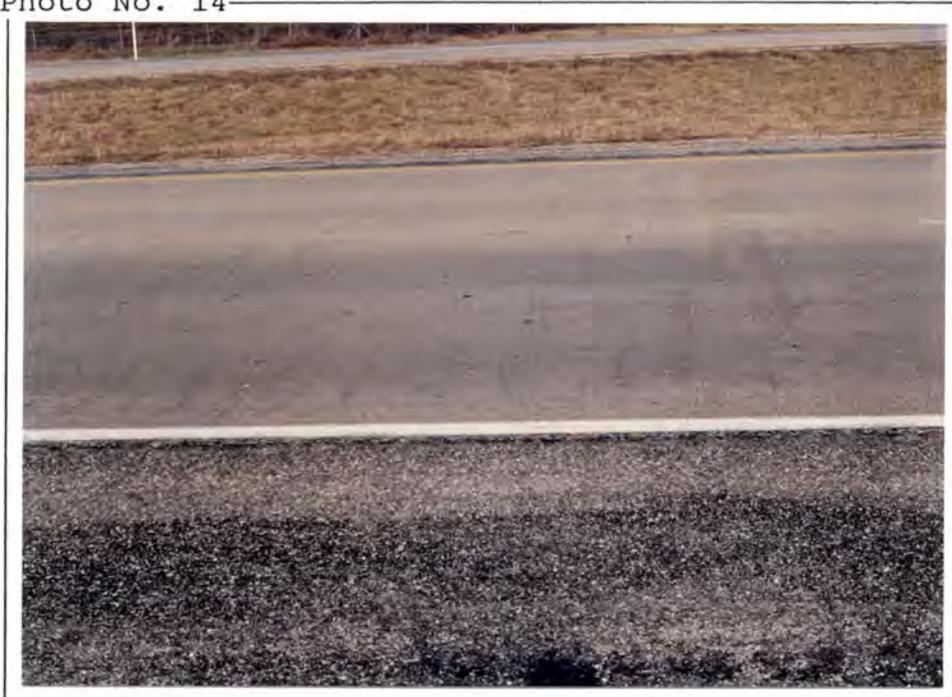
Photo No. 14

a staining pattern seen in all the test sections using the local (Bethany Falls limestone) coarse aggregate as shown in Photos 14 and 15. The staining typically had a transverse or block pattern. Close inspection of this staining did not usually reveal any cracks.

TS #3. Staining at slab number 15.

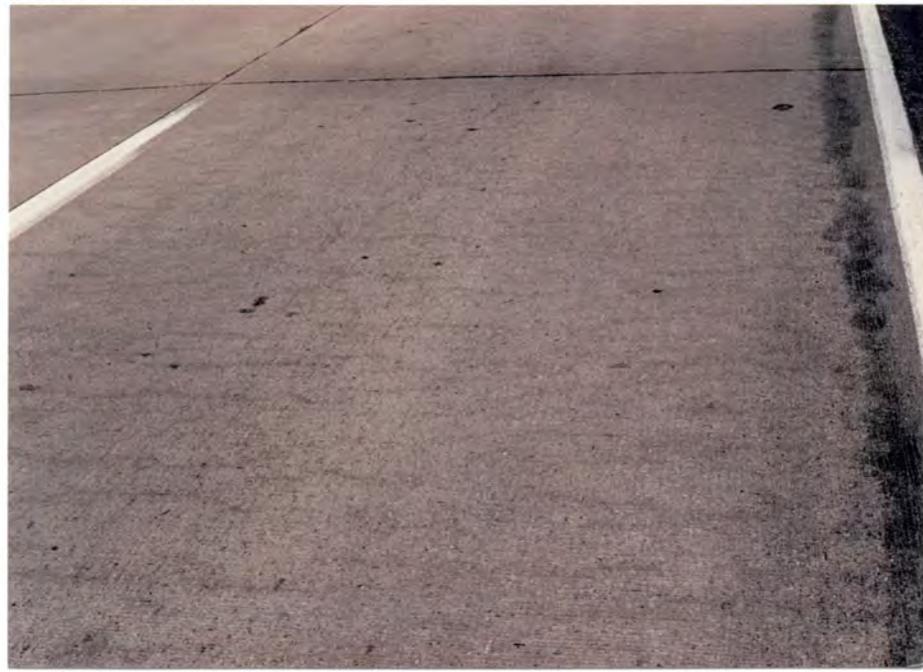
Photo No. 15

TS #5. Staining in driving lane of slab number 13.

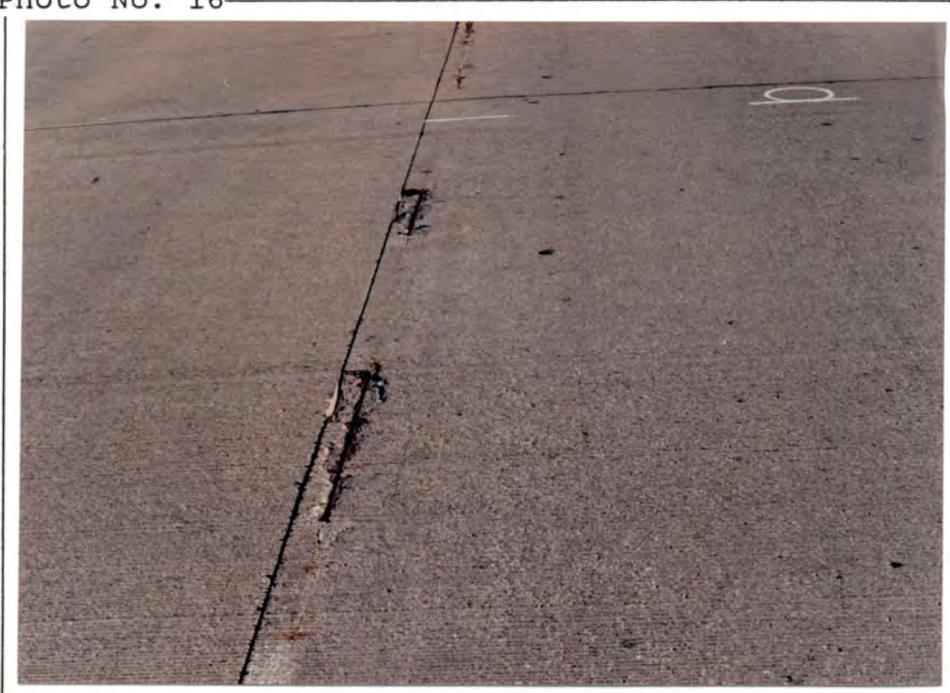
Photo No. 16

Rust staining and spalling was seen in all of the test sections where the wire mesh was too close to the pavement surface. Most of this spalling was in the driving lane approximately 4 inches from the longitudinal joint as shown in Photo 16.

TS #4. Concrete spalling at wire mesh in driving lane of slab numbers 4 and 5.

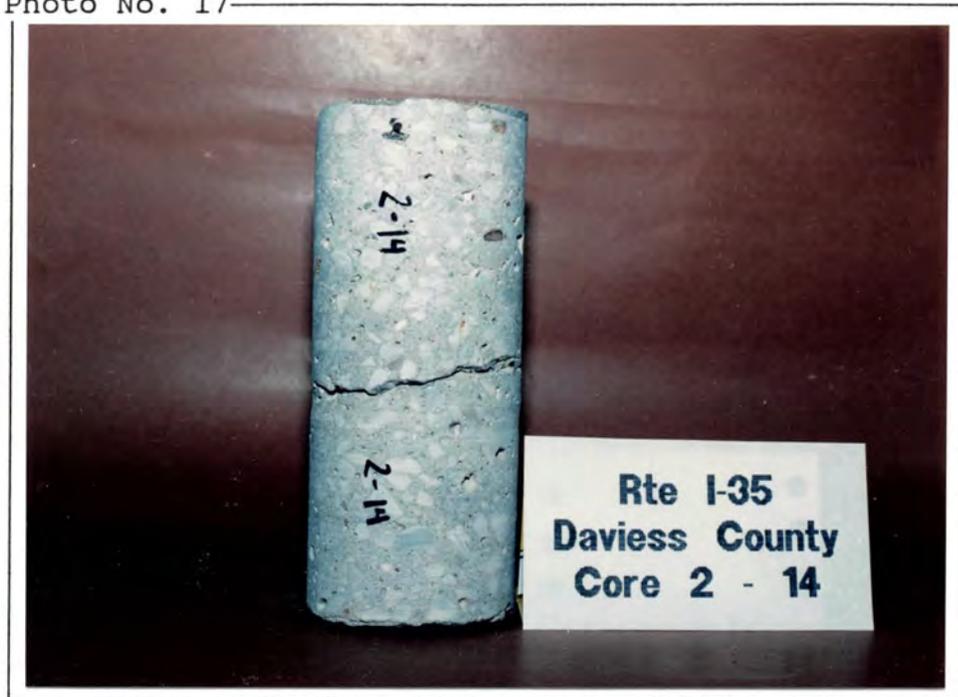
Photo No. 17

Test Section	Joint Number	Description
1	4	Minor cracks in or around a few of the coarse aggregates (CA) - Photo 20.
2	14	Minor cracks in or around CA. One crack at mid-depth across extended across slab - Photos 17 and 18.
3	8	Minor cracks in or around CA. Three cracks at or below mid-depth extended across slab - Photo 19.
4	7	Minor cracks in or around CA. One crack at mid-depth extended across slab.
5	5	Minor cracks in or around CA, mostly near the top of slab.
5	7	Minor cracks in or around CA.
6	14	Minor cracks in or around CA.
7	10	Minor cracks in or around CA.
7	13	Minor cracks in or around CA.
8	14	Minor cracks in or around CA.

Core 2-14, drilled at joint number 14 of test section 2.

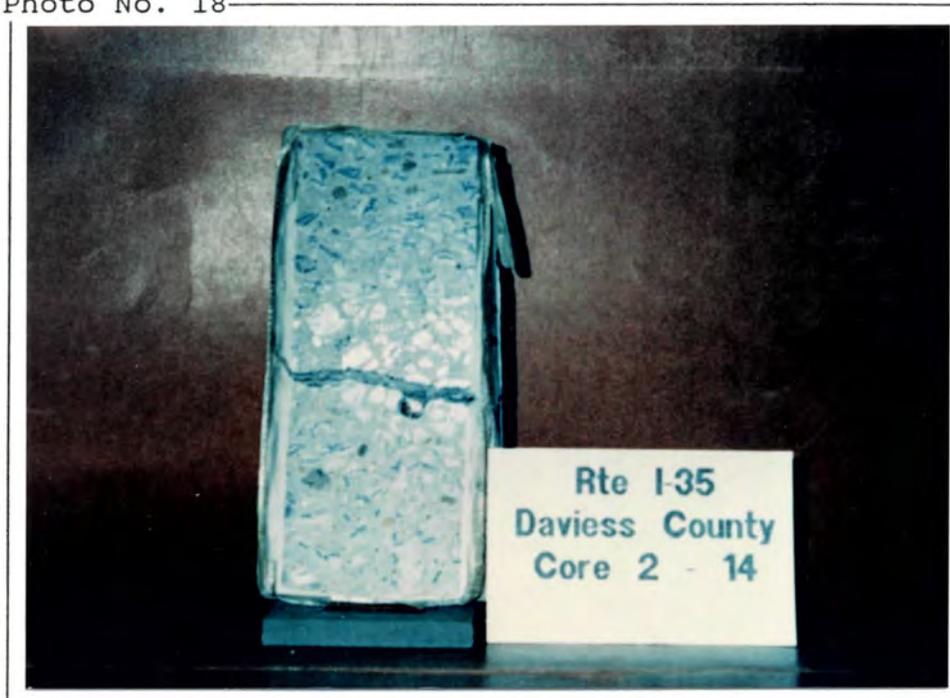
Photo No. 18

Core 2-14 after being sawed, ground and polished and after cracks were marked on the slab.

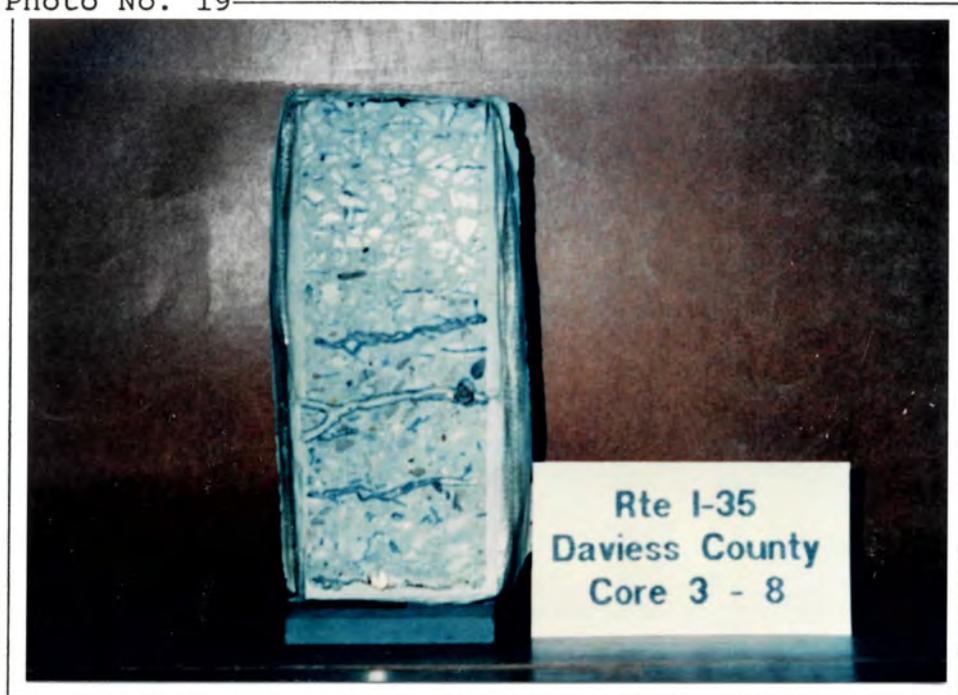
Photo No. 19

Polished slab from core 3-8, with cracks marked.

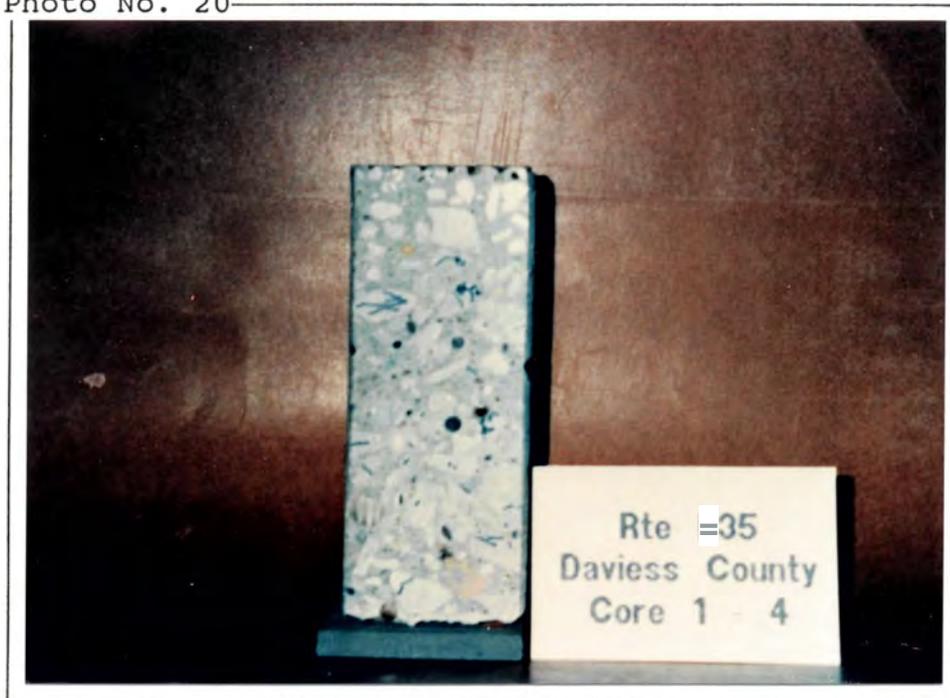
Photo No. 20

Polished slab from core 1-4, with cracks marked.
