Final Report

Asphalt Rubber Overlay Performance Evaluation

Experimental Projects

SUBJECT: Route I-44, Phelps County
Job No. J9I0298
Experimental Project No. MO92-09
F.O. 92-6
Final Report

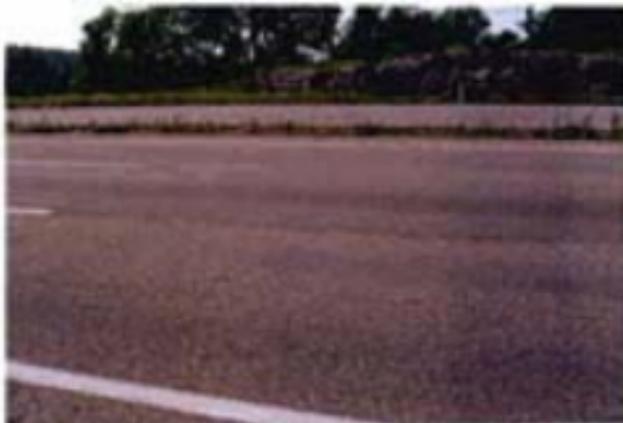
The Type II ARC surface course exhibited low severity reflective and transverse cracking, low severity longitudinal cracking down the center of each lane and low severity cracks at the shoulder and centerline of the road, as can be seen in Figure #1. Pumping was noted at lane mile 11.68 and potholes at Lane miles 11.05 and 12.05, as seen in Figure #2. Rut measurements were taken at the following locations in the driving lane:

Figure #1
Typical Low Severity
Transverse Reflective
and Longitudinal Cracks

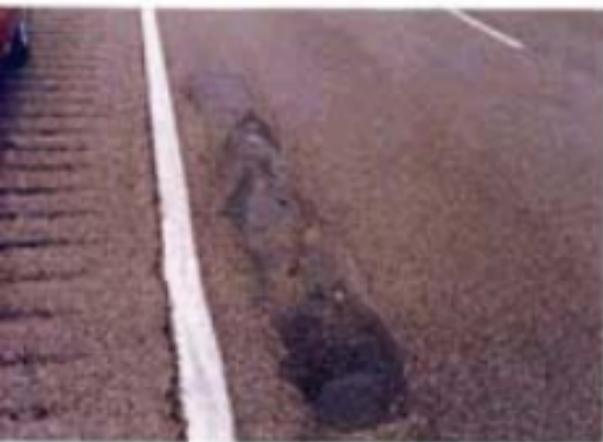
Figure #2
Pothole

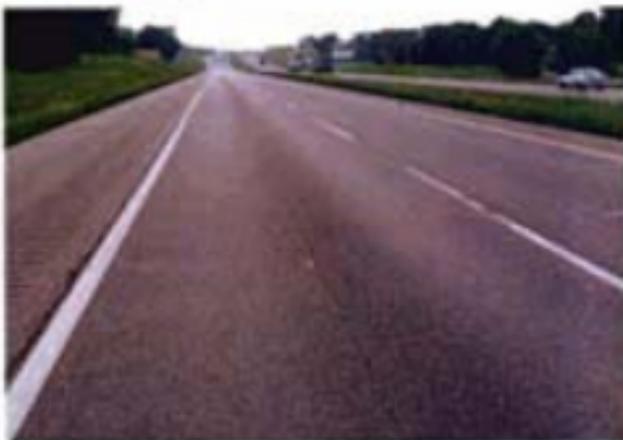
The Type IV ARC surface course exhibited some distress in the driving and passing lane along the center of the lane, and raveling along the centerline, as seen in Figure #3. It also exhibited some pumping, as seen in Figure #4. Rut measurements were taken at the following locations in the driving lane:

Figure #3
Typical Photograph
of Type IV ARC

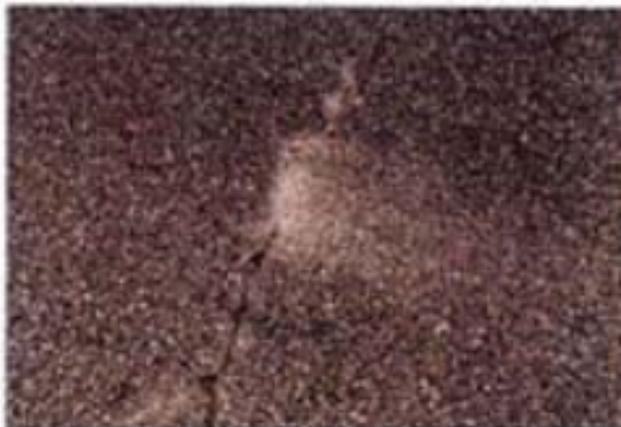
Evidence of subsurface moisture was reported in the initial pavement evaluation of 1991 and was noted during construction of the test section.

Figure #4
Pumping

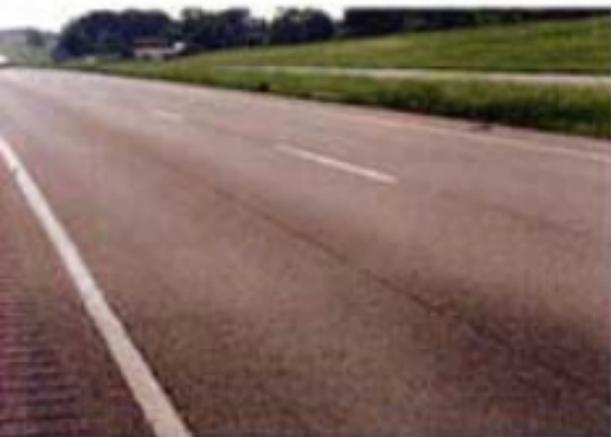
The Type IC control section looked very similar to the Type II and Type IV ARC sections. Low severity longitudinal cracking at the center of the driving lane was evident, as can be seen in Figure #5. Rut measurements were taken at the following locations in the driving lane:

Figure #5
Typical Photograph
of IC Control Section
Low Severity
Longitudinal Crack @
Center of Driving
Lane

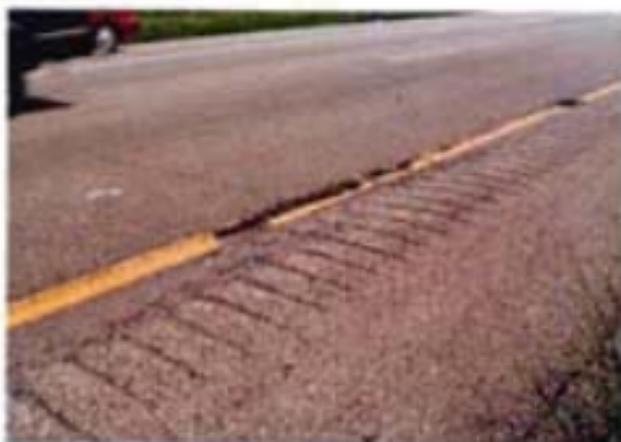
The Type II SBR polymer modified test section exhibited some sub-grade failures, as seen in Figure #6, but no pumping was noted. Also the shoulder had been patched. Reflective cracking

Figure #6
Sub-Grade Failure
at Shoulder Line

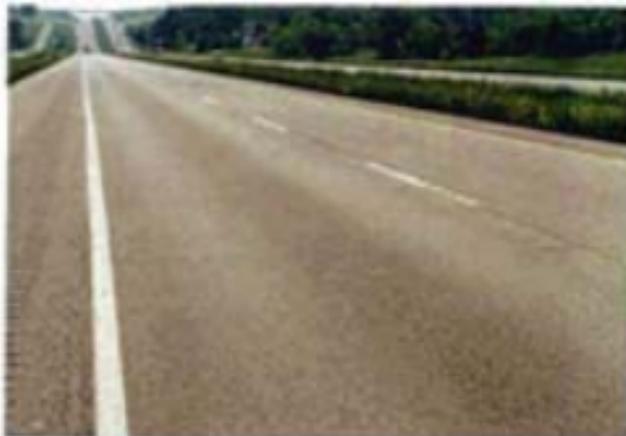
did not seem to be as bad as the ones in the ARC test sections, as seen in Figure #7. No rut measurements were taken due to heavy traffic.

Figure #7
Typical Photograph
of Type II SDB
Modified Asphalt

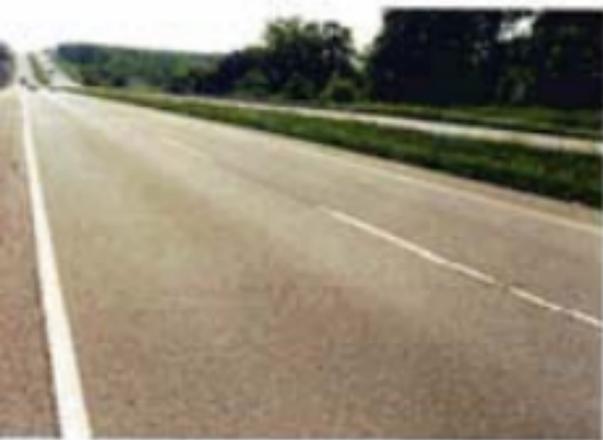
The Type I SBS polymer modified test section visually looked similar to the IC control section and the Type IV ARC test section, as seen in Figure #8. That is the cracking was visually similar. Rut measurements were taken at the following locations in the driving lane:

Figure #8
Typical Photograph
of the Type I SDB
Modified Asphalt

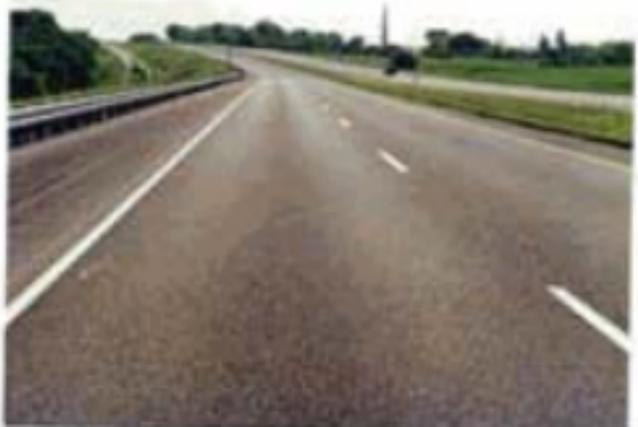
The RMAC section in the westbound lane exhibited a few low severity reflective cracks and no longitudinal cracks were visible, as can be seen in Figure #9. Ground rubber pieces were visible on the surface, as can be seen in Figure #10.

Figure #9
Typical Photograph
of RMAC in the
Westbound Lane

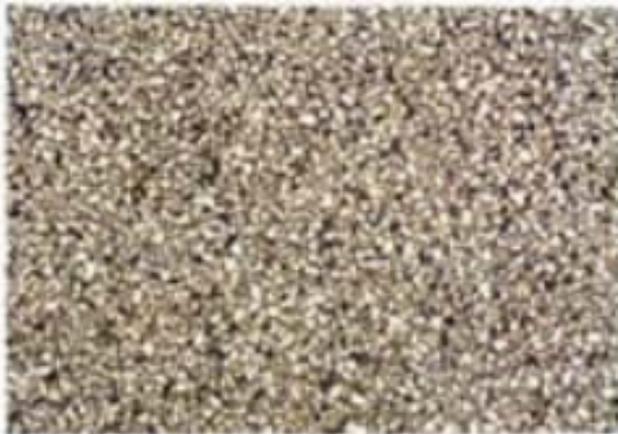
Figure #10
Visible Ground
Rubber

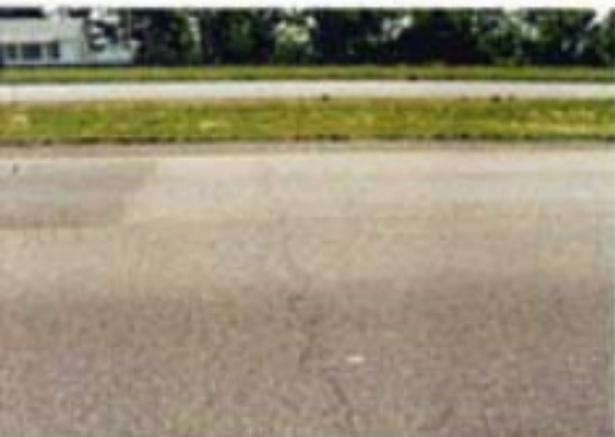
The ARC section in the westbound lane exhibited low severity reflective transverse cracks at every joint and no longitudinal cracks were visible, as can be seen in Figure #11.

Figure #11
Typical Photograph
of ARC in Westbound
lane

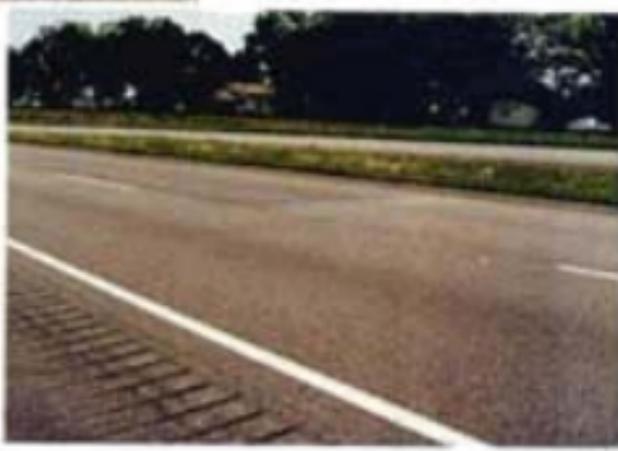
Figure #12, shows the transition from the RMAC into the ARC section in the westbound lane. Figure #13, a close-up photograph shows a transverse reflective crack in the ARC that stops once it reaches the RMAC.

Figure # 12
Transition of RMAC
into ARC in Westbound
Lane

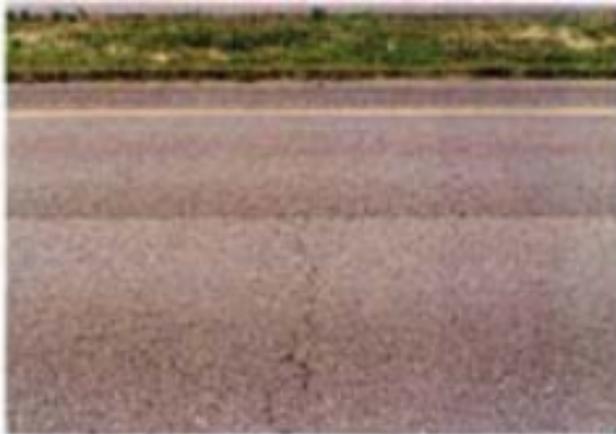
Figure #13
Close-up Photograph of
Reflective Crack in ARC
That Stops at the RMAC

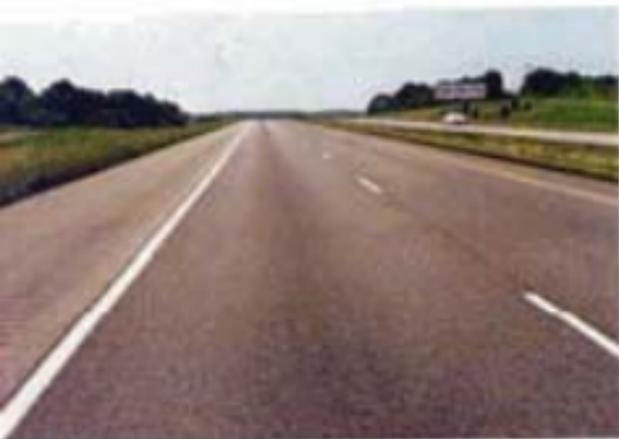
The RMAC section in the eastbound lane is similar to the RMAC section in the westbound lane. Few low severity reflective cracks and no longitudinal cracks were visible, as can be seen in Figure #14. Fatty spots appear in the mat, as can be seen in Figure #15. There were a couple of areas that exhibited Potholes which are believed to be caused by subgrade failure, as can be seen in Figure #16 and Figure #17. Also reflective cracks were visible at Log Mile (LM) 30.25. There were two reflective transverse cracks of moderate severity, as can be seen in Figure #18, and one rated low severity.

Figure #14
Typical Photograph
of RMAC in the
Westbound Lane

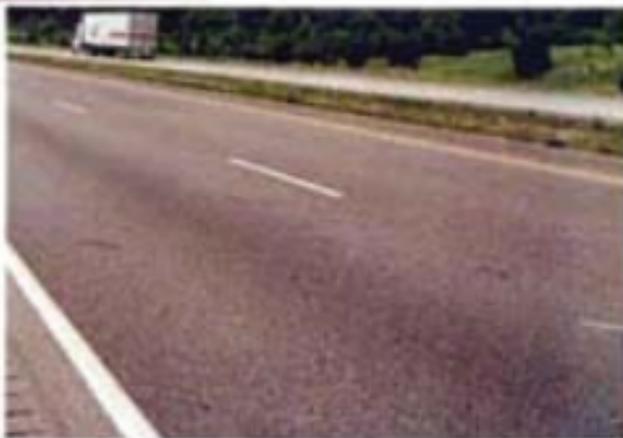
Figure #15
Fatty Spots in
EMAC, Westbound
Lane

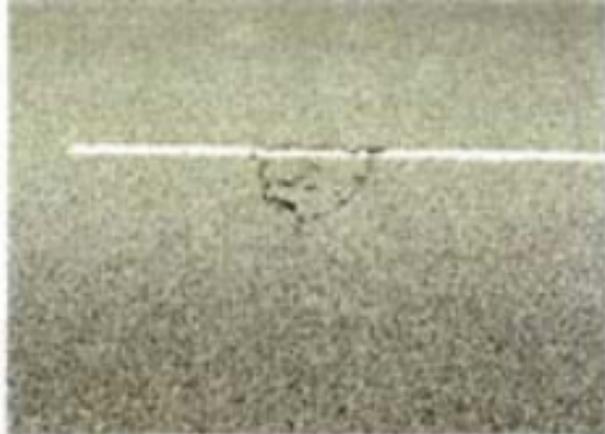
Figure #16
Pothole in RMAC
Westbound Lane

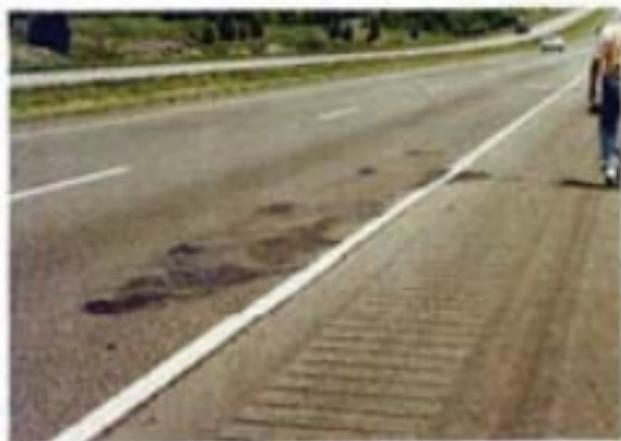
Figure #17
Pothole in RMAC
Westbound Lane

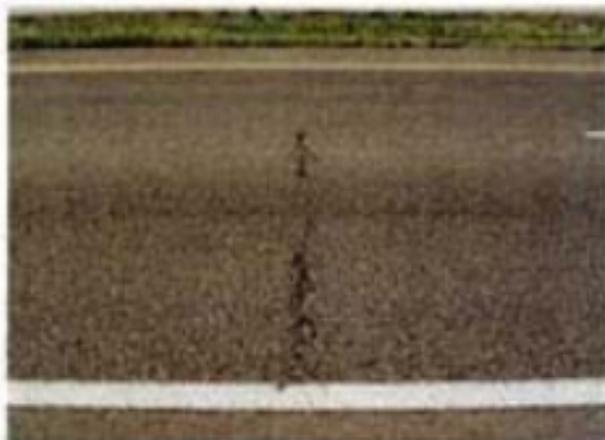
Figure #18
Moderate Severity
Reflective Transverse
Crack in RMAC
Westbound Lane
