MoDOT

RDT 04-018

Evaluation of Cutco Sawing and Sealing Method

RI 00-030

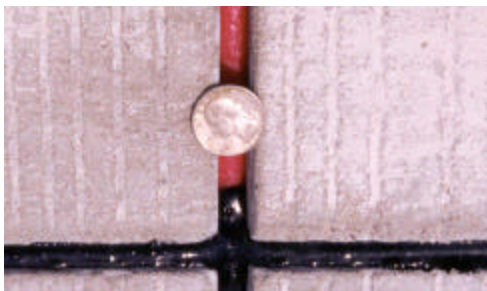
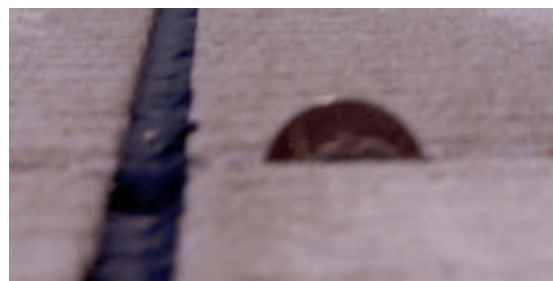
In the early stages of placing the foam backer rod on RT 71 bypass in Newton County, it was determined that the backer rod was not pliable toward the end of the spool. The foam material would not straighten out, it tended to curl and conform to the shape of the spool it came off of. Changing suppliers of the foam backer rod, which met the approval criteria, solved this problem. Placement of the joints sealant application presented no problems. Sealant installation was normal and the only problem that occurred was equipment breakdown, which was taken care of by the contractor on the job site with little or no loss of time (See Figure 9 and 10 for cut and seal dimensions by Cutco).

Figure 9. Joint Filler Installed in Longitudinal Joint Figure 10. Quarter Showing Depth of Backer Rod Before Sealing

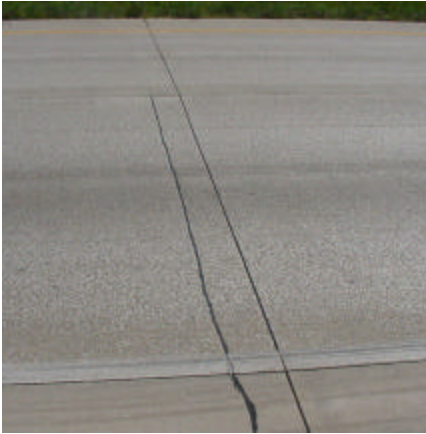
Station 150+00 to 160+00: Station 160 is at the east end of the section. There is one repaired area at mile marker 94 (see Figure 11 below.) Repaired crack is parallel to and about ten inches from the joint. The cause of this cracking is unknown. All of the joints look good.

Figure 11. Crack at Mile Marker 94, RT 44

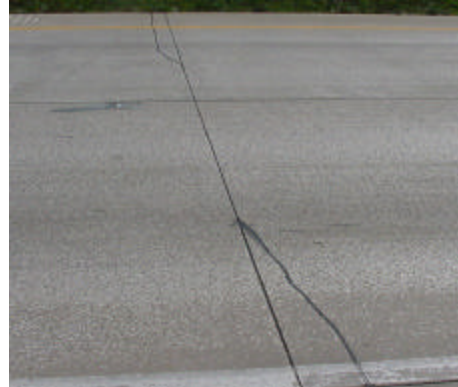
Figure 12. Cracks at Station 74 + 00, RT 44

Station 70+00 to 80+00: Test area is between mile Marker 92 and 93. All of the joints in the section look good with the following exceptions. One joint has two cracks emanating from it (see Figure 12 above). The joint with the two cracks is located just east of station 74 + 00 across from the cell phone tower. Another joint, (one joint west of station 72 + 00), has damage at one corner where the longitudinal joint meets the transverse joint (see Figure 13 below).

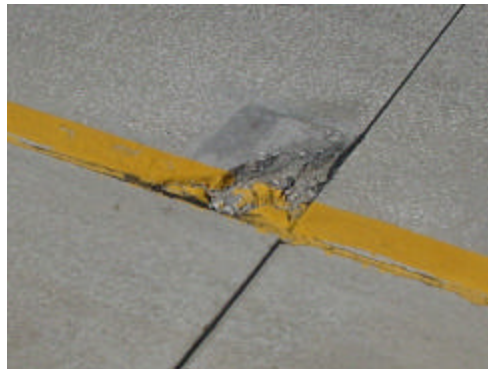
Figure 13. Damage at edge joint intersection at Station 72 + 00, RT 44

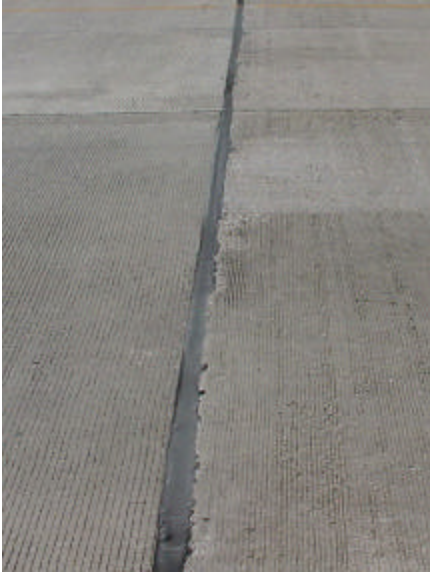
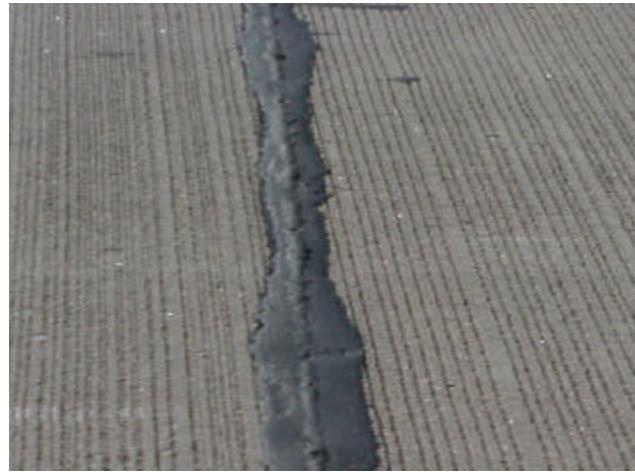
The conventional type joints in northbound lanes are also in excellent condition, with only occasional weed growth between concrete and seal material at the edges of the roadway. Since this is a normal occurrence, and both types of joint exhibit a similar amount of plant growth, it appears that the sealing quality of the two types of joint seal is of equal worth. While the Cutco joint sealing method is more aesthetically pleasing due to its clean appearance (see Figure 13 below), the conventional method seems to perform as well. A conventional joint is generally wider and the sealing material applied in a less clean appearing manner (see joints on Figure 15, 16 and 17). Observing the following joint photographs you can tell the aesthetic difference between the two styles of joint seal.

Figure 15. Conventional Joint Seal Method, RT 71
