Installation and Initial Performance of 60" ADS N-12HC® HDPE Pipes

**Research
Development
and Technology**

Missouri
Department
of Transportation

Current Research Results

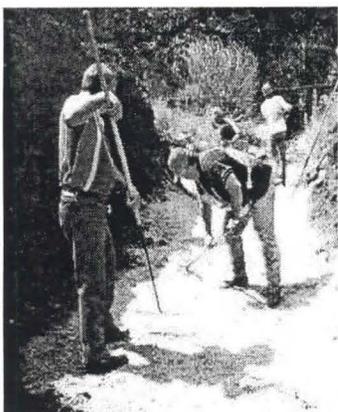
RDT personnel observed both installations. Since the installations, pipe deflections have been monitored. Based on field observations and data analysis, this study concludes that Pipe 2 is performing better than Pipe 1. The most distinguishable factor, which may contribute to this performance difference, is the different compactions these two pipes experienced during the installations. Pipe 2 had much better compaction than Pipe 1 both in bedding and backfilling procedures.

Figure 2.
Pipe 1 Bedding Compaction

Both pipes should be inspected yearly to monitor their performances and be documented accordingly. Any immediate repairs necessary will then be forwarded to the appropriate maintenance personnel. If there are other large size HDPE pipes to be installed in Missouri, this study recommends proper installation procedures be followed.

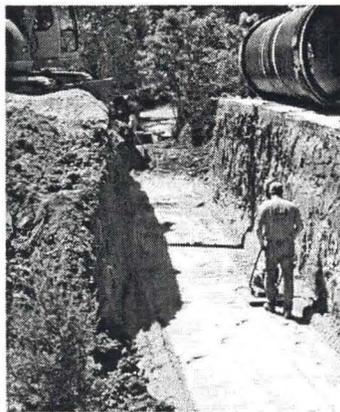
Figure 3.
Pipe 2 Bedding Compaction

Pipe 2 did not get a perfect installation, but it is performing well. The two-week-after-installation deflection was rather small. One year after the installation, the maximum deflection was 5%, and the deflections at other points were considerably lower.
