INTRODUCTION

STATEMENT OF PROBLEM/SCOPE OF WORK

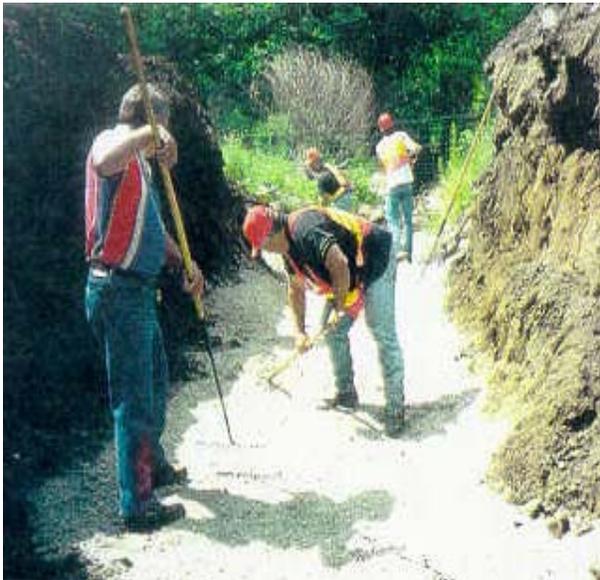
Figure 2. Pipe 1 Bedding Compaction

RDT personnel observed both installations. Since the installations, pipe deflections have been monitored. Based on field observations and data analysis, this study concludes that Pipe 2 is performing better than Pipe 1. The most distinguishable factor, which may contribute to this performance difference, is the different compactions these two pipes experienced during the installations. Pipe 2 had much better compaction than Pipe 1 both in bedding and backfilling procedures.

AASHTO Section 30(Installation) now recommends the deflection be less than 5% of the actual inside diameter 30 days after installation. MoDOT Standard Specifications 730.7 specifies that the internal diameter of the pipe should not be reduced by more than 5% of its base inside diameter when measured not less than 30 days following completion of installation. 42 days after installation Pipe 1 had a maximum deflection of 7.3%, exceeding AASHTO Section 30 recommendations and MoDOT specifications, which is not acceptable. Two years and four months after the installation, the maximum deflection was measured as 8.4%, which is not acceptable, either. Since excessive deflection may lead to pipe cracking, Pipe 1 may require maintenance or replacement sooner than Pipe 2 due to installation procedures, and most likely not due to the actual material or manufacturing of the pipe itself.

Both pipes should be inspected yearly to monitor their performances and be documented accordingly. Any immediate repairs necessary will then be forwarded to the appropriate maintenance personnel. If there are other large size HDPE pipes to be installed in Missouri, this study recommends proper installation procedures be followed.

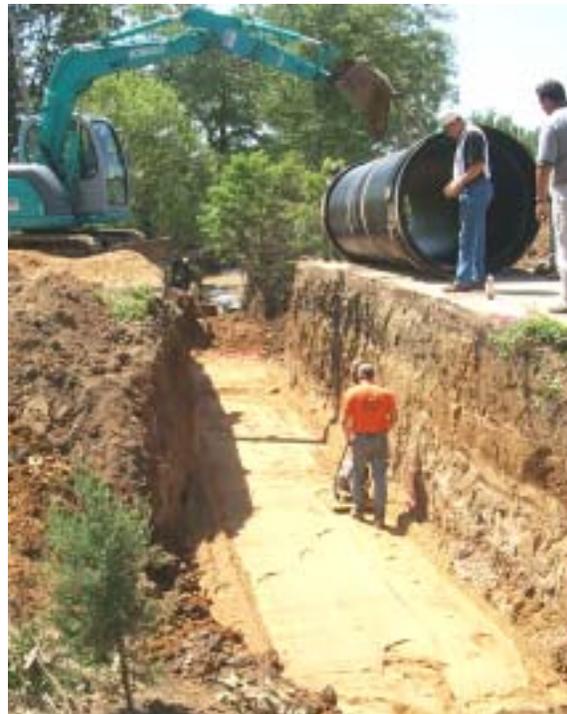
Figure 3. Pipe 2 Bedding Compaction

Pipe 2 did not get a perfect installation, but it is performing well. The two-week-after-installation deflection was rather small. One year after the installation, the maximum deflection was 5%, and the deflections at other points were considerably lower.

Both pipes have joint separations. Pipe 1 had a maximum of 1 3/8" two years after installation, while Pipe 2 had a 2" maximum one year after its installation. But considering the bell overlaps the spigot by 9.57", there may be no threat of leaking. Existence of long-term undermining is not known at this time.
