Bridge Failure Points to Mechanically Frozen Pin

Business Issue

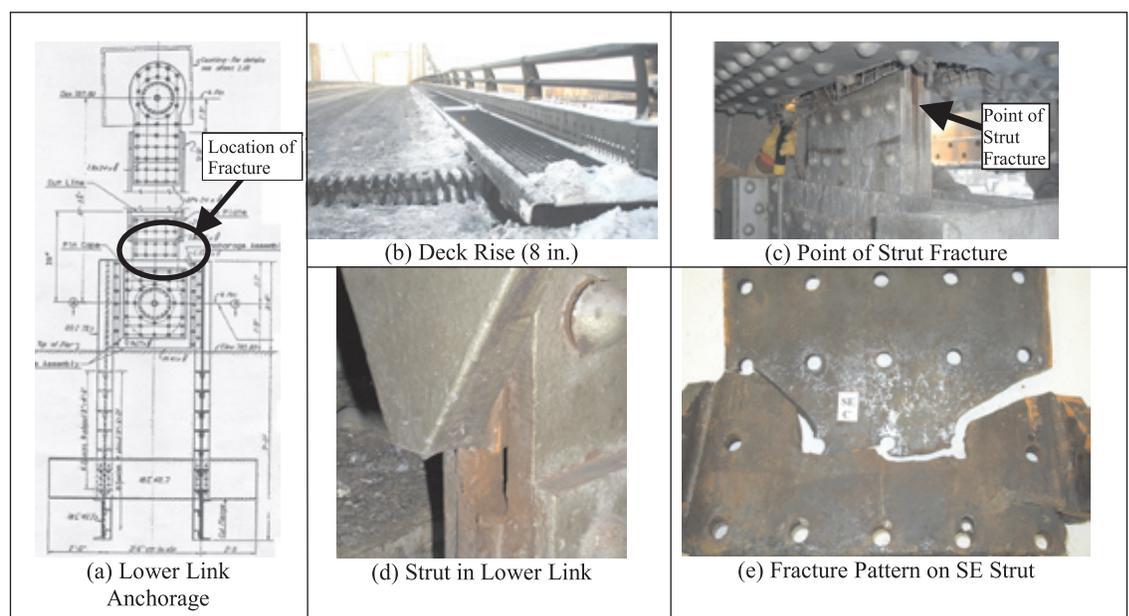
Figure 1. Link Anchorage Details, Fracture Effects and Fracture Details

On January 22, 2003, the Paseo Bridge was closed to traffic when the bridge deck was raised by eight inches as indicated in Fig. 1(b). At the time, temperatures were reported to have hit a record low of -9°F. During inspection the following day, the strut in the southeastern link anchorage assembly was found to be fractured as shown in Fig. 1(c, d, e). Field inspectors found the lower pin in the southeastern hanger was locked up and did not allow for free movement of the superstructure. As a result, the strut was subjected to both tension/compression and bending. Plausible reasons for the strut failure included overstressing, thermal contraction, fatigue, and reduction in fracture toughness associated with low temperatures. MoDOT needed to determine the actual cause and find a way to prevent similar failures in the future.

The Paseo Bridge is a 1,232-foot long, self-anchored suspension structure spanning the Missouri River. Built in 1952, it supports Interstates I-29 and I-35 as well as US Highway 71 with an average daily traffic volume of 89,000 vehicles in 2003. At each end of the bridge, two stiffening girders are tied down to a bridge pier with two vertical hangers. Each hanger consists of a lower link, a strut, and an upper link. The links are connected with the stiffening girder and the bridge pier by two 11-inch diameter pins, as illustrated in Fig. 1(a).

The root cause of the failure was overstressing of the vertical strut due to a locked up pin resulting from a bridge design that did not allow access for maintenance. The mechanical freezing of the lower link pin has been attributed to salt and sand accumulation in the lower link housing, discovered during the bridge inspection two months prior to failure. The overstressing, thermal contraction, fatigue, and reduction in fracture toughness associated with low temperatures were all real conditions, but they would not have caused the failure if the preventative maintenance had been allowed. Several relatively simple recommendations to prevent similar incidences to other bridges and the new struts installed on the Paseo Bridge include:

- Greasing the upper and lower pins during special pin inspections and maintenances to ensure continued free rotation of the struts. This would have prevented the freezing and allows for the free rotation. It is recognized that the design of the bridge had limited access to the lower link pin housing. Therefore, although the two cycles of inspection are adequate, special pin maintenance may be done over a longer time period such as every ten years.

- Partially sealing the lower housings to prevent salt and sand accumulation near the pins or using traps under the finger expansion joints to stop salt and sand debris from dropping to the lower link housing.

- Installing a problem alarm device at a cost of less than \$10,000 to remotely monitor the rotation of all four vertical struts and immediately alert officials should the pins become mechanically frozen. In light of the limited access to the lower link area, greasing pins could be costly, and this recommendation may be a practical solution in some situations.

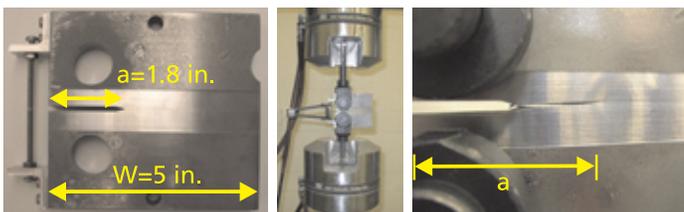
Figure 2. Crack Growth Test: Compact Tension Specimen, Set-up and Crack Growth

The fatigue constants necessary for the residual life prediction after 50 years of service have been determined with testing of 25 specimens. Fatigue tests on the failed strut material indicated an infinite life under normal service conditions when the strut were free to rotate, had no initial defects, or small cracks inherent to steel structures. However, initial defects often exist in steel members, especially around the coped flange of the fractured strut. Therefore, five compact tension specimens were tested as shown in Fig.2 to establish the Paris crack growth law. It was determined from the crack growth law that nearly 1,000,000 cycles (approximately 12 years) of 100% design loading or over 2,500,000 cycles of 50% design loading are required for an initial defect of 0.005 inches in the strut to propagate

to a critical length (over 1.3 or 2.4 inches) causing sudden fracture under normal loading conditions if the pin were free to rotate. Since no visual cracks were recorded during the inspection two months prior to the failure, crack propagation was unlikely the reason for the failure. On the other hand, sudden fracture occurred as a result of the mechanically frozen pin condition at the lower link of the southeastern strut due to substantially increased bending stress as previously mentioned.

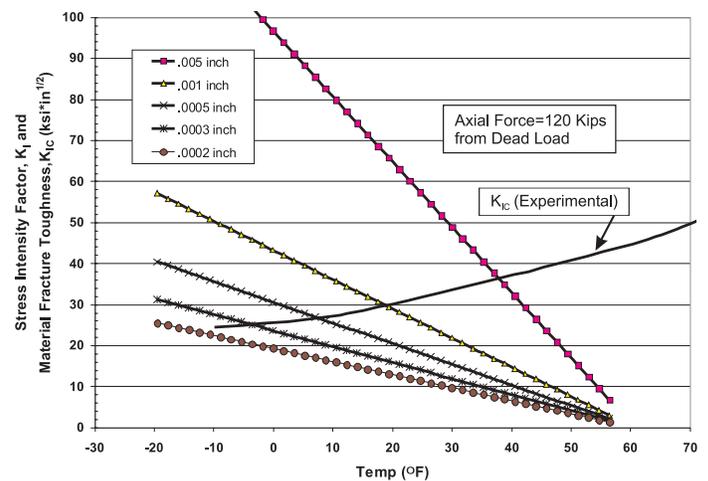
Figure 3. Prediction Chart for Fracture of the Southeastern Strut

To investigate the effect of temperature on the strut failure, Charpy impact testing of 45 specimens was conducted at nine temperatures so that the critical flaw size at the design stress can be determined as a function of the operating temperature from -10° to 136°F. The breaking energy of various specimens was related to the temperatures to which the specimens are exposed. The fracture toughness was then converted from the breaking energy with an empirical relation. It ranges from 24 to 110 ksi*in^{1/2}, as shown in part in Fig. 3 for K_{IC} .

When the fractured strut is simplified into an edge cracked plate subjected to tension and bending, the load-temperature relation established before can be transformed into the relation between the (elastic) stress intensity factor, K_I , and the temperature. The results are presented in Fig. 3 corresponding to each initial flaw size from 0.0002 to 0.005 inches. At a temperature of -10 °F, the strut may fracture suddenly since K_I is larger than K_{IC} when an initial flaw between 0.0002 and 0.0003 inches is present. It must be noted that, on one hand, the conversion equations from the load to the stress intensity factor are a non-conservative estimate to the actual condition. On the other hand, consideration of plasticity around the root of a notch in actual conditions will reduce the stress intensity factors. Therefore, numerical simulations with computer

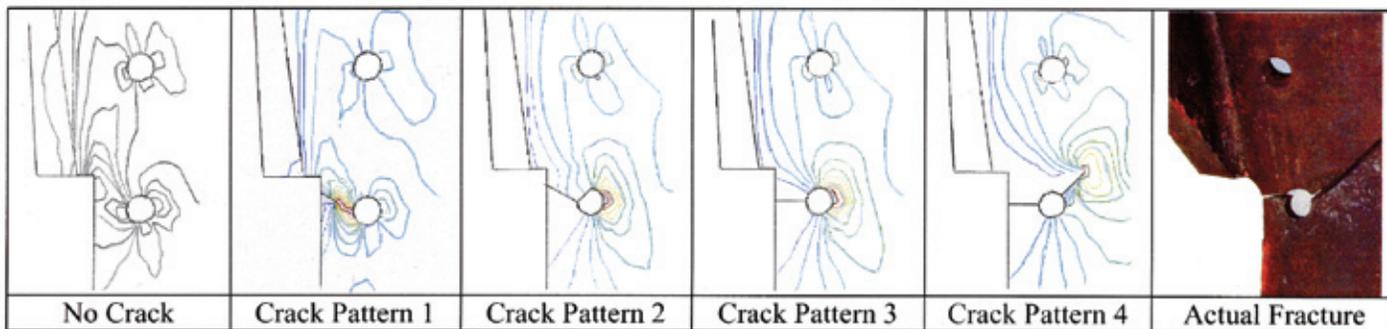
Figure 4. Stress Contours for Crack Initiation Location Determination

a series of local models with various initial crack lengths were established. Each model was analyzed for the same load case. When there are no crack and cracks of various sizes (Crack Pattern 1 through 4), the stress contours are shown in Fig. 4. It is observed from Fig. 4 that crack is likely initiated near the flange coping area due to high stress concentration and propagated towards the closest hole. To further see the propagation of an initial crack, two additional models with a crack length of 0.5 in. for Crack Pattern 1 and 1.1 in. for Crack Pattern 2, respectively, were analyzed. As a result of the previous cracks, the maximum stress occurs in the opposite side of the hole near the flange coping area. To understand how sensitive the location of the maximum stress, the third crack pattern was introduced. By comparing Crack Pattern 2 and Pattern 3, one can see that the locations of the maximum stress identified from the two models are practically the same. To finish up the analysis for crack propagation, the fourth crack pattern was created. By comparing Crack Pattern 4 with the actual fracture pattern, also shown in Fig. 4, it is observed that the models accurately predict the crack initiation and propagation locations of the actual damage pattern.
