Investigations of Failures of Epoxy Polymer Overlays in Missouri

Prepared by
Missouri Department
of Transportation

RI06-020

November 2007

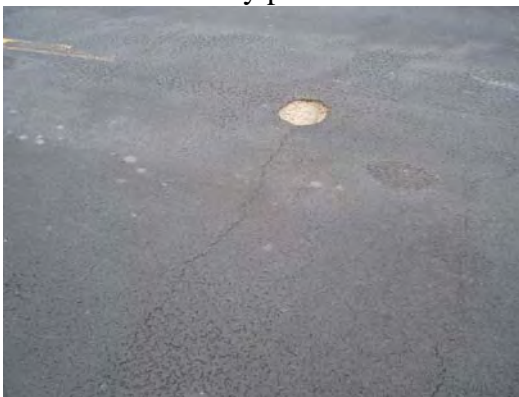
Cracking

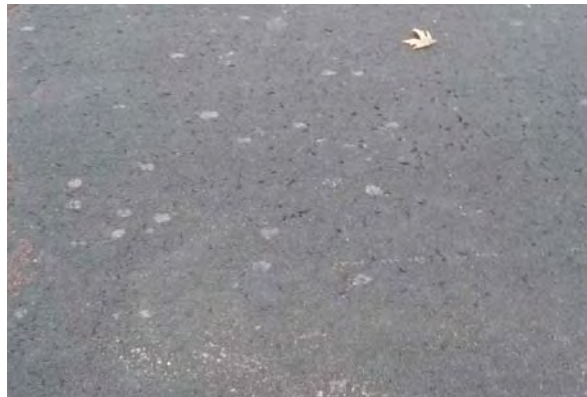
Pitting

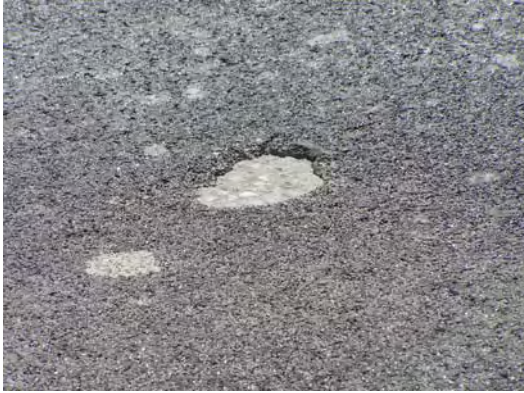
Delamination

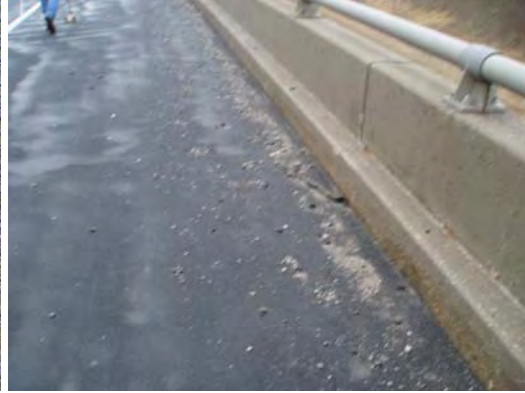
Peeling

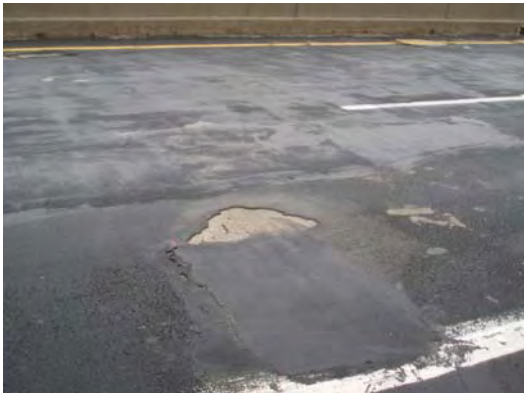
Missing areas of epoxy

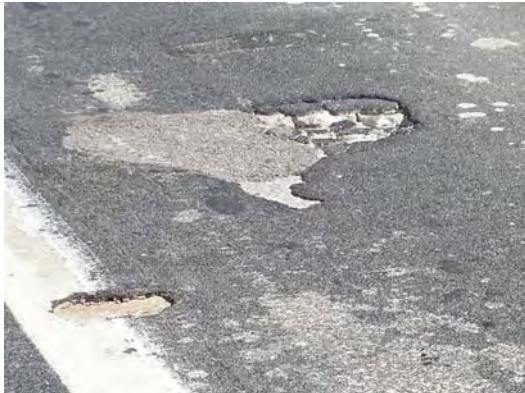
Sunken/cracked areas

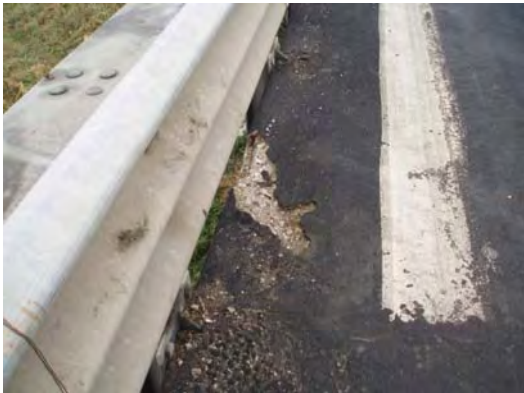
Spalling/loose areas

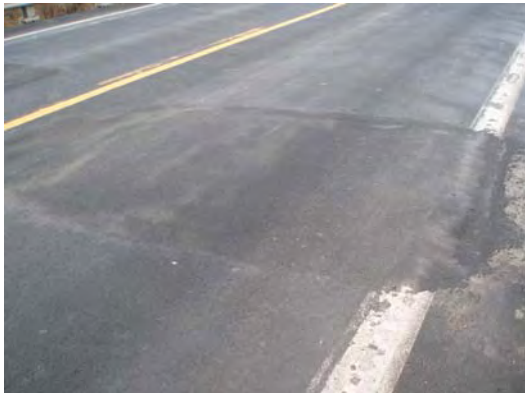
Post overlay Patches

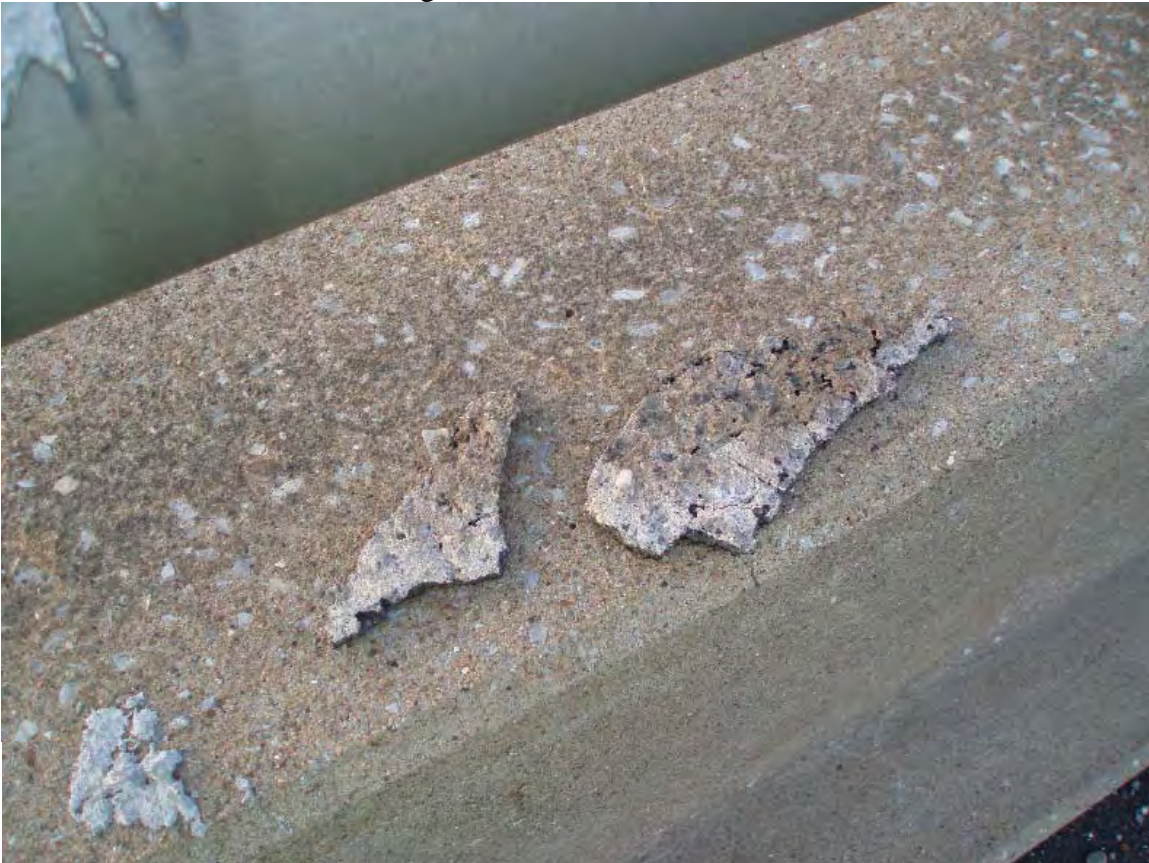
Epoxy polymer overlays are not a “repair” for bridge decks. They are only a means of protecting a deck that is in fairly good condition but is at risk for chloride and water penetration. Once a bridge deck has defects over a significant surface area, an EPO will not provide long lasting protection for the bridge deck and can even hamper repair efforts in the future. MoDOT’s Bridge Division generally recommends placing EPOs on bridge decks that are rated a 7 or higher and have less than 5% of the deck requiring repairs. Information gathered during the investigation indicated that many of the bridges that received overlays had significantly more than 5% defects. Many of the failures observed in the site visits appeared to be a failure of the top surface of the deck as opposed to a failure of the epoxy. Where possible, epoxy that had separated from the deck was examined. In most cases there was a layer of concrete paste on the bottom surface of the epoxy indicating that the epoxy had not debonded from the deck, but that the top surface of deck had delaminated. See Figure 1.

Figure 1. Epoxy Polymer Overlay that has concrete paste attached to the bottom

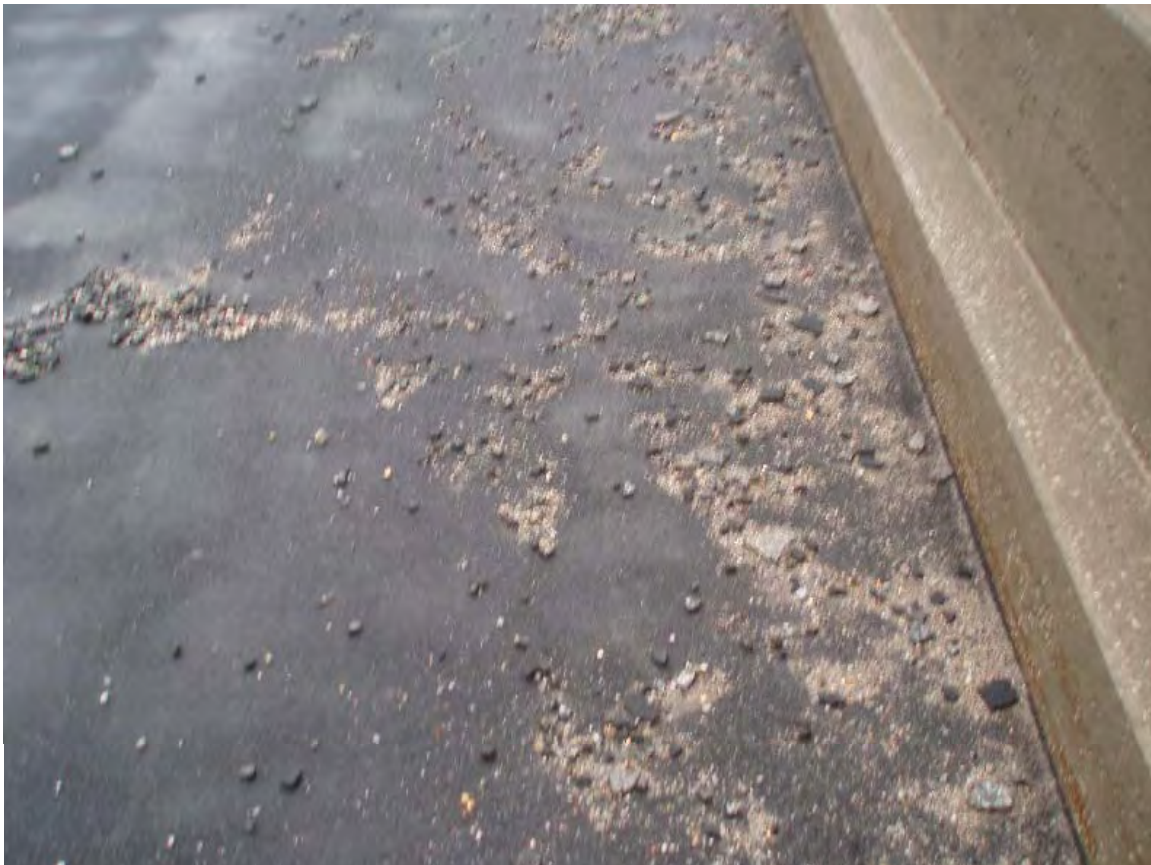
EPOs are initially hydrophobic and should not be exposed to water until they have fully cured. MoDOT’s specs require that the deck is dry and that rain is not in the forecast for 24 hours after placement. However there are some misconceptions about this requirement. Field logs have shown that some contractors consider the deck satisfactory as long as there is not standing water on the deck. One of the approved products is Sikadur 22, Lo-Mod. On the data sheet for the product it refers to a damp deck as being acceptable. However further in the data sheet, the limitations state that for “porous substrates” i.e., concrete bridge decks, the surface must be free of moisture. Inspectors must be aware that the deck must be free of moisture in order to get a good bond between the epoxy and the bridge deck. The Michigan DOT requires a moisture test, ASTM D 4263 “Standard Test Method for Indicating Moisture in Concrete by the Plastic Sheet Method.” This test is simple to perform. It involves taping a polyethylene sheet to the bridge deck for a period of time and then visually inspecting the underside of the sheet and the concrete surface for the presence of water. The ASTM standard requires leaving the plastic sheet in place for 16 hours, however Michigan specs require a minimum of two hours. It is highly recommended that this test be included in the MoDOT specifications to verify that the deck is completely dry. The presence of water in the deck will prevent an adequate bond between the concrete and EPO. This could be behind some of the failures on I-29 in District 1. Unlike many of the failures observed, in this area the epoxy appeared to “flake” off the bridge deck. See Figure 2.

Figure 2. Epoxy “flaking” off the bridge deck
