Macon and Adair County, Route 63, Job J2P0485

Route 63, Howell Co., project J9P0497, HDPE double wall storm sewer, W. Side Rt.63

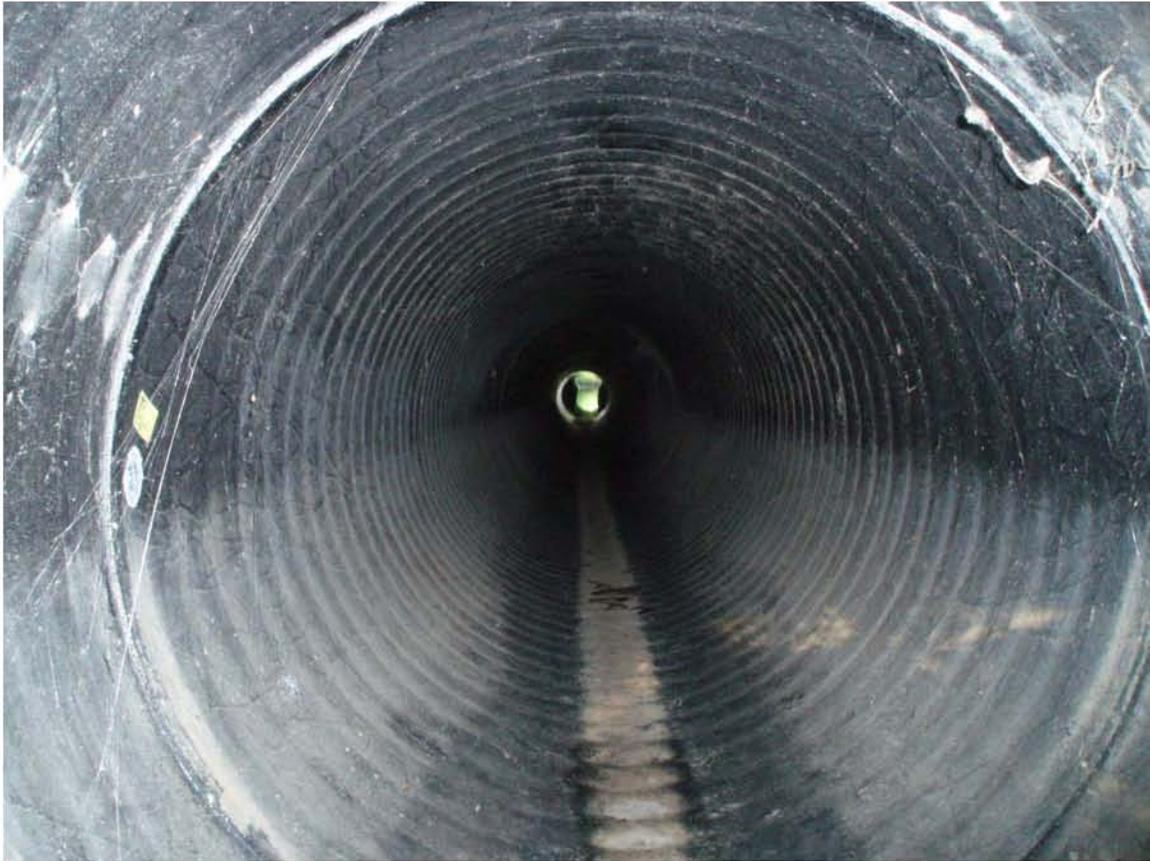
7-30-07, s-210, 30", 2038+00, OF FLE Separation 1.5" at bottom!

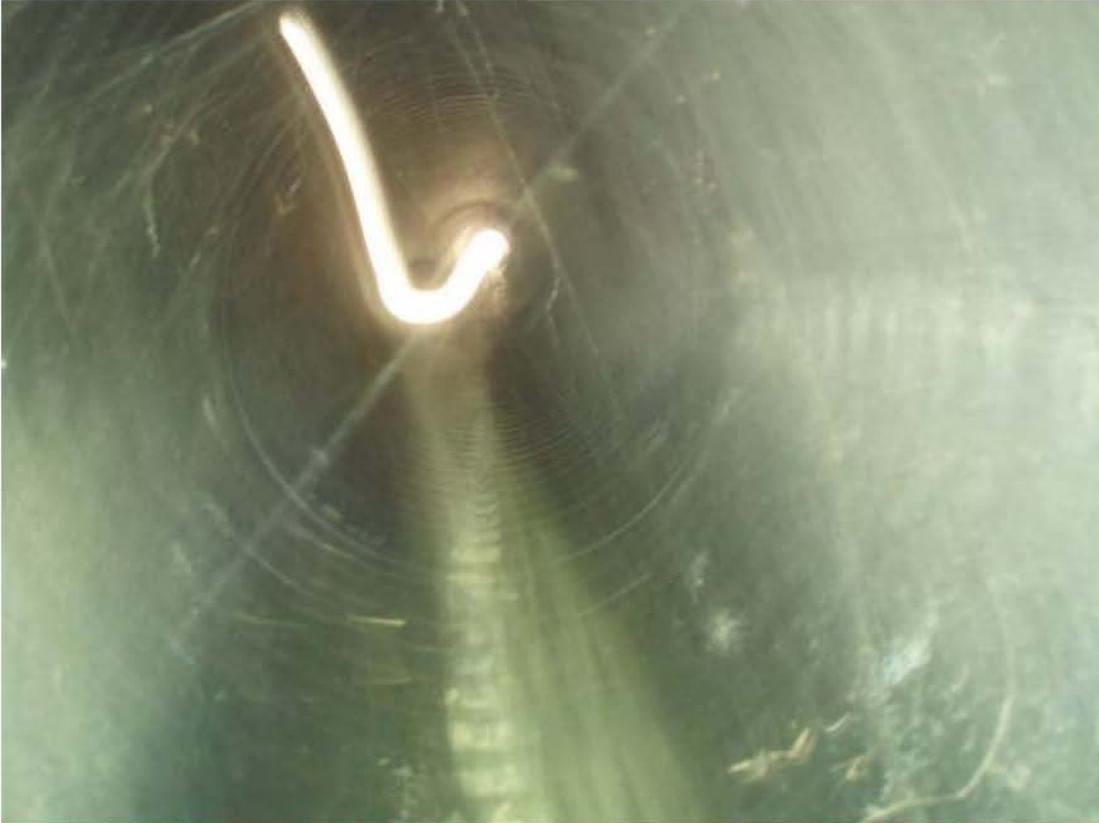
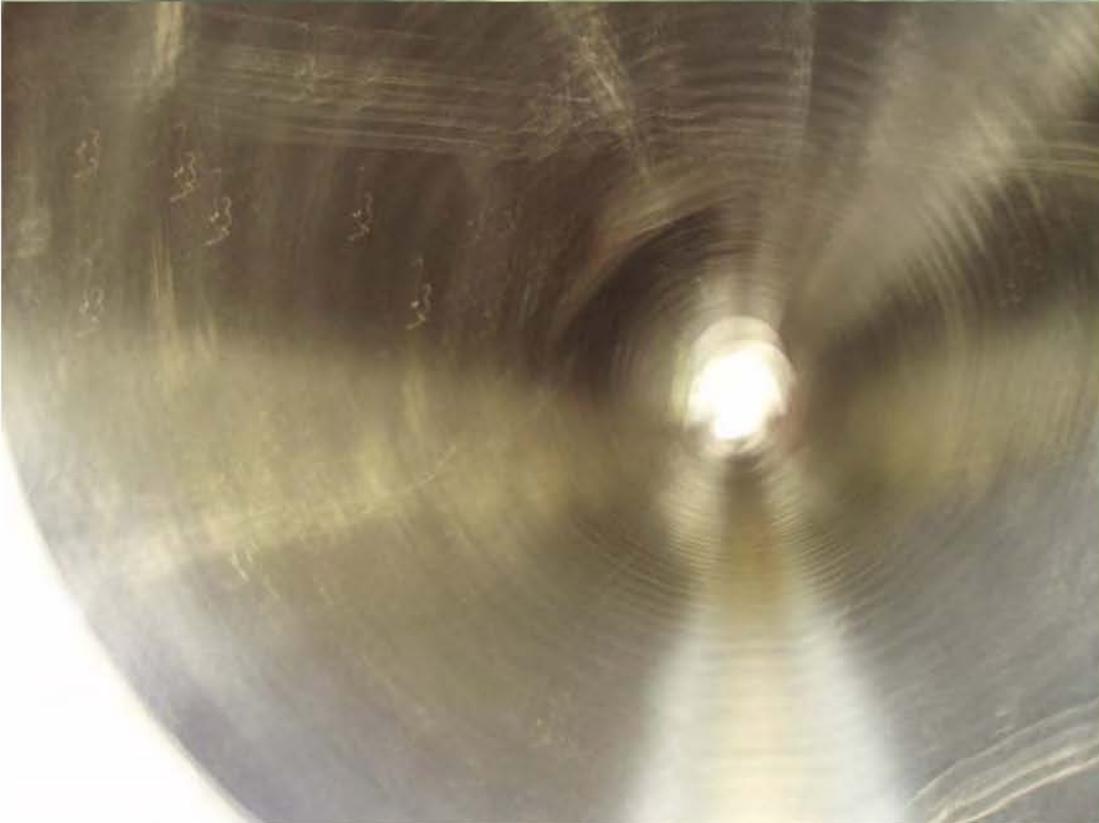
7-31-07, s-158, 30", 1746+00, Inlet 1" Gap at Bottom, joint with FE section.

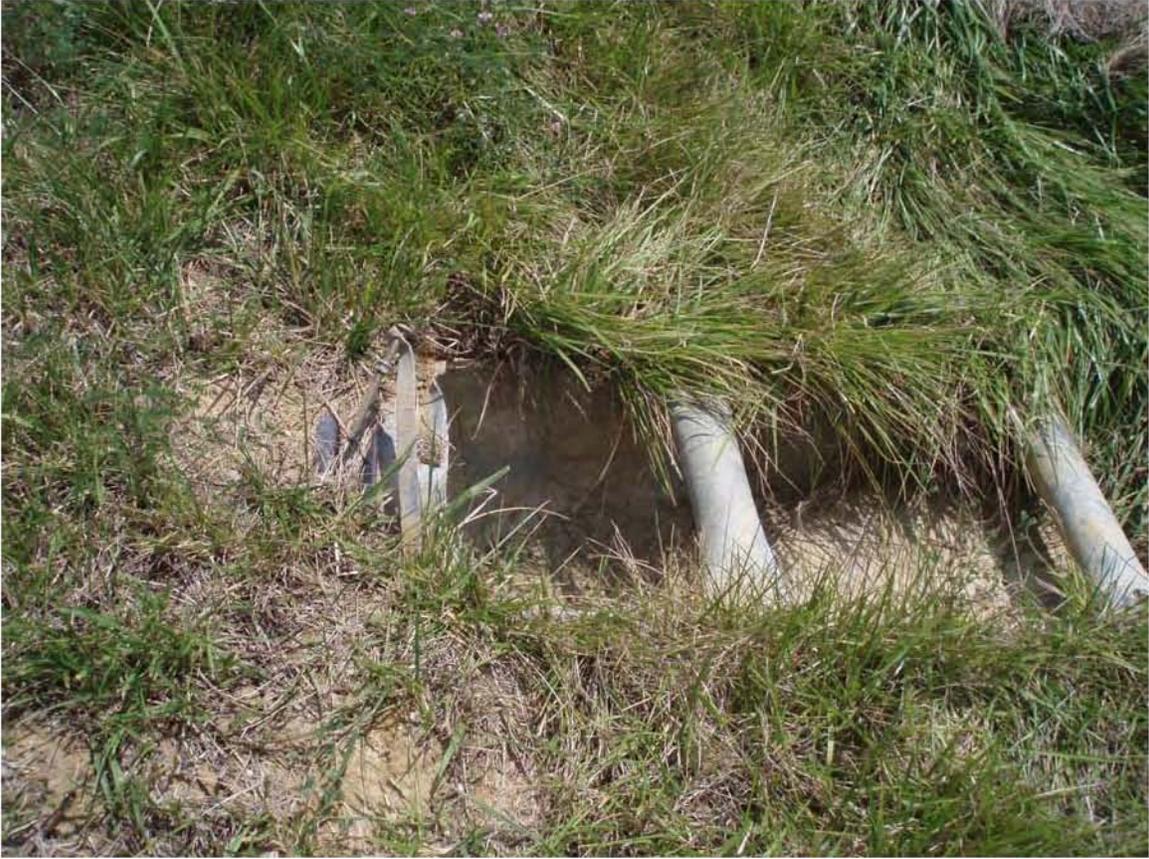
7-31-07, s-157, 18", 1739+00, Inlet, Band Broken on plastic FE section, Pipe Good

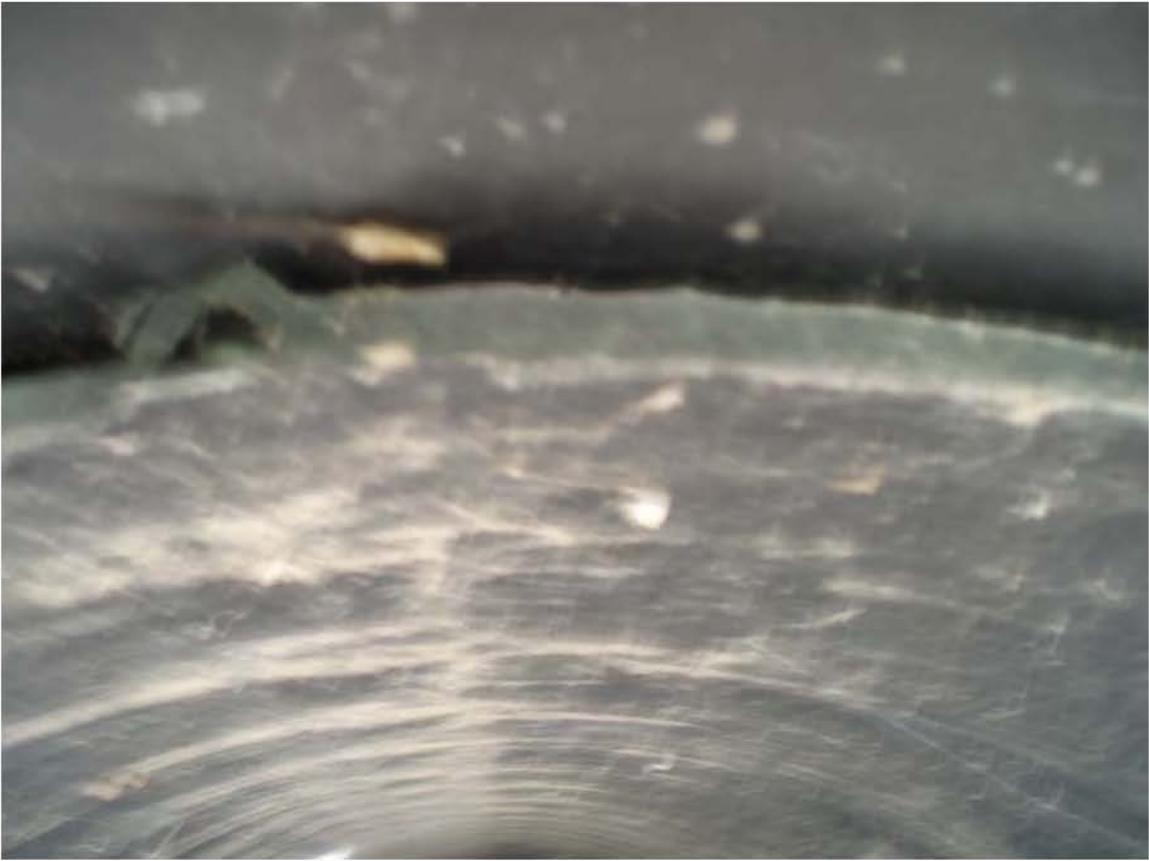
8-1-07, p-129, 30", 1581+29, End flare joint misalignment,

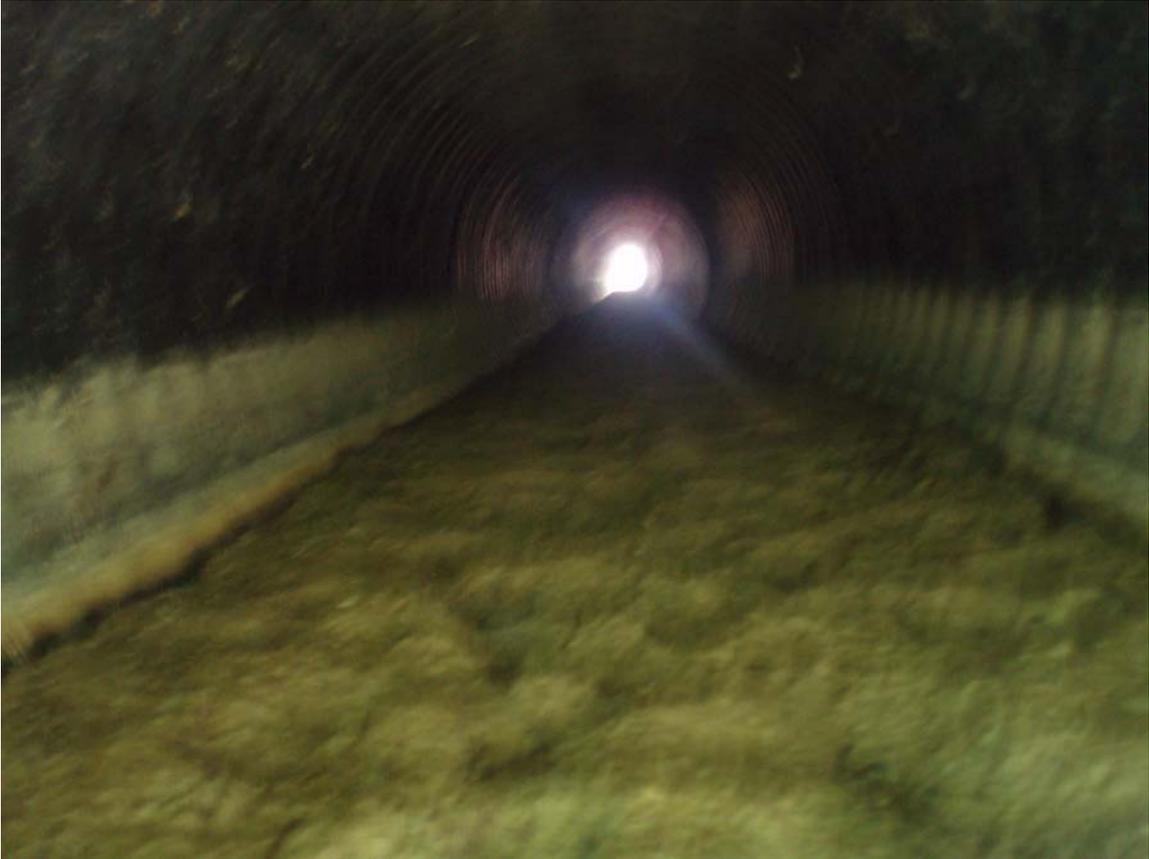
8-1-07, p-094, 24", 1404+94, outlet mower damage,

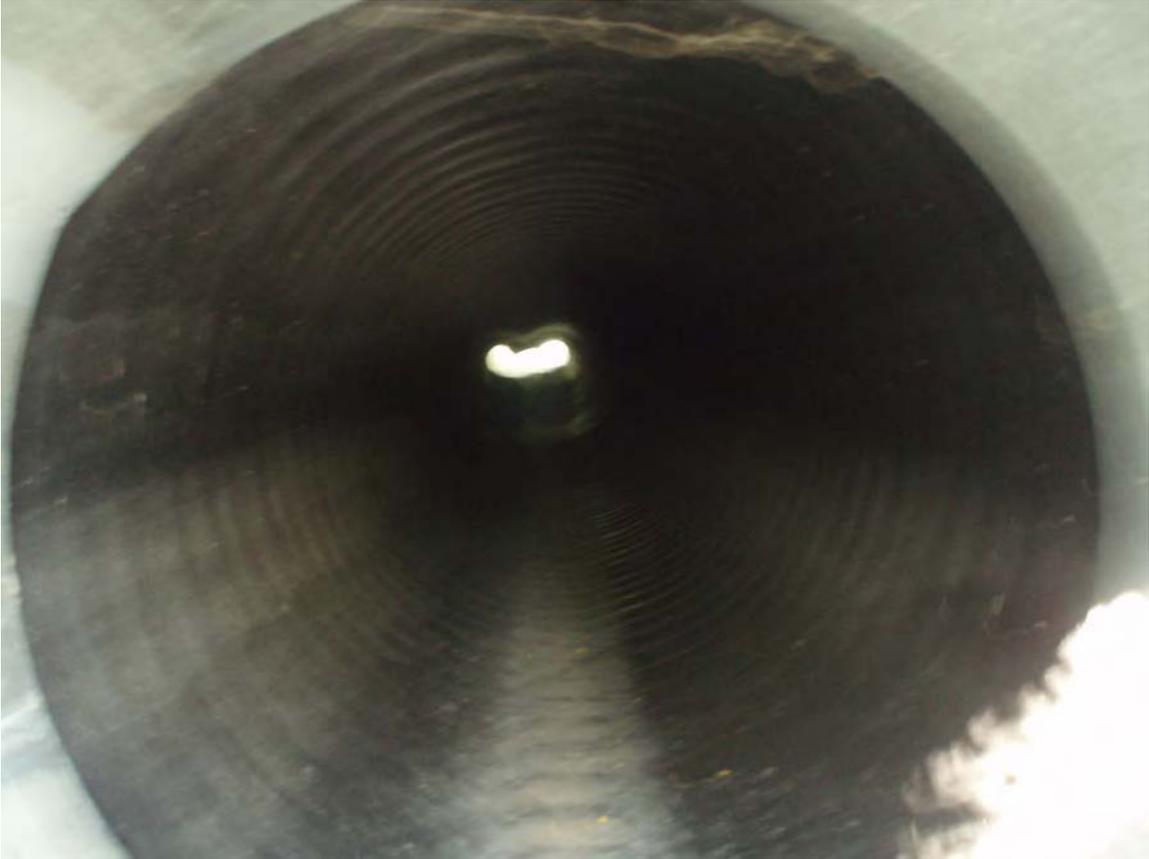
8-2-07, s-038, 42", 1122+03, 12" vert. Crack covered 1 to 3 o'clock at end of pipe , calibrated stick through – deflection , 5%.

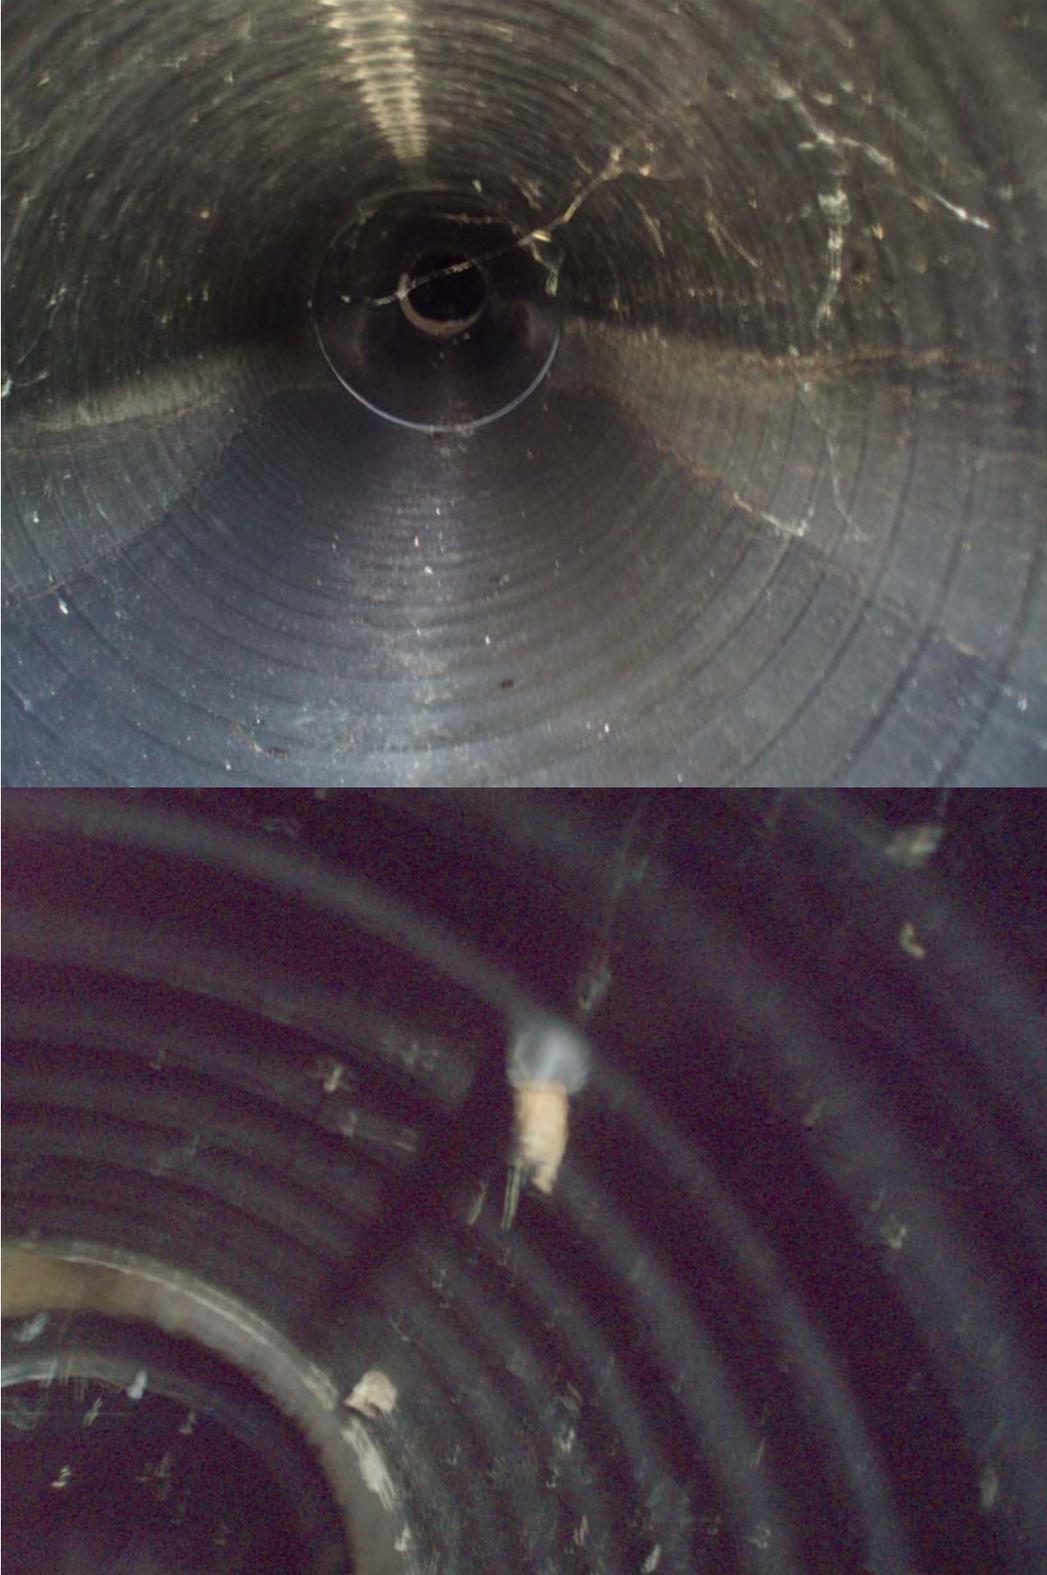
8-6-07, 24" DWP (21" RCP on plans), radius under curb at SW quadrant of Rt. CC & Rt. 63 intersection. Note: rebar (possibly from forming curb above) coming through top of pipe.

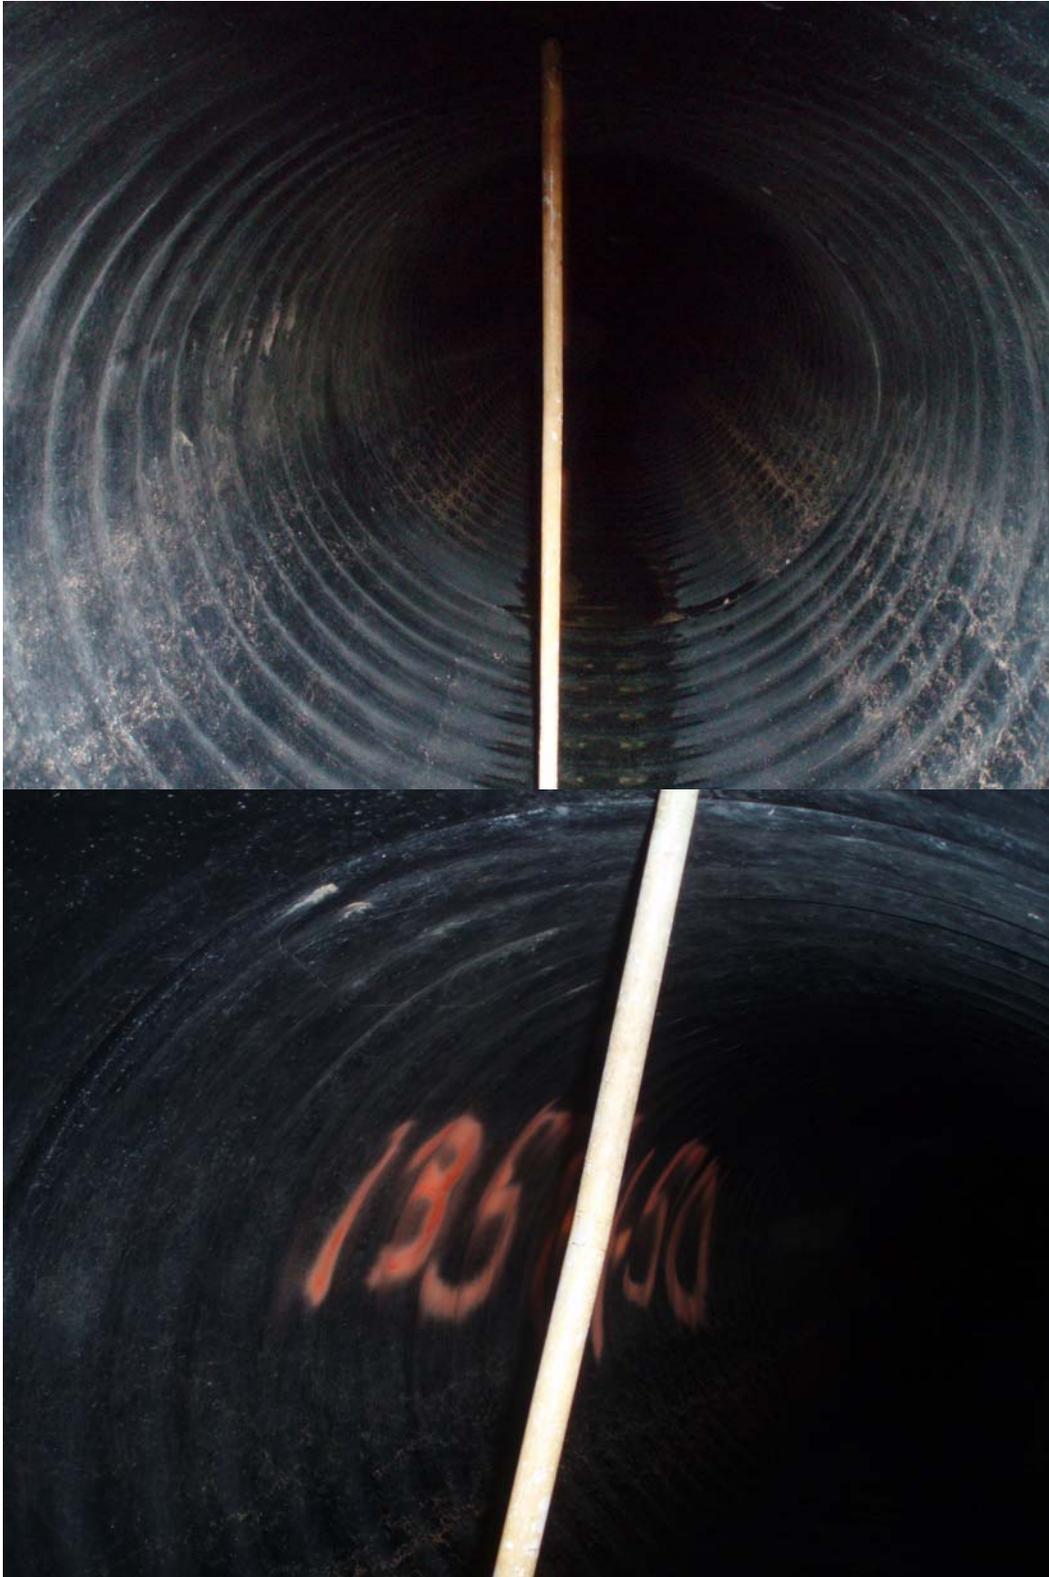
8-7-07, 48", Sta.1363+58 to 1348+00; just at 5% deflection in top photo at approx. Sta. 1360+50, 1" more than 5% (7.5%  $\pm$ ) at bottom @ Sta. 1361+30. NOTE: each 20' stick of pipe at >5% deflection to Sta. 1356+03, 400'+ of pipe out of specs.

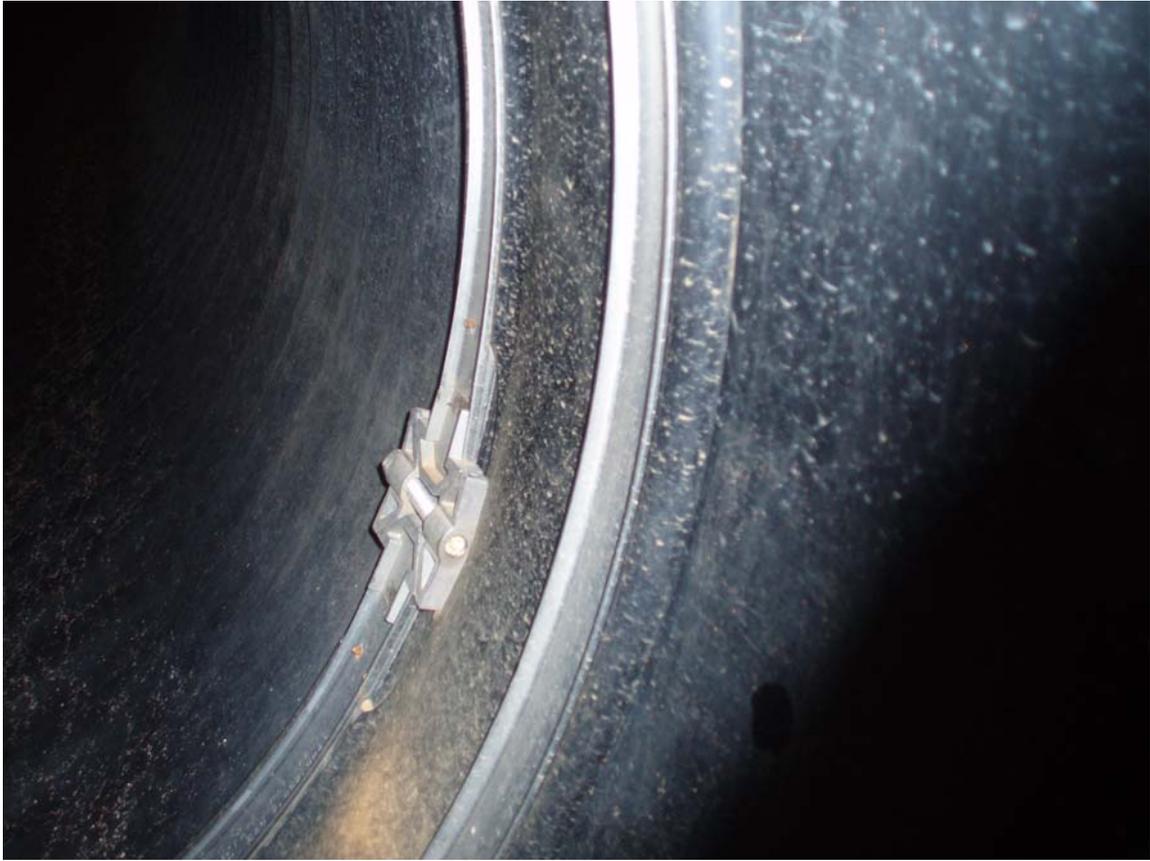
8-7-07, 48", Approx. Sta. 1358+50, repair of transverse cracks made at three locations in 2005 using rubber gaskets and couplers. Rubber gaskets and couplers holding well in 2007. Note: Was some concern there might be water trapped under repair at invert, not shown.

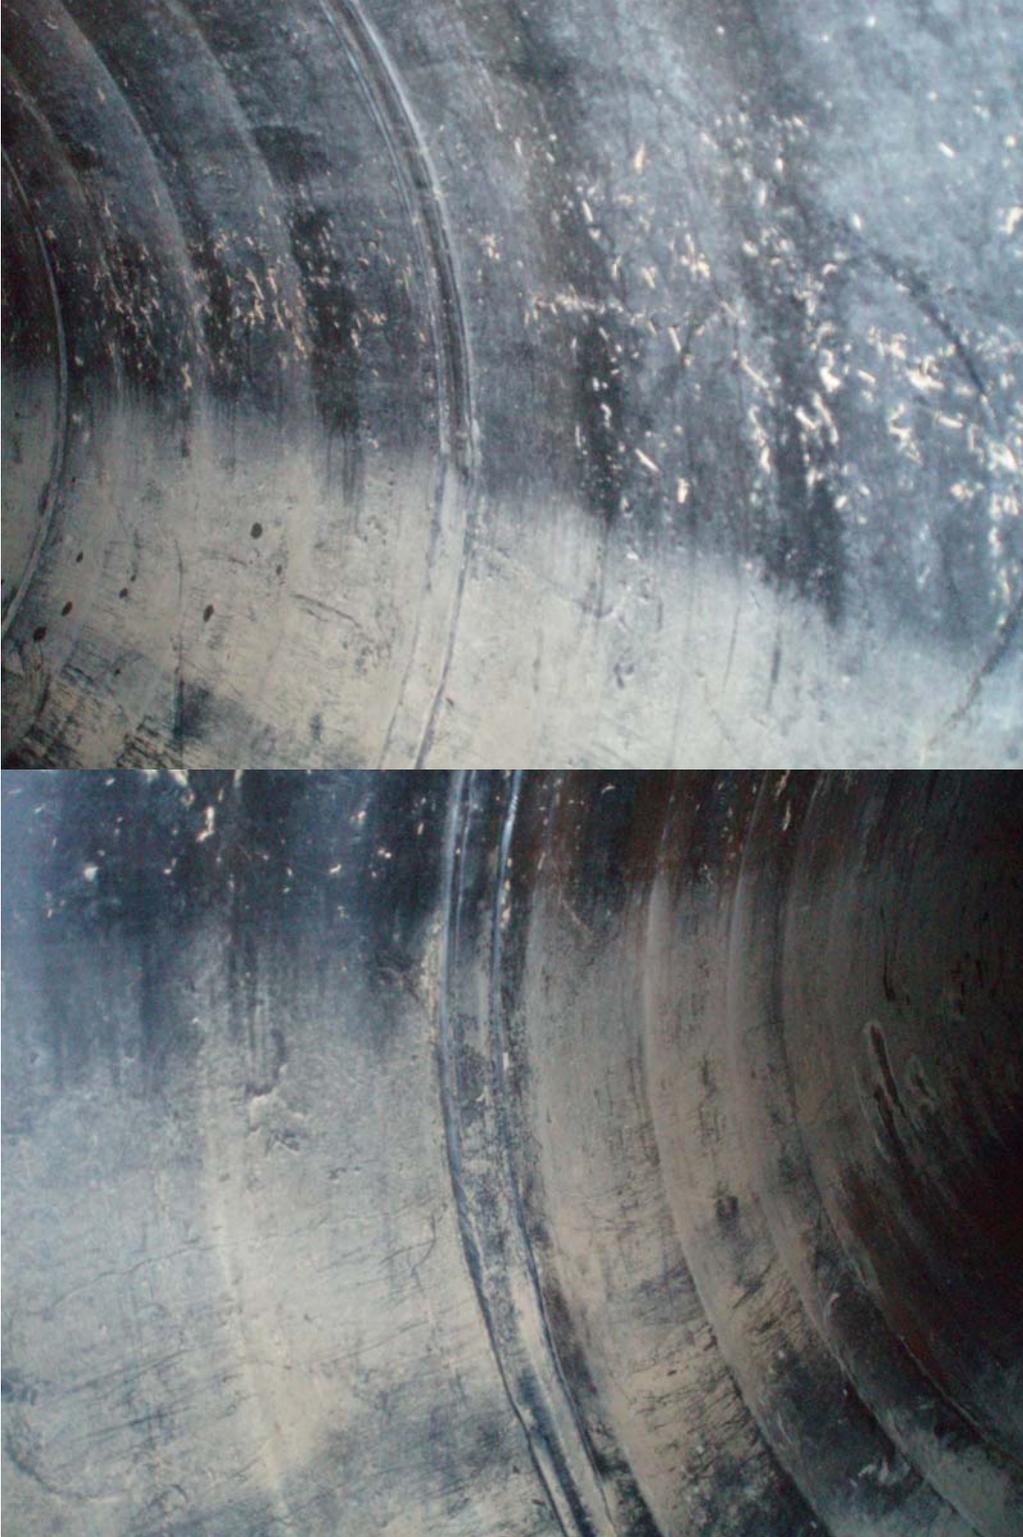
8-7-07, 36", NB & EB, Sta. 1340+48.45 to 4+31.81 Broadway St., ADS rep. & MoDOT technician both crawled through whole 444' run to look at 175' Radius section. Bottom 3 photos show welds on HDPE for 6 - 12° bends plus split couplings used. Everything still looks good.

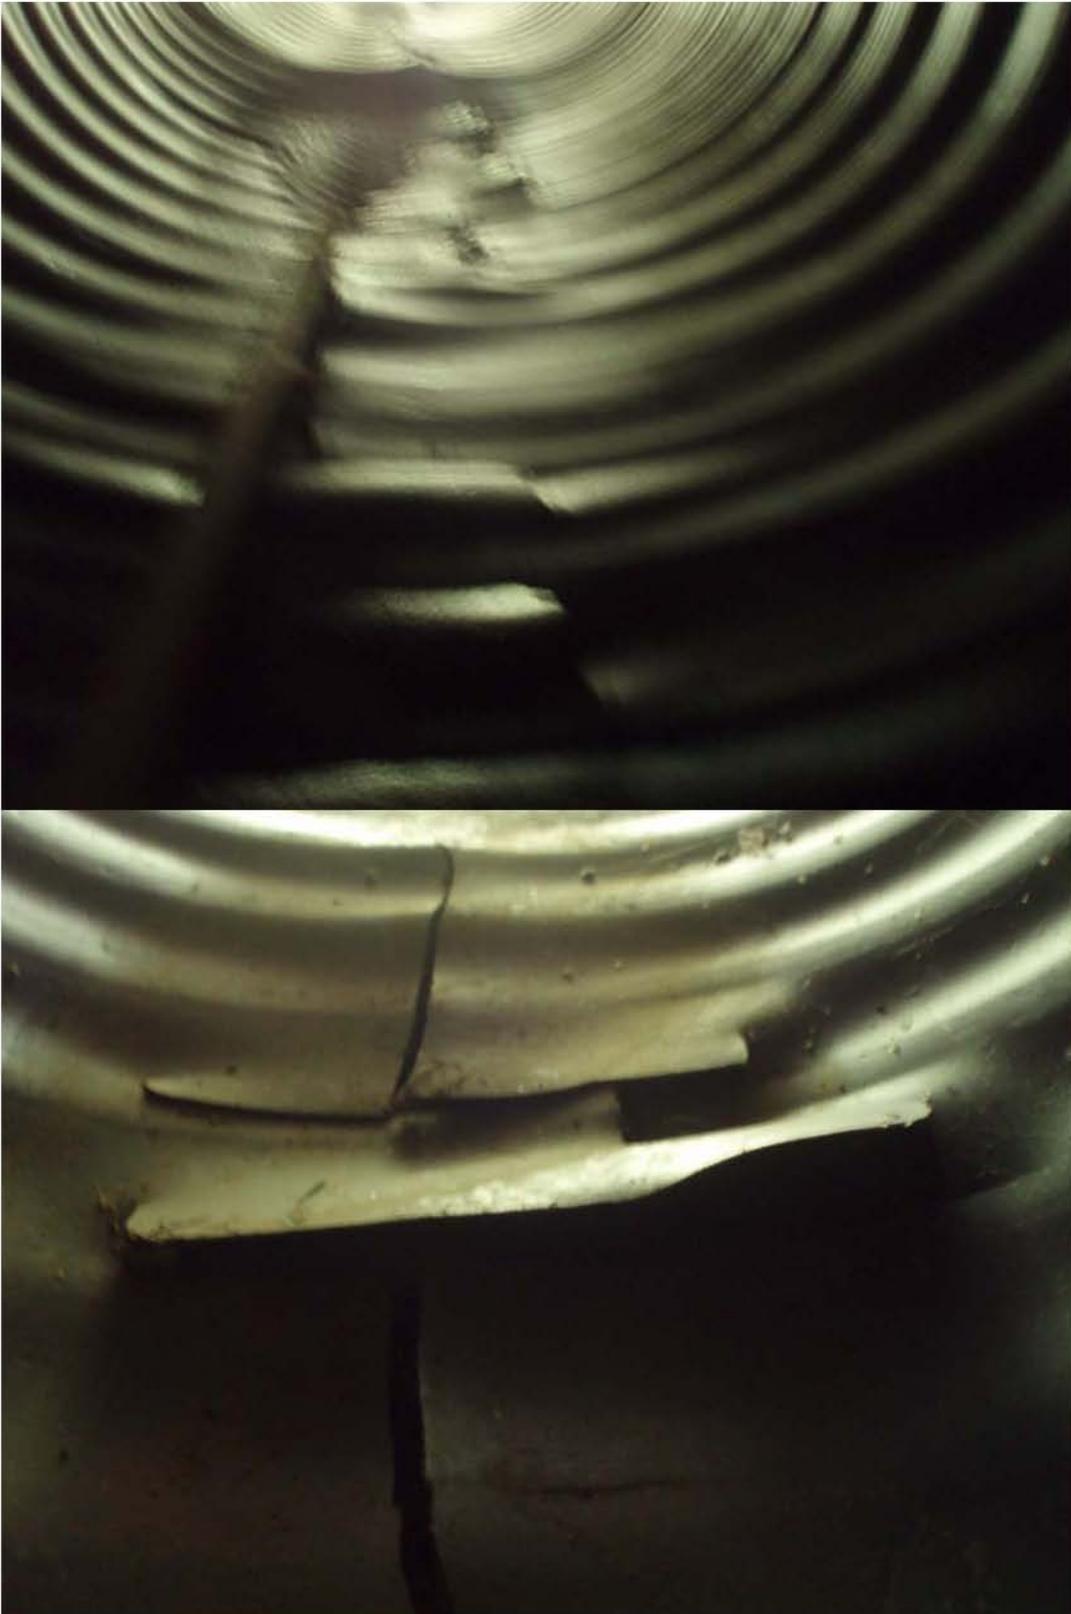
8-2-07, Rt. AA, 1.5 m. W. of Rt. 63, built 2000?, cracked 15' on bottom, transverse and L-cracking

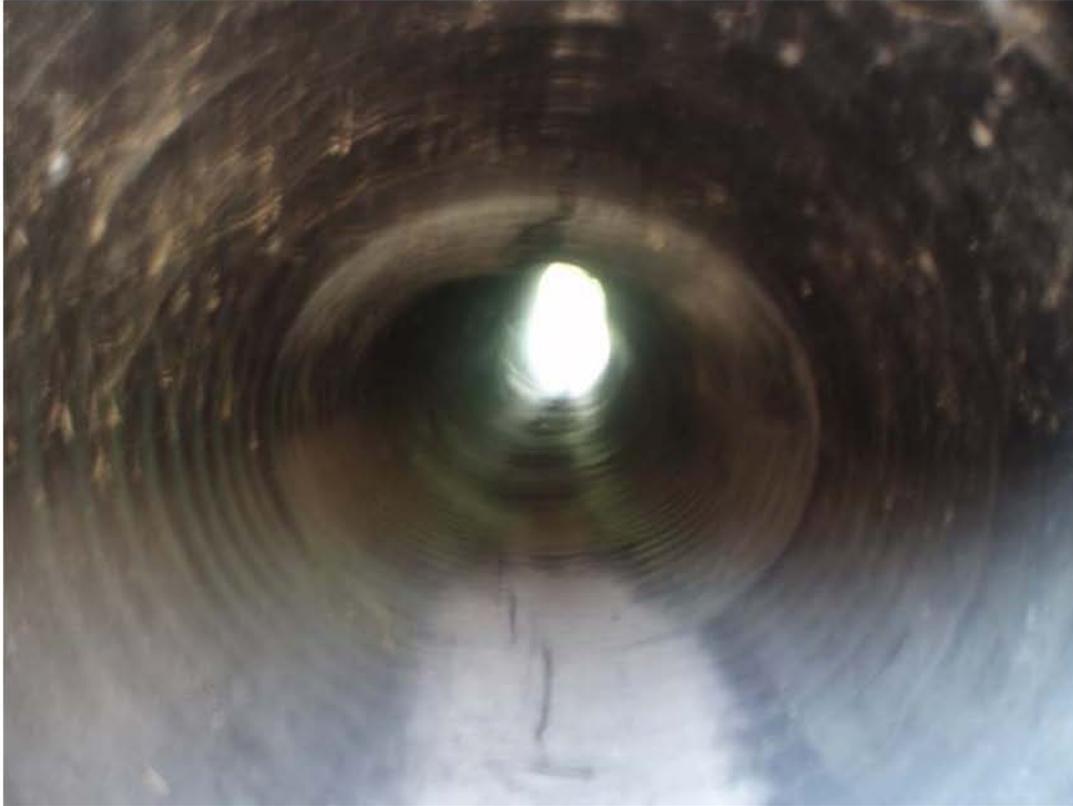
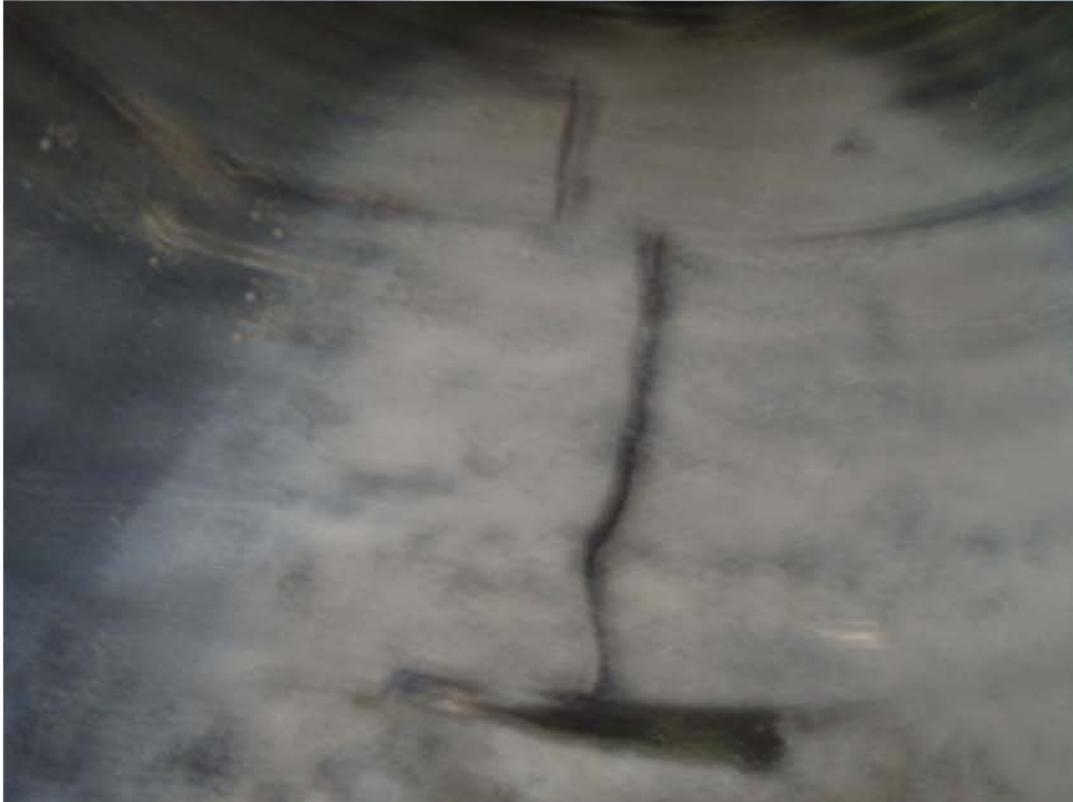
8-3-07, Rt. W, 1.18 W. of Rt. 63, 30", 2' long crack & 5' long crack, smaller Transverse cracks.

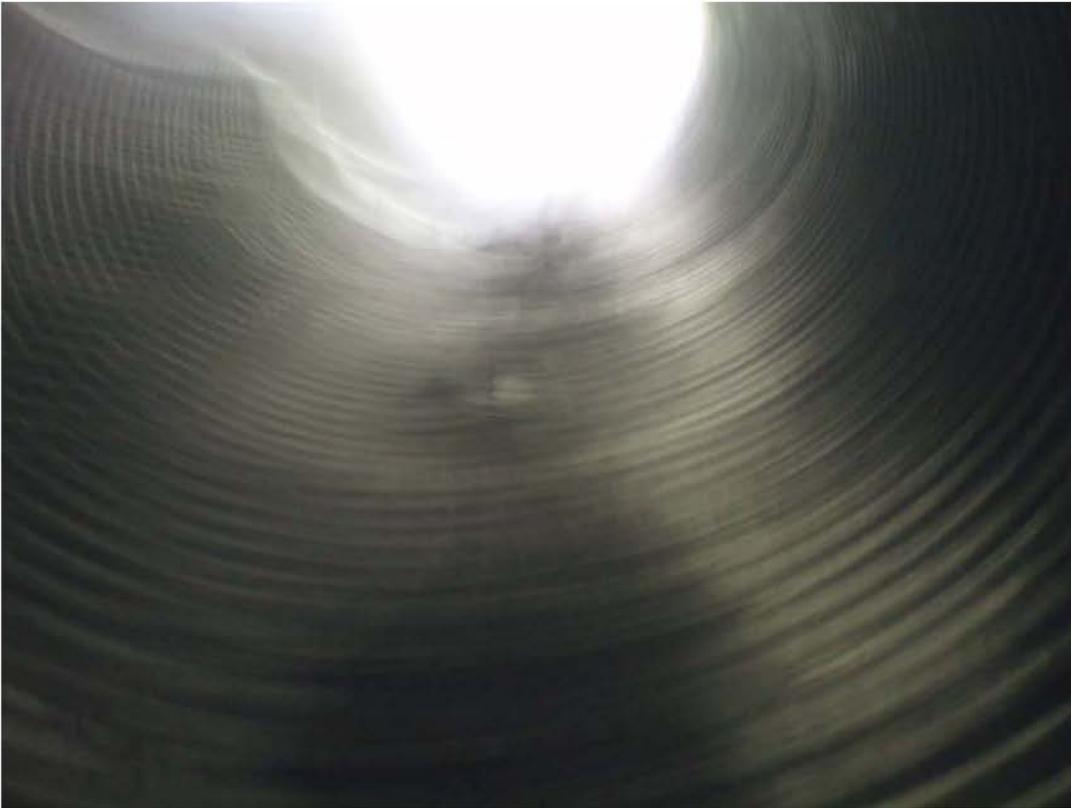
8-3-07, Rt. W, 2.43 m. W. of Rt. 63, Inlet vert. Deflection at shoulder, as installed.

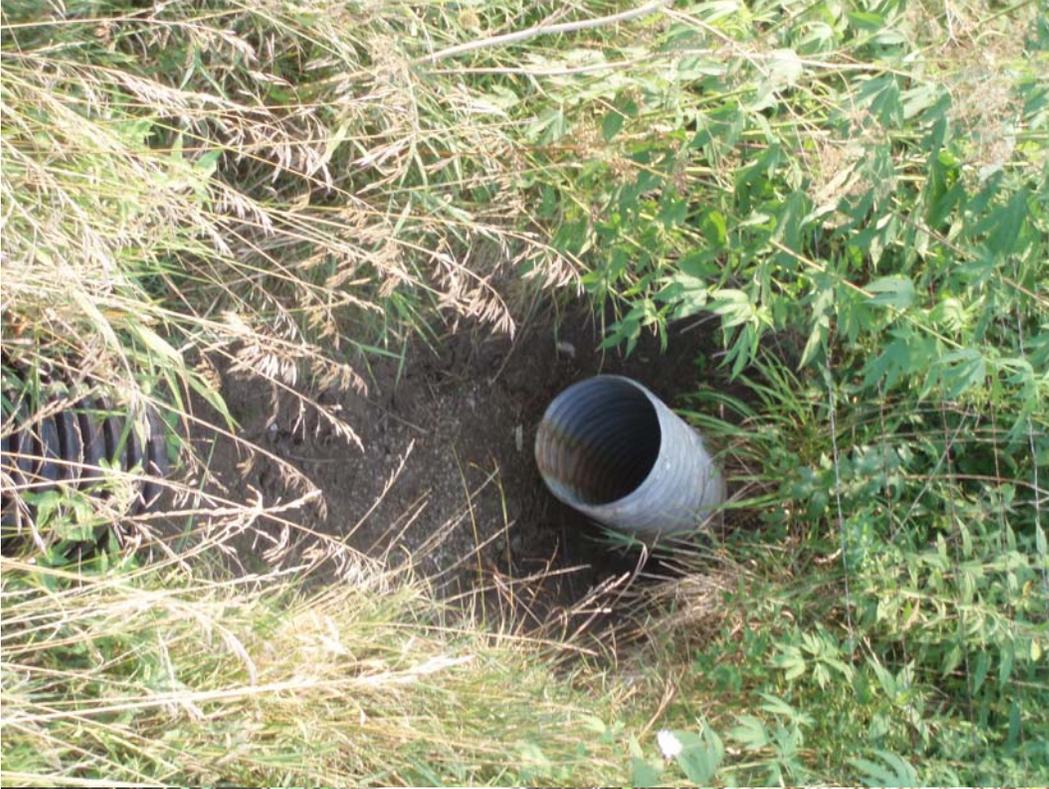
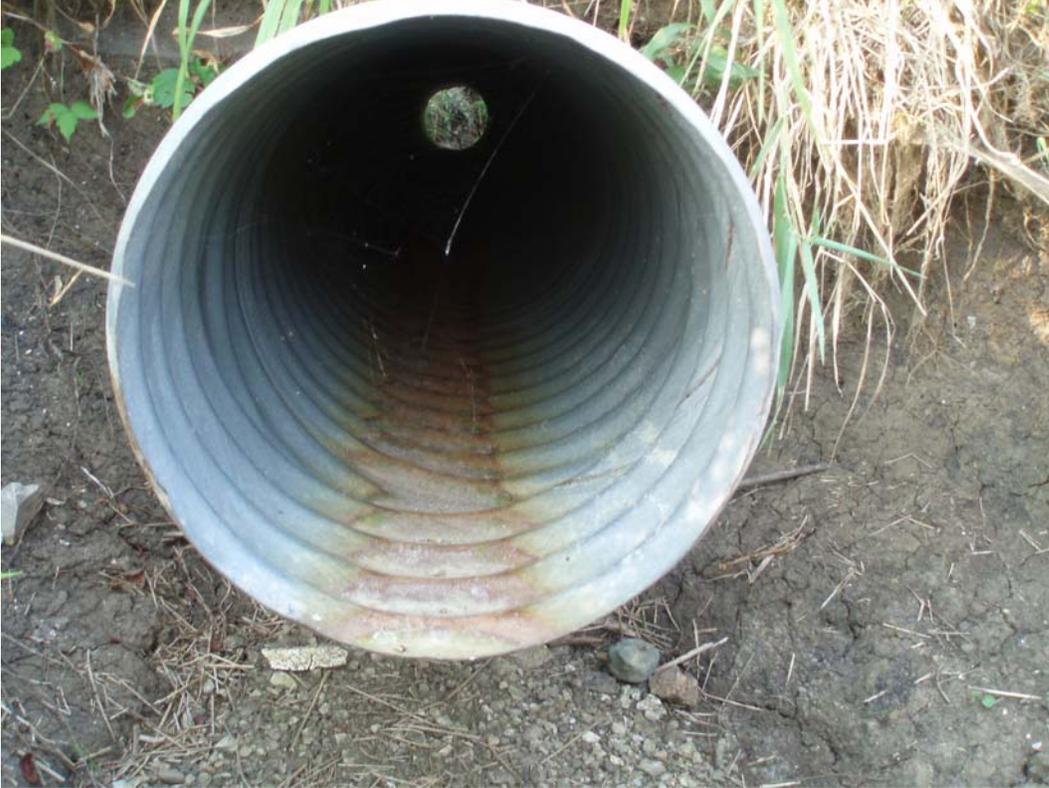
8-3-07, Rt. W, 2.43 m. W. of Rt. 63, CMP at outlet at ROW line, close up of condition inside.

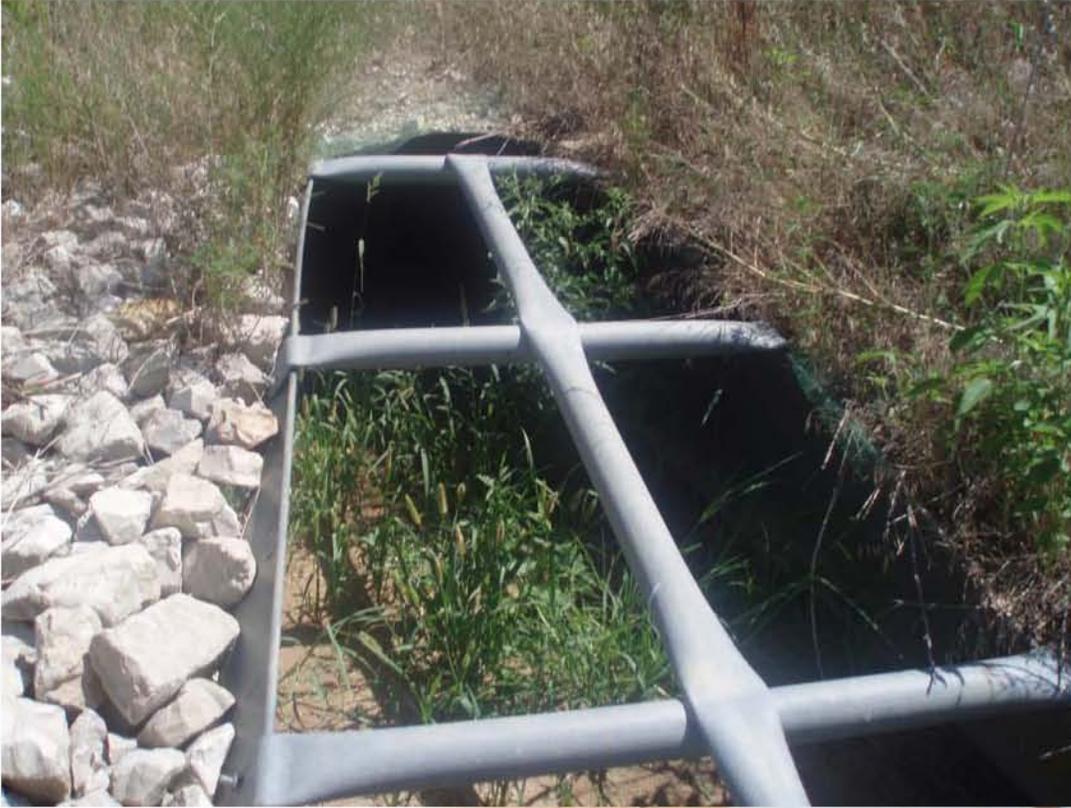
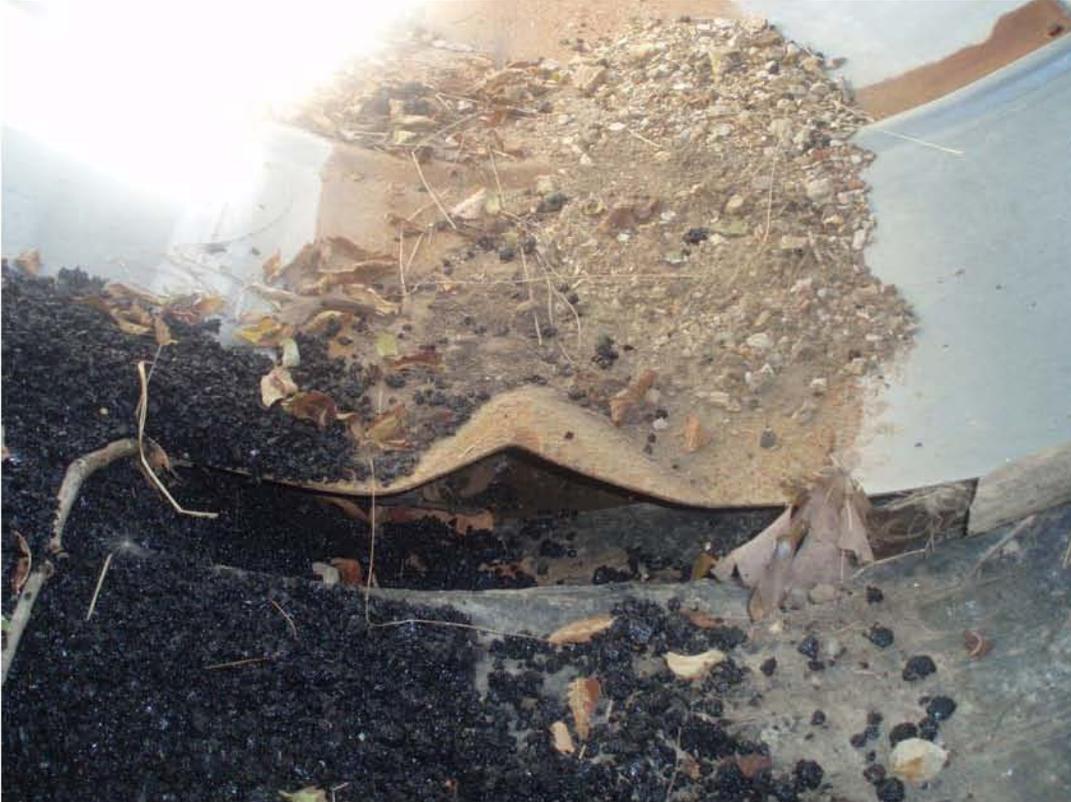
8-8-07, Rt. 142 Ripley Co., under Kelsey Ave. in Naylor, MO, 40% full of sediment, 1 joint separated a hands width (4"), steel FE section damaged.
