**Effectiveness of  
Metal and Concrete Pipe  
Currently Installed in  
Missouri  
(Phase 2)**

Prepared by  
Missouri Department of  
Transportation

**FINAL REPORT**

**January 2008**

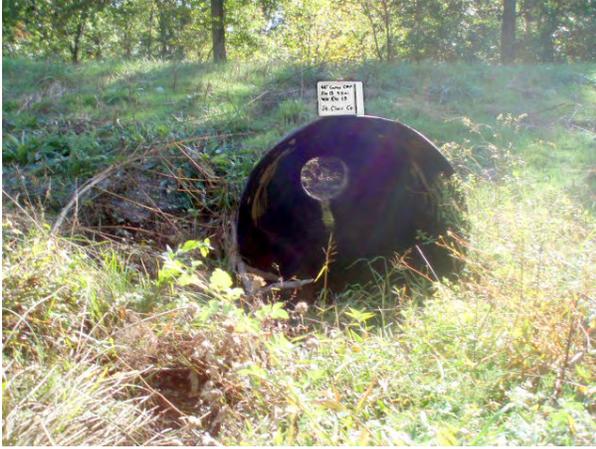
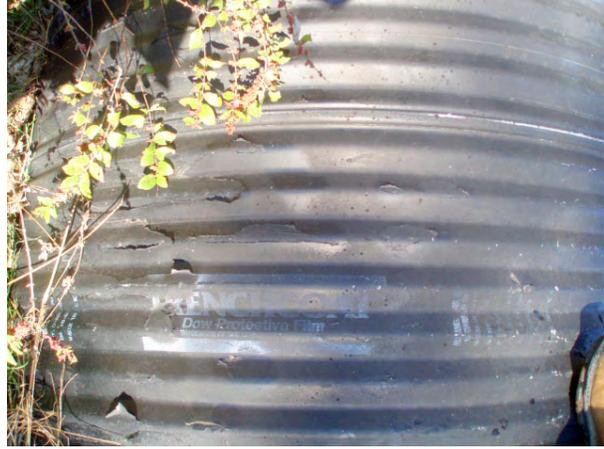
60" PCO pipe, Rt. B St. Clair Co., 4.5 miles W. Rt. 13, installed 1997. Polymer coating flaking off exposed end of pipe due to UV rays.

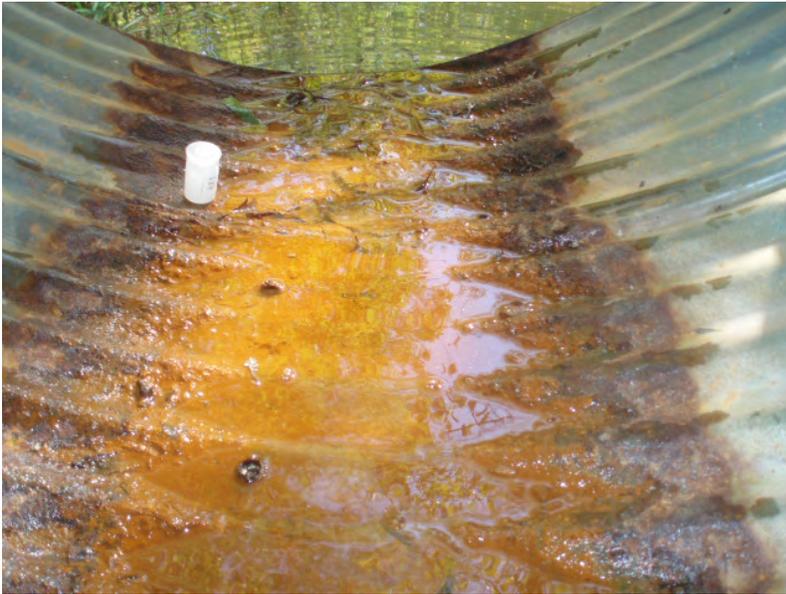
60" PCO pipe, Rt. B, St. Clair Co., Polymer Coated CMP placed in 1997, invert rusted and pitted, 10% section loss in 10 years.

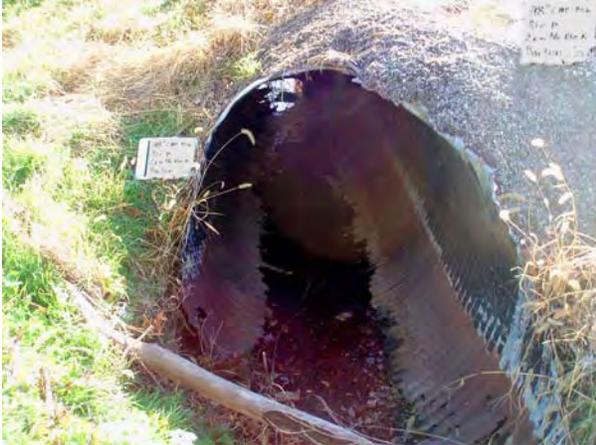
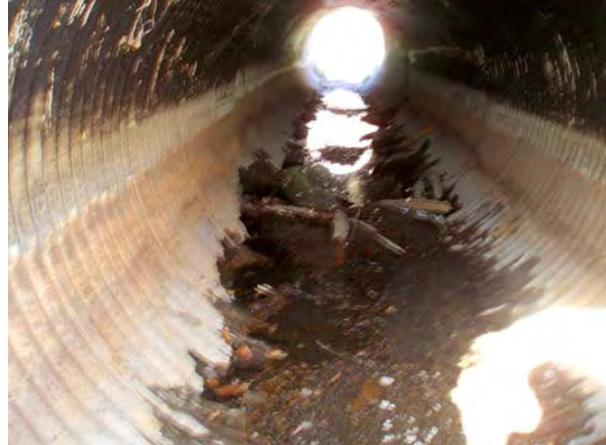
Rt. P, Barton Co., 1960, 48" Bit/Alz pipe, Bitumen and Aluminum coating worn off – invert rusted out. Water sample pH=7.2 but must have been low pH runoff in past.

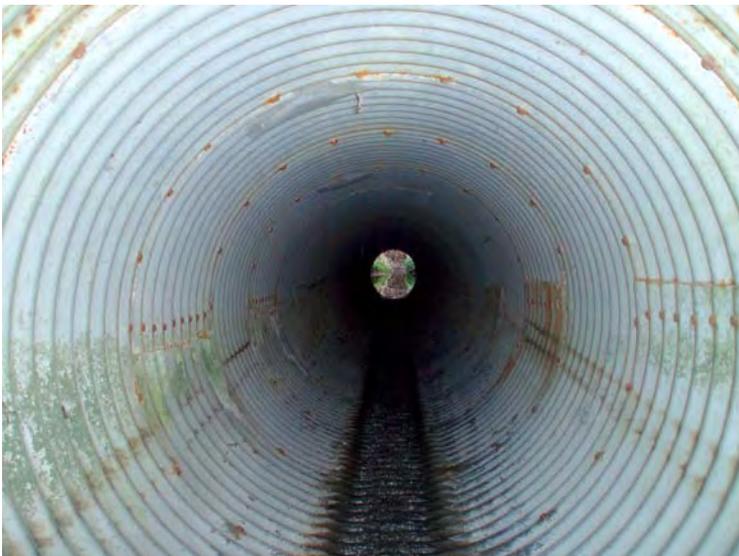
Rt. 246, Nodaway Co., 36"d. ALZ – Original aluminized pipe installed in 1952 with only minor pitting of coating and staining at invert.

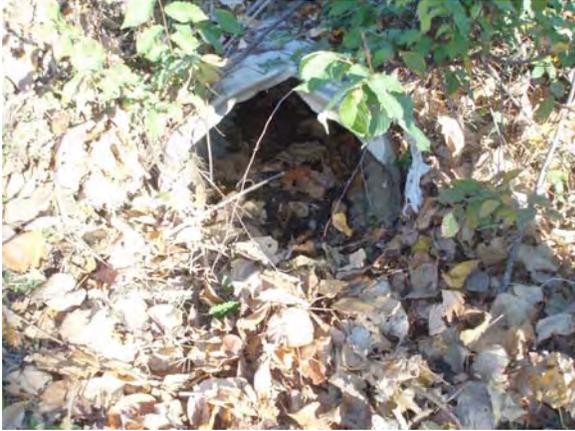
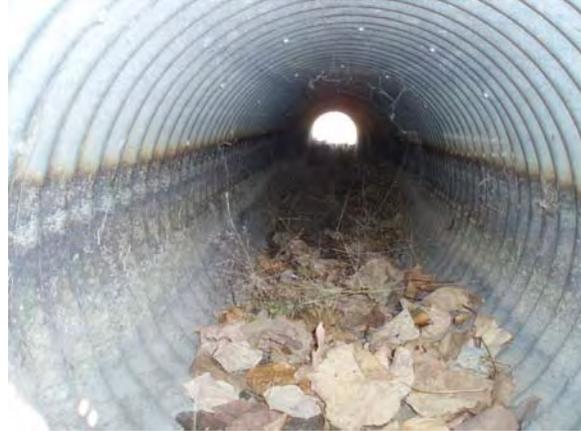
Rt. NN, Barton Co., 1962, 24" Aluminum Alloy – One end mower damaged, stained but no corrosion on invert.

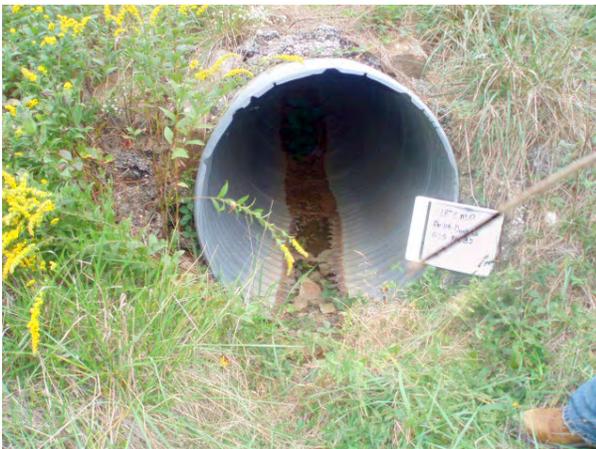
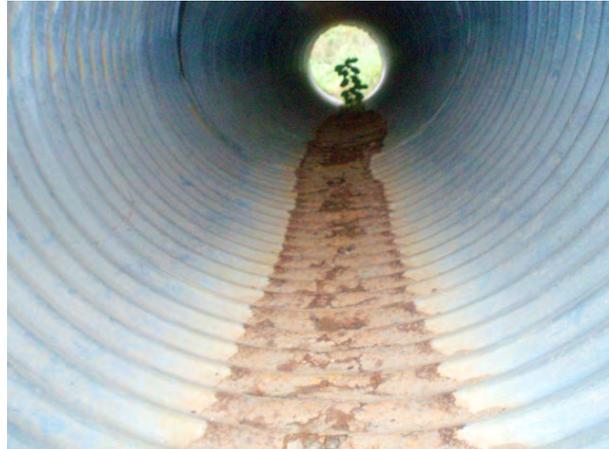
Rt.119, Dent Co., 36" Helical Galvanized Steel – installed 1995 and invert already rusted out the whole length.

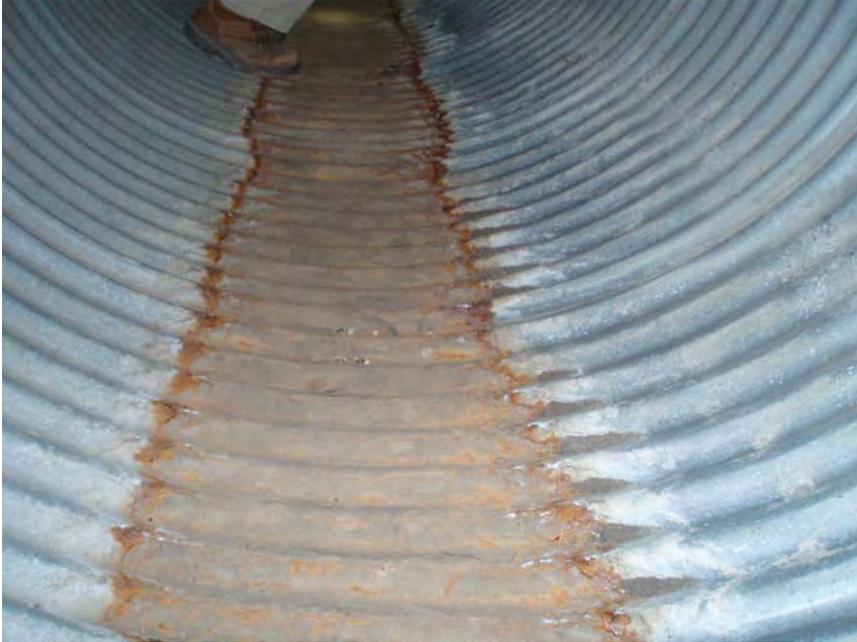
Dekalb Co., Rt. D, 48" d., Helical GSP, installed 1998 – invert rusting and pitting, nine years old.

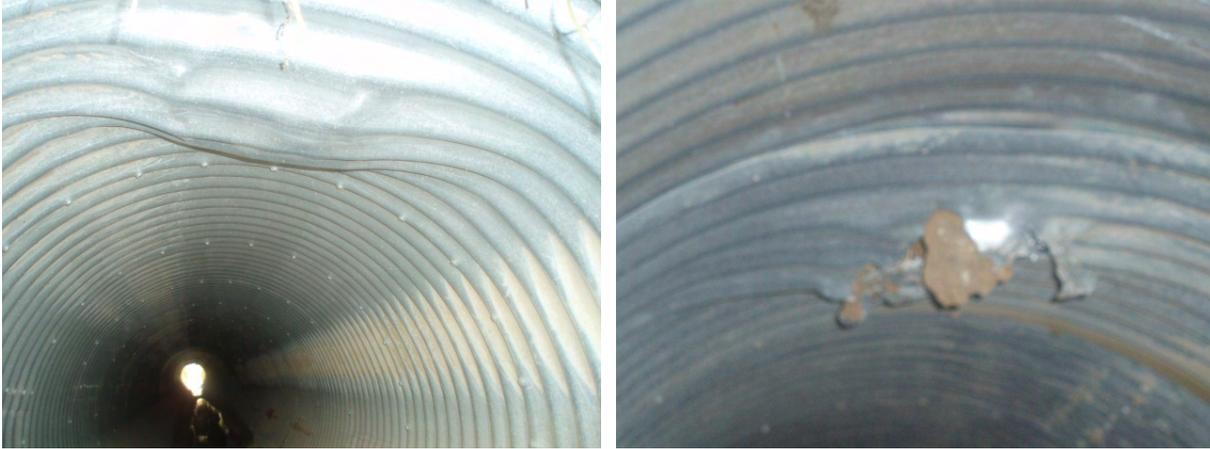
Rt. 61 SBL, Co. Rd. 464, Side Rd. Pipe, Lewis Co. - New 36" riveted GSP –with end crushed in near outlet and hole near inlet end with daylight showing thru.

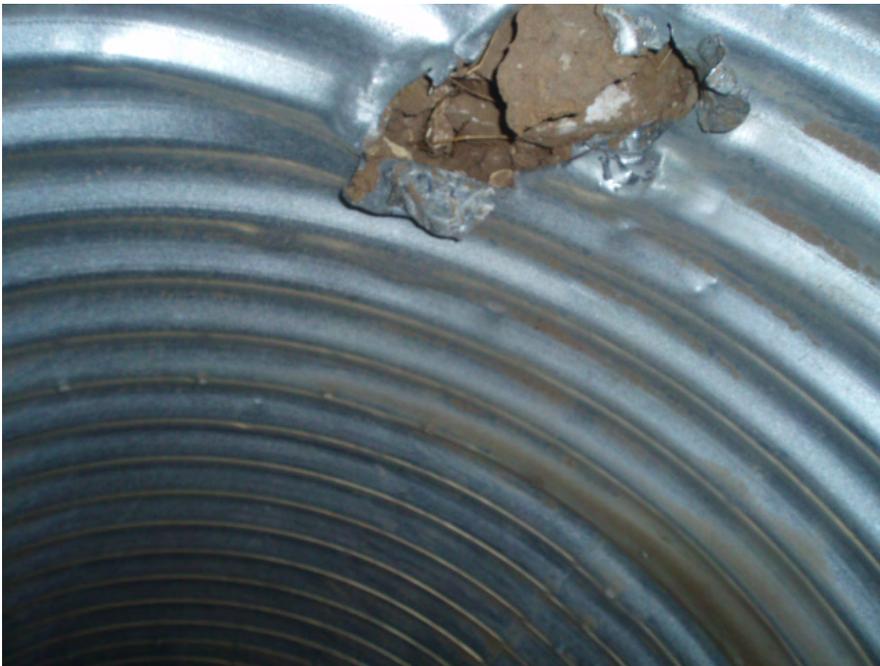
Rt. 61 SBL, Co. Rd. 464, Side Rd. Pipe, 36"d. riveted GSP – 6"diam. hole 2 ft. in from inlet, rocks poking thru.

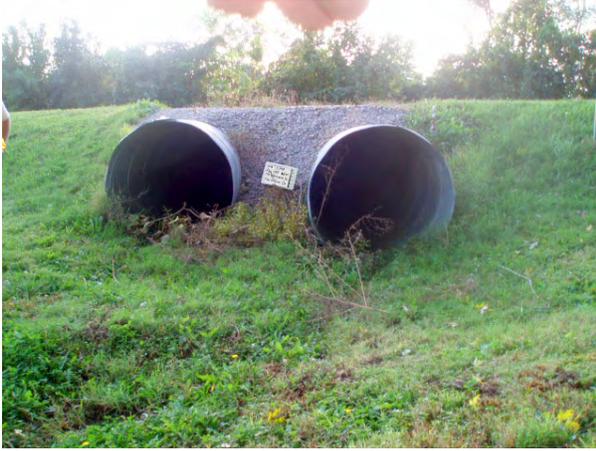
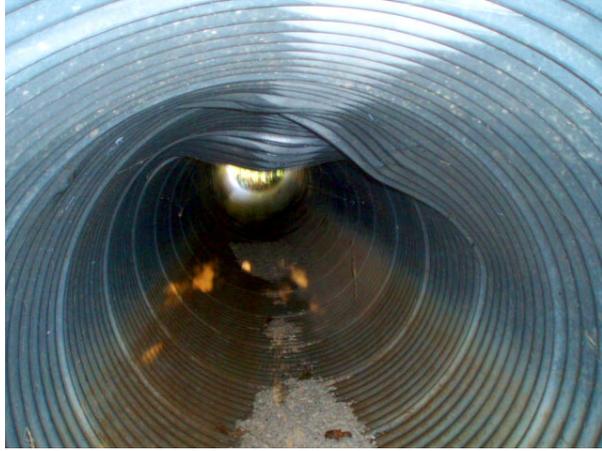
Christian Co., Rt. 125, 8.0 S Co. Ln., 2-48''d. GSP, helical pipe. - Crushed but not torn 4 places.

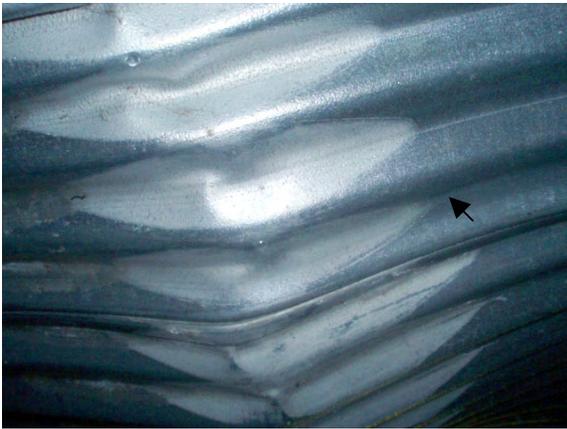
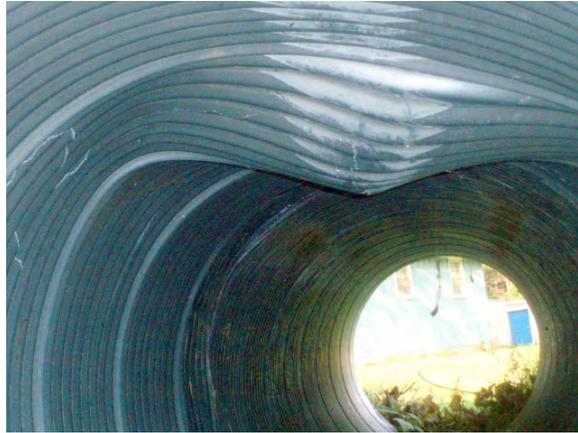
Christian Co., Rt. 125, 8.0 S Co. Ln., 2-48''d. GSP, helical, - crushed on top, 11'' deflection.  
- crushed on top near seam, seam holding.

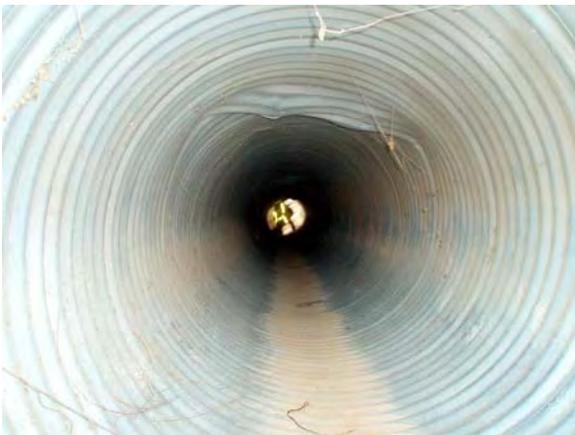
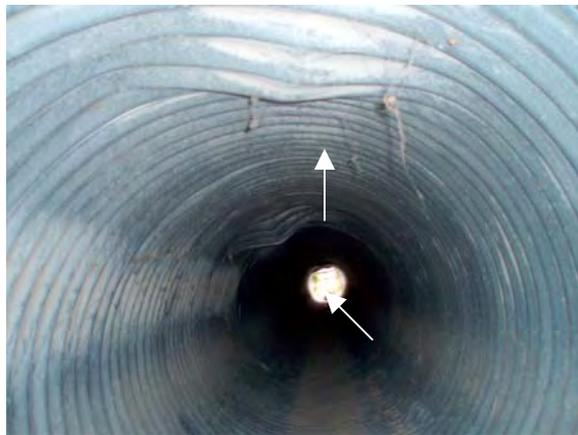
Rt.71, McDonald Co., Sta. 637+09 Lt. -, 36'' Group B –  
worst dent deflected in 5'' at top on seam, and looking from other end - dented two other places at top.

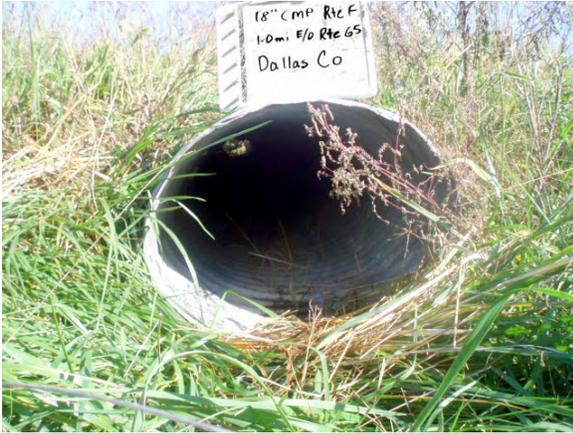
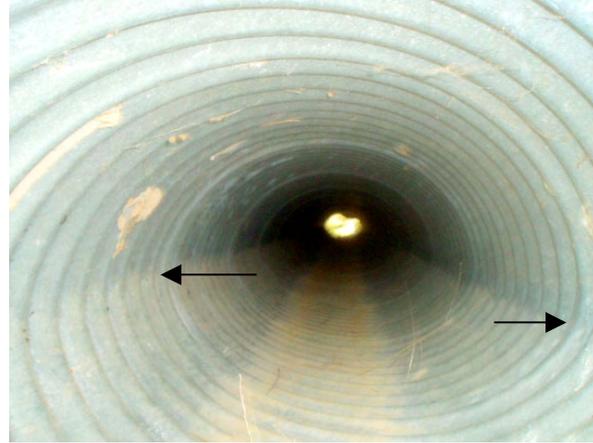
Dallas Co., Rt. F, 18”d. GSP – deflected dimensions are 18” high x 23” wide, inside is bending at different elevations on each side. Assume it is really a 20”d. pipe; Cause - not enough overfill height, vehicle loads transferring straight to pipe.

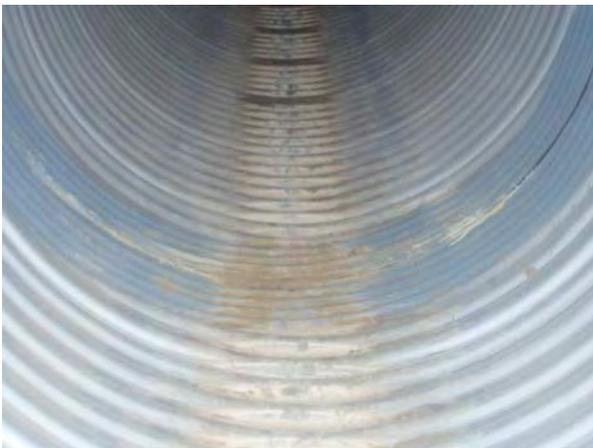
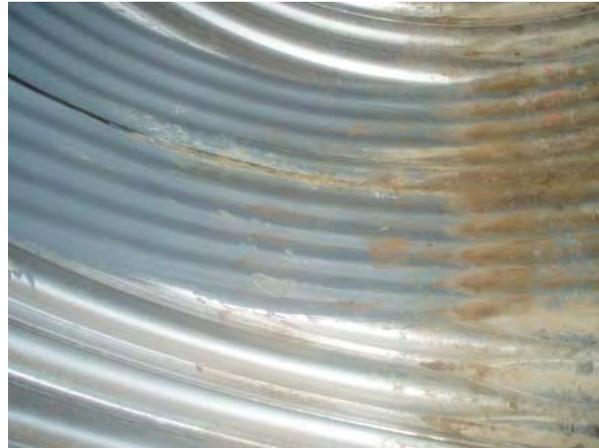
Rt. 50 Cole Co., 72” Helical corrugated pipe – crimped down and re-corrugated approximately 1” deep (close up on rt.). Looks good, has been painted with zinc paint, but the shallow corrugations don’t provide much mechanical grab for the connecting bands on the outside of this 6 ft. diameter pipe.

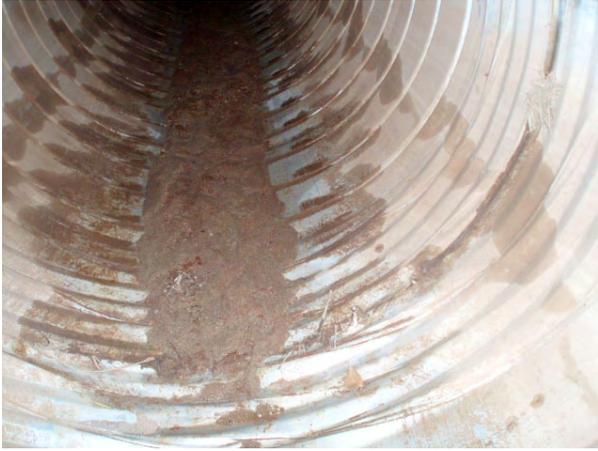
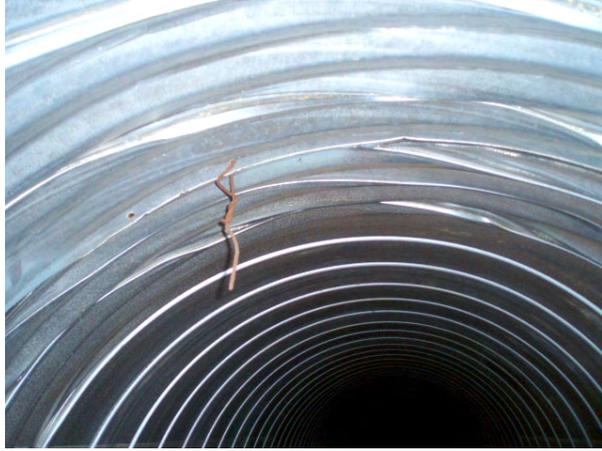
Job J8U0535, Rt. 160, Greene Co., 48" Group B, W. side 0.1 N. of Wadill St. – pipe is helical channel construction, corrugated ends make cleaner joint.

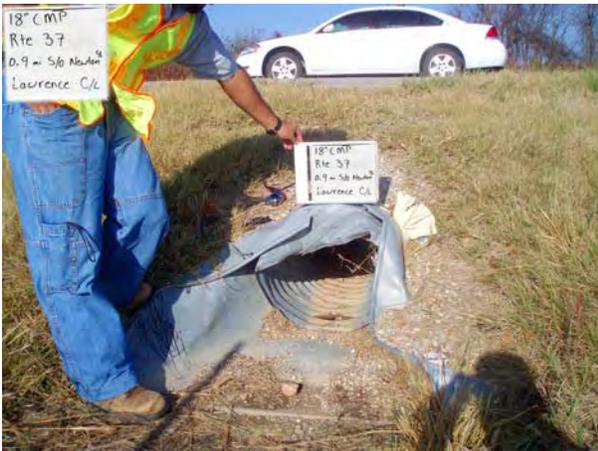
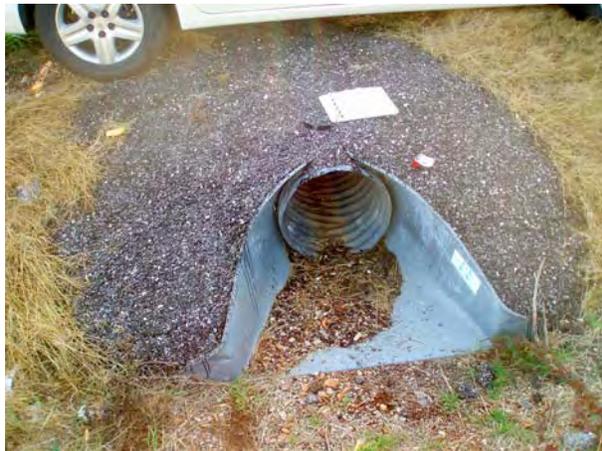
Lawrence Co. Rt. 37, 0.9 S Newton Co.Ln. 18" CMP – crushed pipe end and steel FES, and good backfill around steel FES, other side of road.

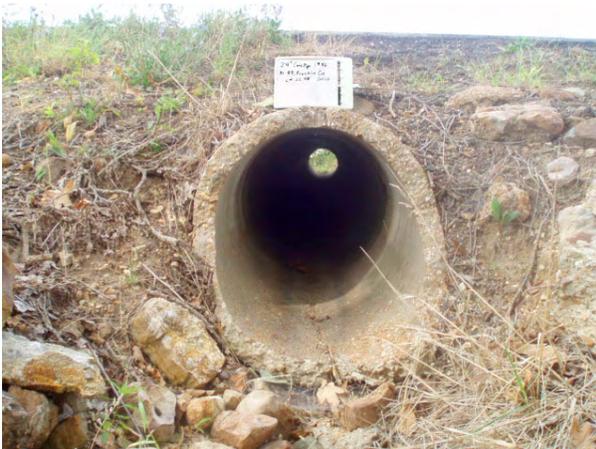
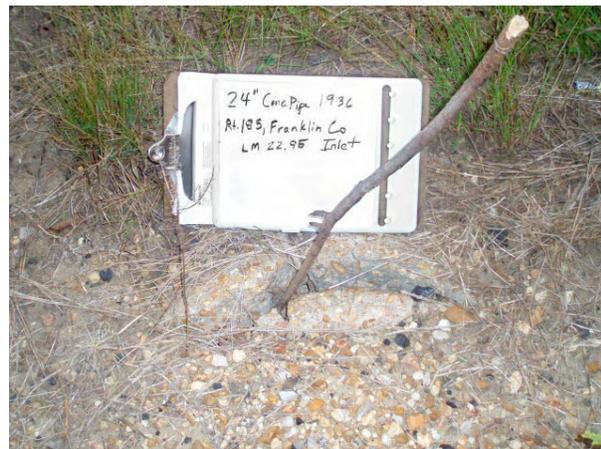
Rt. 185, Franklin Co., 24"d. non-reinforced concrete pipe, 1936 – open gap in pipe with stick in it.

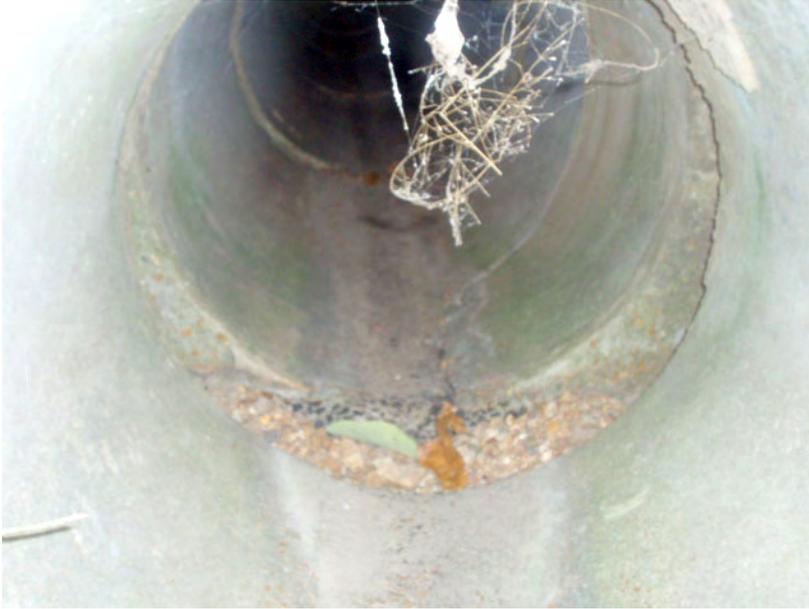
Rt. 185, Franklin Co., 24"d. non-reinforced concrete pipe, 1936 – joints deteriorating.

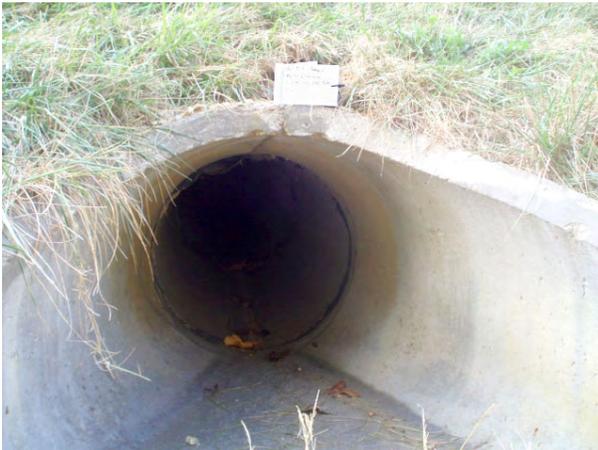
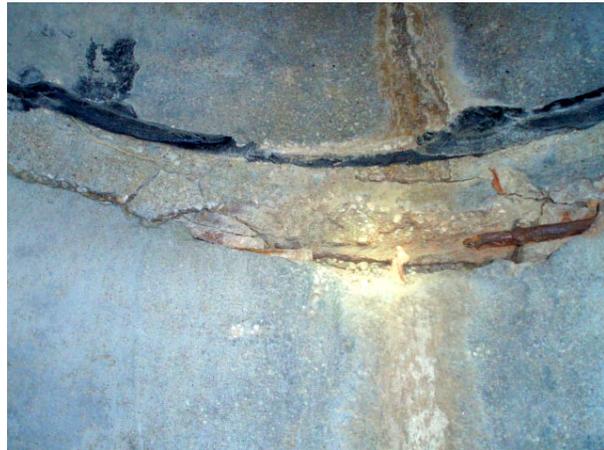
Rt.61, Pike Co., 0.15 Rp.54-61N, 1979, 36"d. RCP- Inlet FES & inlet 1<sup>st</sup> joint deteriorated 6" rebar rusted off.

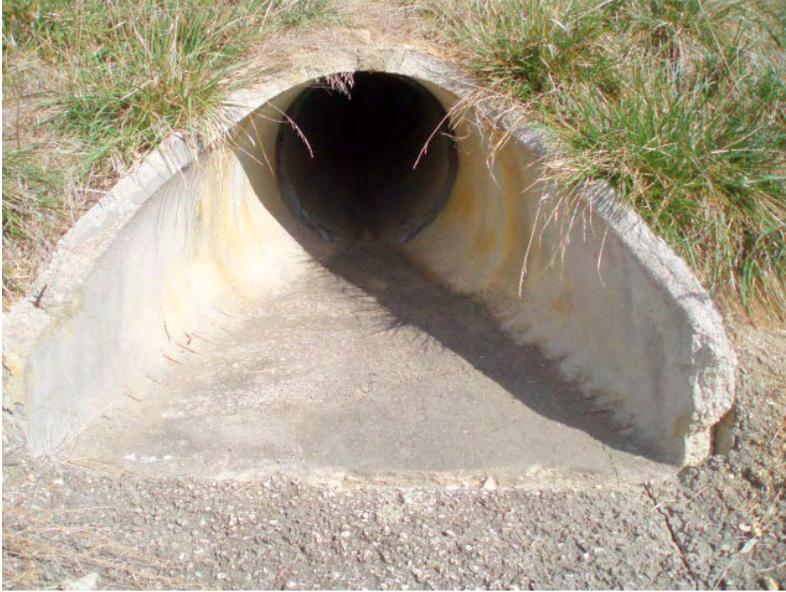
Rt. 61, Pike Co., 0.15 Rp.54-61N, 1979, 36" d. RCP-outlet FES, chewed up by mowers

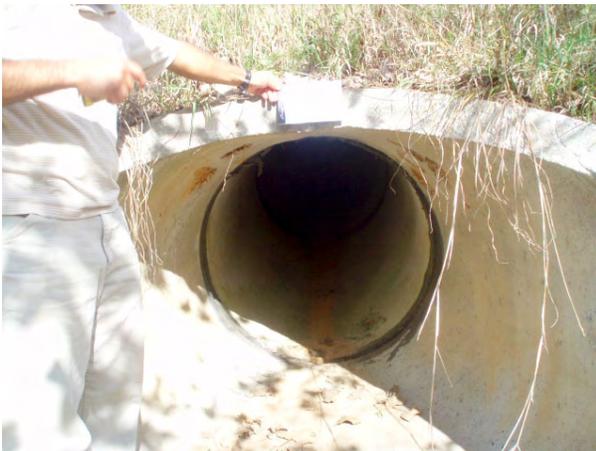
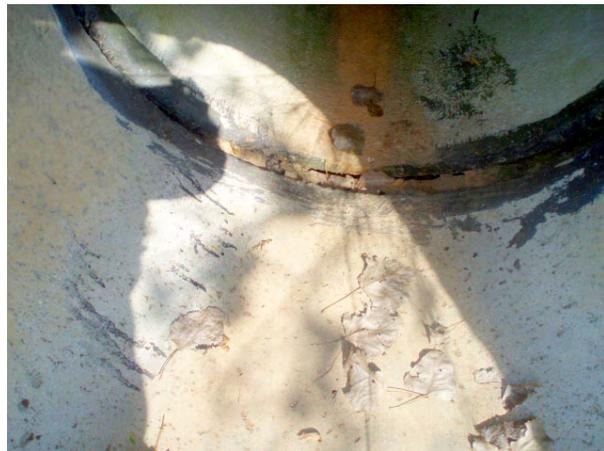
Rt. 61, Pike Co., 1996, 0.7 Ralls Co. Ln., 42" Cl. IV & Cl. III RCP – inlet FES & 3" gap at joint between FES and 1<sup>st</sup> section pipe.

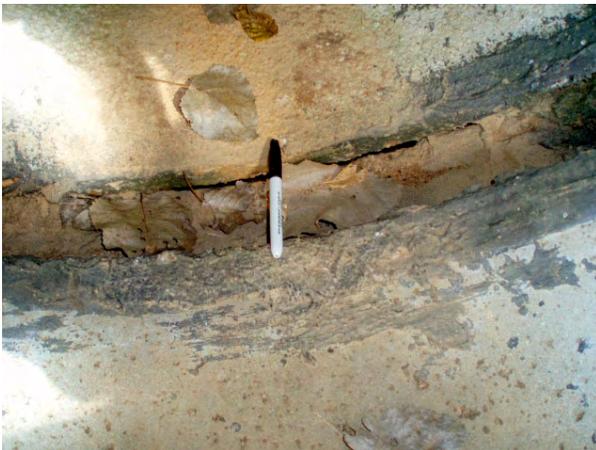
Rt. 61, Pike Co., 1996, 0.7 Ralls Co. Ln., 42" Cl. IV & Cl. III RCP – 4" gap @ outlet FES

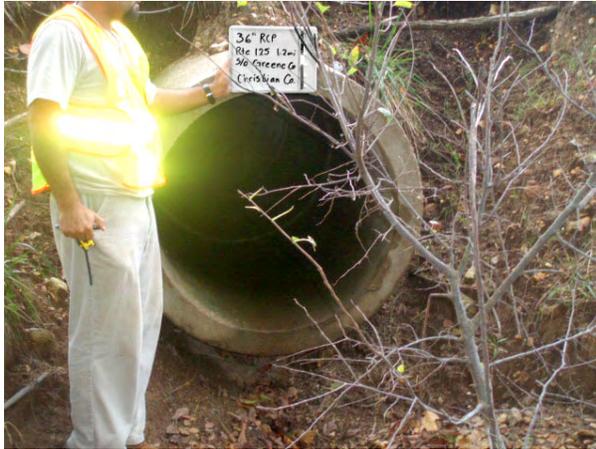
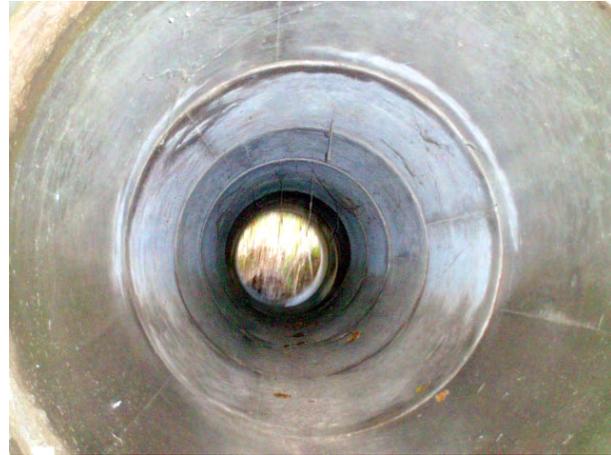
Rt. 125, Christian Co., 1.2 S Greene Co Ln, 1935, 36" RCP – 1935 installation, joints rated 7 condition because 1" gap and open joint at inlet section. 4" gap at joint but not open at outlet end, all interior joints of 4' sections tight.
