RDT 00-012

Pavon[®] Indeck Crack Sealer Evaluation

Addendum to Research Investigation 96-05

APRIL, 1996

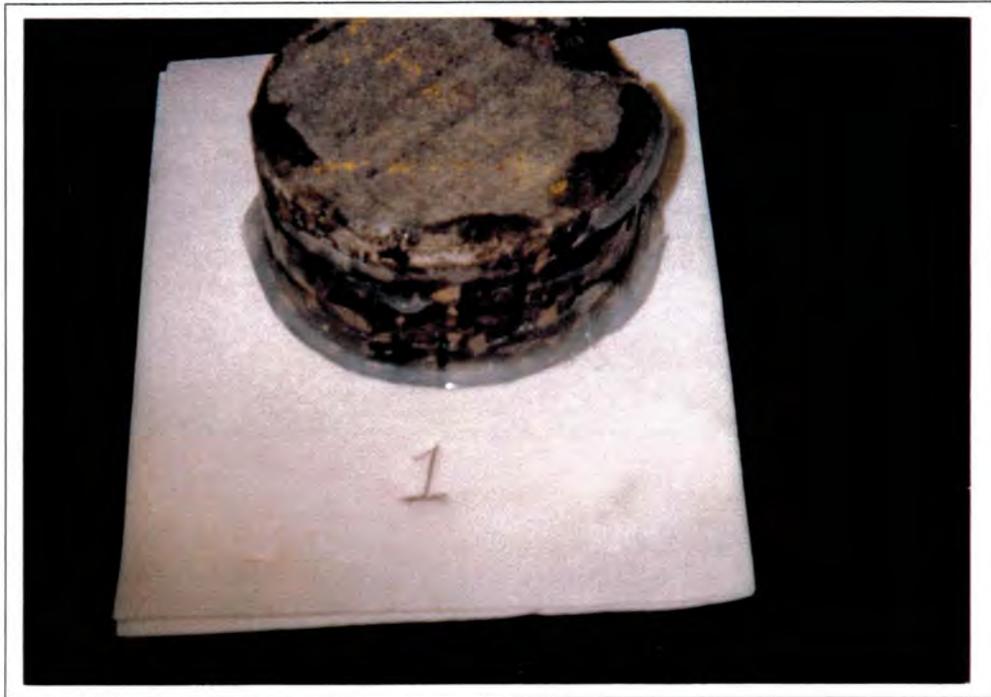
Photo No. 1

Non-cracked core 1 from 2/23/00, 1 year old Indeck, after chloride permeability test.

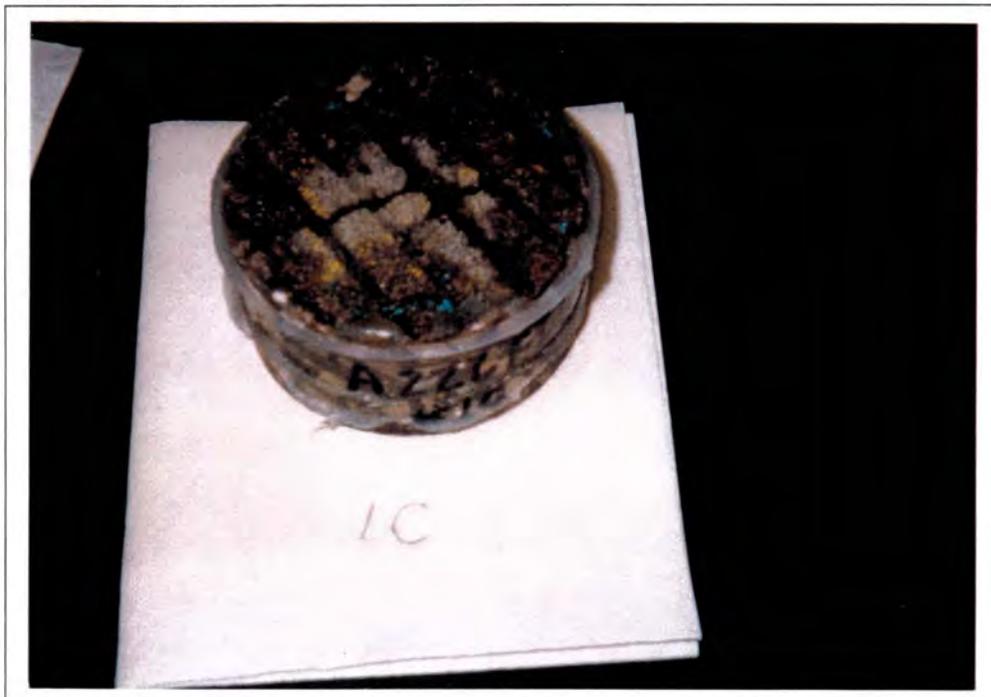
Photo No. 2

Cracked core 1C, typical crack size $0.4 \pm$ mm. Notice almost all Indeck worn off the surface.

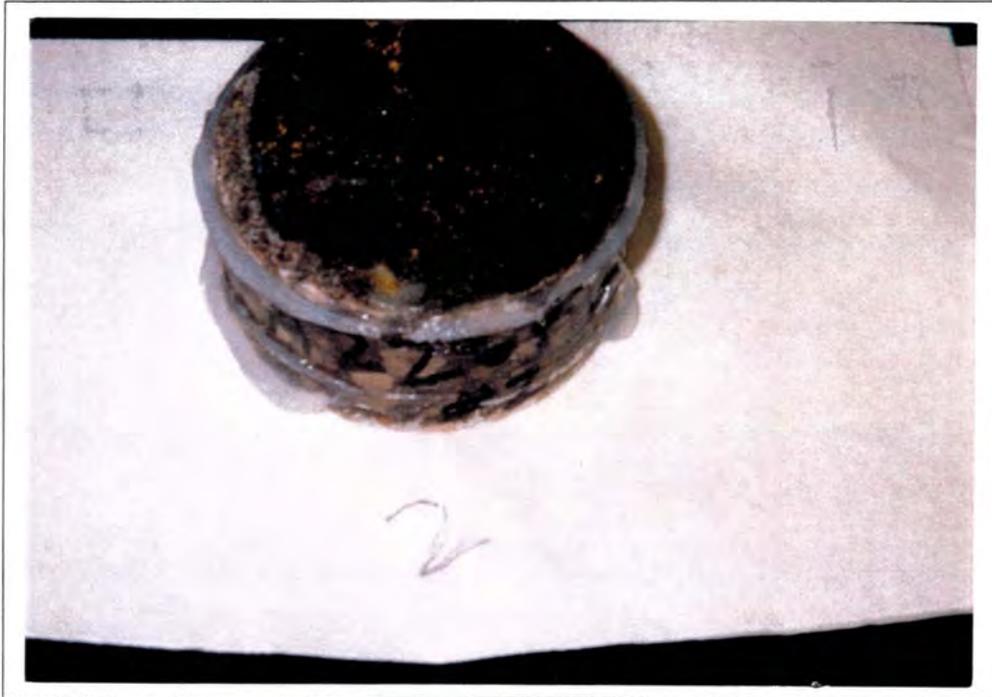
Photo No. 3

Non-cracked core 2 from 2/23/00, 1 year old Indeck, after chloride permeability test. Notice a lot of Indeck still on surface.

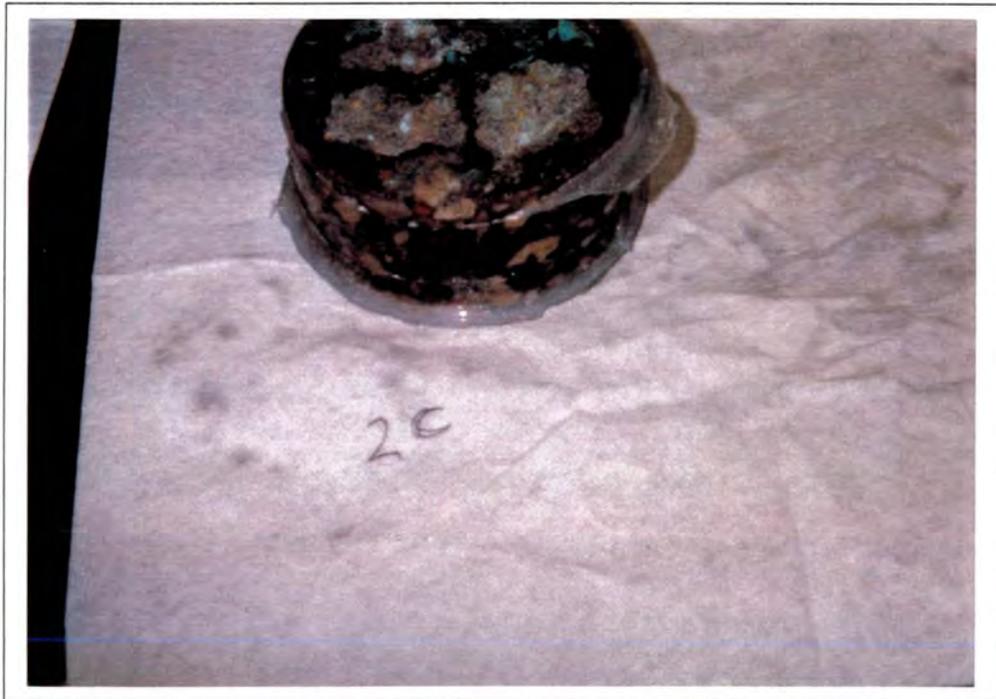
Photo No. 4

Cracked core 2C, typical crack size $0.4 \pm$ mm. Notice several cracks with Indeck in them still visible at the surface.

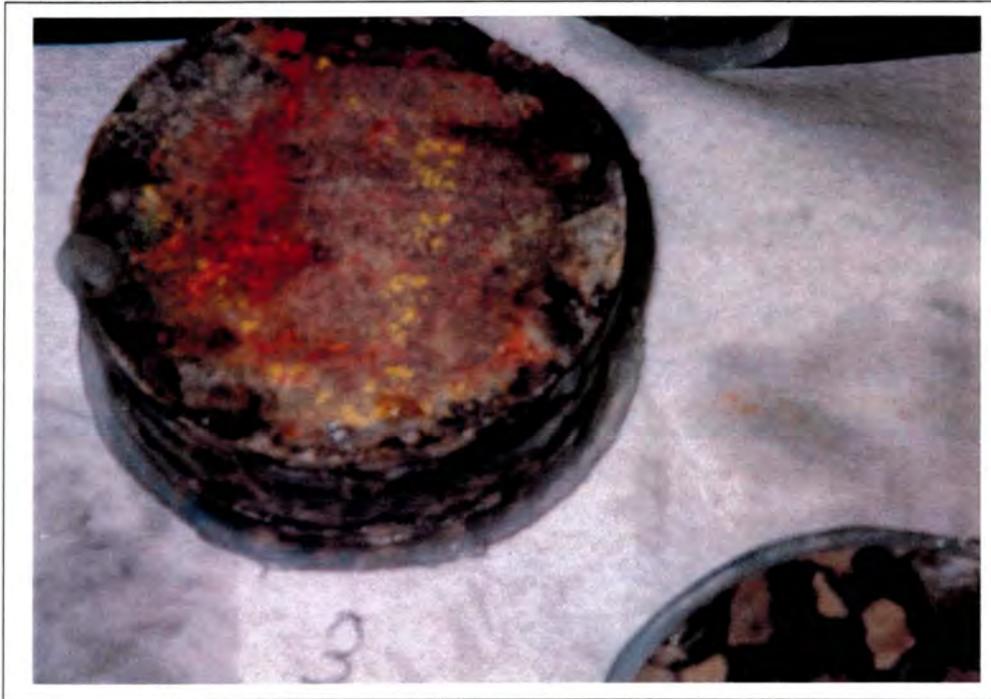
Photo No. 5

Non-cracked core 3 from 2/23/00, 1 year old Indeck, after chloride permeability test. Note most of Indeck worn off the surface.

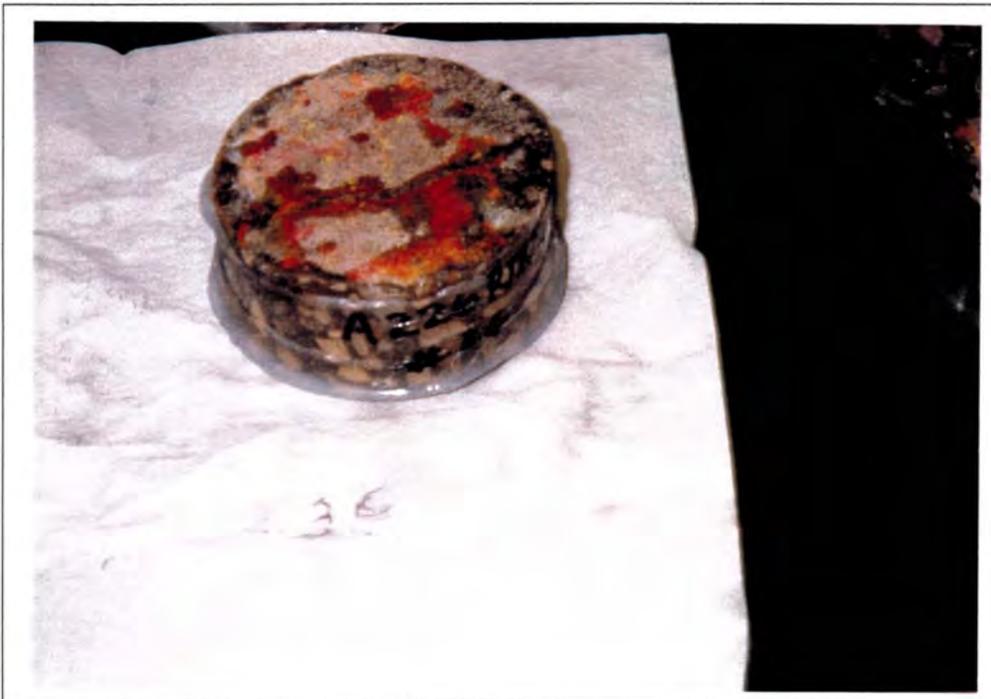
Photo No. 6

Cracked core 3C. Notice the orange staining we believe is from something contaminating the surface from traffic on the bridge, it didn't affect the Indeck.

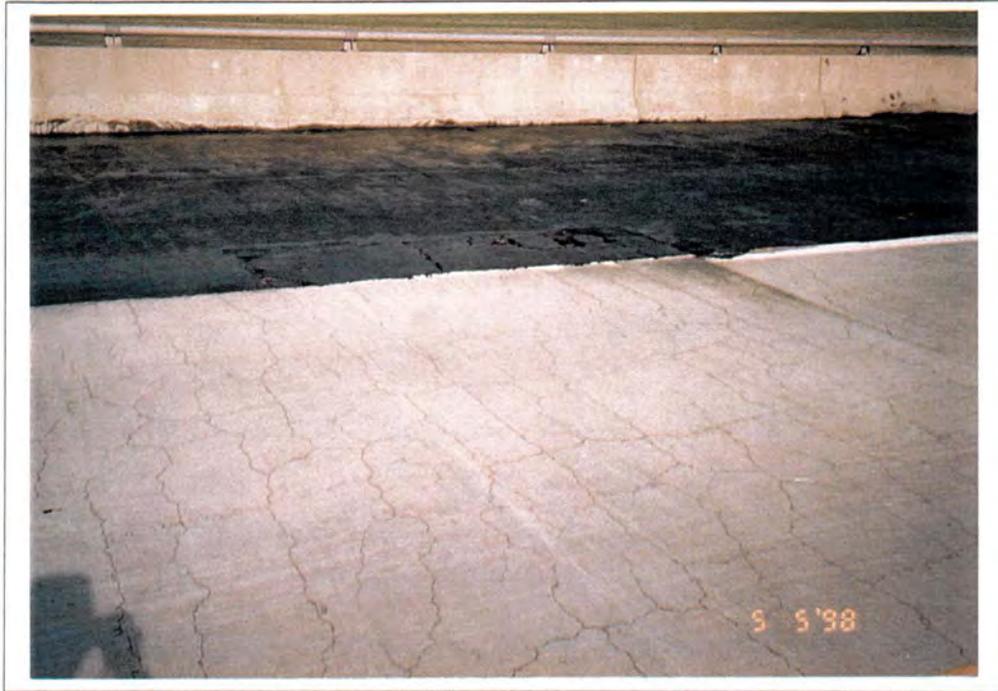
Photo No. 1

Typical map cracking on a low slump overlay in bad shape and Indeck applied to adjacent lane.

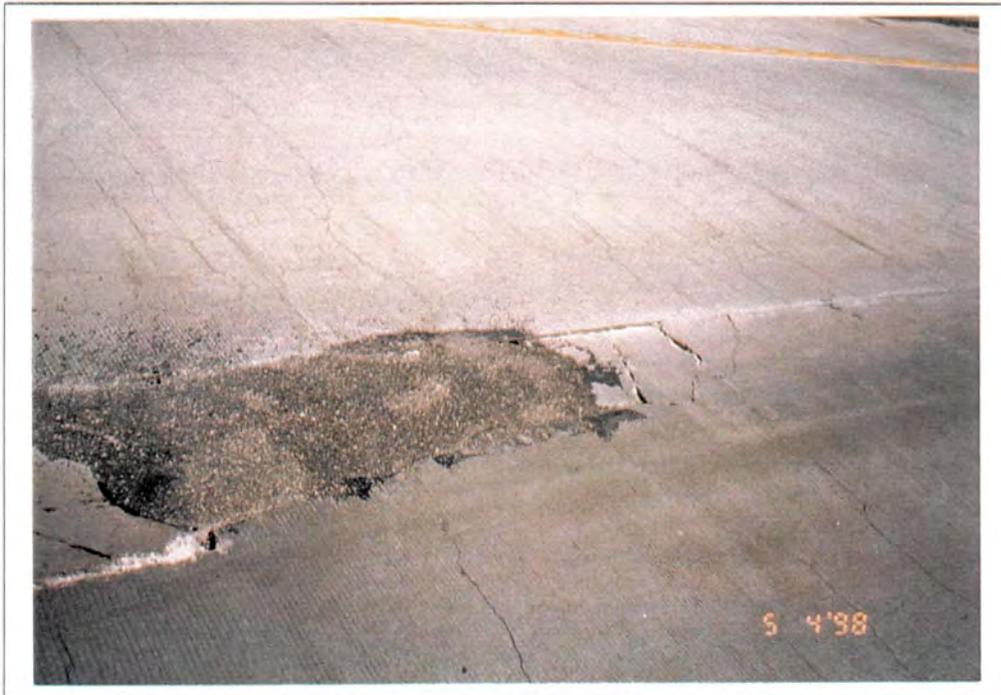
Photo No. 2

Patch also shown above near white line before Indeck applied. Product can not be expected to help areas like this, they need repaired before application.

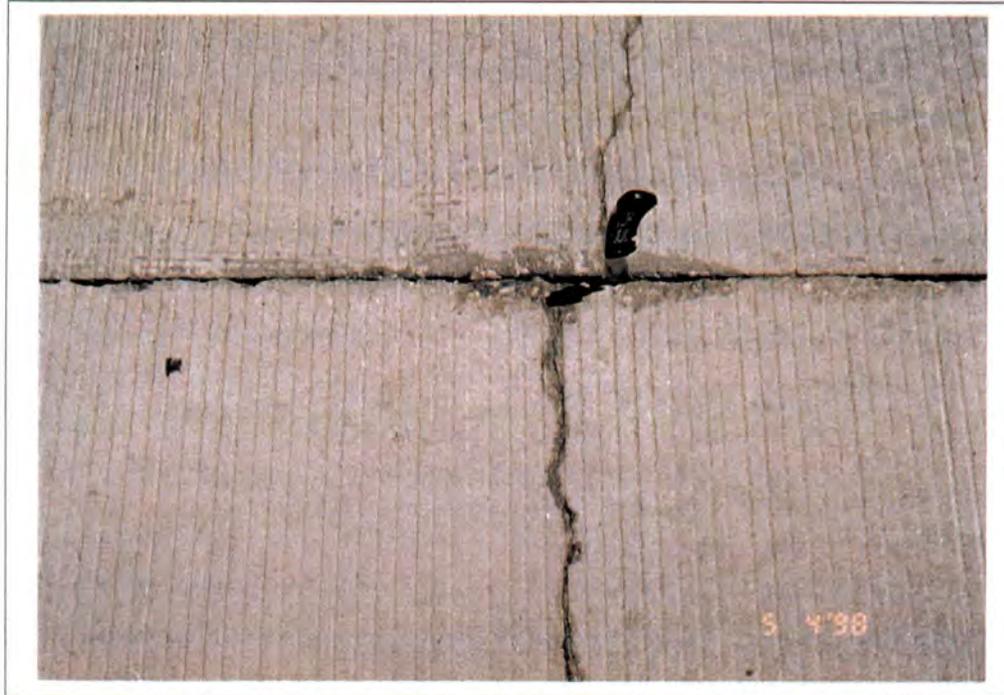
Photo No. 3

Typical open crack, $0.4 \pm$ mm, which Indeck will fill, and open gap at construction joint (knife sticking out) which product will have more trouble effectively sealing.

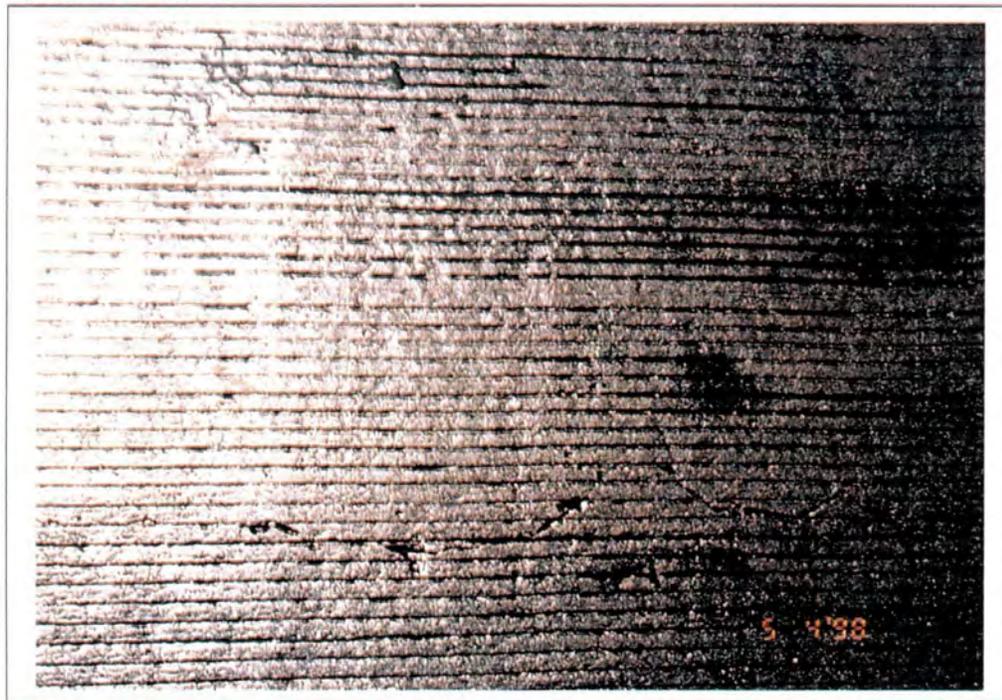
Photo No. 4

Typical open crack with Indeck just applied and worked well into it by squeegeeing and brooming.

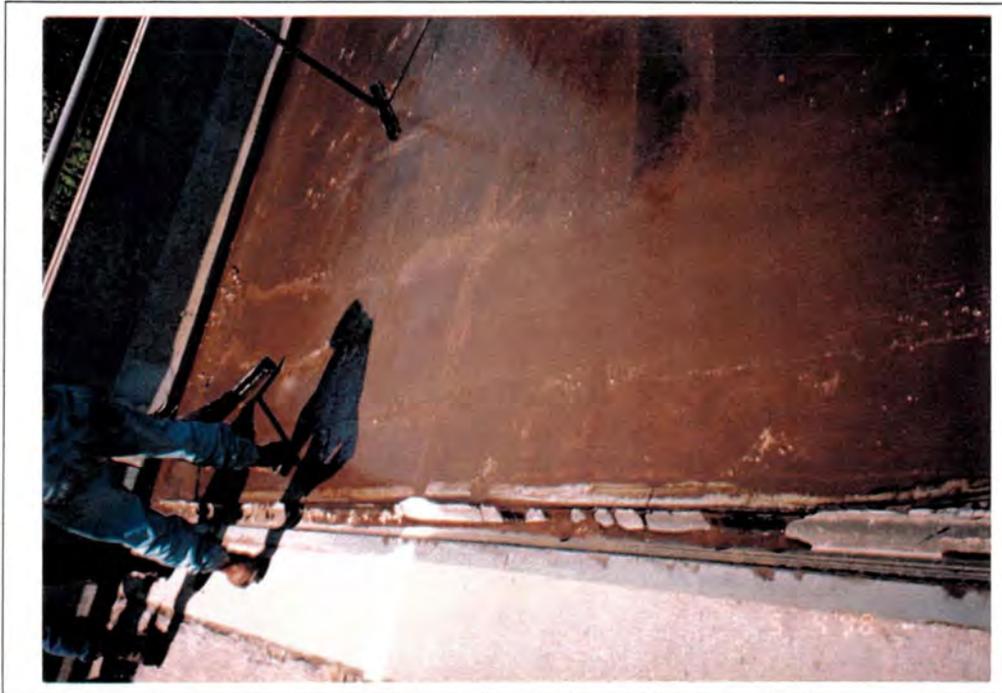
Photo No. 5

Indeck just applied to deck is brown colored before the emulsion breaks and turns black. Notice the good even coverage using squeegees.

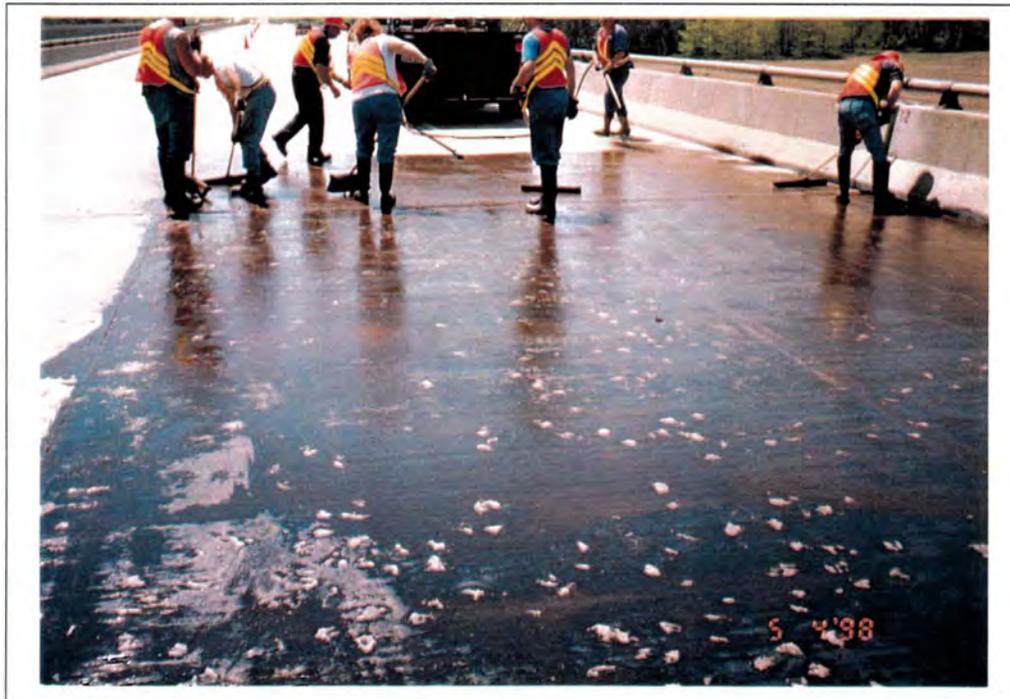
Photo No. 6

Good application procedure using distributor and wand to apply and plenty of workers to squeegee and broom in. Foot tracks won't hurt effectiveness.

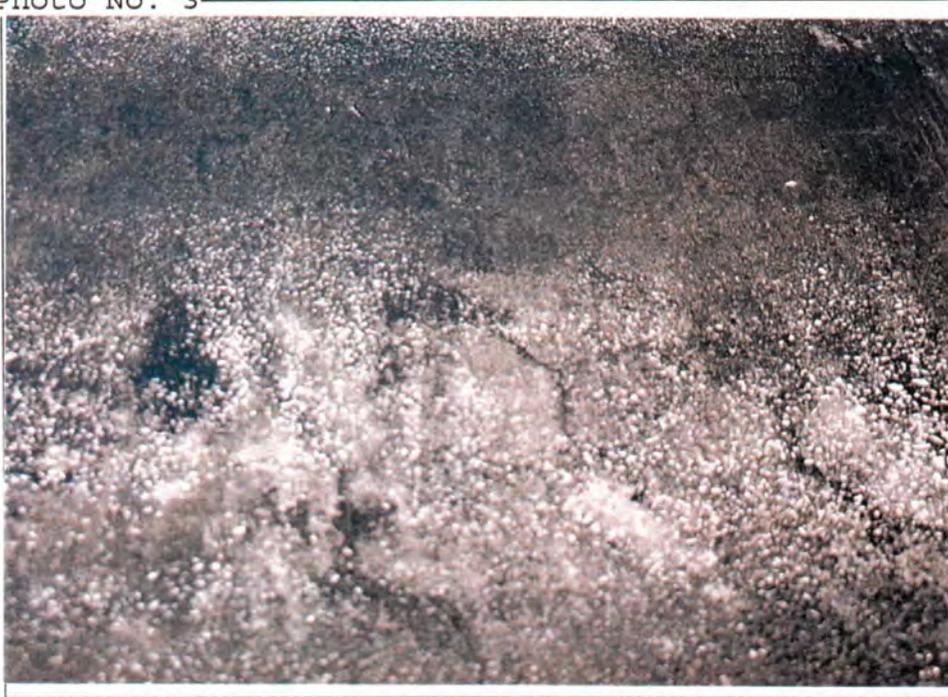
Photo No. 3

Transverse crack (T-crack) near bent.

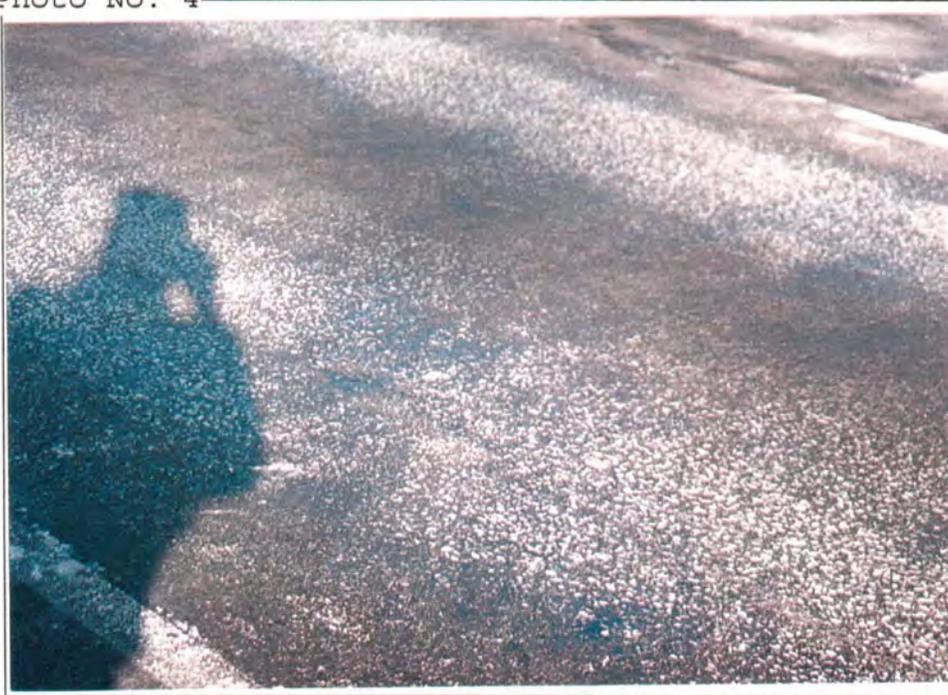
Photo No. 4

Longitudinal (L-crack) cracks in wheelpath filled with Indeck. Also, Indeck covering wearing off in wheelpath.

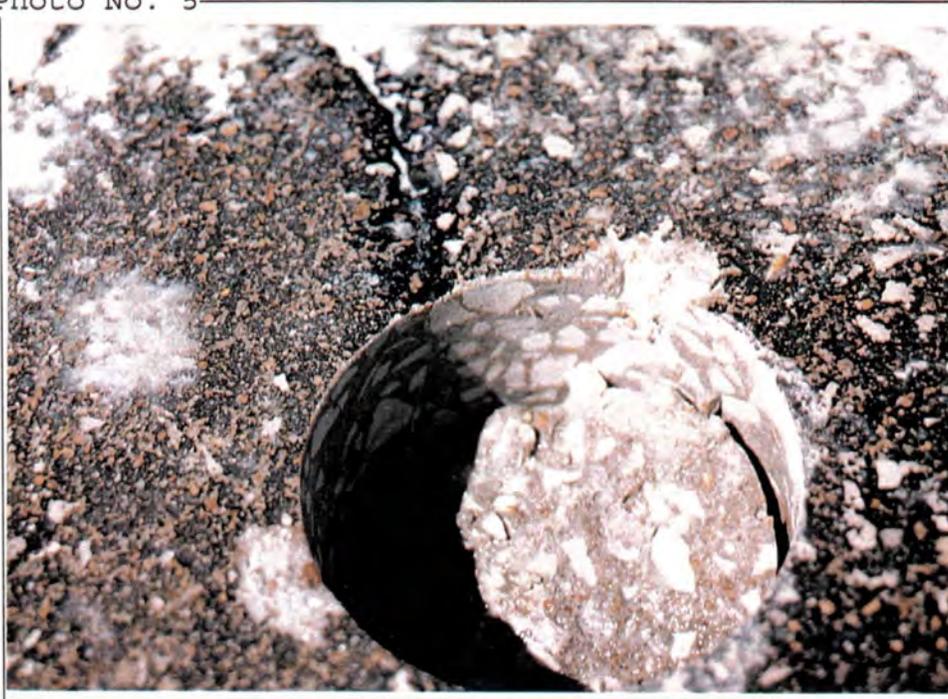
Photo No. 5

Core No. 2 north side of core hole. crack splits with one going down to left and other turns to right. Located in outer wheelpath of driving lane 24' from west abutment.

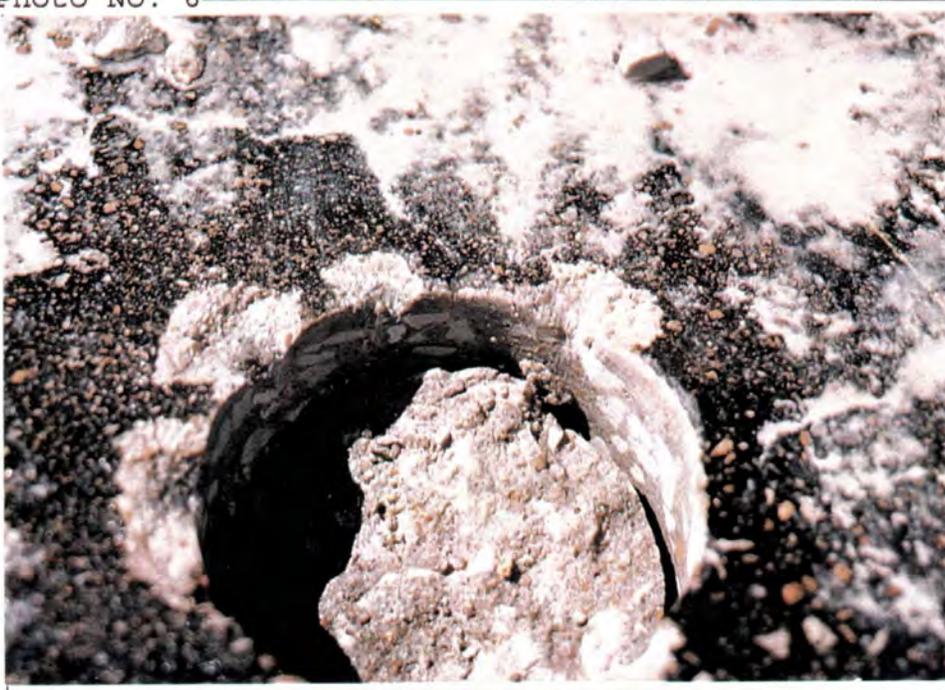
Photo No. 6

Core No. 1, west side hole has fine crack. Located 21' from west abutment in outer wheelpath. NOTE: When core inspected in lab, the crack measured 0.1 mm. The Indeck did not penetrate down the crack. It also didn't fill the crack at the surface.

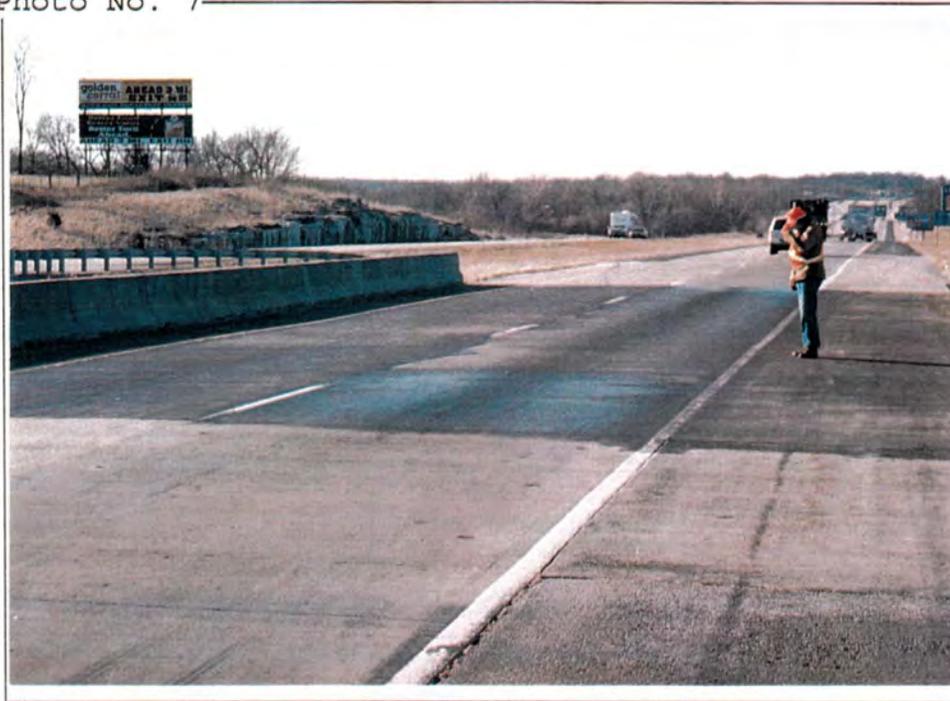
Photo No. 7

Plan view of deck looking south. Note good covering of Indeck still on surface.

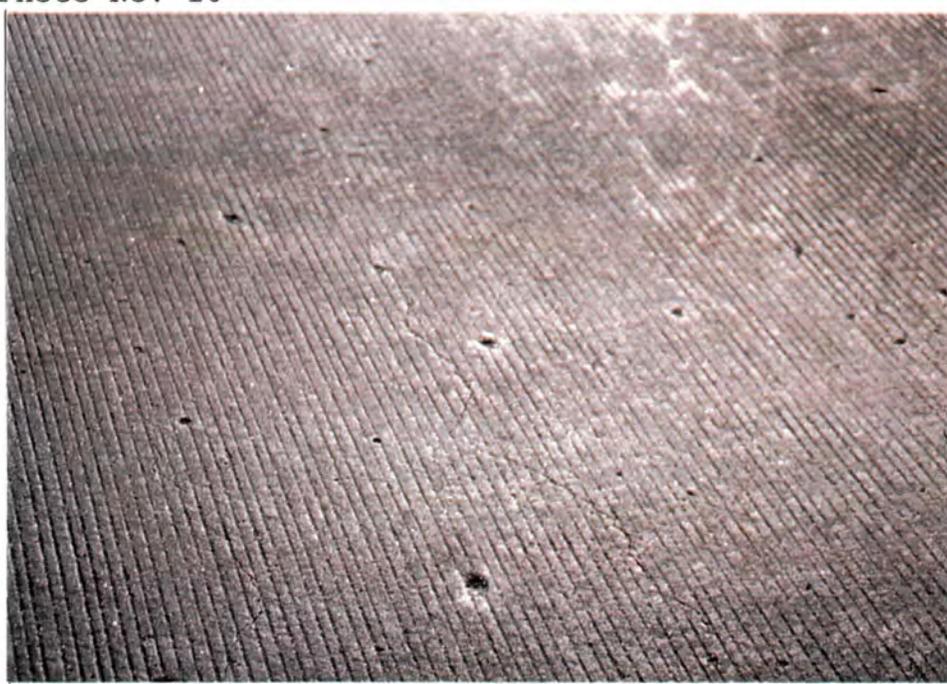
Photo No. 10

T-crack just north of Bent 1.

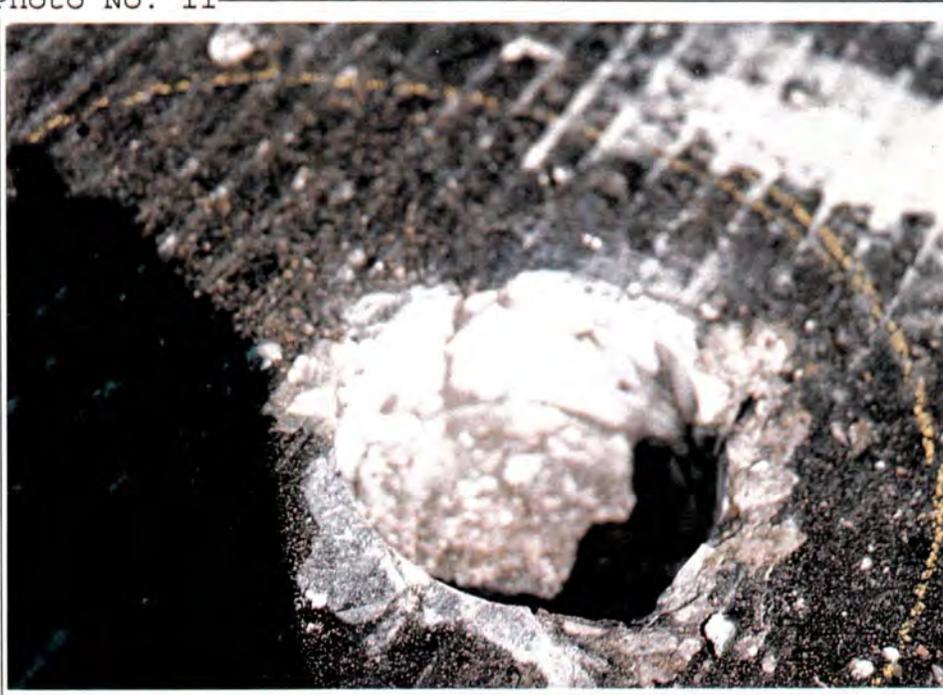
Photo No. 11

NE side hole of Core No. 1. Several cracks, one goes to bottom of core hole.

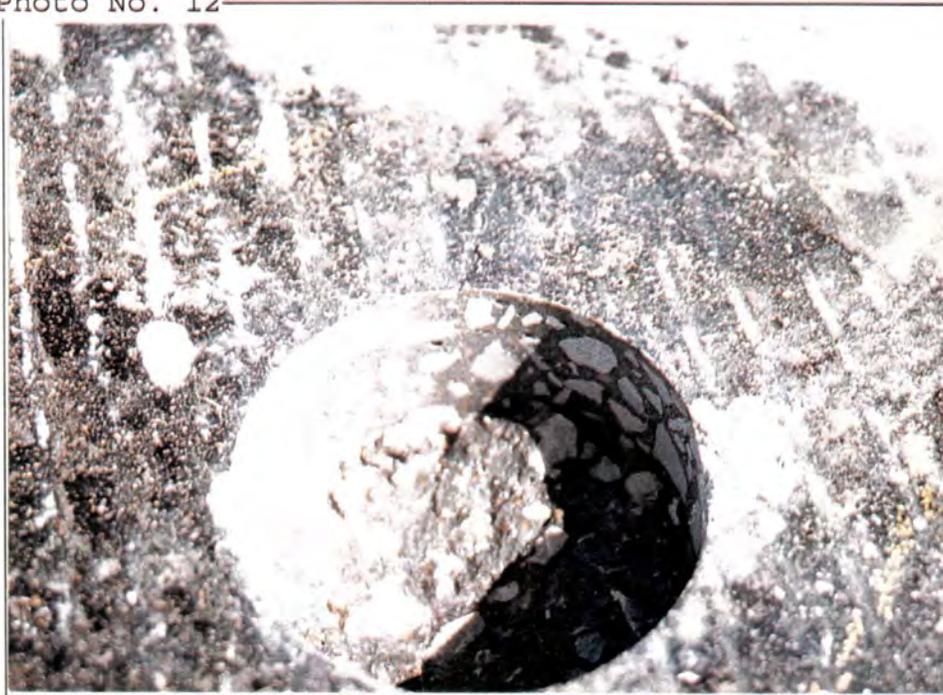
Photo No. 12

West side hole of Core No. 2. T-crack goes full depth of core hole. NOTE: This T-crack was very open (2.75 mm) but the Indeck completely coated it and was still pliable. Within the core, the crack was 0.25 mm and the Indeck penetrated to a depth of 1 1/8".

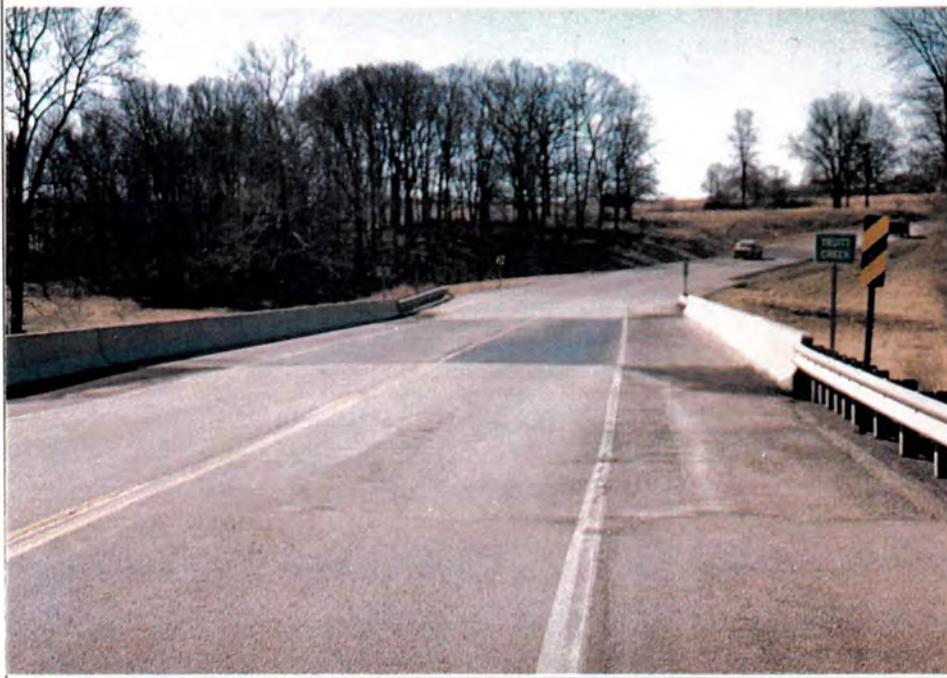
Photo No. 13

Plan view of deck looking south. NOTE: Heavier coverage of Indeck on northwest corner looks shiny.

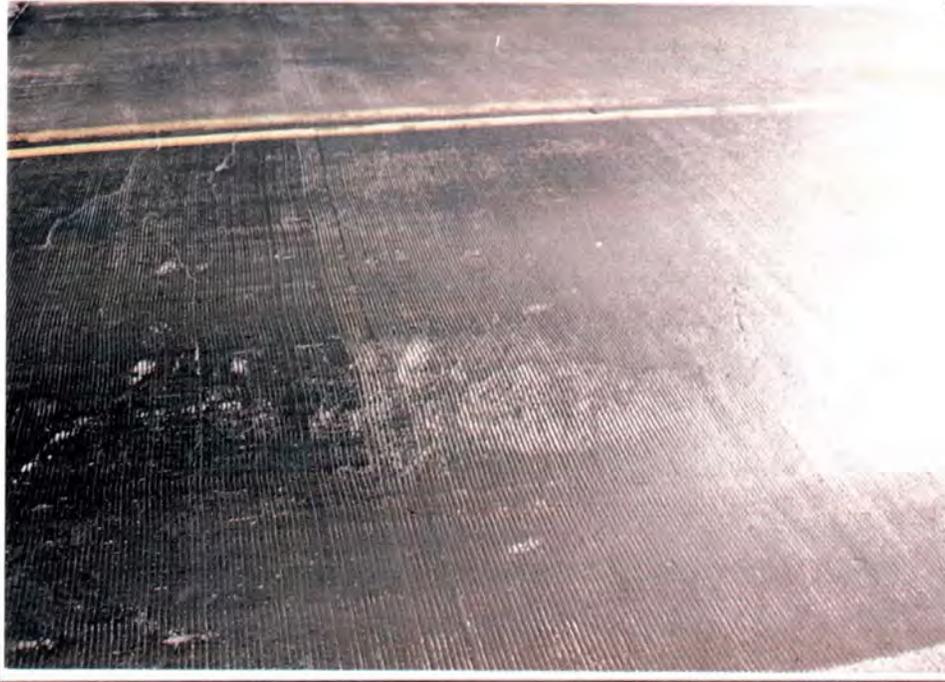
Photo No. 15

Northwest corner of deck shows several open T-cracks in low slump overlay. Also, good coverage of Indeck.

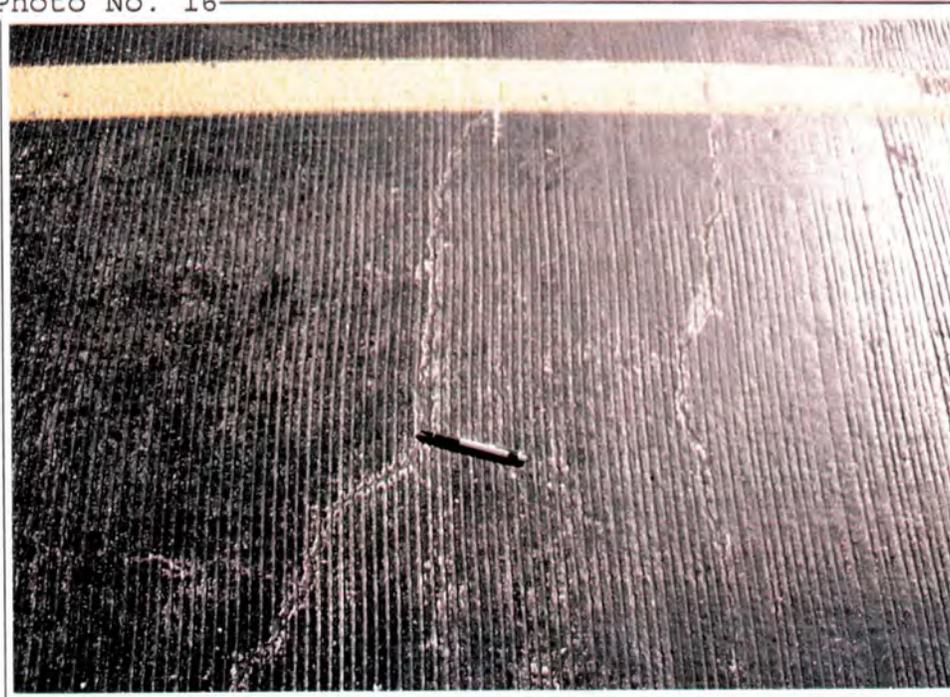
Photo No. 16

Close-up of T-crack showing how well the Indeck filled the crack.

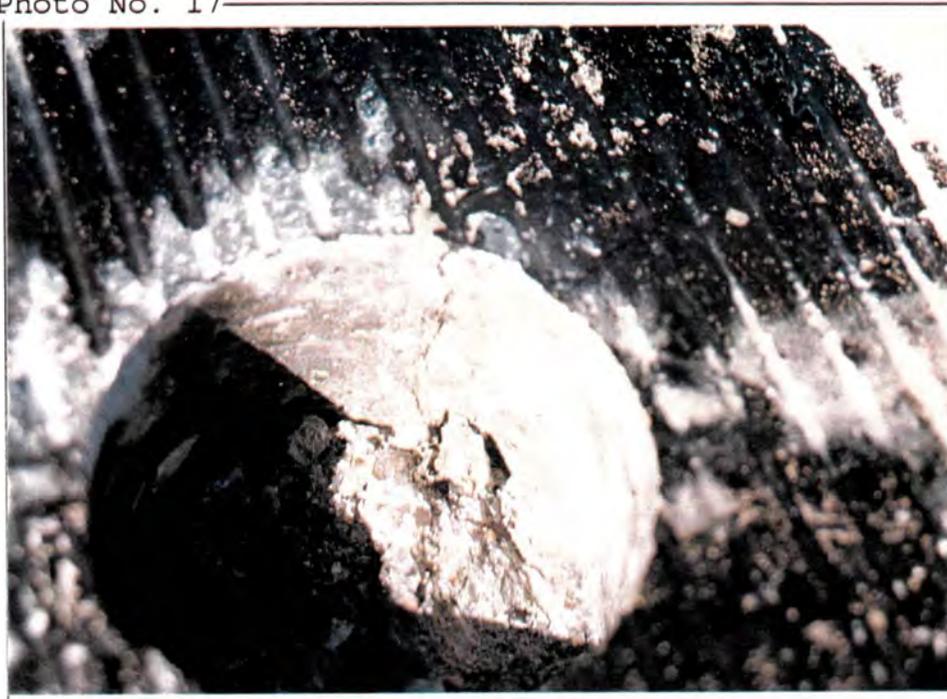
Photo No. 17

West side of hole Core No. 1 showing crack to bottom of hole. NOTE: Drilled 3 1/4" deep and did not get to bottom of low slump overlay. Core located 2" from north abutment in inner wheelpath of southbound lane.

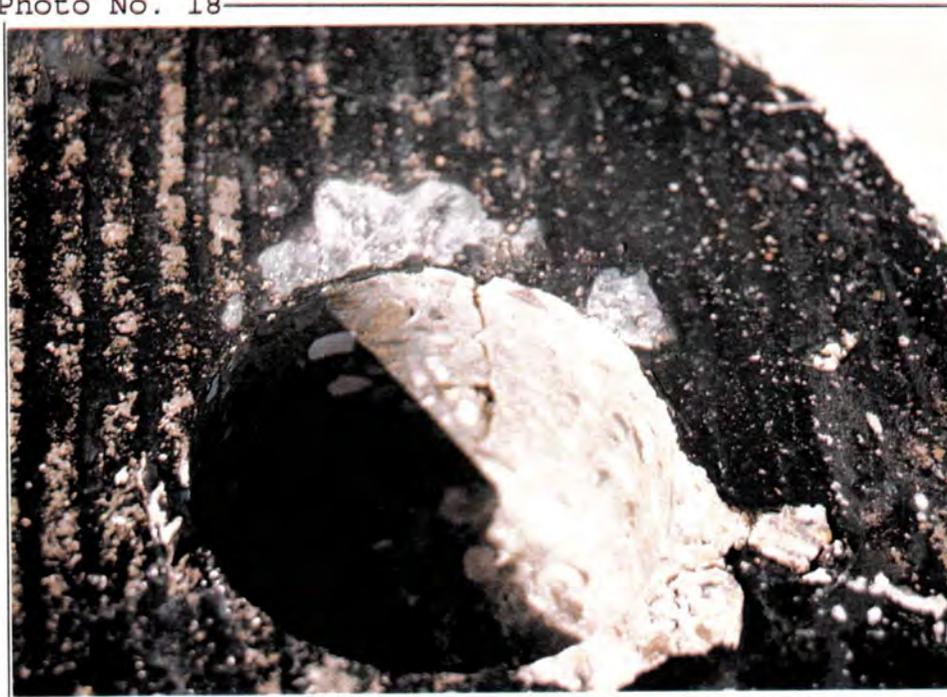
Photo No. 18

Core No. 2, located at center of southbound lane, 6' from north abutment over a large T-crack. West side of hole, crack to bottom of hole. NOTE: Some of excess Indeck peeled off when cored (foreground, right side). Drilled 3 3/4" deep and still within low slump. The bridge originally was flat, shoulders were added and a crown which accounts for low slump being so thick.
