RDT 00-009

Evaluation of Undersealing and Diamond Grinding Rehabilitation

RI86-002 and RI96-017

MISSOURI DEPARTMENT OF TRANSPORTATION
RESEARCH, DEVELOPMENT AND TECHNOLOGY

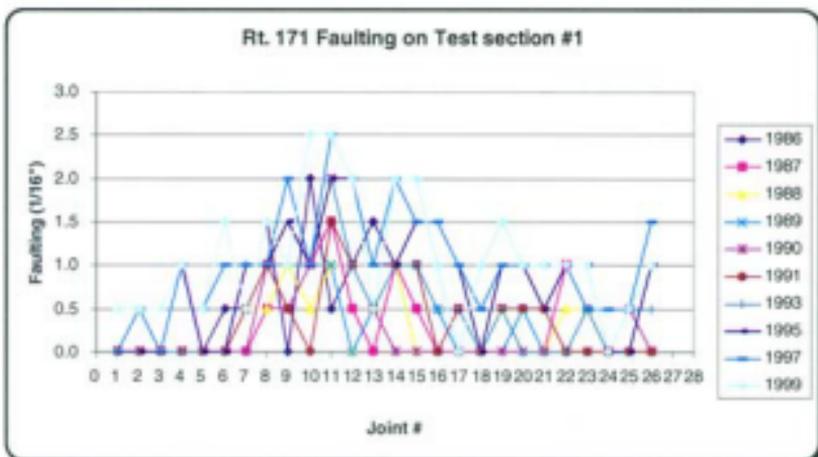
FIGURE 1 Rt. 171 faulting history on Test Section #1

Faulting on the Rt. 171 test sections has increased at a slight pace since 1985. Figures 1 and 2 illustrate the progression at each joint. Each joint fault measurement on the graphs is the average of faulting in the inner and outer wheel paths.

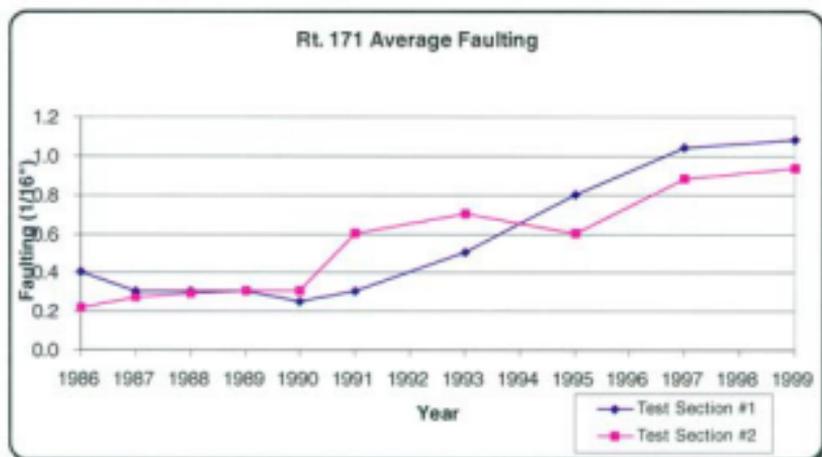
FIGURE 3 Rt. 171 annual average faulting on Test Sections #1 and #2

Average faulting for the entire Test Section #1 (TS1) is slightly over $1/16''$, while average faulting for the entire Test Section #2 (TS2) is slightly under $1/16''$, as shown in Figure 3.

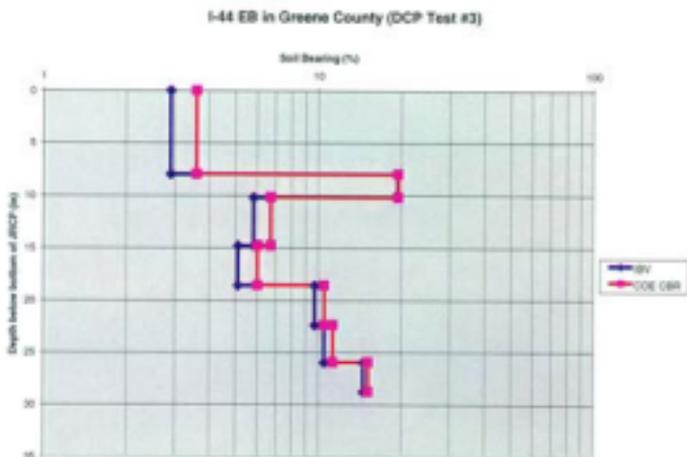
FIGURE 4 DCP results on EB I-44 under old PCCP

DCP testing was performed at several locations in the eastbound driving lane. The penetration index (PI) readings were converted to California Bearing Ratio (CBR) values using a widely adopted Corp of Engineers (COE) formula and to Illinois Bearing Values (IBV), a modified CBR measure that the Illinois Department of Transportation (IDOT) has developed to correlate more closely to their soils. Normally, a CBR value less than or equal to 6 is indicative of a soil requiring stabilization in order to provide adequate support to a pavement structure.

Figure 4 shows rapid DCP penetration under an old section of PCCP after getting past the base material. Figure #5 shows similar results under a recent repair patch, but the immediate high penetration indicates a loss of base material. Both figures clearly illustrate the poor condition of the top 6"-7" of the subgrade.

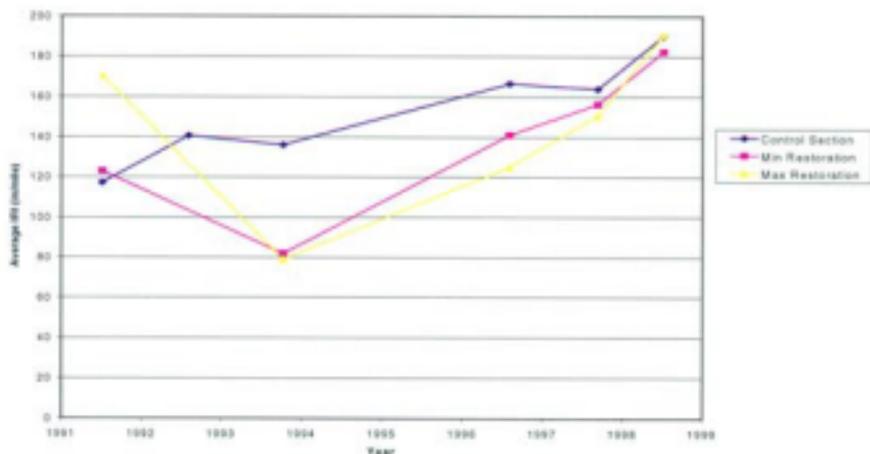
FIGURE 6 I-35 SPS-6 test section IRI performance history

relates to ride (4). Figure 6 shows how the ride on both the minimum and maximum restoration sections at first decreased substantially to a fairly smooth level, but within seven years deteriorated to a level nearly equal with the control section. The initial IRI measurements were taken prior to restoration. Some full depth patch repairs were performed in 1995, but did not appear to interrupt the progression toward higher IRIs.

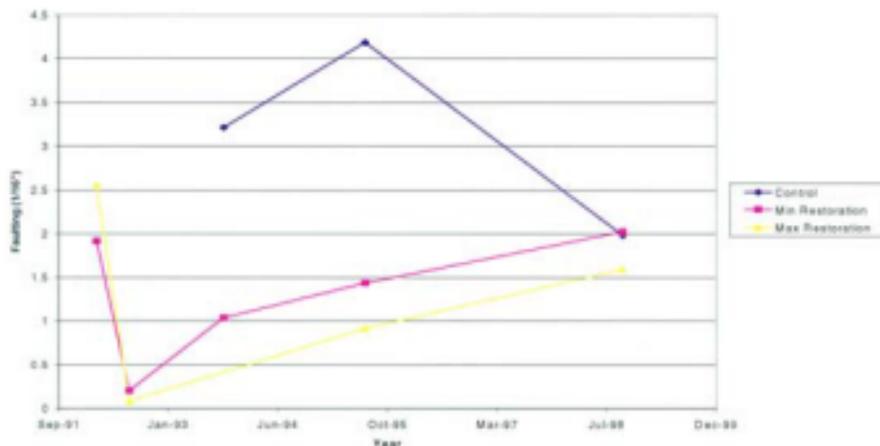
FIGURE 7 I-35 SPS-6 test section faulting performance history

Prior to construction, faulting did not exceed 5/16" at any location on the minimum restoration section and did not exceed 7/16" at any location on the maximum restoration section. The results of the subsequent surveys are shown in Figure 7. The August 1992 survey, conducted soon after construction, indicates virtually no faulting at the joints of the two restoration sections. The full depth patch repairs performed in 1995 occurred mostly at transverse cracks and did not result in any noticeable improvement in joint faulting. The control section underwent multiple maintenance repair operations, which explains the noticeable improvement after 1995. Average wheel path faulting measured during the last survey shows the three sections approaching the same value.
