## Fiber-Reinforced PCC Unbonded Overlay I-29 Atchison County – Performance Update

Missouri  
Department  
of Transportation

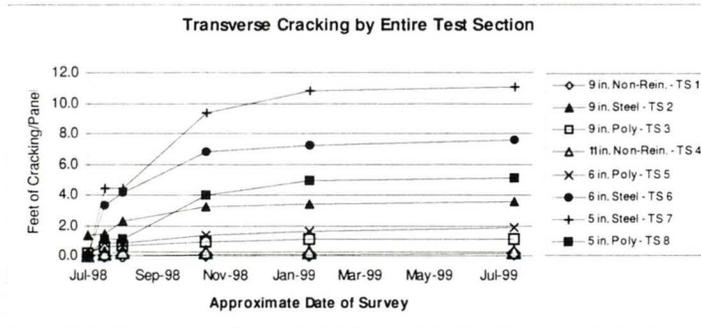
**Figure 1**

Figure 1 shows the amount of transverse cracking for all test sections. This figure represents the relative amount of cracking in each section. Detailed analysis of the cracking is present in the full report, "Evaluation of Fiber-Reinforced Unbonded PCCP Overlay". Some trends with regard to transverse cracking are apparent. Thinner sections exhibited more cracking than thicker sections; longer panels exhibited more cracking than shorter panels and the steel fiber-reinforced sections exhibited more cracking than the polyolefin fiber-reinforced sections.
