MoDOT

RDT 04-004

Void Detection with the Falling Weight Deflectometer

Final Report

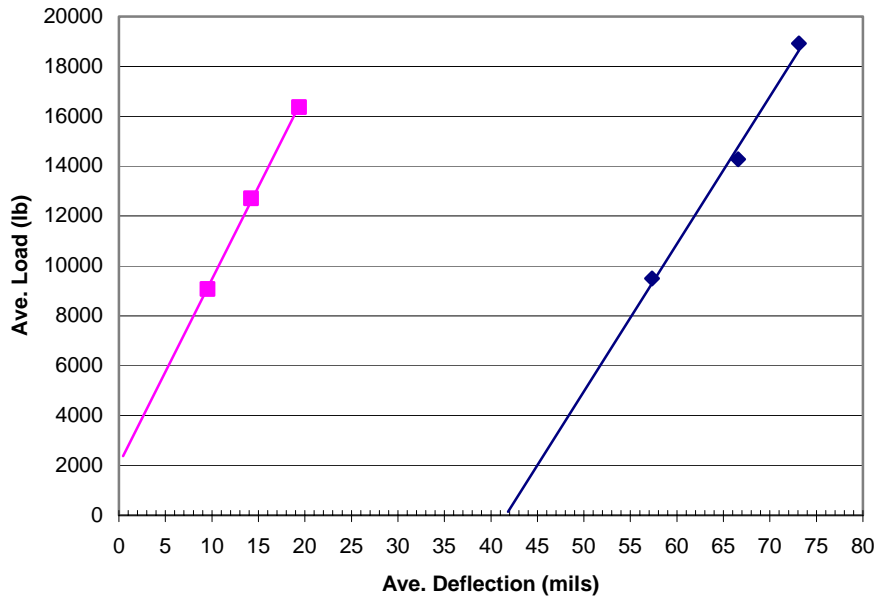
I-44 WB at Bridge A-936 in Lawrence Co.
4th Approach Slab

Sixteen of the 22 slabs showed positive reduction in deflections after undersealing. The average reduction for the 16 improved slabs was 12.70 mils. The reduction for the 4th slab on the approach side of Bridge A-936 was more than double the next highest improvement, so that the average was skewed somewhat by this statistical outlier.
