Slab Stabilization

TECH BRIEF

*This document is a brief technical summary of the MoDOT case study **Slab Stabilization Case Study for Missouri** which is included in a larger report, **Concrete Repair Best Practices: A Series of Case Studies**, Publication no. cmr 17-013, November 2017.*

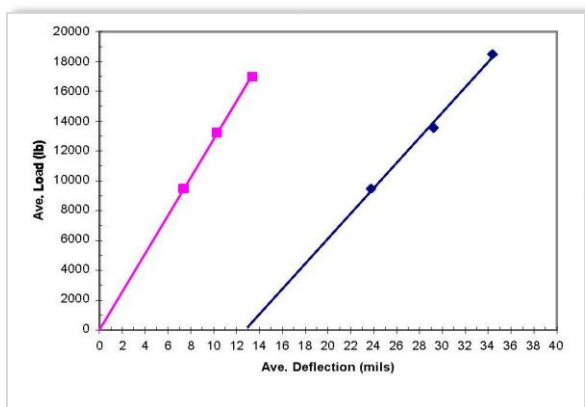
Figure 1. FWD load versus corner deflection before and after undersealing. Note that “after” undersealing the deflection vs. load line goes through the origin indicating restored support).

The “Before Undersealing” plot does not extend through the origin but along the “Deflection” axis, indicating a loss of support beneath the slab/stabilized base (e.g., high deflection for a given load). Once the joint has been injected with material (polyurethane, in this project), the post-stabilization (or undersealing) FWD load-deflection plot extends directly through the origin, indicating that the loss of support has been filled and full support has been restored with a much lower deflections. Missouri DOT concluded that, “The FWD is an efficient tool to use for void

detection under PCC pavement slabs, assuming the rapid void detection procedure is correct. Plotting the linear trend for load-versus-deflection before and after undersealing is simple. The assumptions about linearity, within the 9,000 to 16,000 (lb) range, appear to be accurate based on the plots.” (Missouri DOT, 2004)
