INVESTIGATION OF BRIDGE PIN FAILURES

MISSOURI  
HIGHWAY AND TRANSPORTATION COMMISSION

FINAL REPORT  
to  
Missouri Highway and Transportation Commission  
on  
INVESTIGATION OF BRIDGE PIN FAILURES

November 15, 1987

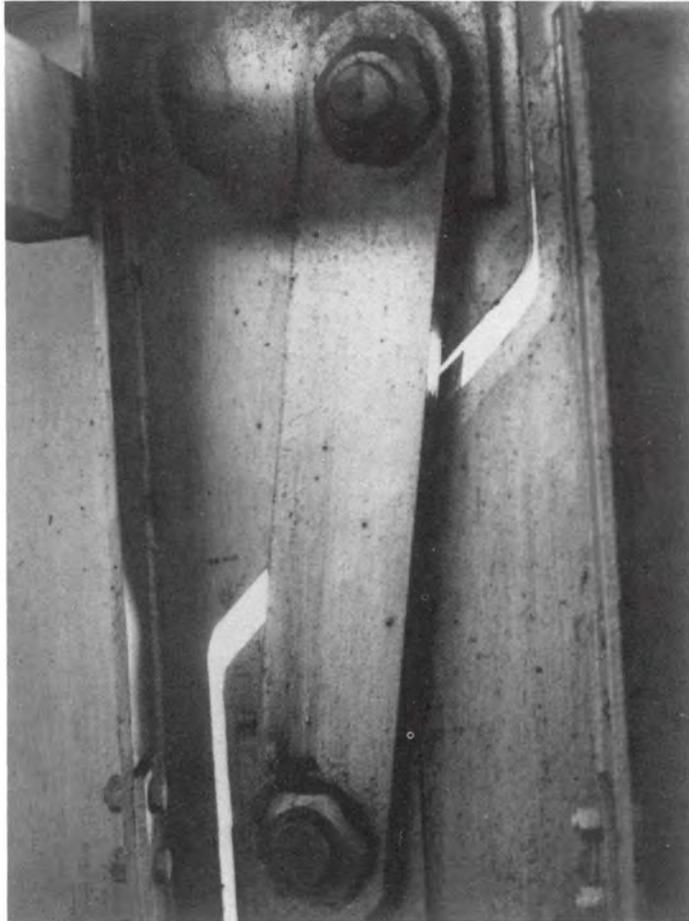
Figure 1: The pin and hanger strap system of support from the Thayer bridge, illustrating the nature of the connection.

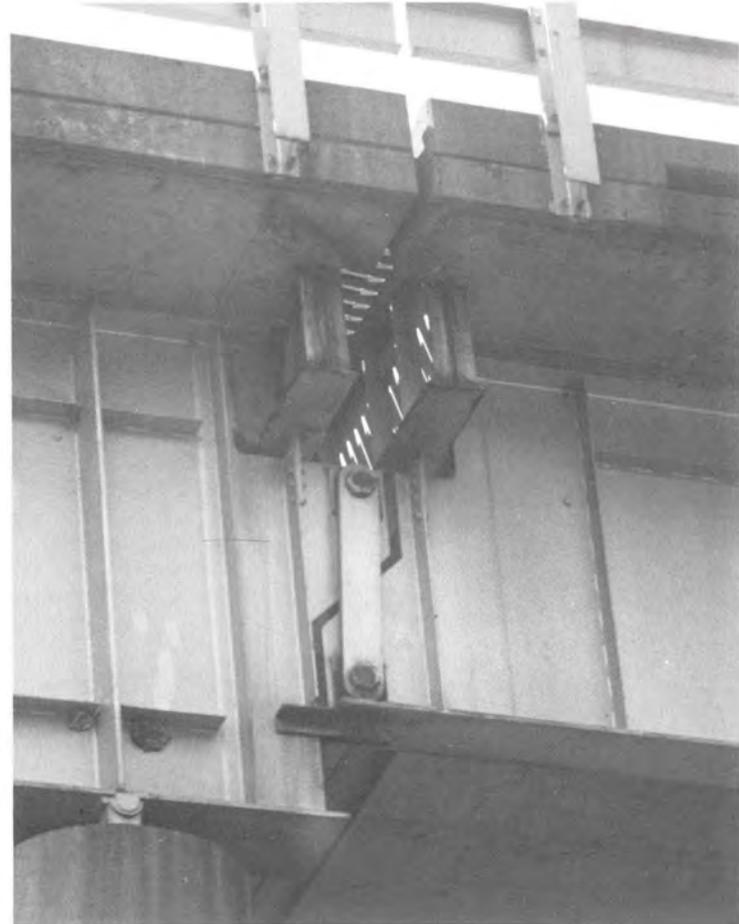
Figure 2: The pin and hanger strap system of support from the Highway B bridge south of Jefferson City. Note that the connection is situated directly below the opening in the road-way.

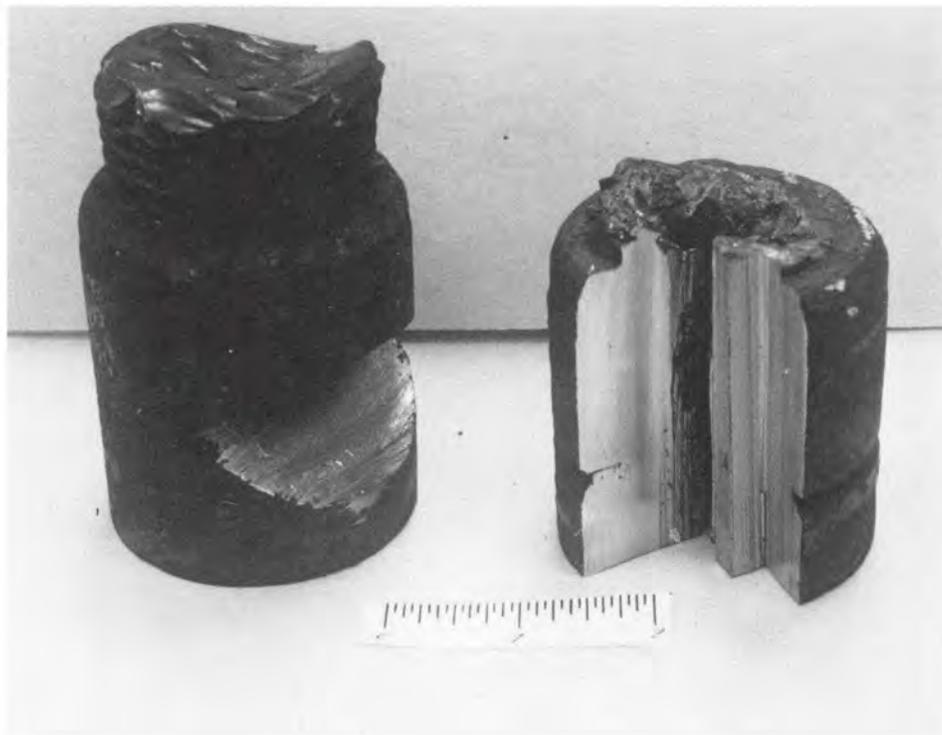
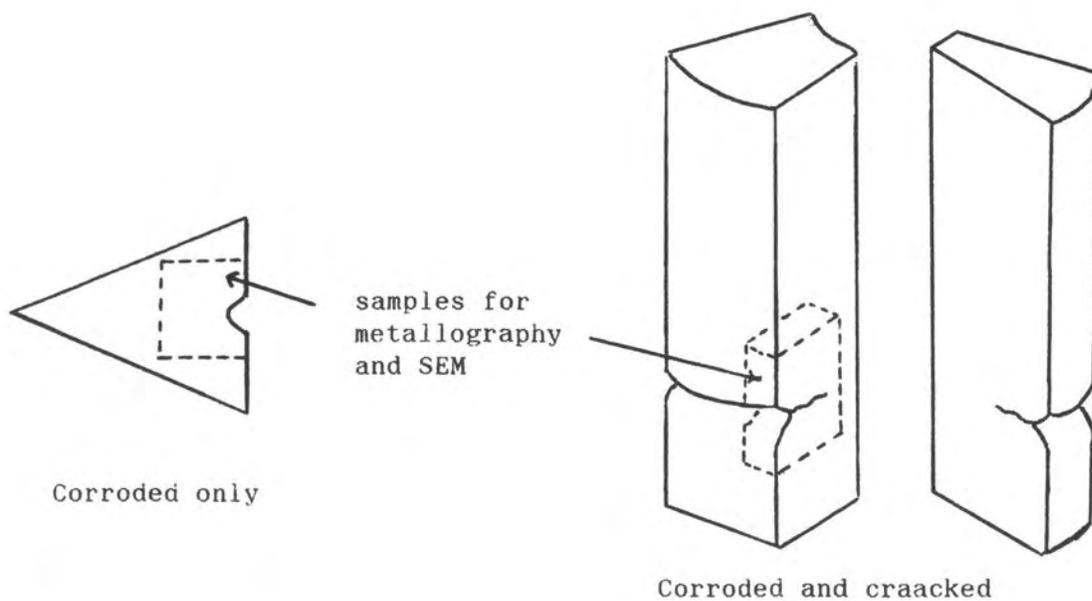
Figure 3: The full pin from the I-55 bridge after sectioning. The pin was first cut into two halves. Additional slices were then obtained from the two halves to provide samples for metallographic and SEM inspection. One of the longitudinal slices was fractured so that the actual crack surface could be observed, shown in greater detail in Figure 4.

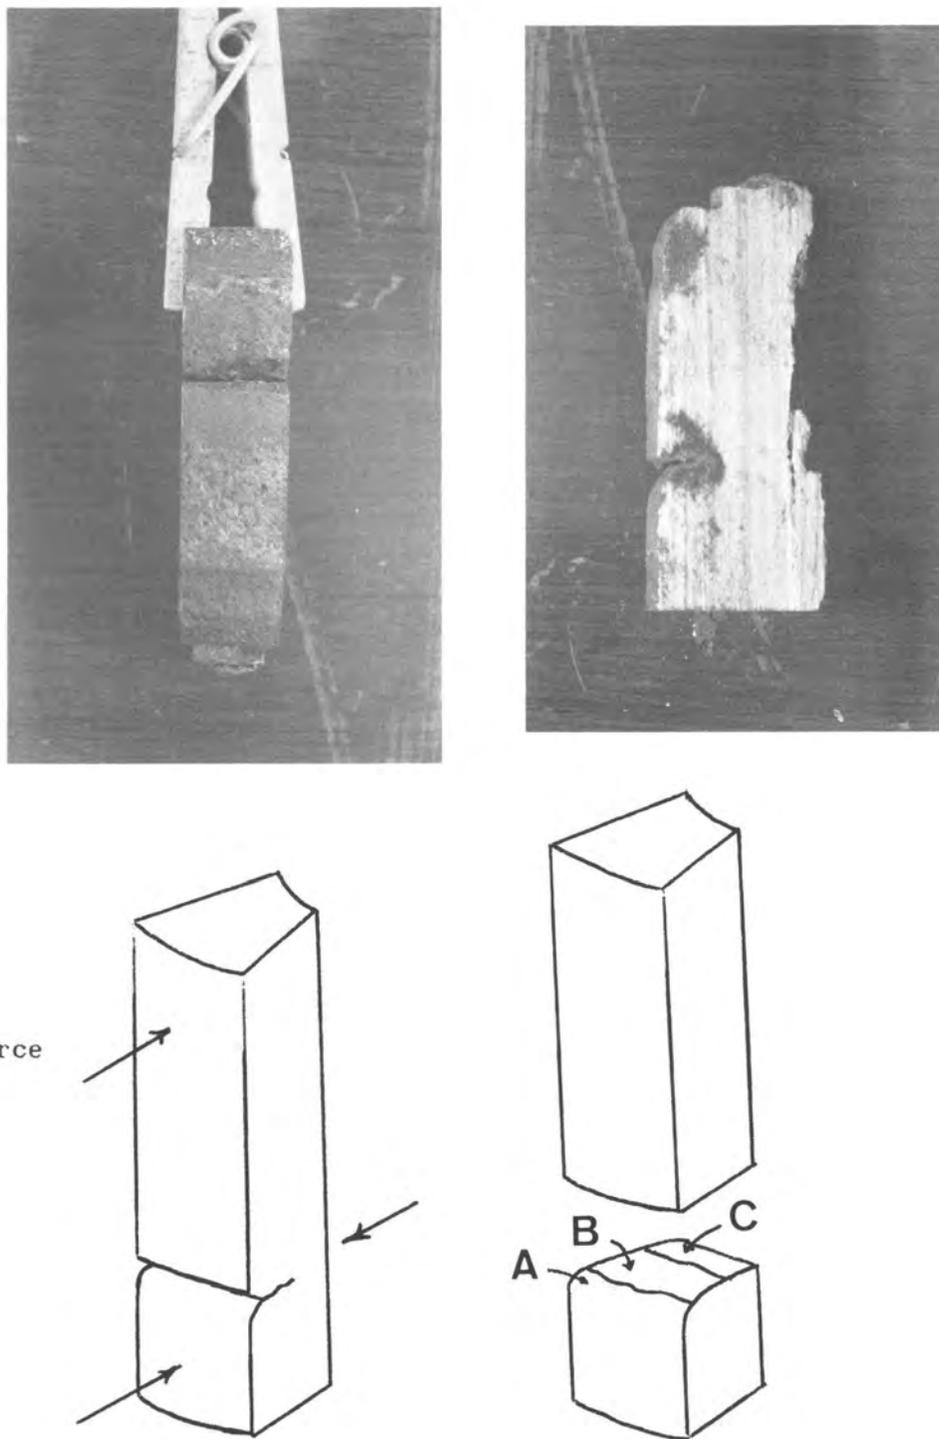
Item #1: The full pin from the I-55 bridge contained two circumferential regions of damage -- one area consisted of a shallow corrosion pit or groove with no visible indication of crack nucleation while the second area consisted of a deeper corrosion pit or groove from whose base a crack had formed. Sections were removed from this pin using a band saw. Figure 3 illustrates some of the cuts that were made. Samples were prepared for metallographic and SEM examination from locations that were only corroded and locations that were both corroded and cracked. In addition, a section was removed in such a manner that the section still contained the crack, Figure 4. This section was trimmed to a suitable size, then fractured; the final surface contained both the crack surface as well as a fresh fracture surface. The surface of the fractured specimen was examined with the SEM.

Figure 4: One of the wedge shaped samples cut from the full pin was fractured, revealing a surface composed of part corrosion pit (a), part corrosion surface that was a part of the crack (b), and a fresh fracture surface (c).

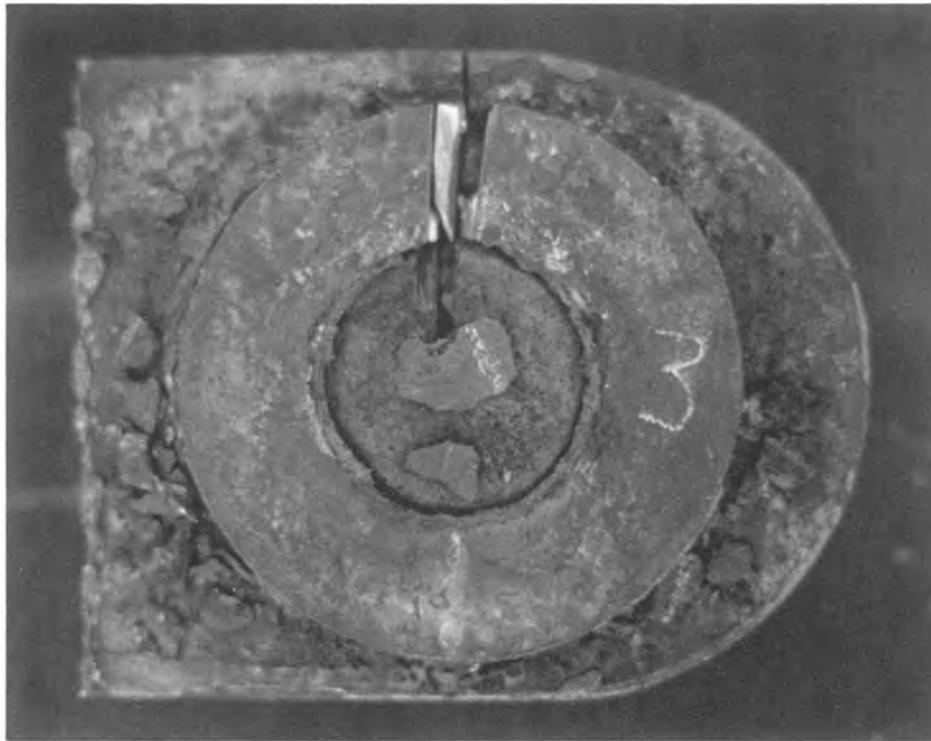
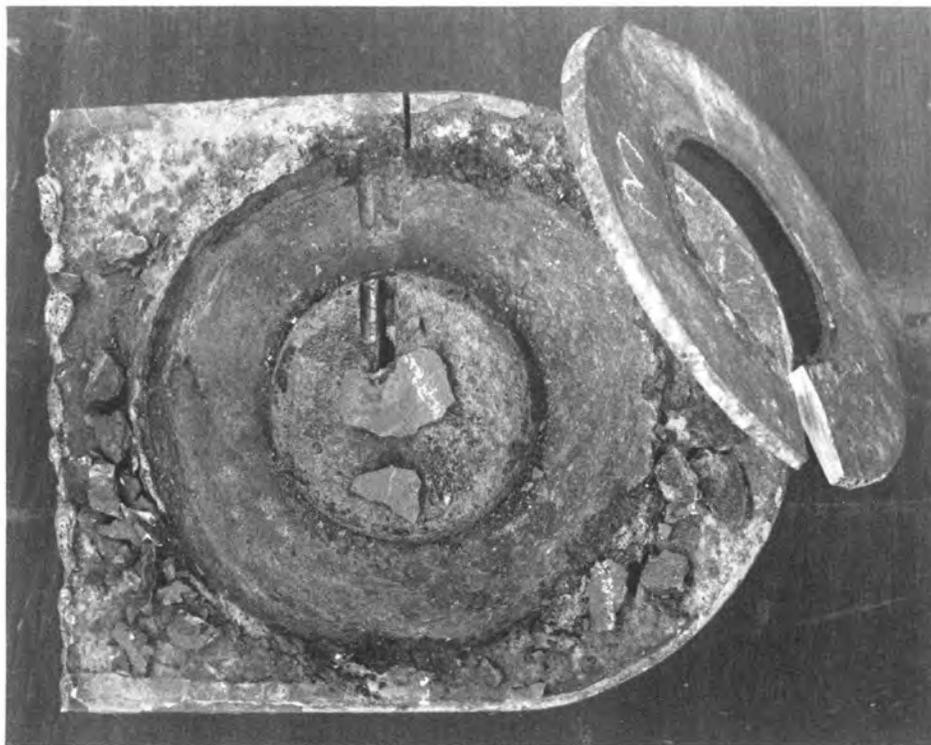
Item #3: This item included a hanger strap-pin-washer junction from the I-55 bridge. This particular pin had actually fractured completely while in place in the bridge; the hanger strap had previously been cut by the Highway Department during their repair. The bronze washer, which was on the opposite side of the strap from the nut, was about flush with the fracture surface of the pin and was still firmly attached to the strap and pin. Initial attempts to cut the strap section containing the bronze washer with a band saw were unsuccessful because of the hardness of the bronze washer. Instead, a power saw with an abrasive wheel was used to cut through the washer. As this was being done, a layer of corrosion product (about 1/16 inch thick) popped off the fracture surface of the pin. Figures 5a and 5b show the section after the cut with the abrasive wheel -- the two fragments on the pin surface are a portion of the remains of the

oxide that popped off during cutting; originally the entire fracture surface of the pin was covered with this material. In addition, at this time the washer separated from the strap.

Figure 5: Photographs of the pin-strap piece containing the bronze washer. (a) The piece after the bronze washer was cut with an abrasive wheel. (b) The piece with the washer removed, showing the thick layer of corrosion product between the washer and the strap, two pieces of corrosion product originally on the pin fracture surface, and the start of the band saw cut.

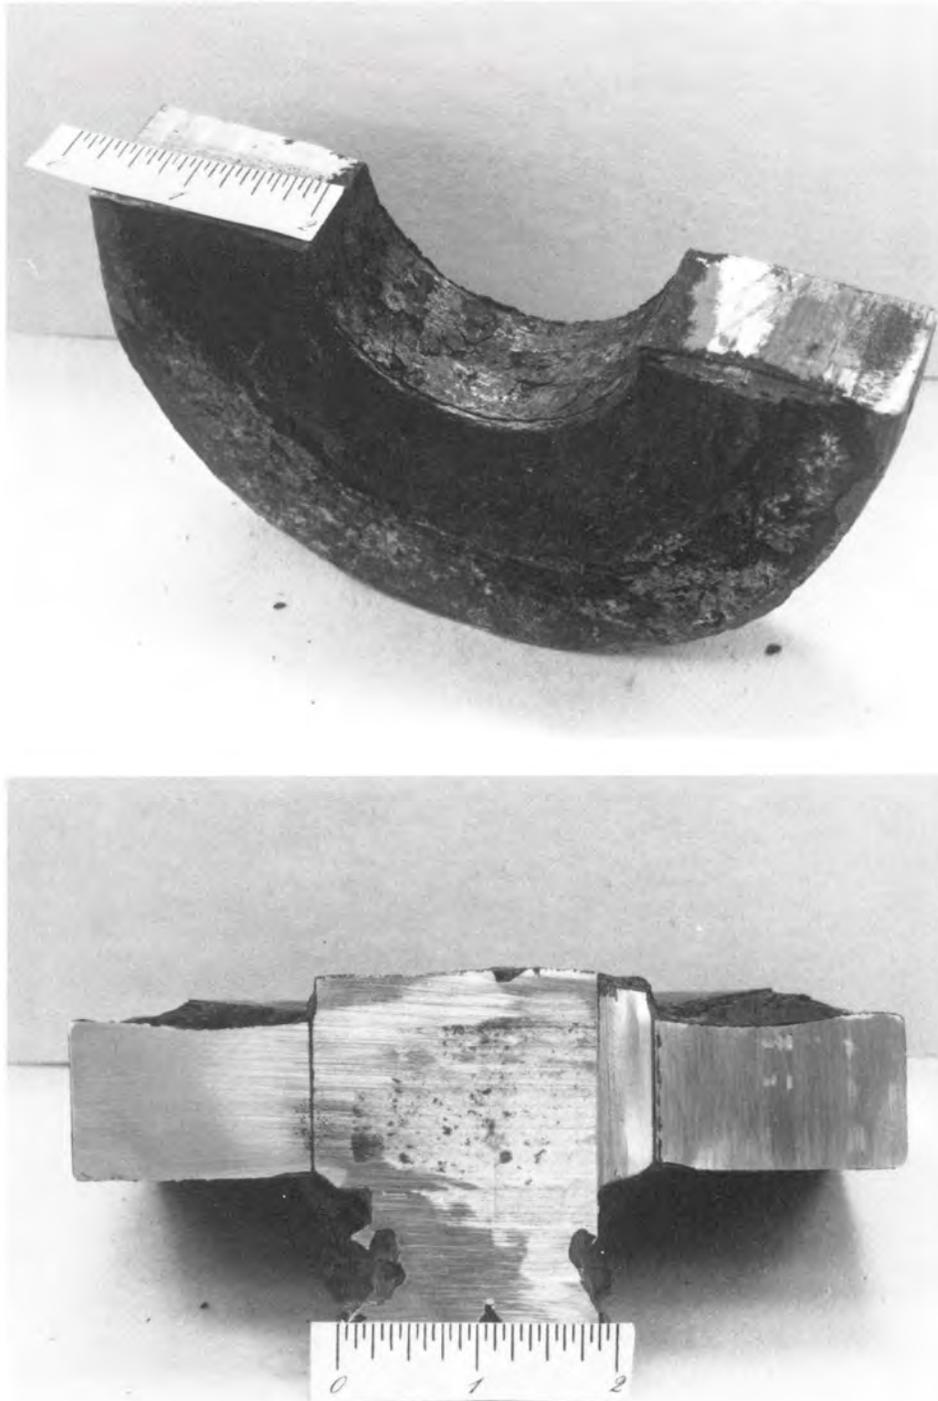
The cut through the strap and pin was then completed with a band saw and, in addition, another section was removed to include the pin-strap interface, Figure 6. This interface was later examined metallographically. The pin fell loose from half of the strap during this cutting process. There was some very thin loose corrosion product between the strap and pin; this product was responsible for freezing of the joint but was not strong enough to firmly hold the pin in the strap after the junction was sectioned. There was a layer of corrosion product (about 1/8 inch thick) between the strap and the prior location of the bronze washer, as can be seen in both Figures 5b and 6. A portion of this layer popped off during cutting and was also saved. Both the corrosion product on the fractured surface of the pin and the product between the strap and washer were examined using the SEM.

Figure 6: Photograph of the pin-strap piece after the band-saw sectioning was completed. (a) Half of the pin fell out of the strap after sectioning was done; (b) the other half remains fixed in the remainder of the strap. In (b), an extra cut was made on the right side so that the interface between the pin and strap could be examined. Note the thick layer of corrosion on the strap at the top of the photograph, with significant metal removal from the strap material.

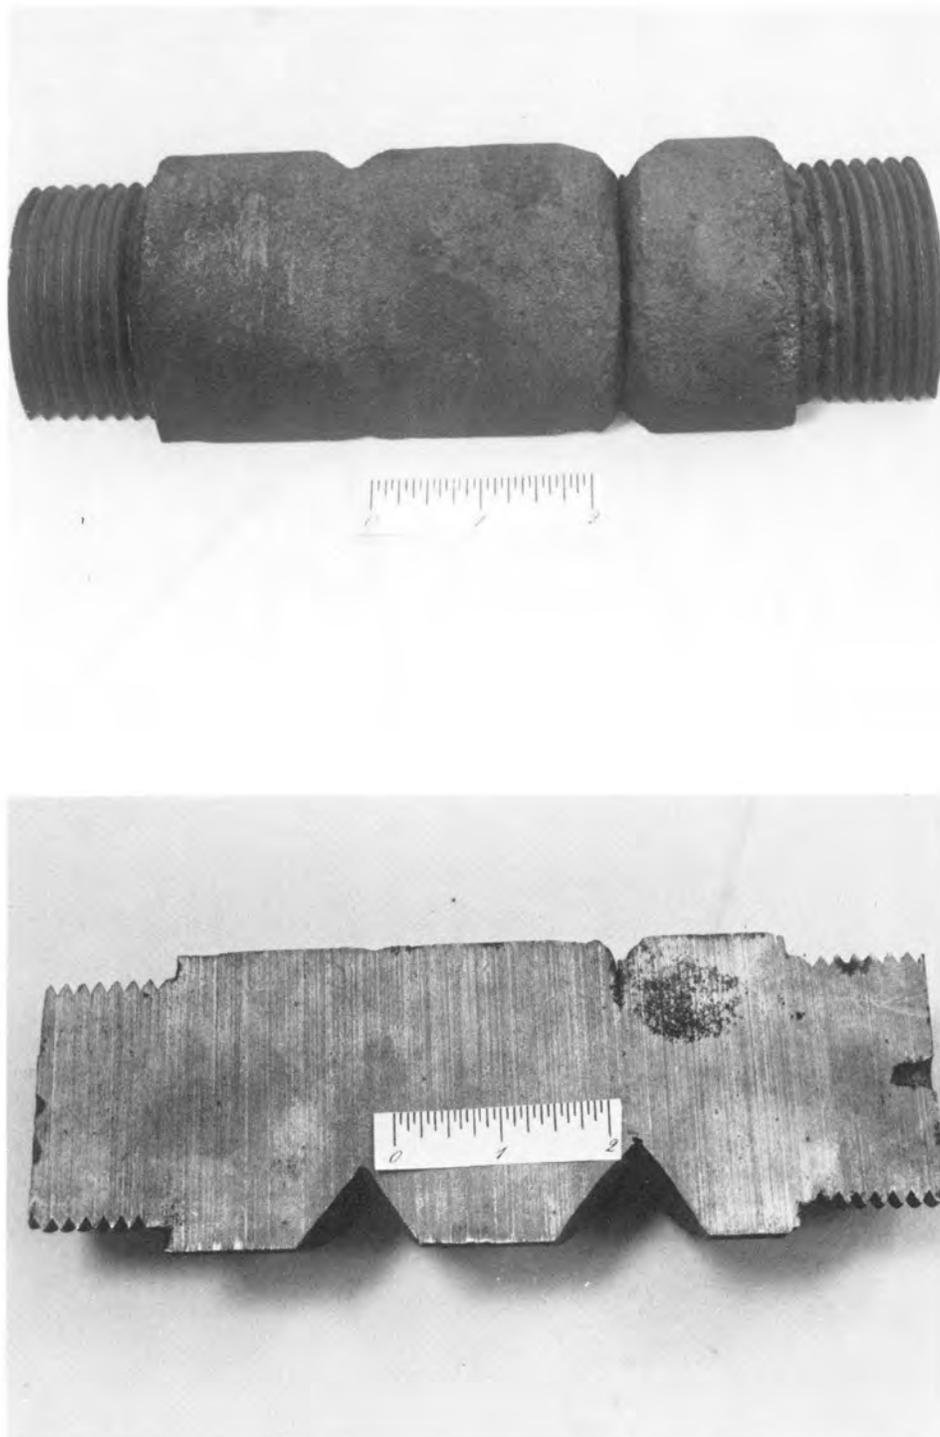
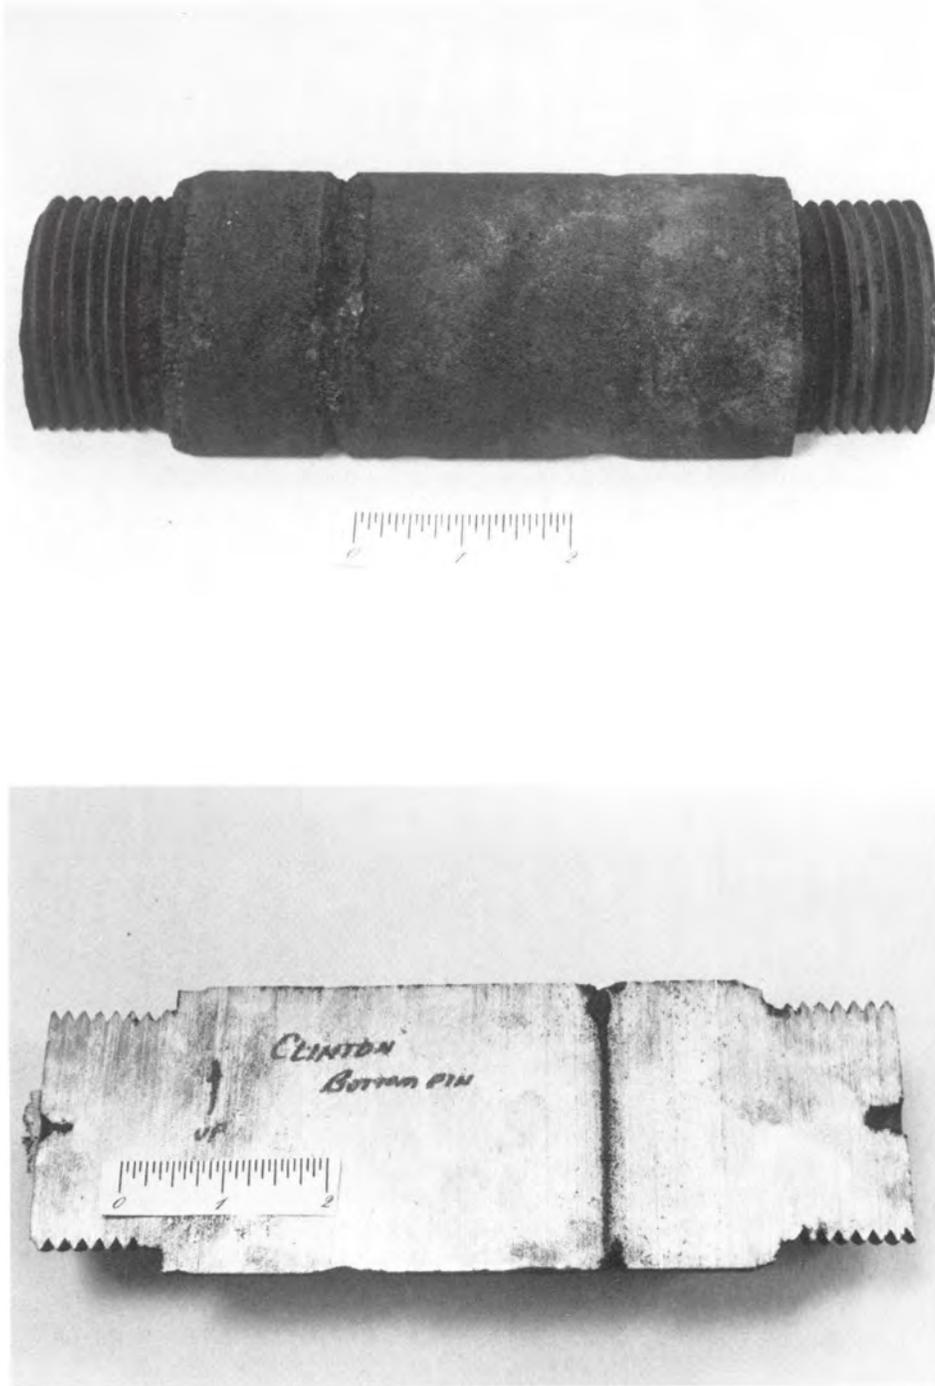
Item #5: As in the I-55 bridge pins, both of the Clinton pins contained two areas of circumferential corrosion. One area contained corrosion only while the second area contained both corrosion and deep cracks. Using the band saw, both the top and bottom pins were cut longitudinally. Figure 7 shows the outside surface as well as the cross-sections of these pins. Two samples were removed from the top pin -- one from the corroded area and one from the corroded and cracked area. These samples were also examined microscopically and with the SEM. Although the bottom pin was also cut longitudinally, no additional samples were removed.

Figure 7: Photographs of the Clinton pins. Note that only mild corrosion occurred at one pin-strap-web junction but deep corrosion and cracking occurred at the second junction on each of the pins. Cracks were about 1/2 inch deep, with combined corrosion plus crack extending about 3/4 inch beneath the original pin surface.

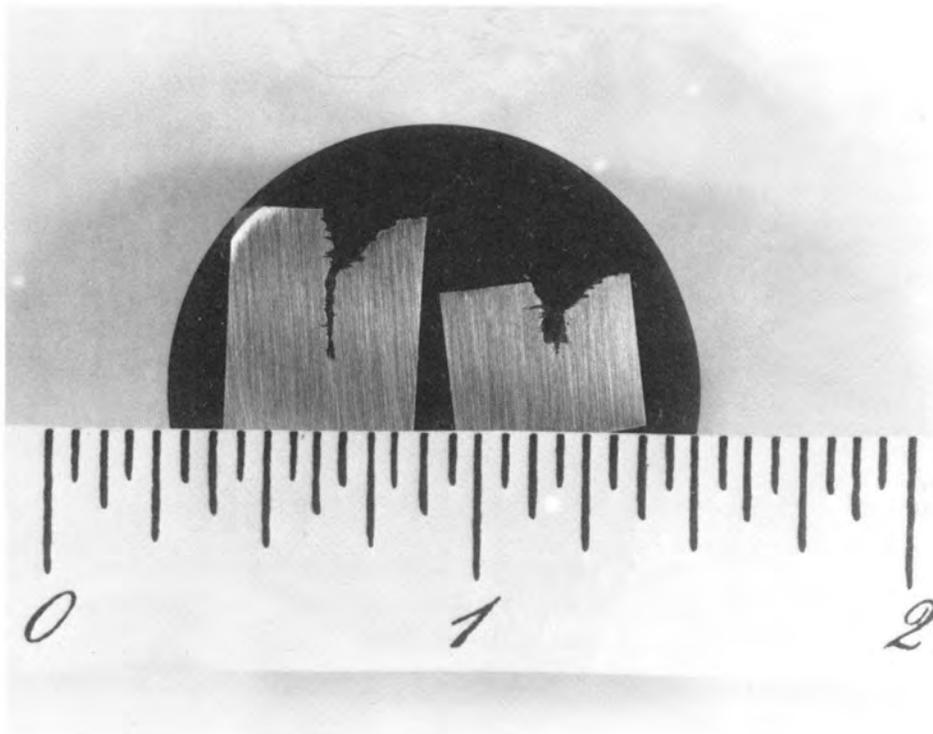
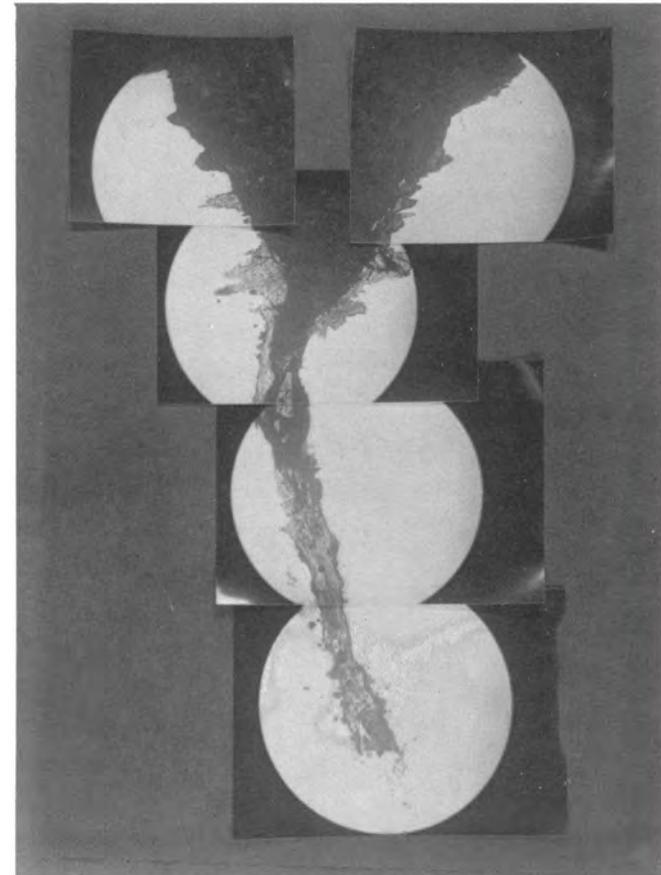
Figure 8: Mounted samples and composite crack photograph in the I-55 full pin. The crack begins at the base of a deep corrosion pit and, in this case, propagates about  $3/16$  inch further into the pin. The total corrosion and crack is nearly  $3/8$  inch.

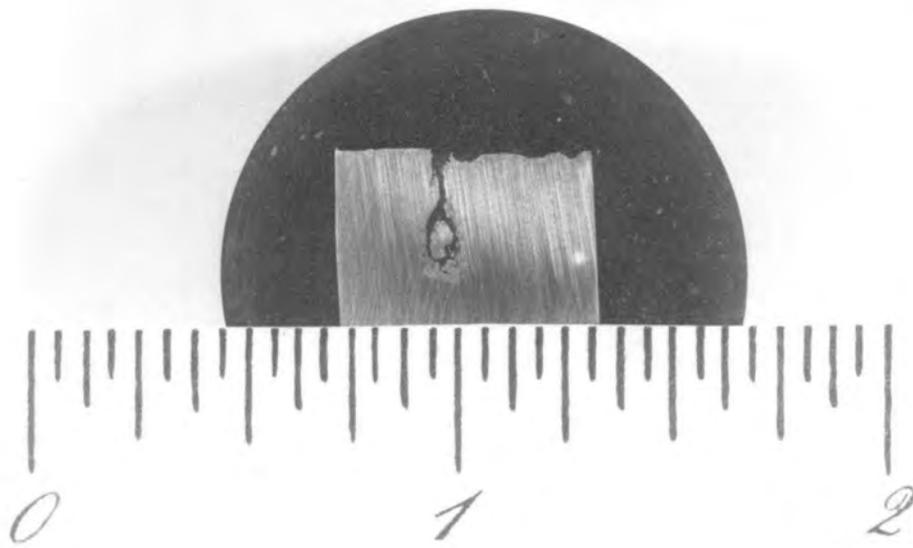
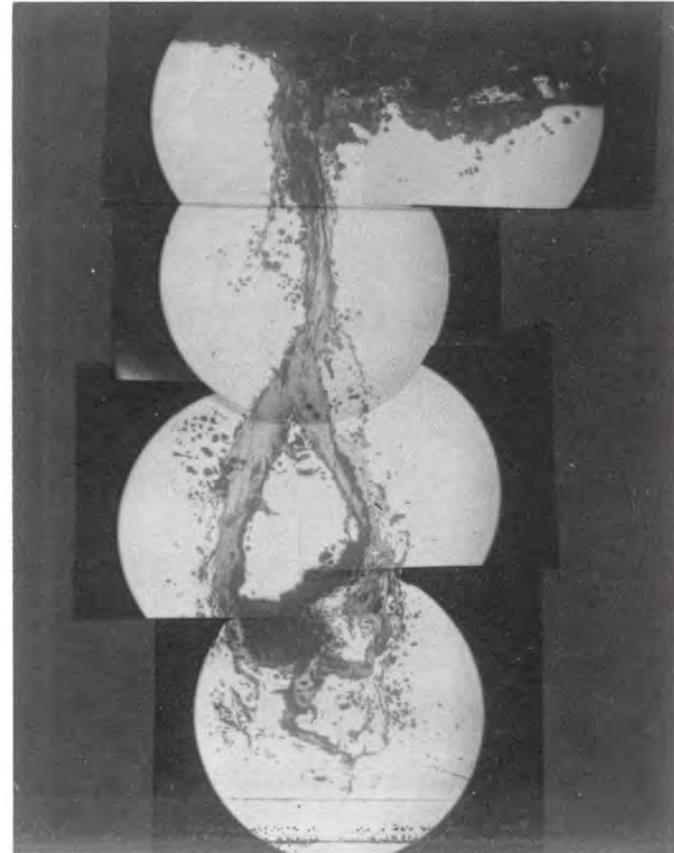
Figure 9: Mounted sample and composite crack photograph from the I-55 half pin. In this case, there is virtually no corrosion pit but the crack extends over 1/4 inch beneath the pin surface. Particularly in this example, extensive branching of the crack and corrosion near the crack is evident.

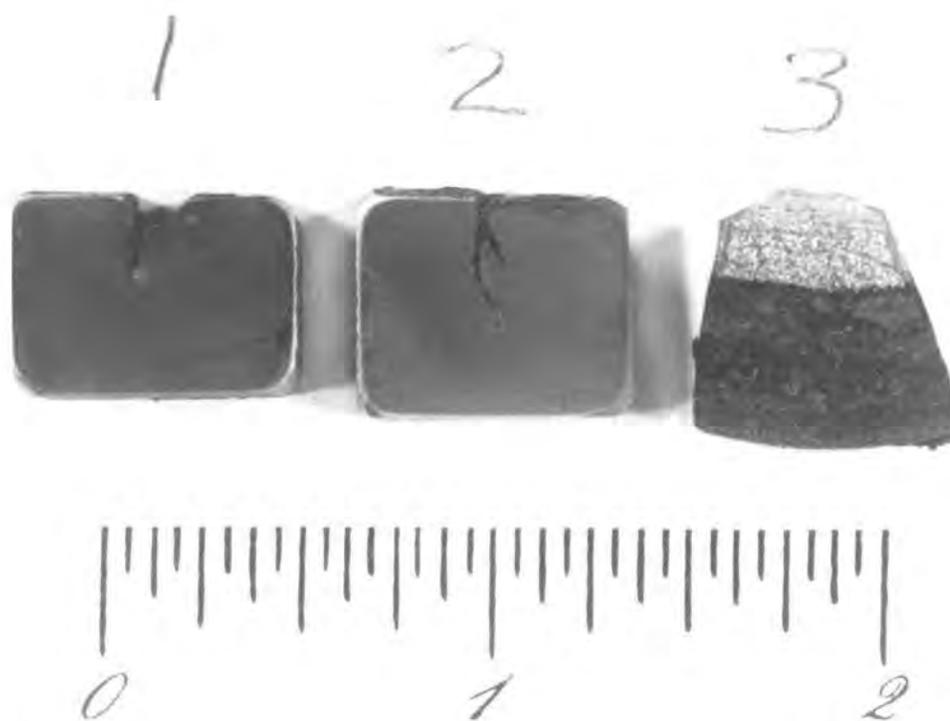
Sample 1: This sample was removed from the full pin from the I-55 bridge. It contained a large rounded corrosion pit with a short crack at its base. This pit with crack was located on the pin adjacent to the interface between the strap and web. The sample was polished through 600 grit polishing paper before the examination and is Sample 1 shown in Figure 10.

Figure 10: Photographs of samples from the I-55 bridge that were examined using the scanning electron microscope. Sample 1 was obtained from the full pin and has both a corrosion pit and a crack; sample 2 was obtained from the half pin and contains a branched crack with little corrosion pit; and sample 3 is the actual crack surface obtained from the full pin. The interface between the bright and dark region denotes the end of the crack -- the bright surface was fractured during preparation of the specimen.

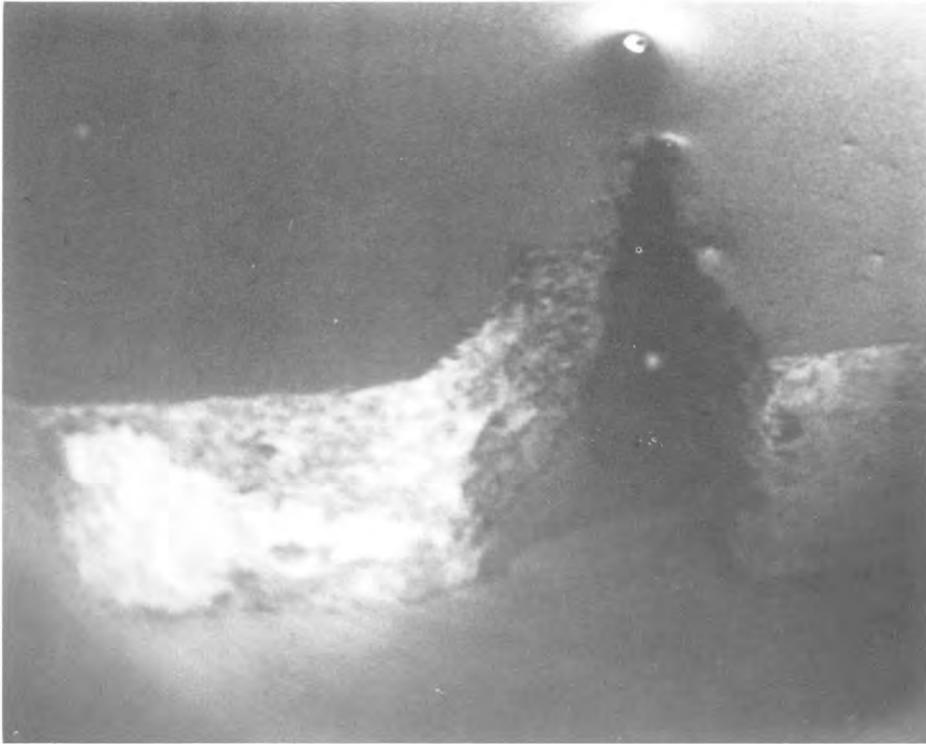
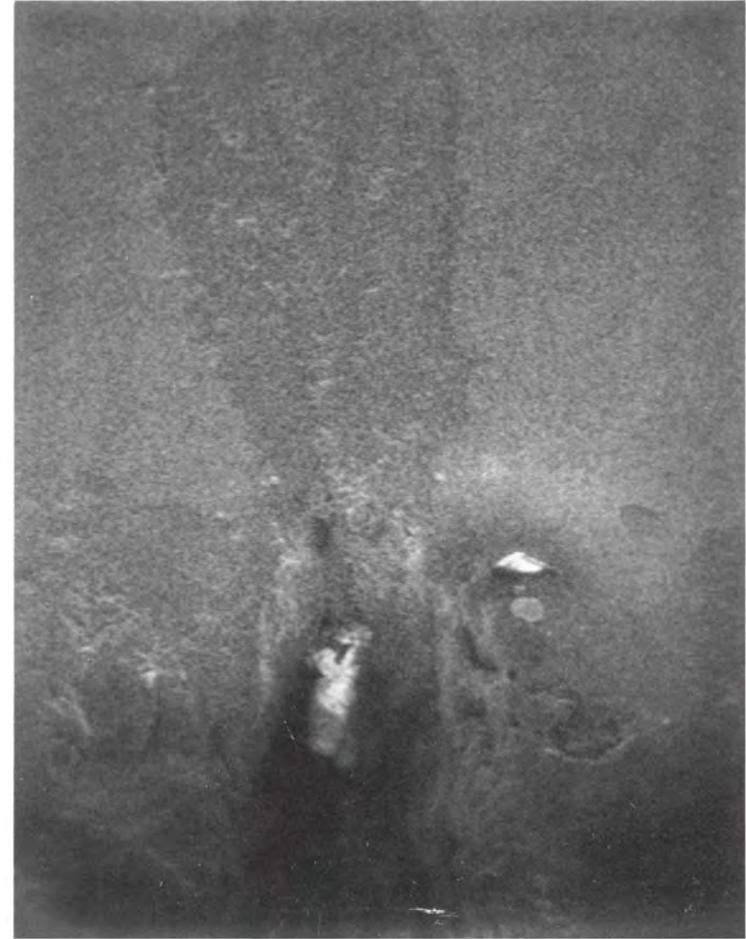
Figure 11a shows the corrosion pit in this sample, while Figure 11b reveals that the crack beyond the pit contains a residue of corrosion products. A slight contrast between the residue and the surrounding steel was observed and is revealed in Figure 11b.

Figure 11: Scanning electron microscope photographs from sample 1 in Figure 10. (a) The corrosion pit and crack (the bright spot near the base of the crack is due to the SEM) x5 and (b) the crack at the base of the corrosion pit, showing some degree of contrast between the matrix material and the crack residue x72.

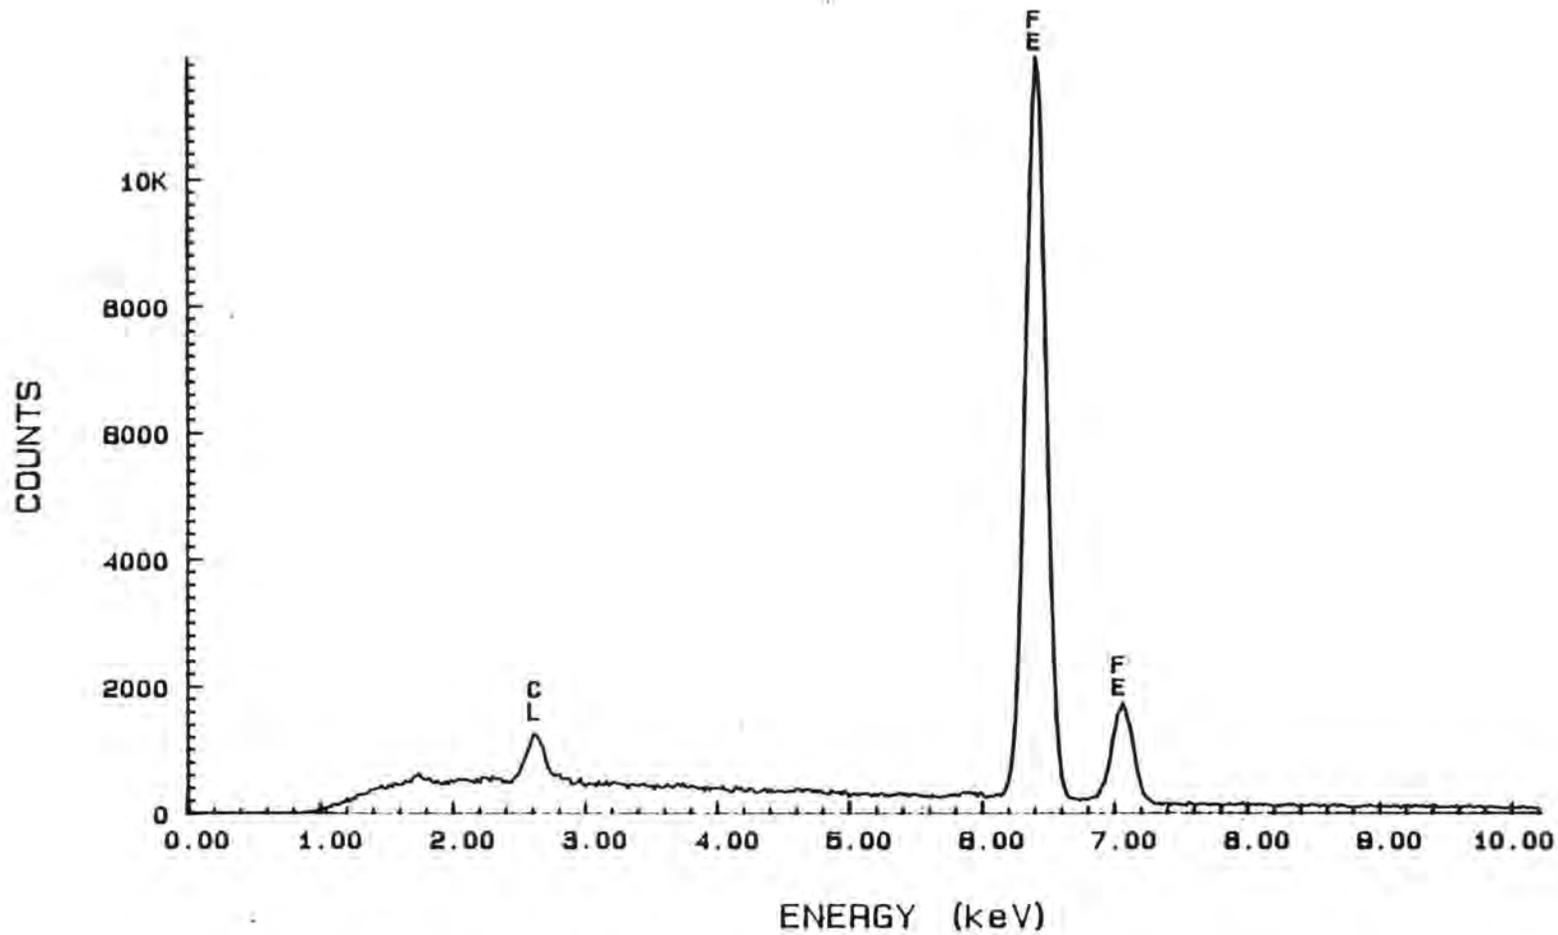
Figure 12 shows the X-ray energy spectrum excited from the residue in the crack. The energy peaks indicate the presence of iron and chlorine. Semi-quantitative analysis using the intensity of the energy peaks suggests that the residue contains 17 wt% (25 at%) chlorine, balance iron in the residue. Accuracy is on the order of plus or minus 5%.

Figure 12: Energy spectrum of X rays emitted from the corrosion product in the crack shown in Figure 11. Note the presence of a significant quantity of chlorine in the residue.

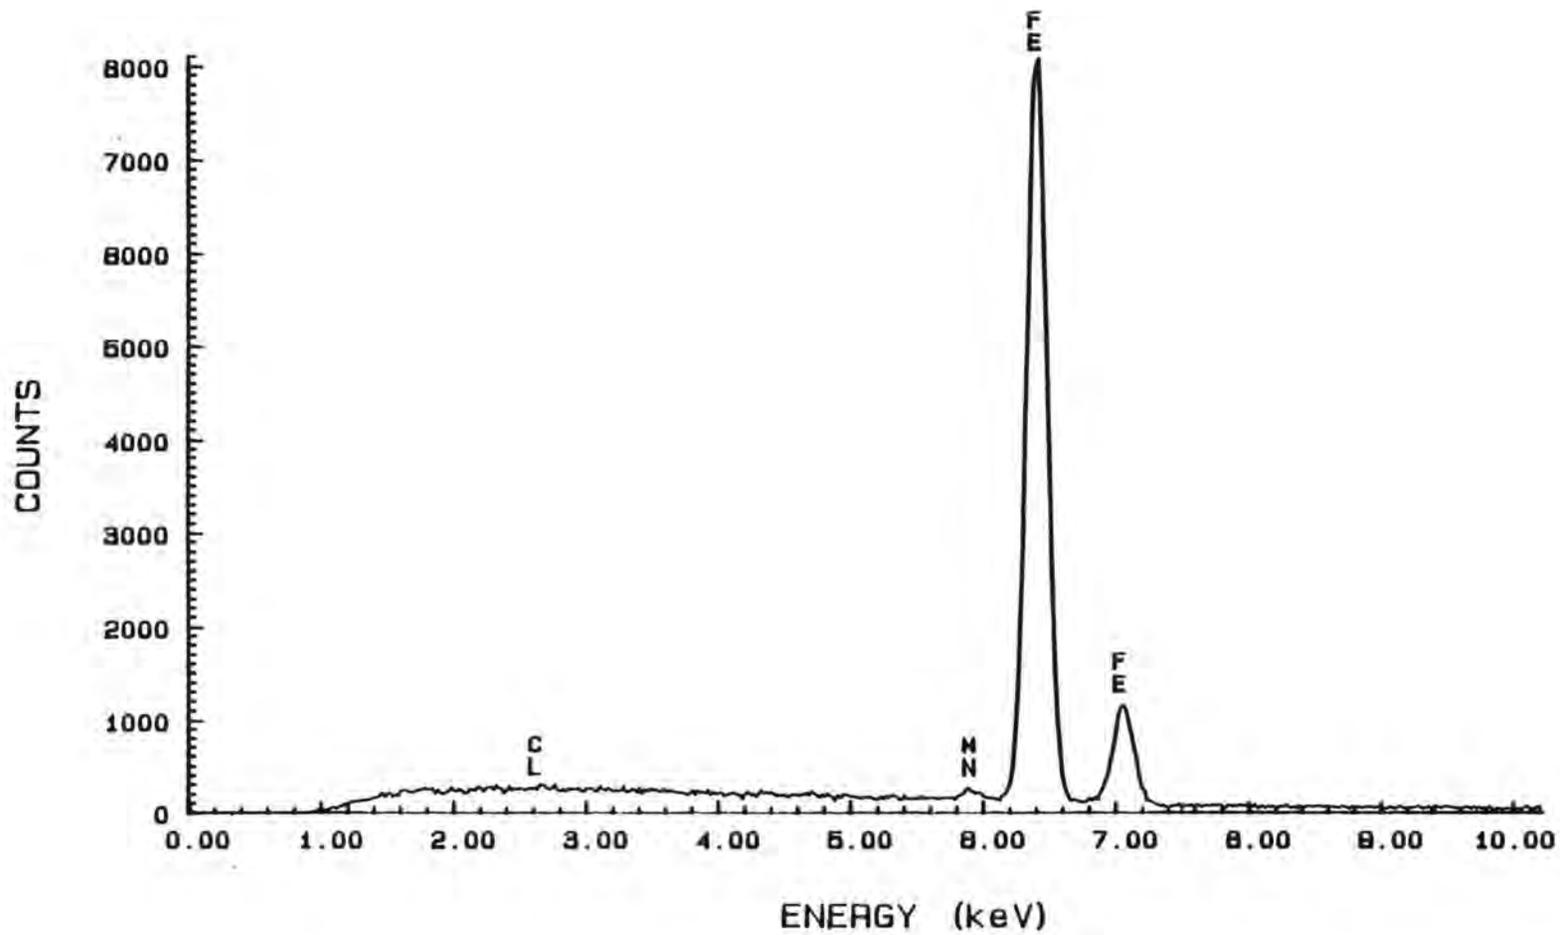
Figure 13 shows that no chlorine is present in the steel; the steel contains iron and a trace of manganese, as would be expected. No carbon is indicated due to the low atomic number of carbon.

Figure 13: Energy spectrum of X rays emitted from the steel matrix near the crack shown in Figure 11. Note the absence of any chlorine in the matrix.

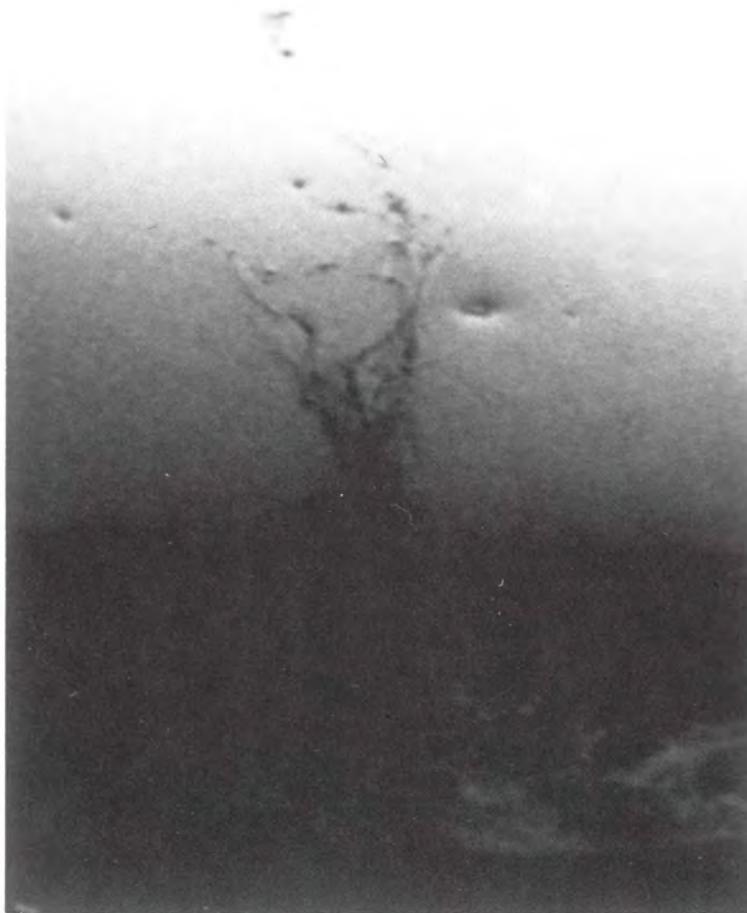
Sample 2: This sample was obtained from the I-55 half pin and has a smaller corrosion pit but a deeper, branched crack than the previous specimen, as shown in Figure 10. This sample was also polished through 600 grit polishing paper. Figure 14 shows the specimen in the SEM. Two areas of the crack residue were examined.

Figure 14: Scanning electron microscope photograph of a crack from the half pin (sample 2 in Figure 10), showing the branched crack that was studied x5.

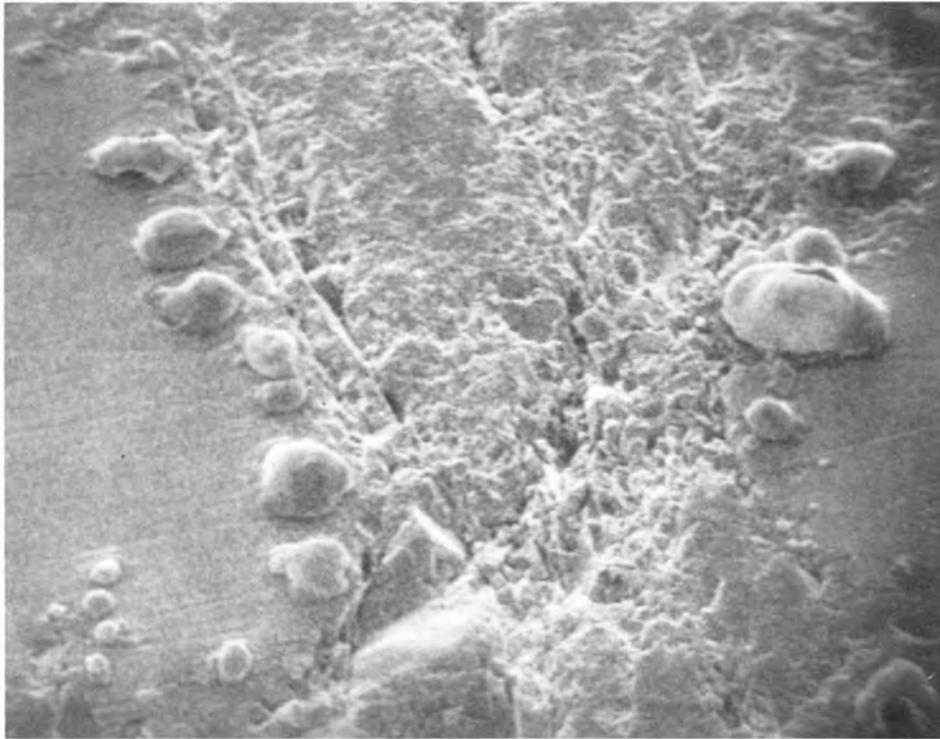
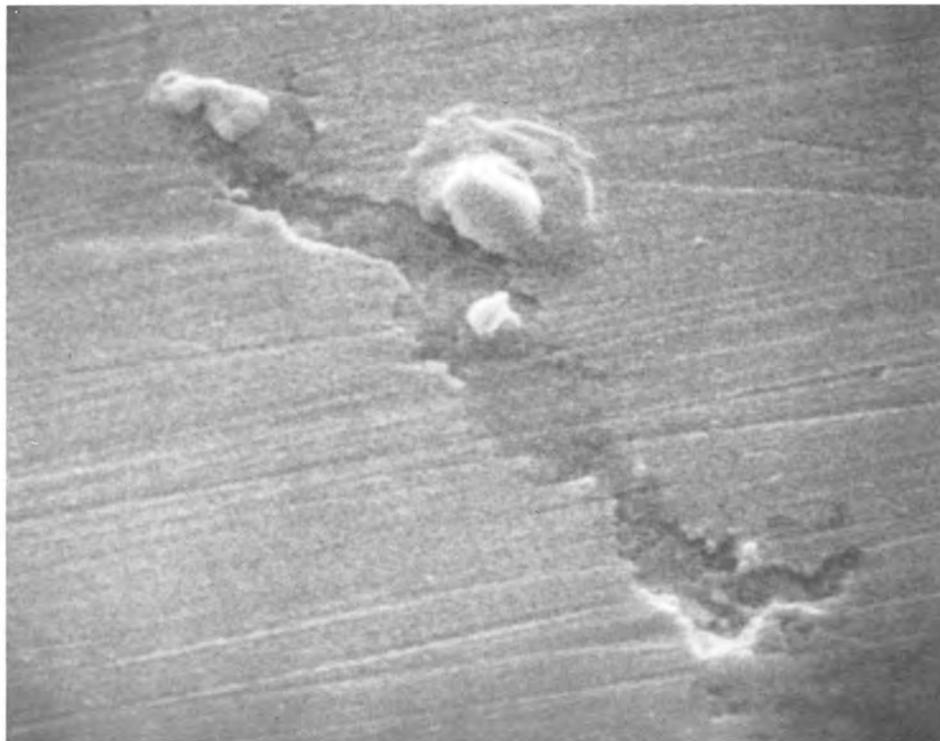
In an area near the surface, Figure 15a, small crystals were present which had apparently oozed out between the residue and the steel on both sides of the crack during the vacuum desiccation that preceded insertion of the specimen into the SEM. The residue itself contained only iron and manganese. Figure 16 shows the typical energy spectrum from the crystals. The crystals contained about 40 wt% (52 at%) chlorine. During preparation of the samples, moisture used to lubricate the sample during polishing apparently dissolved the salt in the residue. The salt solution was then drawn from the residue prior to examination, allowing the crystals to form.

Figure 15b shows an area of the crack lying deeper into the pin, somewhat to the upper left of Figure 15a, where the crack had branched. This area also contains a residue plus small crystals. Figure 17 is the energy spectrum from the residue, which contained 14 wt% (20 at%) chlorine.

Figure 15: Scanning electron microscope photographs of the crack shown in Figure 14. Note the small globules or crystals at the edges of the crack residue. (a) Near the start of the crack. (b) Near the end of the crack. x720.
