INVESTIGATION OF BRIDGE PIN FAILURES

MISSOURI  
HIGHWAY AND TRANSPORTATION COMMISSION

FINAL REPORT  
to  
Missouri Highway and Transportation Commission  
on  
INVESTIGATION OF BRIDGE PIN FAILURES

November 15, 1987

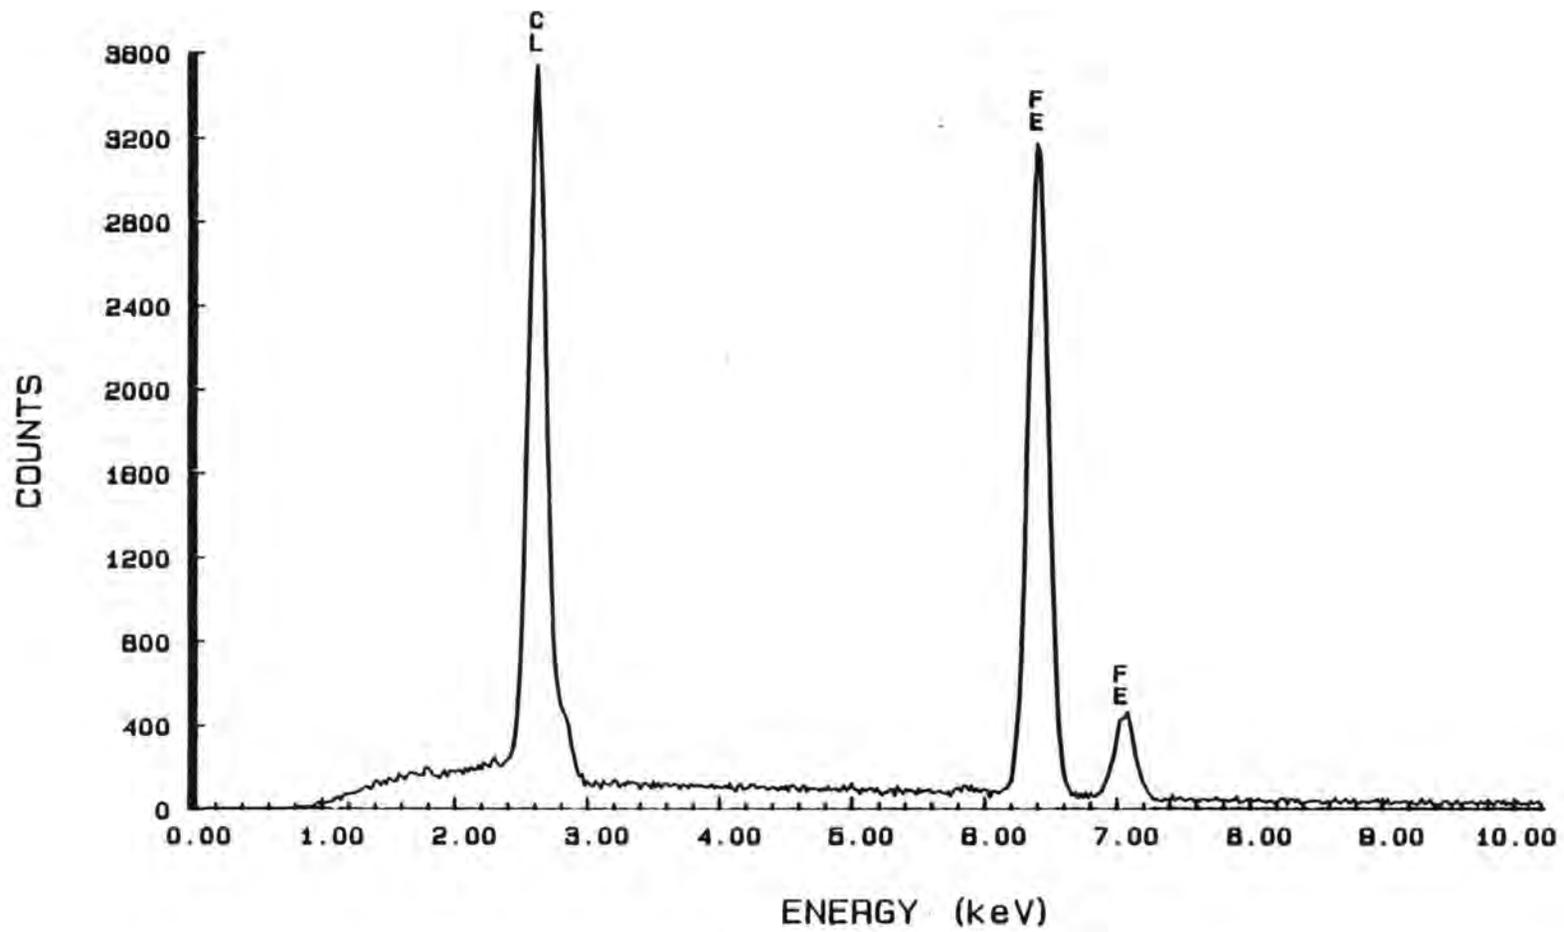
Only chlorine is present in the energy spectrum; sodium, which almost surely is present in the crystals, does not have a high enough atomic number to be detected.

Figure 16: Energy spectrum of X rays emitted from a crystal at the crack residue boundary in Figure 15a. Note the large quantity of chlorine present in the crystal.

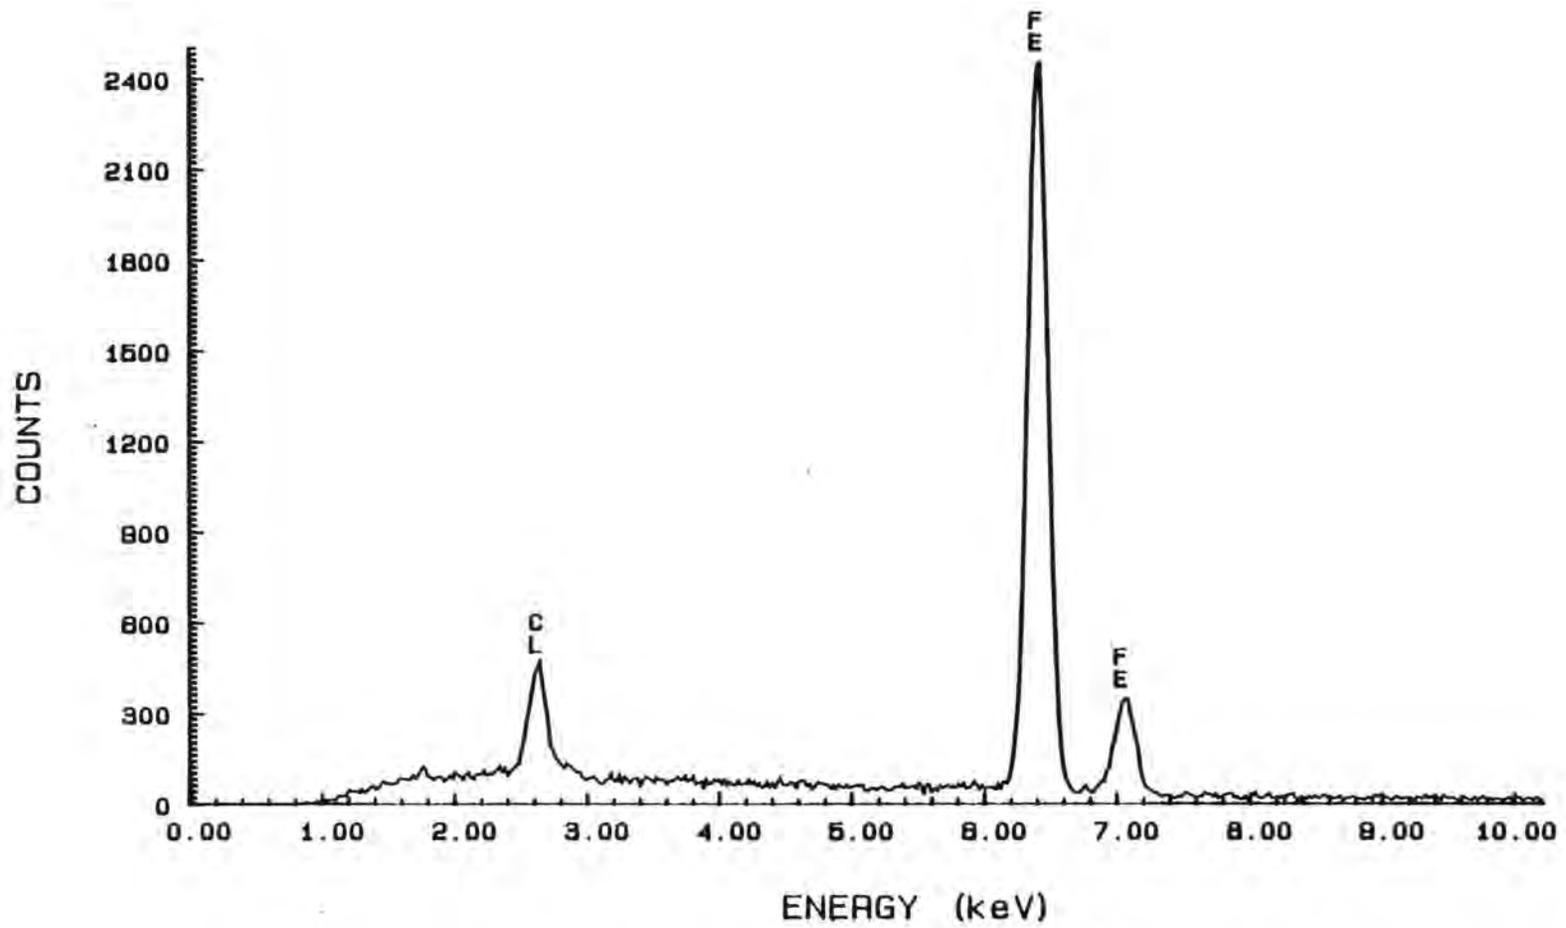
Figure 17: Energy spectrum of X rays emitted from the crack residue in Figure 15b. Chlorine is present in the residue. Note that small crystals are also found at this location in the crack.

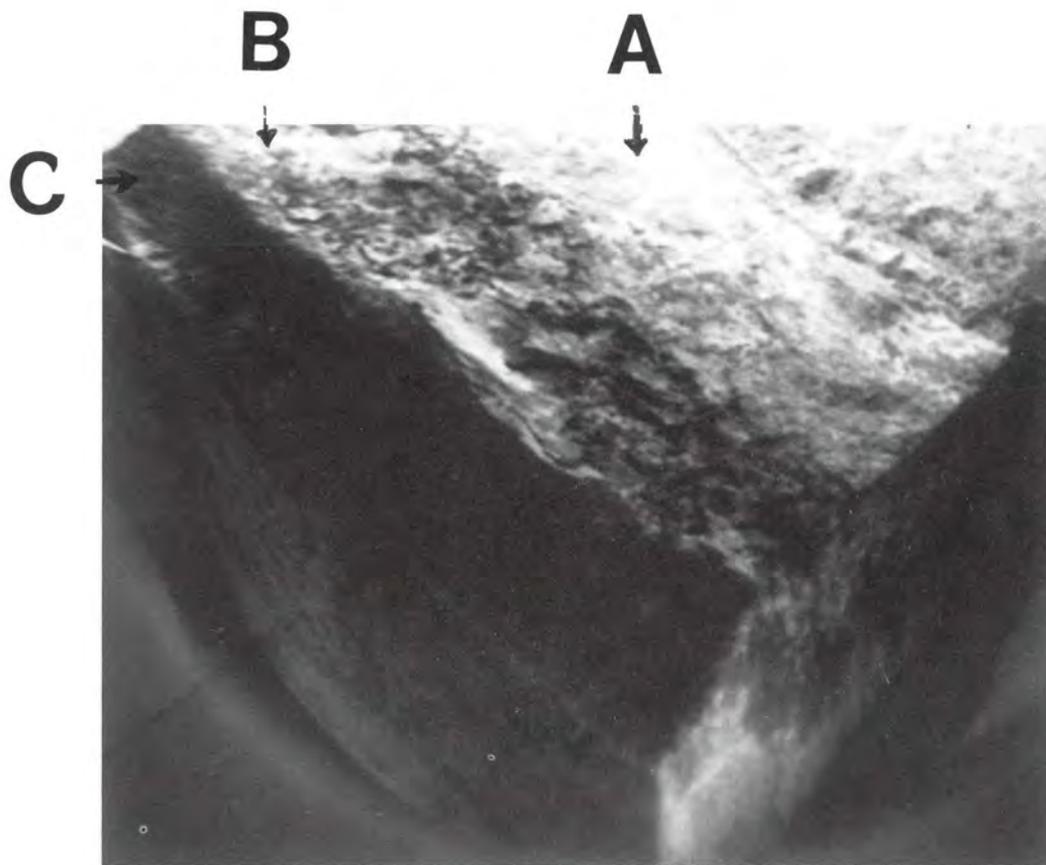
Sample 3: Figure 10 and Figure 18 show the crack-fracture surface that was obtained from the I-55 full pin; the crack began from a rounded corrosion pit in the foreground. Several areas are visible on this surface.

Figure 18: Scanning electron microscope photograph showing the crack surface from the full pin. The rounded area, in the foreground and toward the left side of the photograph, is corrosion pit; the next area is a fracture surface caused by the corrosion crack; and the final area, toward the upper right-hand corner of the photograph, is a fresh fracture caused during the preparation of the sample. x5.

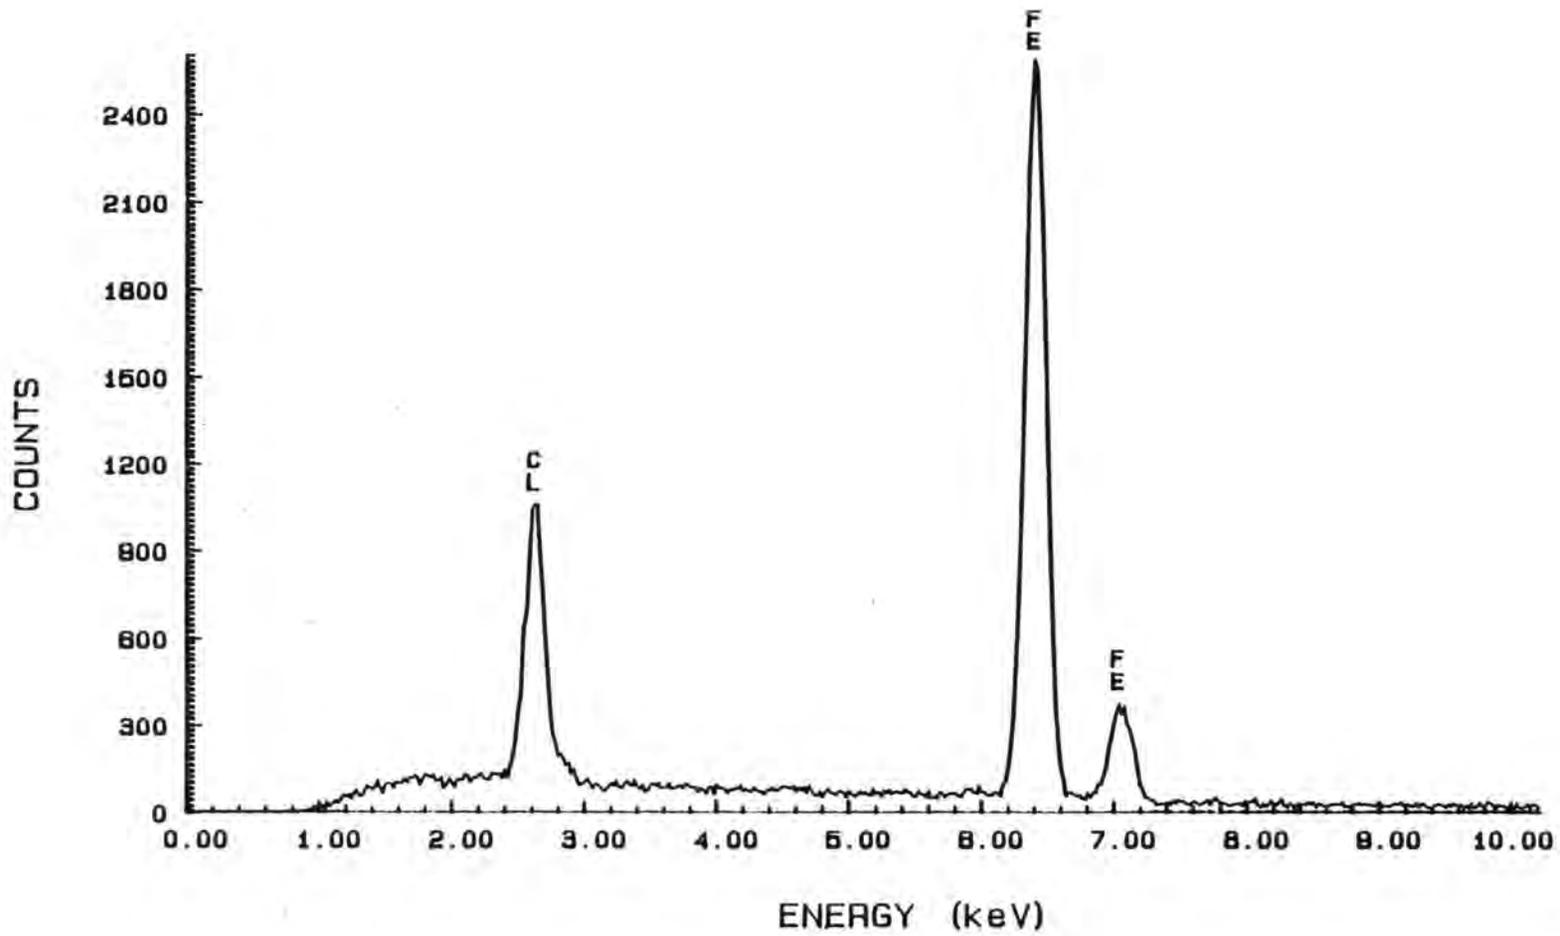
Point A is located on the corrosion crack surface at the deepest part of the crack; Figure 19 shows that chlorine in the amount of 23 wt% (32.5 at%) is present.

Figure 19: Energy spectrum of X rays emitted from the crack surface near the bottom of the crack. Note the large quantity of chlorine indicated by the SEM.

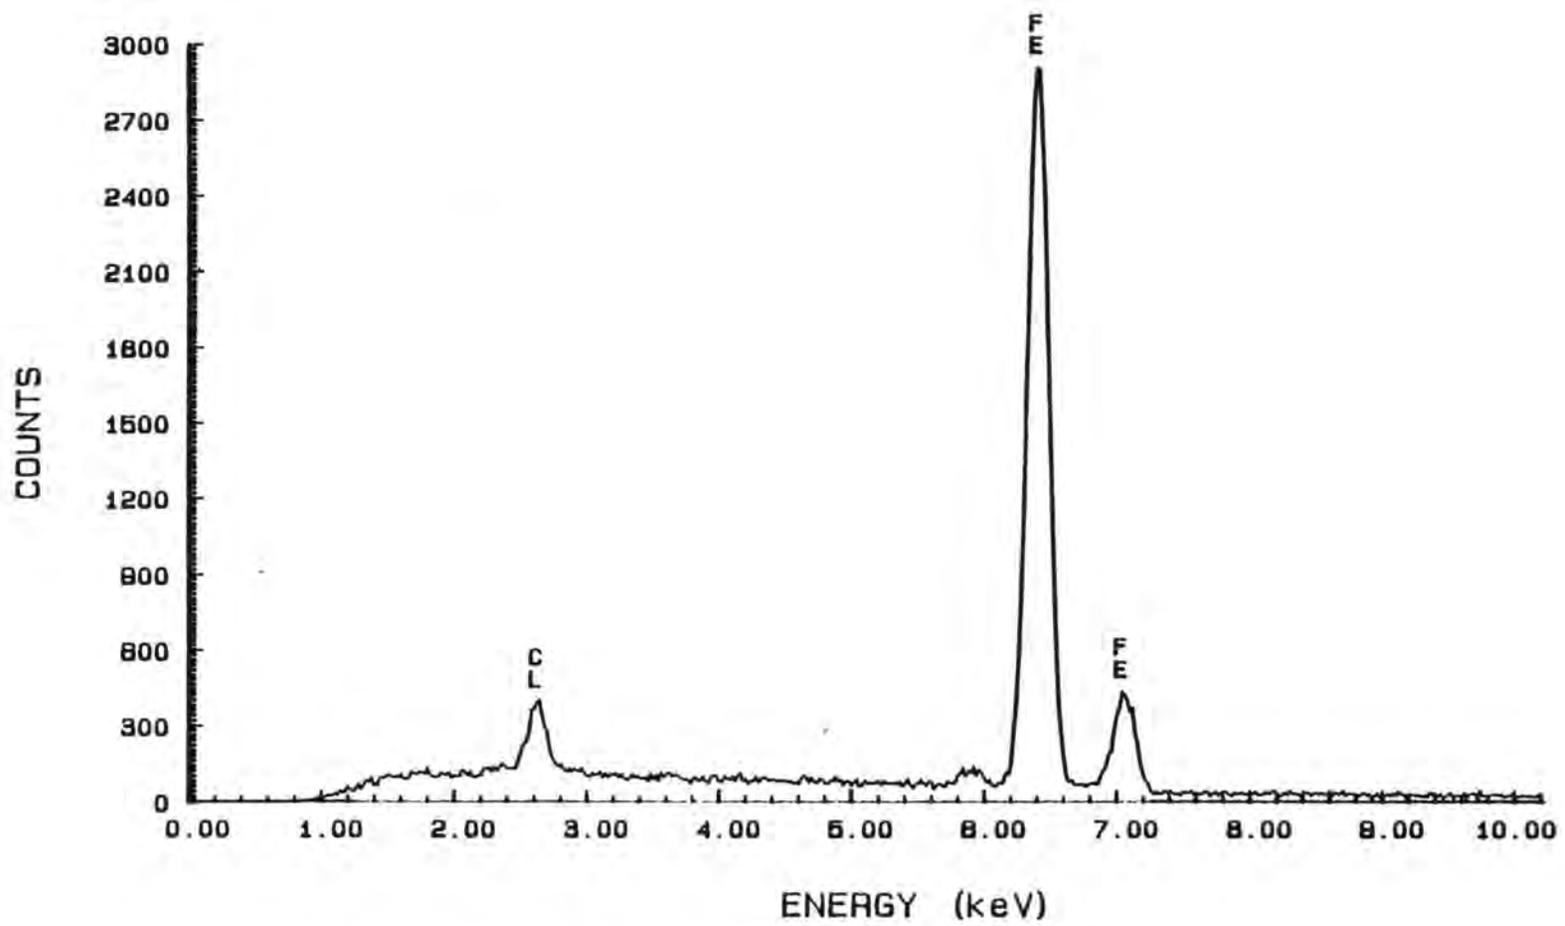
Point B lies on the corrosion crack surface just below the rounded portion of the pit; Figure 20 shows that a smaller amount of chlorine, about 16 wt% (24 at%), is present.

Figure 20: Energy spectrum of X rays emitted from the crack surface just beneath the curved corrosion pit. A smaller amount of chlorine is located here than deeper in the crack.

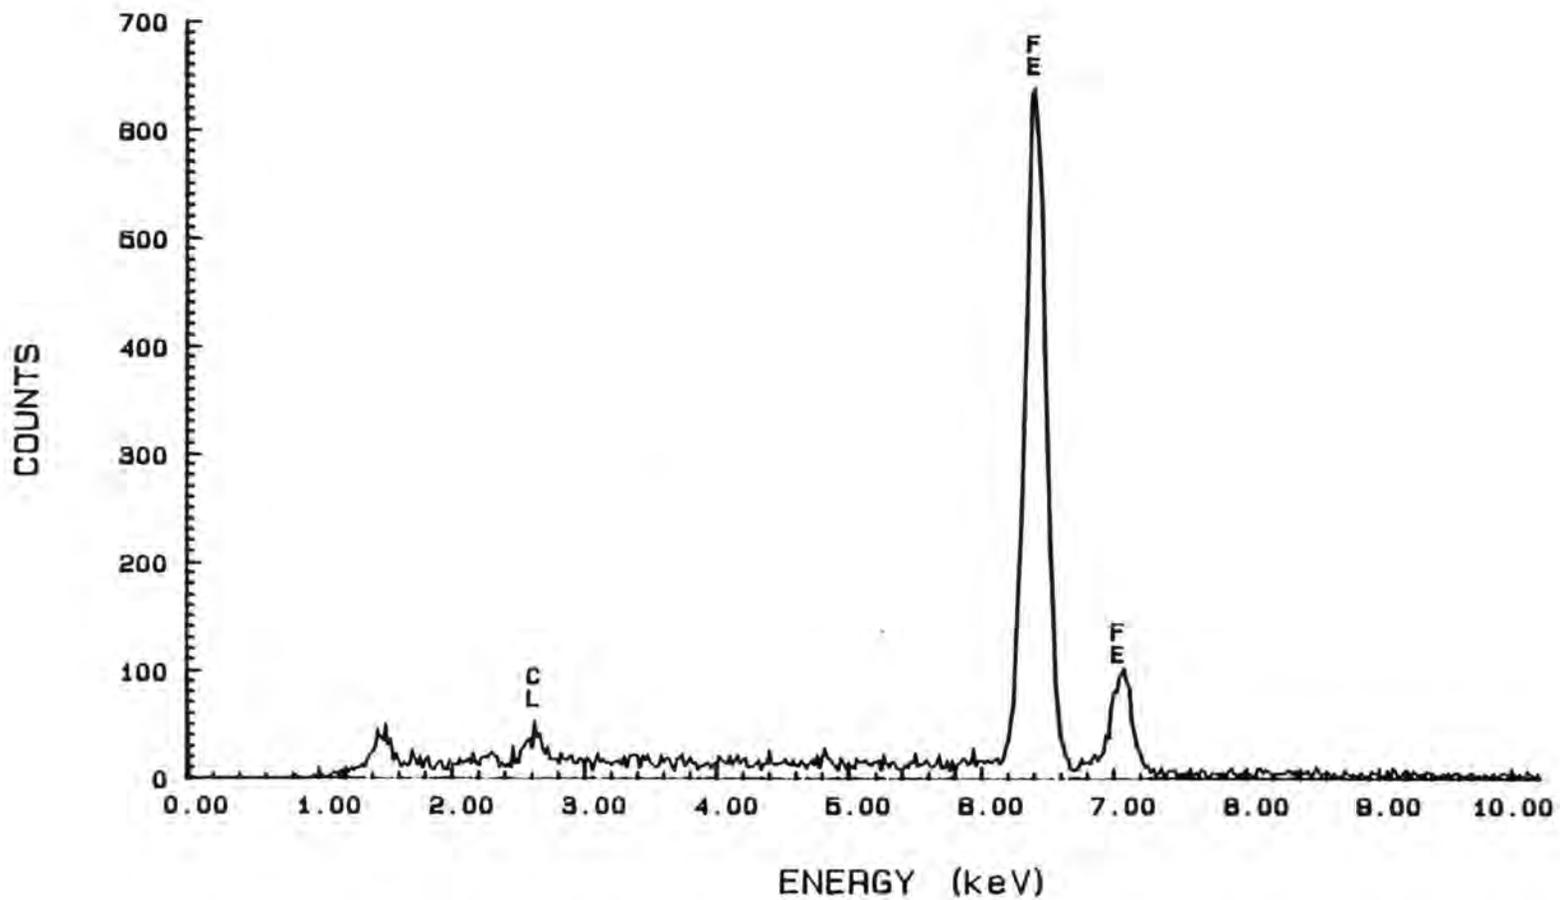
The surface of the rounded pit, point C, contains relatively little chlorine, as shown in Figure 21. Analysis indicates 9.5 wt% (14 at%) chlorine at this point; perhaps most of the chlorine in this area had been washed away by rainfall.

Figure 21: Energy spectrum of X rays emitted from the surface of the curved corrosion pit. Note that the chlorine level is quite small compared to that observed in the actual crack.

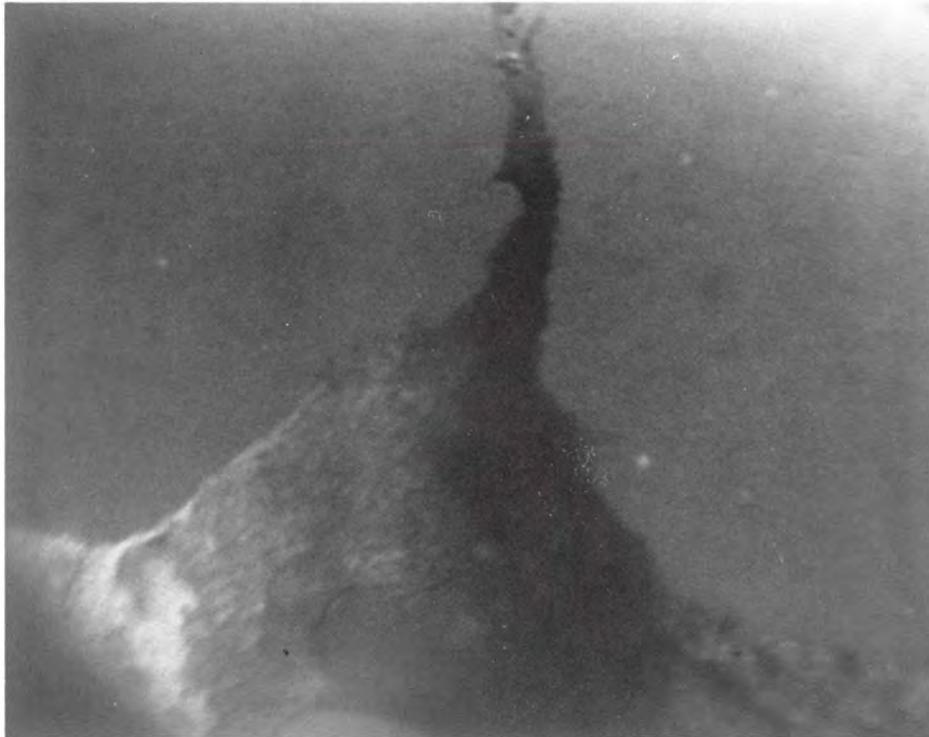
Sample 4: A deep crack from the top pin from the Clinton bridge was examined. Figure 22 shows the sample in the SEM. There is a rounded corrosion pit, followed by a deep open crack, and finally a thin crack still filled with corrosion product. The open portion of the crack may be due to the sand blasting process used by the Highway Department for clean-up. Figure 23 shows the X-ray spectrum observed in parts of the residue; the analysis is 11 wt% (16.5 at%) chlorine. Some locations in the residue showed no chlorine.

Figure 22: Scanning electron microscope photograph of a corrosion pit and crack obtained from the Clinton pin. Note that the crack does not appear to be filled with any corrosion product, probably because the pin had been sand blasted prior to inspection. x5.

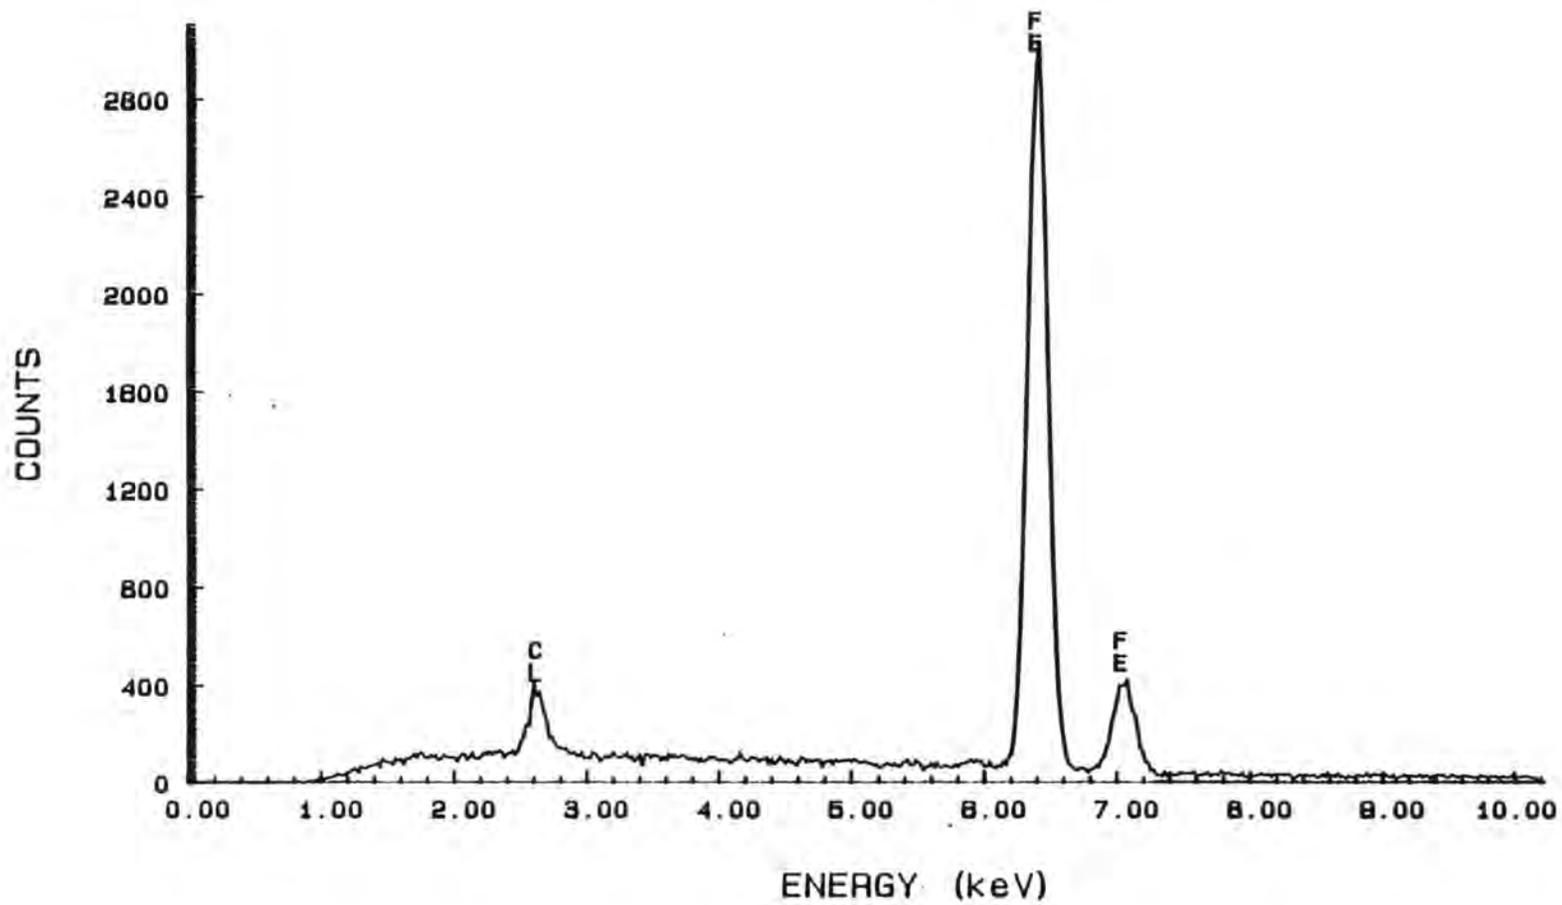
Figure 23: Energy spectrum of X rays emitted from the corrosion product in the Clinton pin, showing the presence of chlorine.

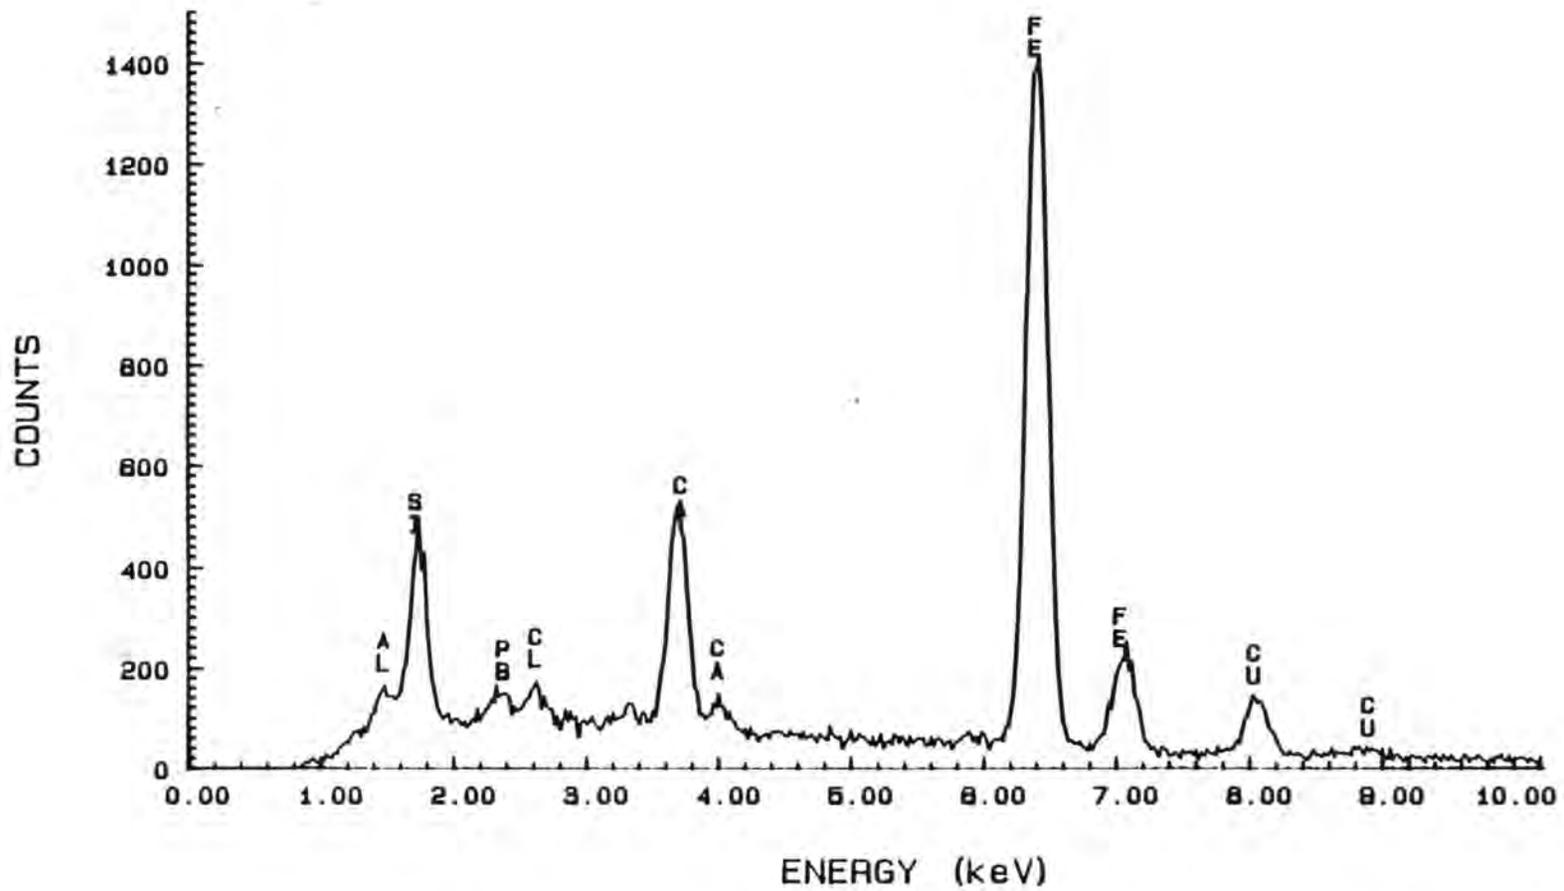
The thinner residue that flaked off the fracture surface contained a significant amount of copper, silicon, and calcium, Figure 24. The source of the copper and silicon was the bronze washer. The calcium might be from calcium chloride since calcium chloride had been used to salt this particular bridge; little chlorine was observed, however. Eight different elements were detected in this residue and the SEM was not able to give a reasonable semi-quantitative analysis of the material.

Figure 24: Energy spectrum of X rays emitted from the corrosion product on the fractured pin of the pin-strap piece. Note the variety of elements present in the deposit, including copper and calcium.

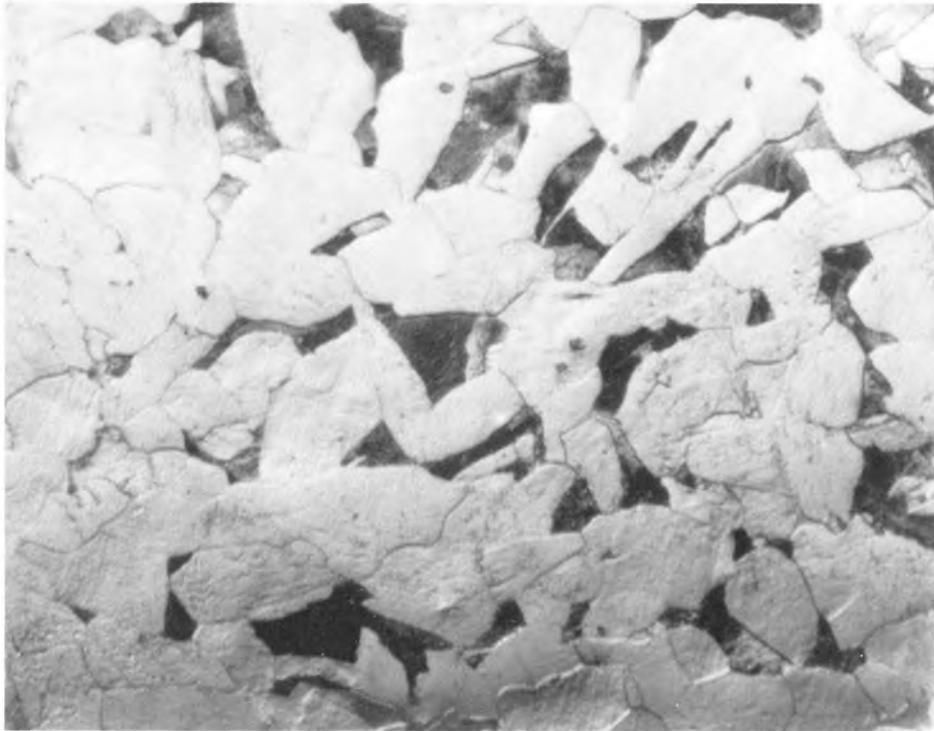
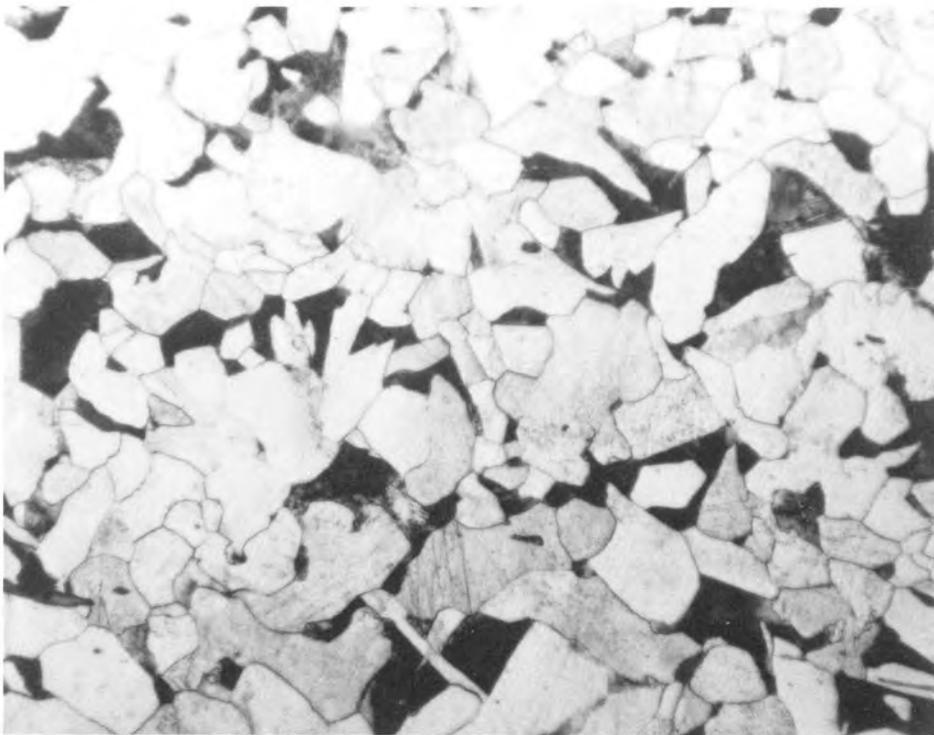
Figure 25: Photomicrographs of the matrix of the pins, showing a typical structure for a 1010 steel. The dark patches are pearlite, while the white areas are ferrite. The ferrite grains are equiaxed and contain no strain lines. x250.

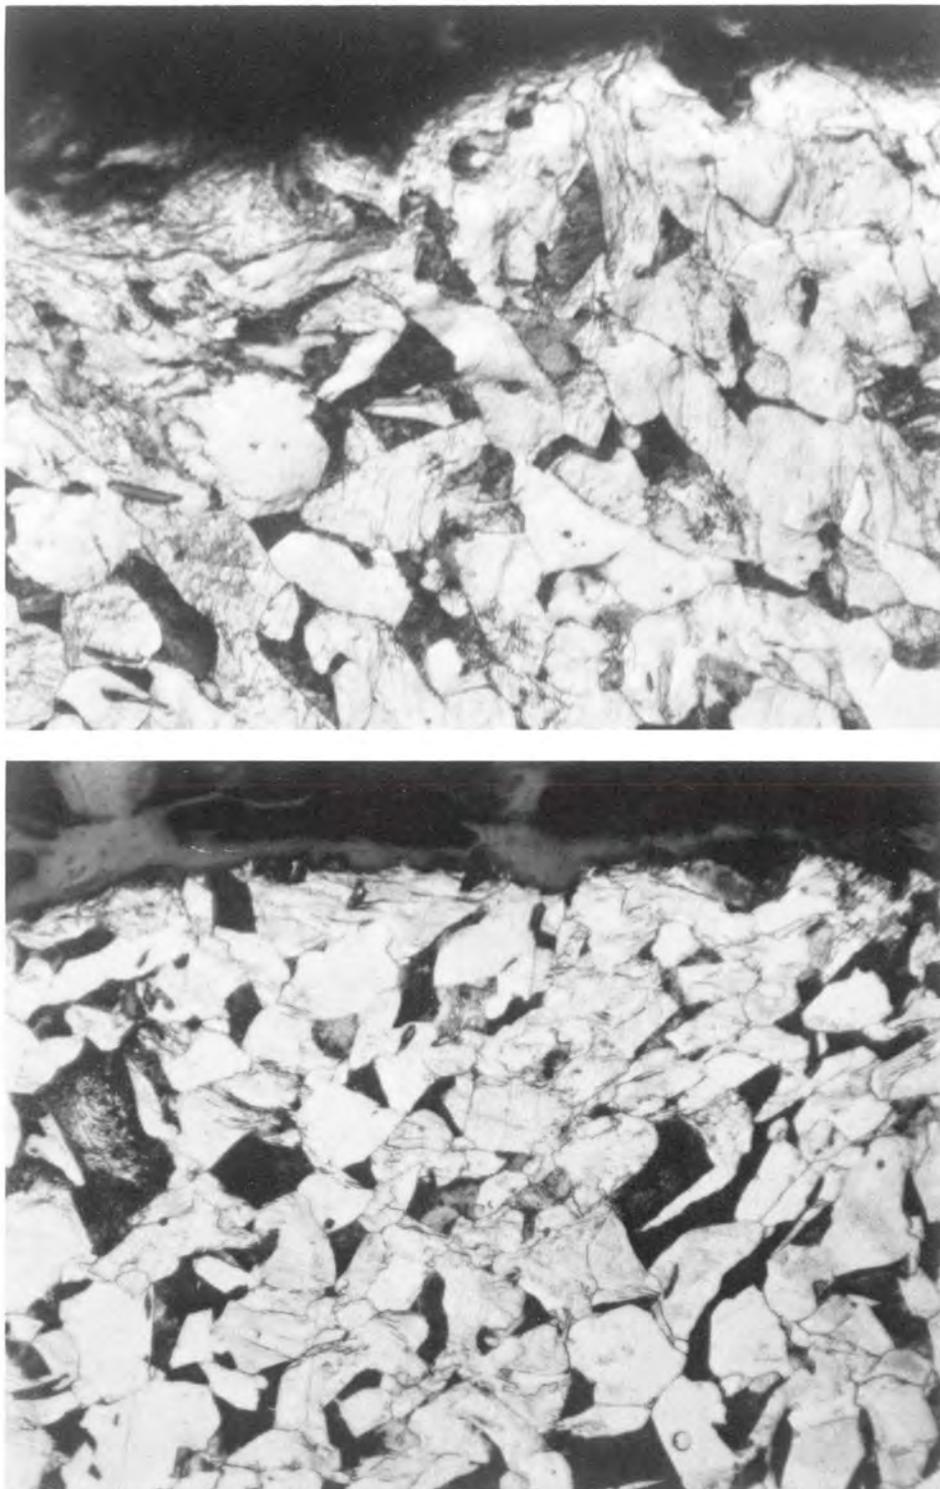
The ferrite grains contained strain markings adjacent to deep cracks; however no strain markings were observed when only corrosion had occurred and no strain markings were observed in the bulk of the pins. This held true for all of the pins that were inspected in this manner. Figure 26 includes two examples of strain markings in the ferrite near cracks. The presence of these strain markings, plus some indication of distortion of the ferrite grains, indicates that these areas were subjected to a localized overload. It appears that considerable plastic deformation of the steel pin occurs, either after the crack has formed or perhaps helping to initiate the crack.

Figure 26: Photomicrographs of the steel pin adjacent to cracks and corrosion pits. (a) The matrix next to the crack in a Clinton pin and (b) the matrix next to the crack in an I-55 pin. Note the dark strain marks in the ferrite grains next to the crack. x250.

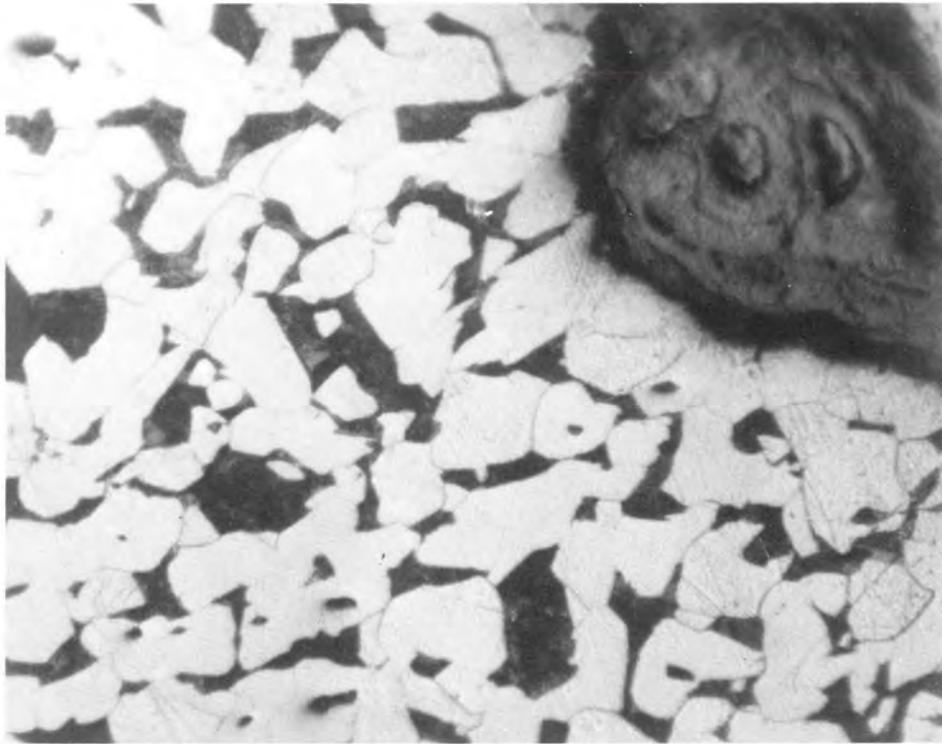
Evidence of plastic deformation was only found in the steel very close to crack surfaces. Figure 27 shows an example of ferrite, without strain markings, adjacent to a corrosion pit from which no crack has yet begun. The pin-strap-web junction at this area had not yet frozen, a torsional overload had not yet developed, and therefore corrosion without cracking was the only noticeable damage. Similar structures were found in all of the areas in which a corrosion groove but no cracking was observed.

Figure 27: The matrix next to a corrosion pit from which no crack developed. No strain marks are observed in the ferrite next to the corrosion pit. x250.
