**Research
Development
and Technology
Division**

Missouri
Department
of Transportation

Joint Load Transfer and Slab Loss of Support Analysis

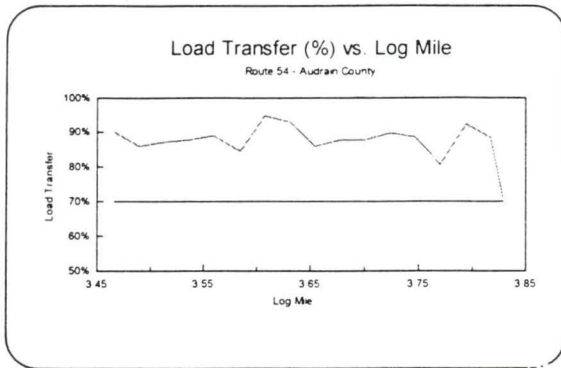
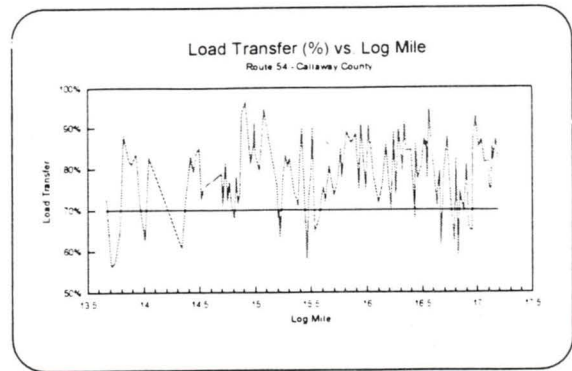
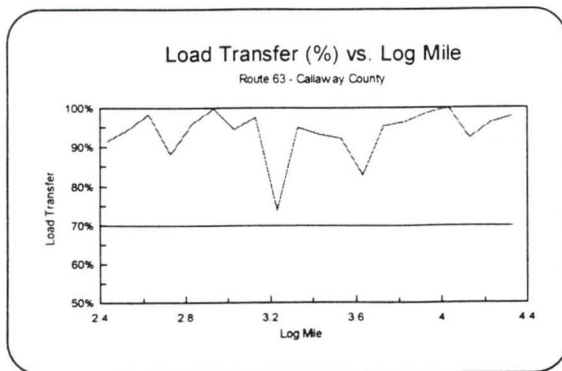
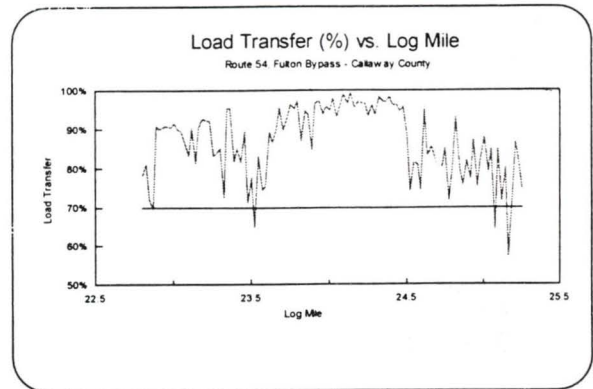
MoDOT's Falling Weight Deflectometer was used to analyze the pavement performance of the four recently constructed pavement sections. The center deflection values, deflection basin areas, and corner deflection values were plotted for all pavements. The NCHRP Void Size Estimation Procedure was used to find slab loss of support. The joint load transfer efficiency was also plotted vs. log mile for each project as shown in the following figures.

The center deflection and deflection basin area plots show that the pavements are in good structural condition. According to the Void Size Estimation Procedure, none of the pavements exhibited any sign of voids beneath the pavement. The major difference was reflected in the joint load transfer values. The Route 54, Callaway County pavement's load transfer values were irregular, with nearly 20% of the joints being below the limit for good load transfer (70% load transfer). The other pavements' values were more constant and higher on the average. This report discusses the possible explanations for the low load transfer and concludes that the 15' joint spacing is not at fault and supports the opinion that the saturated subgrade/base (as described in the report) could be the cause for the poor results.

Additional research into the effects of subgrade moisture and/or drainable bases, such as 2 foot rock fill, is recommended.
