DEVELOPMENT OF DESIGN CRITERIA  
FOR CUT SLOPES IN LOESS

**STUDY NO. 74-1**

**MISSOURI STATE HIGHWAY DEPARTMENT  
DIVISION OF MATERIALS AND RESEARCH**

**FINAL REPORT**

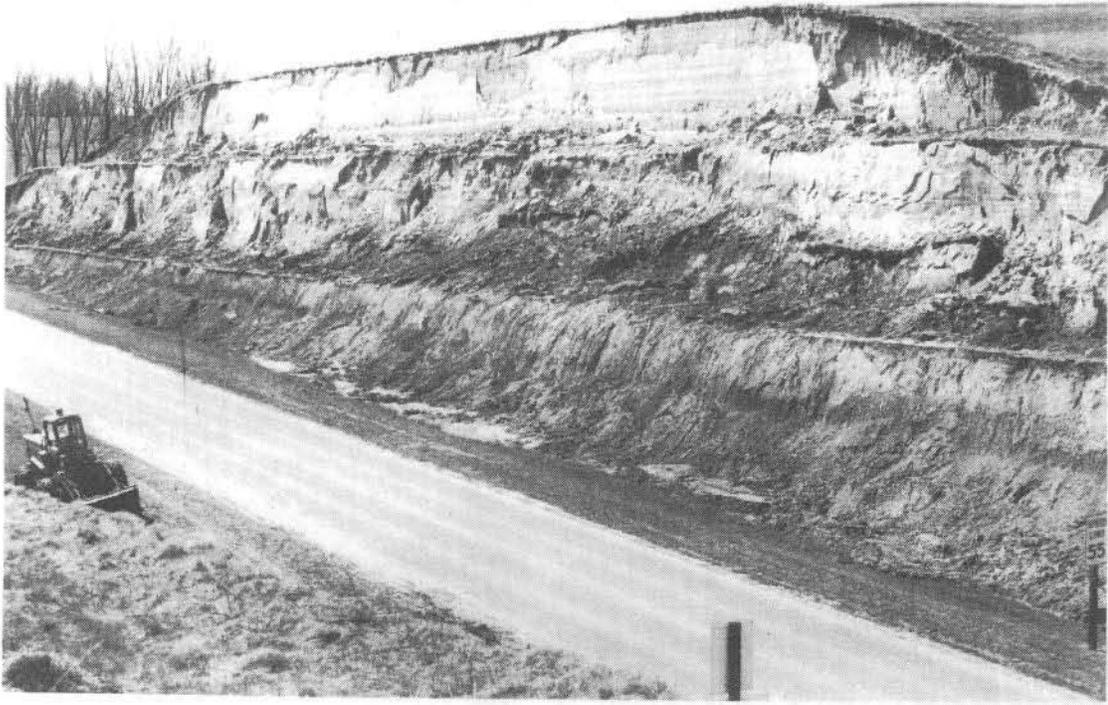
Figure 2. Example of a stepped slope which has failed  
(Howard County, Route D(87))

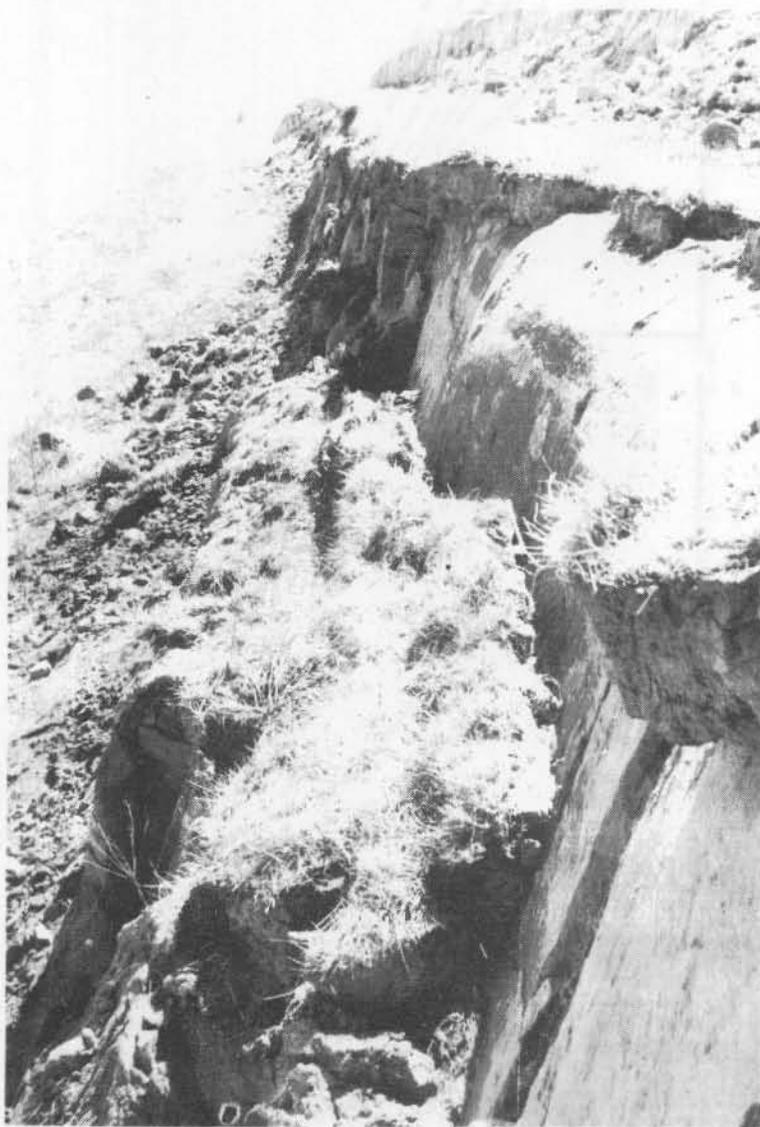
A fourth requirement, unique to loess slopes, is that the slope be steep enough to fail after the ice lense melts. Ice lense development was found to occur approximately 18 to 24 inches behind the face and, to a lesser extent, below the bench above a vertical slope. With thawing, failure occurs along the ice plane with liquefaction of the soil usually apparent after failure. An example of this type of failure is illustrated in Figure 8.

Figure 8. Freeze damage to a north facing stepped slope (Holt County, Route I-29)

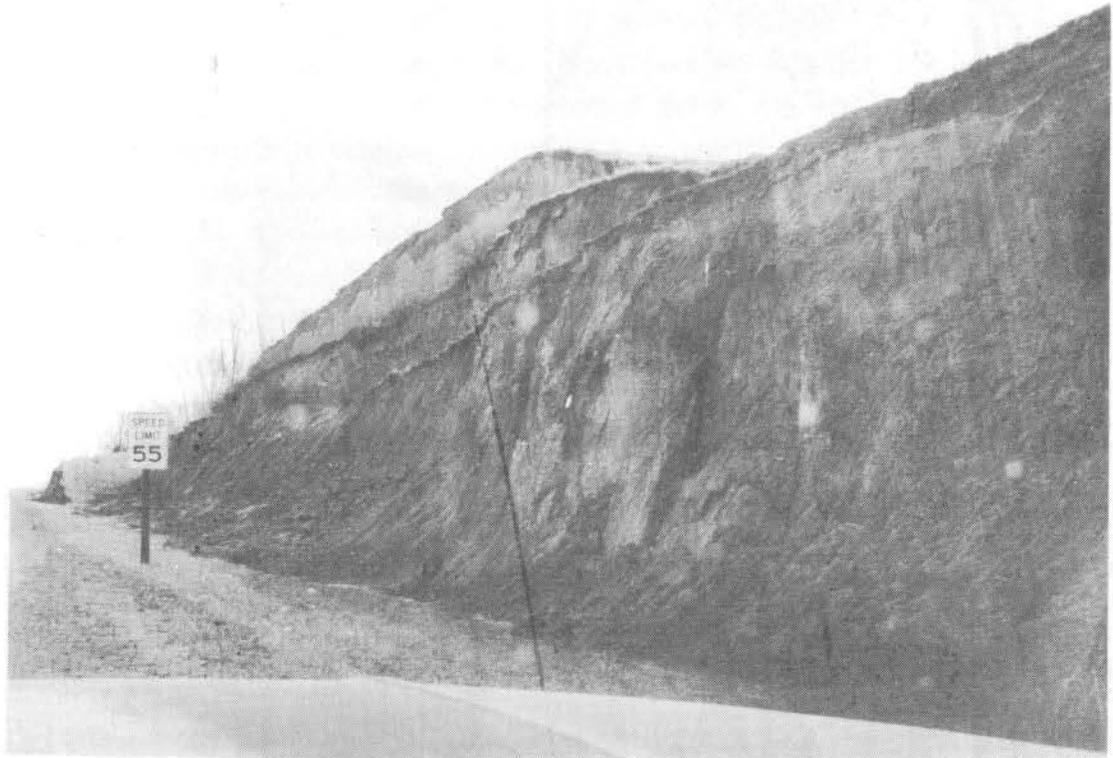
Figure 9. Slides and heavy frost damage due to truncation of a water table at the level of the second bench in northeast facing cut (Howard County, Route D(87))

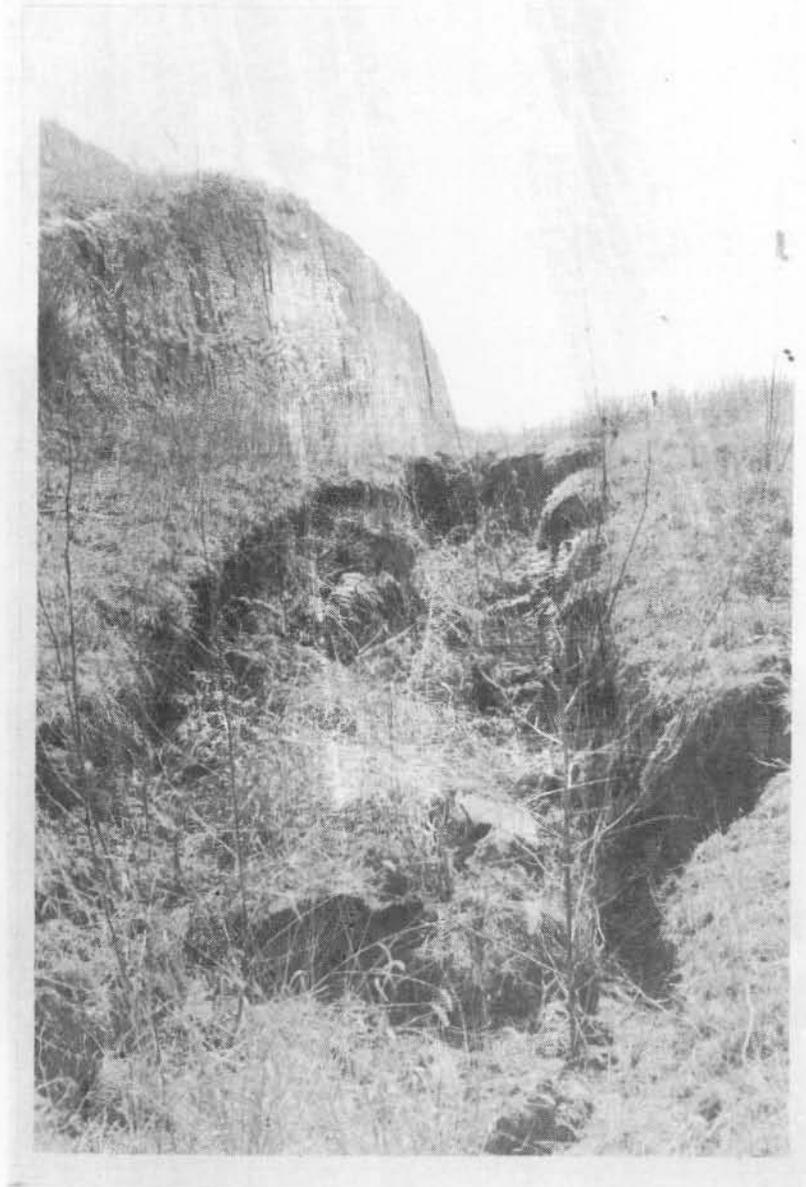
Figure 10. Collapse and erosion due to excessive water concentration at the end of a sodded V-shaped bench (Holt County, Route I-29)

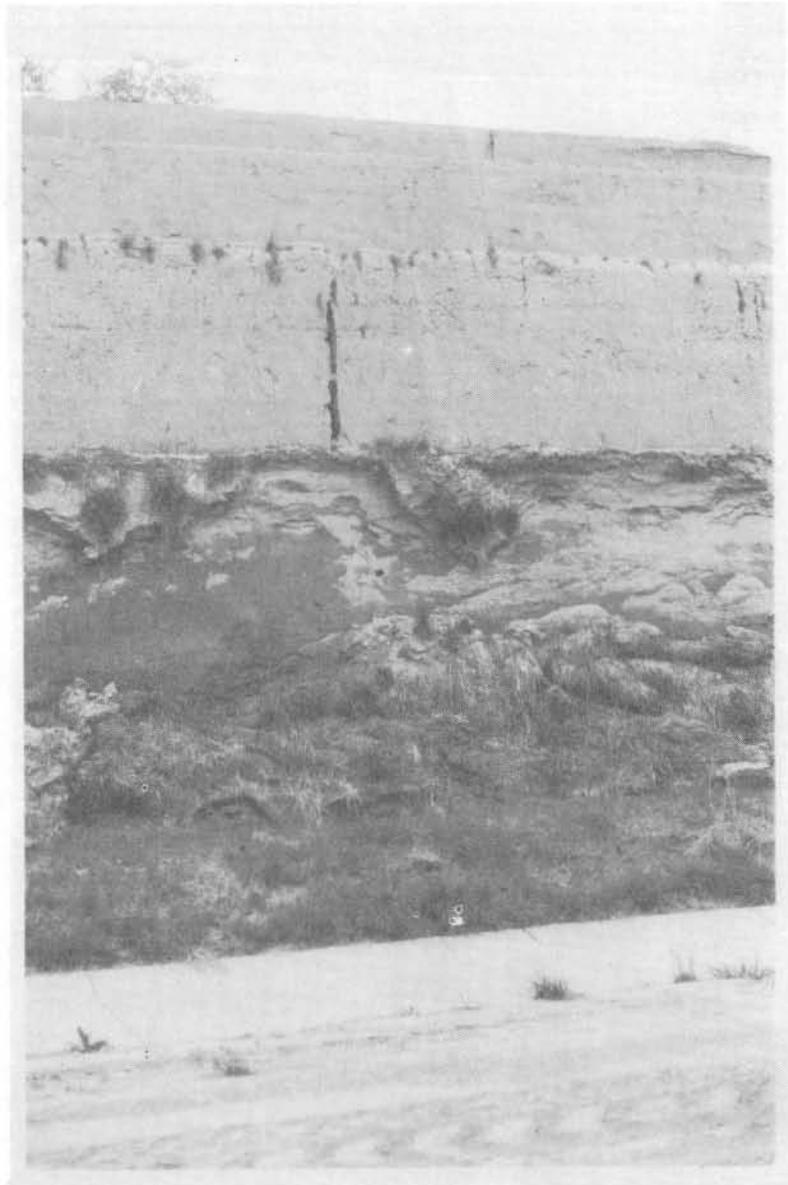
Figure 11. Slope damage due to persistent seepage from a truncated water table. Piping outlets in the face above are also evident (Holt County, Route I-29)

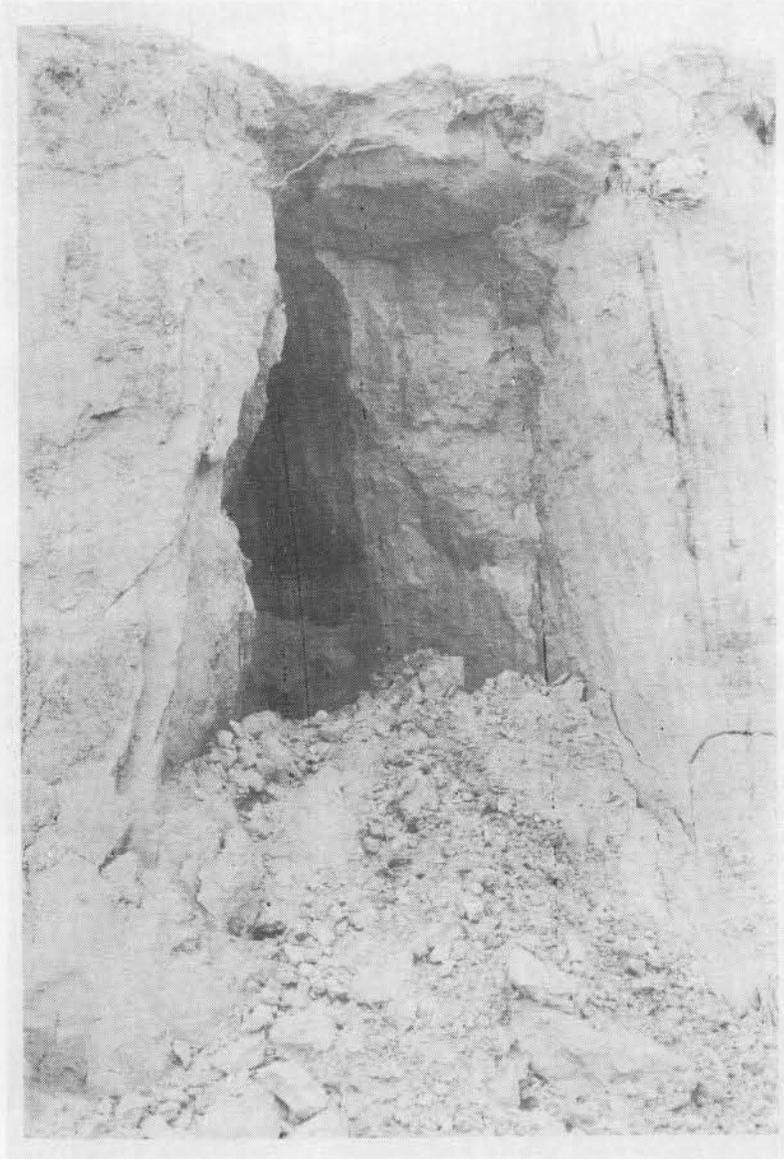
Figure 12. Piping damage to a vertical face  
(Holt County, Route I-29)

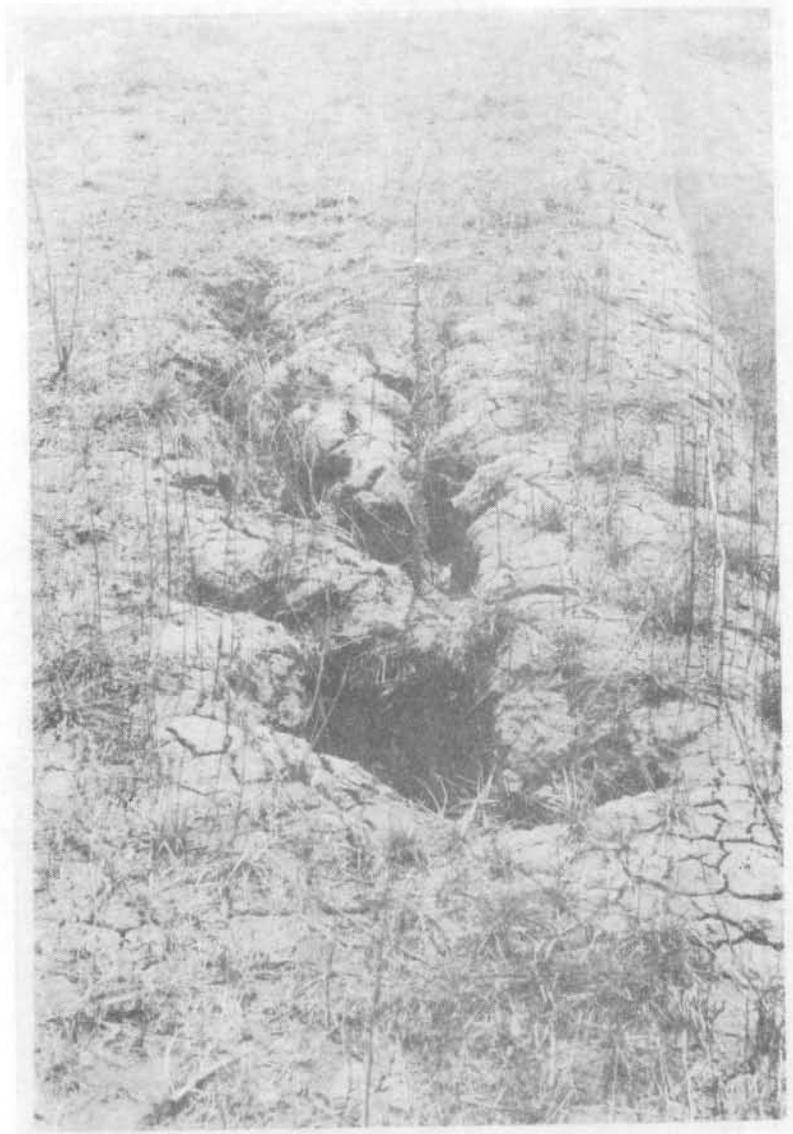
Figure 13. Piping inlets on a bench originating from frost damage (Holt County, Route I-29)

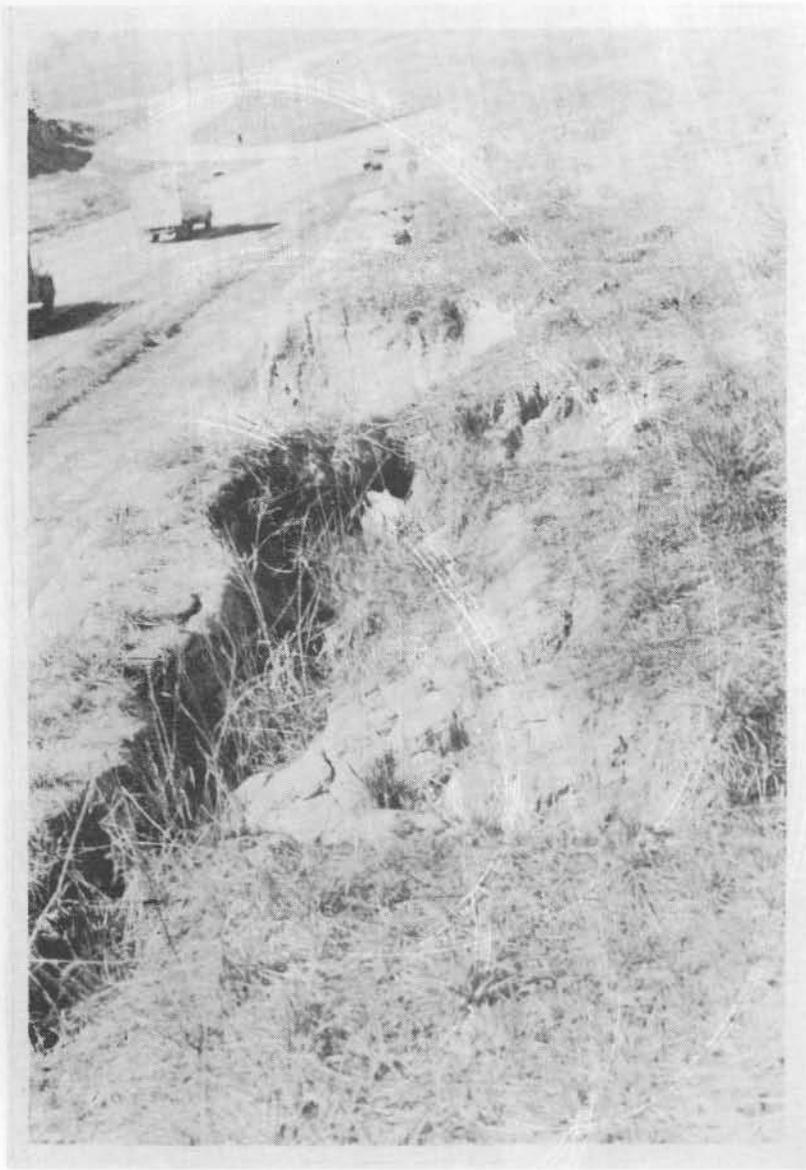
Figure 14. Bench erosion following frost damage (Atchison County, Route 136)

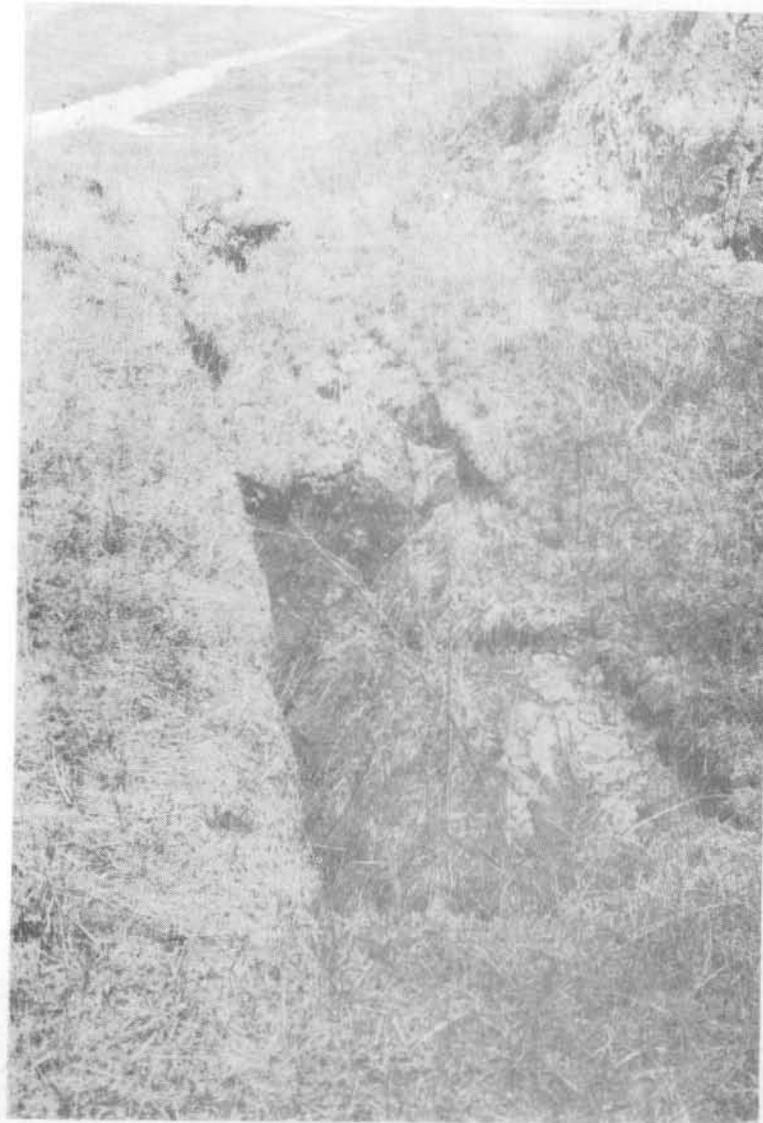
Figure 15. Piping damage and progressive erosion due to insufficient bench gradient (Holt County, Route I-29)

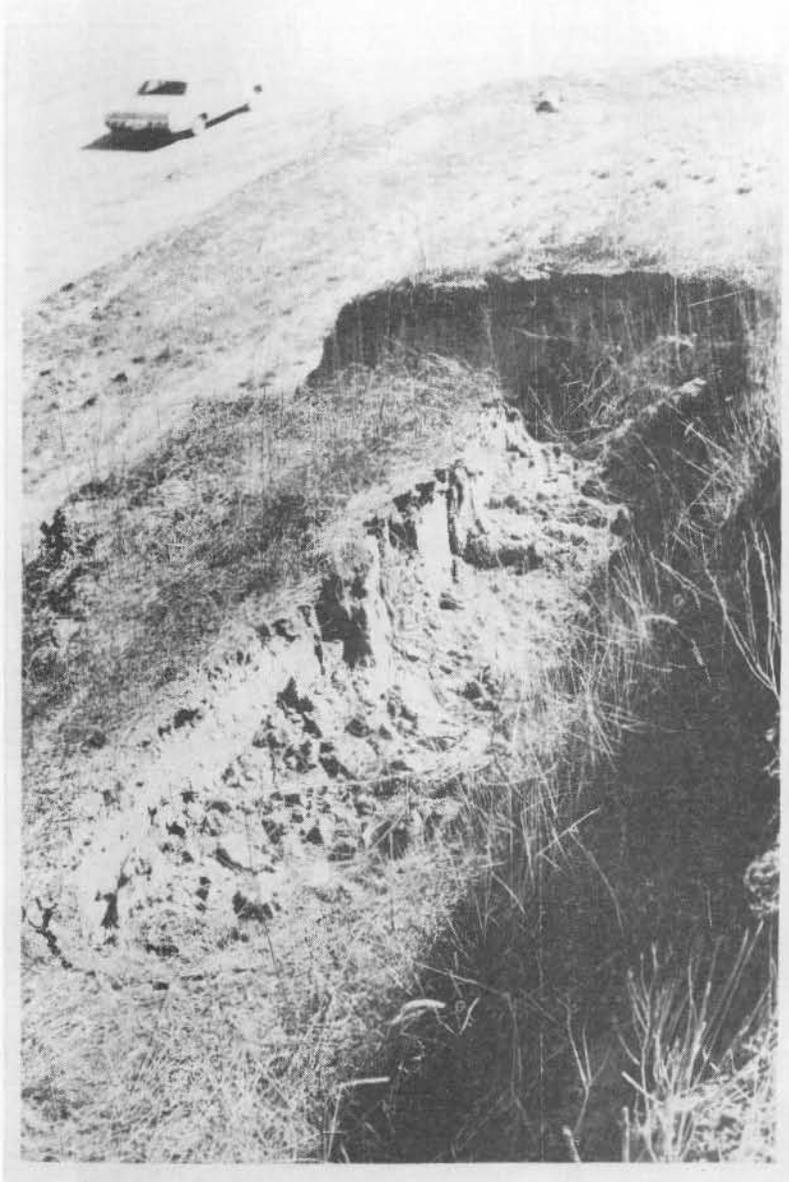
Figure 16. Collapse failure progressing in a sodded bench (Atchison County, Route 136)

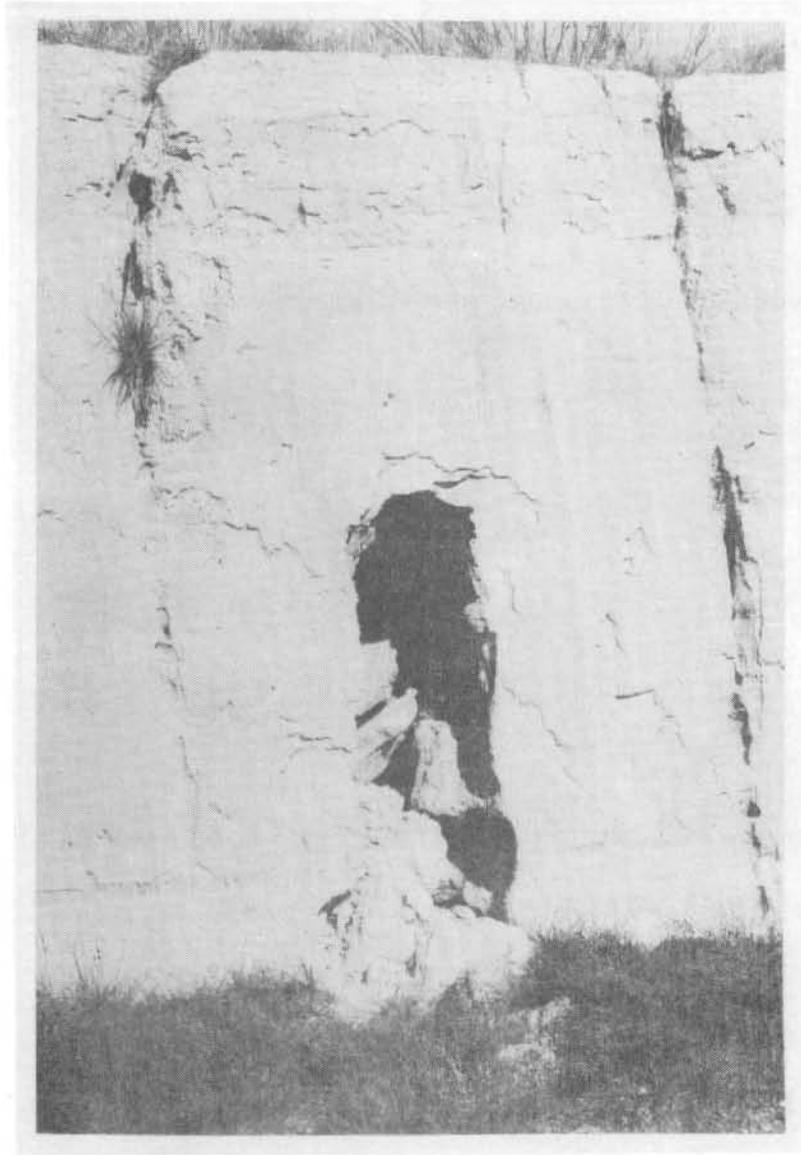
Figure 17. Piping outlet in a near vertical face  
(Holt County, Route I-29)

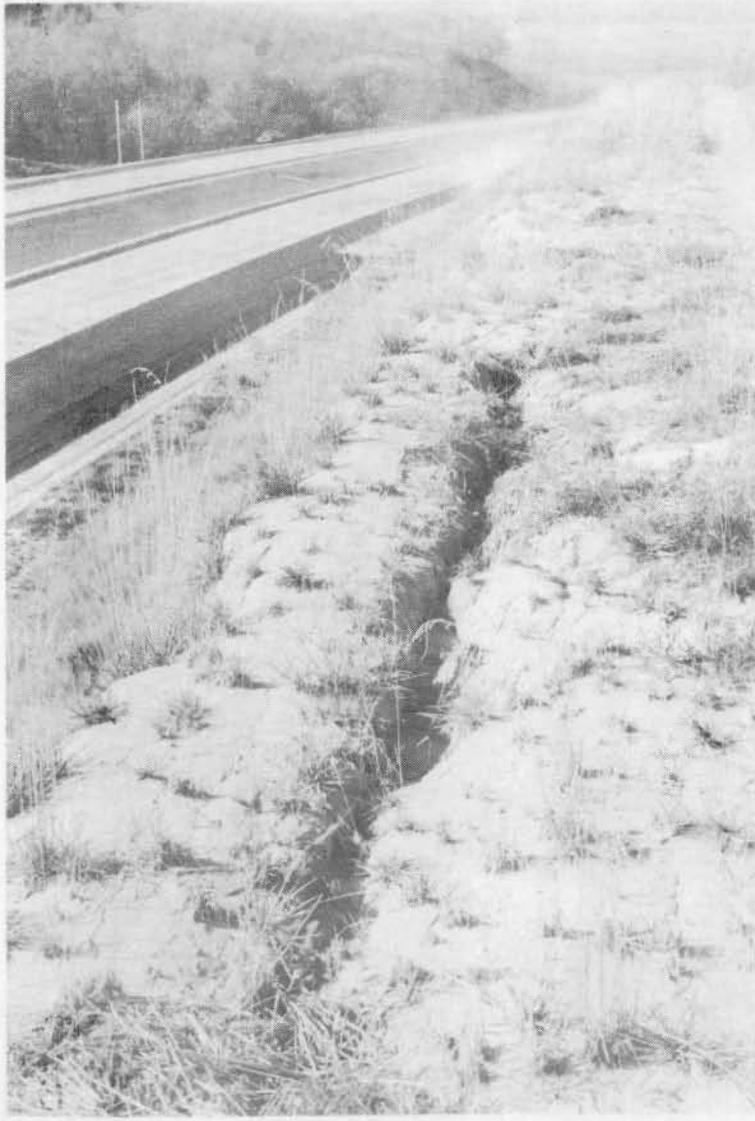
Figure 18. Piping inlets above the face shown in Figure 17 (Holt County, Route I-29)

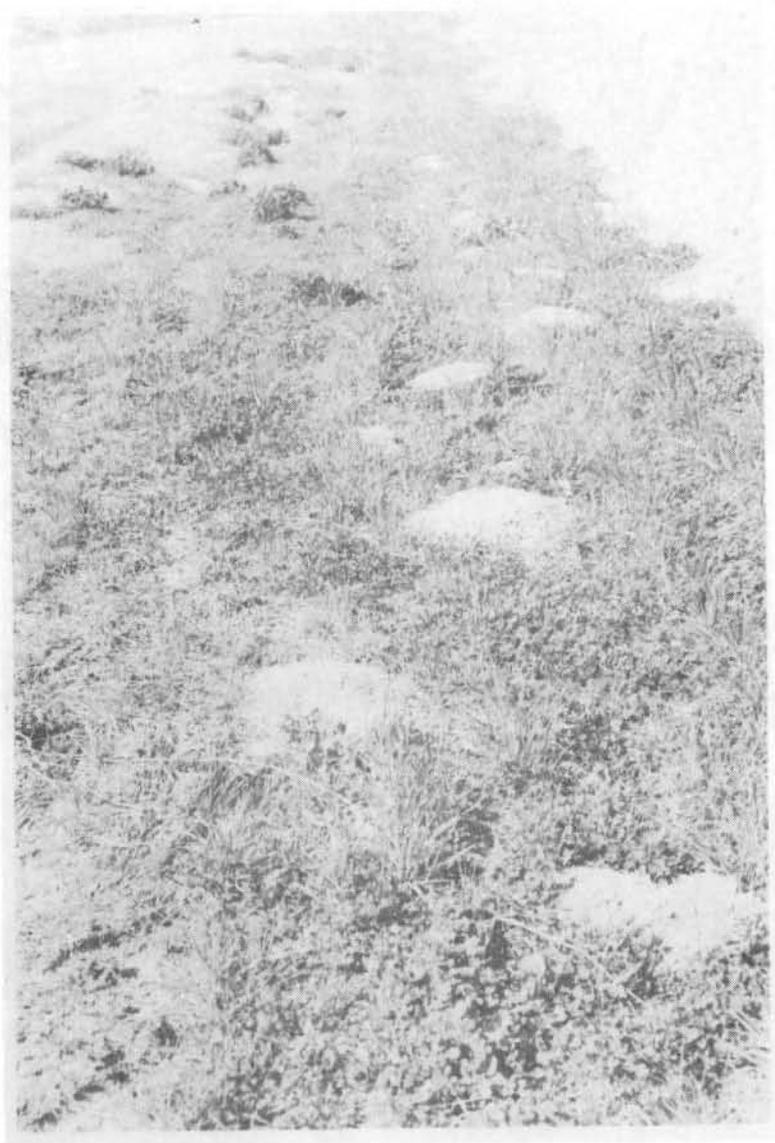
Figure 19. Rodent damage on a bench which can cause piping (Atchison County, Route 136)

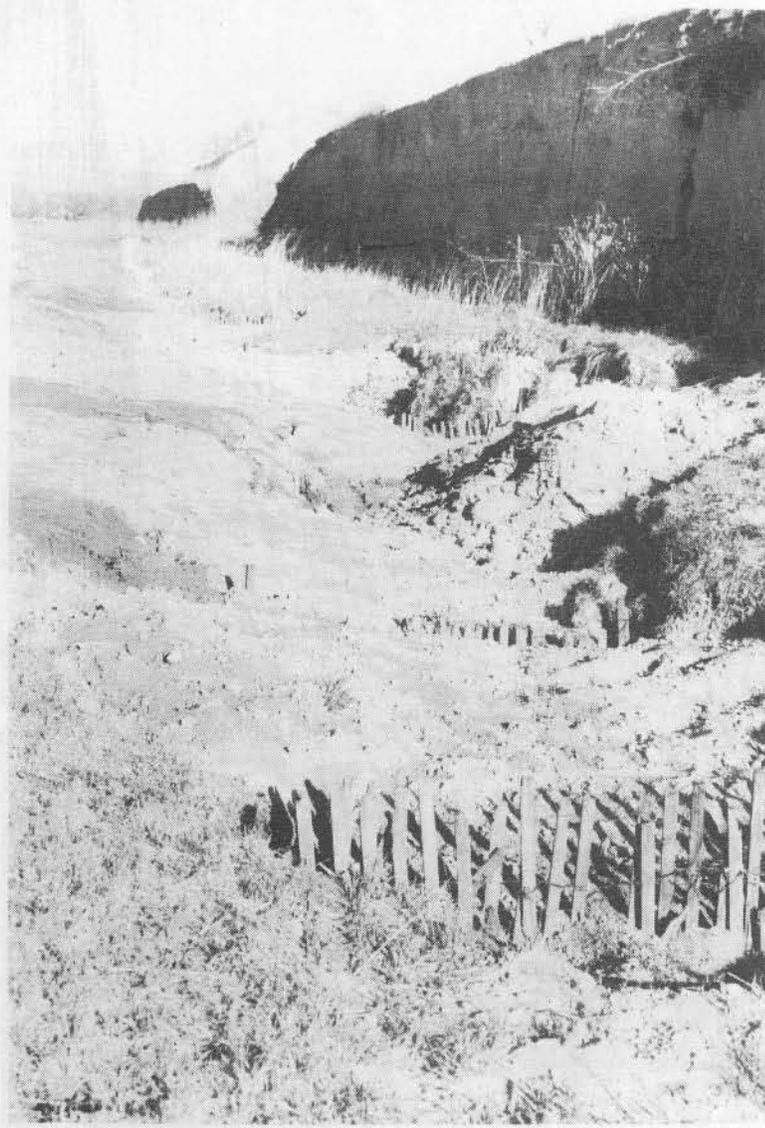
Figure 20. An attempt to control ditch erosion by catching siltation from erosion of the cut slopes (Holt County, Route F(159))

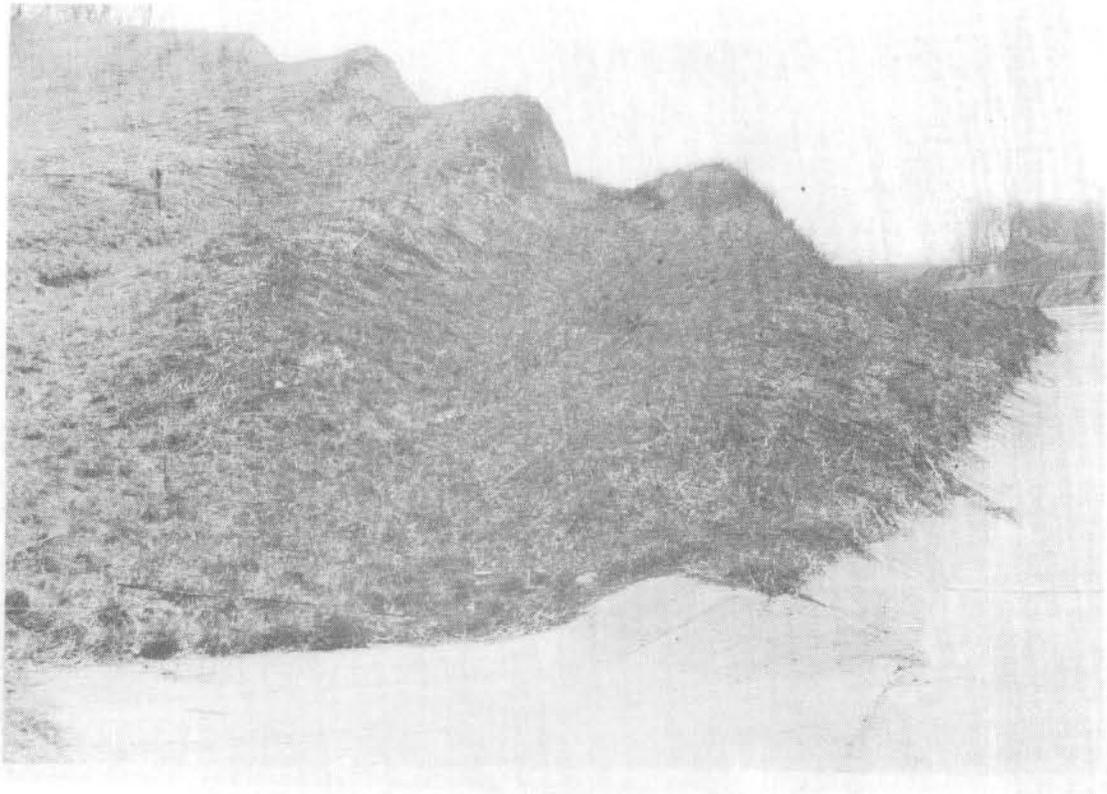
Figure 21. Erosion on a sodded V-shaped bench (Holt County, Route I-29)

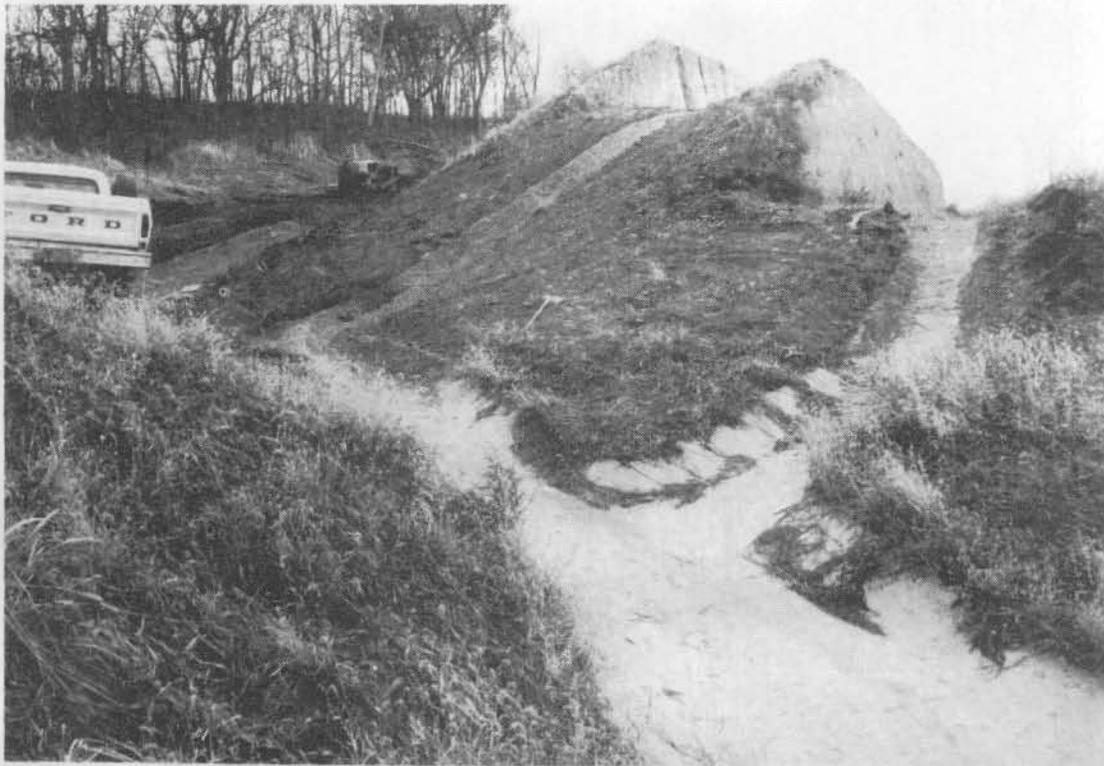
Figure 22. Extensions on paved ditches to control bench erosion (Holt County, Route I-29)

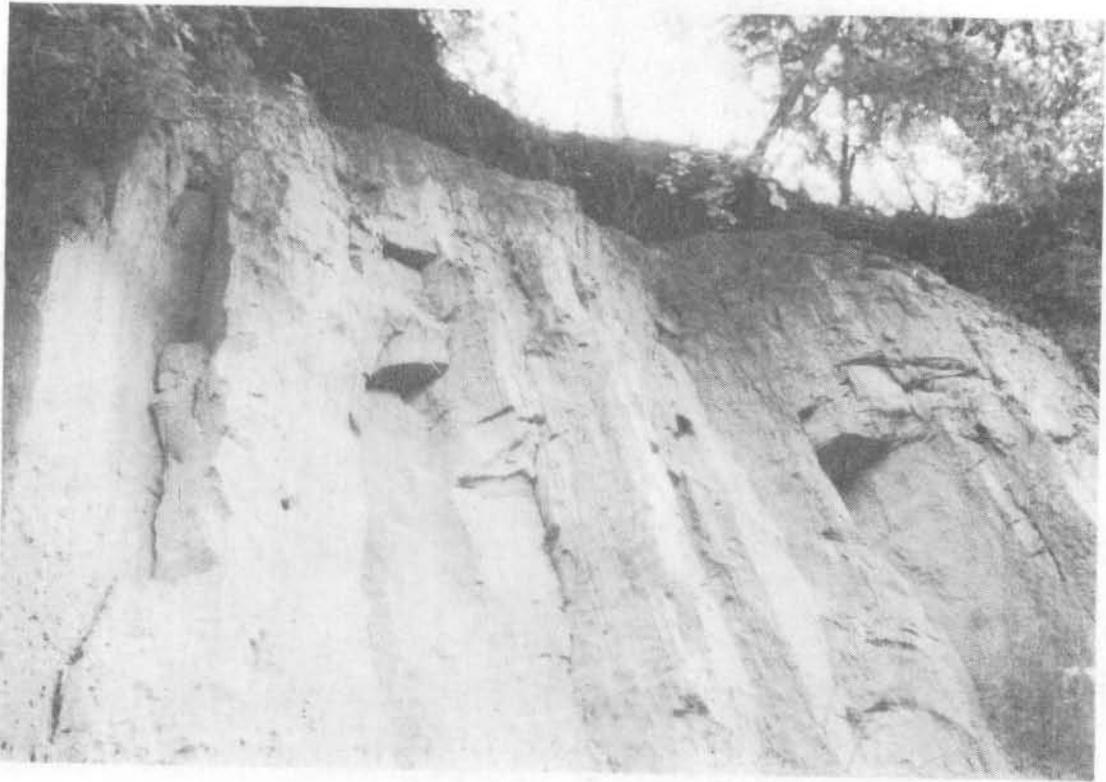
Blocks and slabs of hard soil often fall from vertical faces of loess due to shrinkage cracks developing from volume change. With shrinkage potential a function of clay content, density, and moisture, most failures occur shortly after faces of wet, "clayey" loess are first exposed to drying. Typical pictures of volume change effects are shown as Figures 23 and 24.

Figure 23. Slabbing occurring along natural joints in loess (Boone County, Route 40)

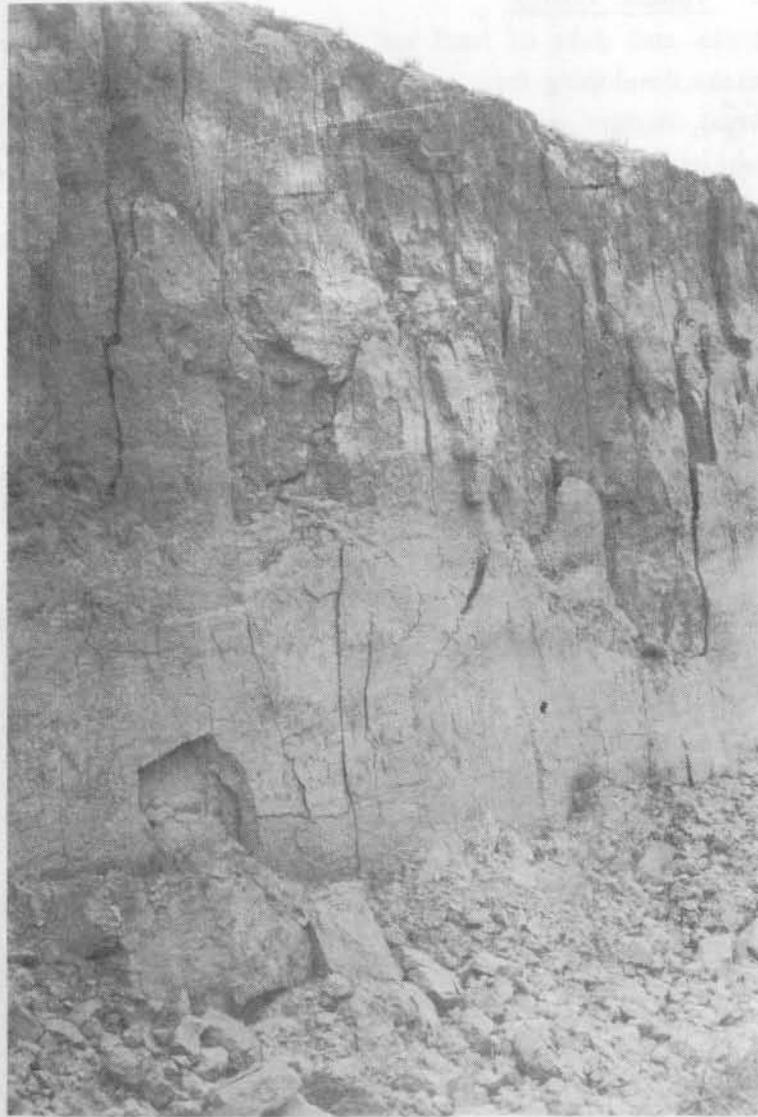
Figure 24. Shrinkage cracks in "clayey"  
loess (Clay County, Route 210)

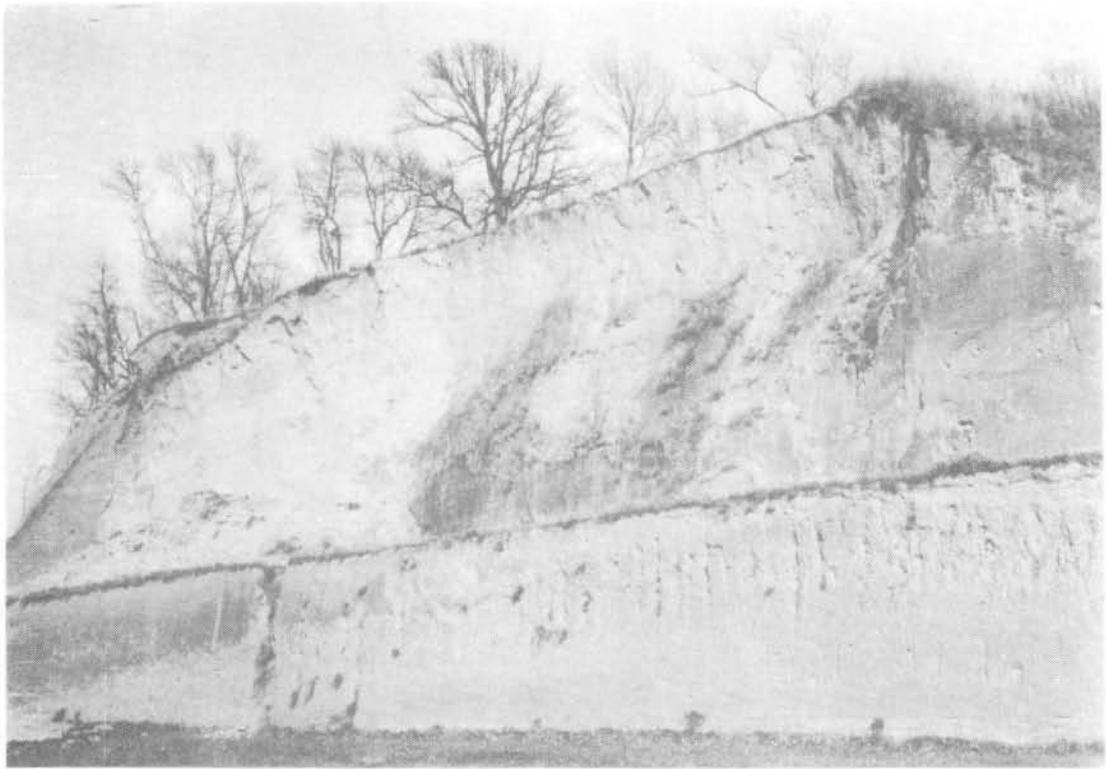
Slides usually follow a parabolic or semi-circular failure arc in loess. A slide failure of a 50 foot near vertical (1/4:1) slope is shown in Figure 25. A schematic of typical slide failure, with the characteristic steep scarp and large slump berm is shown as Figure 26

Figure 25. A slide in a 50 foot near vertical face (Atchison County, Route 136)

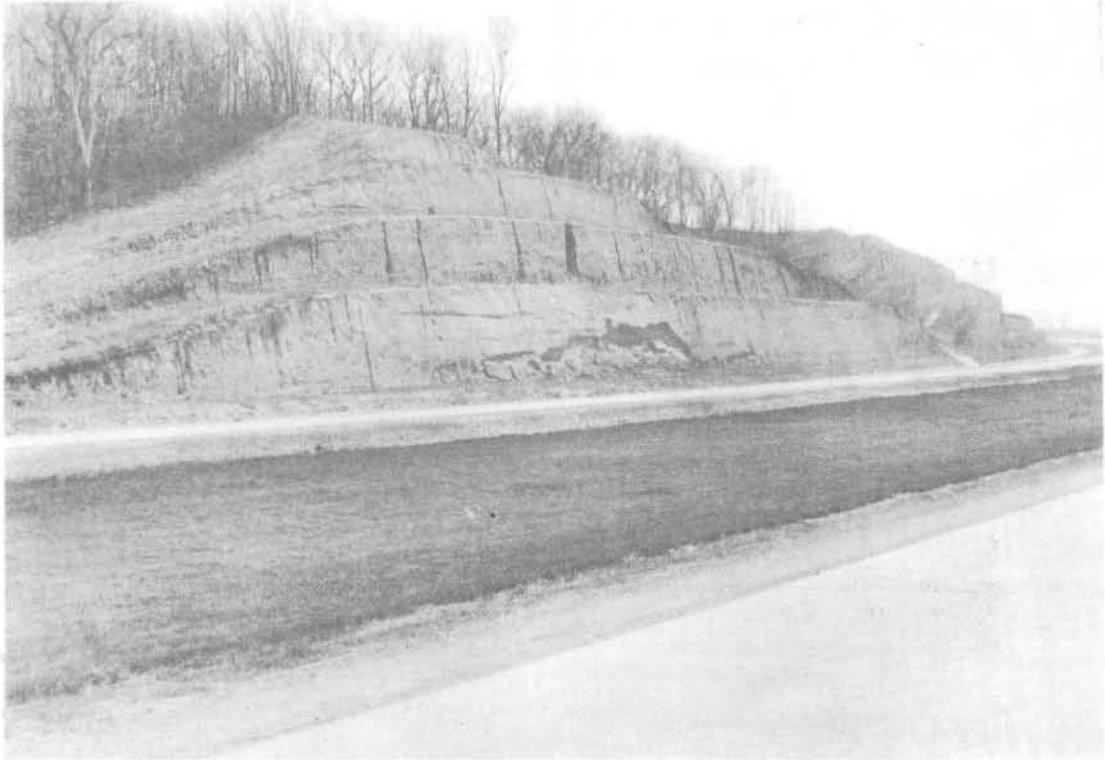
This is a progressive type of distress originating as a local slough near the base of a vertical slope. It effectively steepens the slope, sometimes establishing an overhang, and eventually contributes to a stability failure. It is most frequently found where a vertical rise truncates a water table or a stratum having very low cohesive strength (as a sand lense) or excessive moisture content. A typical example which will probably progress to slope failure is shown in Figure 27.

Figure 27. Slope damage due to a truncated water table  
(Holt County, Route I-29)

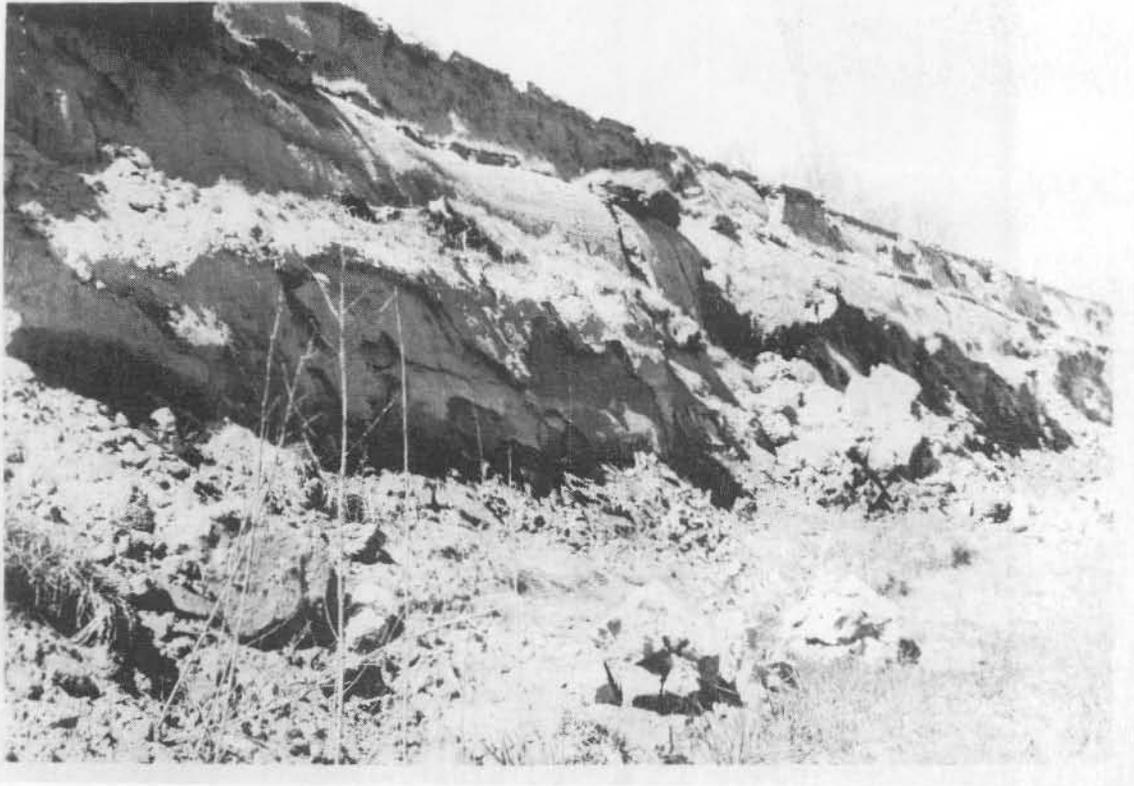
Figure 28. Stepped slope approaching an effective 1.5 to 1 with degradation by erosion and slides (Holt County, Route I-29)

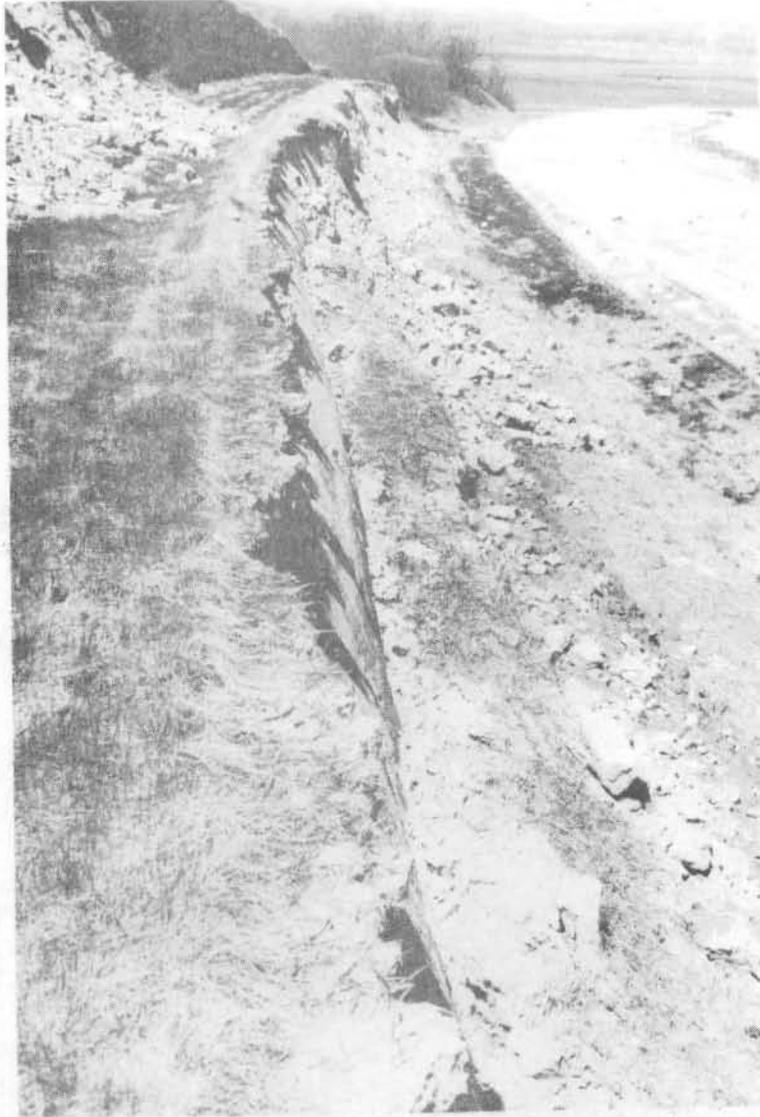
Figure 29. Slump blocks resulting from frost damage are evident on this north facing slope (Holt County, Route I-29)

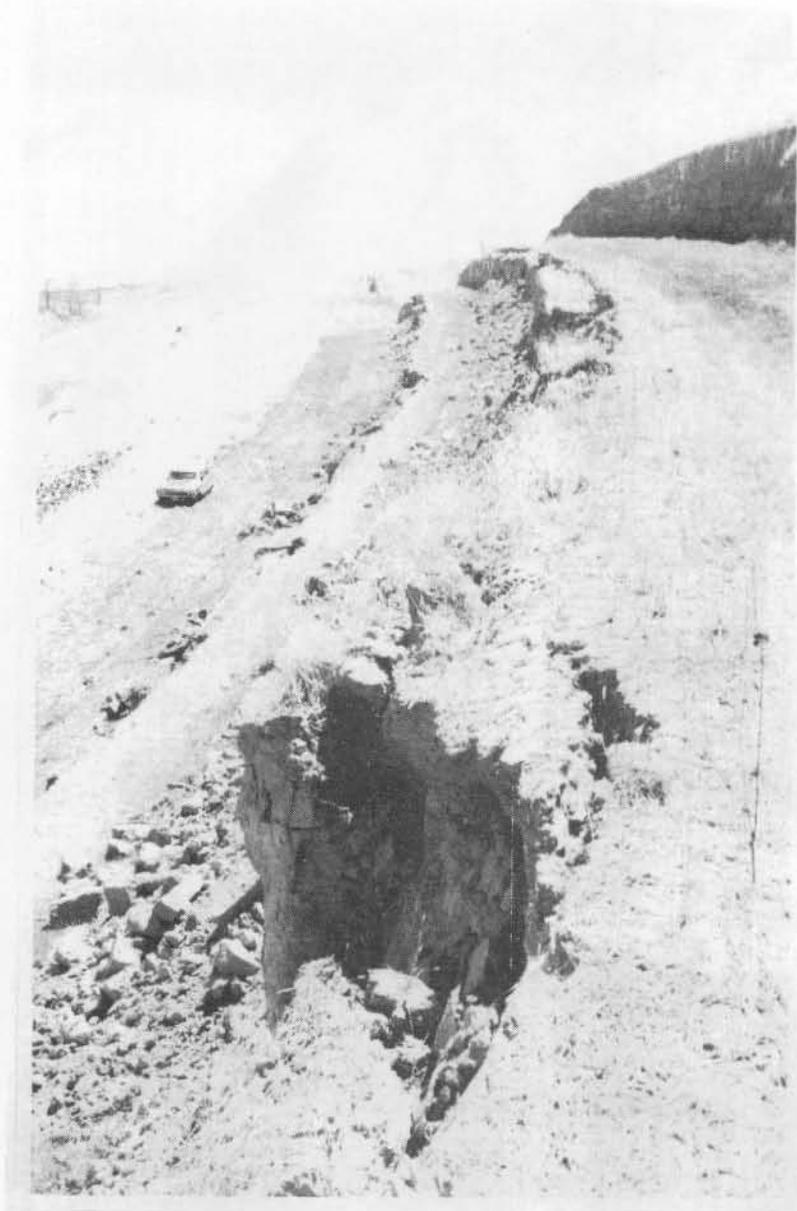
Figure 30. Failure plane from ice lense development is evident on this north facing slope (Holt County, Route I-29)

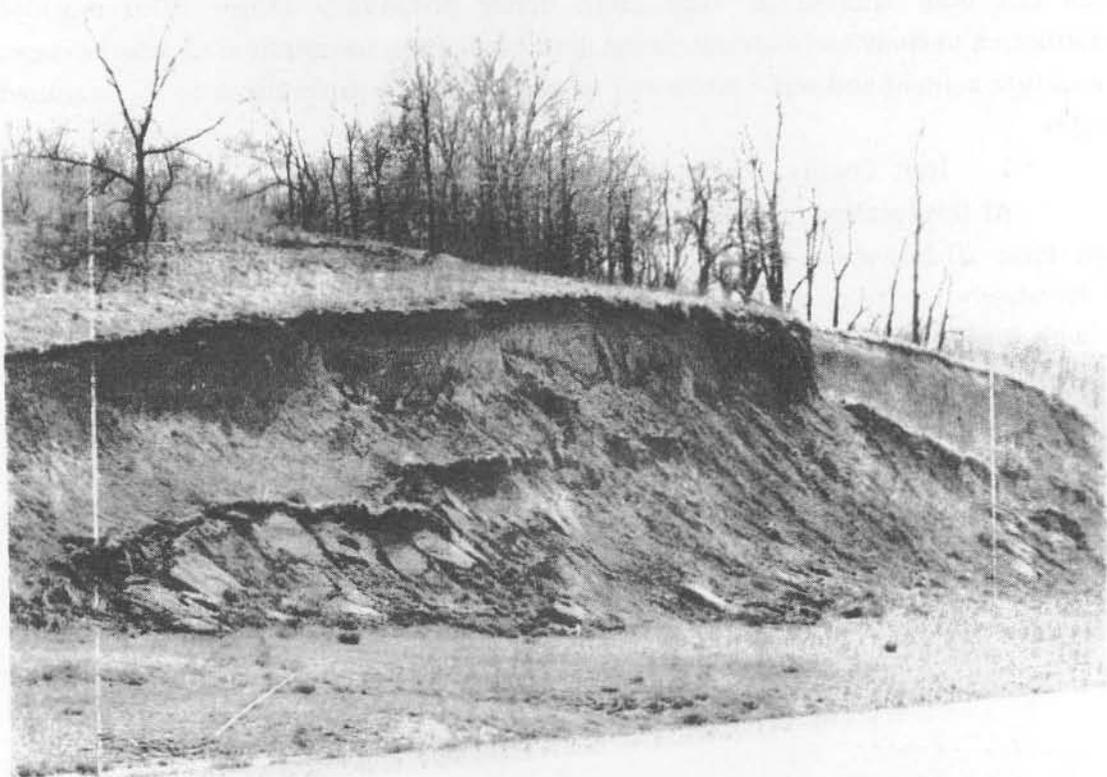
Figure 31. Frost damage to a vertical slope  
(Clay County, Route 210)
