A STUDY OF DETERIORATION IN CONCRETE BRIDGE DECKS

Division of Materials and Research
Missouri State Highway Department

A Progress Report On
Investigation 59-2A
HPR 1(4)-30

Jefferson City, Missouri
October 1965

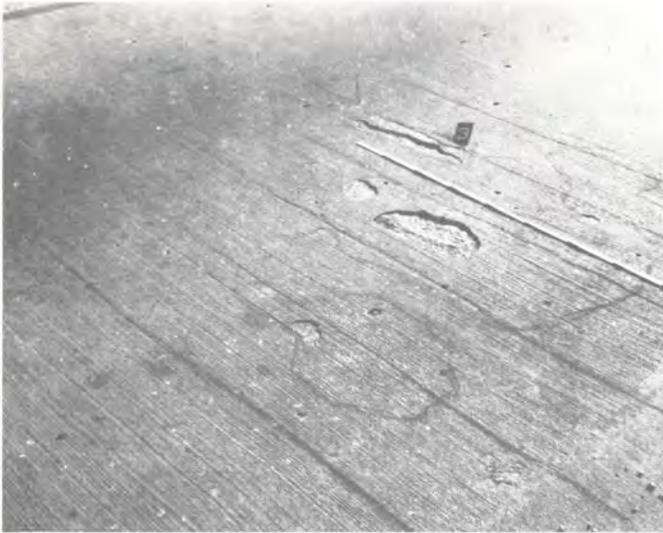
A. Pot holes and outline of fracture plane areas. Straight lines marked on surface indicate cracking over top transverse steel.

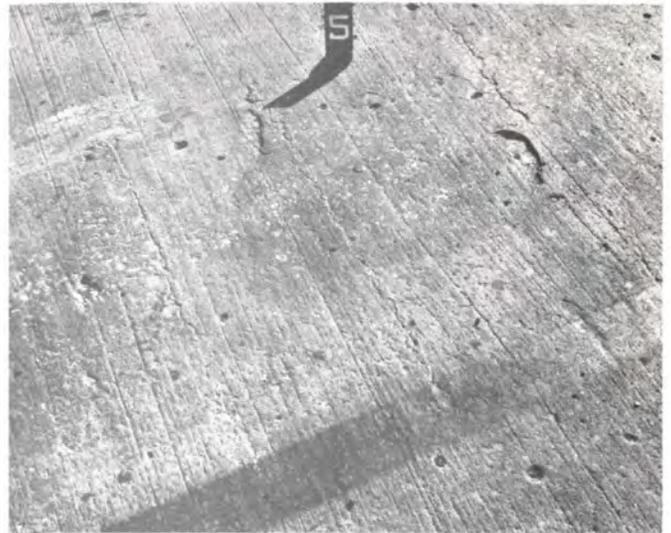
B. Incipient pot holes and cracking over top transverse steel.

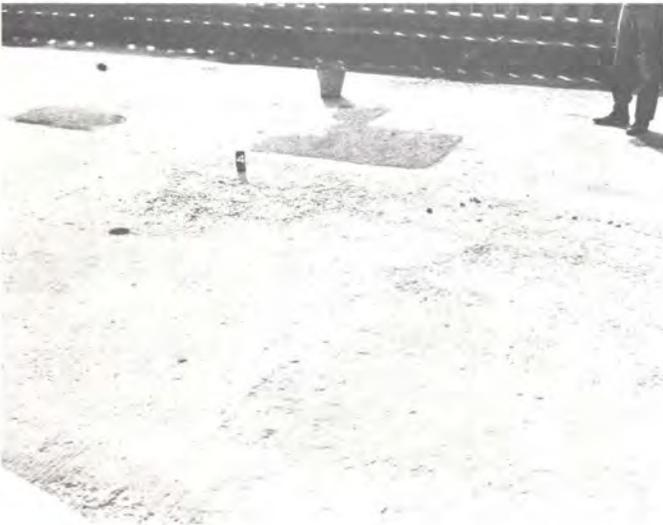
C. Stage 2 surface mortar deterioration grading into stage 1 at edges and in foreground.

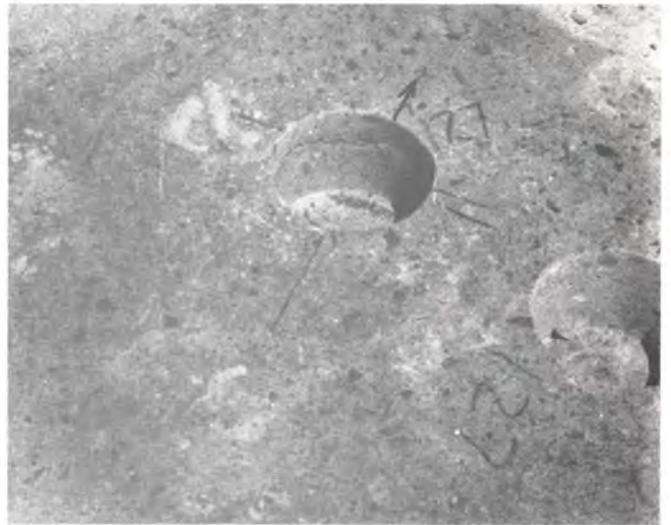
D. Core hole in fracture plane area showing fracture in wall of hole.

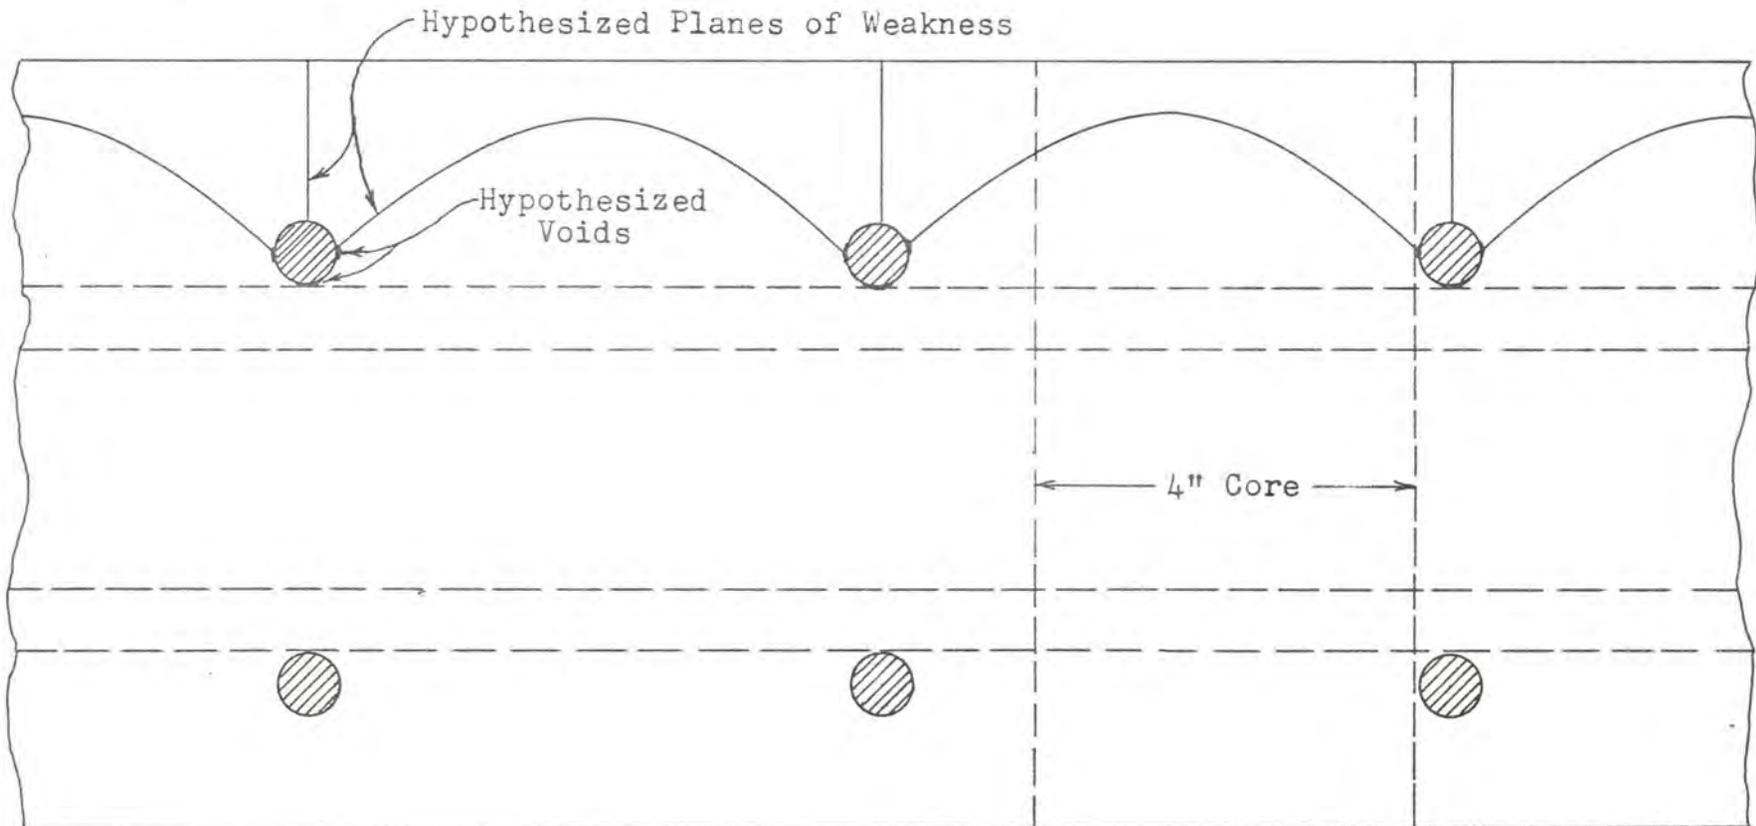
FIGURE 6

HYPOTHESIZED VOIDS AND PLANES OF WEAKNESS SHOWN IN A PARTIAL CROSS-SECTION OF BRIDGE DECK

The partial underfilling of the forms during construction may result in the deposit of a scum (laitance) which may drain from the surface of surrounding concrete to underfilled areas, and this laitance can prevent a strong bond between the concrete in the bottom layer and the concrete placed on top. The amount of laitance is dependent upon the water-cement ratio, the elapsed time before final placement of the top layer of concrete in the underfilled areas, and the method of placing and finishing the top layer. If the top of this bottom layer of concrete coincides with the level where the plane of high water gain occurs, a deposit of laitance would accentuate the strength loss in the plane of weakness, and the effects of succeeding factors which would have changed the plane of weakness by itself into a fracture plane will be even more pronounced.
