Airport Runway Pavement Marking Staining Study

The Problem

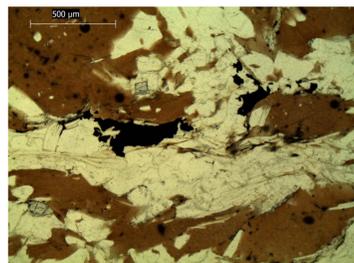
Keene Petrographic Slide

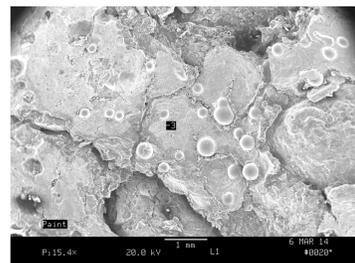
Laconia Paint Chip SEM Analysis

- ✓ Scanning Electron Microscope identified iron on the stained paint locations. Petrographic analysis associates the staining with opaque iron oxide, iron sulfide and iron oxyhydroxide minerals. Accelerated oxidization tests promoted rust staining.
- ✓ Proven industry methods to mitigate the staining include pressure washing and modifying the Federal Specification TT-P-1952E paint specification by including a rust inhibitor.
- ✓ 20-year life cycle cost analysis indicates that modification of the TT-P-1952E paint for paint types I, II and III is more cost effective than using the standard paint.
- ✓ Matching bead type with paint type is required for proper marking visibility.

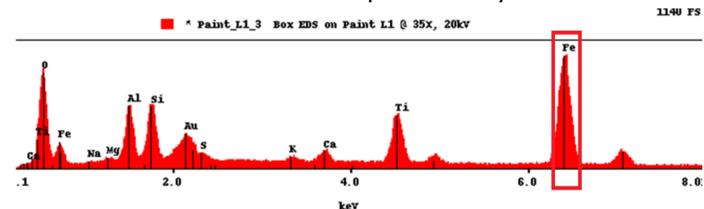
Laconia Elemental Spectrum for Paint Chip Above

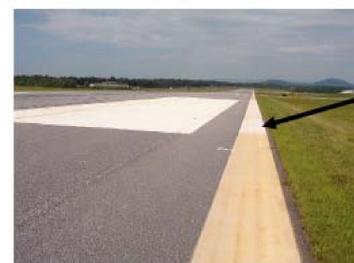
Grooved (Black Arrow) & Not Grooved Pavement

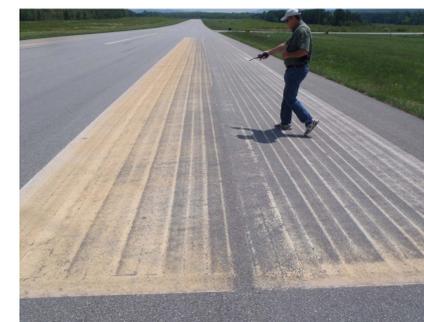
Mt. Washington Regional Airport Rust Stained Threshold Markings

- ✓ According to industry experts, rust discoloration can be removed by pressure washing.
- ✓ The life cycle of paint can be extended to 6-plus years by using a modified TT-P-1952E paint per the paint manufacturers.
- ✓ Recommended methods for follow-on studies include the use of a modified TT-P-1952E paint, the use of solvent based paints, asphalt sealers, grooving of markings and clear coating of paints. Conduct accelerated oxidization testing to prove viability of recommendations before field studies.

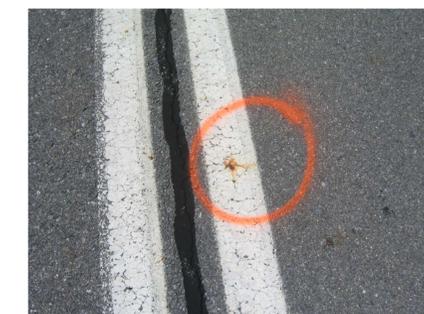
Concord Municipal Airport Runway 12-30 Rust Spot
