MISSOURI COOPERATIVE HIGHWAY RESEARCH PROGRAM,
REPORT

✓✓
"STATIC AND FATIGUE BEHAVIOR OF
CONTINUOUS-COMPOSITE BEAMS WITH
HIGH-STRENGTH BOLTS AS SHEAR CONNECTORS"

LAWRENCE N. DALLAM

JUNE, 1970

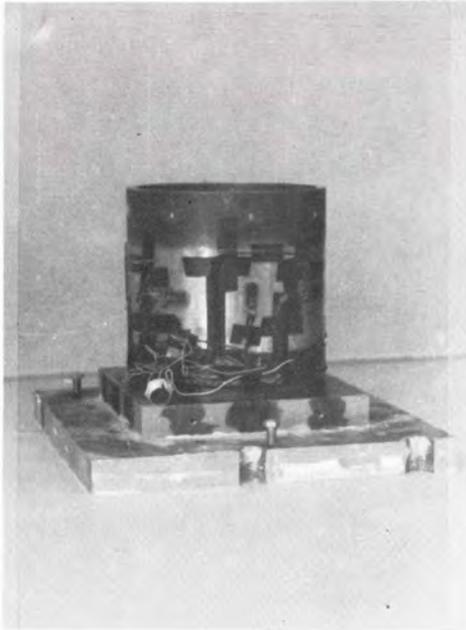
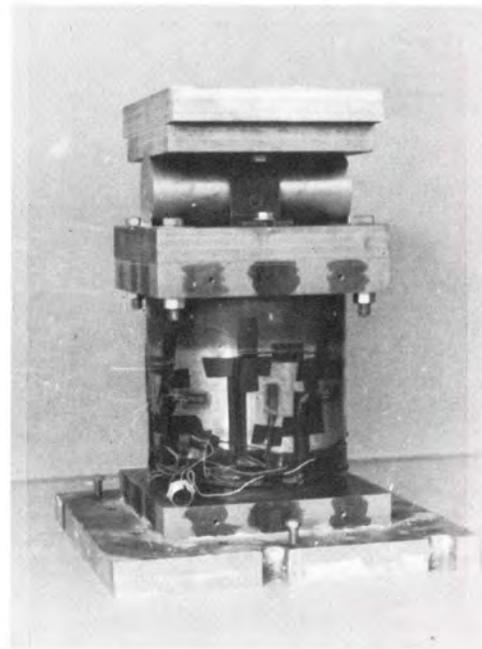
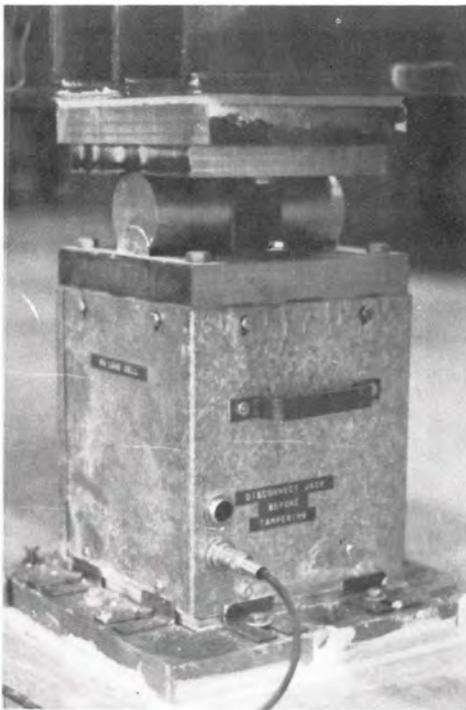
Figure 15a Load Cell Core

Figure 15b Load Cell
as Support

Figure 15c Load Cell
Ready to Use

One-eighth inch deep grooves were machined into two $9 \times 9 \times 1\frac{1}{8}$ inch plates to fit the top and bottom of the cylinder. A third plate was machined to fit a three inch diameter solid cylinder which was to act as a knife edge and was bolted to the top plate. Another plate was machined to fit the solid cylinder to act as a bearing plate between the beam and the load cell. Finally, the cylinder was enclosed in 16 gage galvanized plates, loosely bolted to the top and the bottom plates in order not to carry any load but to protect the inner core of the load cell. The leads from the gages were wired permanently to a jack-plug which was attached to the galvanized plates (Figure 15a, b and c).
