Analysis of Cold In-place Recycled Asphalt Pavements

A research study by Organizational Results in cooperation with the Northwest District and the Maintenance Division

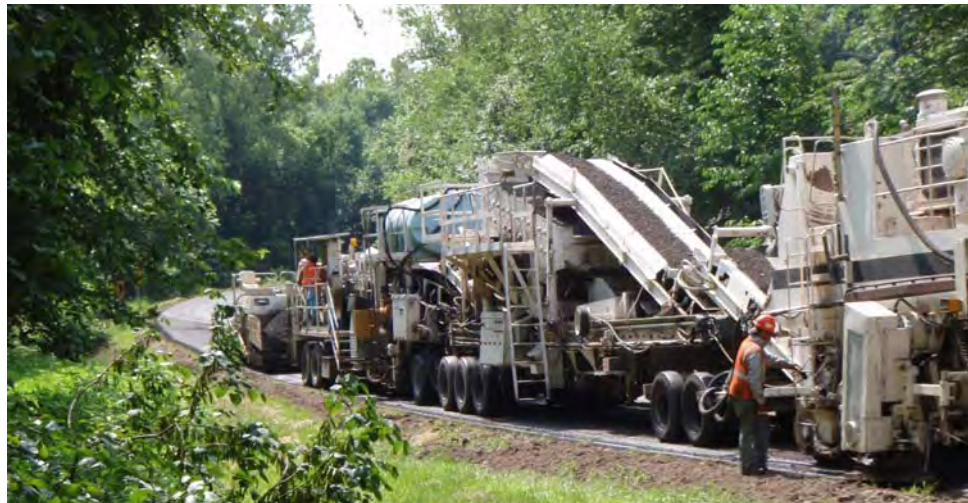
Figure 1 – Paving train

The paving train used on the project consisted of an oil tanker truck connected to a Caterpillar PR-1000 Pavement Profiler (*Figure 1*). The train logistics were as follows: The oil tanker truck supplied the pug mill mixer with the asphalt emulsion and was pushed along the roadway by the milling machine. The milling machine connected to and was followed by a screening/crushing machine. The screening/crushing machine received the milled pavement from the milling machine by means of a conveyor. The screening/crushing machine then diverted oversized material into an impact crusher to further break up the asphalt matrix. The screening and crushing process continued until all of the reclaimed material had been sorted through the vibrating screens and conveyed to the pug mill mixer. The pug mill mixer was connected to the back of the screening/crushing machine. The mixer weighed the material and an on-board microprocessor continuously adjusted the flow of asphalt emulsion, water and other liquid additives to the milled material. The millings were uniformly coated for maximum long-term

cohesion and surface strength before the recycled material was placed on a conveyor to flow into the conventional hot-mix paver. A Cedarapids rubber track paver was equipped with automatic screed controls that spread the recycled asphalt to the specified depth and width. Finally, two rollers followed the paving train. The first roller was a 30-ton seven-wheel pneumatic tire roller, followed by a Cat 3116T double drum vibratory roller.

For several decades, CIR has been used nationwide and is considered a cost-effective alternative to more common methods of rehabilitating asphalt roadways. CIR has also evolved into a continuous train operation. This train operation consists of the following equipment:

- A powerful milling machine that can cut full or partial depth and full lane width in a single pass,
- A screening/crushing machine,
- A continuous flow pug-mill mixer,
- A conventional hot-mix paver, and
- Heavy rollers to compact the mixture on the roadway.

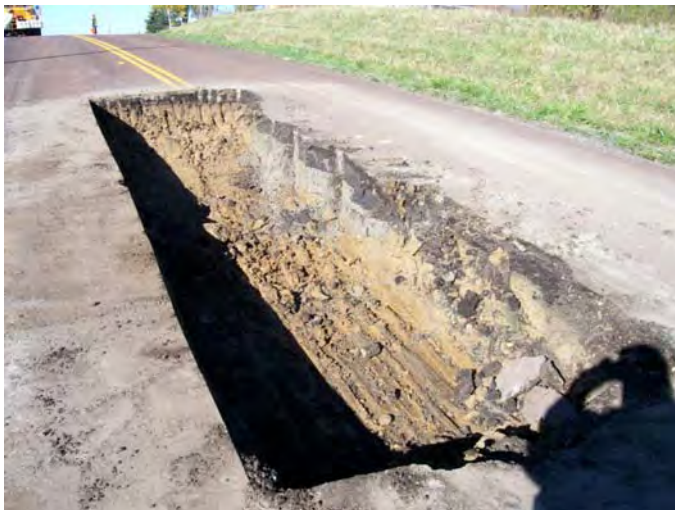
Figure 2 – Maintenance repairs

Maintenance crews tried to repair these failures by removing the failed area down to a depth of approximately two feet (*Figure 2*). Once the wet clay subgrade was removed, crushed limestone was placed in the hole and compacted before a cold-mix asphalt patch was placed. The early failures were sporadic at first, but became more numerous as time passed. All of the failed areas were outside of the test sections that were set up prior to construction.

The CIR project in Gentry Co. has been open to the traffic for more than one year. Immediately after construction, the comments from the traveling public were quite favorable. However, within five weeks after the routes were opened to traffic, the first of many failures in the road surface began to appear. Areas of fatigue cracking were first noticed before the surface began to break up and the underlying subgrade worked its way to the surface. The subgrade turned out to be wet clay.

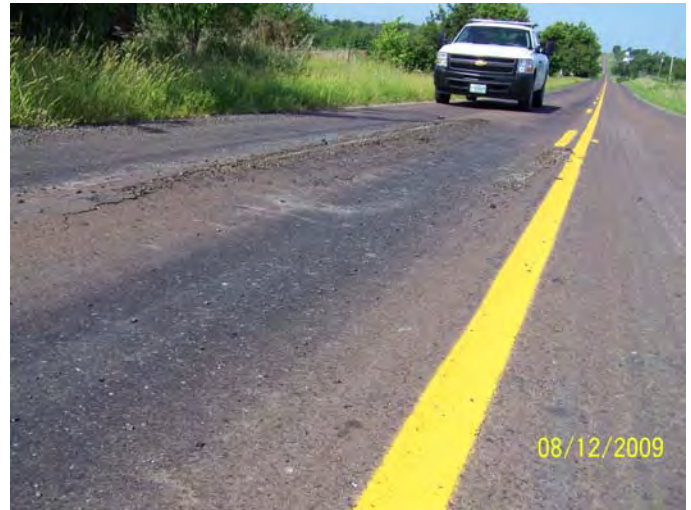
Figure 3 – Pavement rutting

The rutting and fatigue cracking that was so prevalent throughout the test sections prior to construction were eliminated with the CIR placement. After 6 months of service, there was no evidence of rutting in any of the test sections and only a small amount of low severity fatigue cracking was found. Rutting in the test sections did appear during the one-year survey and was

almost identical to the severity that was recorded prior to construction. The fatigue cracking wasn't as severe as it was prior to construction, but the areas of fatigue cracking did increase dramatically when compared to the six-month visual distress survey.
