RDT 02-013

# Missouri Guide for Pavement Rehabilitation

RI 00-008

November, 2002

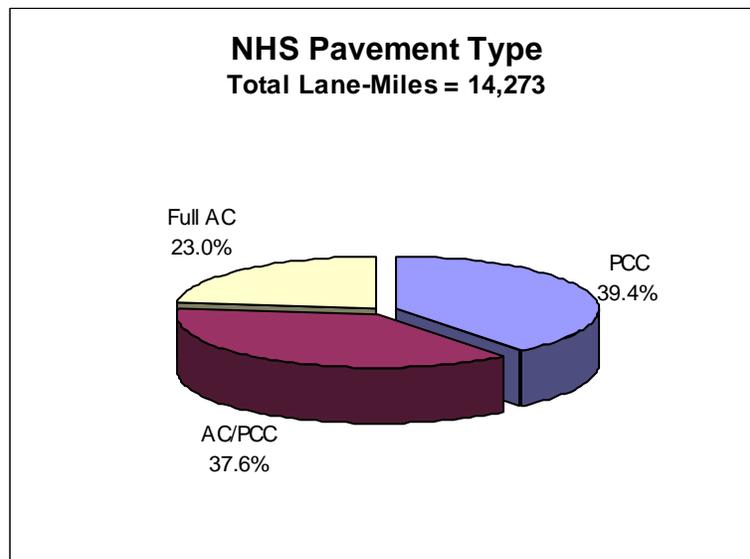
The pie chart below reveals that Missouri's NHS is primarily Portland cement concrete (PCC) or PCC overlaid with asphalt concrete (AC). The percentage of AC/PCC may actually be higher and full-depth AC lower because of uncertainty about the historical records for some full-depth AC pavements. The entire Interstate system was originally paved with PCC, except for a few short stretches on I-44.

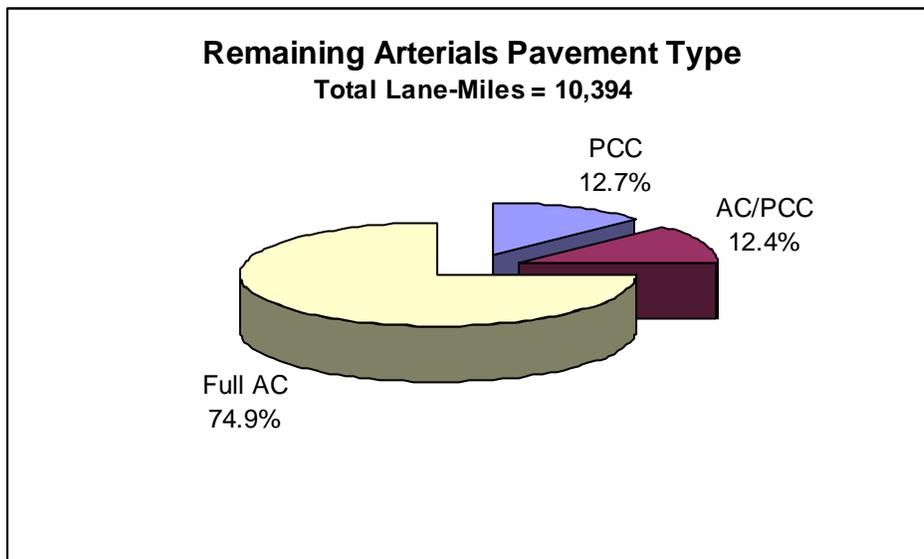
The pie chart below reveals that nearly 75 percent of the lane-miles in this category are full-depth AC. The rest is evenly split between bare and overlaid PCC. The percentage of AC/PCC may actually be higher and full-depth AC lower because of uncertainty about the historical records for some full-depth AC pavements.

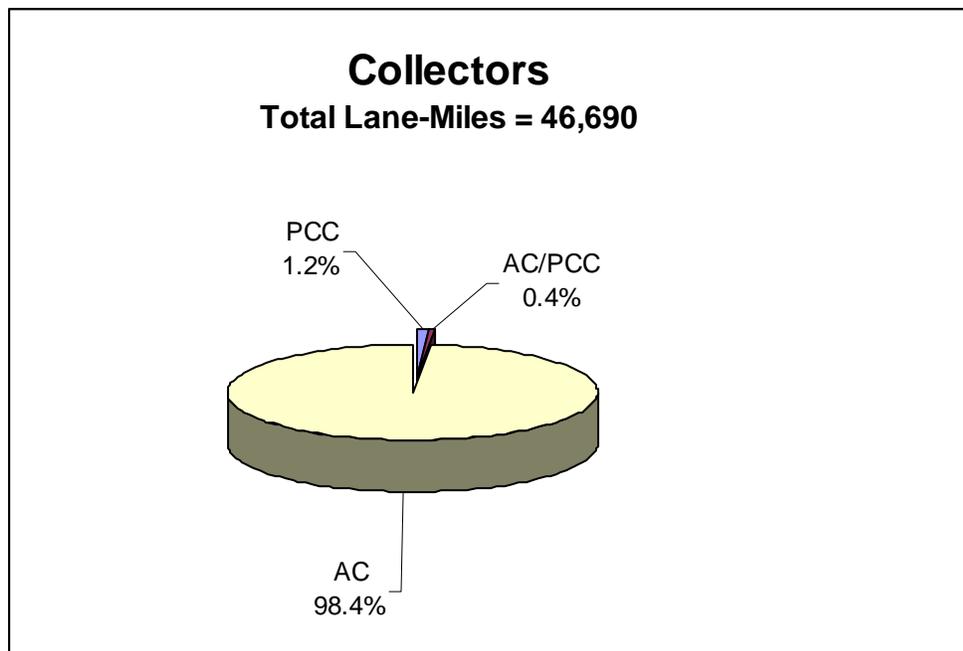
The following pie chart indicates that these routes are predominantly AC.

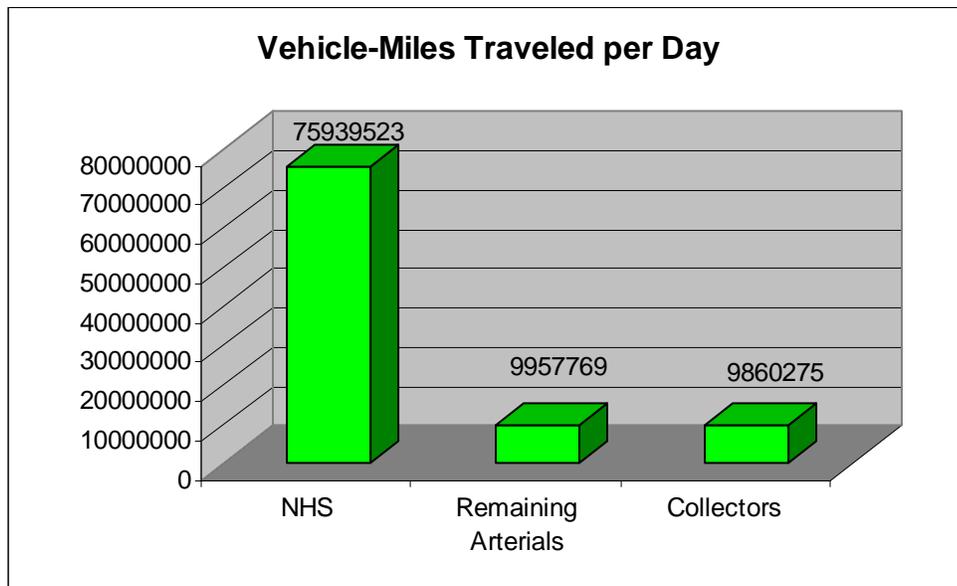
The cumulative number of vehicle-miles traveled (VMT) on the NHS is approximately 80 percent of all VMT on the Missouri state system. This equates to carrying 80 percent of the traffic on 20 percent of the lane-miles. The other 20 percent is split nearly even between remaining arterials and collectors; however, remaining arterials have less than 25 percent the lane-miles that collectors have.

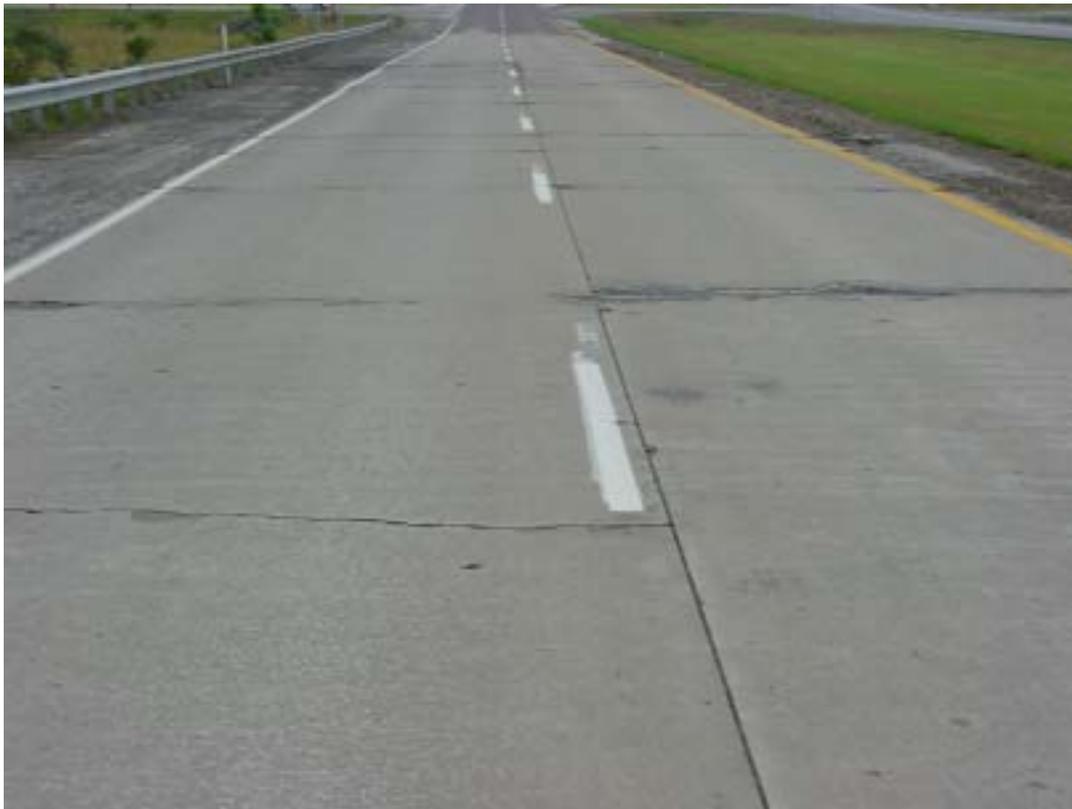
Until 1993 JRCP was the standard design in Missouri. Design thickness ranged from 8 – 11 inches. Joint spacing was 61.5 feet. JRCP performance was often marred by faulting, spalling and general deterioration at joints and sometimes at working third point panel cracks. D-cracking in the northwestern part of the State often accelerated these failures. Outside of these problems, the PCC slabs remained intact for a long time. The biggest concern over this type of design, assuming proper base support, drainage and good quality coarse aggregate are present to keep it structurally sound, is the effect of temperature and moisture-induced slab curvature on ride.

JRCP on NB US 54 in Callaway County

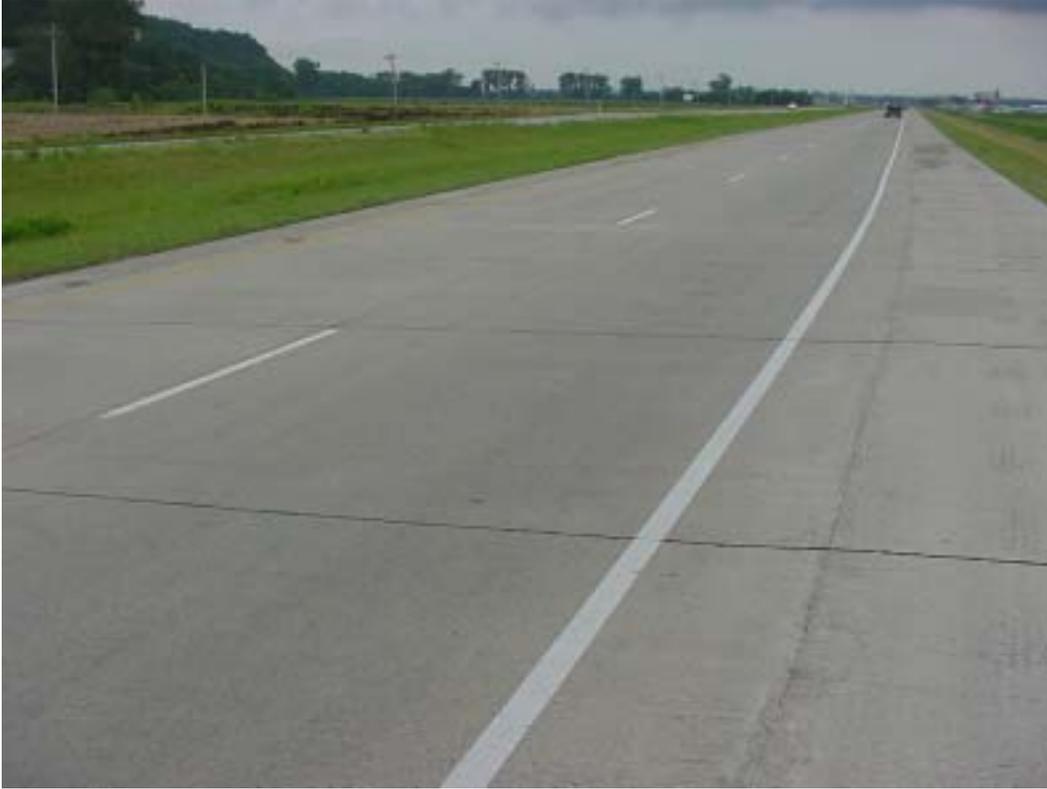
Prior to 1994 Missouri had occasionally built some 30-foot JPCPs. These pavements tended to form mid-panel cracks. Since 1994 all PCC pavements in Missouri have been built with the JPCP style. Driving lane slabs are paved 14-feet wide or 2 feet beyond the edge line. Joint spacing is 15 feet, which has virtually eliminated natural mid-panel cracking. Joints are doweled. Slab thickness is 11-14 inches on NHS and other arterial roads, much greater than the older JRCP design. The preferred base type is a 2-foot, daylighted rock base, which provides a stiff platform as well what is currently believed to be a very drainable layer. Performance to date has been excellent.

JPCP on SB US 63 in Boone County

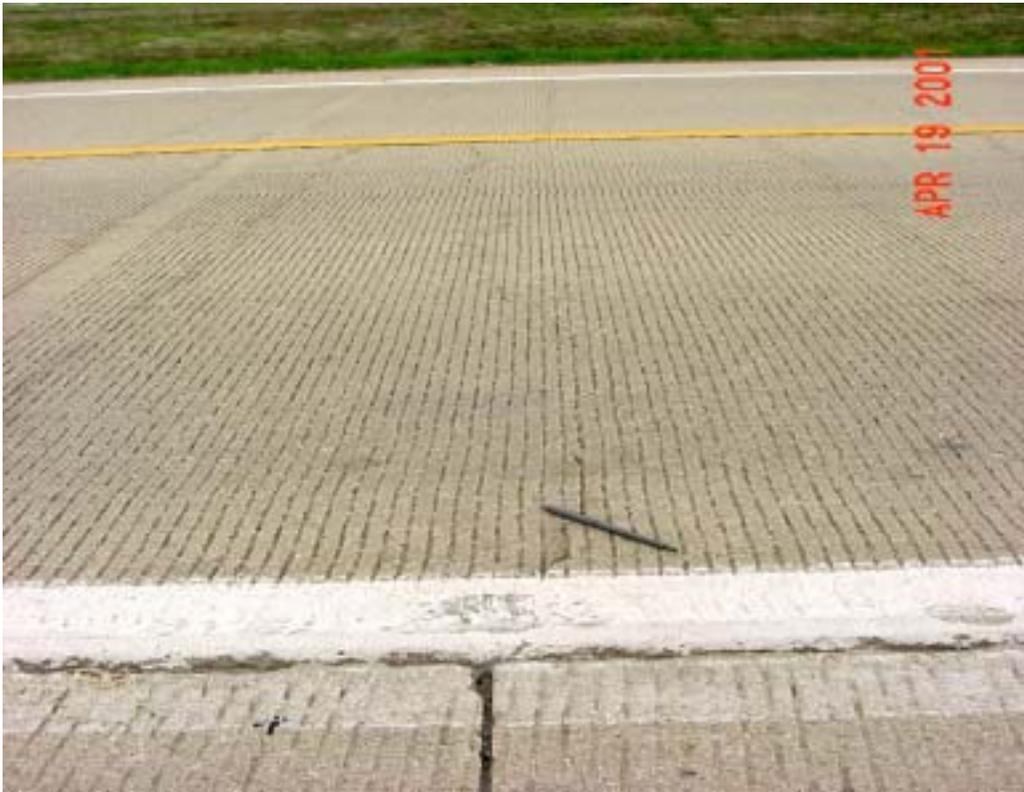
Continuously reinforced concrete pavement (CRCP) has continuous wire mesh or tied longitudinal rebar across its entire area. The reinforcement is usually placed slightly above slab mid-depth. There are no joints. The slab cracks naturally from shrinkage in 4-5-foot transverse spacing. The cracks are held tight by the steel. The picture below illustrates ideal crack spacings and openings for a CRCP.

Illinois CRCP

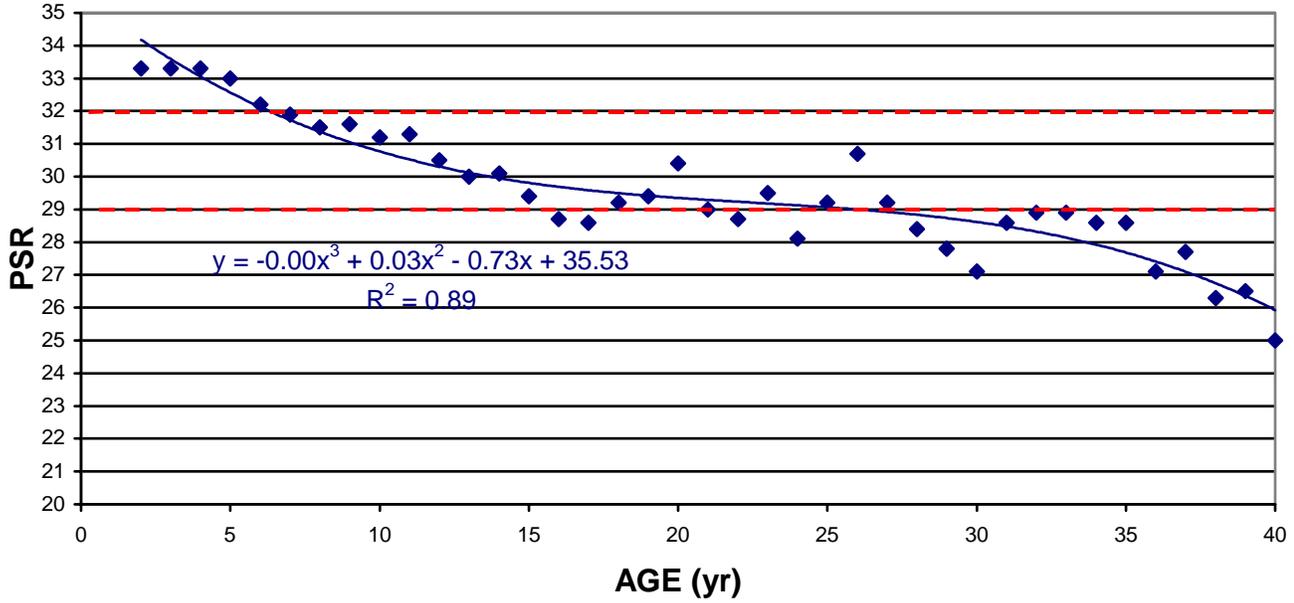
Average PCCP PSRs deteriorate gradually for the first sixteen to seventeen years and then level off somewhat. A 3<sup>rd</sup> degree polynomial regression approximates the trend well. Maintenance activities such as patching and joint repairs probably account for some of the leveling, however; it would be very difficult without accurate maintenance histories to measure what affect the improvements had on the performance scores. Whatever the case, it can be assumed the conditions were judged not to merit resurfacing. Average time before PCCPs descend to an unacceptable PSR is around 25 years. Ride and condition trends are similar to PSR.

Cummulative length - 10,234 miles

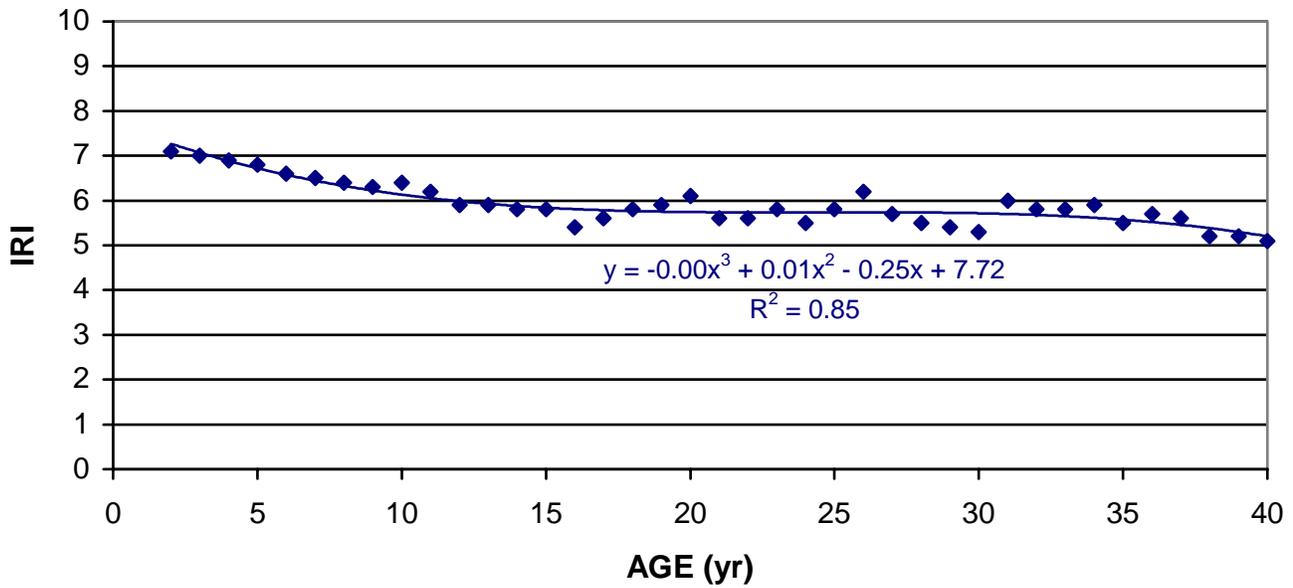
### Ride for PCC on Divided NHS

1995-2000 ARAN Data

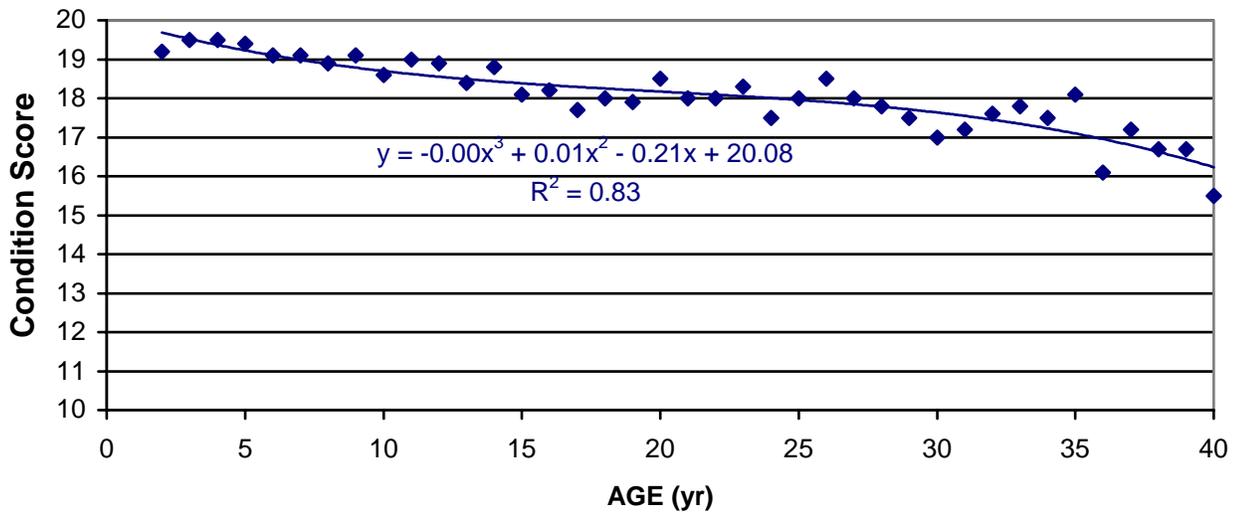
## Condition for PCC on Divided NHS 1995-2000 ARAN Data

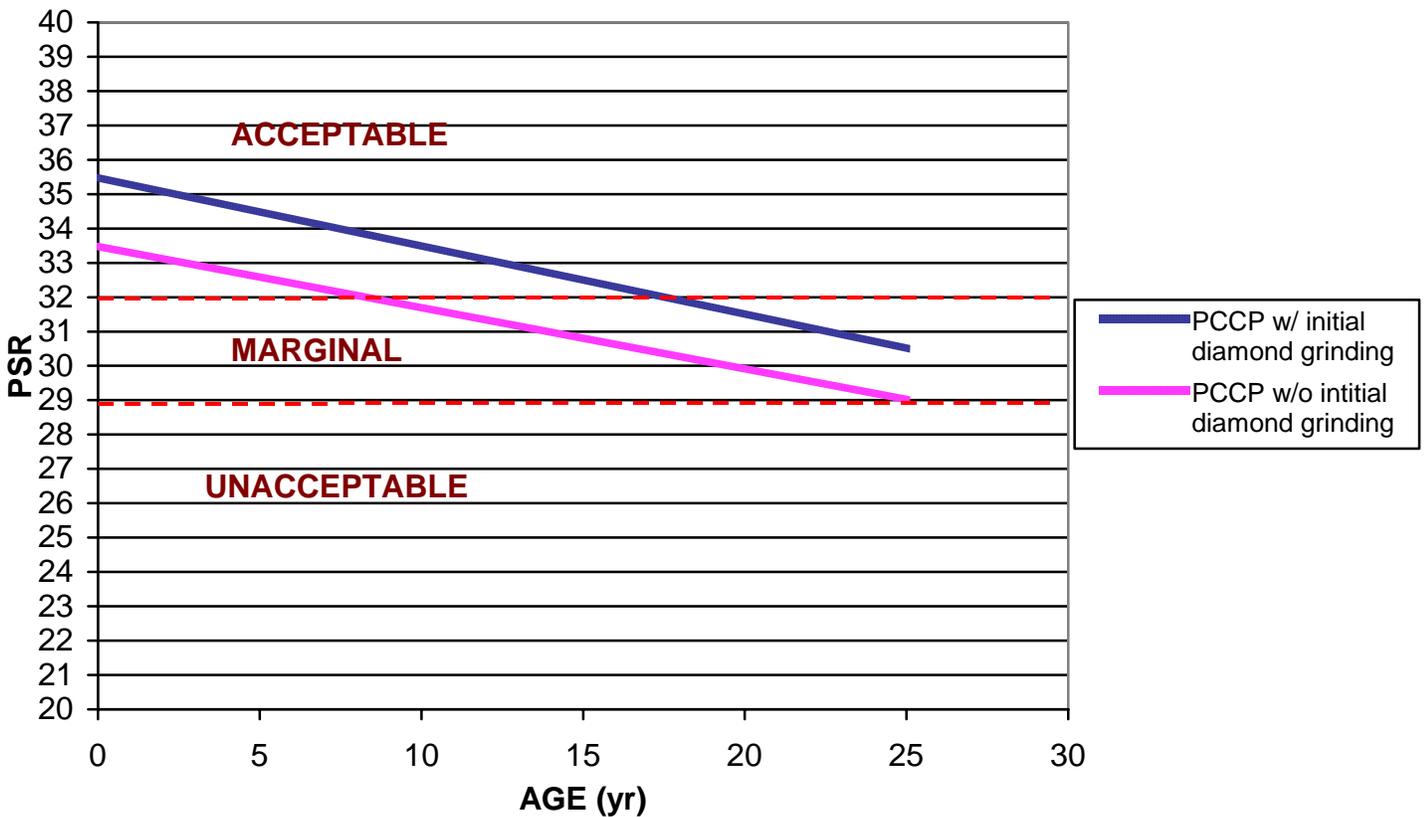
To illustrate this concept, let's look at two PCCPs that are identical in every way, except that one has had its surface diamond ground while the other has not. Assume the change in Condition scores for each is 1.5 points over a 25-year period, which is consistent with the historical average in the previous Condition chart. Then assume the change in Ride for the non-diamond ground PCCP is approximately 1.5 points, which is consistent with the historical average in the previous Ride chart and that this is 85 percent of the change in Ride for the diamond ground PCCP. Based on the ARAN data for the US 60 diamond grinding project, it can also be assumed the overall initial increase in PSR for a diamond ground PCCP is around 2 points. Therefore, the diamond-ground pavement starting with a PSR of 35.5 would drop to 30.5 after 25 years, while the non-diamond-ground pavement would change from 33.5 to 29.

### Effect of Initial Smoothness on PCCP Performance Life

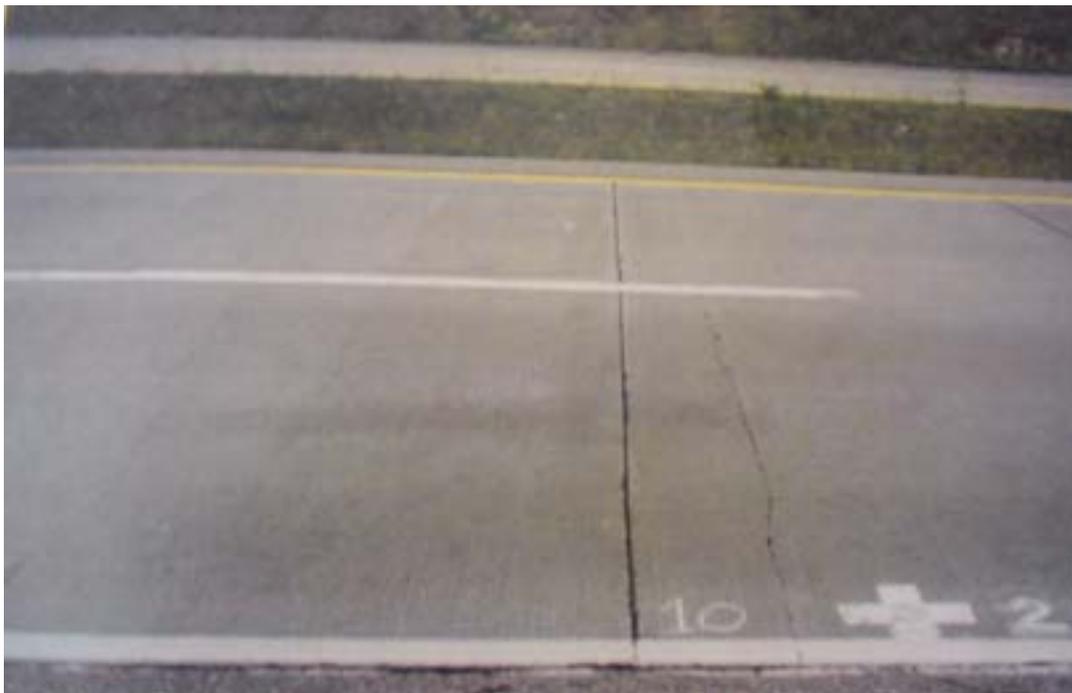
The U.S. 67 project contained test sections with bonded overlay thickness ranging from 3-5 inches. There were problems with debonding and excessive transverse and longitudinal cracking on some sections, which appeared to be related to the type of surface preparation. Other portions of the pavement are doing well.

Bonded concrete overlay on NB US 67 in Jefferson County

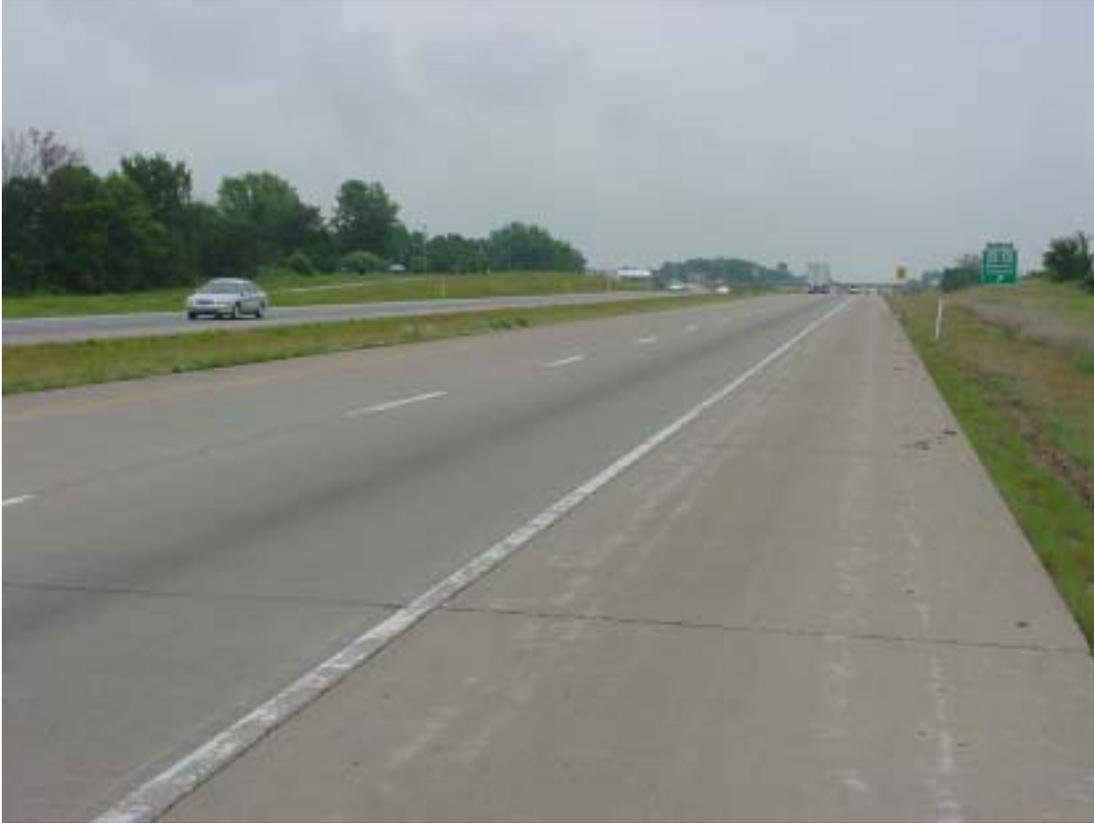
Unbonded PCC on I-70 in Callaway County

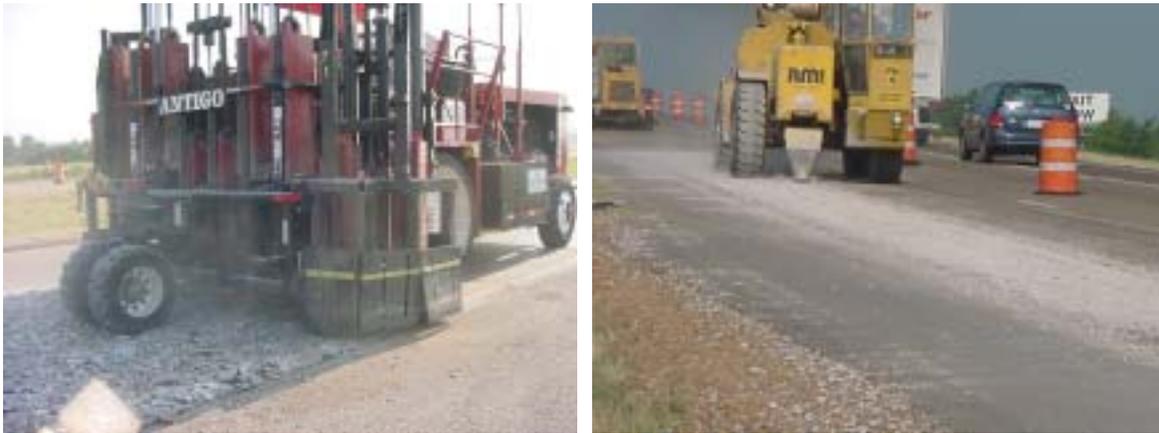
States word their rubblization specifications to allow use of either the multiple head breaker (shown at left below) or the resonant breaker (shown at right below), although pavement engineers in each state may have their own preferences for one or the other.

Multiple-head breaker (left) and Resonant breaker (right)

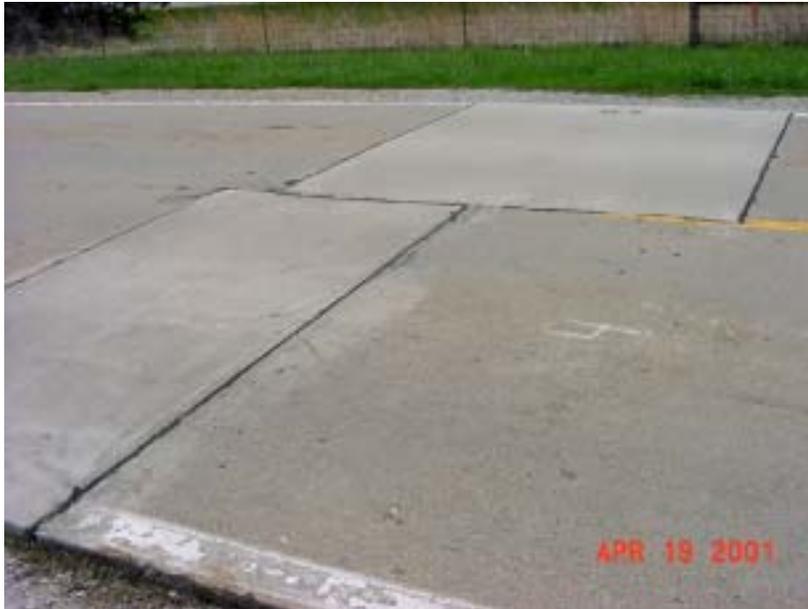
been studied in past Missouri research efforts, but no known estimate of extended pavement service life was ever developed. The photo below shows typical full-depth repairs.

Full-depth repairs

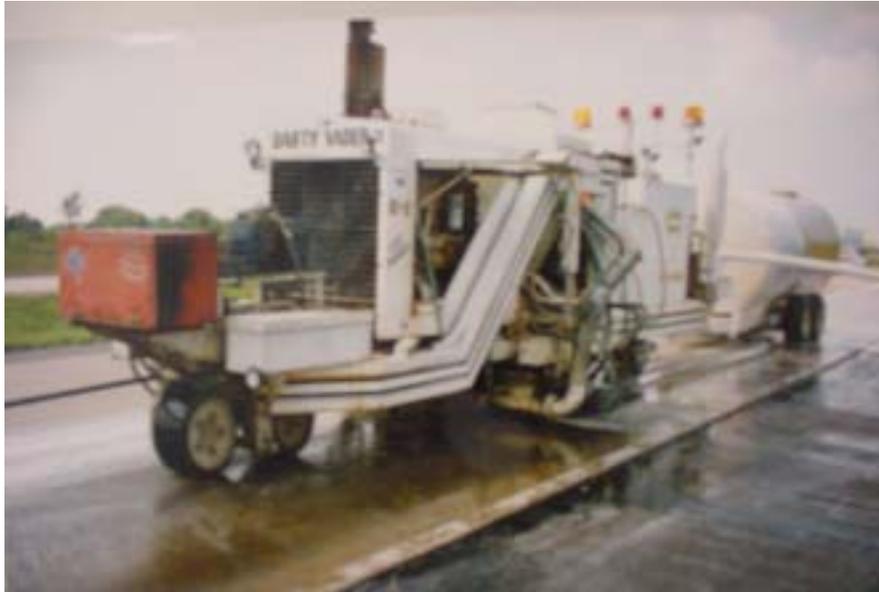
Based on these results it was recommended that diamond grinding in Missouri be limited to pavements with adequate load transfer and support and maximum average faulting around one-half inch. Expected service lives should be five to ten years depending on the type and condition of the pavement.

Diamond grinding on I-44 in Greene County

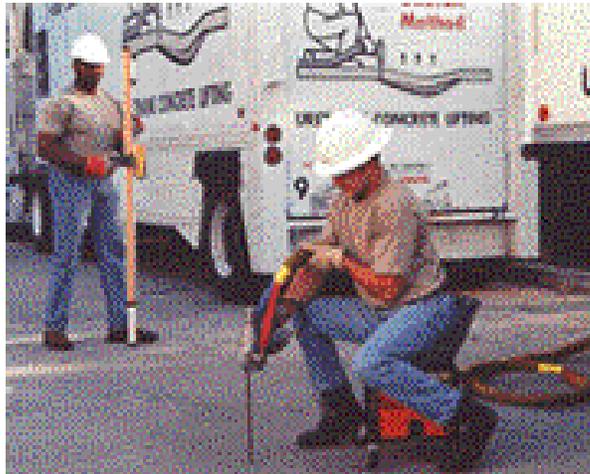
Missouri has had extensive experience undersealing, both by maintenance forces and contractors. In fact, Missouri may be one of the few remaining states that uses it routinely. The performance of undersealed slabs has never really been monitored in Missouri, often because they are about to be covered with an AC overlay.

Polyurethane undersealing

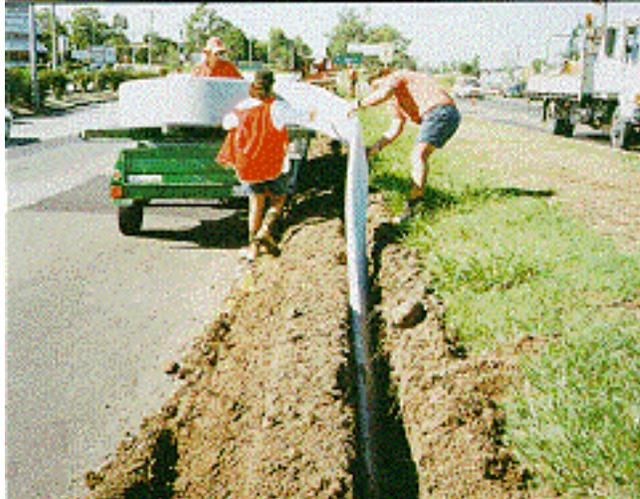
Missouri has retrofit longitudinal edge drains on a few projects including several test sections at the LTPP site in Harrison County. It has been difficult to tell if they have had any real impact. Although there is water coming out of the retrofit outlets, it appears to be collecting only local moisture close to the pipes.

Geocomposite edge drain retrofitting

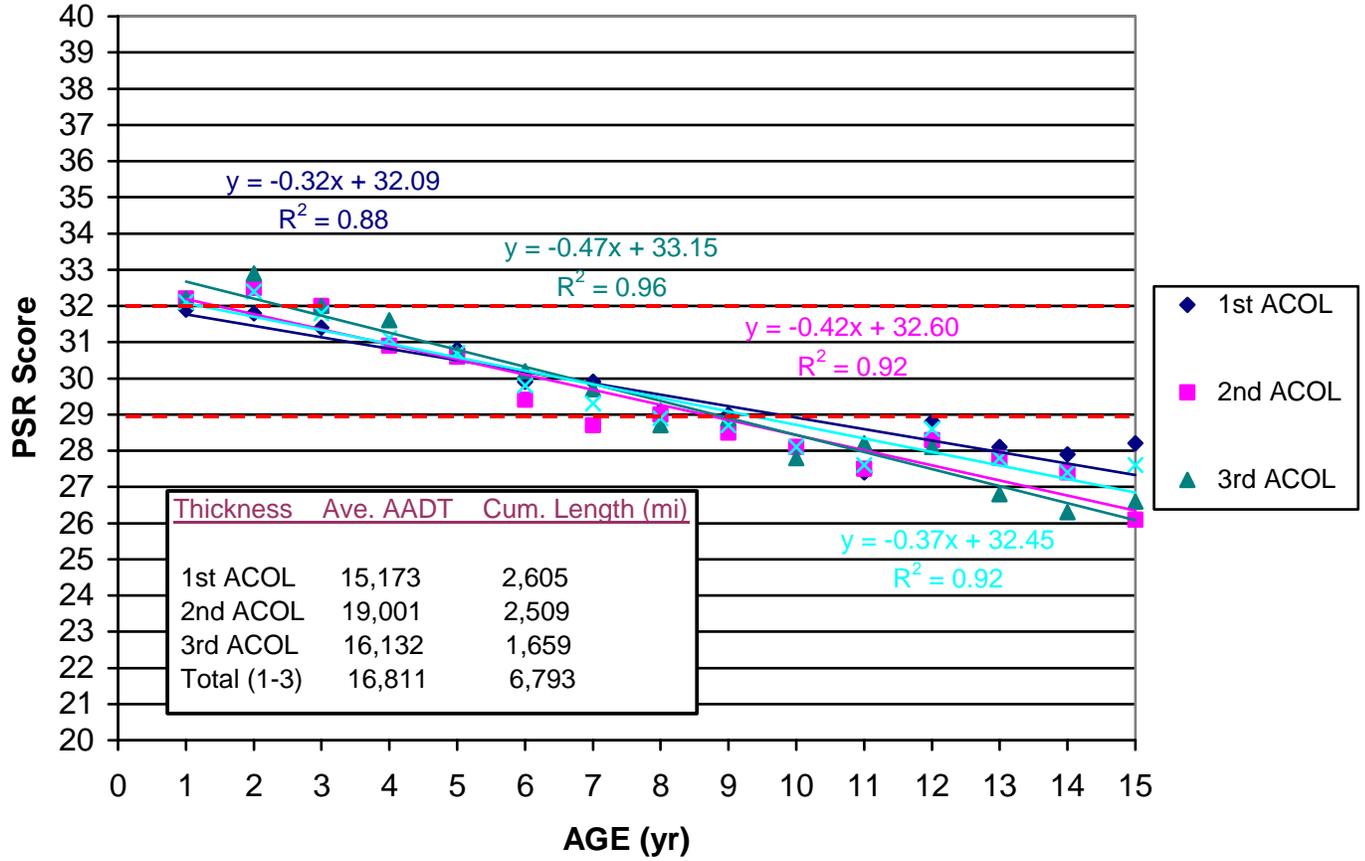
## PSR for ACOL by Number on Divided NHS 1995-1998 ARAN Data

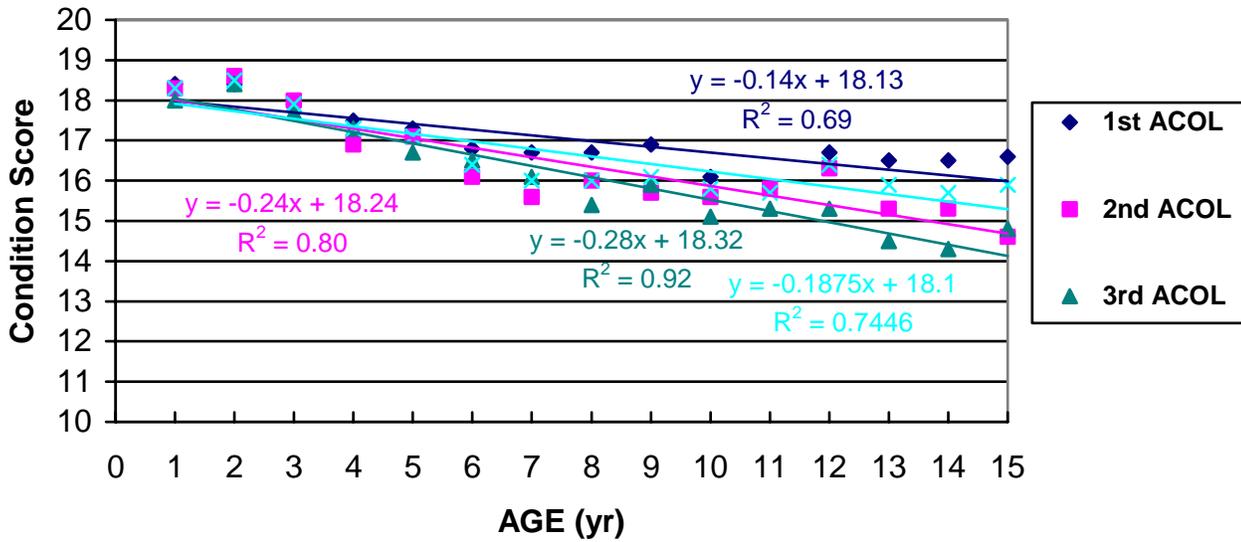
## Condition for ACOL by Number on Divided NHS

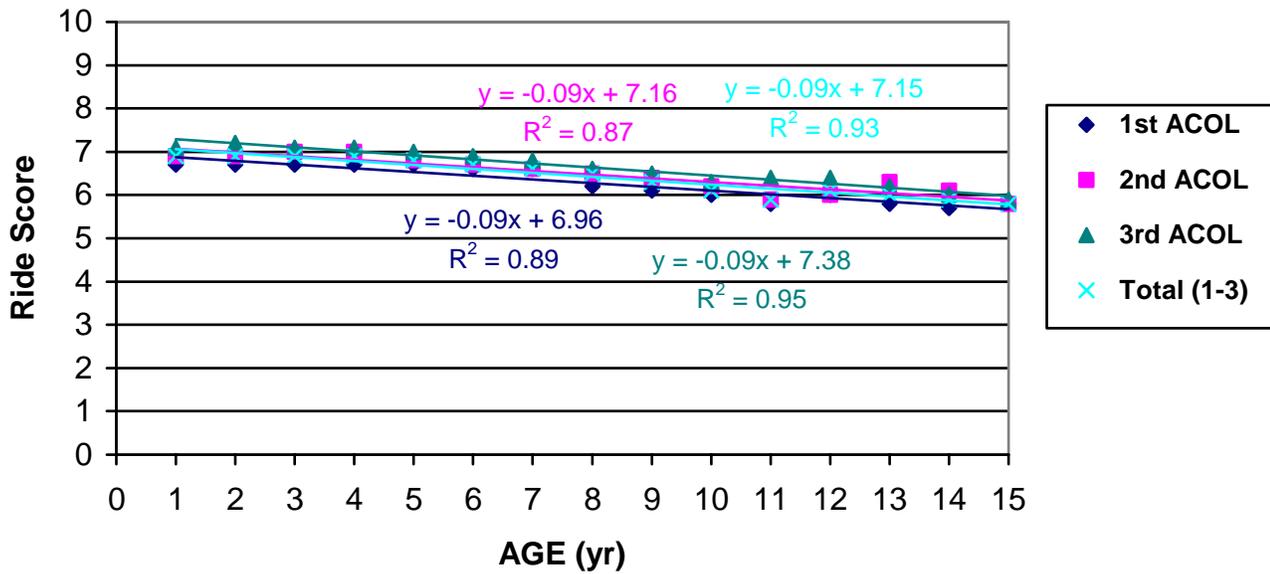
## Ride for ACOL by Number on Divided NHS

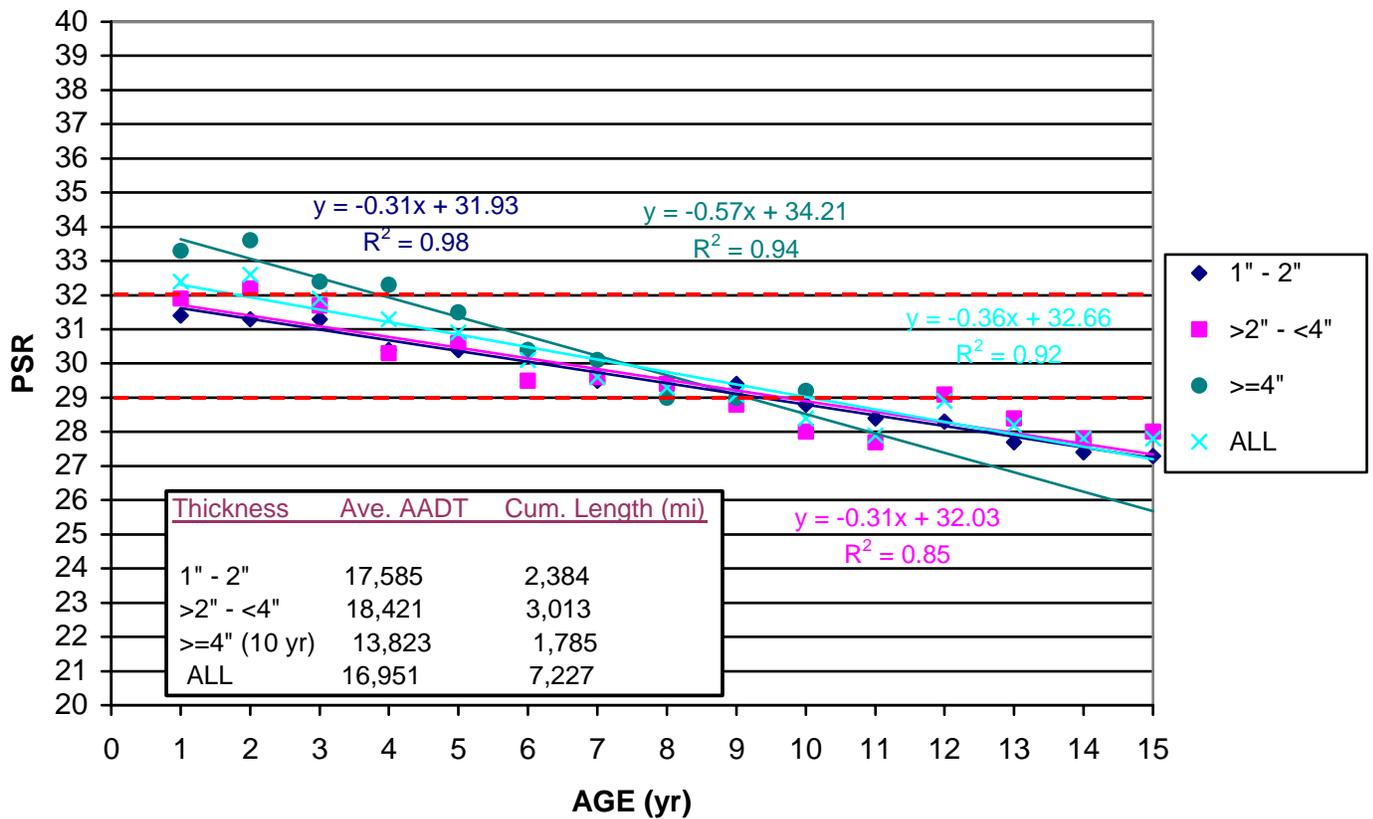
Deterioration for each ACOL by thickness follows a linear regression fairly well, although the condition trend for the >2” – <4” range is more erratic. Overlays >= 4” did not have enough mileage beyond ten years to be statistically meaningful and so what data they had were excluded in the analysis (the extension of the >=4” trendlines after 10 years are a spreadsheet limitation and should be ignored). Average PSRs reach an unacceptable level between nine and ten years. Thicker overlays outperform the thinner ones during the first five years, converge with them during years six through eleven.

**PSR for All ACOL by Thickness on Divided NHS**  
**1995-1998 ARAN Data**

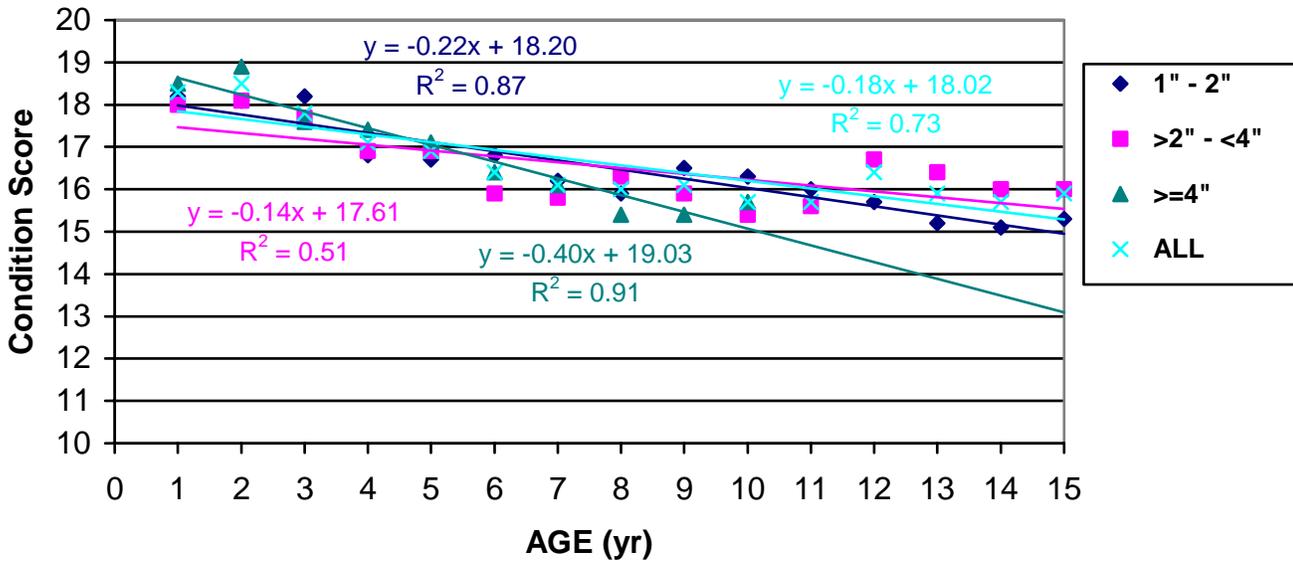
## Condition for ACOL by Thickness on Divided NHS

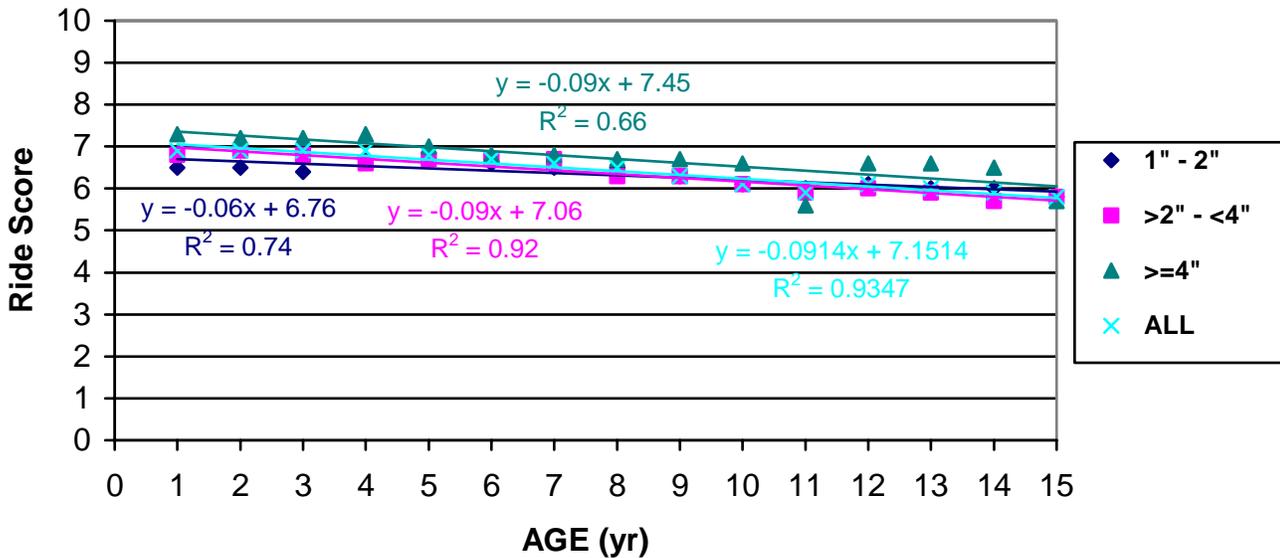
## Ride for ACOL by Thickness on Divided NHS

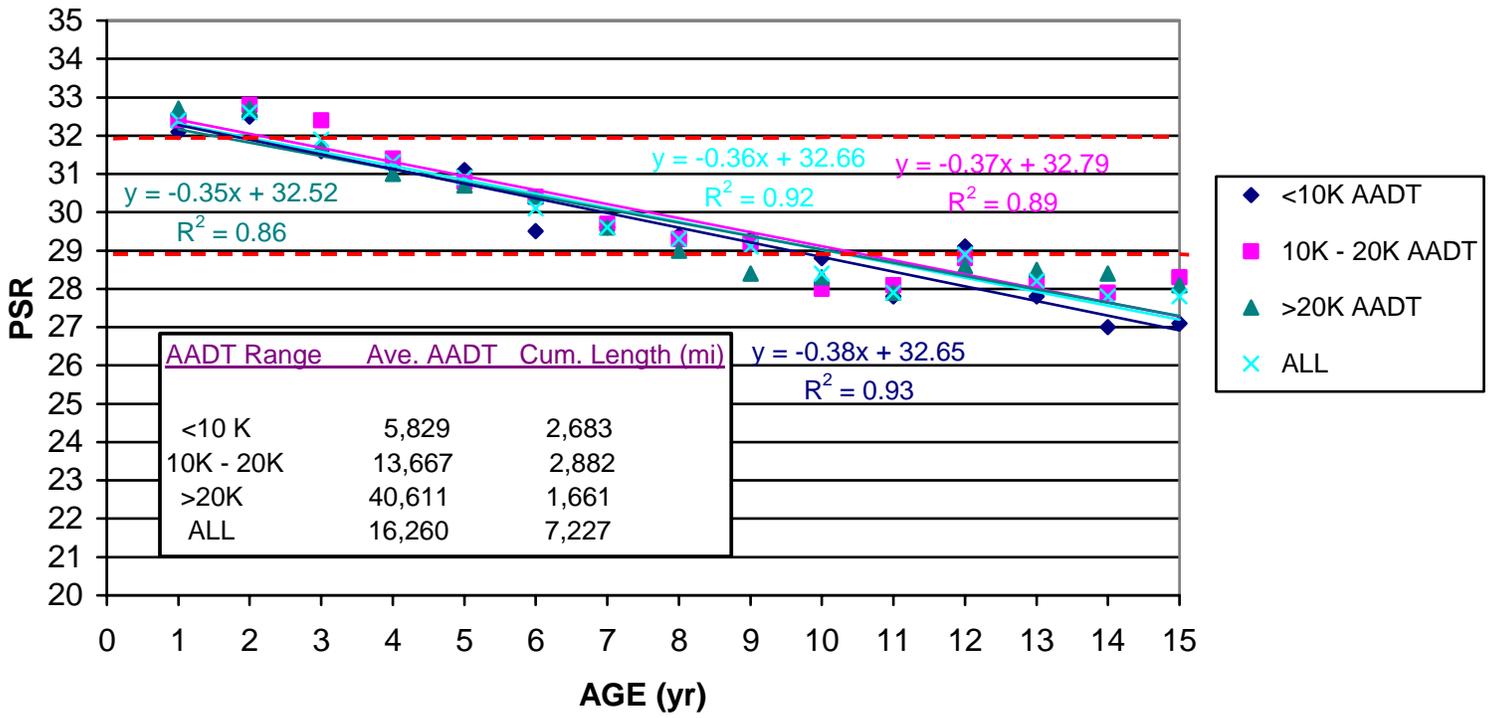
### PSR for ACOL by AADT on Divided NHS 1995-1998 ARAN Data

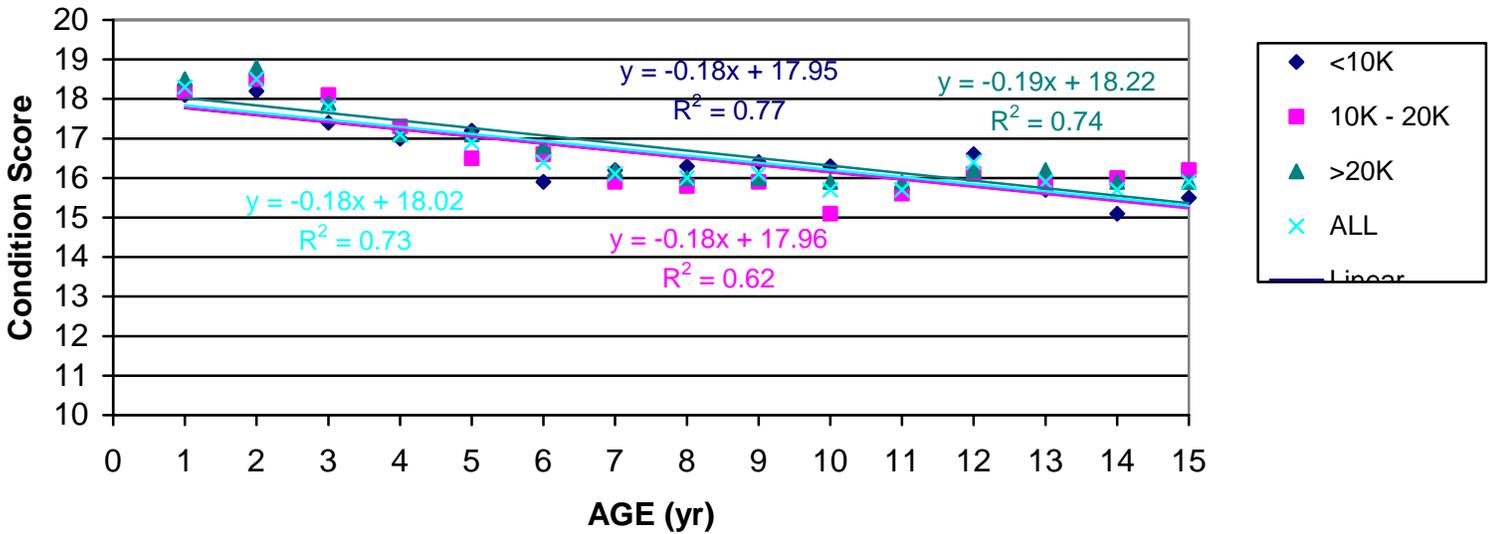
## Condition for ACOL by AADT on Divided NHS

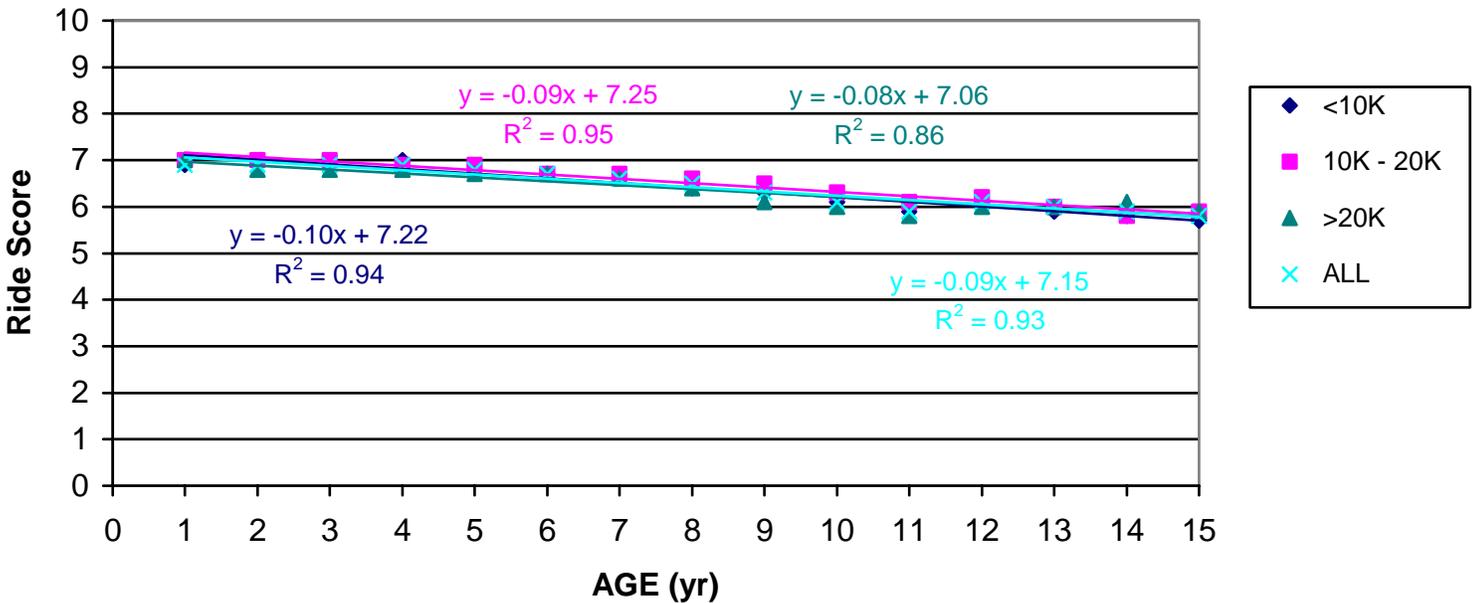
## Ride for ACOL by AADT on Divided NHS

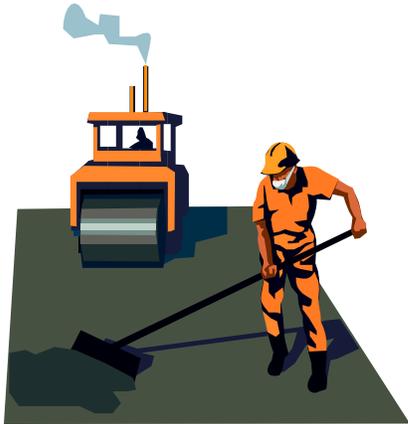
The average service life that ACOLs on divided NHS routes, regardless of number, thickness, or AADT, remain at least marginal ( $PSR \geq 29$ ) is approximately ten years.

Initial overlays sustain better performance for a longer period than later overlays. Thicker ACOLs have not provided significantly longer service lives than thinner ones, although more data for ACOLs  $\geq 4''$  older than ten years is required to make a stronger case. No clear relationship between AADT level and performance is evident.

**PAST AVERAGE  
PERFORMANCE LIFE**  
(at least marginal) FOR  
AC/PCC OVERLAYS ON NHS  
= **10 YEARS**

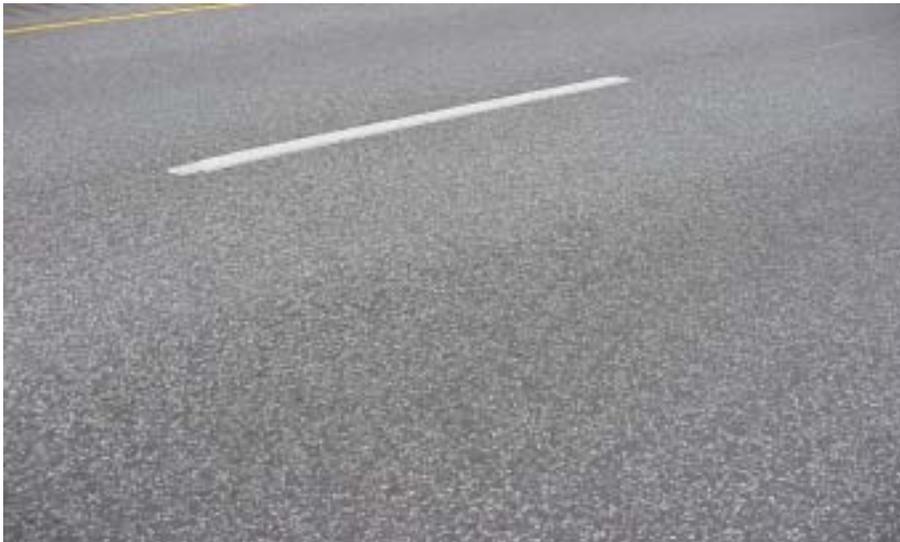
Stone matrix asphalt (SMA) overlays are an alternative to standard hot mix wearing courses. Their stone-to-stone matrix, blend of superior coarse aggregates and fiber additives are designed to withstand rutting and wear. SMAs were first placed in Missouri in 1991. Most SMA wearing courses were placed on I-B binder mixes, which have since been replaced by SP250 (Superpave) mixes.

SMA on WB I-70 in Boone County
