RDT 02-013

# Missouri Guide for Pavement Rehabilitation

RI 00-008

November, 2002

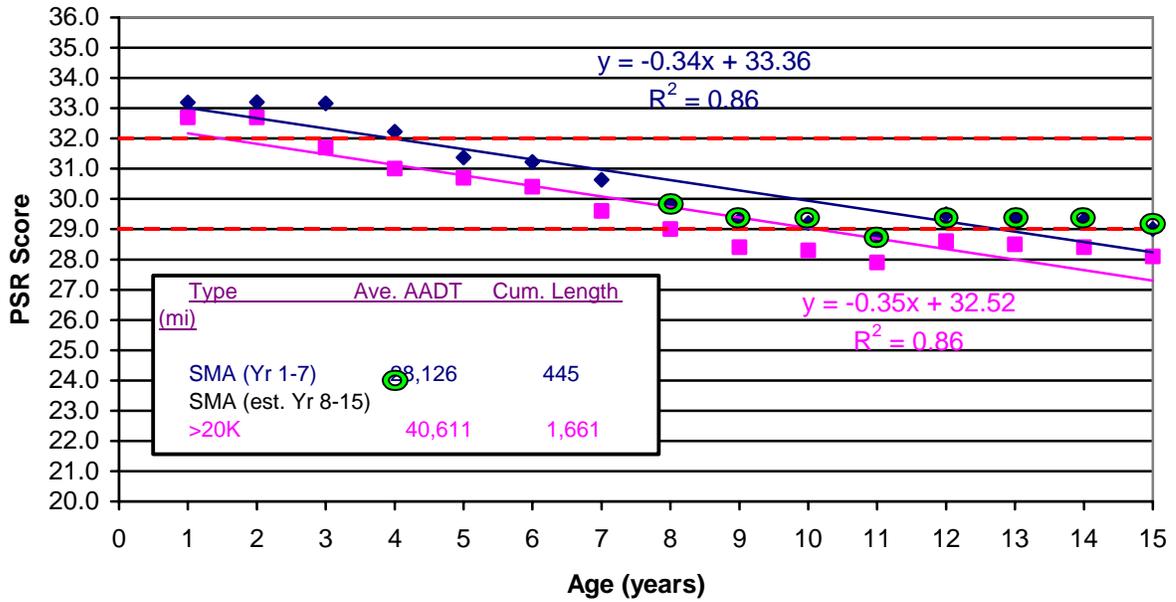
### PSR for Stone Matrix Asphalt vs ACOL (> 20,000 AADT)

Based on this estimated extrapolation of performance data SMA overlays have roughly two more years of serviceable life than conventional ACOLs. The reasons for this increase seem to be identified in the rutting and cracking graphs below. SMAs appear to slow down the advent of reflective cracking more than conventional ACOLs. Also, their rutting, after initial traffic compaction, saw no increase, whereas conventional ACOL rutting kept growing.

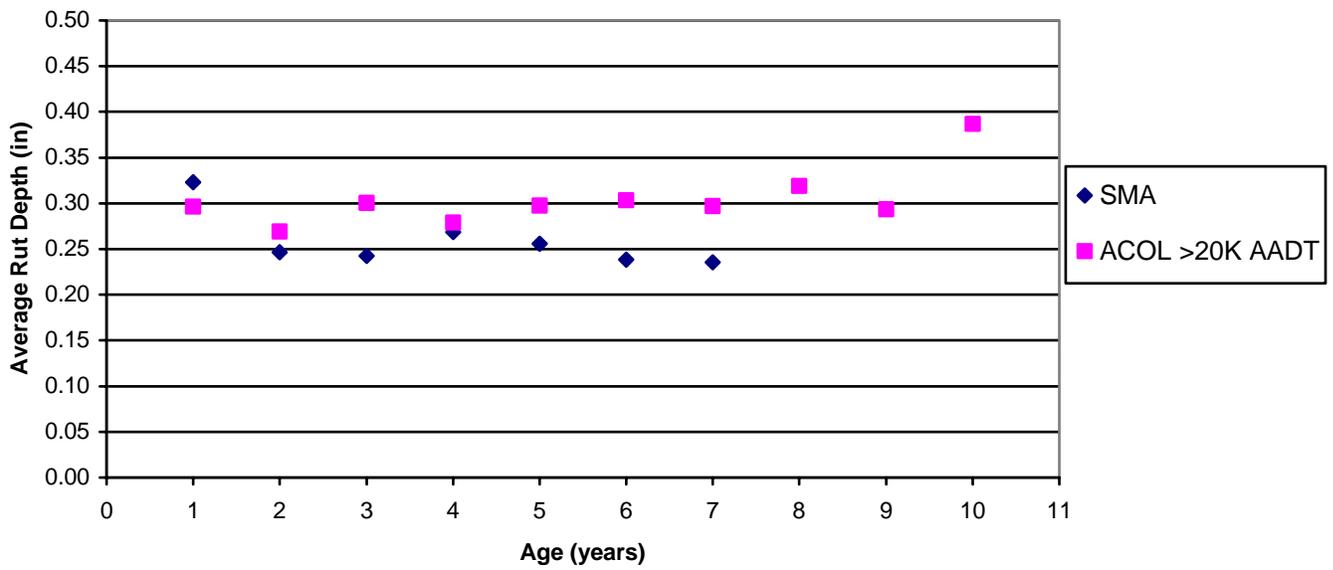
### Rutting for Stone Matrix Asphalt vs All ACOL (> 20,000 AADT)

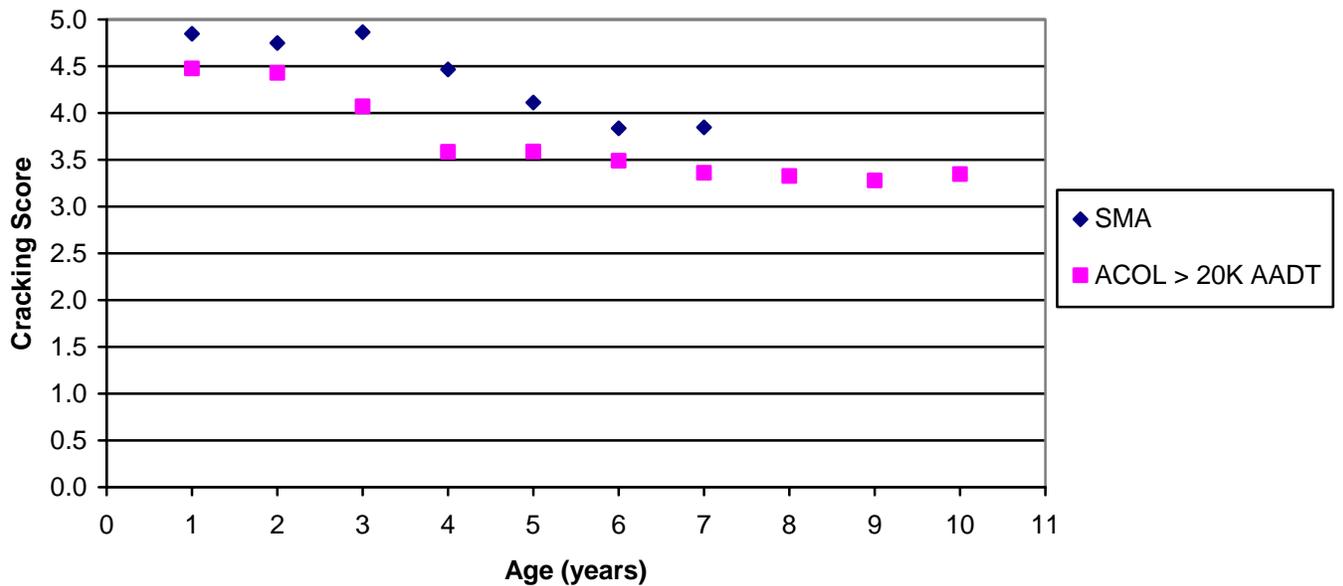
### Cracking for Stone Matrix Asphalt vs ACOL (> 20,000 AADT)

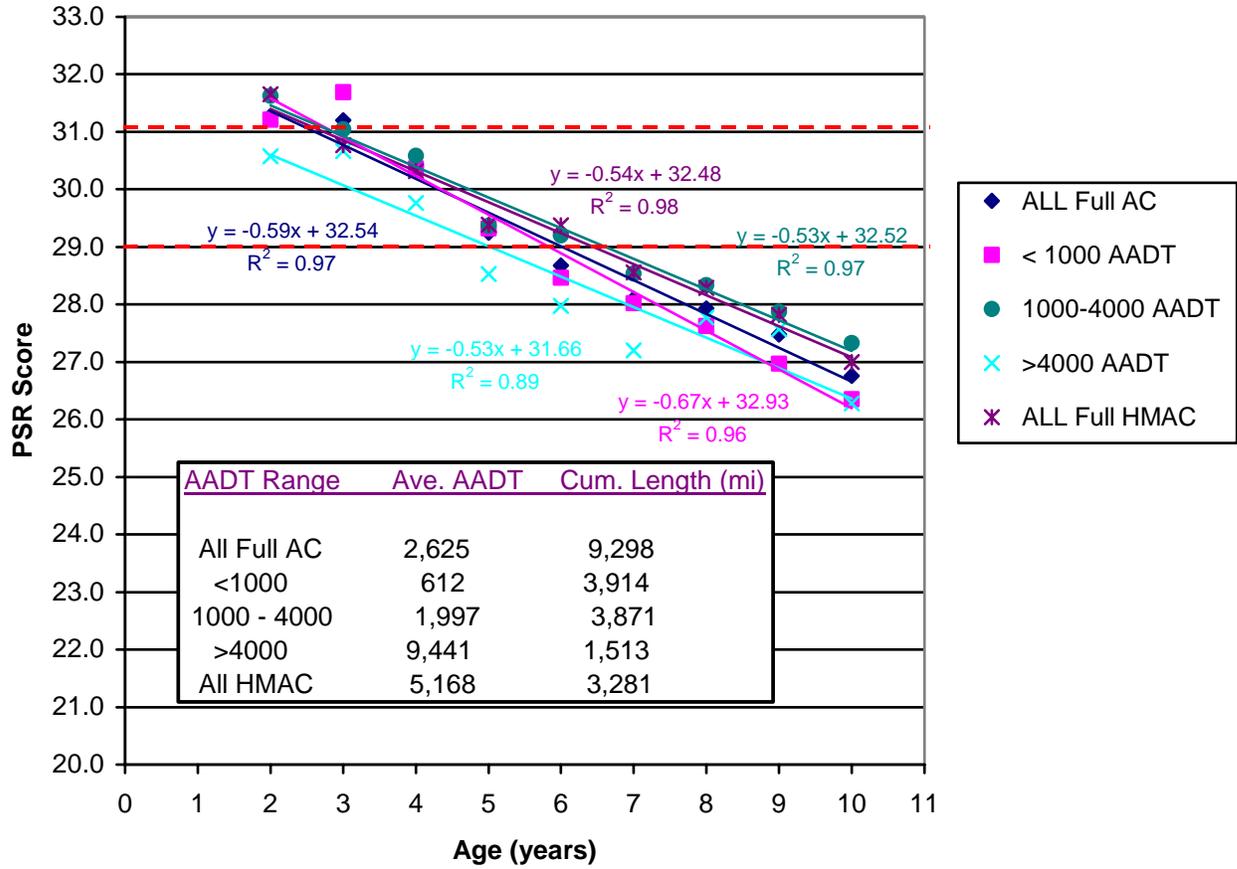
## PSR for AC/AC on Arterials 1995-1998 ARAN Data

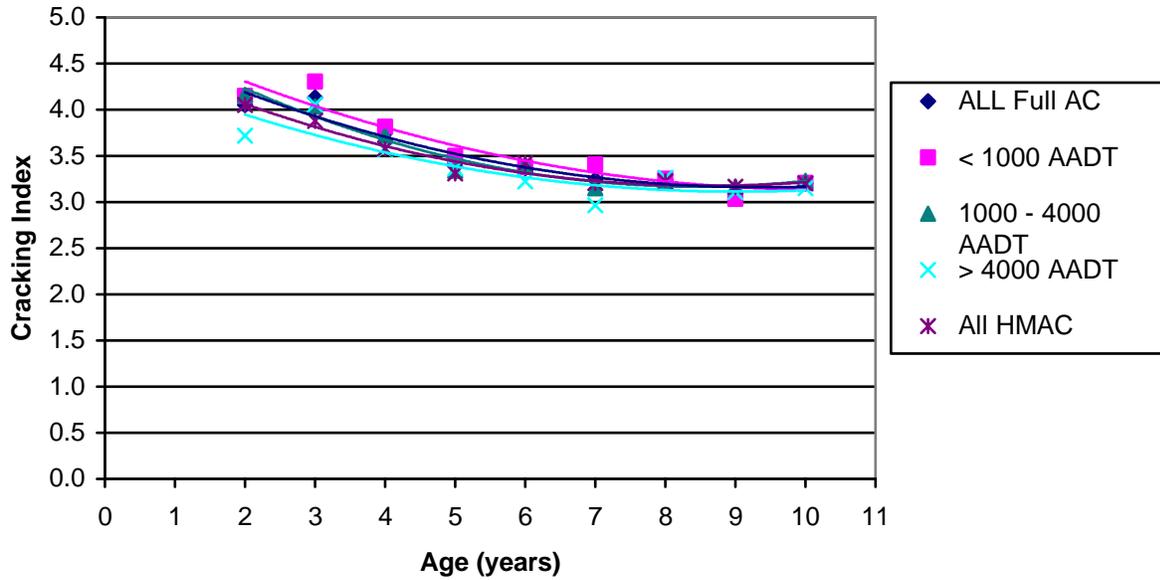
## Cracking for AC/AC on Arterials 1995-1998 ARAN Data

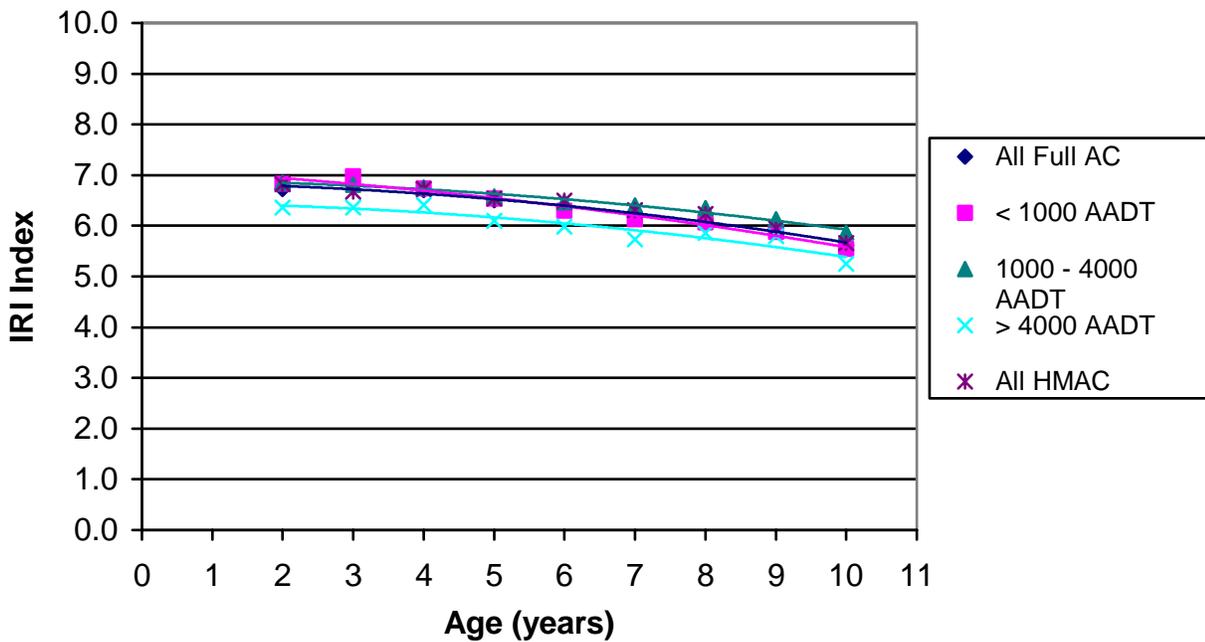
## Ride for AC/AC on Arterials 1995 - 1998 ARAN Data

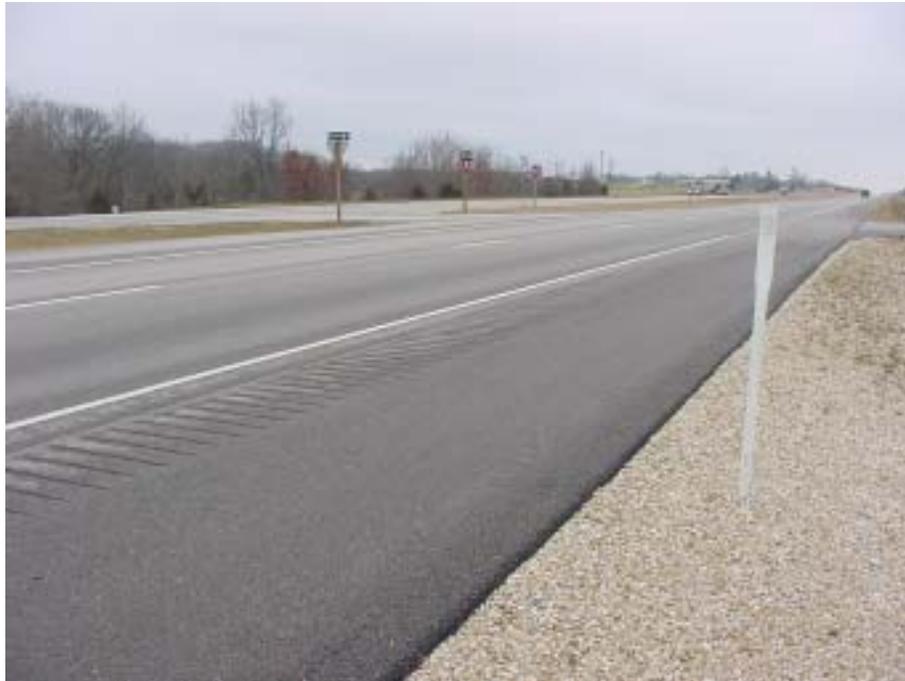
Missouri has constructed a handful of full-depth Superpave pavements. As with Superpave overlays, the performance of full-depth Superpave mixes in Missouri is difficult to ascertain for the same reasons that no other state has been able to; they haven't been down long enough. We have two to three years of data for two projects, Route 21 in Iron County and U.S. 54 in Camden County. Early performance on these projects has been superb.

Full depth Superpave pavement on northbound US 63 in Boone County

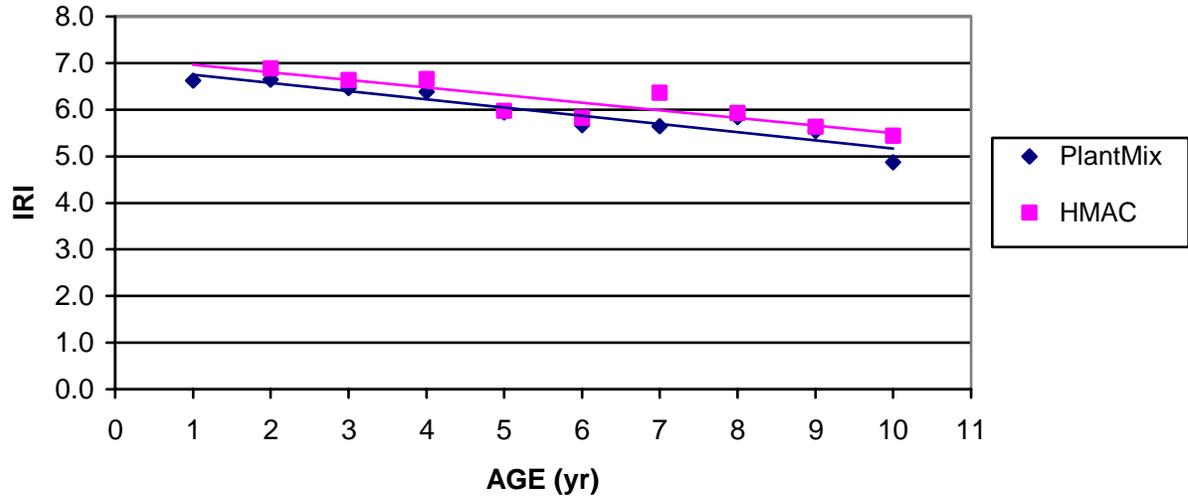
The IRI and condition graphs below provide a picture of how the full depth AC collectors increase in roughness and visual distress.

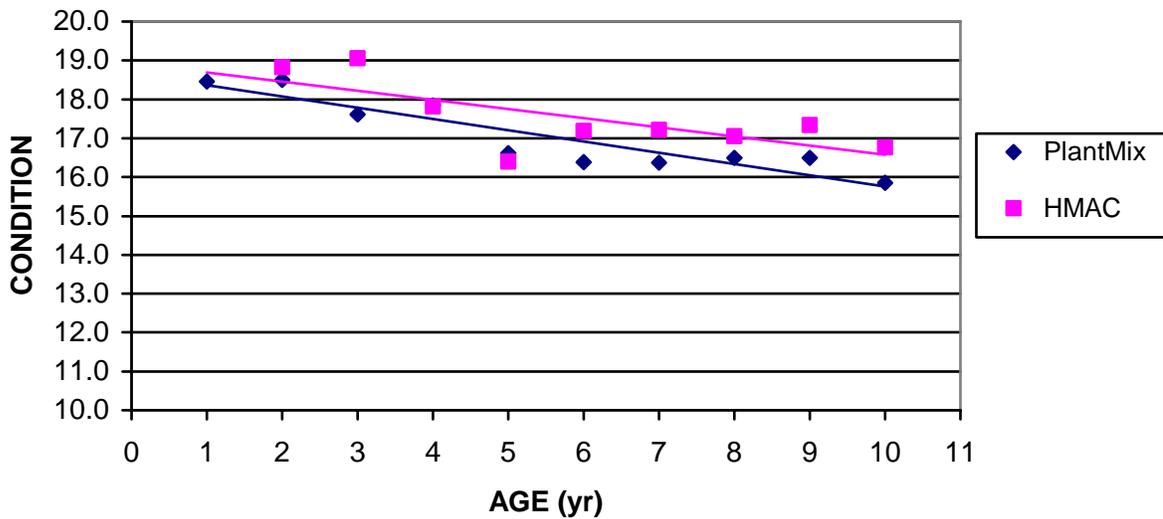
## Condition for AC/AC on Collectors

1995-1998 ARAN Data

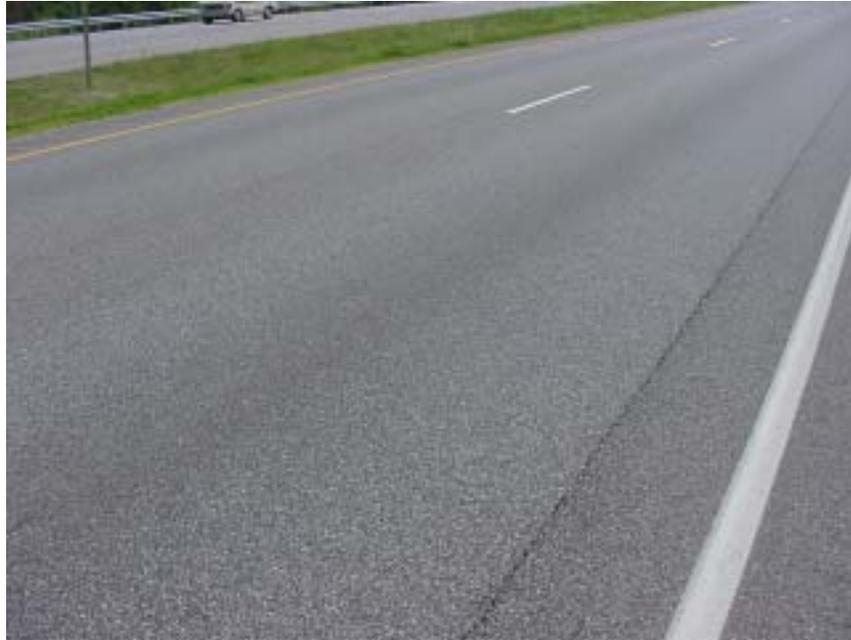
First and most importantly, Superpave mix designs are expected to yield high performance dividends. The rigorous mix and binder testing specifications raise the bar for product acceptability.

Full depth Superpave AC on US 54 near Camdenton

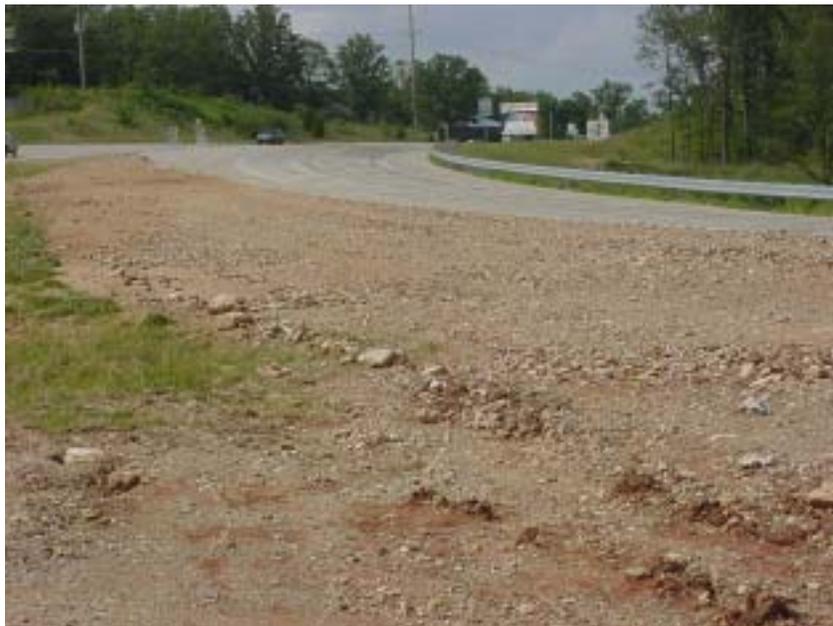
Second, the two-foot rock base, when used, provides superior support. Unlike thick PCC, which is theoretically nearly impervious to moderate changes in base and subbase stiffness, AC pavements greatly benefit from stiffness increases. This layer reduces fatigue by decreasing bottom radial strains, and rutting by better withstanding vertical compressive stresses.

Two-foot rock base on US 54 near Eldon

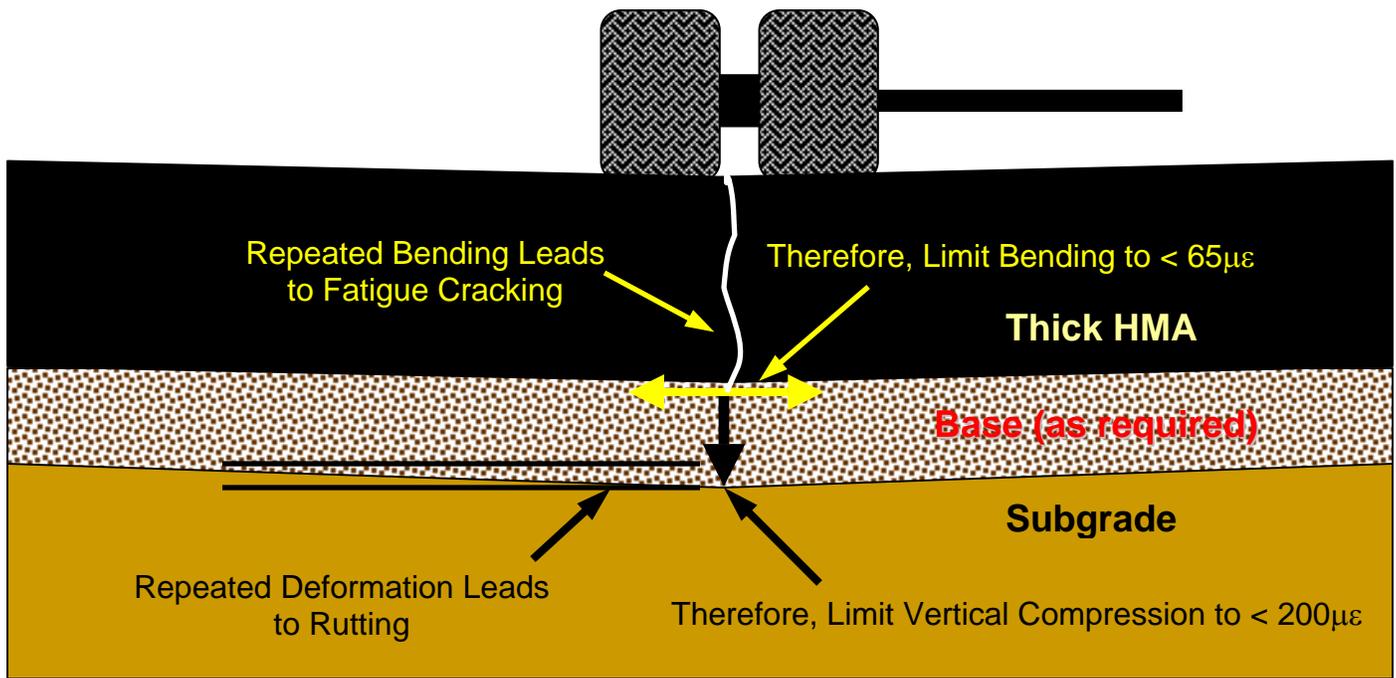
“Perpetual pavement” is an expression coined by the National Asphalt Pavement Association (NAPA) and the Asphalt Institute (AI) to describe a full-depth AC design that pushes back the traditional time for rehabilitation. The concept is not really new, but better defined. Since the two fundamental pavement responses that initiate distresses in AC are tensile strains at the bottom of the AC layer (which lead to fatigue cracking) and compressive stresses on top of the unbound base or subgrade (which leads to rutting), then the pavement need only be designed to minimize them. Providing a stiff, thick surface course on top of an intermediate binder layer dissipates compressive stresses. Constructing a rich, densely compacted bottom layer renders the pavement immune to repetitive tensile strains. The combined layer thickness is significant.

Perpetual Pavement Design
