Evaluation of Stainless Steel Reinforcement in Bridge Decks

Follow up and Final Report

RI00-027

October 2007

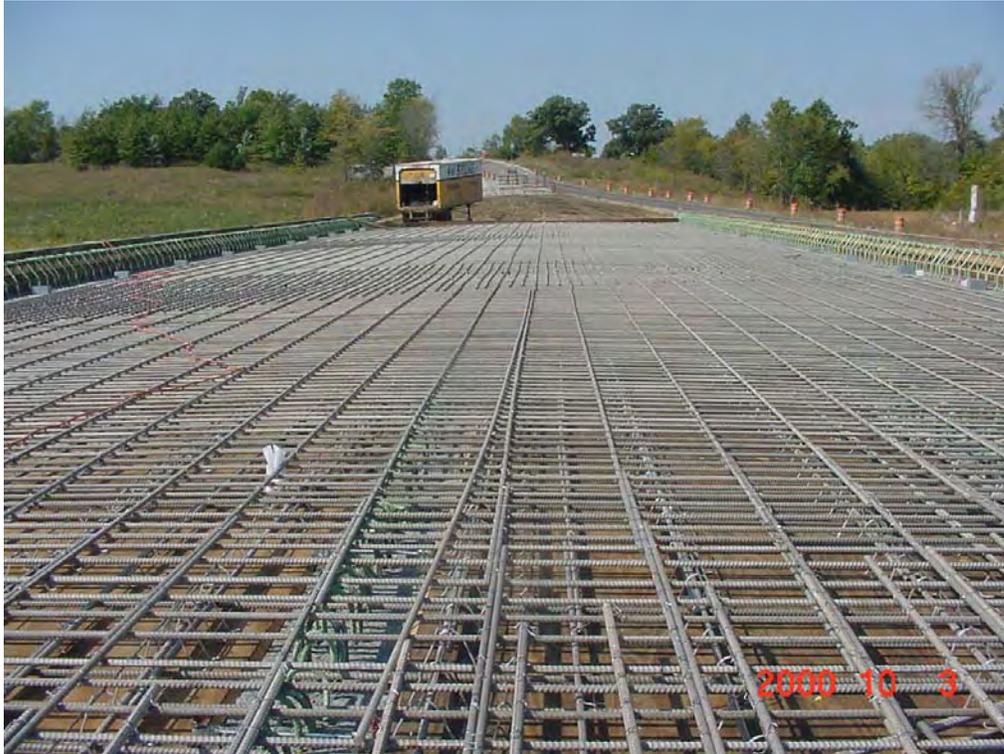
MoDOT is using innovative materials to design longer lasting reinforced concrete bridge decks. Stainless steel reinforcement has greater corrosion resistance than that of the conventional reinforcement. In this project, bridge A6059, the first in Missouri utilizing stainless steel reinforcement in the deck (see Figure 1) was completed in 2001.

Figure 1. Stainless Steel Reinforcement of Bridge A6059

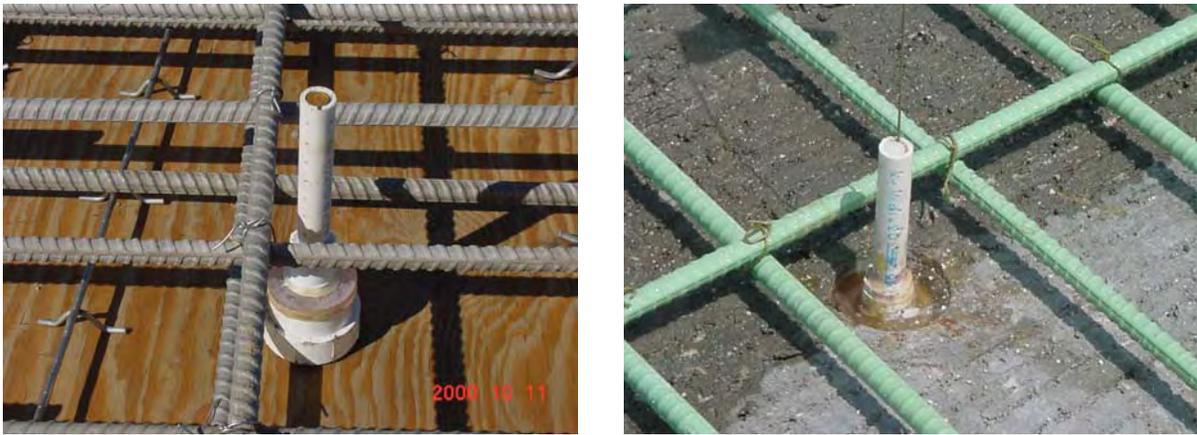
Figure 2. Sensor Housings Installation

An evaluation of the constructability and performance of stainless steel reinforcement was conducted. The bridges will be researched utilizing non-destructive tests to monitor salt application and chloride penetration in correlation to presence of (or lack of) corrosion. Fiber optic chloride sensors were incorporated into both bridge decks. Ten sensors were set on each bridge at different horizons. The sensor housings were installed during the deck construction before concrete was poured. See pictures in Figure 2 for the installation of sensor housings. The picture on the left is for the stainless steel bridge deck, and the one on the right is for the epoxy coated rebar bridge. Cylinders were taken to establish the compressive strength of the concrete for each bridge. Cylinders were also taken and tested for chloride permeability of both bridges according to AASHTO T277. Chloride samples were taken from the cylinders to get a base line chloride content of the concrete. These original properties (in some cases measured at 1 year old) of the concrete are listed in Table 1. Fiber optic chloride sensors were installed into the sensor housings shortly after the bridges were open to traffic. In addition, half-cell potentials were taken and will continue to be taken to determine corrosion rates on the bridge containing stainless steel reinforcement.
