RDT 05-008

# **Failure Investigation of the Steel Strut on the Paseo Suspension Bridge**

RI 03-015

June, 2005

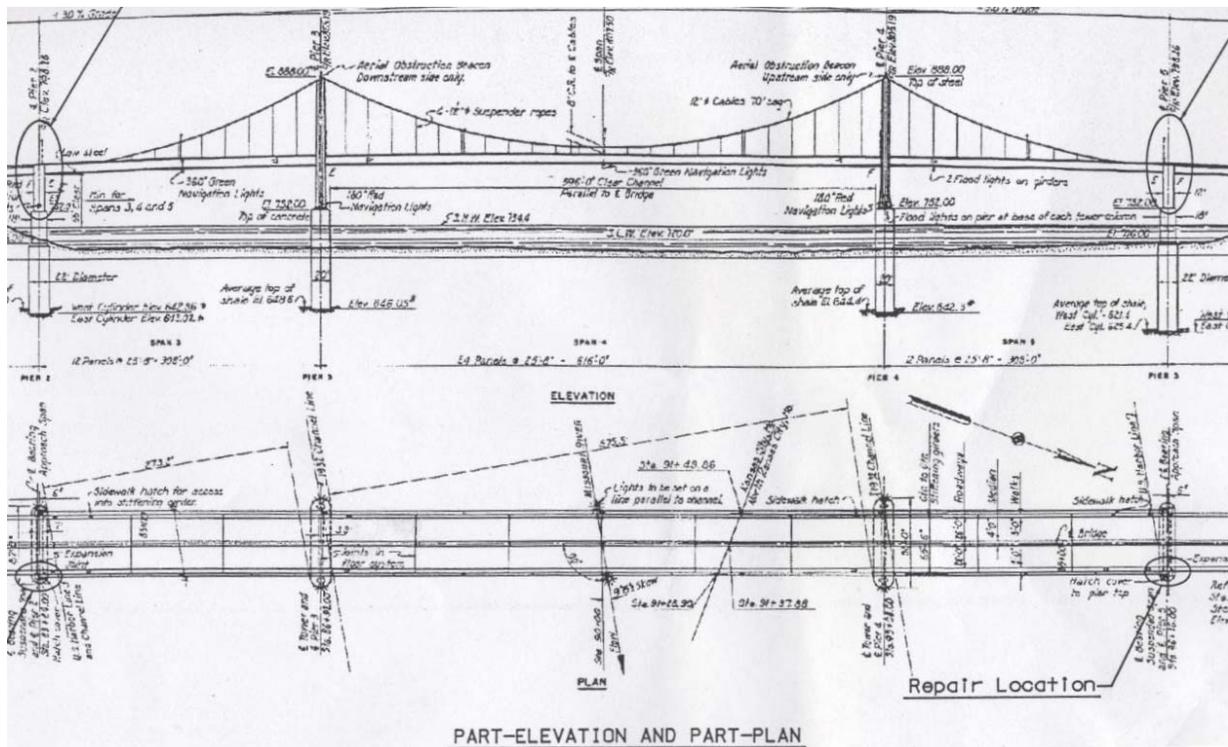
Figure 1.1. Plan and Elevation View of Paseo Bridge

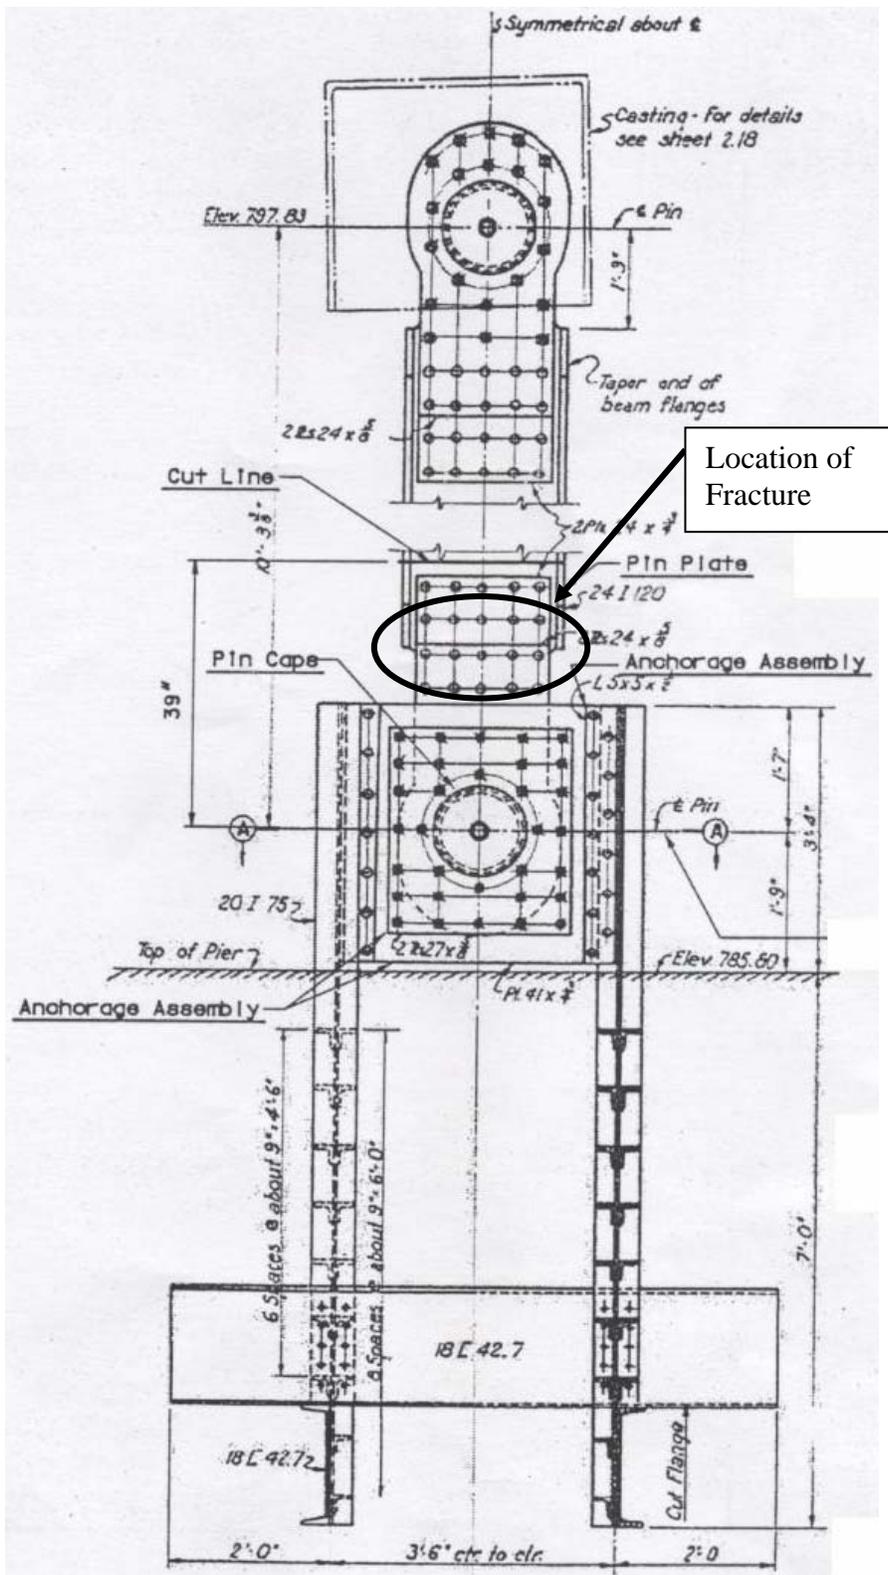
Figure 1.2 Link Anchorage Details

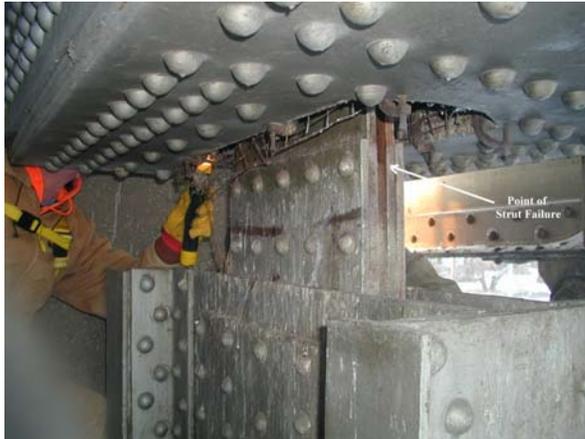
Figure 1.4 Point of Strut Failure

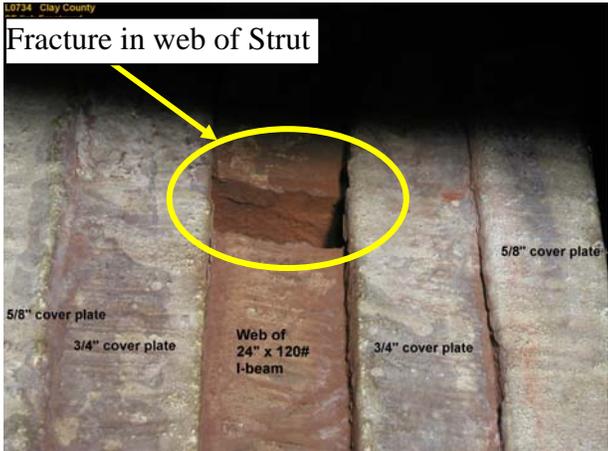
Figure 1.5 Fractured Strut Web Detail

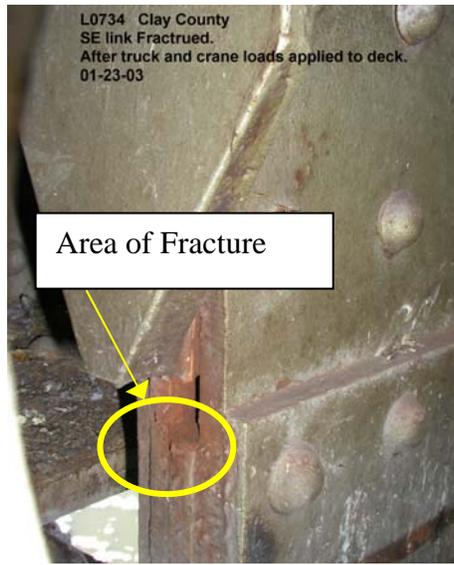
Figure 1.6 Lower Link Anchorage

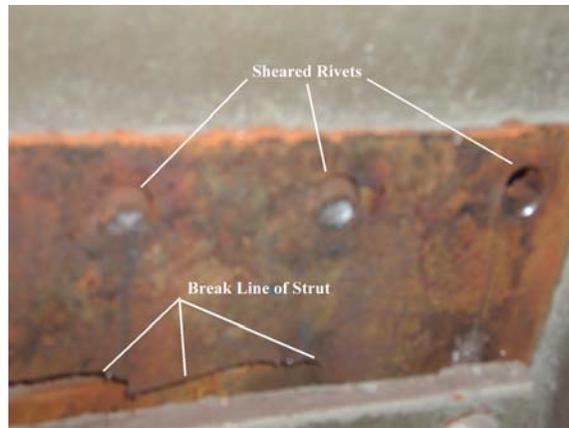
Figure 1.7 Shear Damage of Rivets and Fracture Surface

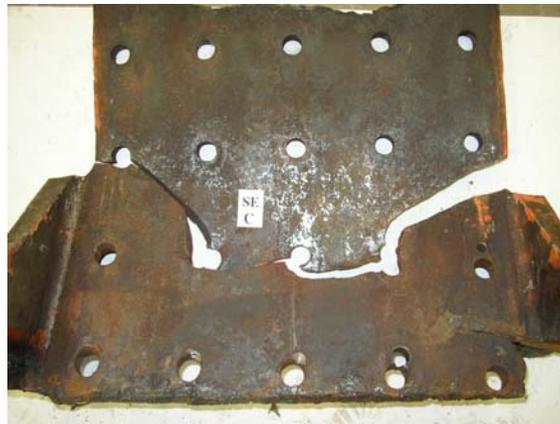
Figure 1.8 Fracture Pattern of SE Strut Web

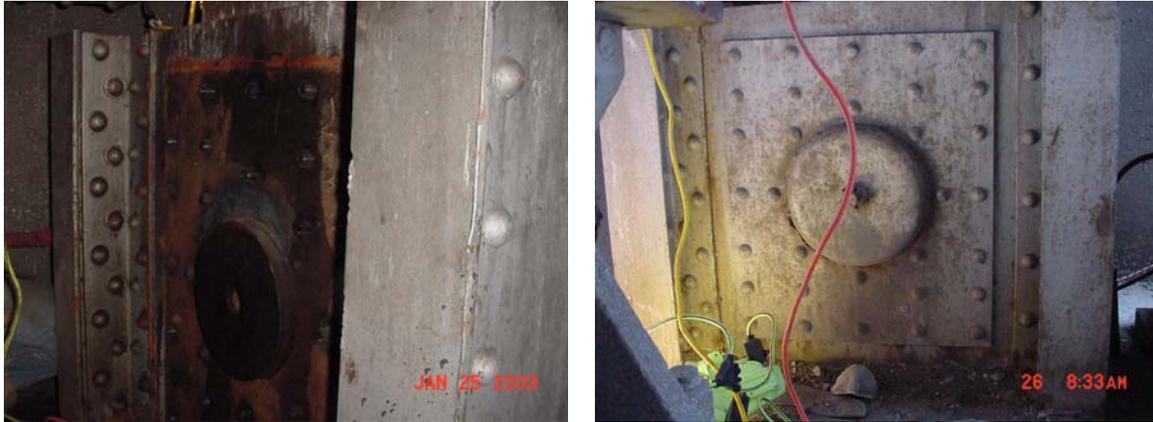
Based on the reports from field inspectors, the lower pin in the southeastern hanger was frozen and did not allow for free rotation of the superstructure. The surface condition of the pin on the Southeastern side was severely corroded. This can be seen from the comparison between two pins (Southeastern (a) vs. Southwestern (b) sides) in Figure 1.9.

(a) Southeastern Pin

(b) Southwestern Pin

Figure 1.9 Comparison of Pin Conditions

2. Partial sealing the lower housings to prevent salt and sand accumulation near the pins or providing traps under the finger expansion joints to stop salt and sand debris from dropping to the lower link housing. These corrosive materials damage and/or clog free rotation.

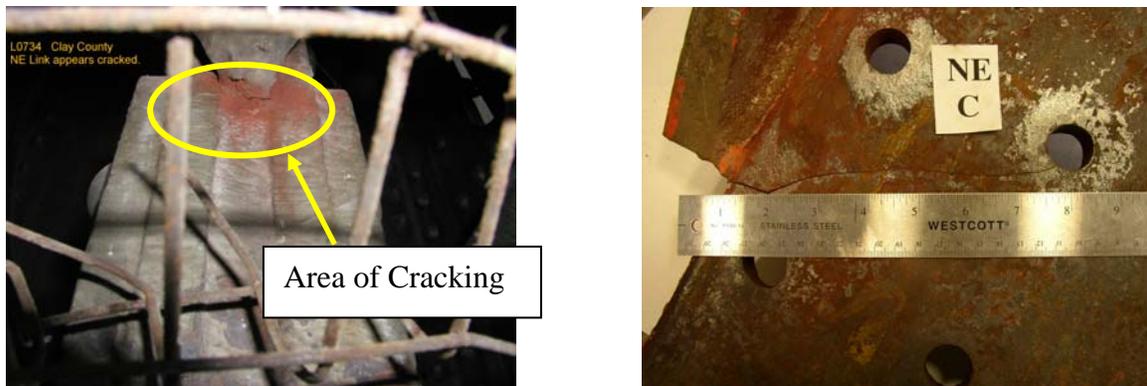
The decision was made to replace all four hangers of the bridge including the fractured one. When the strut on the Northeastern hanger was removed, it was also found to have been cracked, see Figure 1.10. However, careful inspection by engineers revealed that this crack was due mainly to overstressing as a result of fracturing of the southeastern strut.

Figure 1.10 Cracking in Northeastern Strut

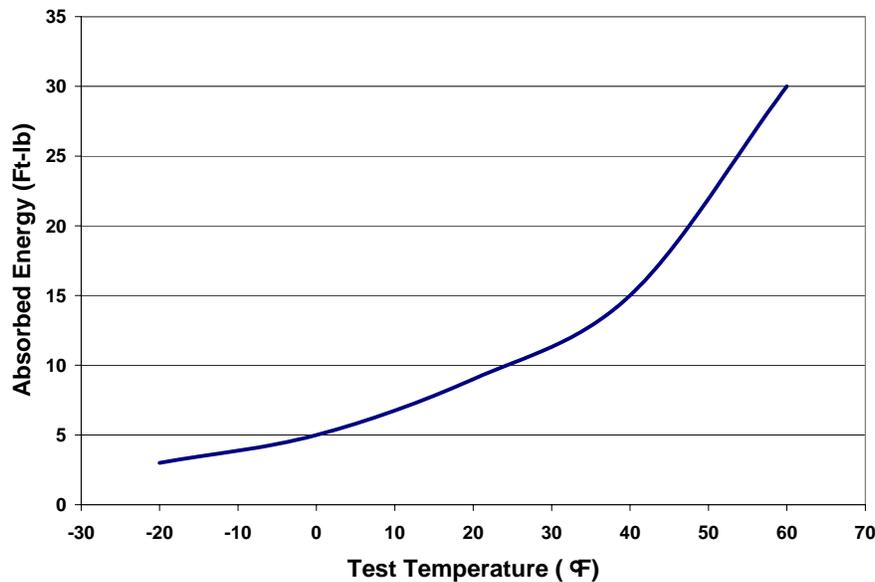
Charpy V-notch impact test results for A-36 steel can be found in Structural Alloys Handbook (Holt et al., 1996). The specimens were from service failure, brittle fracture of a stringer bridge, and reported by Frank (1974). Results from his findings, interpreted from a plot, are shown in Figure 2.1.

Figure 2.1 Charpy V-Notch Impact Test Results (Frank, 1974)

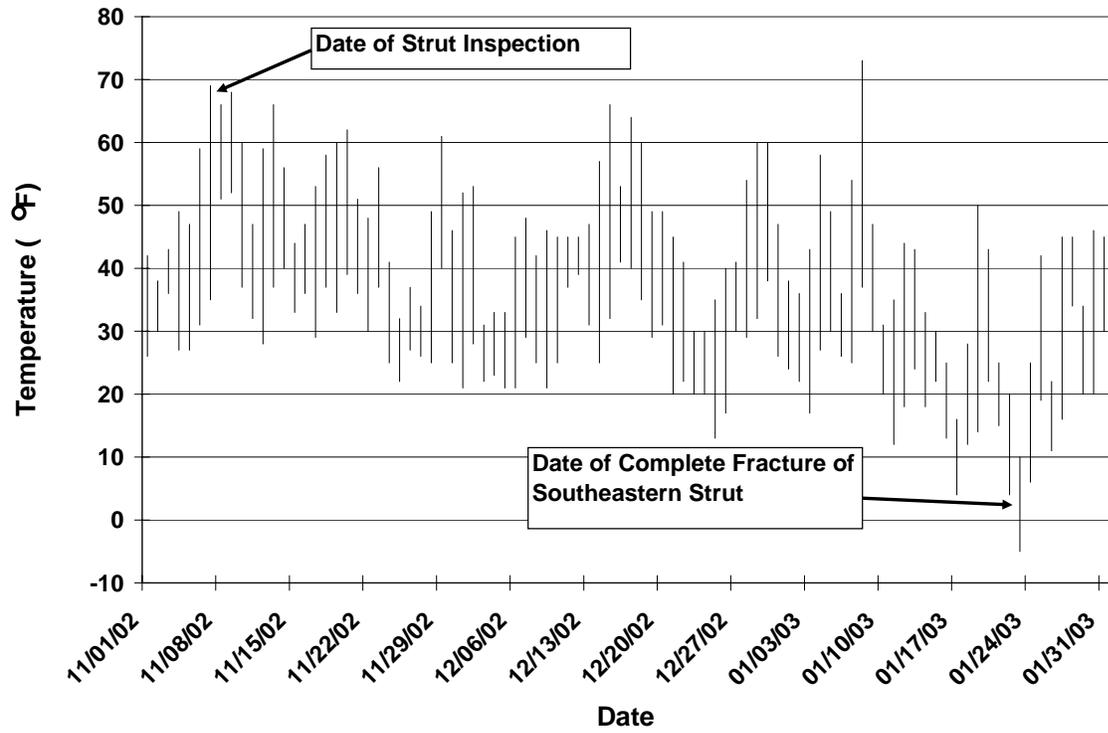
The temperature at the time fracture occurred on the Southeastern vertical strut was reported to be approximately 9°F below zero. Daily temperature data, reported for the downtown airport in Kansas City, MO, was obtained to analyze what temperatures the bridge was exposed to during the period following the Parson's inspection. The day fracture occurred was the coldest day since the Parson's report that longitudinal motion was observed for the links. Figure 2.2 shows the temperature history giving the daily high and low for the months of November, 2002 until January, 2003.

Figure 2.2 Temperature History for Downtown Kansas City Airport

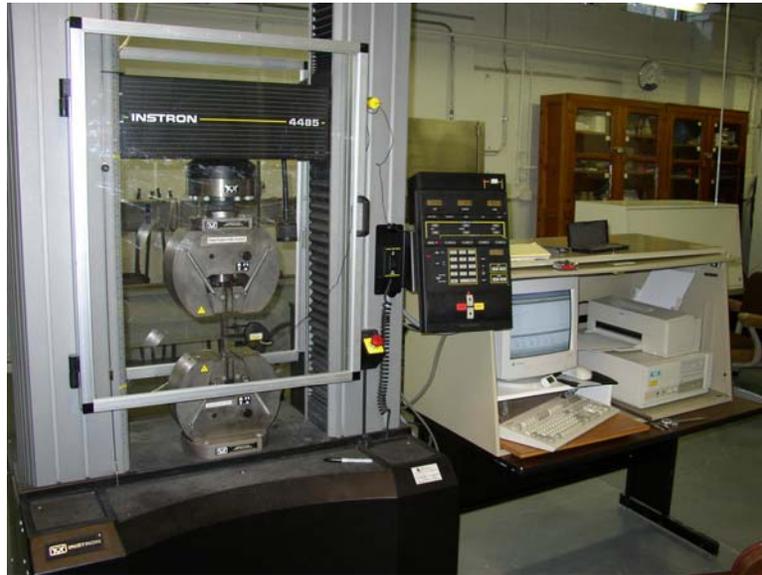
calibrated one inch extensometer was attached to each specimen to measure longitudinal strain. After failure, measurements were taken on each specimen to ensure fracture occurred at a minimum of two widths away from the grips, Figure 3.3. The third specimen was determined as an invalid test due to this criterion.

Figure 3.1 Instron 4485 and Data Acquisition System

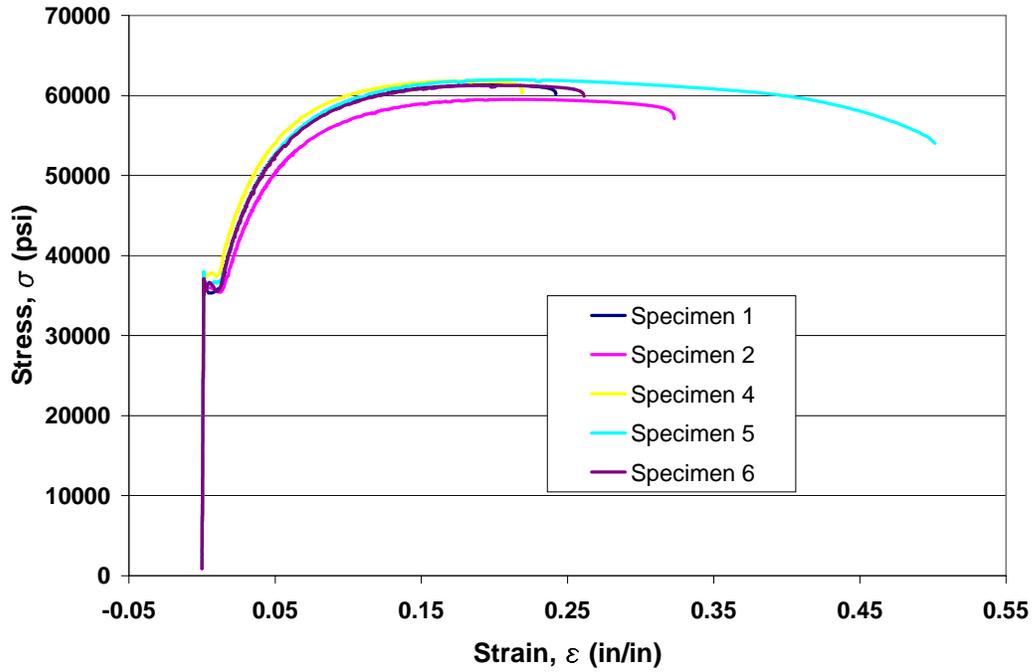
Upon completion of five valid tests at room temperature, material constants were determined by the automated data retrieval software. The constants were then verified from the raw data. These material constants included yield stress,  $\sigma_y$ , ultimate stress,  $\sigma_u$ , and Young's Modulus,  $E$ . Yield stress was determined by 0.2% offset method, whereby stress deviation from the linear portion of the stress-strain curve by more than 0.2% resulted in the return of a value for  $\sigma_y$ . Ultimate stress was found using the peak value on the engineering stress-strain curve. Young's Modulus was calculated as the slope of the linear portion of the stress-strain curve prior to yield stress. Measurements were taken using precision calipers on the cross section of the fractured area. These measurements were used to calculate fracture stress,  $\sigma_f$ , and percent reduction in area, %RA. Figure 3.4, shows the engineering stress-strain curves obtained from valid tests for this material. Individual specimen stress-strain curves as well as additional data generated by the data acquisition system are available in Appendix A. Table 3.2, lists the aforementioned constants found from testing. Averages from the five valid tests were determined and used as the accepted constants. These values compare well to Frank's findings of tensile properties from bridge components (Frank, 1974) of the same decade mentioned in the Literature Review section of this report.

Figure 3.4 Engineering Stress-Strain Curves

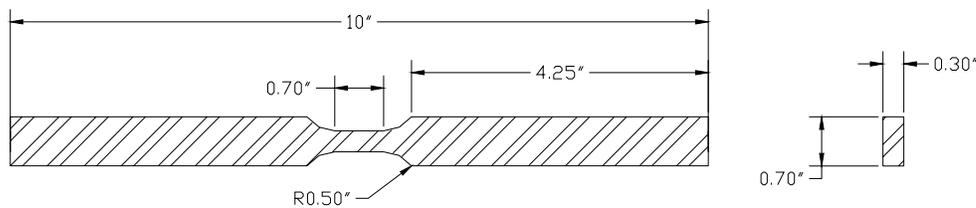
Specimens were machined according to ASTM E 606 under the provisions of flat-sheet fatigue specimens with rectangular cross sections. As with the static tensile testing specimens, the long axis or length of the specimens were oriented so that tensile loads during testing corresponded to the vertical axis in the strut during service loading conditions. Again, the limiting dimension was the width of the specimen which correlates to plate thickness, 0.75 in., minus material removed during surface grinding processes to remove any surface imperfections which would significantly reduce the fatigue life of the specimen. A total of 30 specimens were produced from the material. It should be noted that the specimens here were not fabricated from the fractured Southeastern strut, rather the Southwestern strut. Figure 4.1, shows the fatigue specimen dimensioning.

Figure 4.1 Fatigue Specimen Dimensions

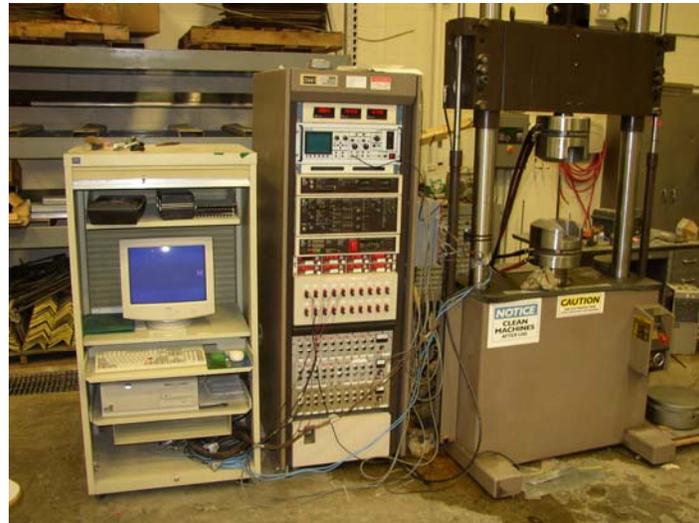
Figure 4.2 MTS 880 and Data Acquisition System

Testing was done in the High Bay Structural Lab of the Civil Engineering Department at the University of Missouri-Rolla on an MTS 880 equipped with digital data acquisition interfaced with LabView. Figure 4.2, shows the MTS 880 and data acquisition system. Longitudinal strain was measured two ways in the specimen, using a calibrated two inch extensometer and 0.5 in. strain gages. Since the available extensometer gage length was longer than the specimen gage length, strain data collected from it was always lower than that collected from the strain gages, thus extensometer measurements were used only to verify strain gage values. Figure 4.3 shows the test set-up with the strain devices attached.

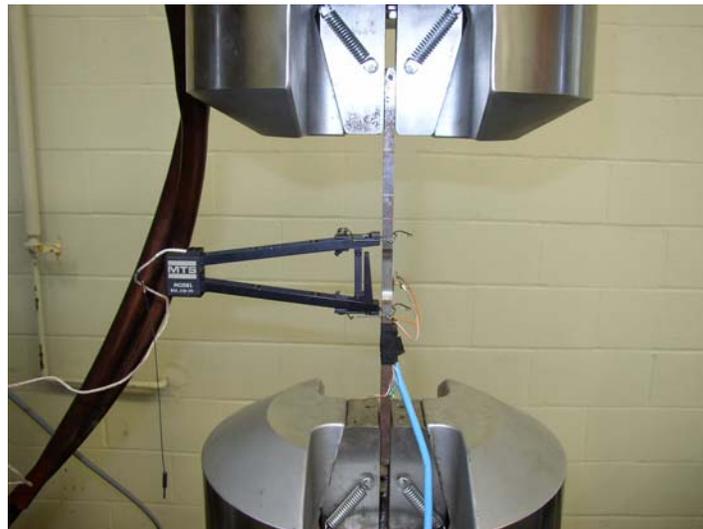
Figure 4.3 Longitudinal Strain Measurement Devices

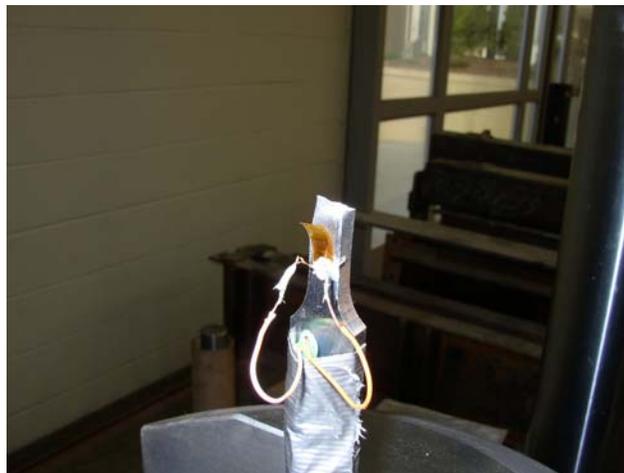
Figure 4.4 Failure of Fatigue Specimen

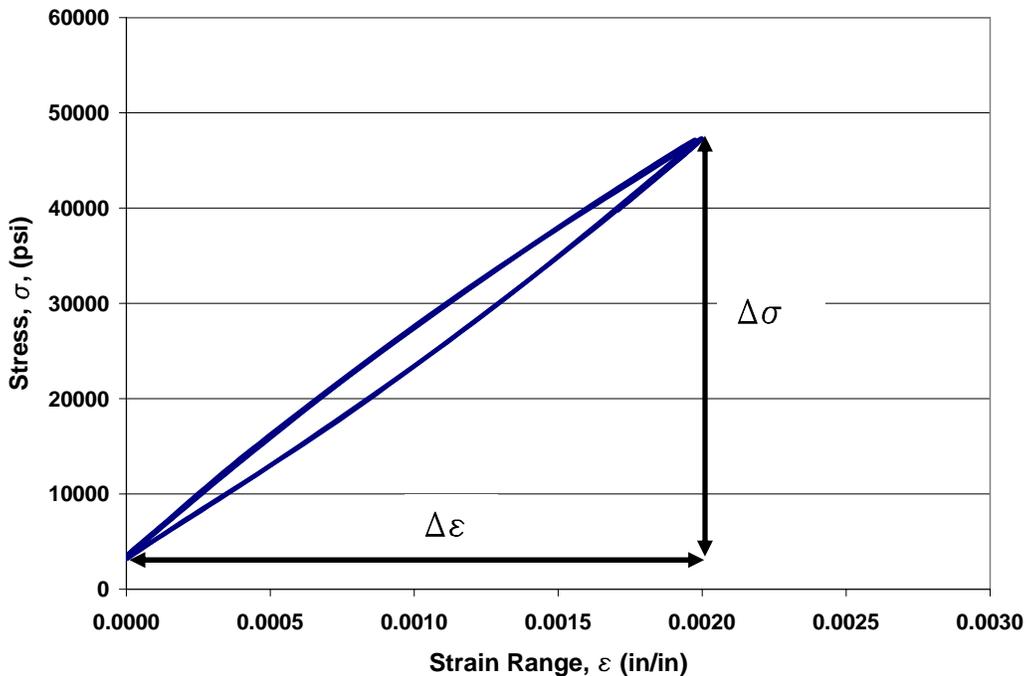
Figure 4.5 Typical Hysteresis Loop for Specimen 15

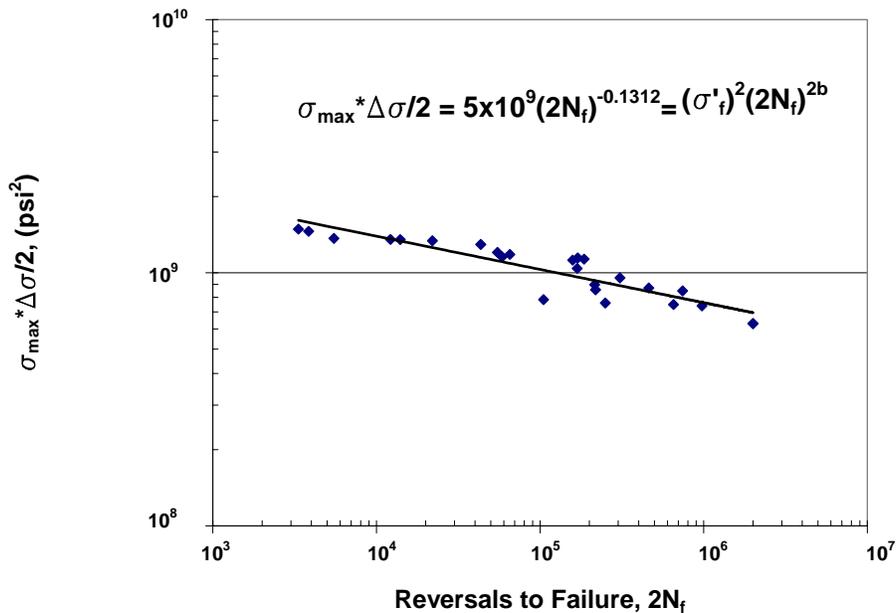
The empirical material constants, as defined in the Smith, Watson, Topper equation, were determined from fitting power law relationships to the plots of stress amplitude versus reversals to failure and plastic strain amplitudes versus reversals respectively on log-log scales. Figures 4.6 and 4.7 show these plots and the corresponding power law curve fit produced in Excel. Table 4.2 lists the empirical constants found from the curve fits. The empirical constants are needed to predict the crack initiation life.

Figure 4.6 Power Law Curve Fit for Stress Amplitude vs. Reversals to Failure

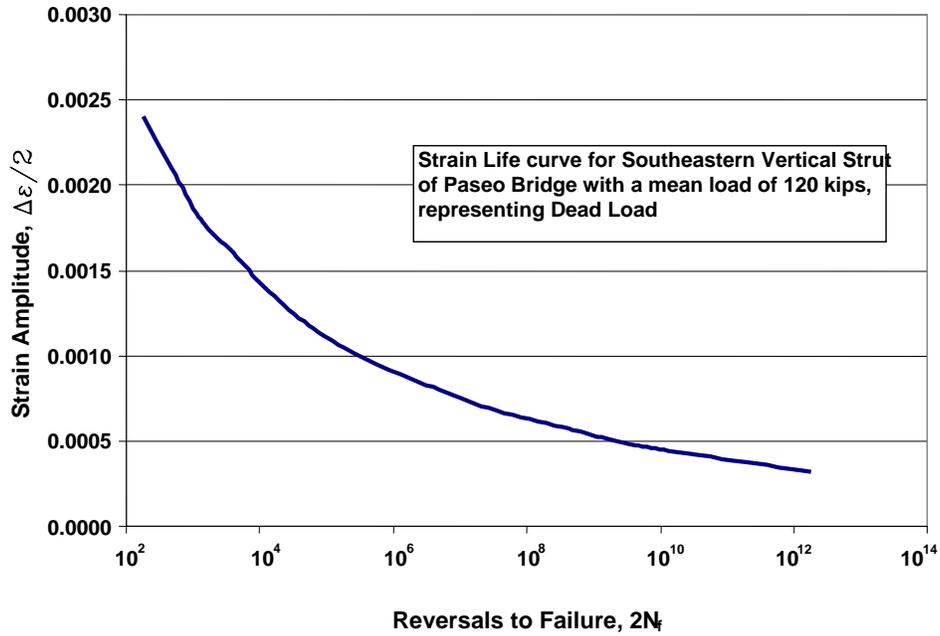
Using the residual life curve in Figure 4.10, the predicted residual life of the vertical struts, assuming the pin was not mechanically frozen, is found to be practically infinite. This is calculated by taking the number of cycles for 100% live load,  $10^8$ , and dividing by the daily number of cycles, 230, found in Section 7.5 of this report. The resulting value is nearly 1200 years. It should be noted, that this value is for fully reversed loading at 100% of the design live load and a constant dead load value of 120 kips.

Figure 4.9 Strain Life Curve for Paseo Bridge Struts

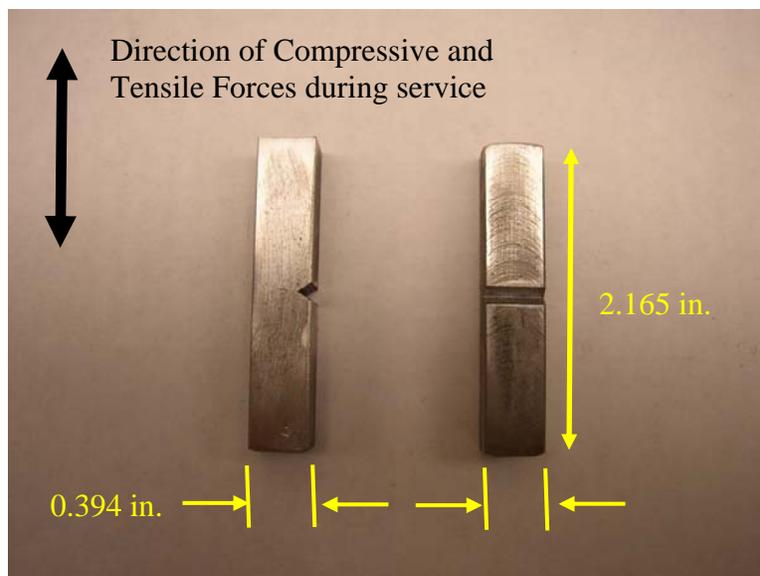
Standard dimensions were used for the Charpy V-notch specimens, measuring 2.165 in. in length and having a cross section of 0.394 in. by 0.394 in. The V-notch is located midspan, with regards to length having a depth of 0.079 in. with a notch angle of 45°. Charpy V-notch impact specimens can be seen in Figure 5.1.

Figure 5.1 Standard Charpy V-Notch Specimens

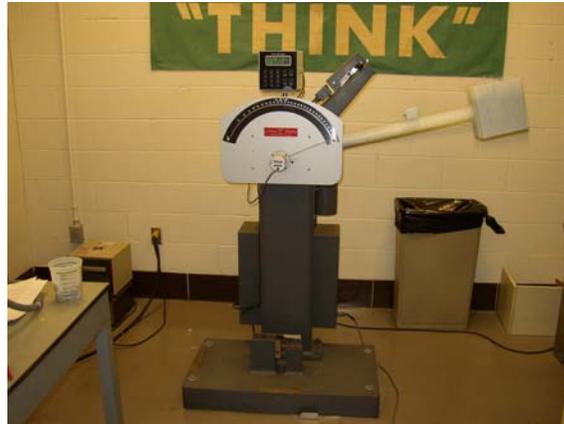
Charpy V-notch impact testing was done in a metallurgical lab at the University of Missouri-Rolla. Tests were performed using a calibrated Tinius Olsen Model 84 Universal Impact Tester, Figure 5.2. The tester has an anvil where specimens are placed and a swinging pendulum which rotates down to fracture the specimen. Data in the form of breaking energy is displayed and is calculated from the change of kinetic energy of the swinging pendulum after impact.

Figure 5.2 Tinius Olsen Model 84 Universal Impact Tester

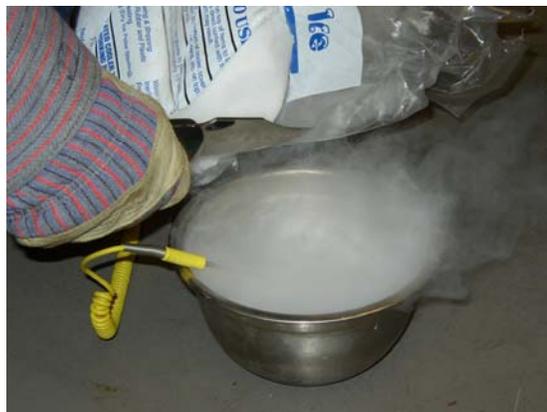
Figure 5.3 Dry-Ice and Alcohol Bath

The temperature range chosen,  $-10^{\circ}\text{F}$  to  $140^{\circ}\text{F}$ , represents the temperature range the material was likely exposed to during service. Temperatures below room temperature were obtained using an alcohol bath and dry ice, see Figure 5.3. The specimens were submerged in the alcohol in an insulated container and the temperature monitored using a submersible probe as flakes of dry ice were put in the bath. Figure 5.4 shows the temperature being measured at the lower end of the scale  $-10^{\circ}\text{F}$ . Temperatures were monitored in the bath and kept relatively constant for 20 minutes prior to impact to minimize temperature gradients within the specimen material. Temperatures above room temperature were obtained using a laboratory oven and again sufficient time given for stabilization of internal temperatures.

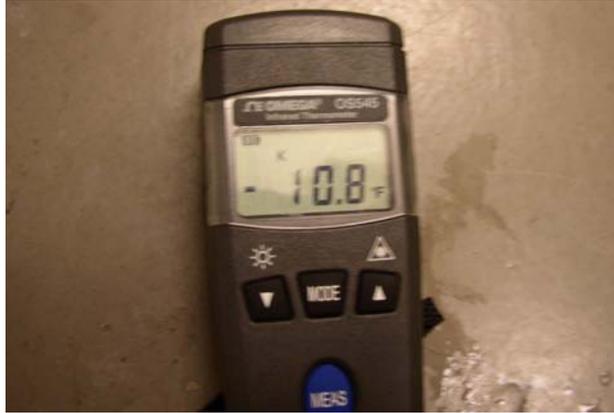
Figure 5.4 Temperature as Measured from Alcohol Bath

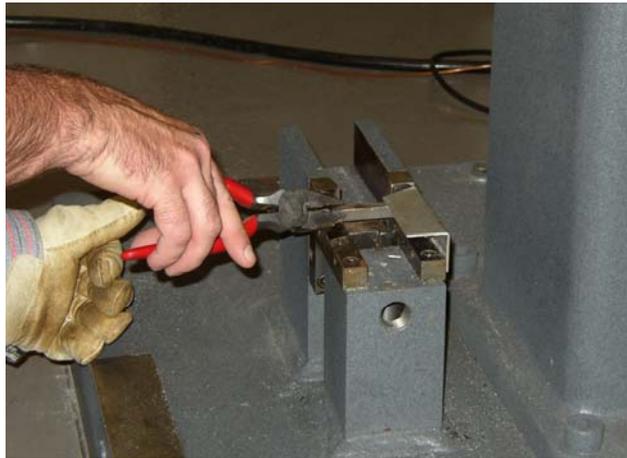
Upon reaching equilibrium of the desired temperature, specimens were quickly removed from the bath or oven and placed in the anvils of the impact tester, Figure 5.5. The pendulum was released from its starting position and allowed to swing through and strike the specimen causing fracture. The breaking energy,  $C_v$ , was recorded and the test repeated until five valid tests had been performed at each temperature. Test validity, given in ASTM E 23, was determined as complete fracture of the specimen.

Figure 5.5 Placing Charpy V-Notch Specimen in Anvil

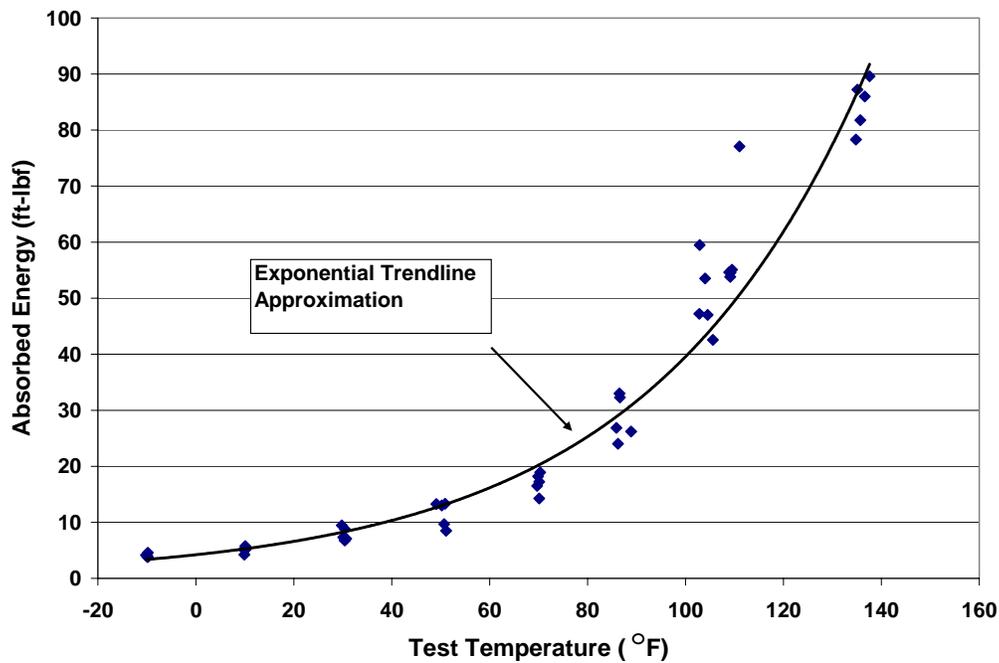
Since this is an empirically derived equation, Equation 5.1 is valid using the units of psi and inch for Young's Modulus, E, and fracture toughness,  $K_{IC}$ . Units of Charpy breaking energy, Cv, must be ft-lb. Barsom used this relationship in developing the AASHTO fracture toughness requirements for bridge steels (Phaal et al., 1997). Table 5.1 shows the fracture toughness,  $K_{IC}$ , calculated using Equation 5.1 and the average breaking energy of the five specimens at each temperature level tested.

Figure 5.6 Absorbed Energy at Temperatures Tested

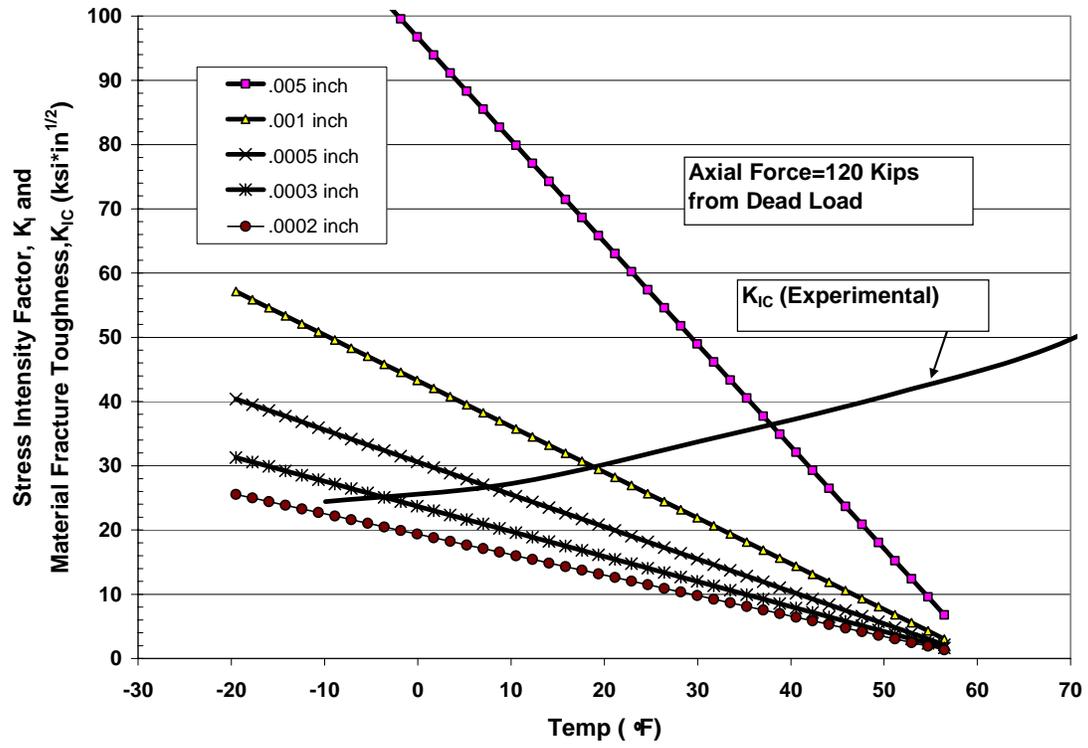
The applied axial force was from dead load alone. The moments applied were a function of temperature, caused by thermal contraction of the bridge deck, assuming the lower pin was mechanically frozen such that the strut was in a completely vertical position. These moments were obtained from a SAP 2000 model of the bridge discussed in Section 7 of this report. A zero moment condition exists at 60°F, the temperature at which structural dimensions were given. Figure 5.7 shows the relation between stress intensity factor and temperature, as well as the fracture toughness obtained from the Charpy impact tests. This figure can be considered as a supply-demand diagram. The “supply” curve or the  $K_{IC}$  is the positively sloped curve in Figure 5.7. The “demand” curves are the negatively sloped lines, each representing the stress intensity factor,  $K_I$ , at the given temperature. Where the “demand” curves cross and lie above the “supply” curve sudden fracture occurs. For example, with an initial crack length of 0.001 inch, sudden fracture of the Southeastern strut would occur at 20°F with no live load present. It should be reminded that this is for the strut being mechanically frozen in the vertical position. Moments generated from the thermal contraction of the bridge are much lower as the frozen position of the strut is at an increasing angle toward the deck. This would shift the “demand” curves to the left in Figure 5.7, as would a less conservative estimate of the stress intensity factor.

Figure 5.7 Prediction of Fracture of Southeastern Strut

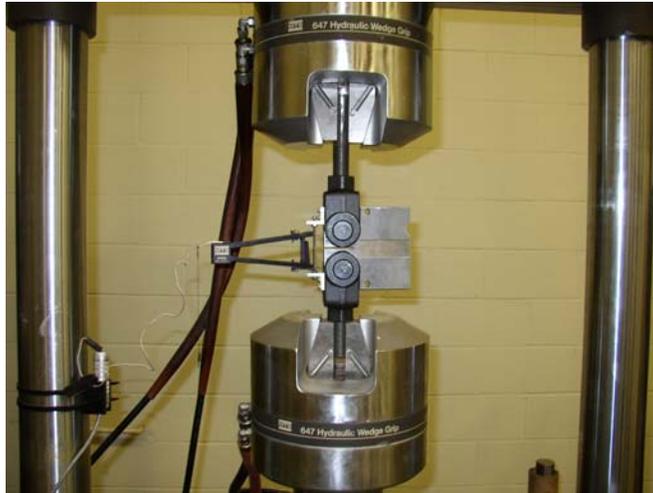
Specimens were tested in the Structural High-Bay Lab at the University of Missouri-Rolla using the same MTS 880 and data acquisition system as the fatigue specimens. Specimens were attached to the MTS grips using a clevis and pin assembly as outlined in ASTM E 647. Specimens were tested under cyclic loading fluctuations in the form of a sine wave at 5 Hz. The loading sine wave had a maximum value of 11,000 lbs. and a minimum value of 400 lbs. Again, due to errors generated in the data retrieval system, zero load was approached but avoided. An extensometer, as shown in Figure 6.4 can be used to check crack length by the compliance method (ASTM E 647). Figure 6.4, shows the test set up prior to testing. After measurable crack growth was noticed in the specimens, measurements were taken on both the front and rear faces using precision calibrated calipers. Measurements of crack length,  $a$ , were taken every 3000 cycles, see Figure 6.5, and repeated until the specimen failed. Data for the five valid tests is supplied in Appendix D.

Figure 6.4 Crack Growth Test Set-up

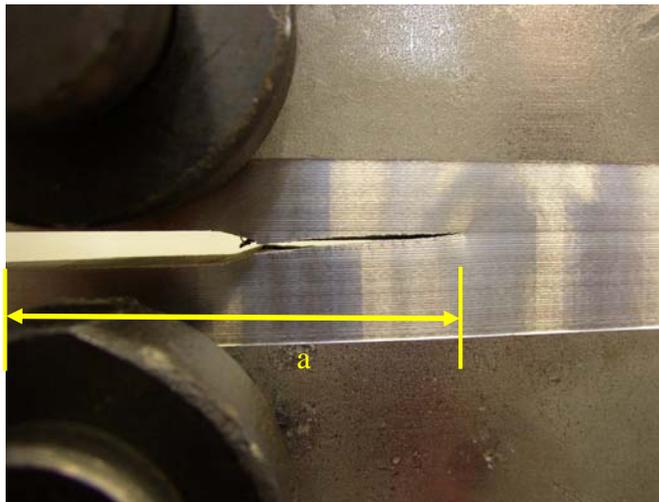
Figure 6.5 Crack Measurement During Growth

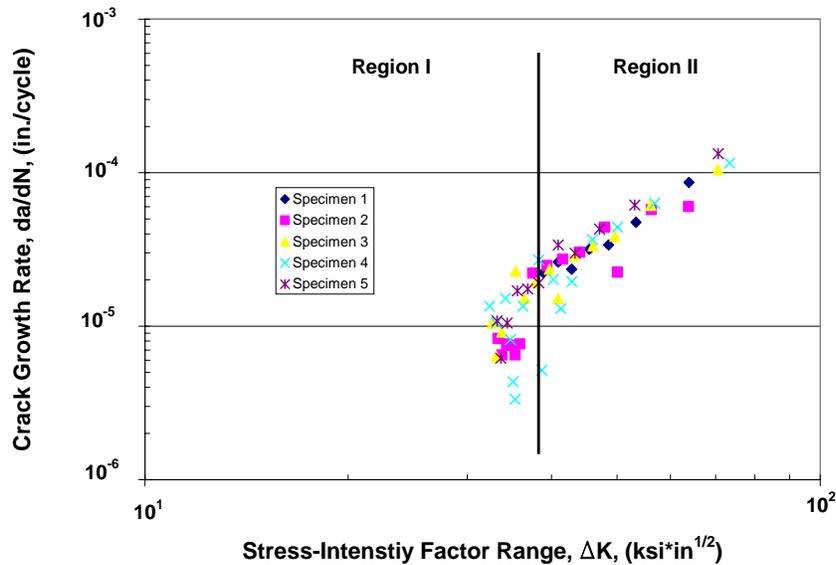
The variable B is specimen width, plate thickness in this case, and W is dimension from load line to back face, see Figure 6.3. Stress-intensity factors were calculated for each crack length measured. The change in crack length per cycle,  $da/dN$ , was calculated by dividing the crack length measurements by the number of cycles elapsed between measurements. The stress-intensity factor ranges were then plotted versus the change in crack length per cycle calculations on a log-log scale and are given in Figure 6.6.

Figure 6.6 Plot Showing Regions I and II

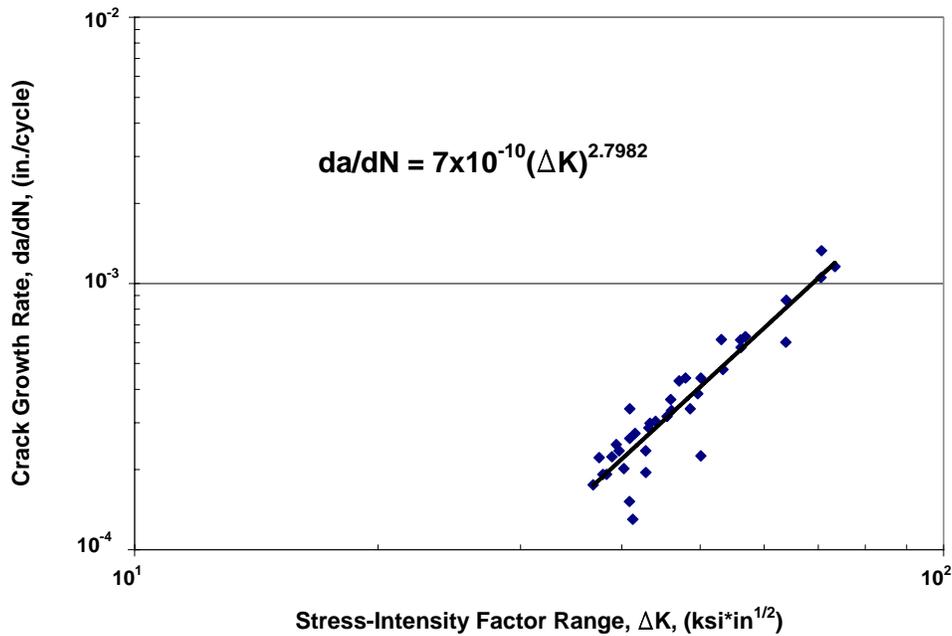
revealed from this curve fit and are  $7 \times 10^{-10}$  and 2.8, respectively. These values are consistent with the findings of Barsom (1971) and confirmed by Fisher (1989).

Figure 6.7 Power Law Curve Fit to Determine Paris Law Constants

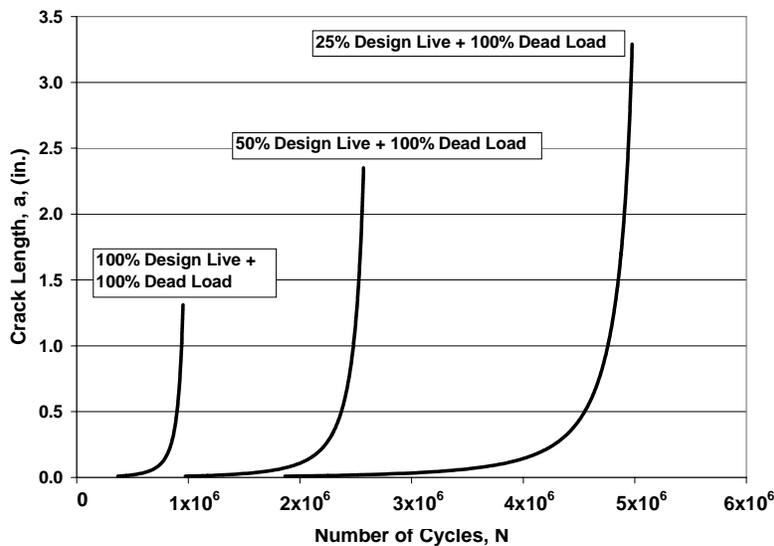
The number of cycles was then summed at each successive crack length interval to get the total number of elapsed cycles since initial crack length. Crack propagation life estimation curves were then generated for three different loading conditions on the struts. It should be noted that only tensile live loads were used, as compressive forces do not contribute to crack growth. So the stress range was from zero to max for each condition. The curves are given in Figure 6.8, and were calculated for a temperature of 60°F, where  $K_{IC}$  was estimated to be 45 ksi\*in<sup>1/2</sup>, that was interpolated from the values given in Table 5.1. The curves terminate at the critical crack length, or crack length corresponding to sudden fracture for the given loading conditions.

Figure 6.8 Crack Propagation Life Estimation Curves

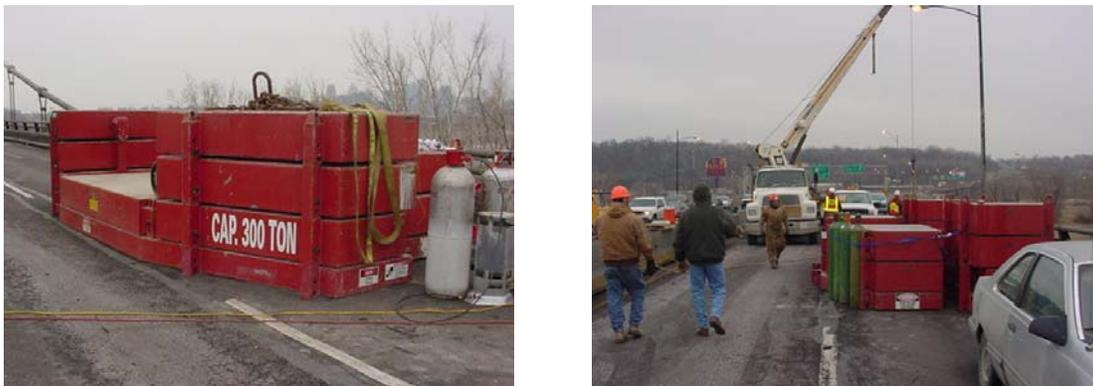
Dead load on the strut was calculated from ballast payload that was placed on the bridge during replacement of the strut assemblies. Approximately 240 kips was placed on the end of the bridge during repositioning of the deck, see Figures 7.1. From this payload, and assuming equal load distribution between the two struts at each end of the bridge, the dead load on the failed strut equaled to 120 kips, the same as calculated during retrofit design.

Figure 7.1 Dead Load Ballast Used During Deck Repositioning

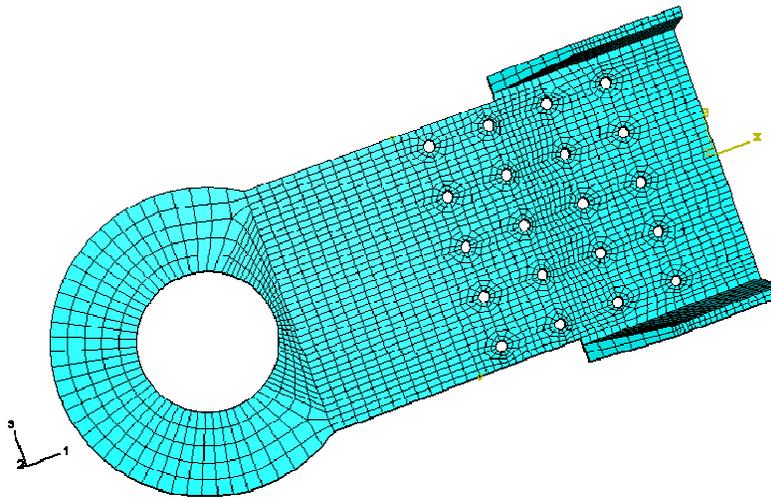
A model of the middle plate of the strut or the original S24 x 120 member was developed which consisted of the lower 43 inches as measured from the center of the lower pin. This length was chosen to provide four rows of rivet holes, two above, and two below the location of crack initiation. This model, referred to as the global model, consisted of 8835 nodes and 5408 hexahedral elements and can be seen in Figure 8.1.

Figure 8.1 ABAQUS Model of Middle Plate of Strut Assembly

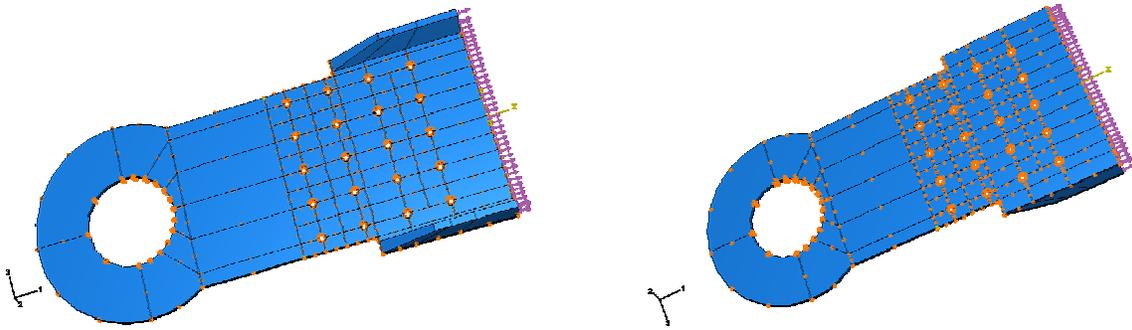
The surface of the hole for the 11-inch diameter pin is fully fixed in the global model and the back surface of the plate is constrained, as the model is only  $\frac{1}{2}$  of the middle plate. In other words, the plate thickness of the global model is 0.375 in. instead of 0.75 in., the thickness of the actual strut web. Front and back views of the global model are given in Figure 8.2.

Figure 8.2 Front and Back Views of Modeled Strut

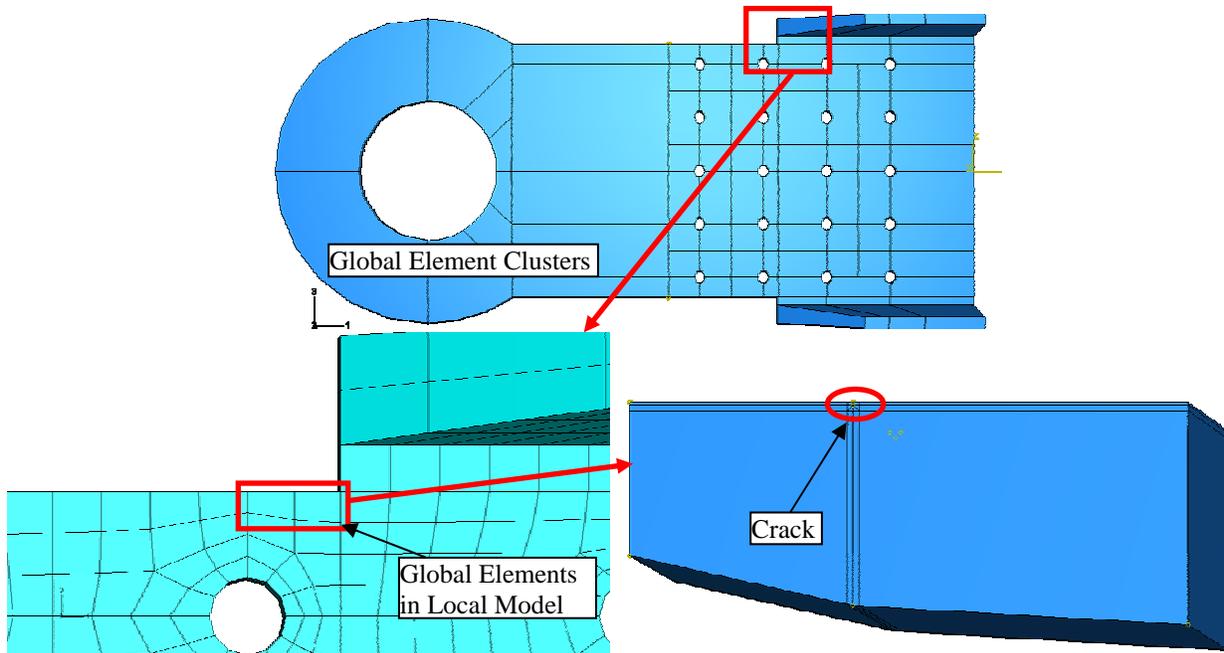
A local model of the area of crack initiation was produced from individual elements of the global model. This allowed for a finer mesh, thus more accurate calculations in the area of crack initiation. The location of the local model in relation to the global model is shown in Figure 8.3. Two global elements were chosen from the global clusters of elements and used as the boundaries for the local model elements.

Figure 8.3 Local Model Relationship to Global Model

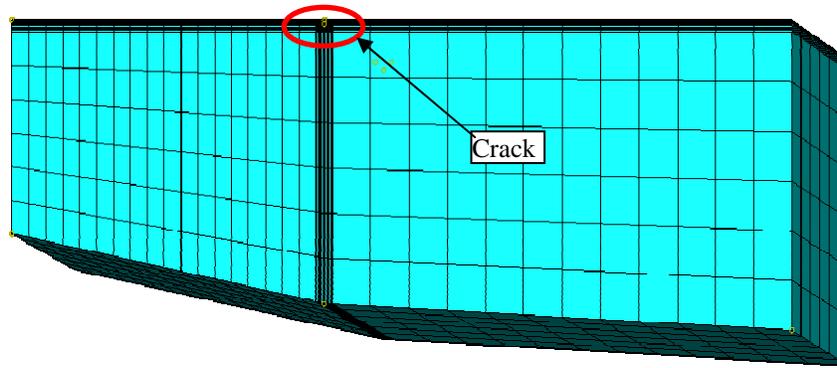
Figure 8.4 Three Dimensional Mesh of Local Model

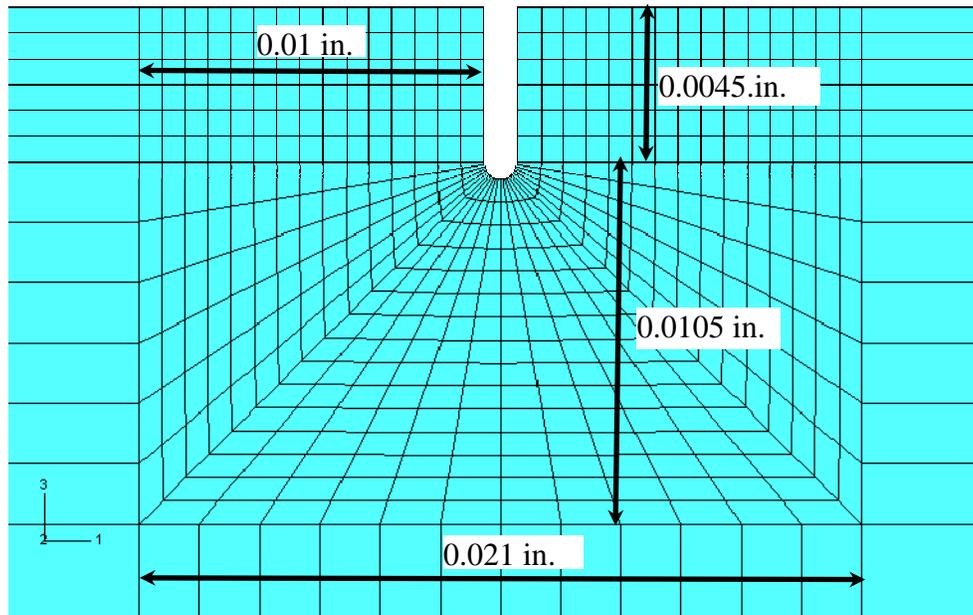
The mesh at the crack tip for the model with a 0.005 in. long crack is given in Figure 8.5. It should be noted that the physical width of the crack was 0.001 in. and the radius of the crack tip was modeled as 0.0005 in.

Figure 8.5 Mesh around Crack Tip of Local Model
