RDT 05-008

# **Failure Investigation of the Steel Strut on the Paseo Suspension Bridge**

RI 03-015

June, 2005

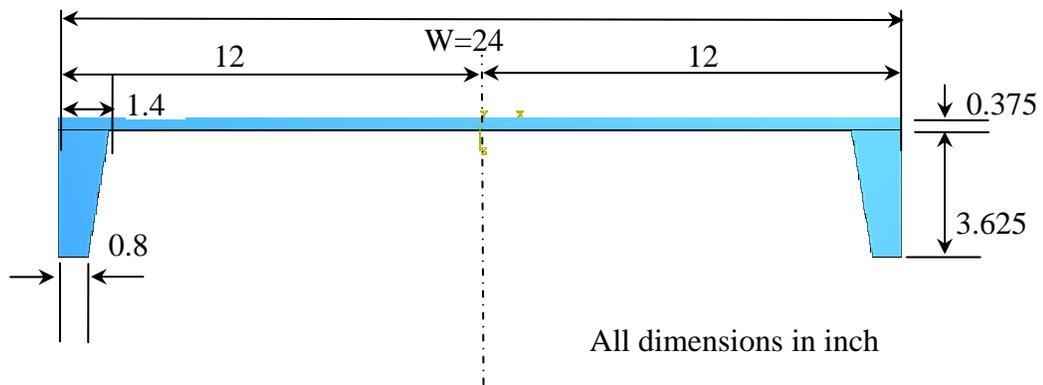
The combination of axial forces and moments were converted to distributed surface stresses applied on the top surface of the global model including the flanges. Figure 8.6 shows the dimensions where the stresses were applied to the global model. Figure 8.7 shows how the loads from axial forces and moments were combined and converted to stresses applied to the surface in Figure 8.6.

Figure 8.6 Cross Section Dimensions of Global Model

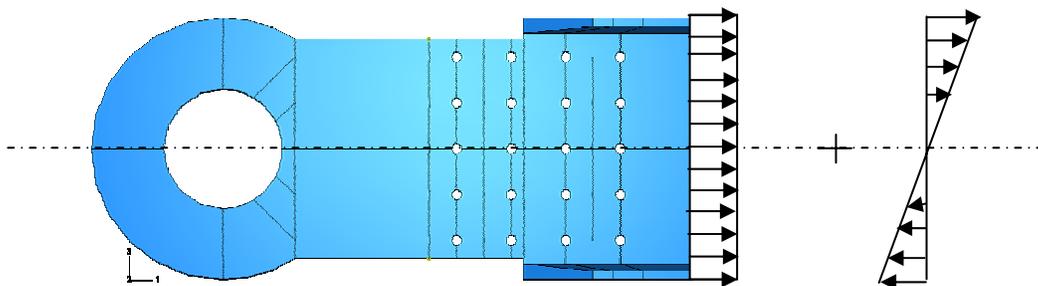
Figure 8.7 Illustration of Stress Application to the Global Model

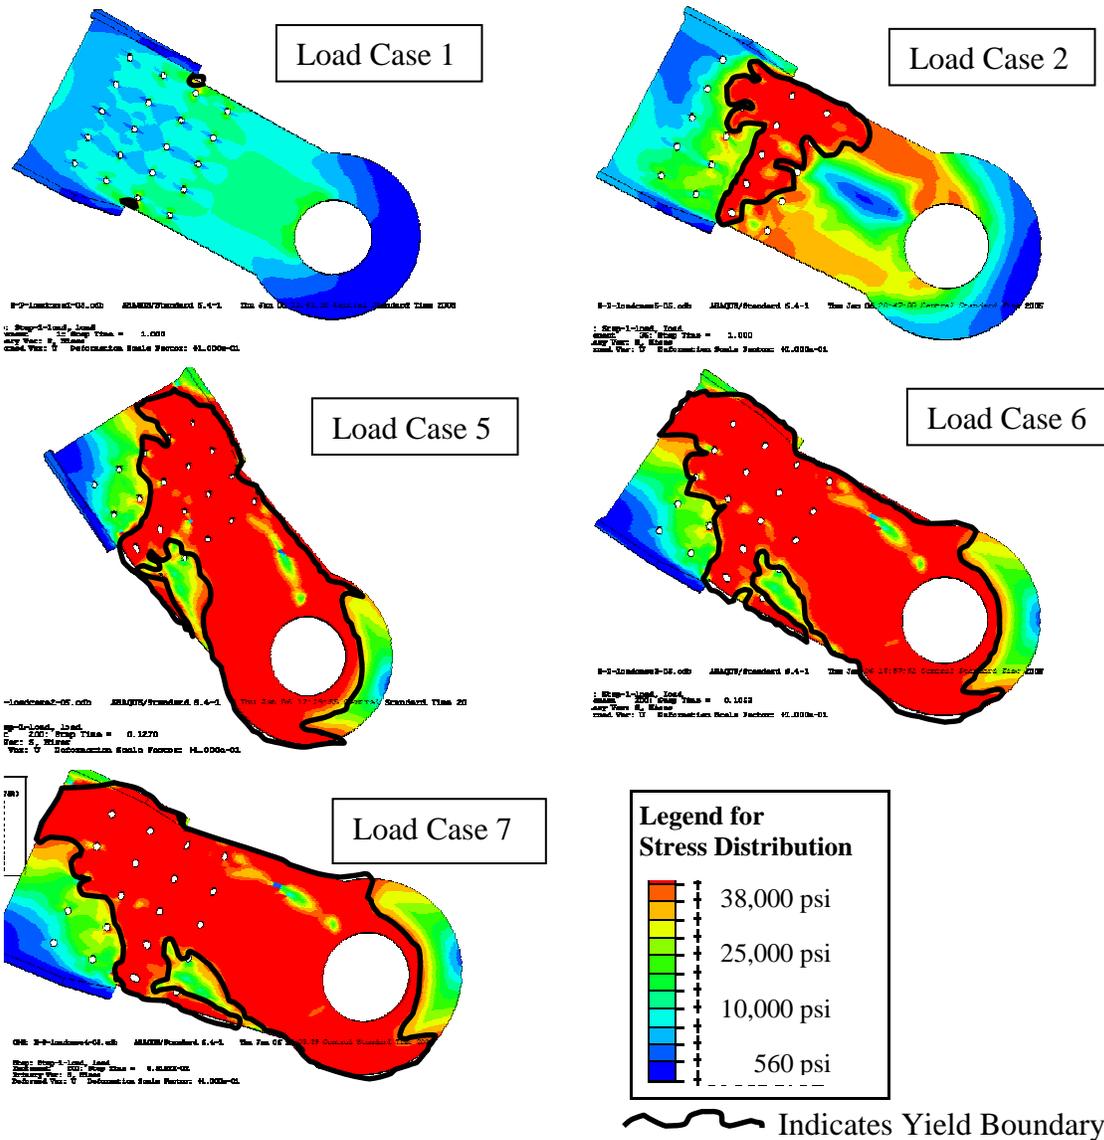
Figure 8.8 Progression of Plastic Deformation Areas for Selected Load Cases

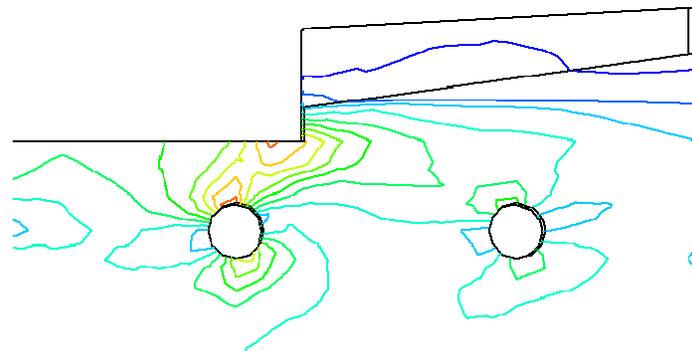
To identify the location of crack initiation and propagation, a series of local models with various initial crack lengths were established in ABAQUS. Each model was analyzed for Load Case 1. When there is no initial flaw or crack, the stress contour is shown in Figure 8.9. It is observed from Figure 8.9 that crack is likely initiated near the flange coping area due to high stress concentration and propagated towards the closest hole. To further see the propagation of an initial crack, as shown in Figure 8.10, two additional models with a crack length of 0.5 in. for Crack Pattern 1 and 1.1 in. for Crack Pattern 2, respectively, were analyzed. Their corresponding stress contours are presented in Figure 8.11. As a result of the previous cracks, the maximum stress occurs in the opposite side of the hole near the flange coping area. To understand how sensitive the location of the maximum stress, the third crack pattern was introduced in Figure 8.10. Its corresponding stress contour is also presented in Figure 8.11. By comparing Crack Pattern 2 and Pattern 3, one can see that the locations of the maximum stress identified from the two models are practically the same. To finish up the analysis for crack propagation, the fourth crack pattern in Figure 8.10 was created and the stress contour is shown in Figure 8.11. By comparing Figure 8.11 with the actual fracture pattern, illustrated in Figure 8.12, one can conclude that the models accurately predict the crack initiation and propagation locations of the actual damage pattern.

Figure 8.9 Mises Stress Contour in Load Case 1 for Crack Initiation Location Determination

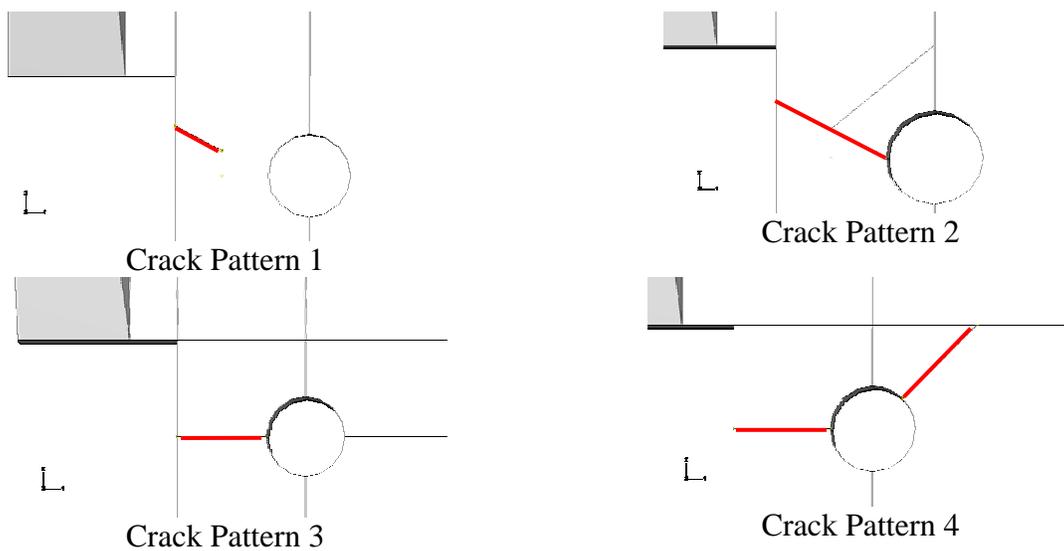
Figure 8.10 Crack Patterns

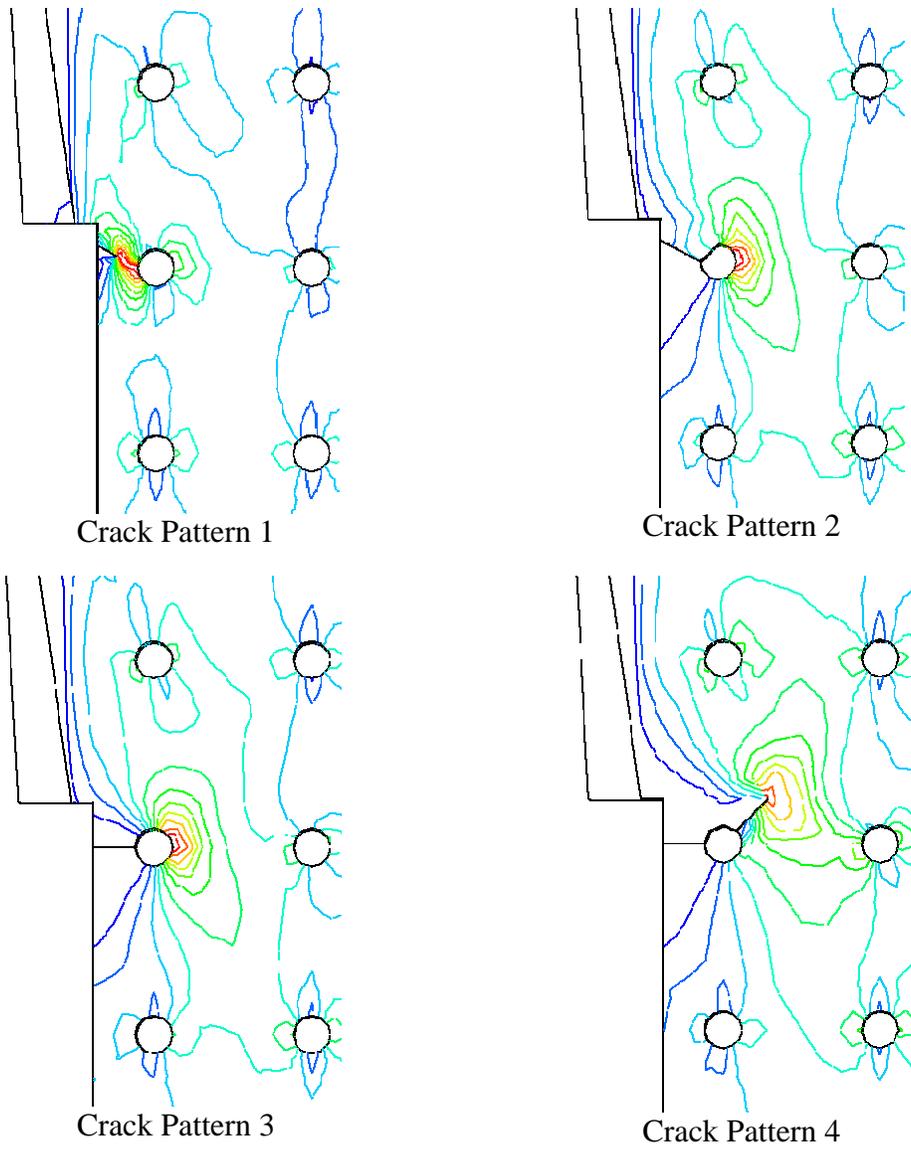
Figure 8.11 Mises Stress Distribution for Different Crack Patterns in Load Case 1

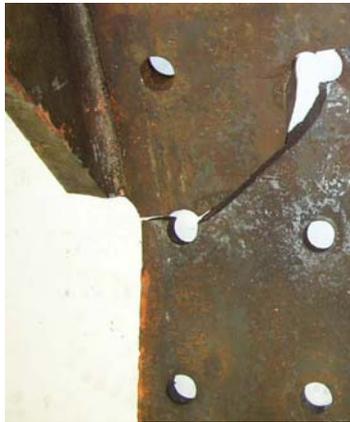
Figure 8.12 Actual Crack Propagation Pattern
