# Monitoring Vibrations on the Jefferson City Truss Bridge

Final Report Prepared for Missouri Department of Transportation  
May 2016

Project TR201605

Report cmr16-012

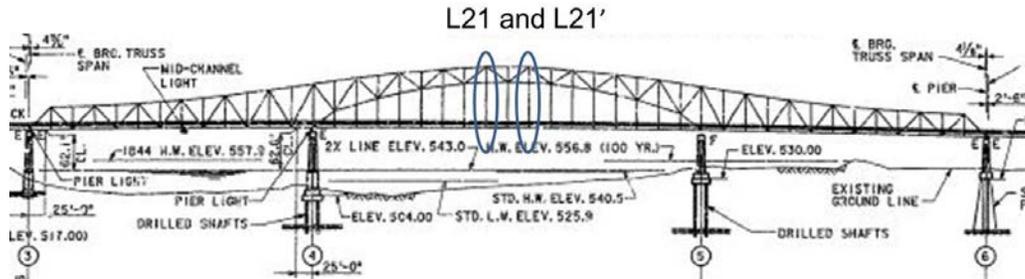
**Figure 1. Elevation view of Bridge A-4497 showing the location of vertical members L21 and L21'.**

Bridge A-4497 carries Rt. 54/63 across the Missouri River in Jefferson City, MO. The vertical members that were the subject of the study were members L21 and L21' as shown in Figure 1. There were four members monitored as part of the research; two on the East truss and two on the West truss. Member L21 is located on the west side of the truss centerline and L21' is located on the east side of the truss centerline. The I-shaped vertical members were comprised of two steel flanges (0.75 x 12 in.) and a web plate (0.375 x 19.5 in).

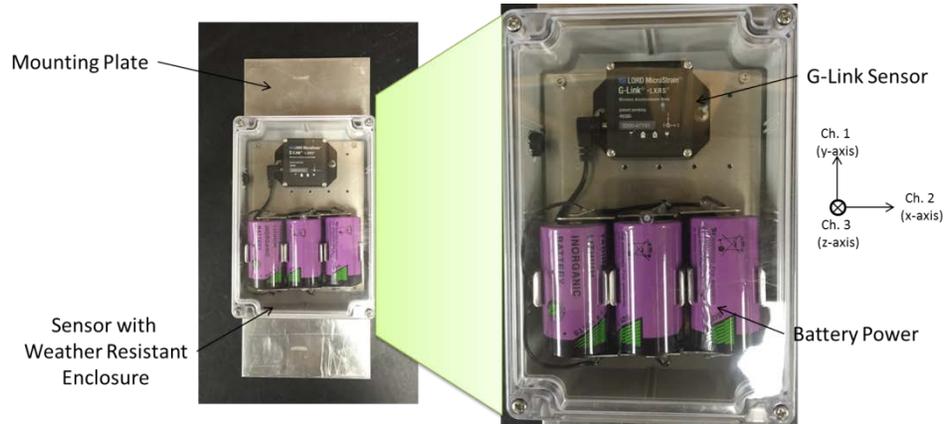
**Figure 2: Image of a Microstrain G-Link sensor with its power supply and enclosure attached to the mounting plate.**

Four wireless Microstrain G-Link sensor nodes were used to monitor vibrations of the vertical members. The Microstrain G-Link sensor is a battery-operated high-speed tri-axial accelerometer with user-programmable sampling rates of up to 4096Hz. These sensors are capable of measuring accelerations of up to 10 g. Figure 2 shows a photograph of one of the sensor nodes. The sensor node and supporting batteries were mounted in a weather resistant enclosure. In order to attach the enclosure to the flanges of the vertical members, an aluminum mounting plate was fabricated and attached to the back of the enclosure. The mounting plate with the sensor enclosure was attached to the flanges of the vertical member using small flange clamps. In this orientation, the y-axis of the accelerometer was aligned vertically with the member such that vibrations resulting from member resonance would not be expected on the vertical axis of the sensor (channel

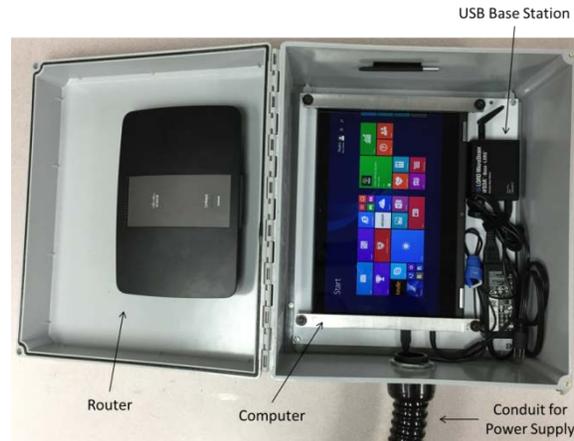
**Figure 3: Data acquisition system integrated with all the essential components.**

Figure 3 shows an image of the data acquisition system that is comprised of a Dell Laptop, Microstrain USB base station, Cisco router, and a conduit for power supply; these are all enclosed in a fiberglass enclosure. The data acquisition enclosure was used to protect the base station and computer from the elements. The laptop and USB base station were both attached to a mounting plate via screws and the mounting plate was attached to the fiberglass enclosure. The router was attached to the enclosure via Velcro strips. The laptop computer was used to run the software necessary for the wireless sensor nodes to communicate with the Microstrain USB base station and to store the data received from the sensors. The router was used for wireless communication with the computer for the purpose of downloading data. An Ethernet connection was also used to download the data. The system was powered by AC power provided on-site.

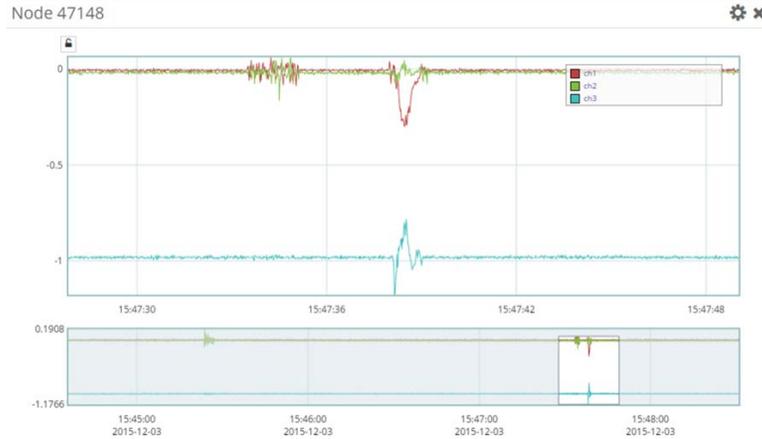
**Figure 4: Sample data collection using the SensorConnect software.**

The software package, SensorConnect (beta version), was used for this research due to its ability to record and read the large data files collected during testing. Figure 4 is an image of the SensorConnect display screen with the USB base station and the nodes collecting data. The nodes were programmed to sample at a continuous rate of 16 Hz based on laboratory testing and video analysis as described in later sections of the report.

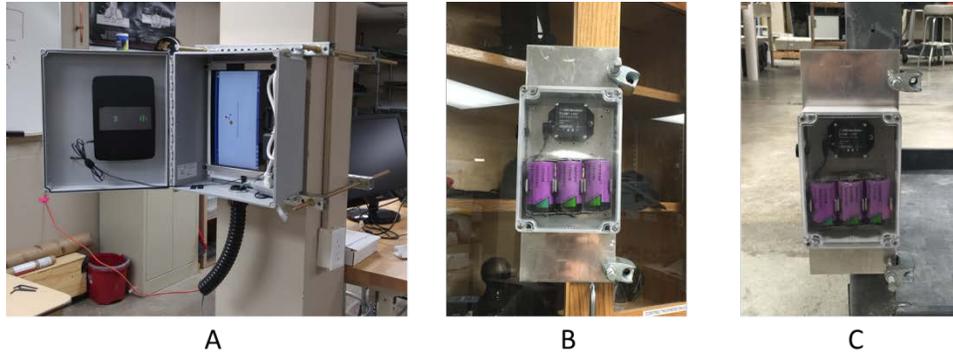
**Figure 5: System lab setup. (A) data acquisition system attached to a column, (B) sensor node attached to a cabinet, (C) sensor node attach to a moving cart.**

The monitoring system was tested in the laboratory to ensure proper operation of the monitoring systems. Testing in the lab was geared towards troubleshooting the data collection system and ensuring that data was being successfully collected and downloaded. Figure 5 illustrates the system in a lab setup. The data acquisition system was attached to a column to simulate the system attachment in the field and the sensor nodes were mounted to various objects in the lab, such as a cabinet or a moving cart. Data was collected over a time period of several weeks and downloaded periodically to simulate the anticipated field conditions. These tests were used to ensure that the software was operating reliably, data could be downloaded without interruption to the operation of the system, and so that estimates could be developed for the time required to download data sets of different sizes.

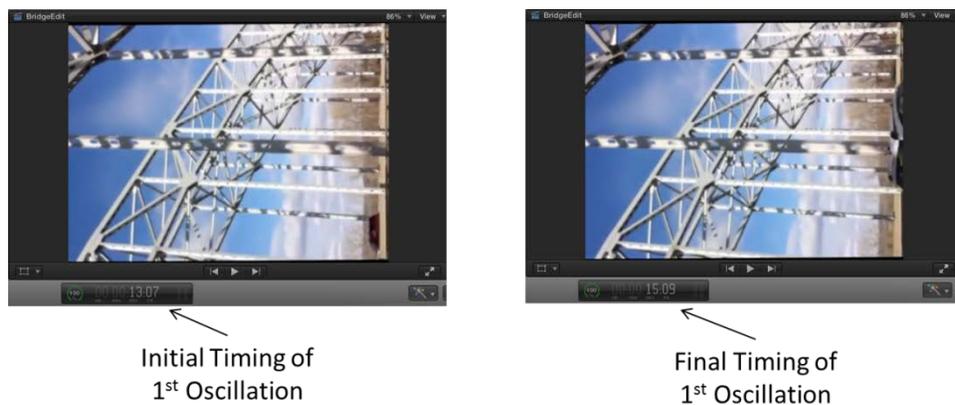
**Figure 6: Initial (left) and final (right) timing of the first oscillation at 10% of the original video speed.**

As shown in the figure, the change in time for a single oscillation was determined to be 0.203s. The frequency was then calculated to be 4.84Hz for a single cycle of vibration. A similar analysis was completed for five cycles of oscillations using the video at reduced speed. The time necessary for five oscillations was determined to be 9.90s. Based on these data, it was concluded that the members were oscillating at a frequency

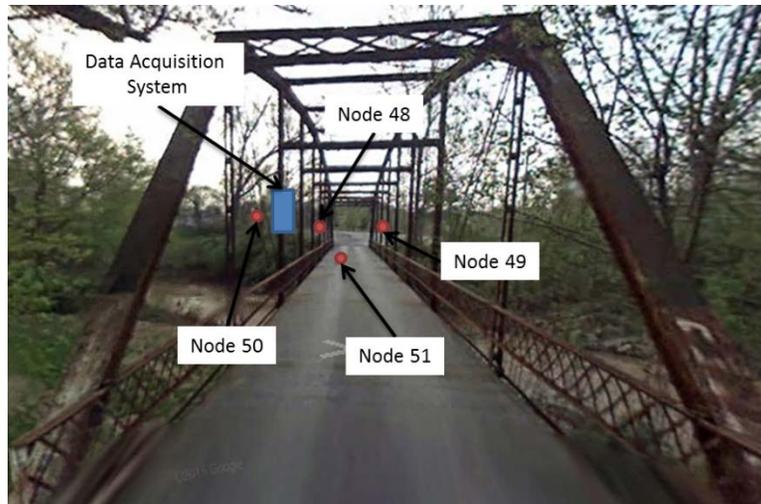
**Figure 7: Schematic of the placement of the data acquisition system and the wireless sensors (Google maps).**

A field implementation test of the monitoring system was performed to ensure that all components of the system would perform adequately in the field and to practice field installation. The data acquisition system was installed on a vertical member of a pedestrian truss bridge located near the University of Missouri. During the test, nodes 48, 49, and 50 were attached to diagonal tension ties, and Node 51 was placed on the deck of the bridge. Figure 7 is a schematic of the placement of the data acquisition system and the wireless sensor nodes. The sensor nodes on the tension ties were mounted on tension ties that were observed to be carrying different amounts of tensile load based on their vibrations following an impact on the tie. Different amounts of tension in the diagonal ties produce different frequencies when impacted. This allowed for a variety of different vibration frequencies to be tested. Figure 8 shows the attachment of the data acquisition system to the vertical member and the sensor placement on the tension tie and the bridge deck.

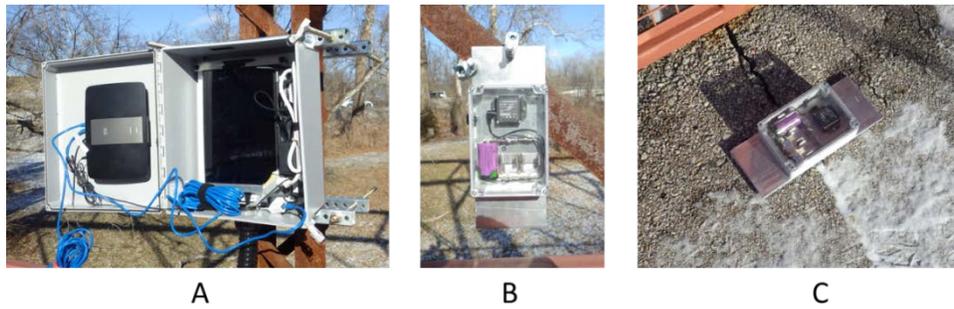
**Figure 8: (A) Attachment of the data acquisition system, (B) attachment of sensor to a tension tie, (C) placement of sensor on the deck.**

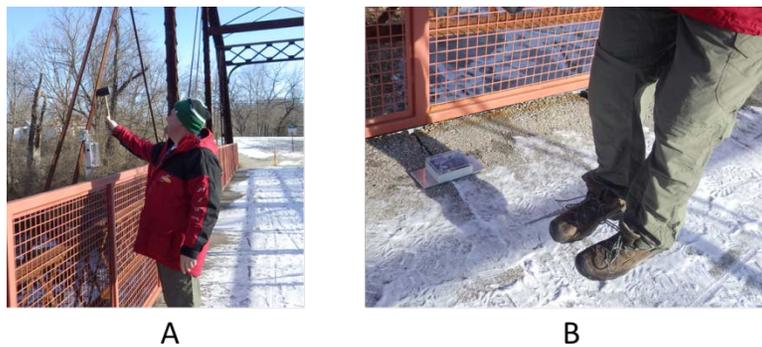
**Figure 9: Types of impacts. (A) Impact on a tension tie via rubber mallet, (B) impact on the deck by jumping.**

Testing of the sensors was completed by initiating the data acquisition software with a defined sampling rate of 4, 8, or 16 Hz. The diagonal tension tie was then impacted twice using a rubber hammer near each of the sensor nodes. The sensor node located on the bridge deck was excited by jumping on the bridge deck. Figure 9 shows the impacts on a tension tie with a rubber mallet (Figure 9A) and a jump near the sensor on the deck of the bridge (Figure 9B).

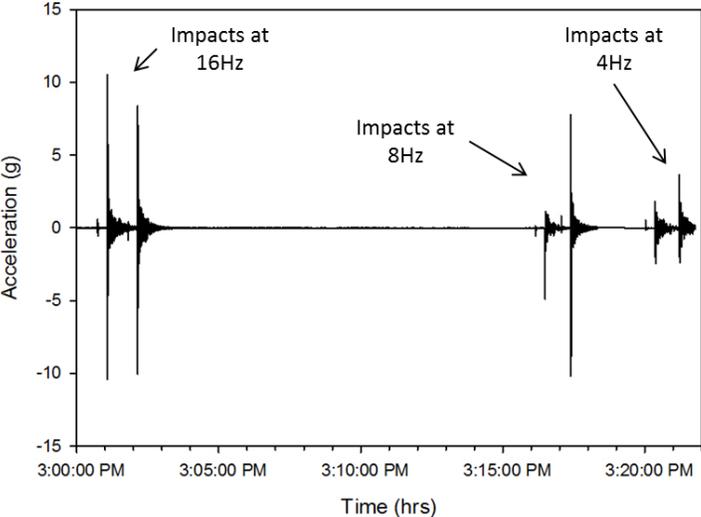
**Figure 10: Data collected for Node 48.**

Figure 10 shows the results of the impacts near sensor Node 48 with different sampling rates used for each set of two impacts. The data shown in the figure was assembled from different tests (using different sampling rates) to illustrate the effect of different sampling rates. The effect of different data acquisition rates are clearly observed in the different impact sets. As shown in the figure, the amplitude of the impacts is not properly reproduced in the digital data when acquisition rates of less than 16 Hz were used. This effect is caused by the under sampling of data, i.e., data sampling rate not

being sufficiently high. Sampling rates of greater than 16 Hz were not considered due to practical limitations. Specifically, data sets would be too large to be efficiently downloaded in the field. Because the sampling rate of 16 Hz was three times the frequency calculated through the video analysis and exceeds the minimum sampling rate of 10 Hz, it was determined to be adequate to meet the objectives of the research. Using the sampling rate of 16 Hz, seven days of data collection from the four accelerometers produced two Gigabytes of data.

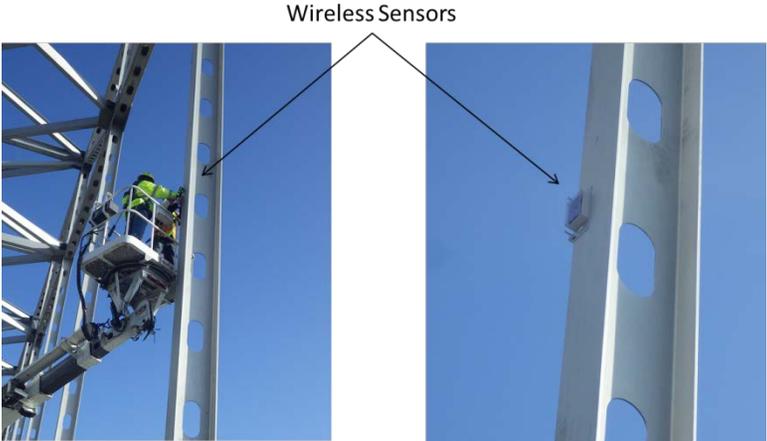
**Figure 12: Installation of one of the wireless sensor nodes.**

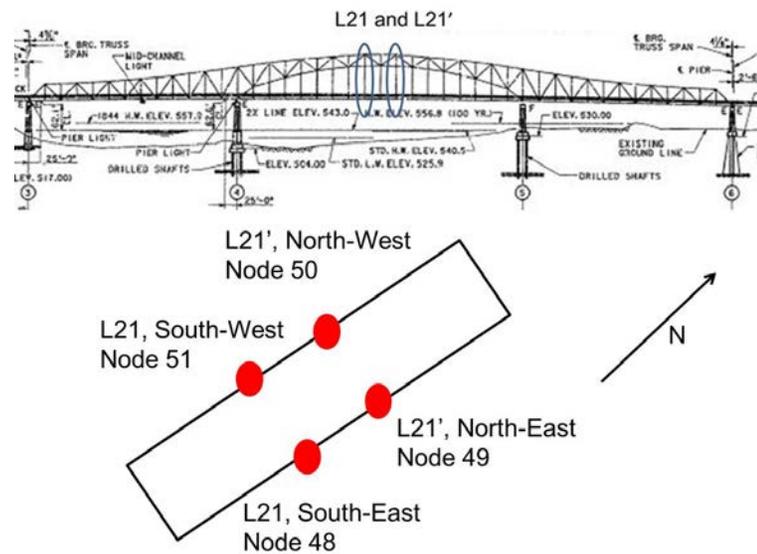
**Figure 13. Schematic diagram showing location of sensor nodes mounted on verticals L21 and L21'.**

Table 1 includes a summary of the location of the sensor nodes as mounted on the JC Bridge. Figure 13 shows the locations of the sensor nodes on the JC Bridge in a schematic diagram. In the figure, the elevation view of the bridge is shown (top) and the location of the sensor nodes on the verticals is shown.

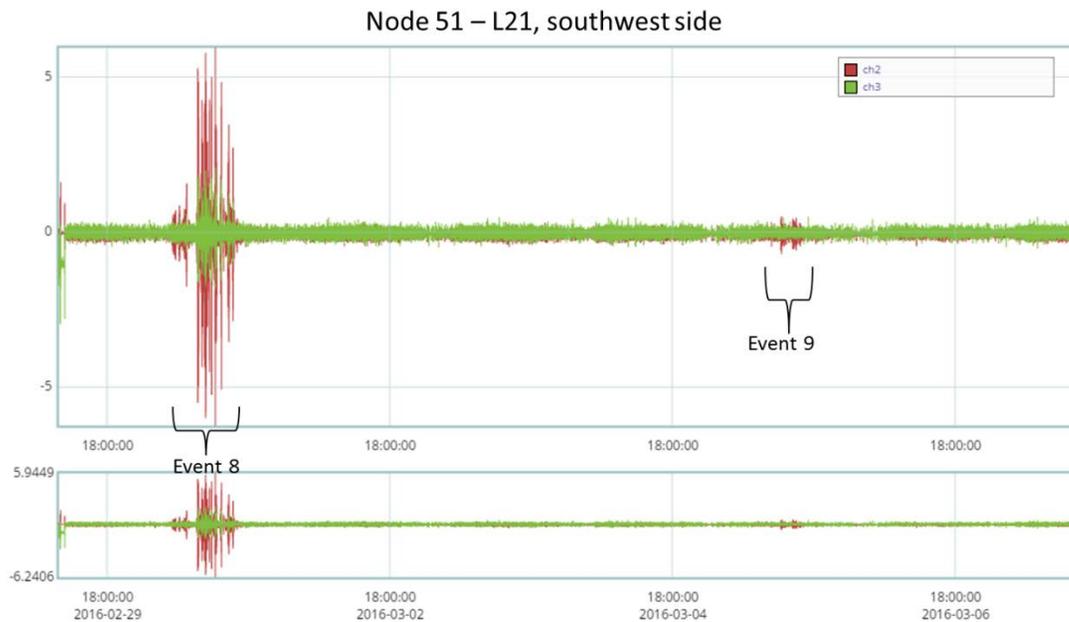
**Figure 14: Typical acceleration data from a vertical member showing two “events”.**

Data collected during this time period was analyzed to identify when resonance vibrations were occurring on the bridge. The nominal vibrations occurring on the verticals during normal traffic loading was analyzed and it was determined that the nominal vibrations were generally 0.25 g or less. Based on these data, a resonance “event” was identified as a vibration amplitude of greater than 0.25 g for an extended period of time, typically more than 1 hr. Figure 14 shows typical data collected on a vertical member. As shown in the figure, events were identified from the peak amplitudes of vibrations. During the 42 days of testing, eleven different “events” were identified in the data. As shown in Figure 14, vibration amplitudes varied during a typical “event” and these variations were grouped together to form an individual “event.”

As shown in Figure 14, data was collected only for channels two and three of the tri-axial node sensors. Channel 2 and channel 3 collected data in the x-axis and z-axis respectively as described previously. The peak acceleration for channels 2 and 3 of each individual node for each event is shown in Table 3. These peak accelerations were determined by finding the highest acceleration experienced during an individual event. The greatest peak lateral accelerations occurred on Node 51 (L21, southwest) with an acceleration of 7.10g, while the greatest peak torsional acceleration also occurred in the same node with an acceleration of 2.44g. Overall, Node 51 exhibited the highest peak acceleration, both laterally and torsional for all of the events analyzed. The second highest overall peak lateral acceleration occurred in Node 50 (L21', northwest), while the second highest overall peak torsional acceleration occurred in Node 48 (L21, southeast).

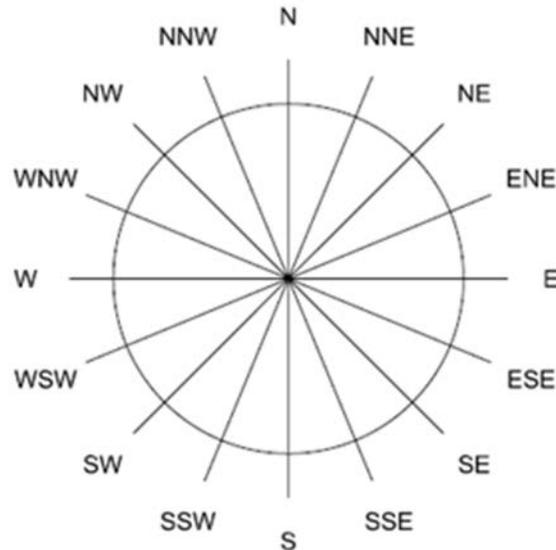
**Figure 15: Wind direction and degrees.**

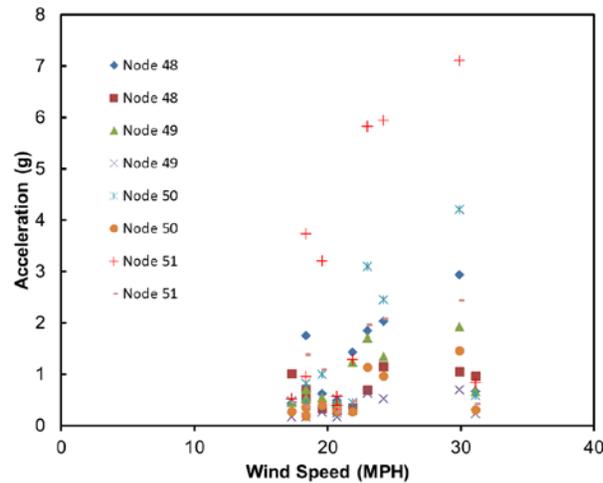
**Figure 16. Graph showing correlation between maximum winds and maximum accelerations.**

Figure 16 shows the correlation between the maximum winds recorded for each event with the maximum acceleration measured by each sensor node. As shown in the figure, sensor node 51 typically exhibited much higher accelerations than other sensor nodes; sensor node 50 also exhibited higher accelerations than other sensor nodes. These sensor nodes were located on verticals L21 and L21' on the west side of the bridge.

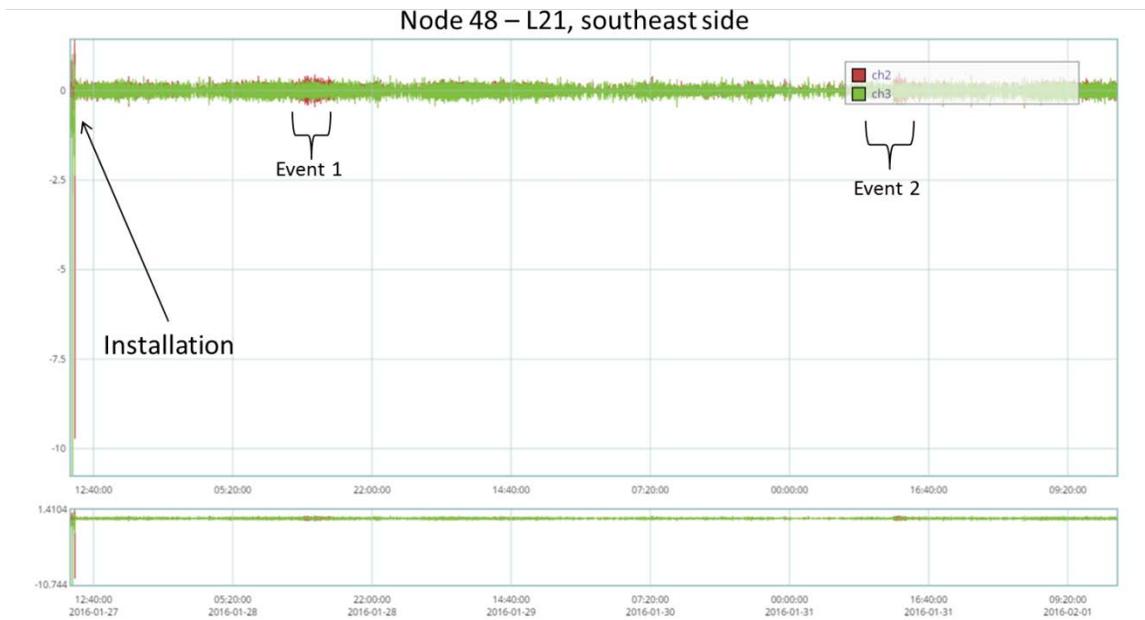
Figure 17: Data collected for Node 48 between January 27, 2016 and February 1, 2016.

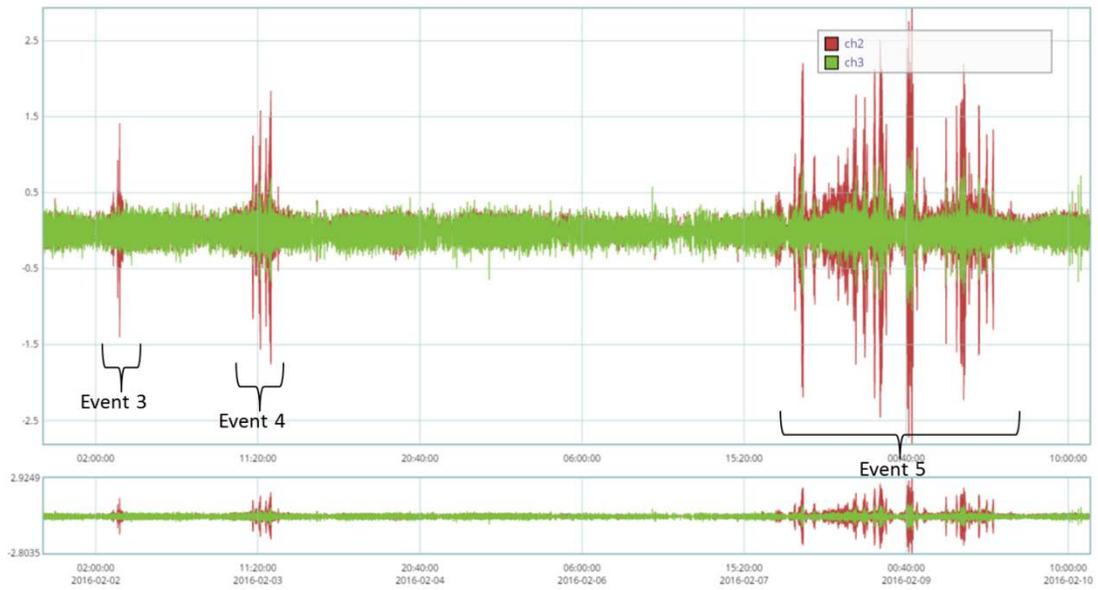
Figure 18: Data collected for Node 48 between February 1, 2016 and February 10, 2016.

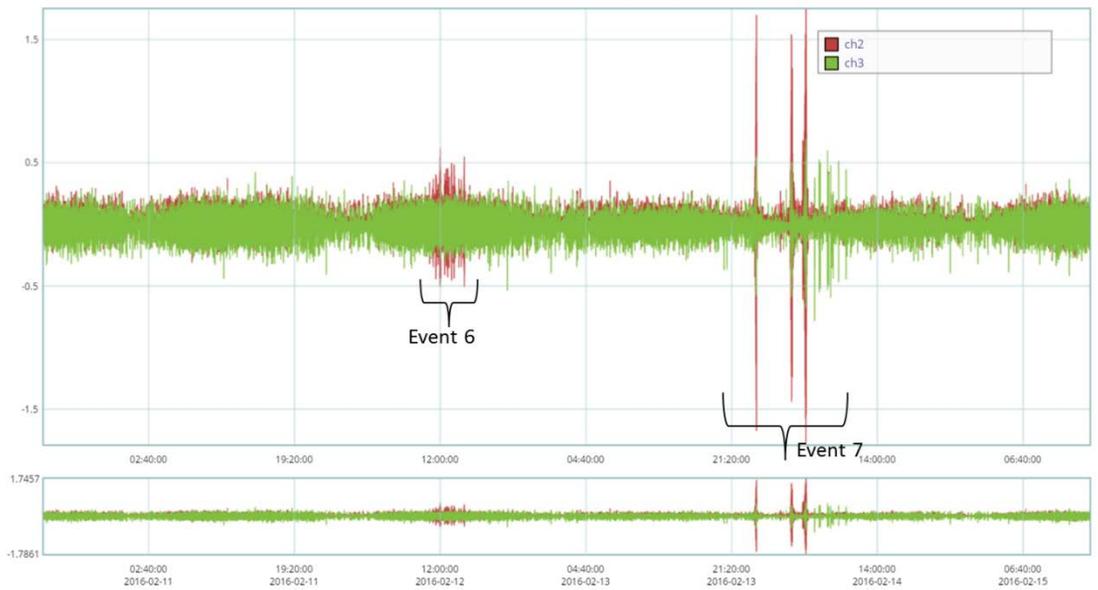
Figure 19: Data collected for Node 48 between February 10, 2016 and February 15, 2016.

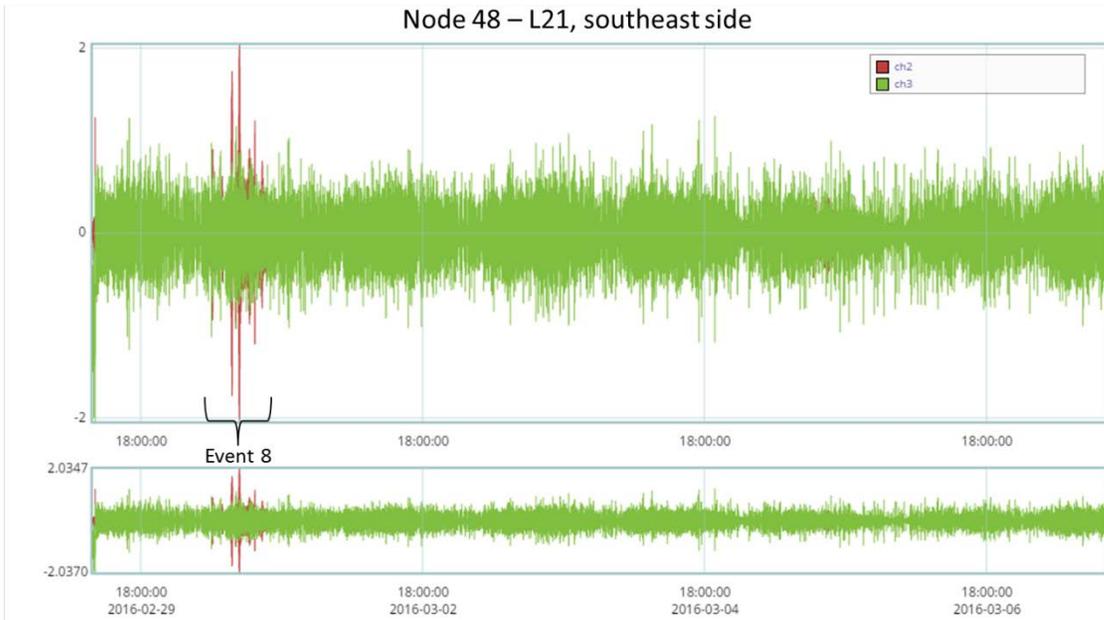
**Figure 20: Data collected for Node 48 between February 29, 2016 and March 7, 2016.**

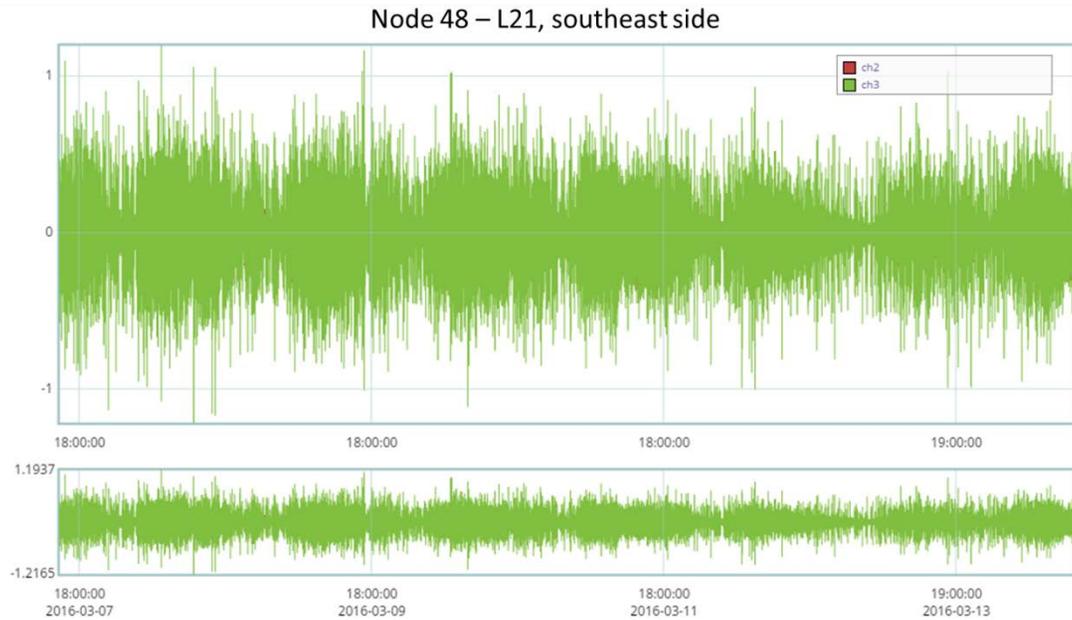
**Figure 21: Data collected for Node 48 between March 7, 2016 and March 14, 2016.**

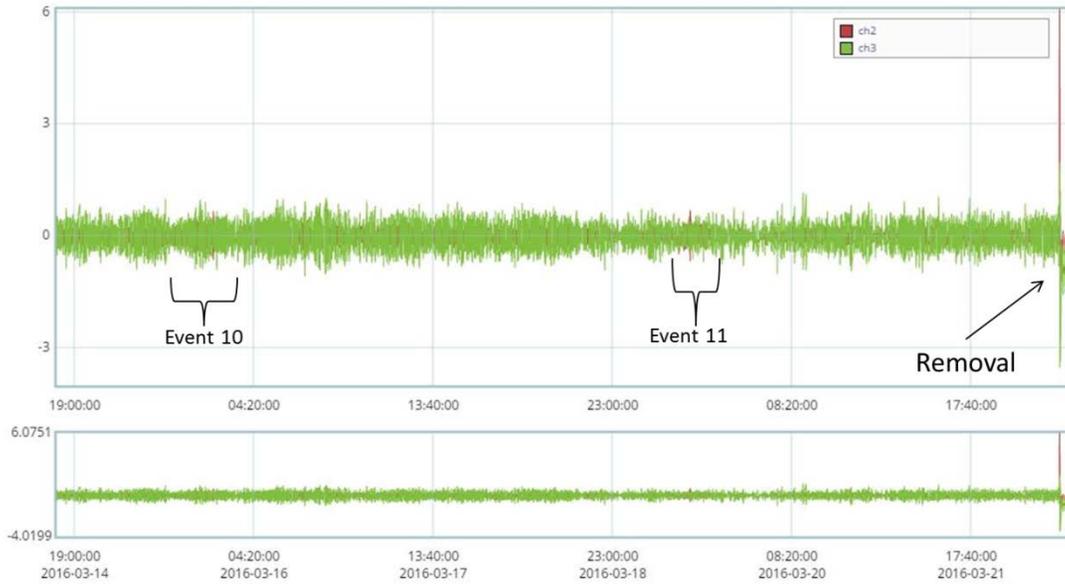
Figure 22: Data collected for Node 48 between March 14, 2016 and March 22, 2016.

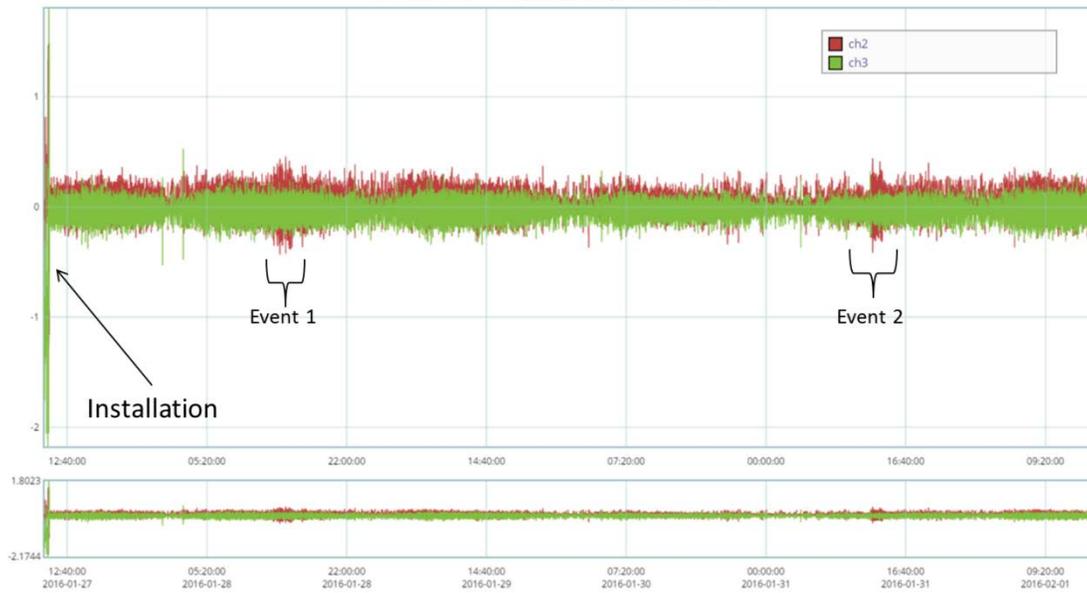
Figure 23: Data collected for Node 49 between January 27, 2016 and February 1, 2016.

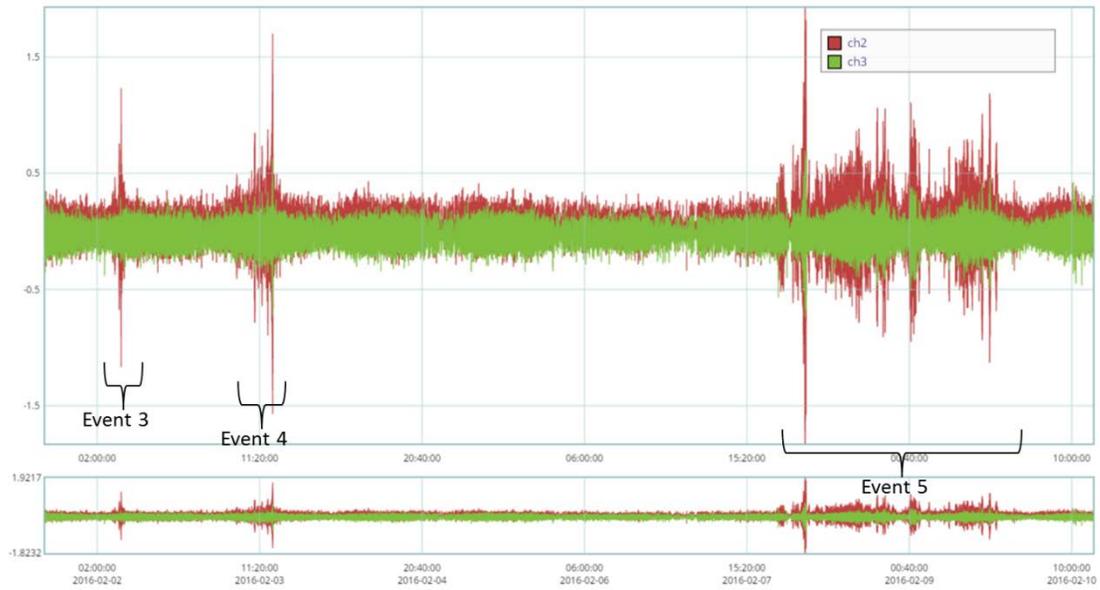
Figure 24: Data collected for Node 49 between February 1, 2016 and February 10, 2016.

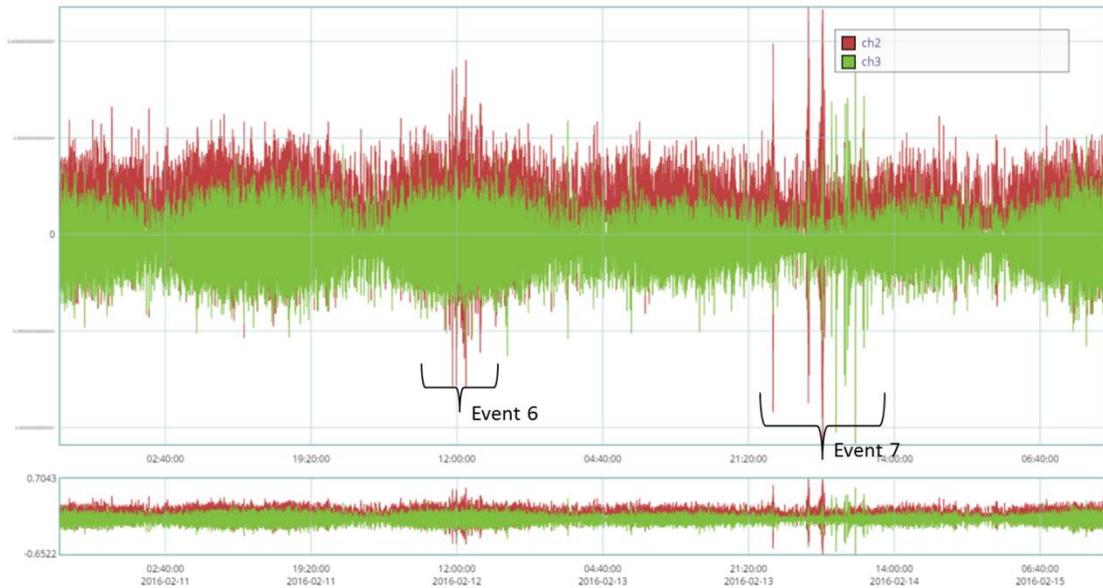
Figure 25: Data collected for Node 49 between February 10, 2016 and February 15, 2016.

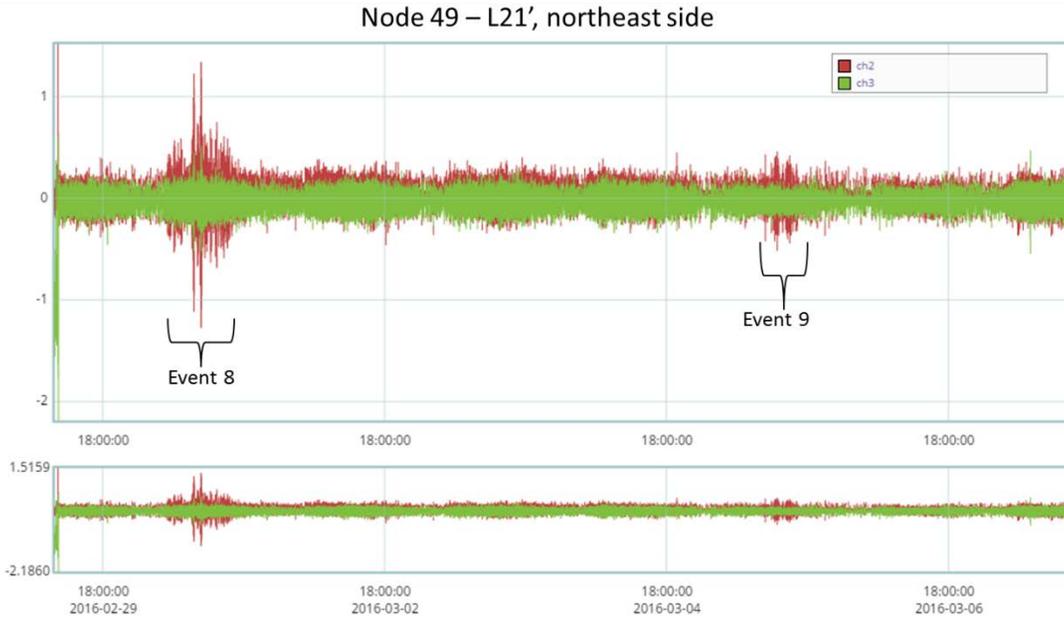
**Figure 26: Data collected for Node 49 between February 29, 2016 and March 7, 2016.**

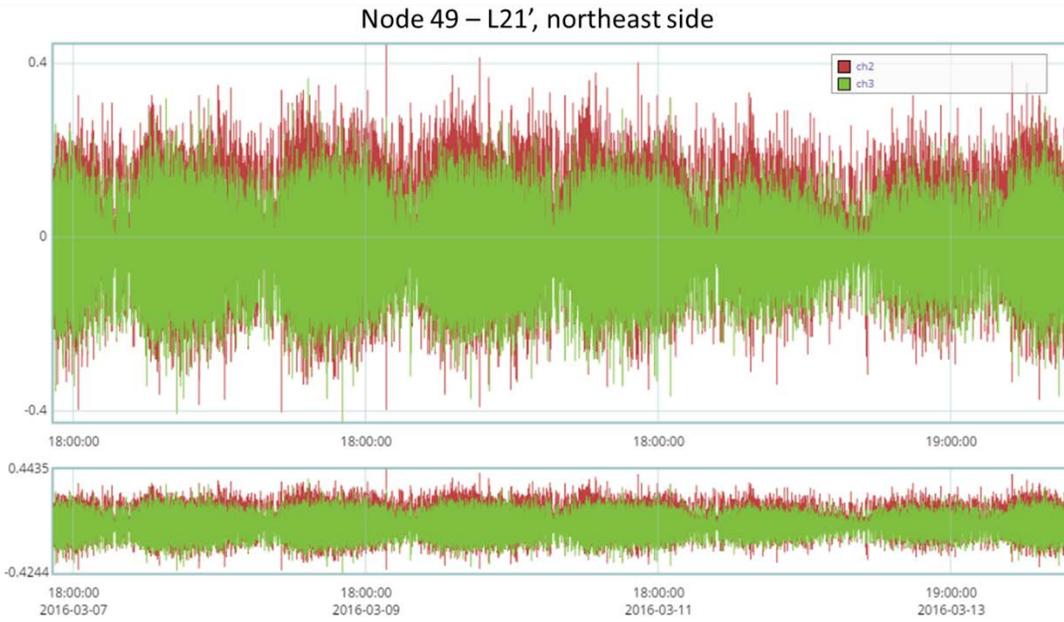
**Figure 27: Data collected for Node 49 between March 7, 2016 and March 14, 2016.**

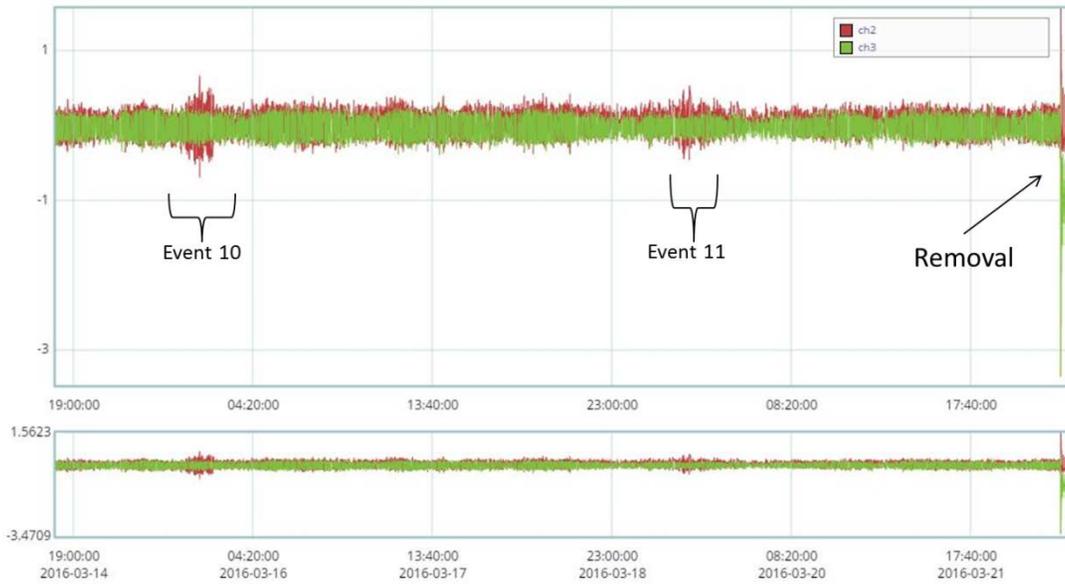
Figure 28: Data collected for Node 49 between March 14, 2016 and March 22, 2016.

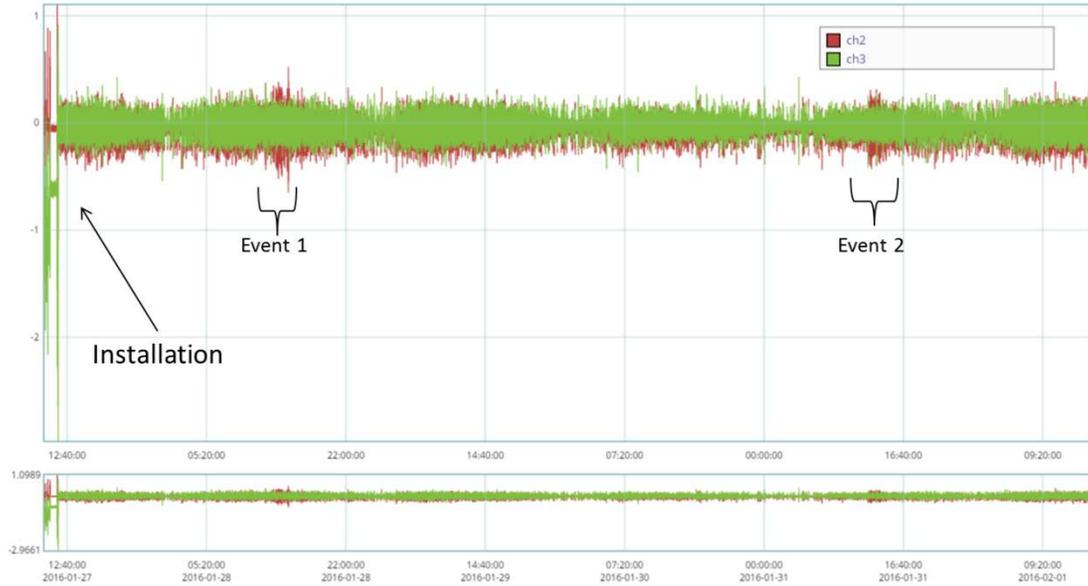
Figure 29: Data collected for Node 50 between January 27, 2016 and February 1, 2016.

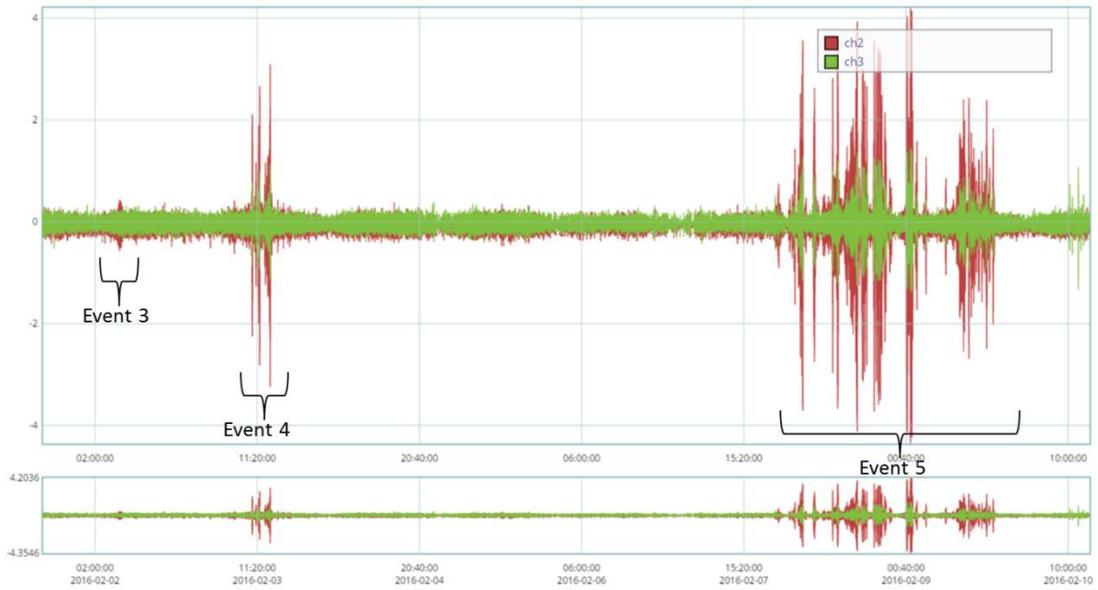
Figure 30: Data collected for Node 50 between February 1, 2016 and February 10, 2016.

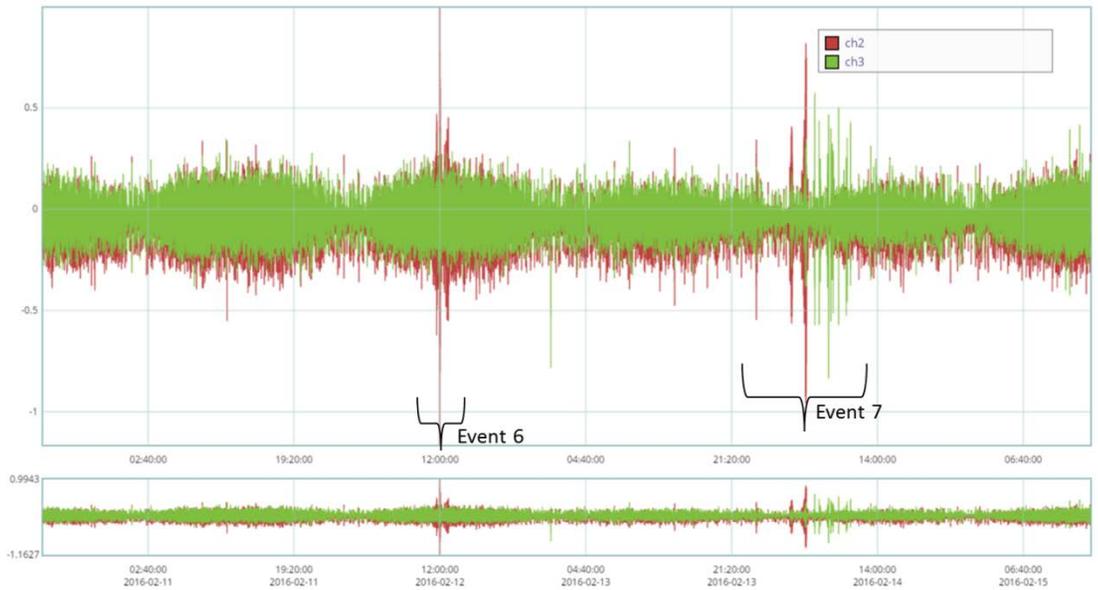
Figure 31: Data collected for Node 50 between February 10, 2016 and February 15, 2016.

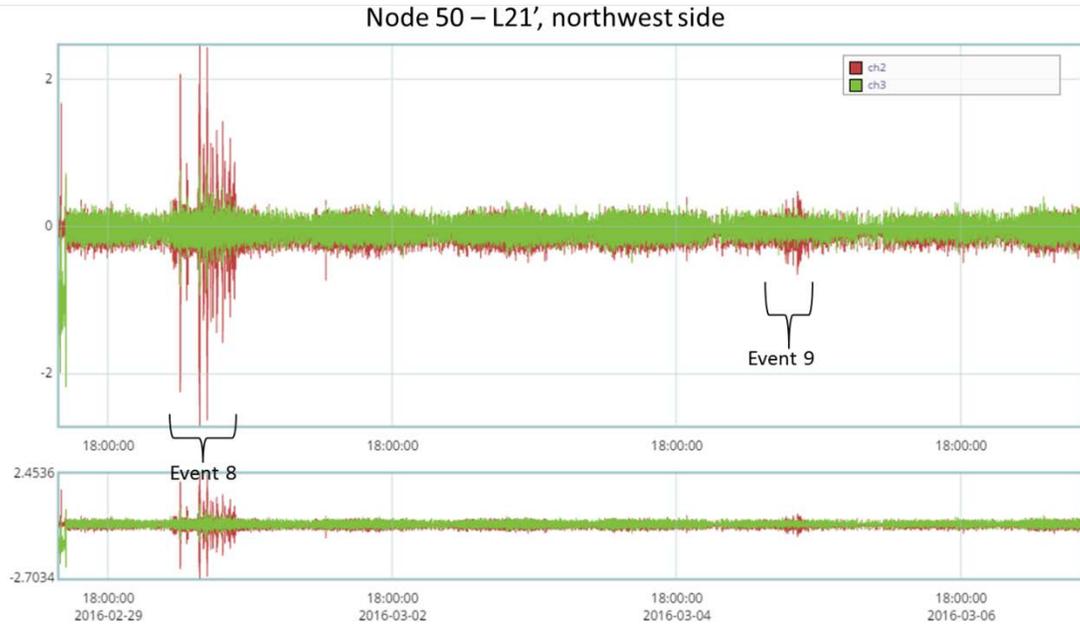
**Figure 32: Data collected for Node 50 between February 29, 2016 and March 7, 2016.**

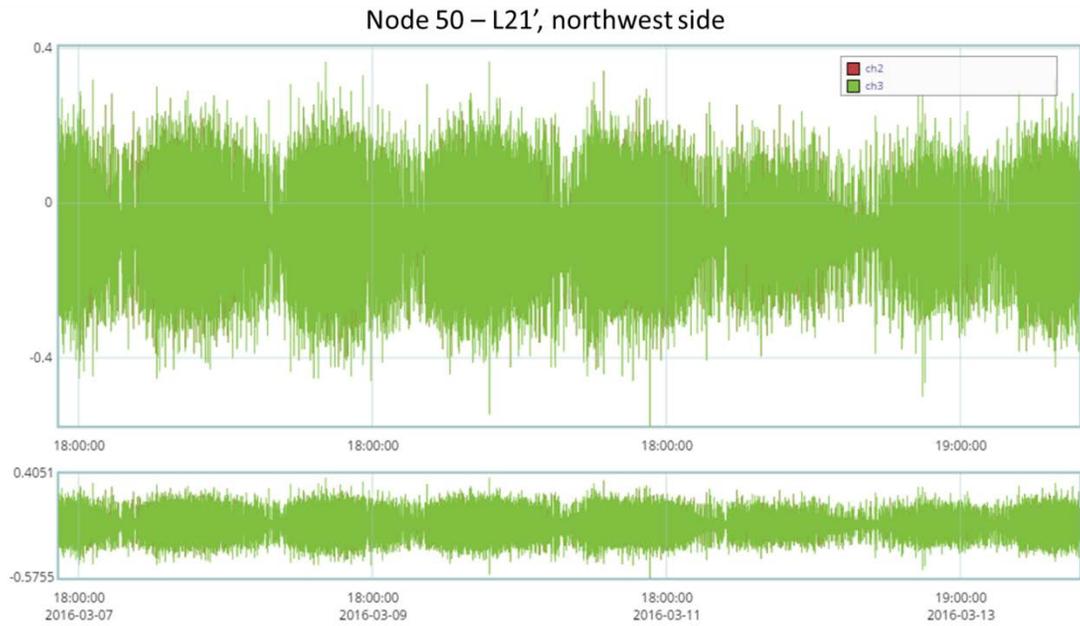
**Figure 33: Data collected for Node 50 between March 7, 2016 and March 14, 2016.**

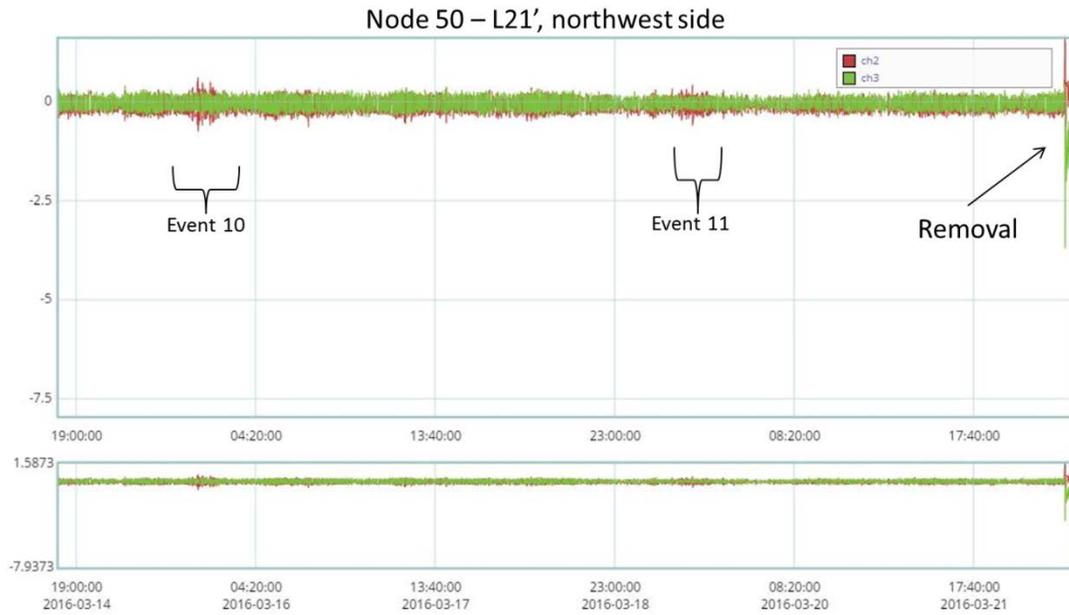
Figure 34: Data collected for Node 50 between March 14, 2016 and March 22, 2016.

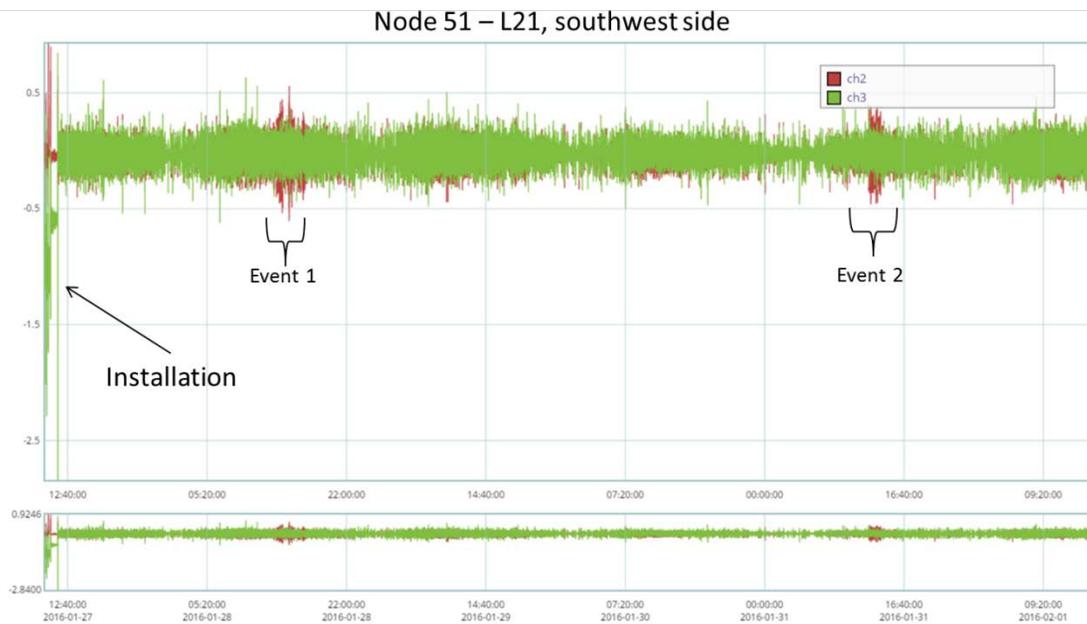
Figure 35: Data collected for Node 51 between January 27, 2016 and February 1, 2016.

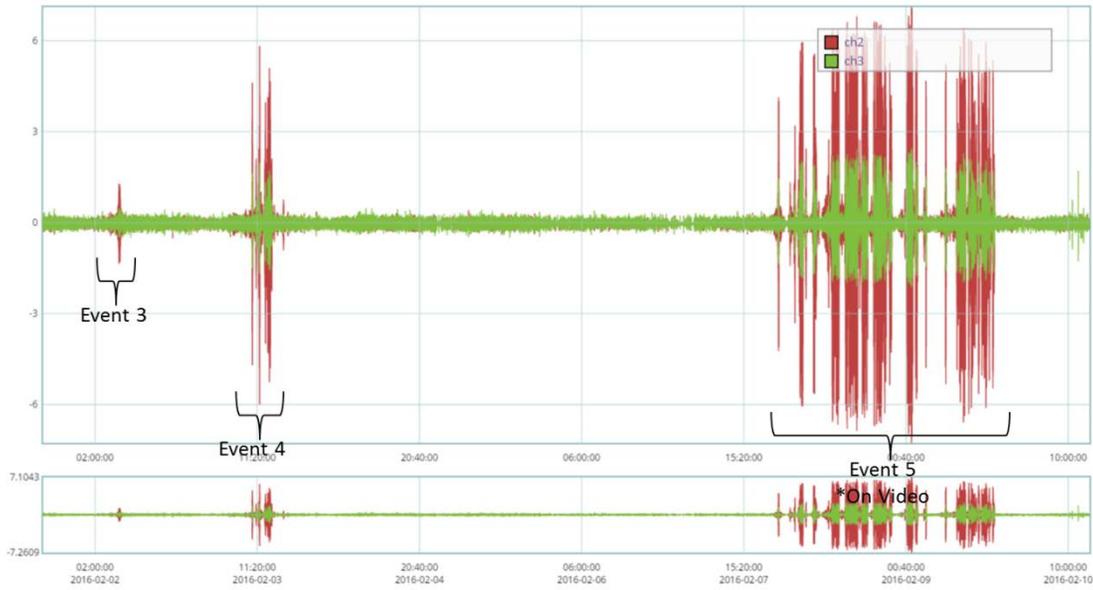
Figure 36: Data collected for Node 51 between February 1, 2016 and February 10, 2016.

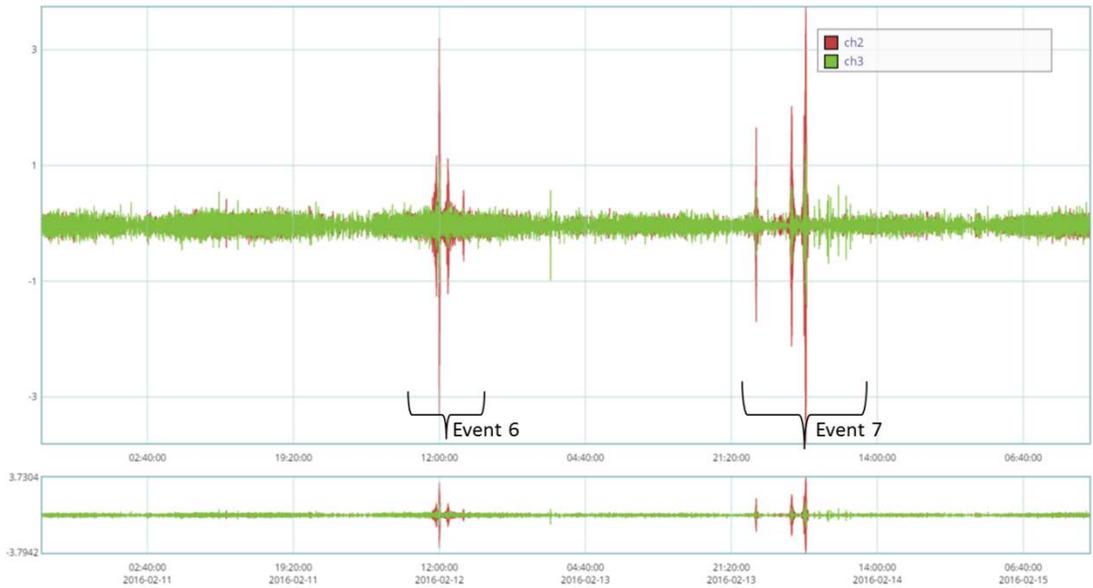
Figure 37: Data collected for Node 51 between February 10, 2016 and February 15, 2016.
