# Monitoring Vibrations on the Jefferson City Truss Bridge

Final Report Prepared for Missouri Department of Transportation  
May 2016

Project TR201605

Report cmr16-012

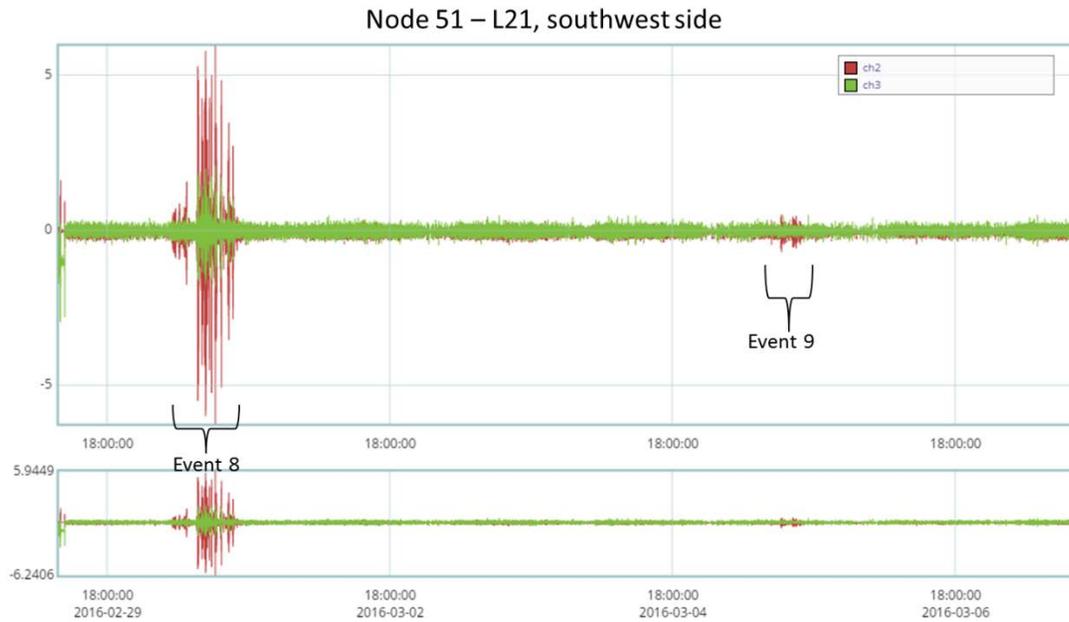
**Figure 38: Data collected for Node 51 between February 29, 2016 and March 7, 2016.**

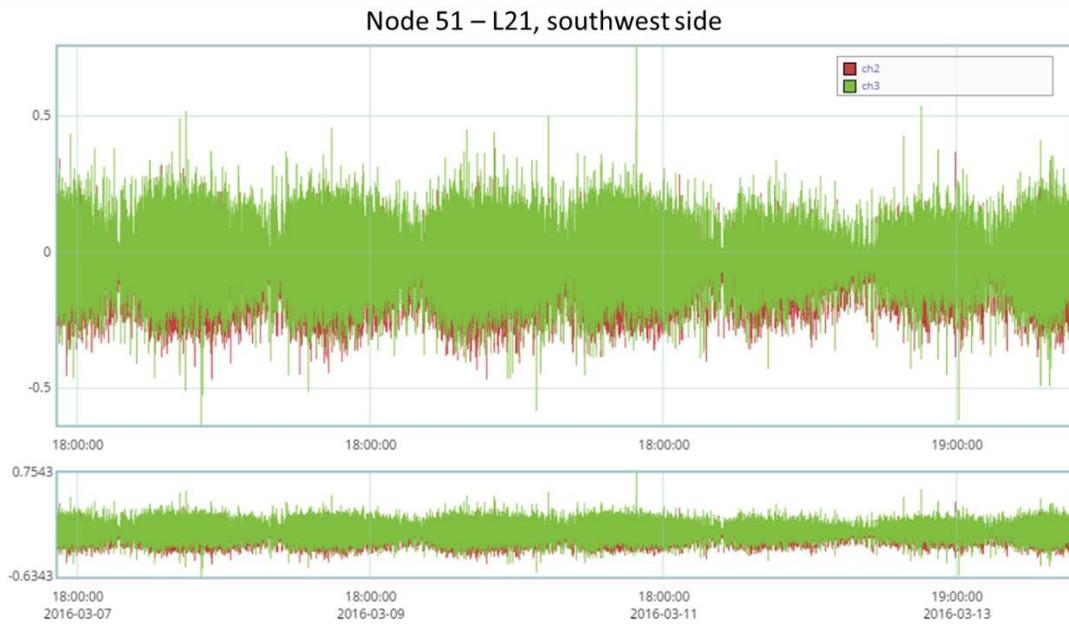
**Figure 39: Data collected for Node 51 between March 7, 2016 and March 14, 2016.**

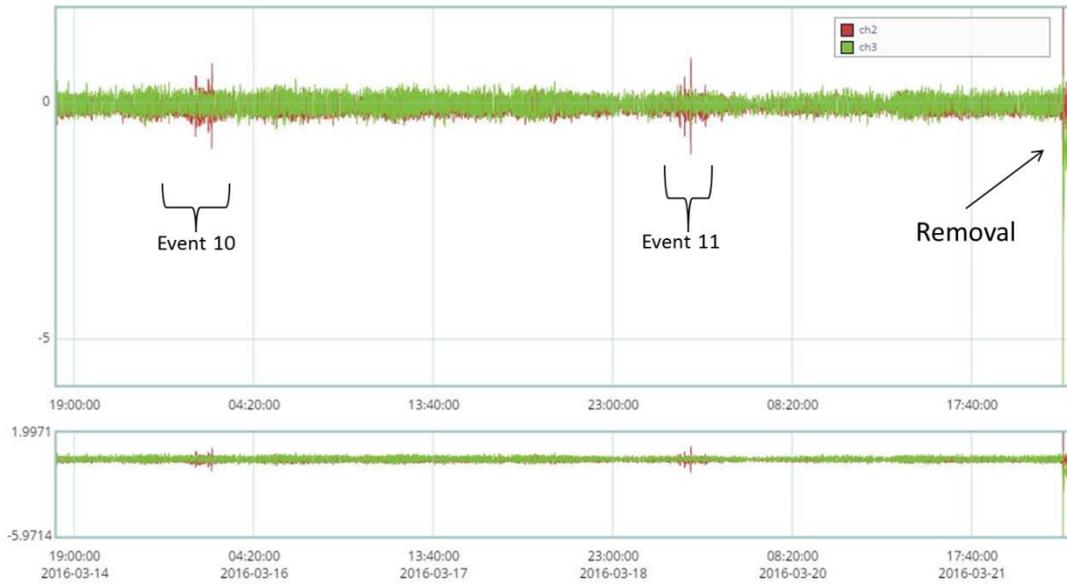
**Figure 40: Data collected for Node 51 between March 14, 2016 and March 22, 2016.**
