Historical & Photographic Documentation of the Lamine River Bridge

Bridge No. K0236
Cooper County, Route 41

Historic Documentation
Bridge K0236, Highway 41 across the Lamine River
Cooper County, Missouri
MoDOT Job Number J5S2197

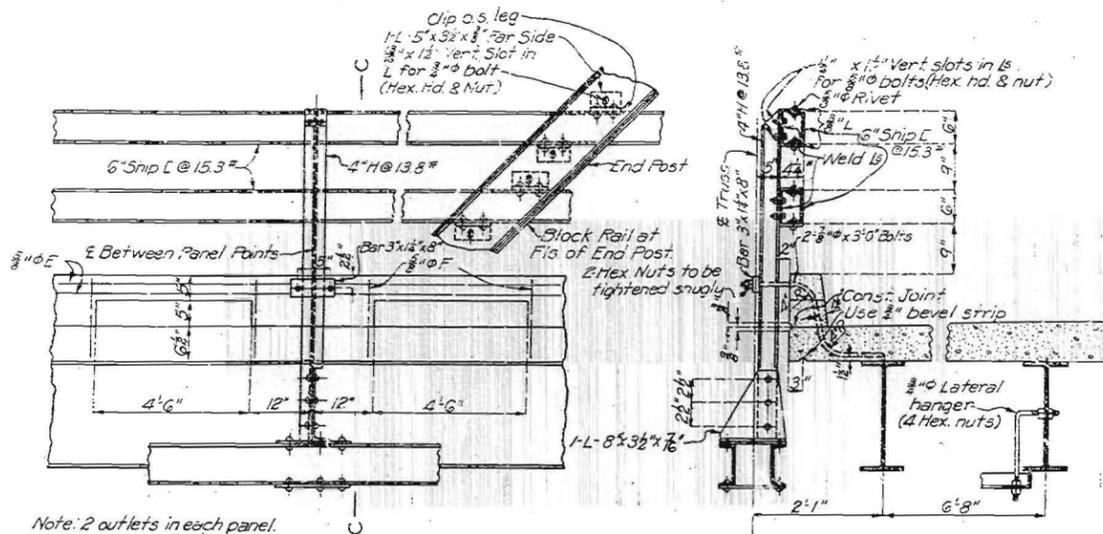
PART ELEVATION OF HANDRAIL & OUTLETS

Note: 2 outlets in each panel.

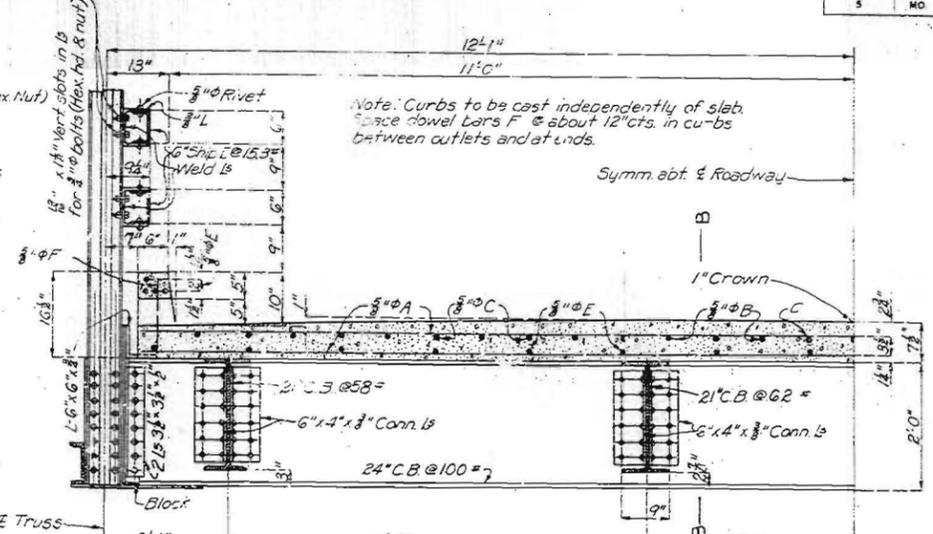
HALF TRANSVERSE SECTION A-A

Note: Channel rail to be adjusted for horizontal alignment by use of full size metal shims placed between rail support and the rail connection angles. Shims of 3/8" and 1/2" thickness to be furnished with structural steel. Cost of shims to be included in price bid for other items.

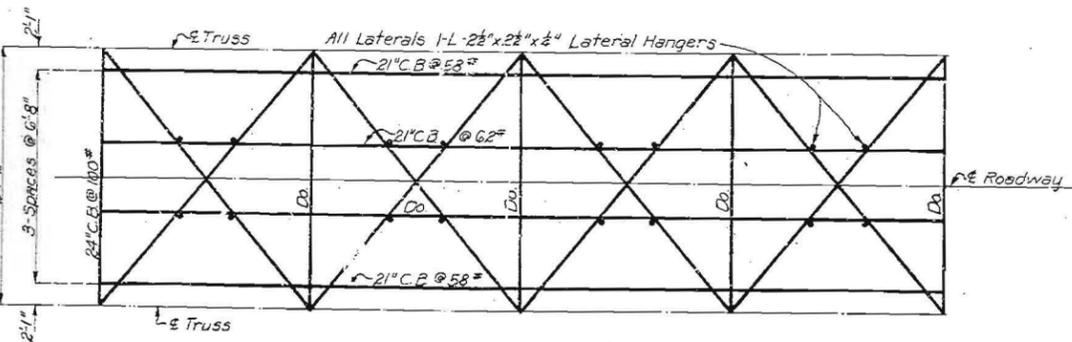
80' TRUSS

Note: For General Notes see Sheet No. 1. Rivets 3/4", Holes 1/2" unless otherwise noted. For details of shoes see Std. S-207. Details of truss similar to those shown on Std. S-880.

Similar problems arose with span 3, one of the 80 foot pony truss approach spans. In that case additional false work was added during construction to raise the panel points to achieve an acceptable camber prior to riveting.²⁸

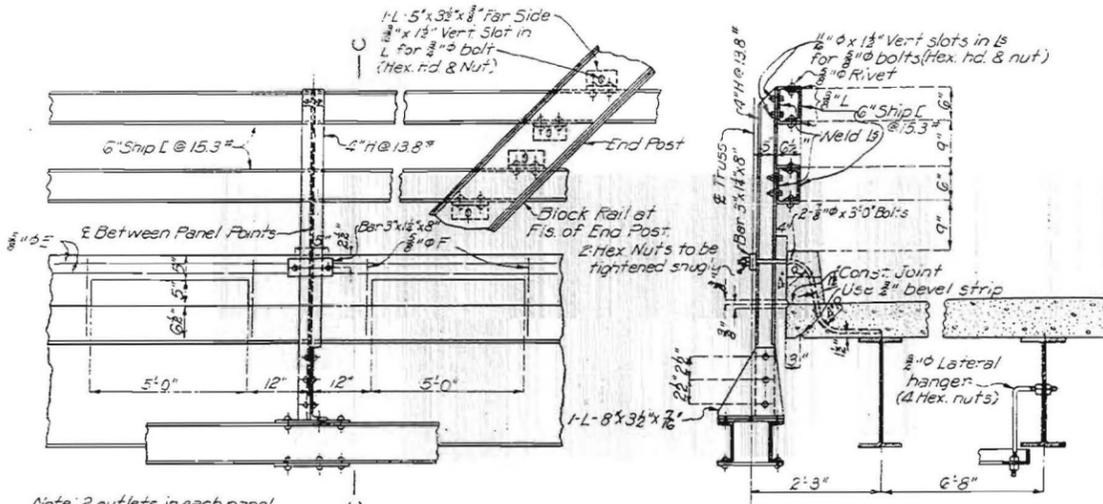
PART ELEVATION OF HANDRAIL & OUTLETS

Note: 2 outlets in each panel.

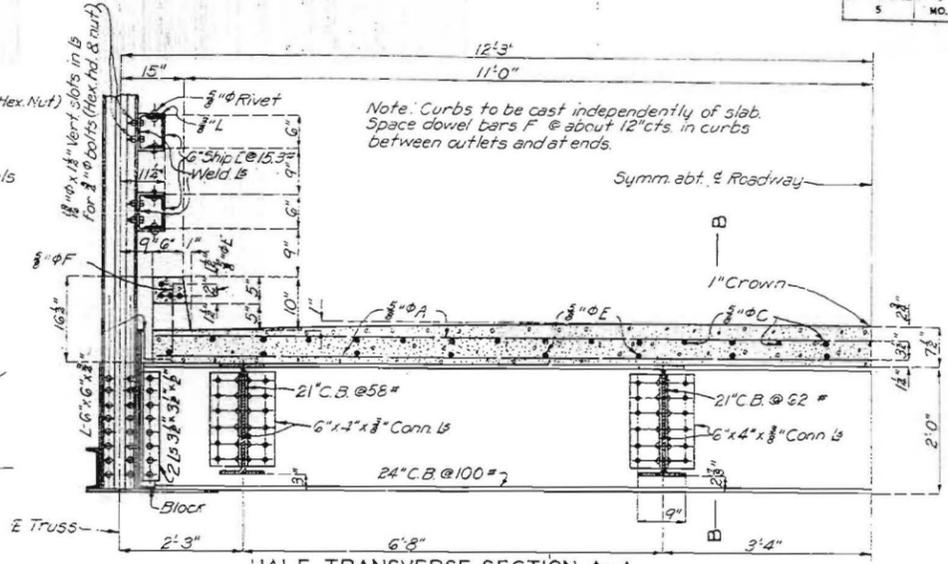
HALF TRANSVERSE SECTION A-A

Note: Channel rail to be adjusted for horizontal alignment by use of full size metal shims placed between rail support and the rail connection angles. Shims of 1/8" and 1/4" thickness to be furnished with structural steel. Cost of shims to be included in price bid for other items.

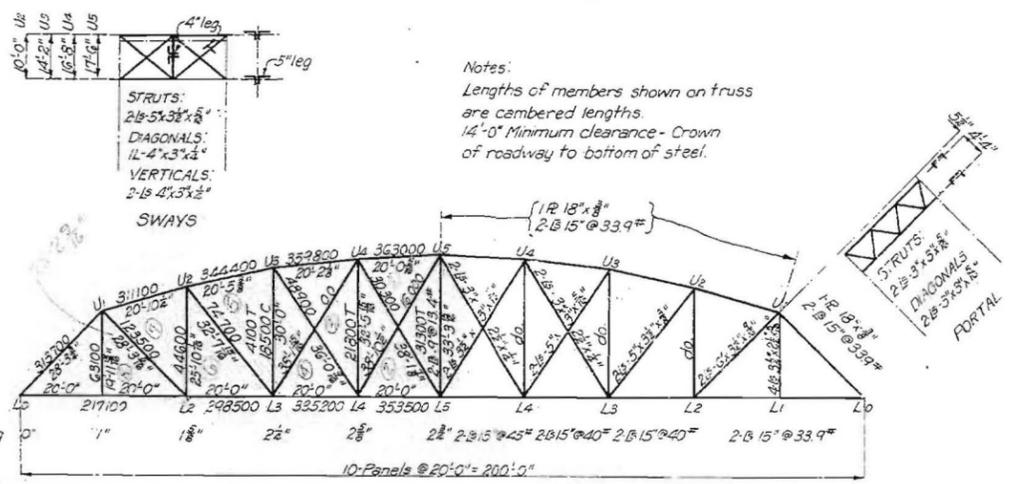
TRUSS

Note: For General Notes see Sheet No. 1. Rivets 3/8", Holes 1/2" unless otherwise noted. For details of shoes see Std. S-612. Details of trusses similar to those shown on Std. S-820C, except revise L4-L5 to take only 6 holes cut for net section Camber as shown on this sheet.

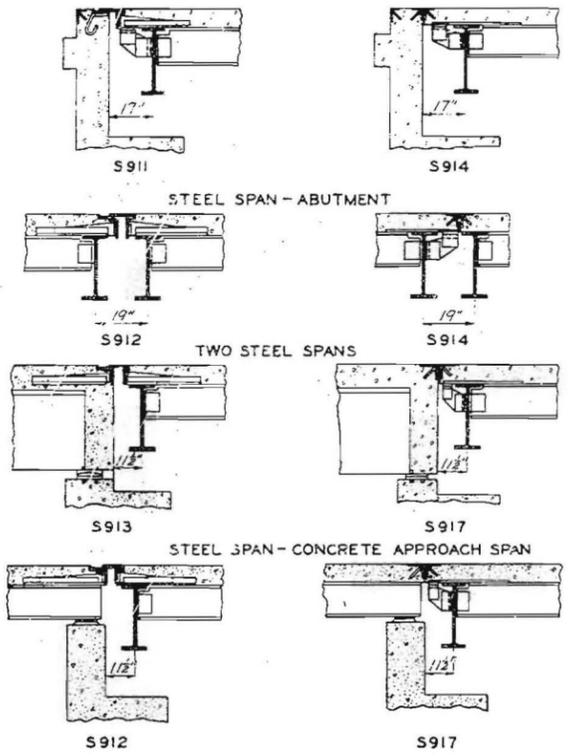
DETAILS OF SLAB ENDS

EXPANSION ENDS

FIXED ENDS

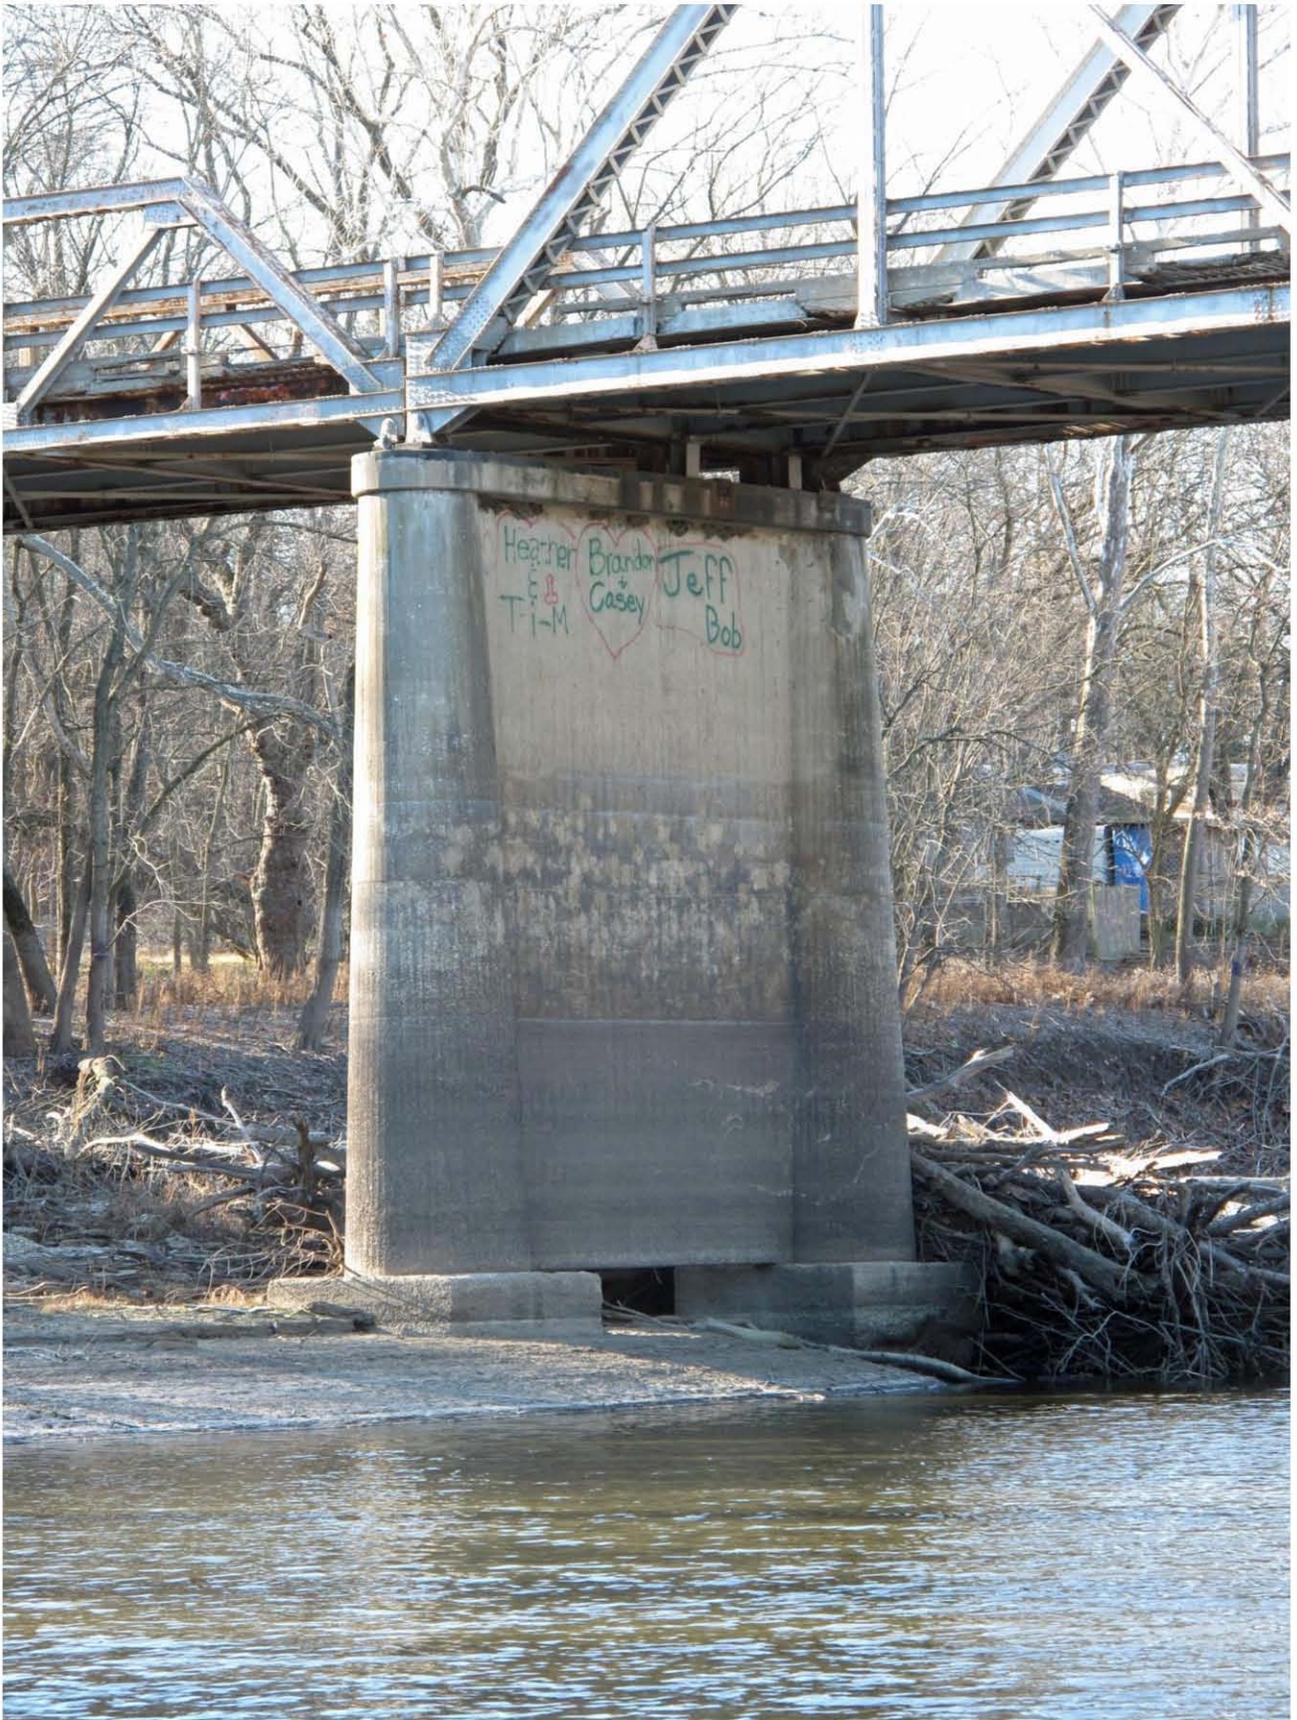
#5 of 24: Pier 4, facing southwest.

The biggest issue encountered while constructing the substructure of the bridge happened during the excavation for pier 4 in the river channel. On July 21 the steel truss of the original river crossing (which had been destroyed during the 1905 flood) was encountered. The debris had to be removed before excavation could continue for the pier.²⁴ There was considerable discussion between the State Highway Department and Carrothers & Crouch about who had responsibility to pay for removal of the old truss. The State Highway Department position was that the truss was not their responsibility, Carrothers & Crouch wanted to be paid for the labor involved in removing the obstruction. It took a week to resolve the differences and the State Highway Department agreed to pay a lump sum of \$1000 for removal of the debris, including compensation for future delays caused by the same.²⁵

The debris was removed on August 12 but there continued to be problems with the excavations for pier 4. The cofferdam for pier 4 was difficult to drive and broke several times, threatening to lose all the excavation work done.²⁶

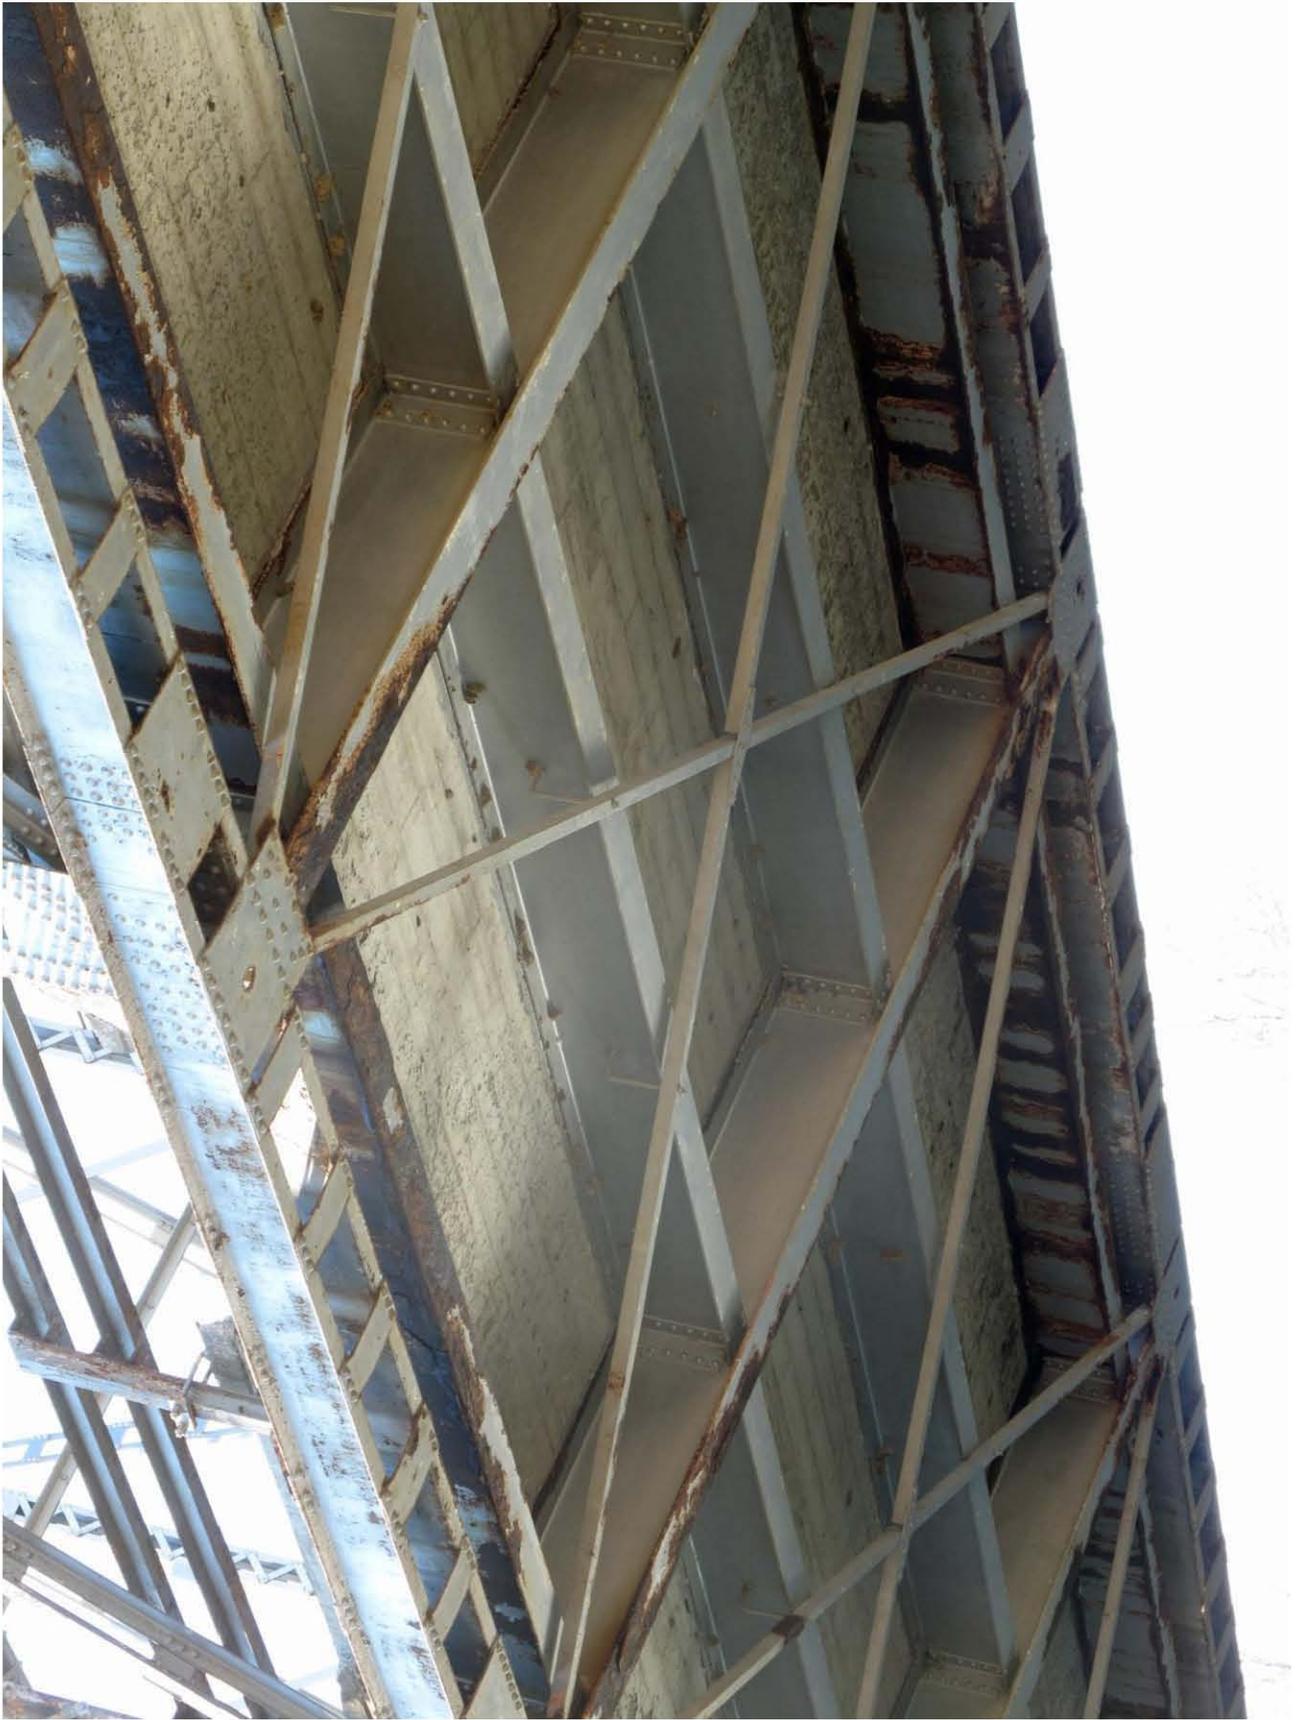
#7 of 24: Detail, underside of main span, facing west.

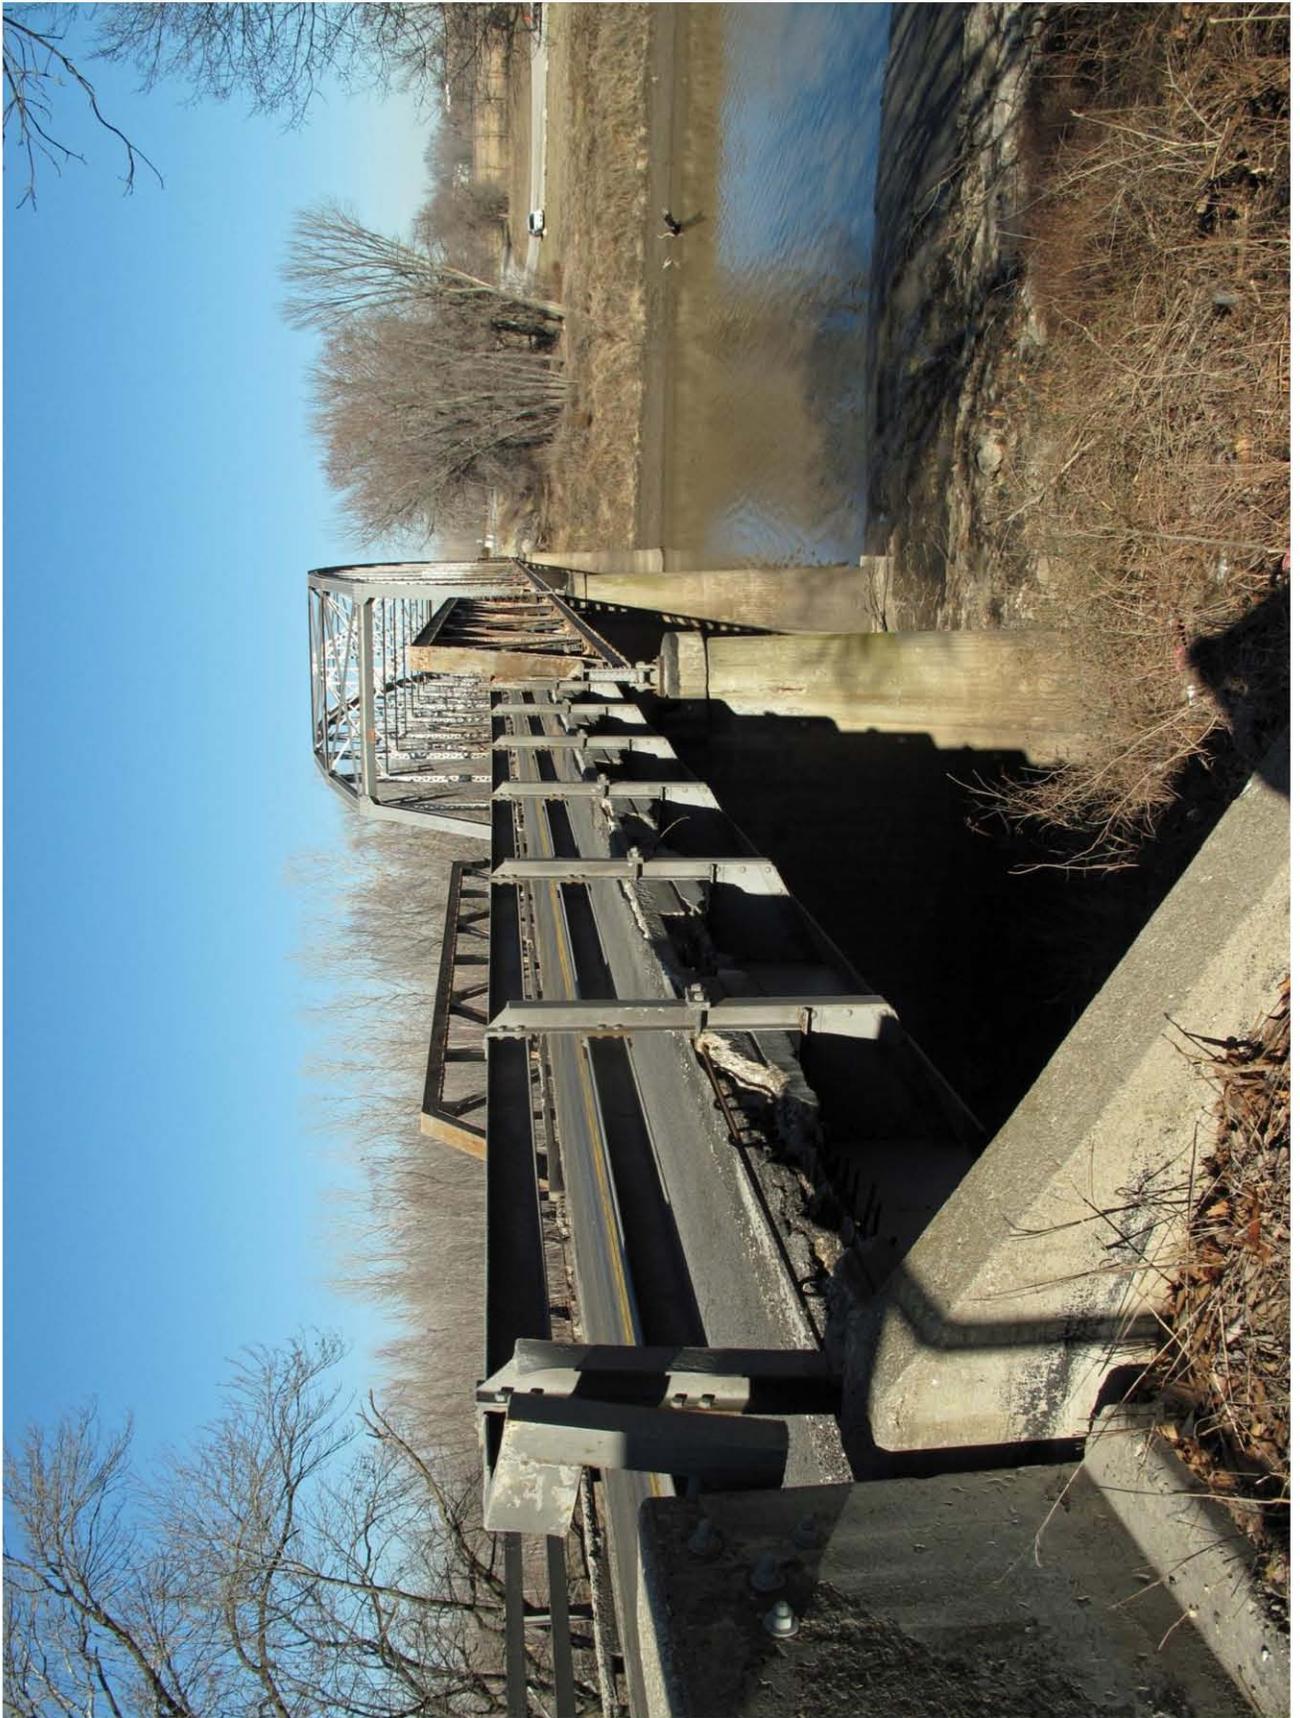
#18 of 24: Bottom chord, east side of span, facing north.

While the excavation was underway in Cooper County, the trusses had been fabricated by the St. Louis Structural Steel Company in Illinois and shipped to the job site. During an on-site inspection in August, it was discovered that the 200 foot truss was not meeting the camber requirements shown on the bridge plans. Company engineers worked with State Highway Department Bridge engineers to develop solutions to solve the problem. The problem was solved by changing the moving the rivet angels up three-quarters of an inch on the bottom chord of the truss.²⁷

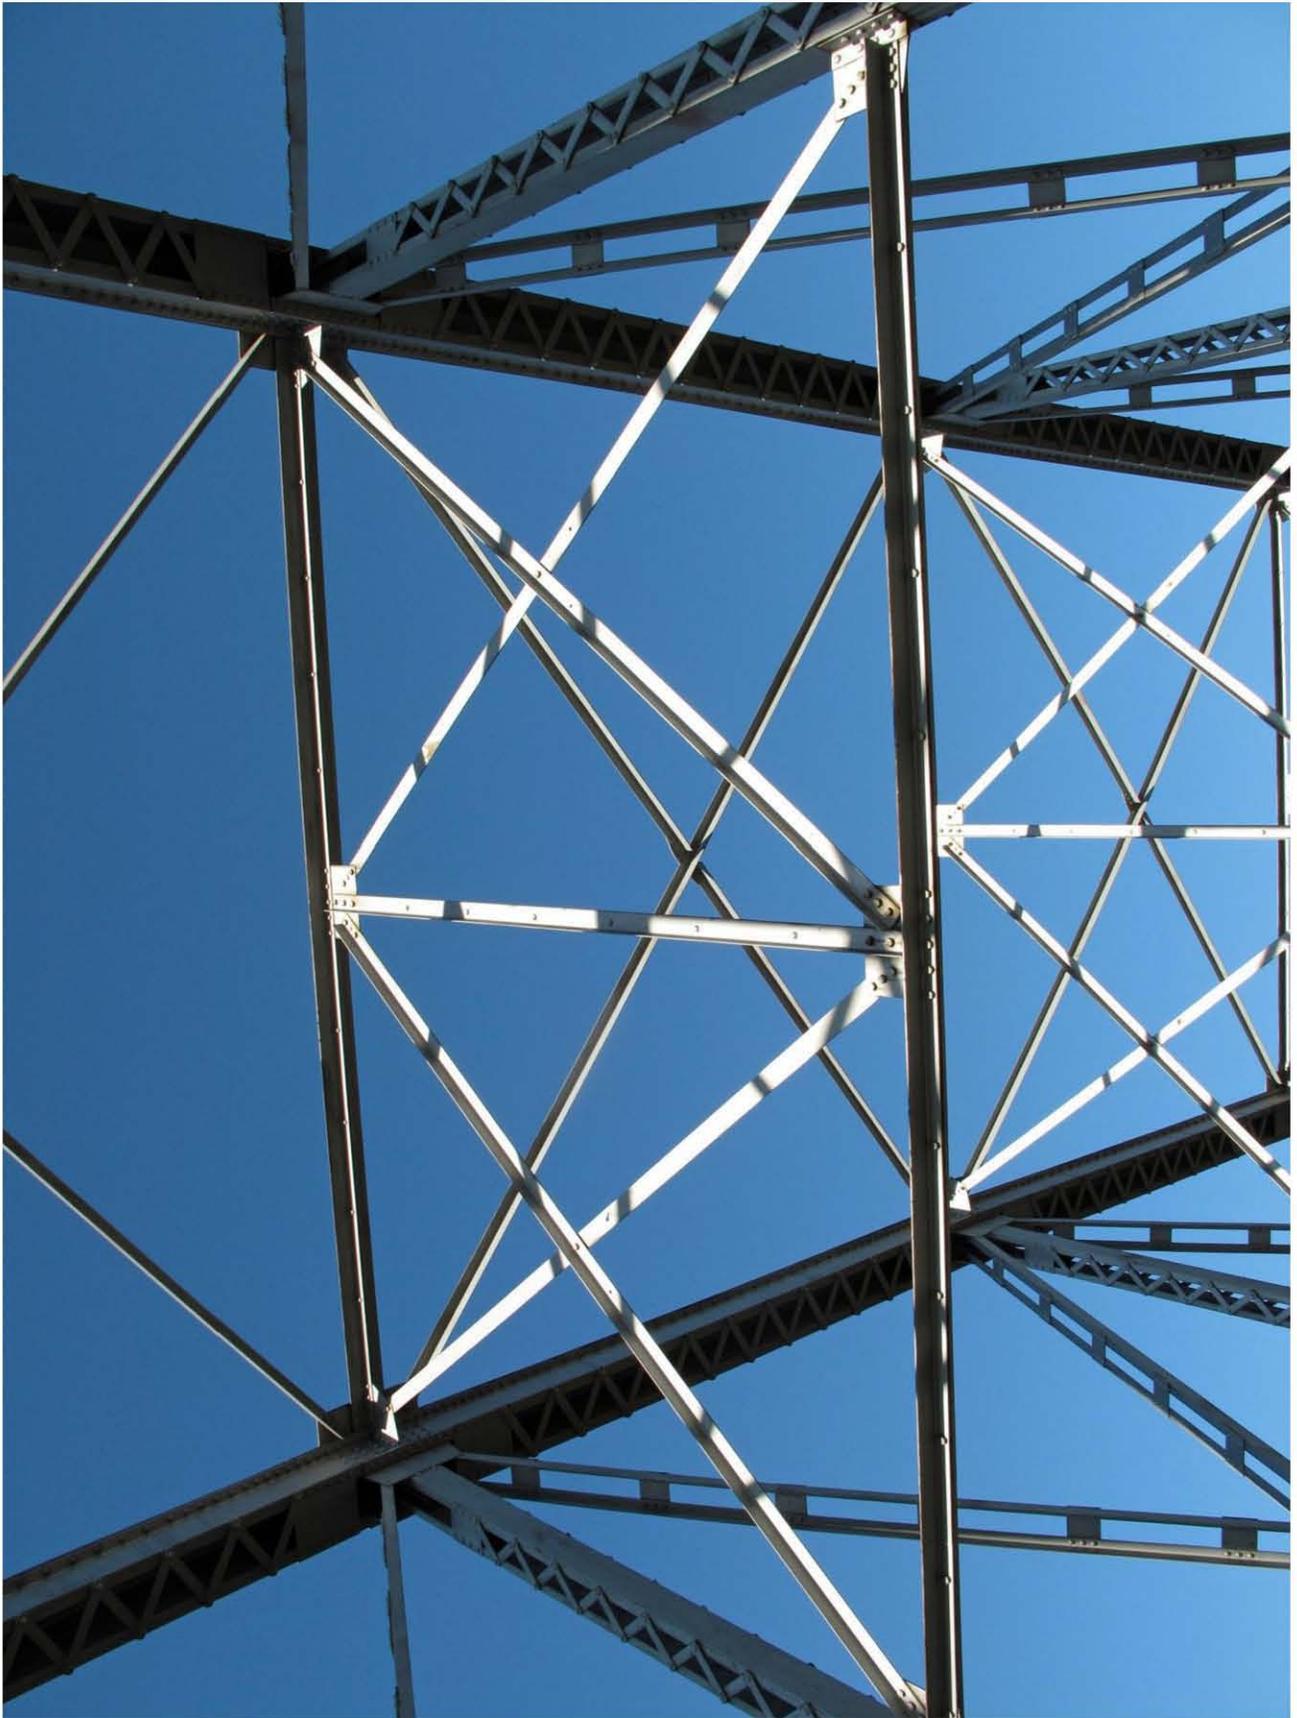
#20 of 24: Detail of top strut and sway bracing, facing north.

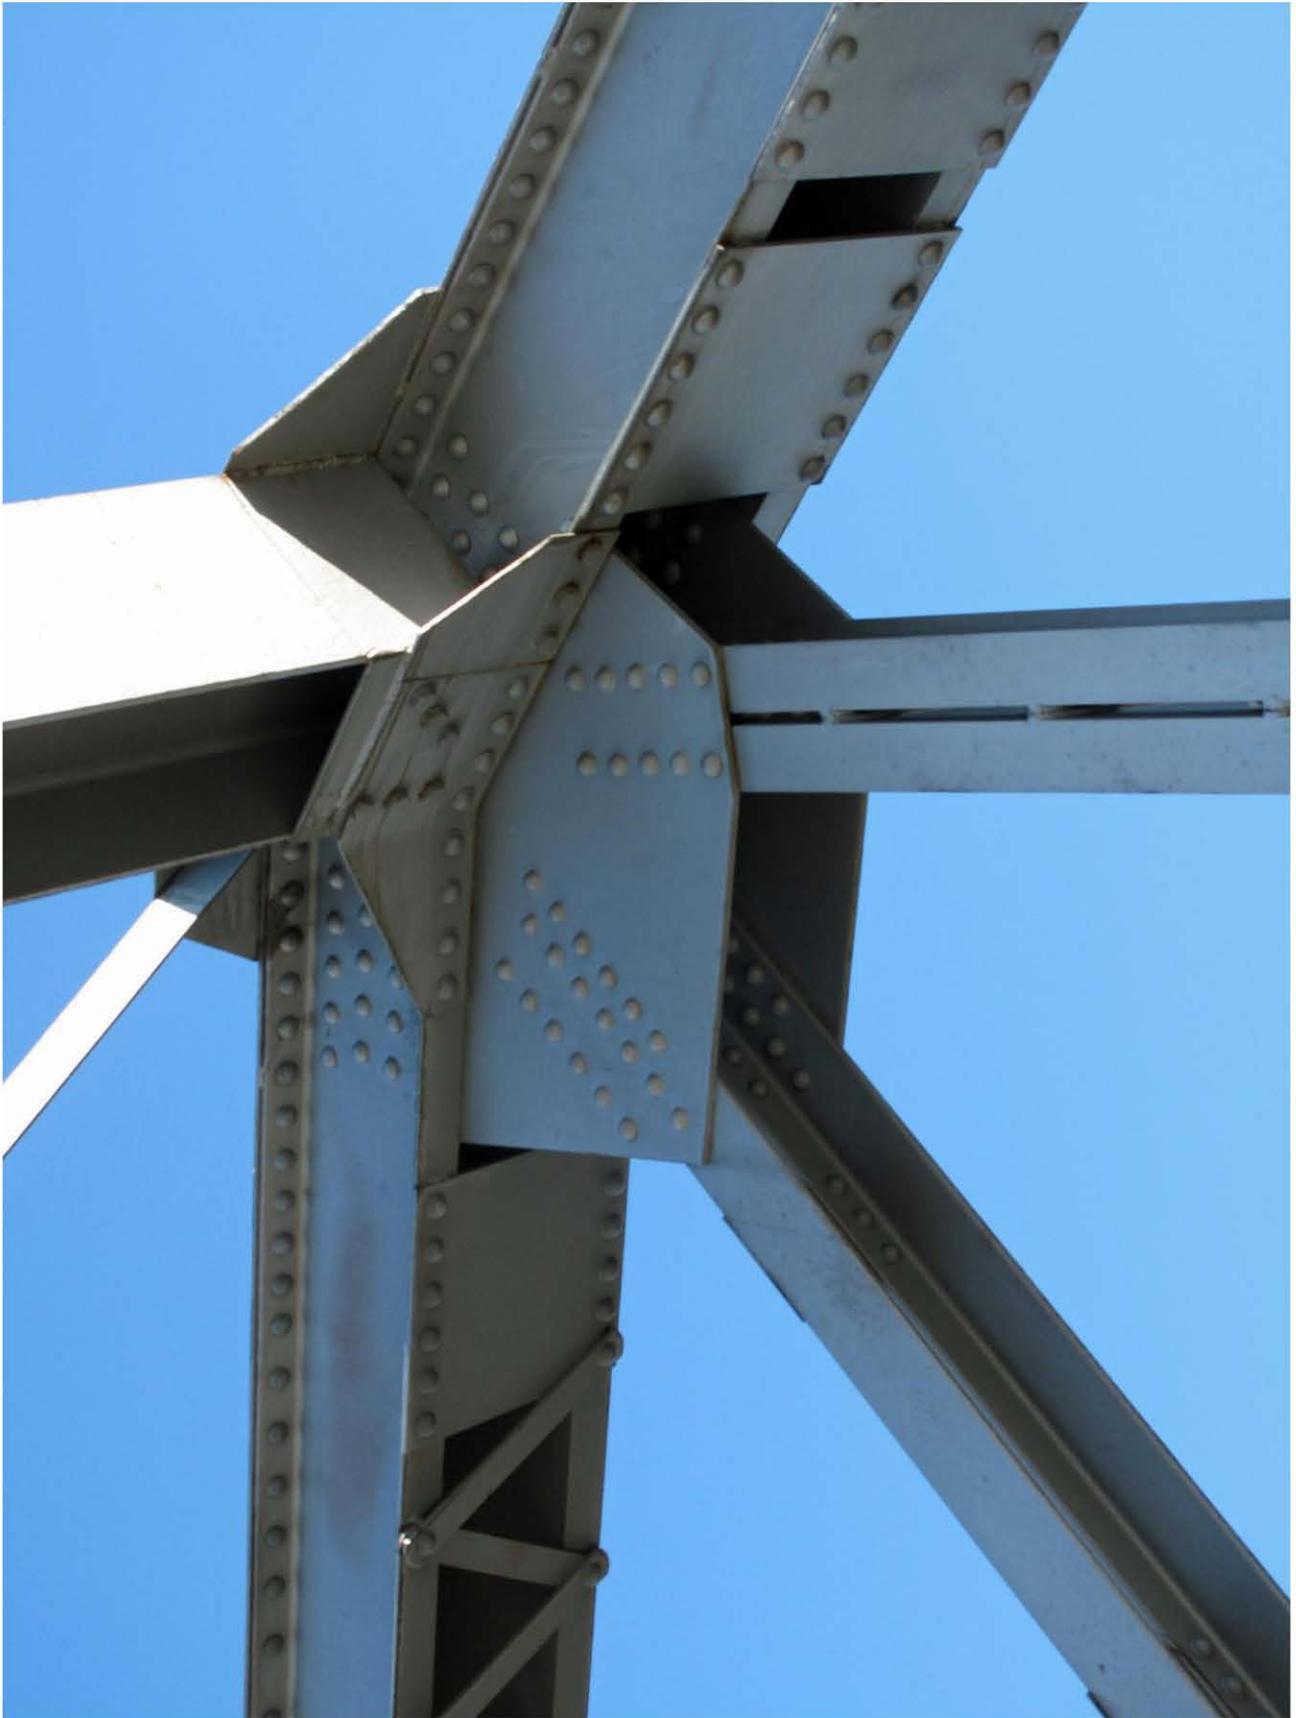
#21 of 24: Detail of connections of inclined end post, portal bracing and hip vertical, south portal, facing east.

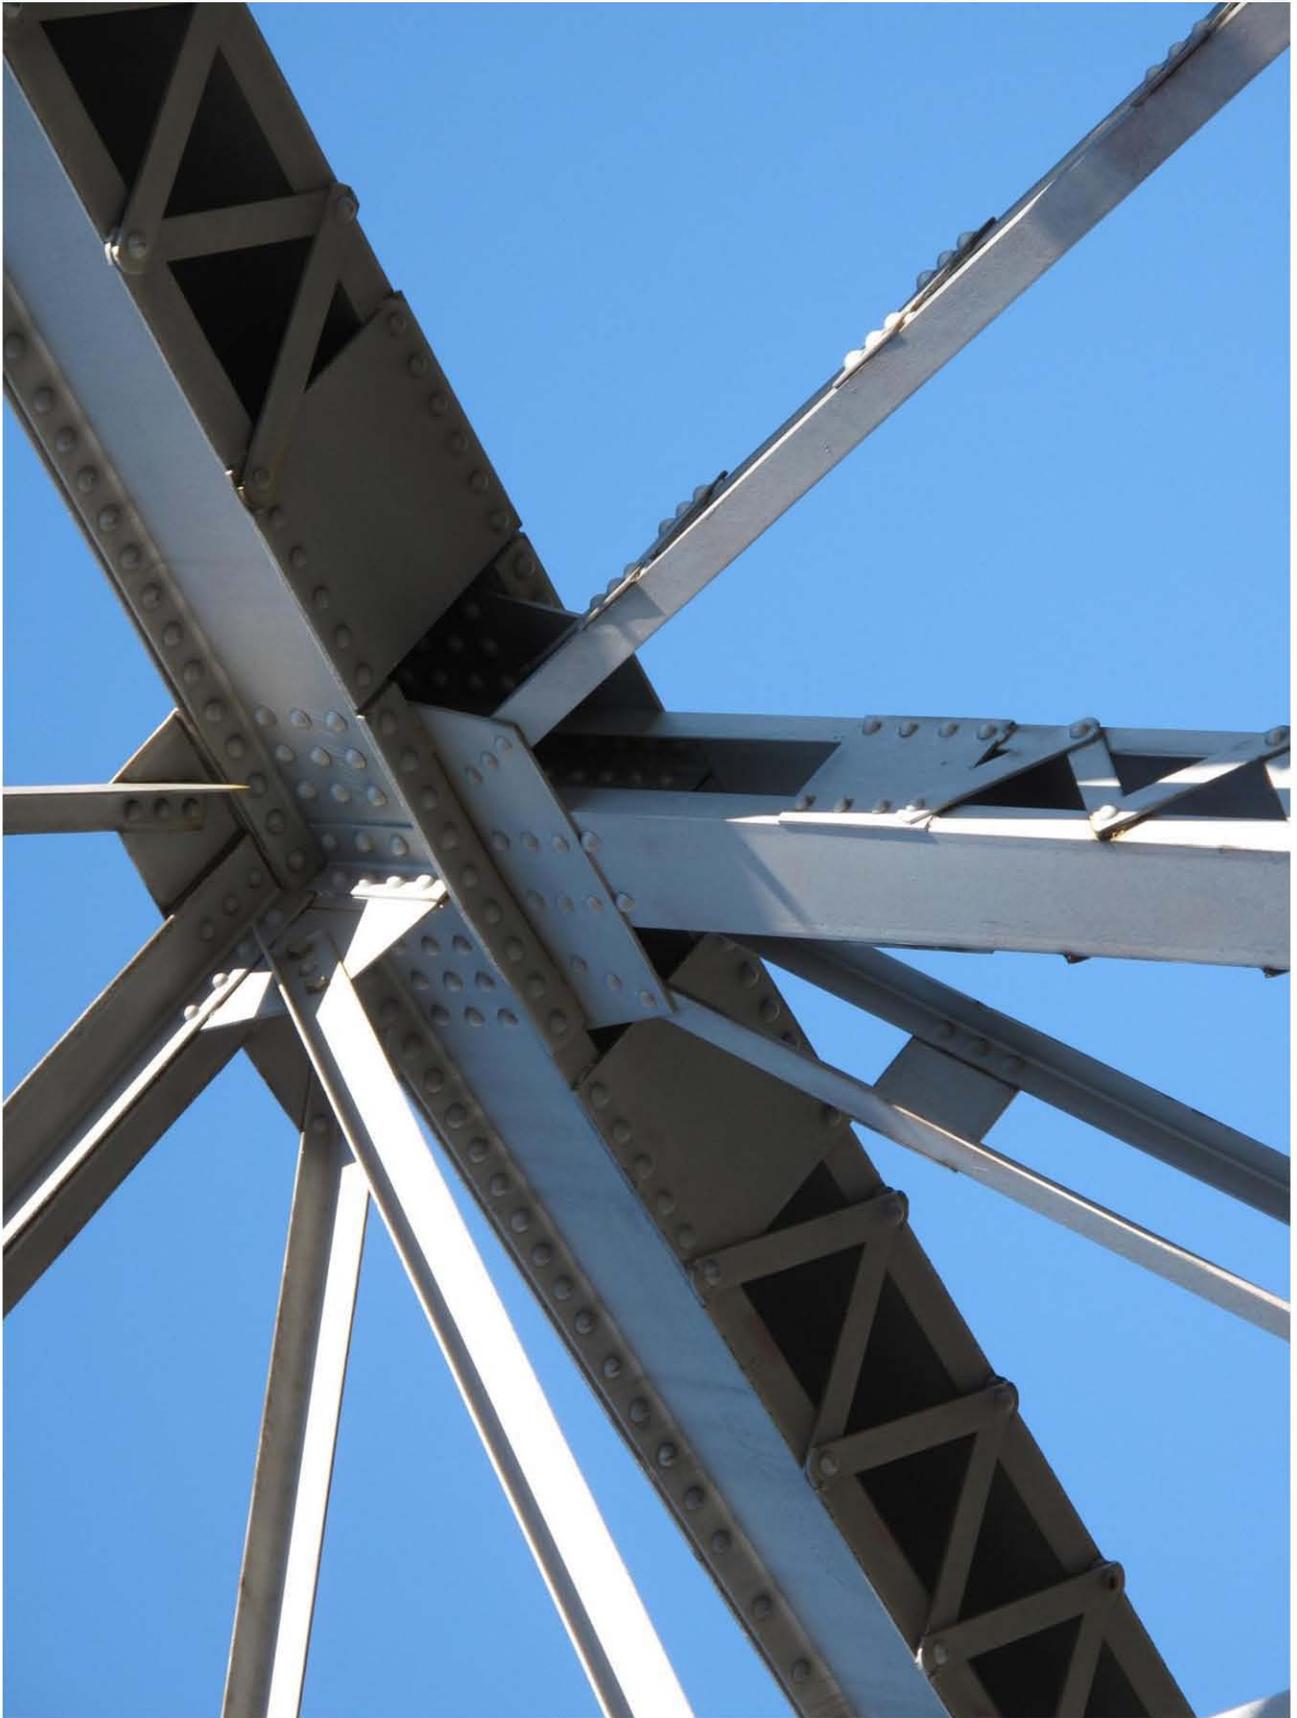
#22 of 24: Detail of connections of vertical post, diagonals, top chord, top lateral bracing and top struts.
