COOPERATIVE HIGHWAY RESEARCH PROGRAM
REPORT 71-4

INVESTIGATION OF PAINTS AND GLASS BEADS USED IN TRAFFIC DELINEATION MARKINGS

PHASE 2

MISSOURI STATE HIGHWAY DEPARTMENT
FEDERAL HIGHWAY ADMINISTRATION

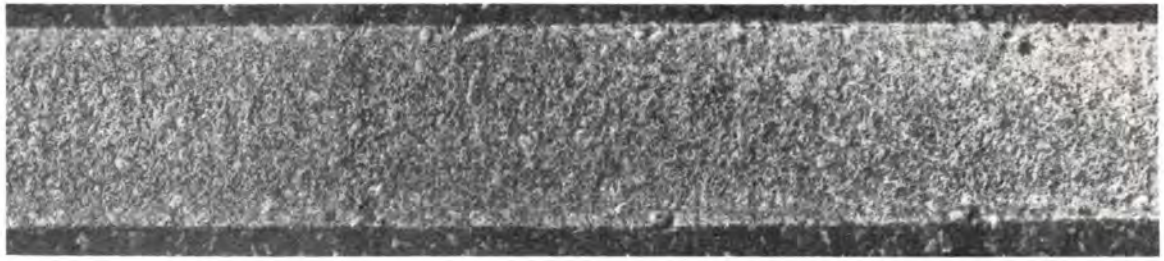
Figure 8a - Photographic Record of Missouri Dispersion Resin-Varnish, White, Paint on Asphaltic Concrete Pavement

Date: 10-14-70 Average Appearance Rating: 10.0

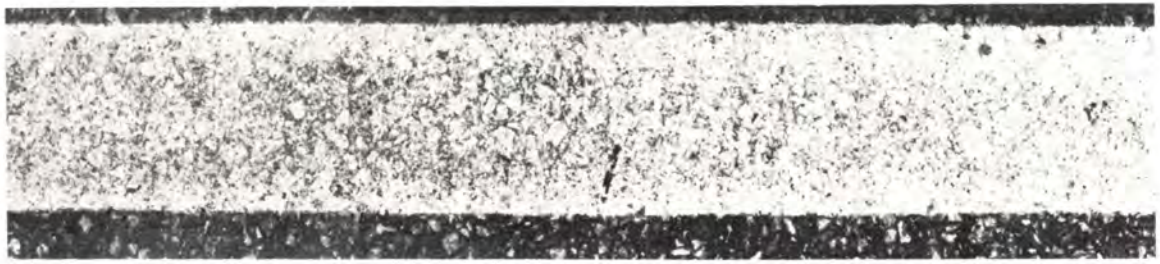
Date: 10-28-70 Average Appearance Rating: 7.7

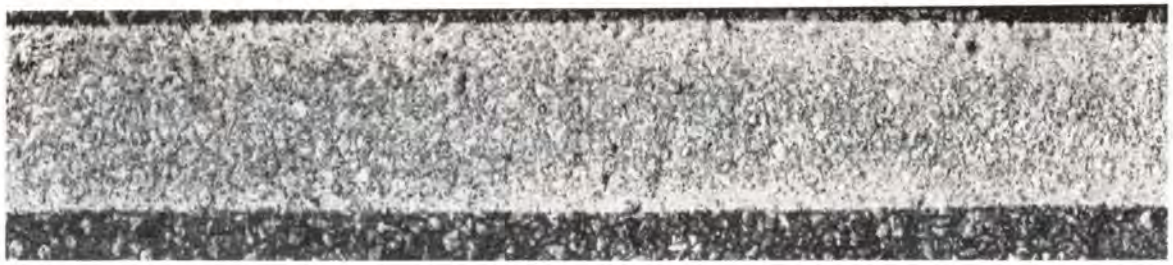
Date: 11-12-70 Average Appearance Rating: 6.1

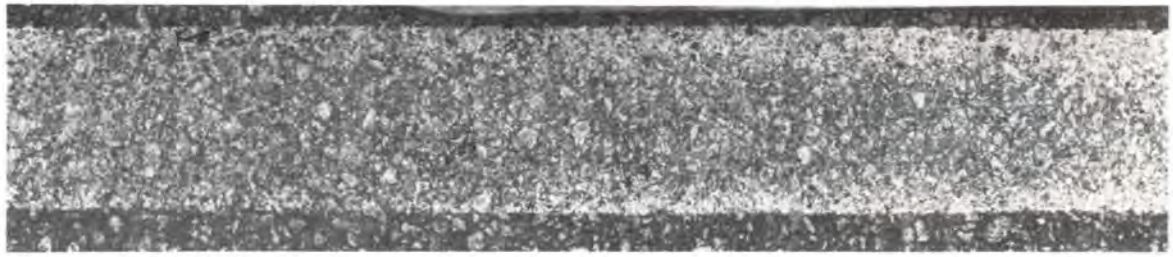
Date: 11-25-70 Average Appearance Rating: 6.0

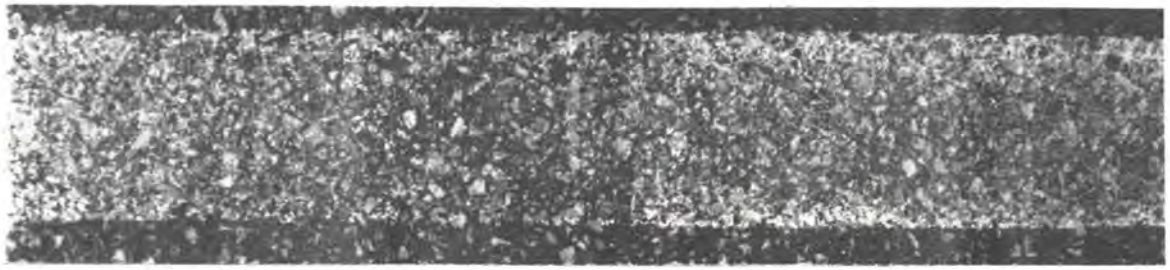
Date: 12-16-70 Average Appearance Rating: 4.0

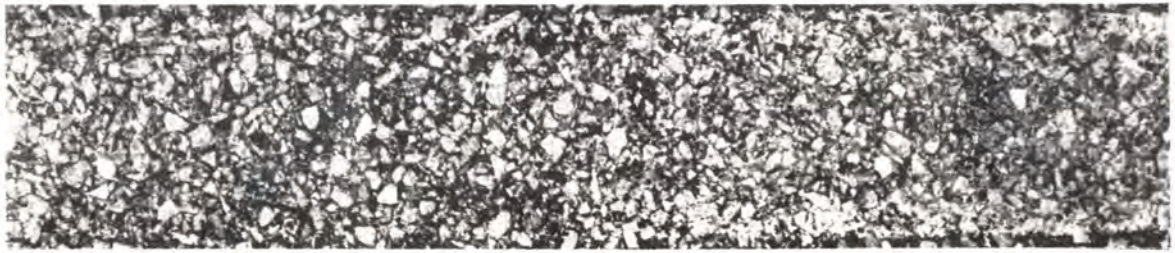
Date: 12-22-70 Average Appearance Rating: 2.7

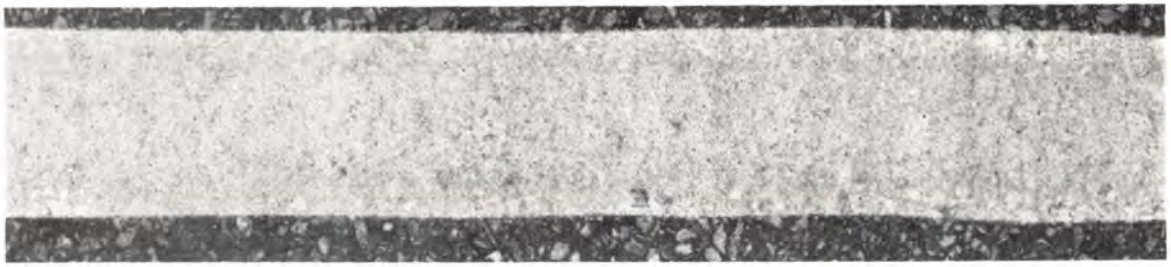
Figure 8b - Photographic Record of Missouri Chlorinated Rubber-Alkyd, White, Paint on Asphaltic Concrete Pavement

Date: 10-14-70 Average Appearance Rating: 9.2

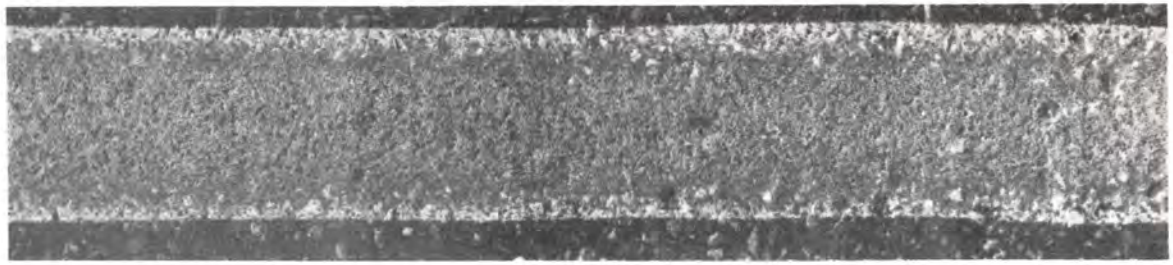
Date: 10-28-70 Average Appearance Rating: 7.8

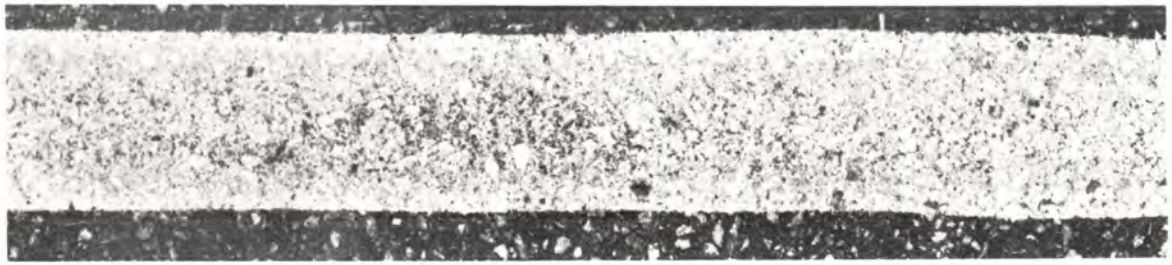
Date: 11-12-70 Average Appearance Rating: 5.8

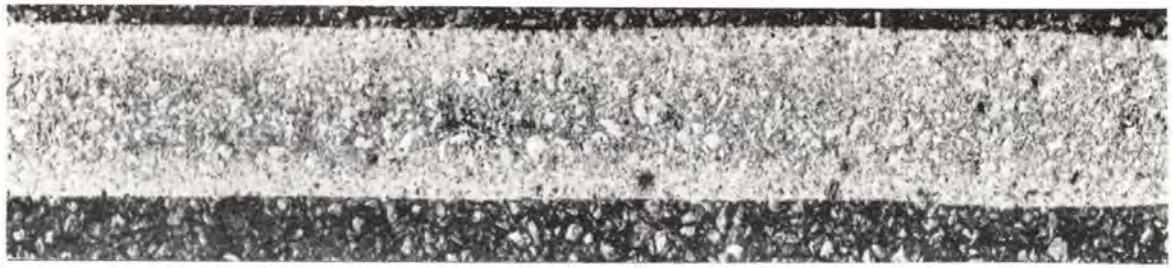
Date: 11-25-70 Average Appearance Rating: 7.3

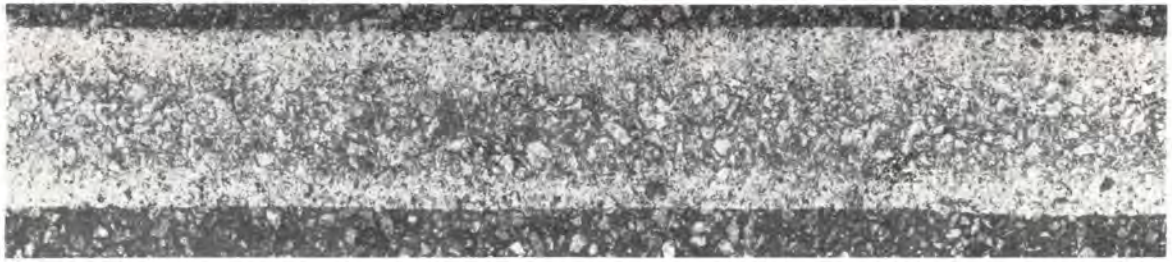
Date: 12-16-70 Average Appearance Rating: 6.6

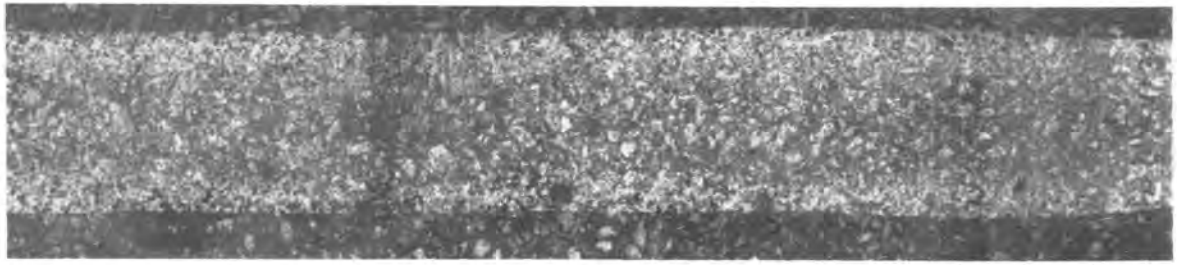
Date: 12-22-70 Average Appearance Rating: 5.0

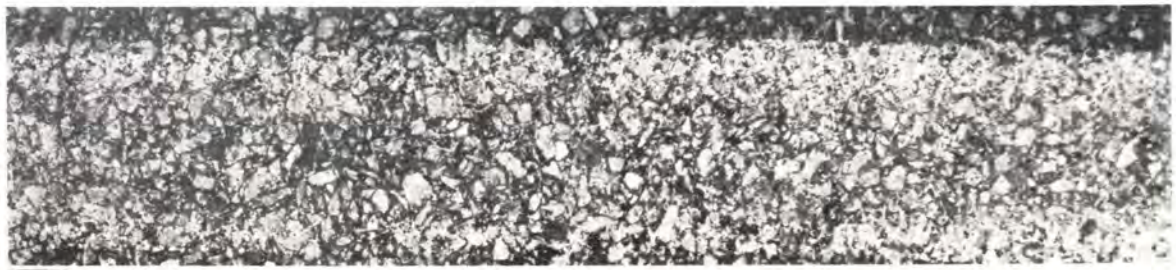
Date: 1-4-71 Average Appearance Rating: 2.4

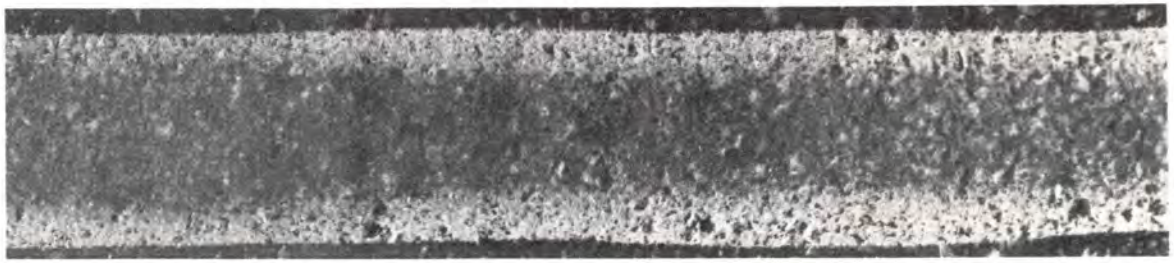
Figure 8c - Photographic Record of High Heat Paint Type "G", White, on Asphaltic Concrete Pavement

Date: 10-14-70 Average Appearance Rating: 8.8

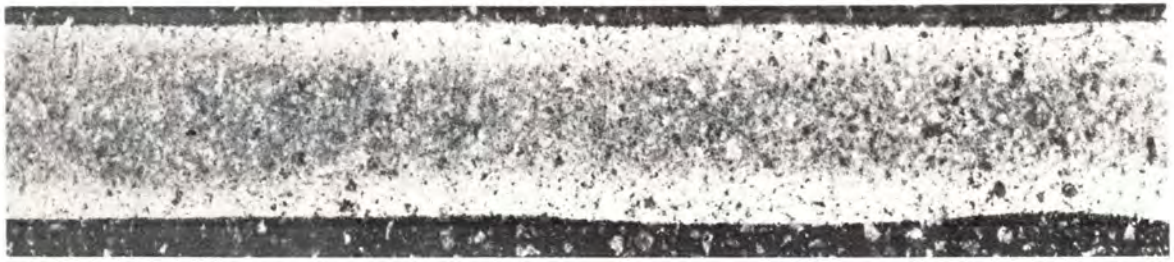
Date: 10-28-70 Average Appearance Rating: 8.0

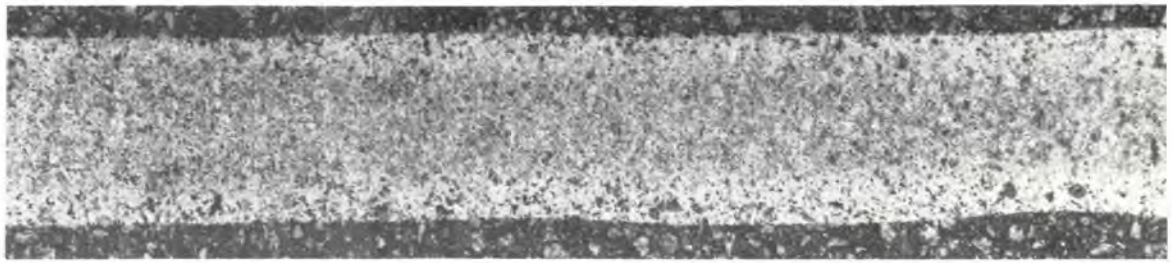
Date: 11-25-70 Average Appearance Rating: 7.0

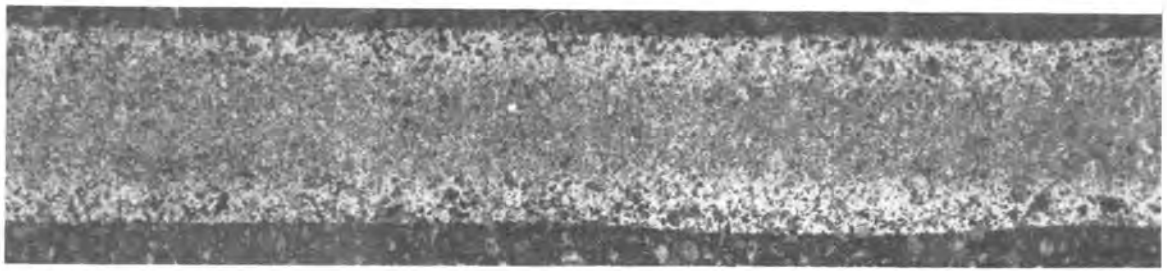
Date: 12-16-70 Average Appearance Rating: 6.0

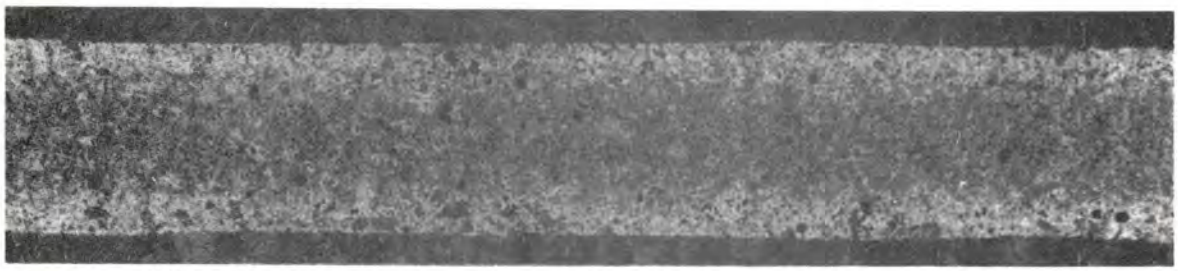
Figure 9a - Photographic Record of Missouri Dispersion Resin-Varnish, White, Paint on Concrete Pavement

Date: 10-14-70 Average Appearance Rating: 9.6

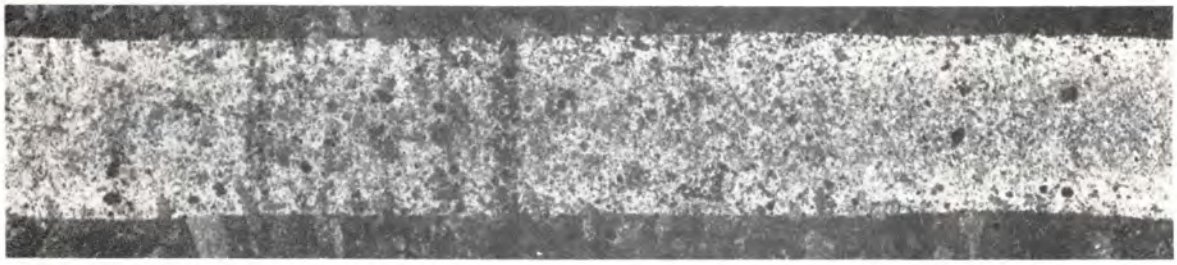
Date: 10-28-70 Average Appearance Rating: 6.9

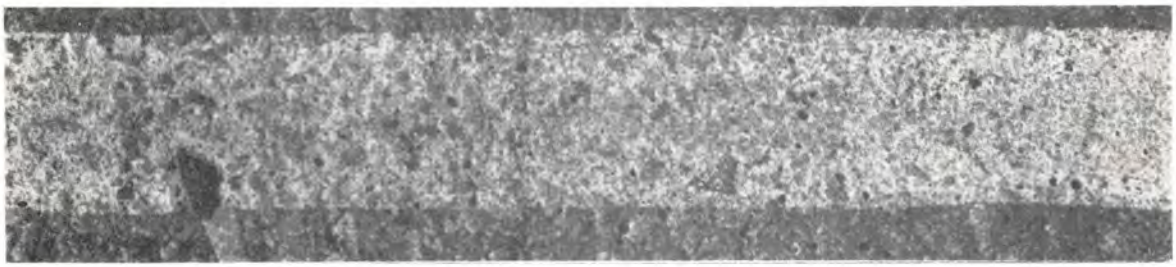
Date: 11-12-70 Average Appearance Rating: 3.3

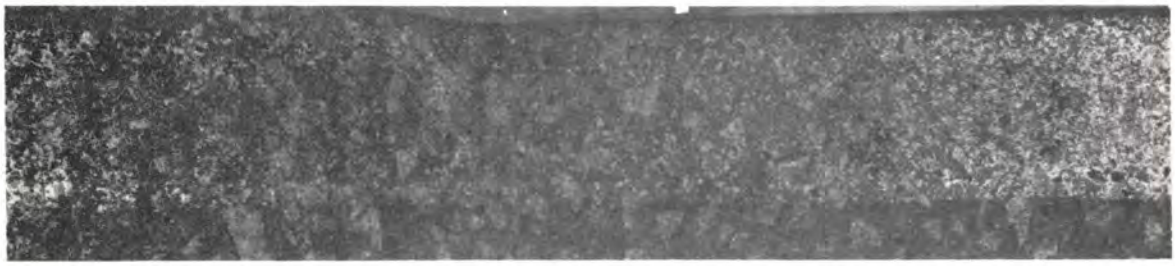
Date: 11-25-70 Average Appearance Rating: 1.0

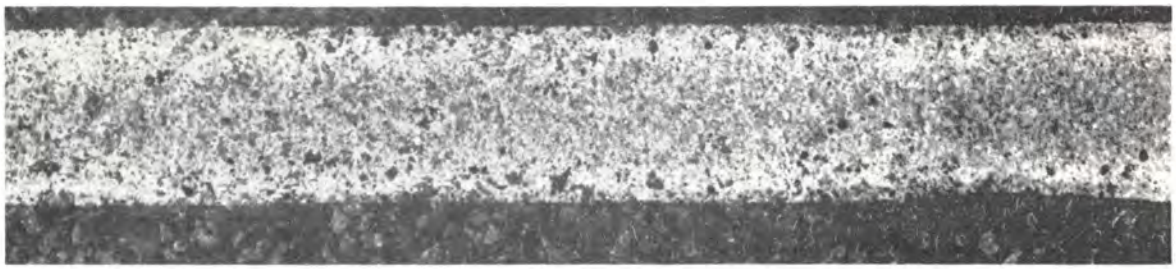
Figure 9b - Photographic Record of Missouri Chlorinated Rubber-Alkyd, White, Paint on Concrete Pavement

Date: 10-28-70 Average Appearance Rating: 6.2

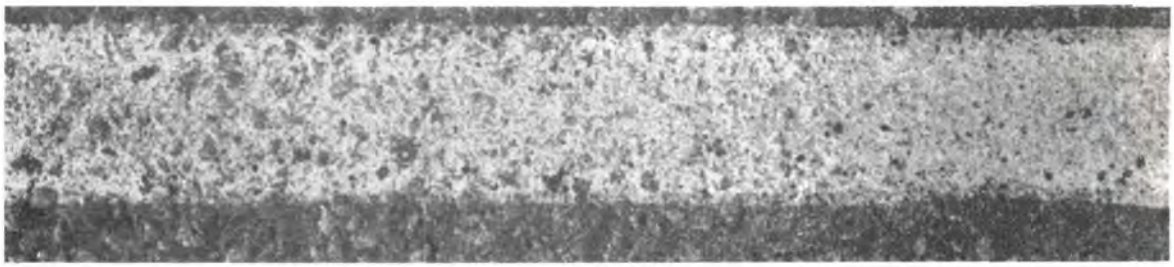
Date: 11-12-70 Average Appearance Rating: 3.8

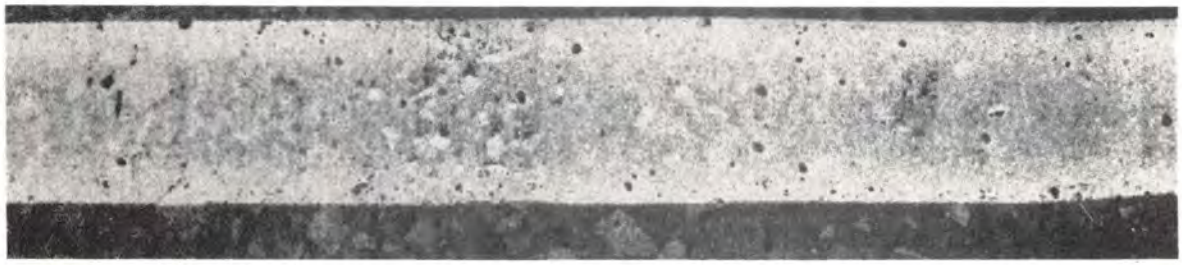
Figure 9c - Photographic Record of High Heat Paint Type "G", White, on Concrete Pavement

Date: 10-14-70 Average Appearance Rating: 9.0

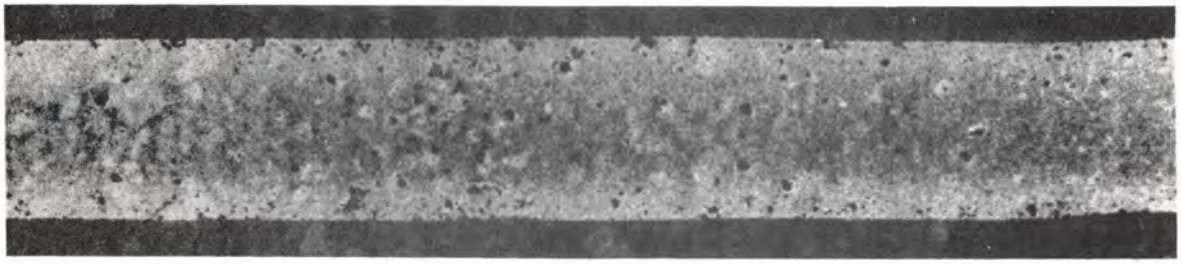
Date: 10-28-70 Average Appearance Rating: 7.2

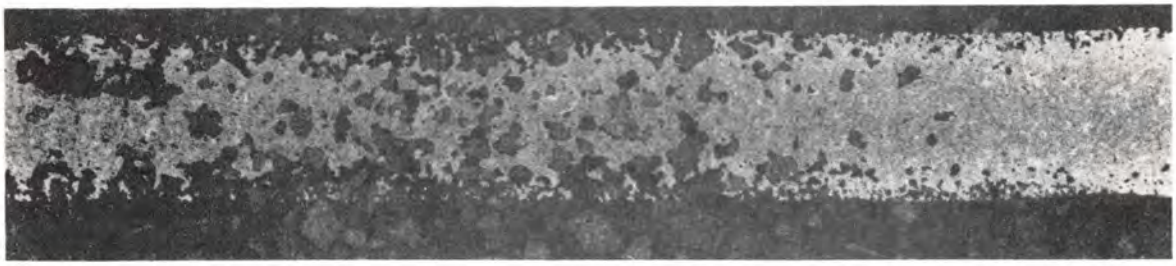
Date: 12-16-70 Average Appearance Rating: 2.8
