REPAIR AND STRENGTHENING OF IMPACTED PC GIRDERS ON BRIDGE A-4845

JACKSON COUNTY, MO

Final Report

Project No. RI01-016

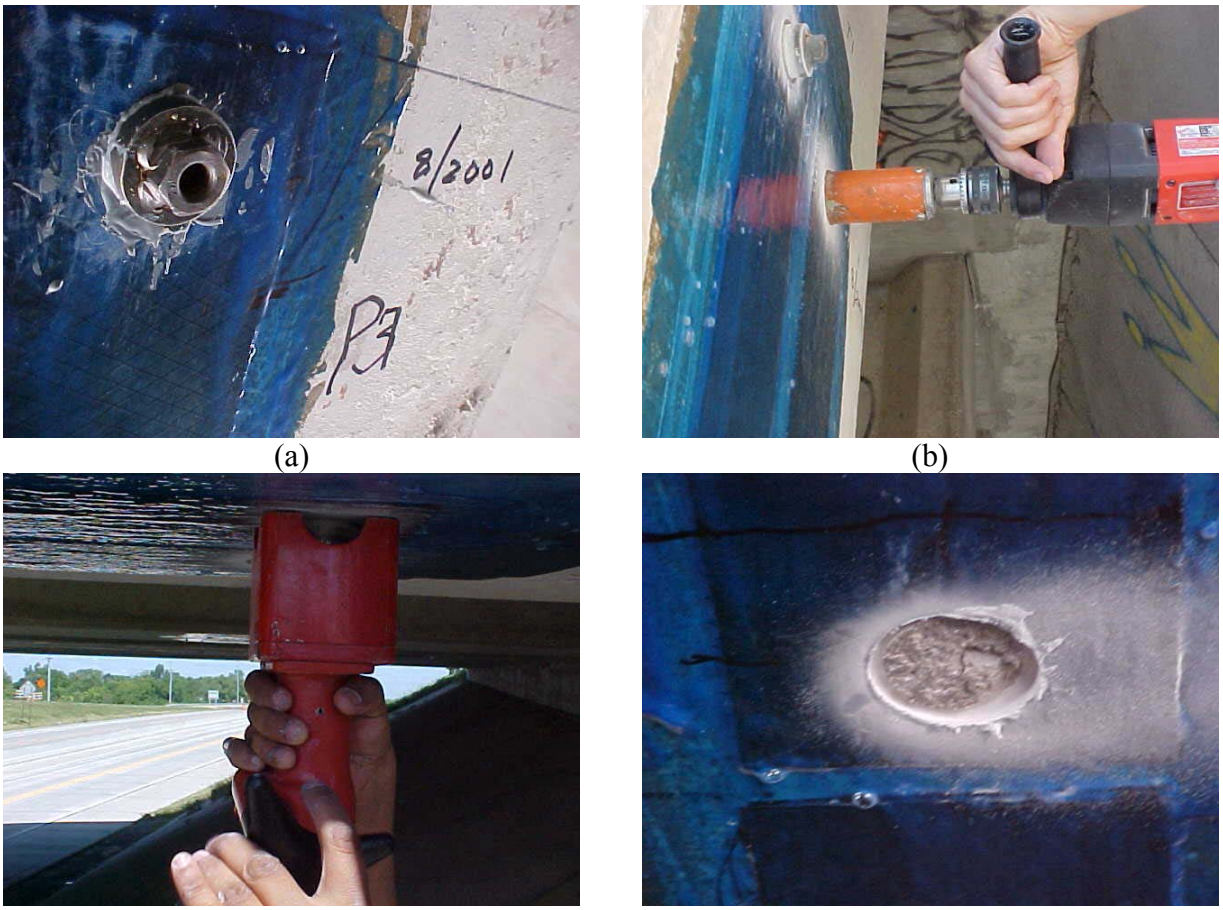
Figure 8 – Pull-off Test Procedures

The pull-off test is a simple and straightforward test to perform. A fixture of 1.625-in. diameter is adhered to the surface of the FRP with an epoxy adhesive (Figure 8a). After the epoxy is allowed to cure and the fixture is firmly attached to the FRP, the fixture is isolated from the surrounding FRP with a core drill (Figure 8b). The test apparatus is then attached to the fixture and aligned so that tension is applied perpendicular to the concrete surface (Figure 8c). A force is applied at a constant rate until the fixture detaches from the surface (Figure 8d). There are three possible failure modes for the pull-off test; 1) failure in the concrete substrate, 2) failure at the interface FRP laminate-concrete, or 3) failure in the epoxy adhesive compound (fixture delamination). Of the three failure modes, the third one is unacceptable in that it shows fixture installation problems. The second failure mode may be indicative of a bond durability problem. The first failure mode is the desirable one and should occur at a stress value larger than 200 psi. A full description of the pull-off test for concrete repair evaluation is given in the International Concrete Repair Institute's "1999 Concrete Repair Manual" (ICRI, 1999).

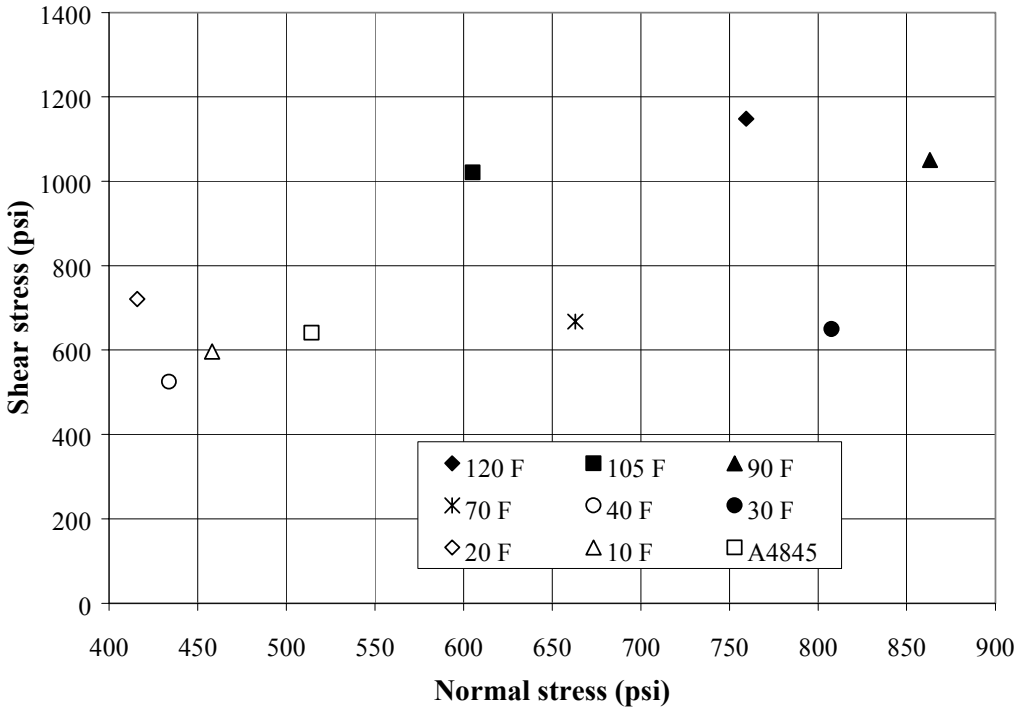
Figure 12 – Relationship Between Results Obtained by Pull-Off and Torsion Tests

The results of the torsion tests indicate that the bond is as strong as that indicated in the pull-off tests. This is consistent with results obtained in the laboratory as shown in Figure 12. In this figure, the data from A4845 bridge (hollow square) are compared with results obtained from eight series of specimens on which the FRP laminate was applied on a concrete substrate having temperature ranging from 10 to 120 ^{o}F (Khataukar, 2001).
