APPENDIX A

QUESTIONNAIRE SURVEY AND RESULTS

SPALLING SOLUTION OF PRECAST-PRESTRESSED CONCRETE BRIDGE DECK PANELS

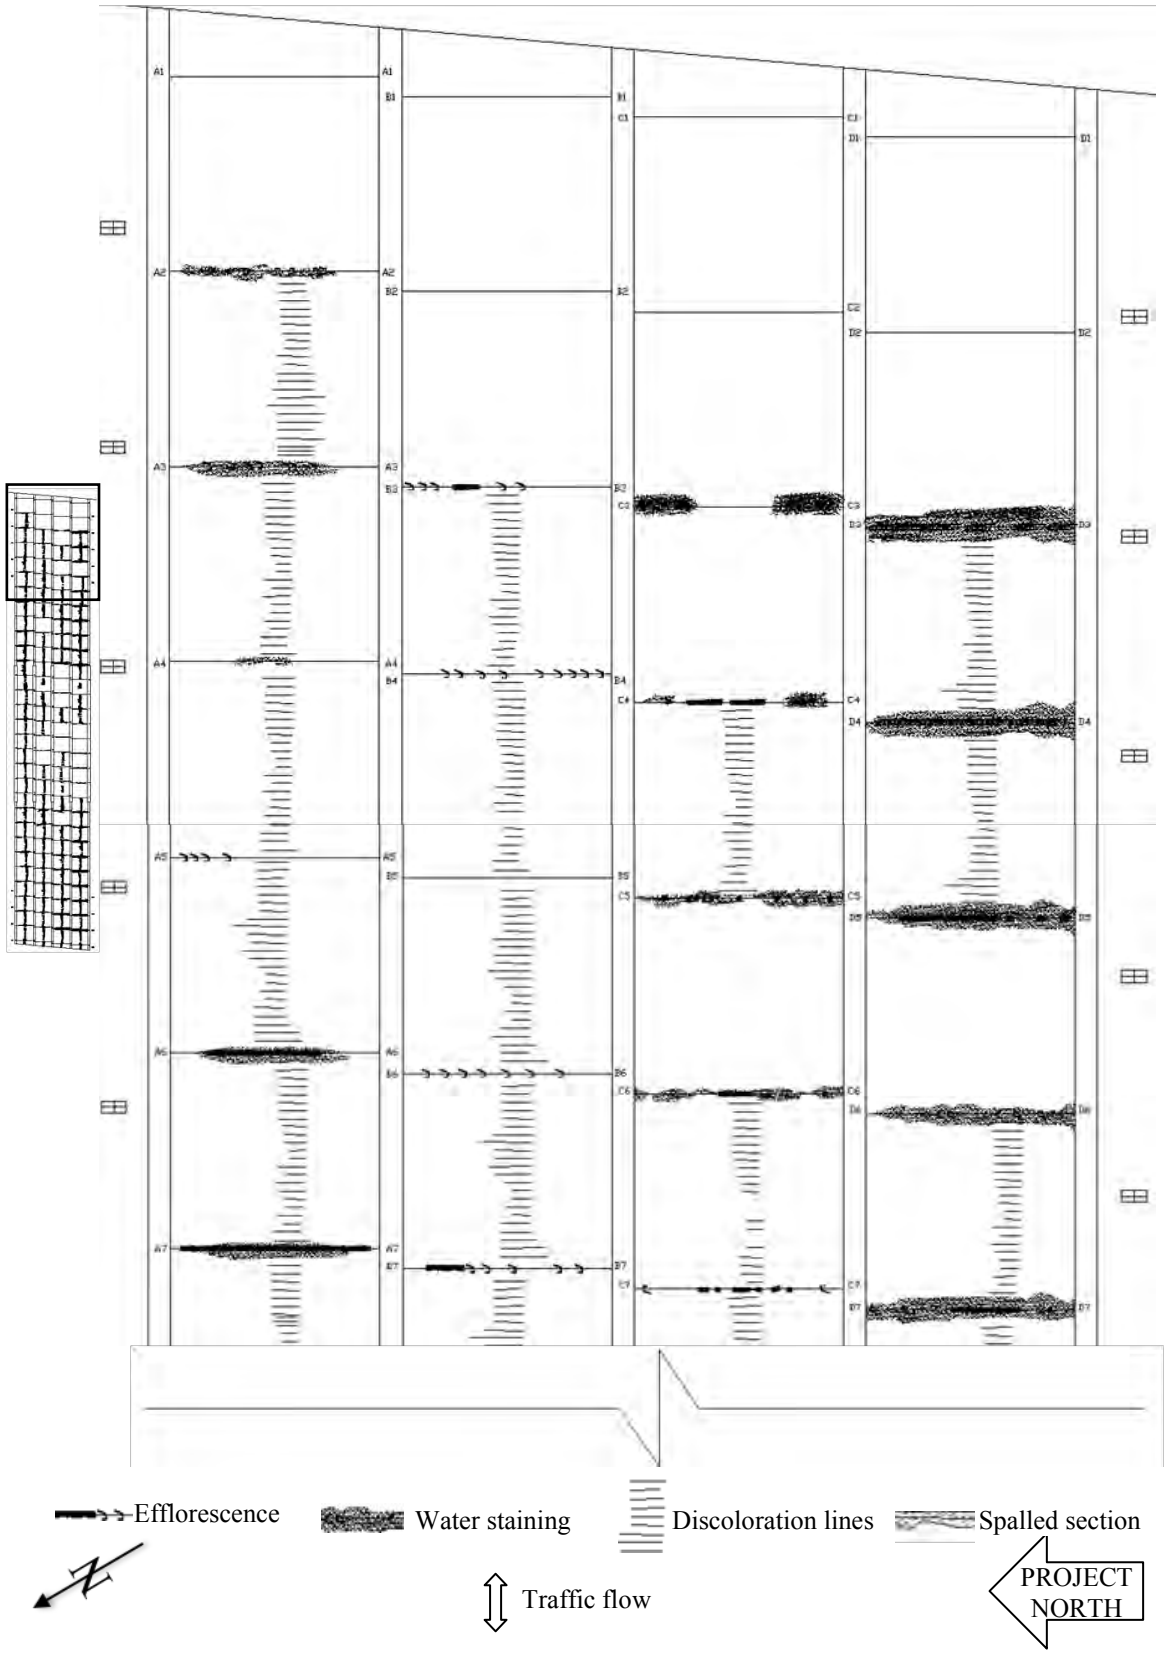
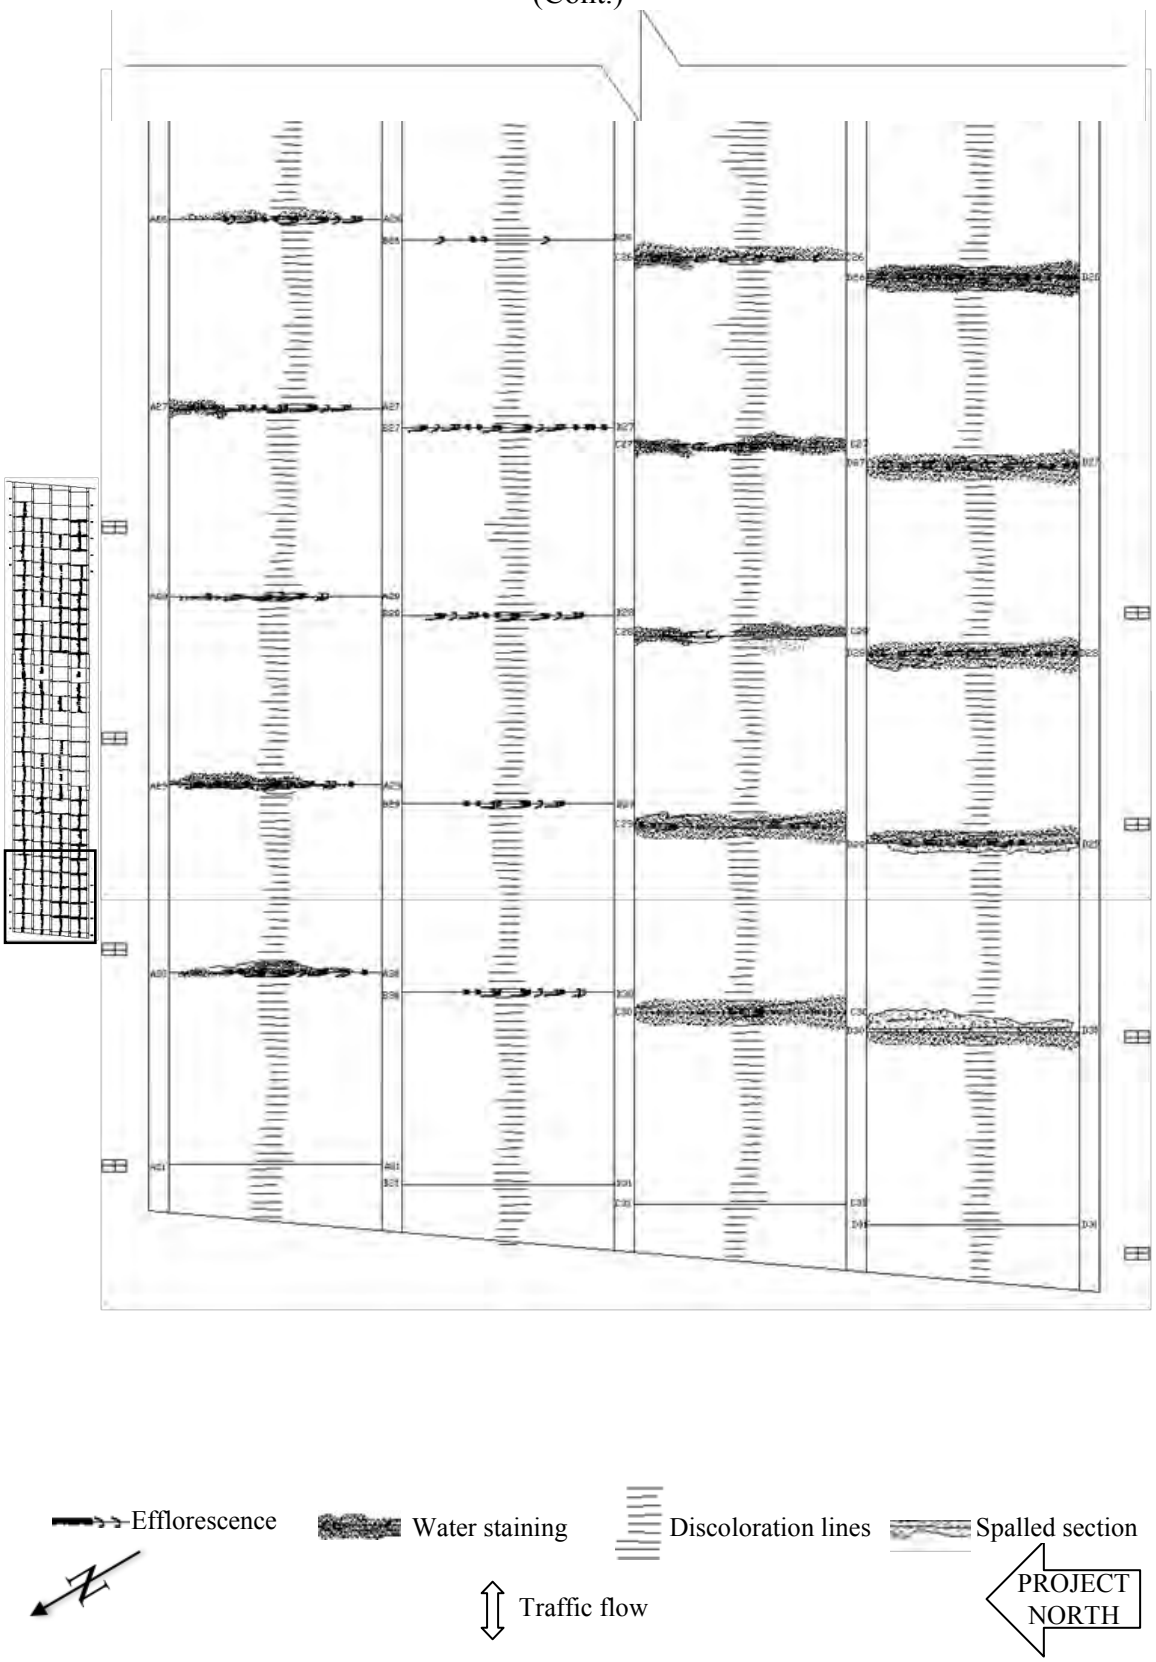
Figure B-1 Visual Inspection Data from the Bottom Surface of the Bridge Deck – Bridge A4709 (Cont.)

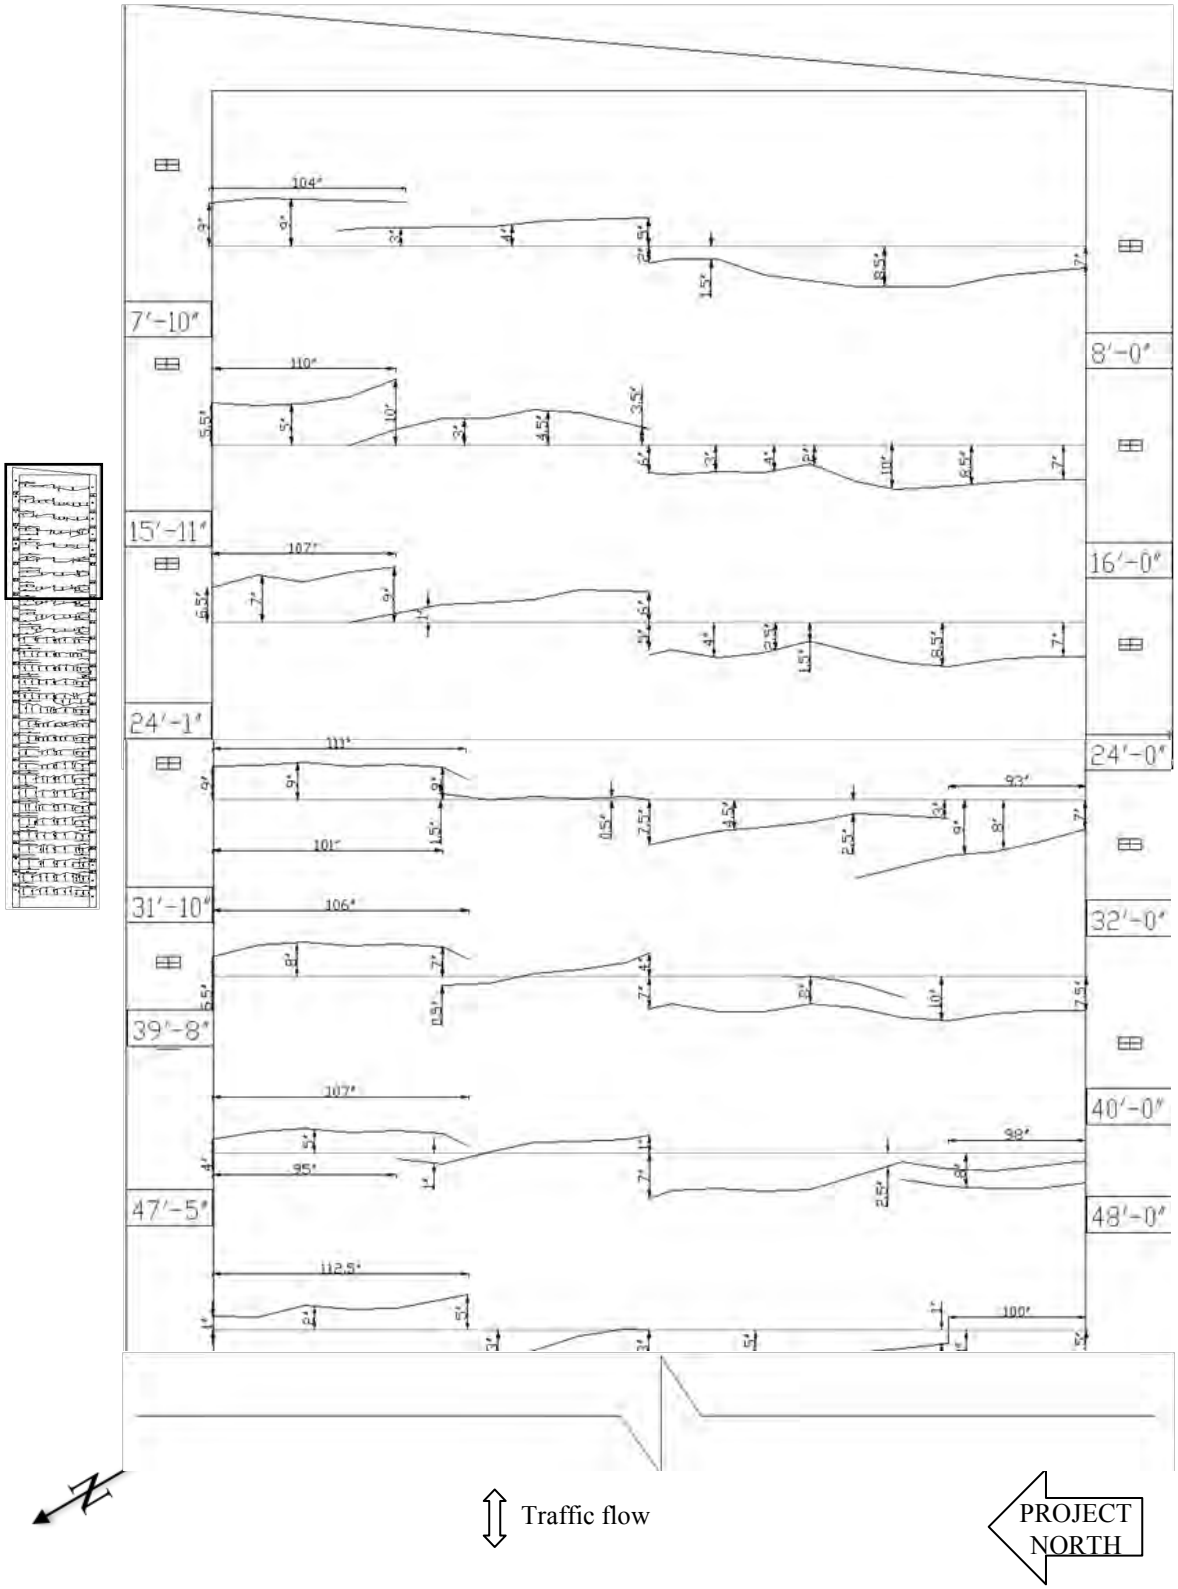
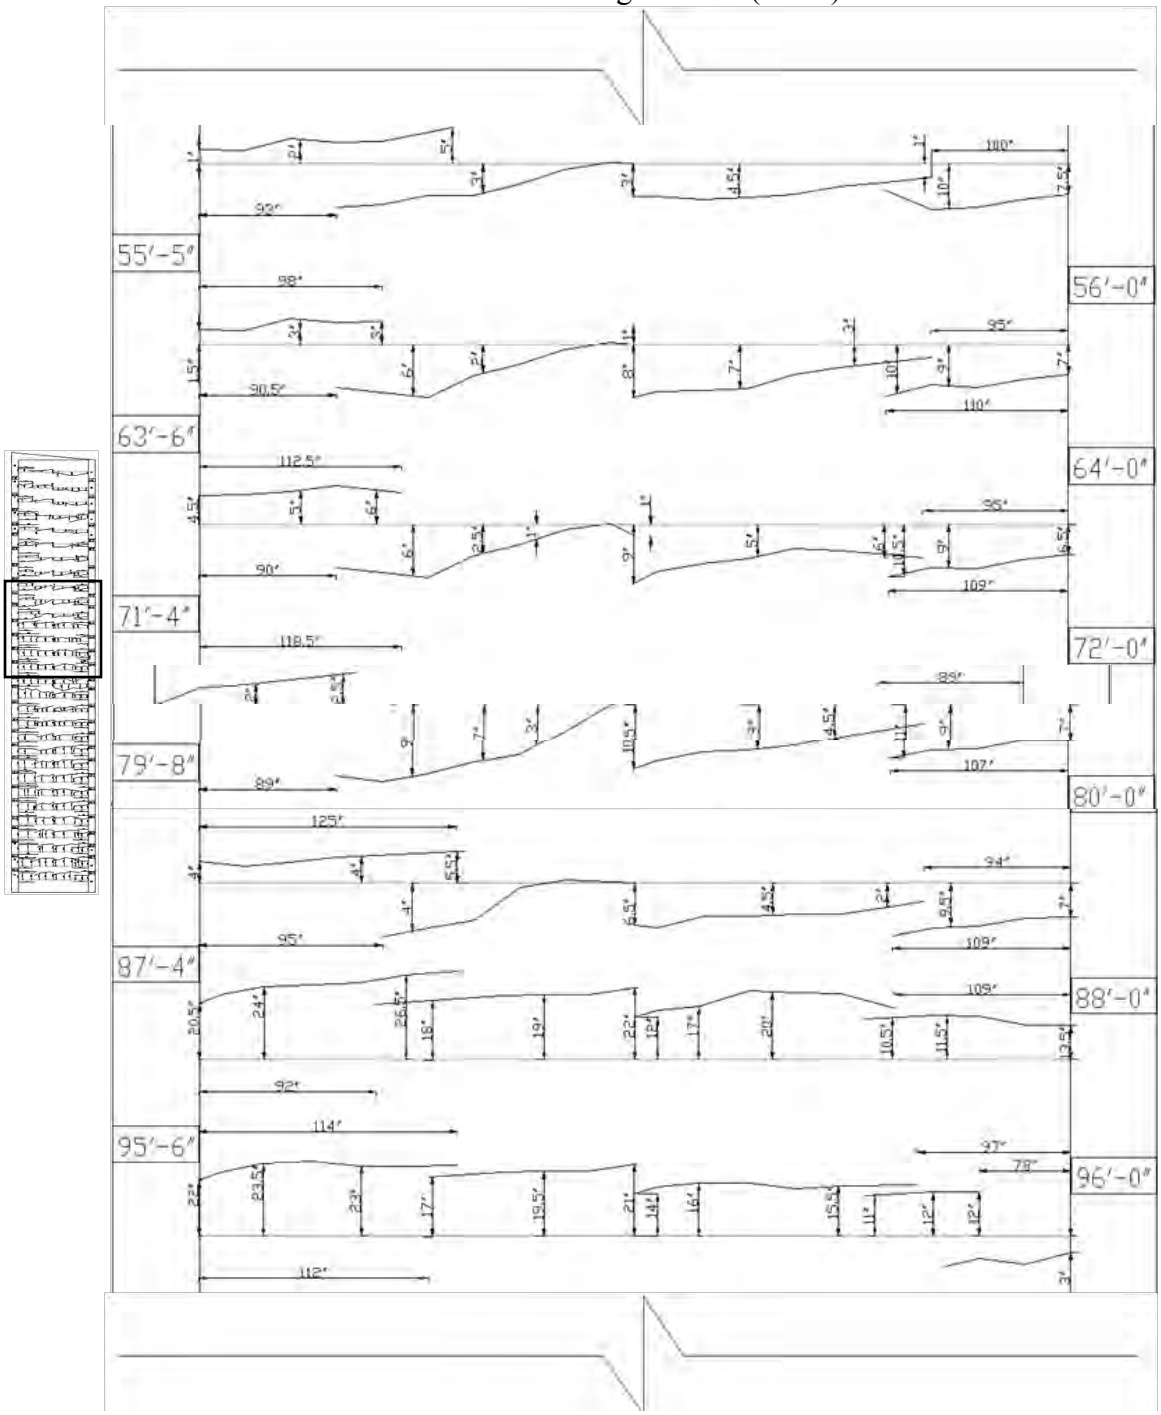
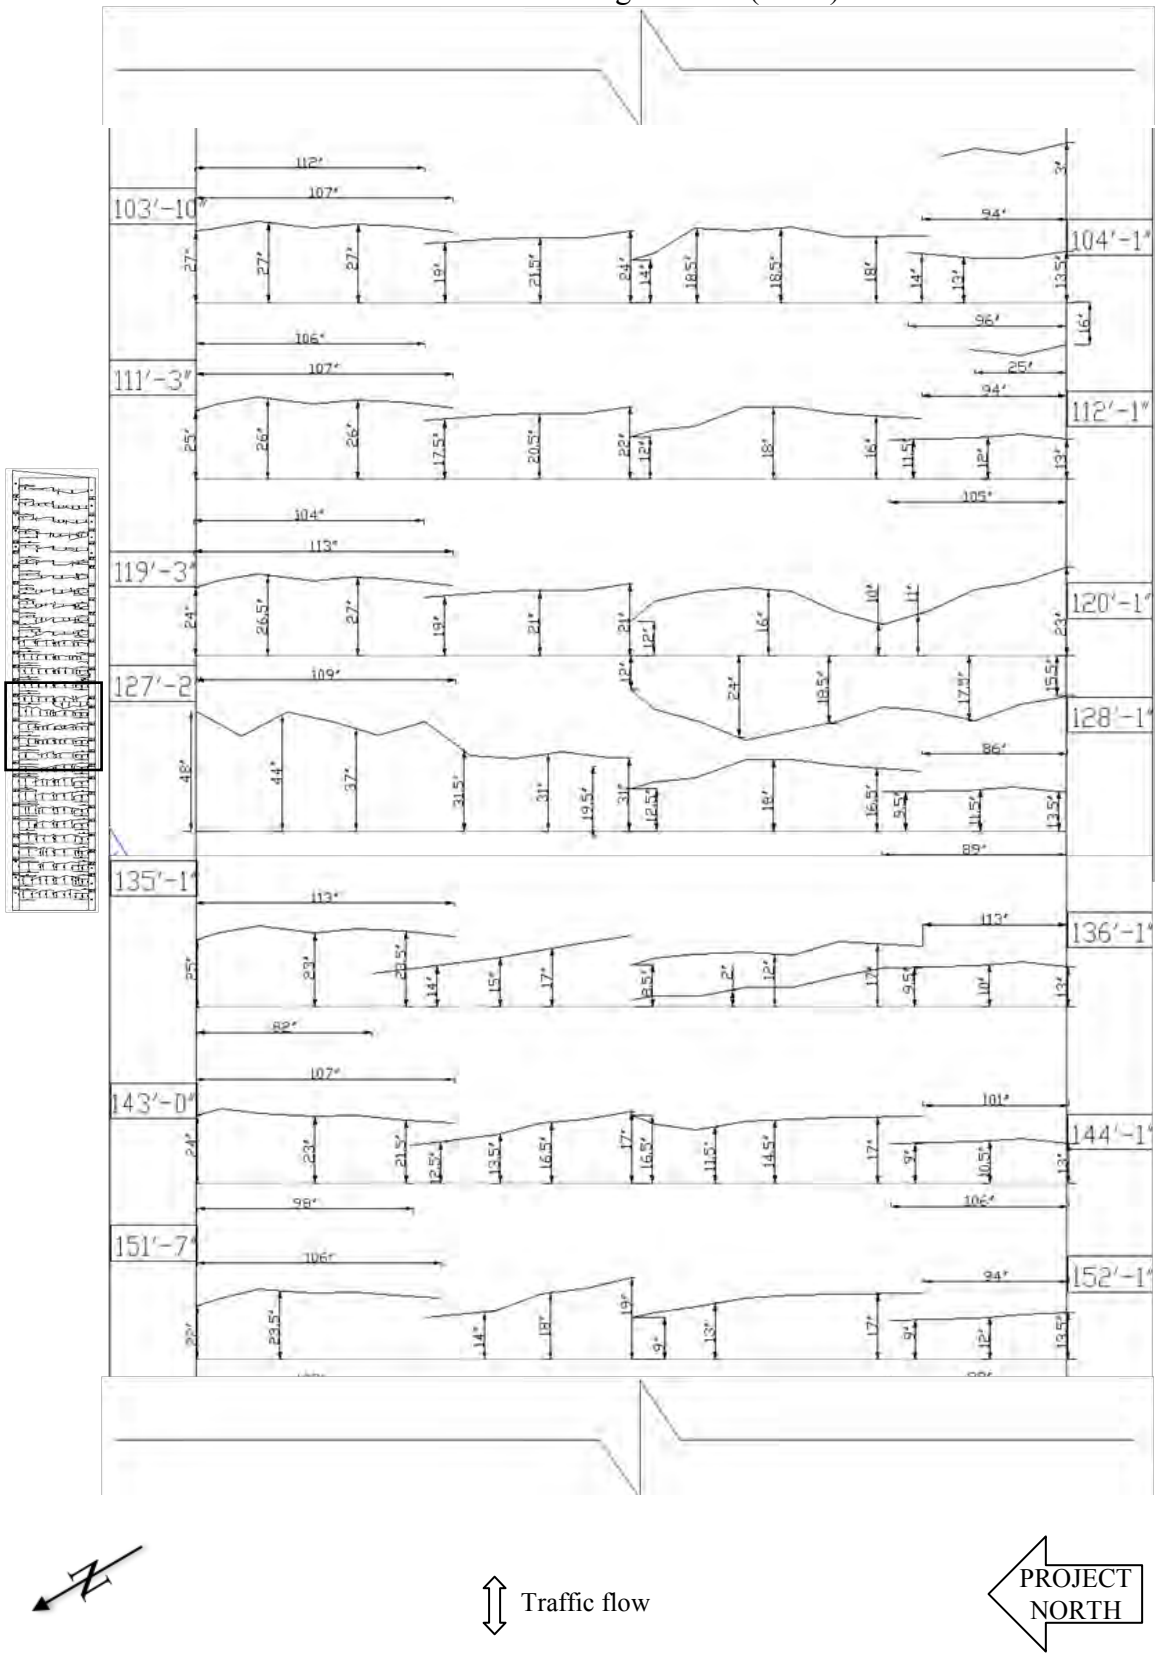
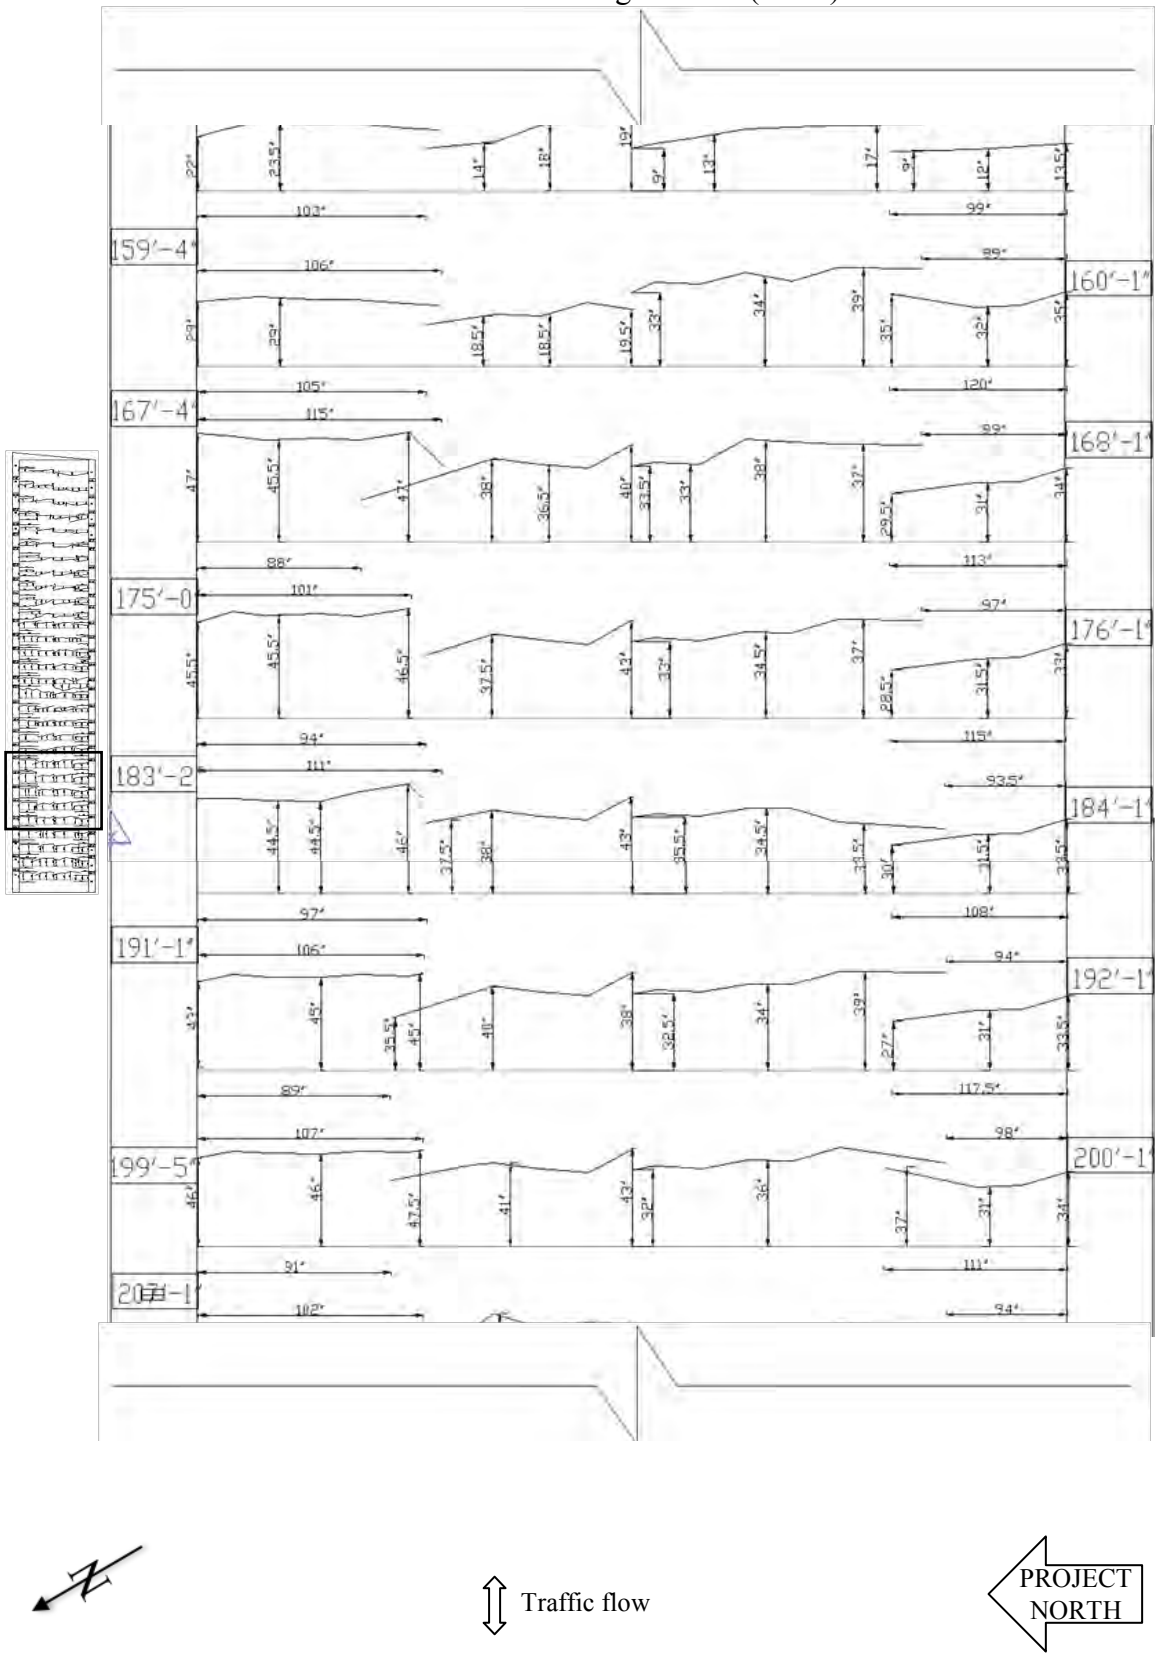
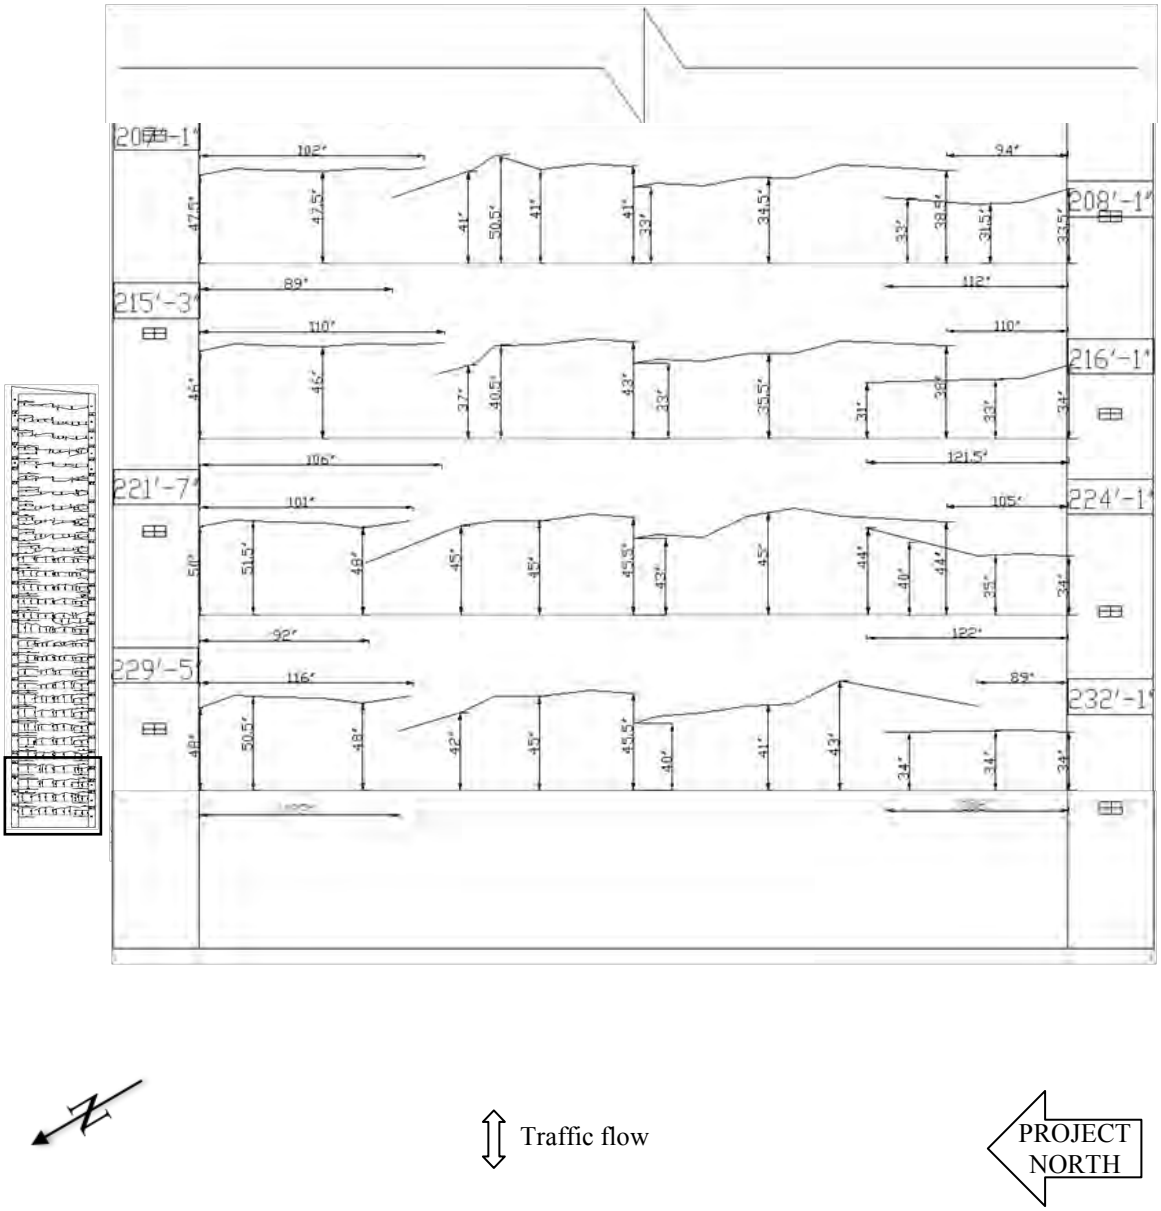
Figure B-2 Visual Inspection Data from the Top Surface of the Bridge Deck - Crack Map and Drain Locations – Bridge A4709A4709

Figure B-2 Visual Inspection Data from the Top Surface of the Bridge Deck - Crack Map and Drain Locations – Bridge A4709 (Cont.)

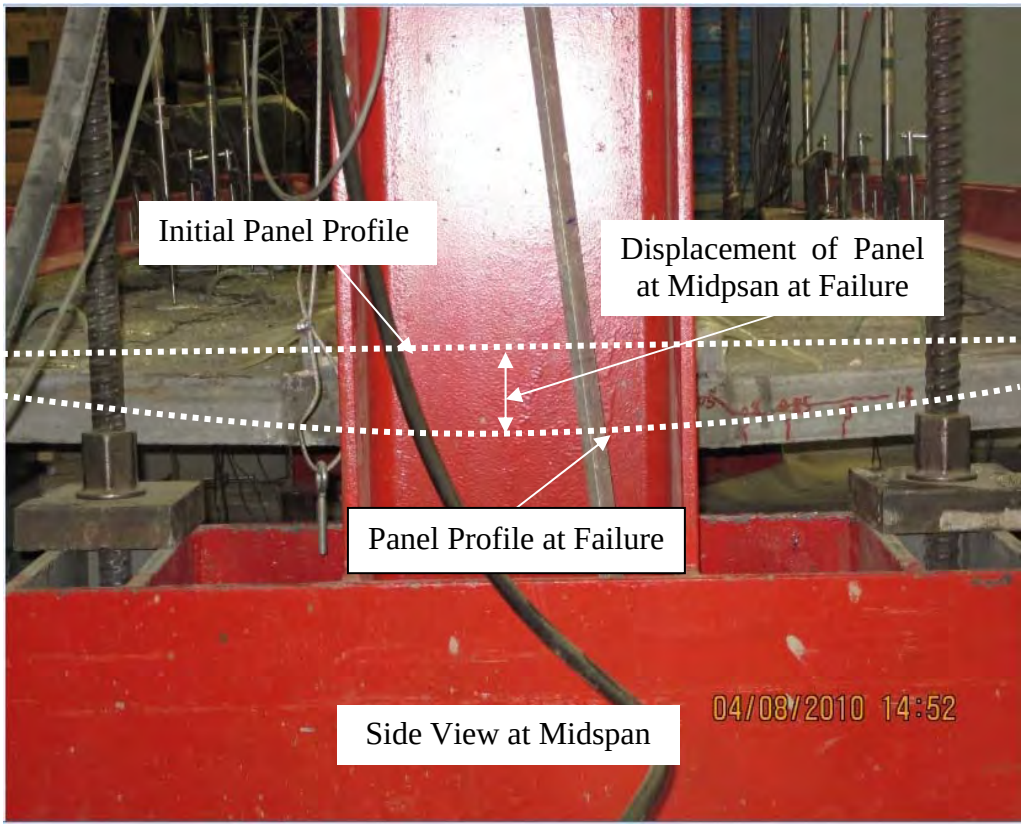
Figure C- 24 Flexural Failure at Midspan by Concrete Crushing of Panel ECST-NC-SL

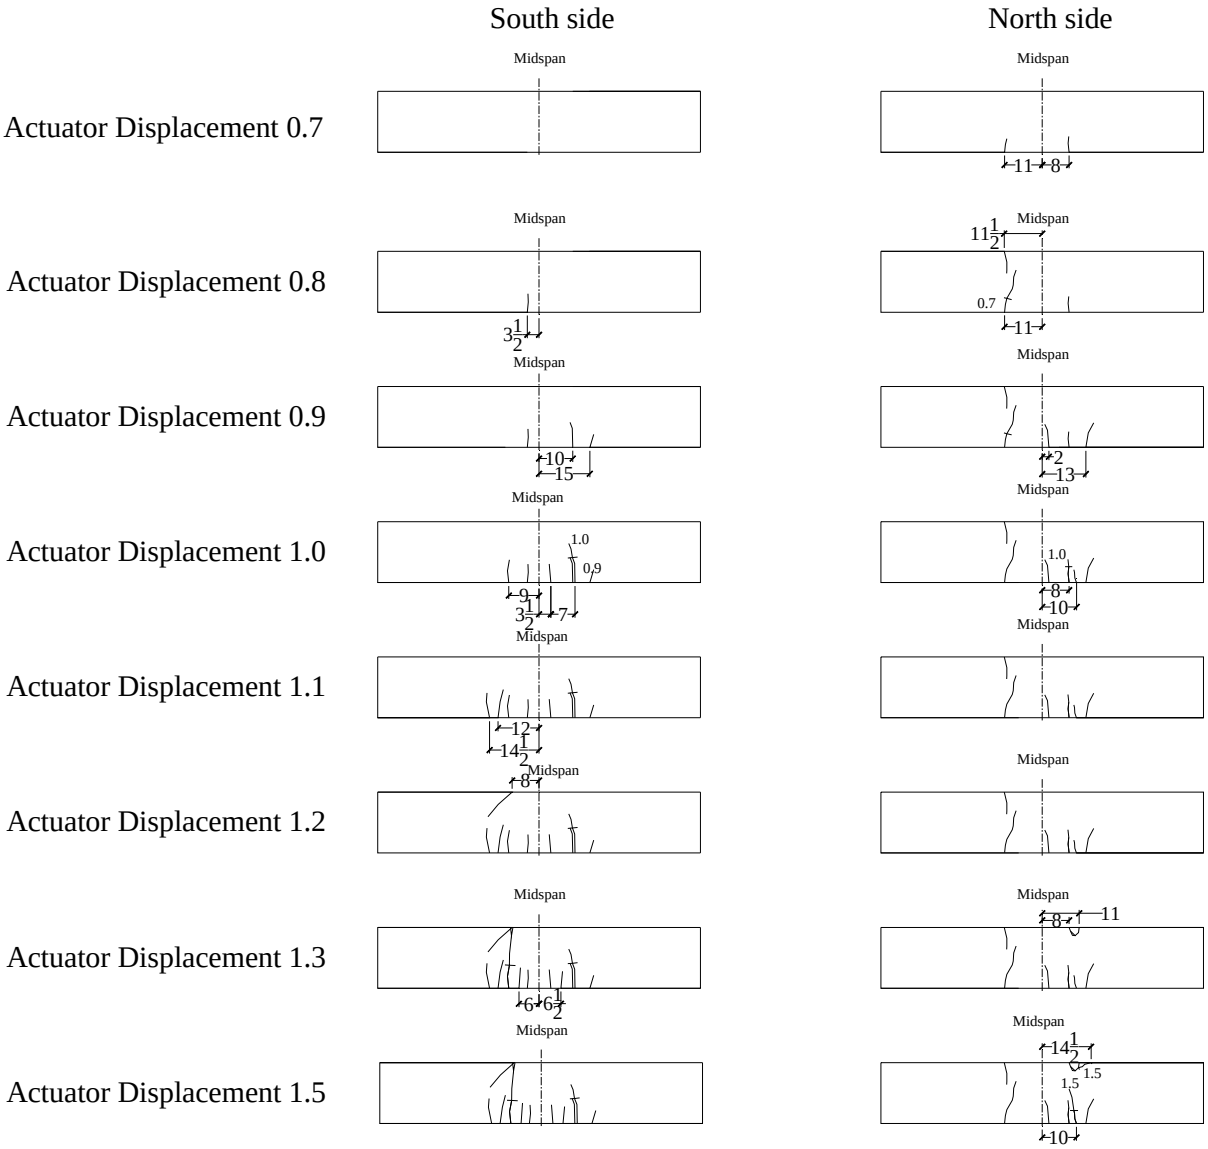
Figure C- 40 Flexural Failure at Midspan by Concrete Crushing of Panel CFRPT-NC-SL

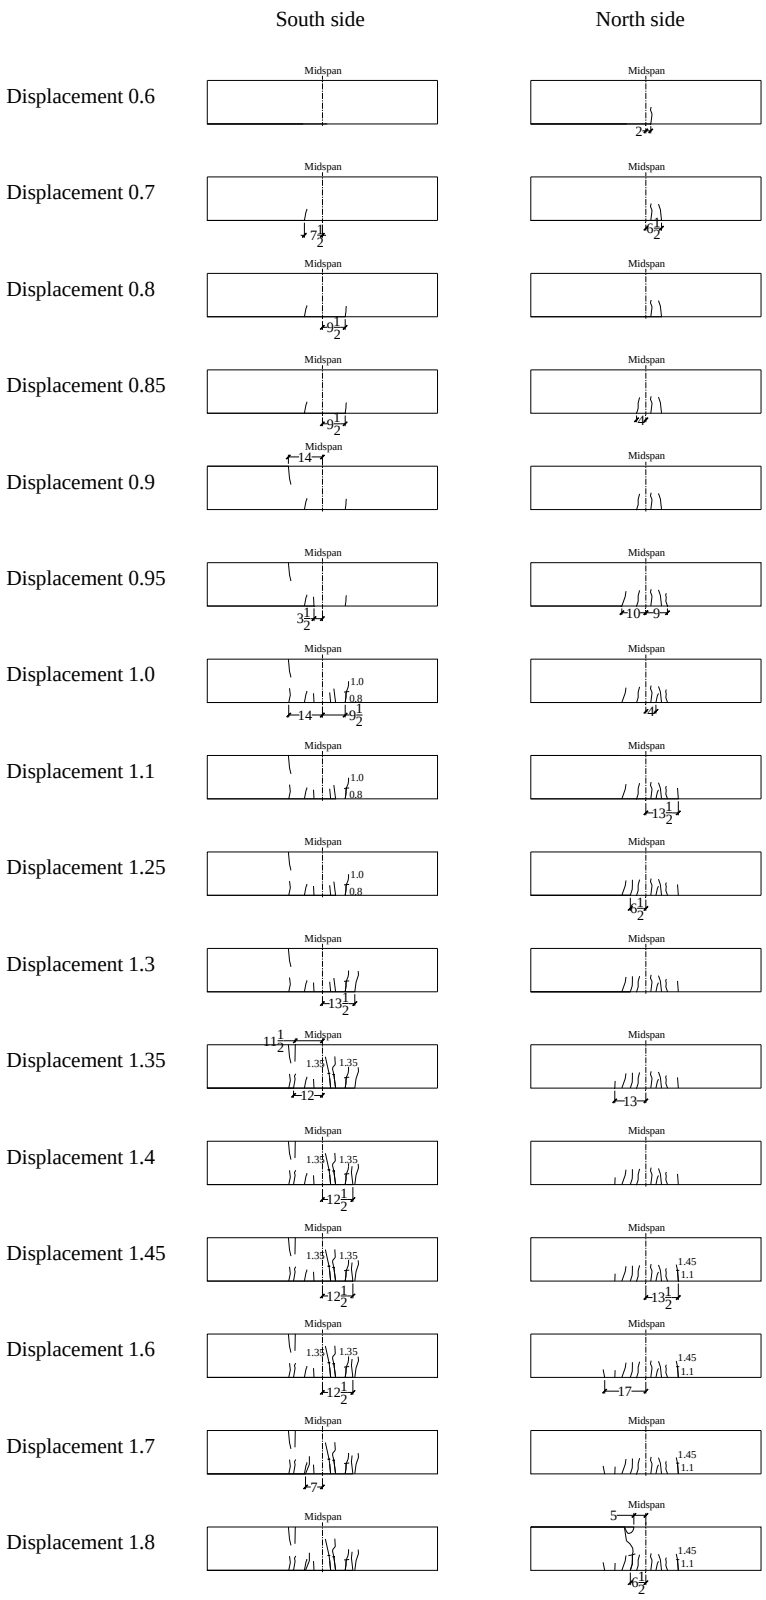
Figure C- 48 Flexural Failure at Midspan by Concrete Crushing of Panel CFRPT-FRC-SL

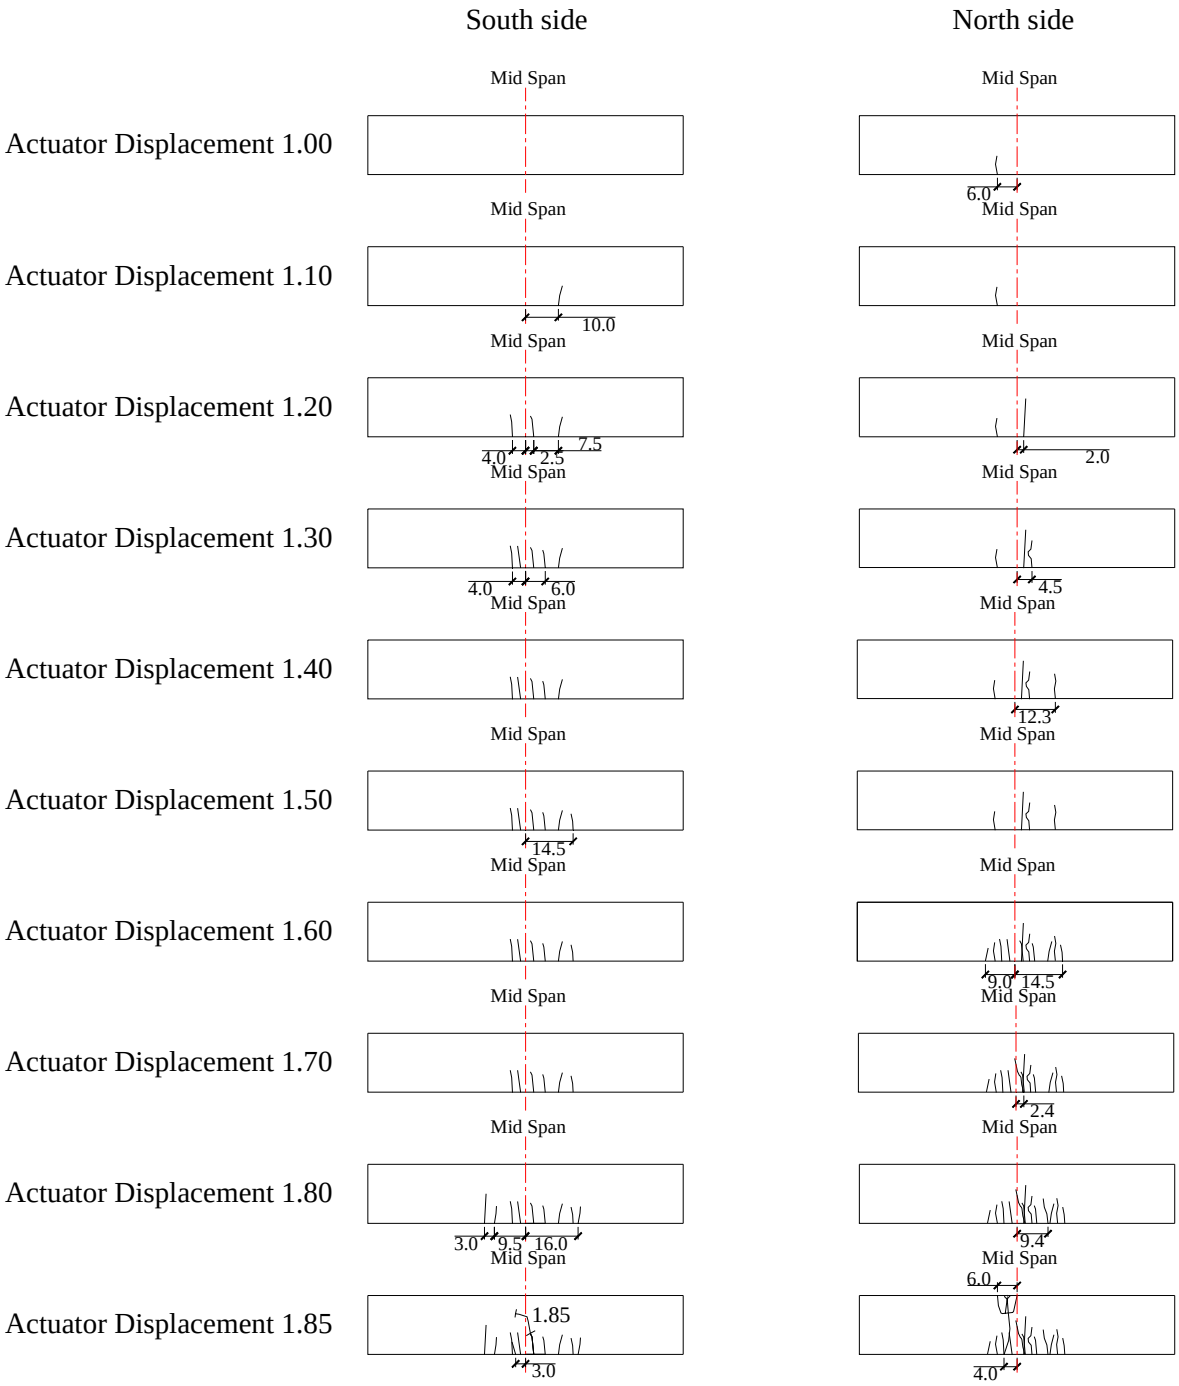
Figure C- 56 Flexural Failure at Midspan by Concrete Crushing of Panel ST-NC-FL

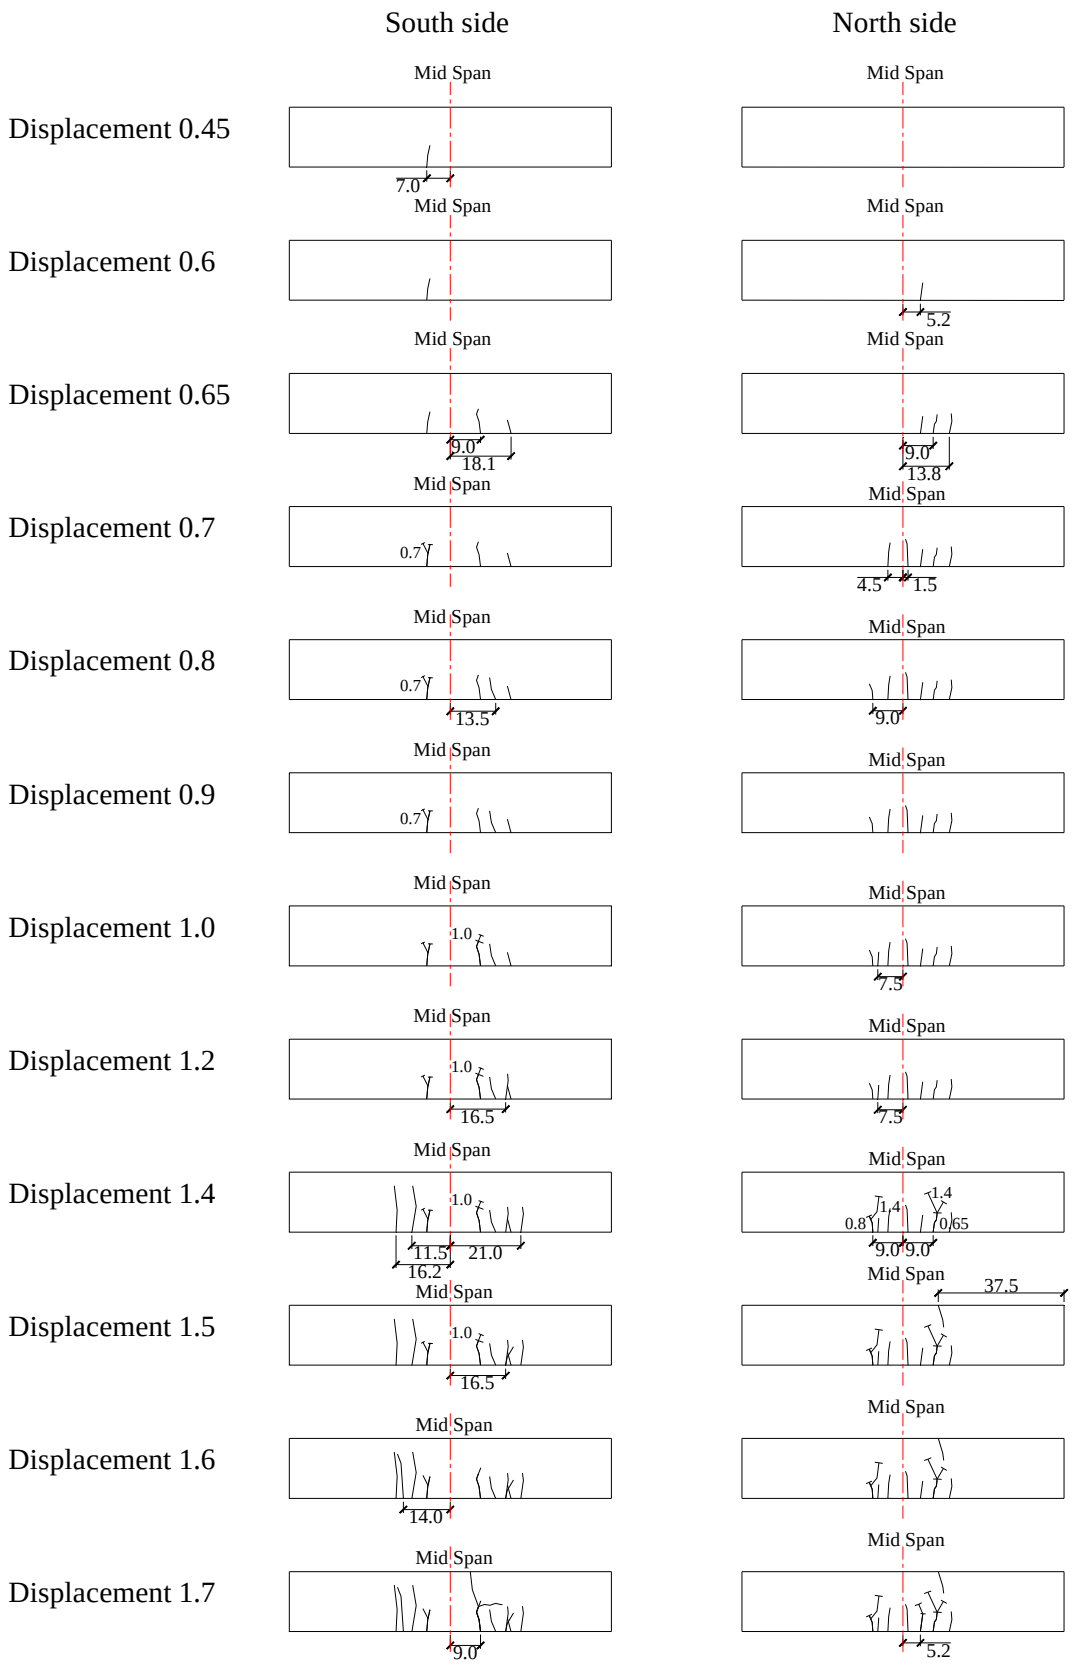
Figure C- 65 Flexural Failure at Midspan by Concrete Crushing of Panel ST-FRC-FL

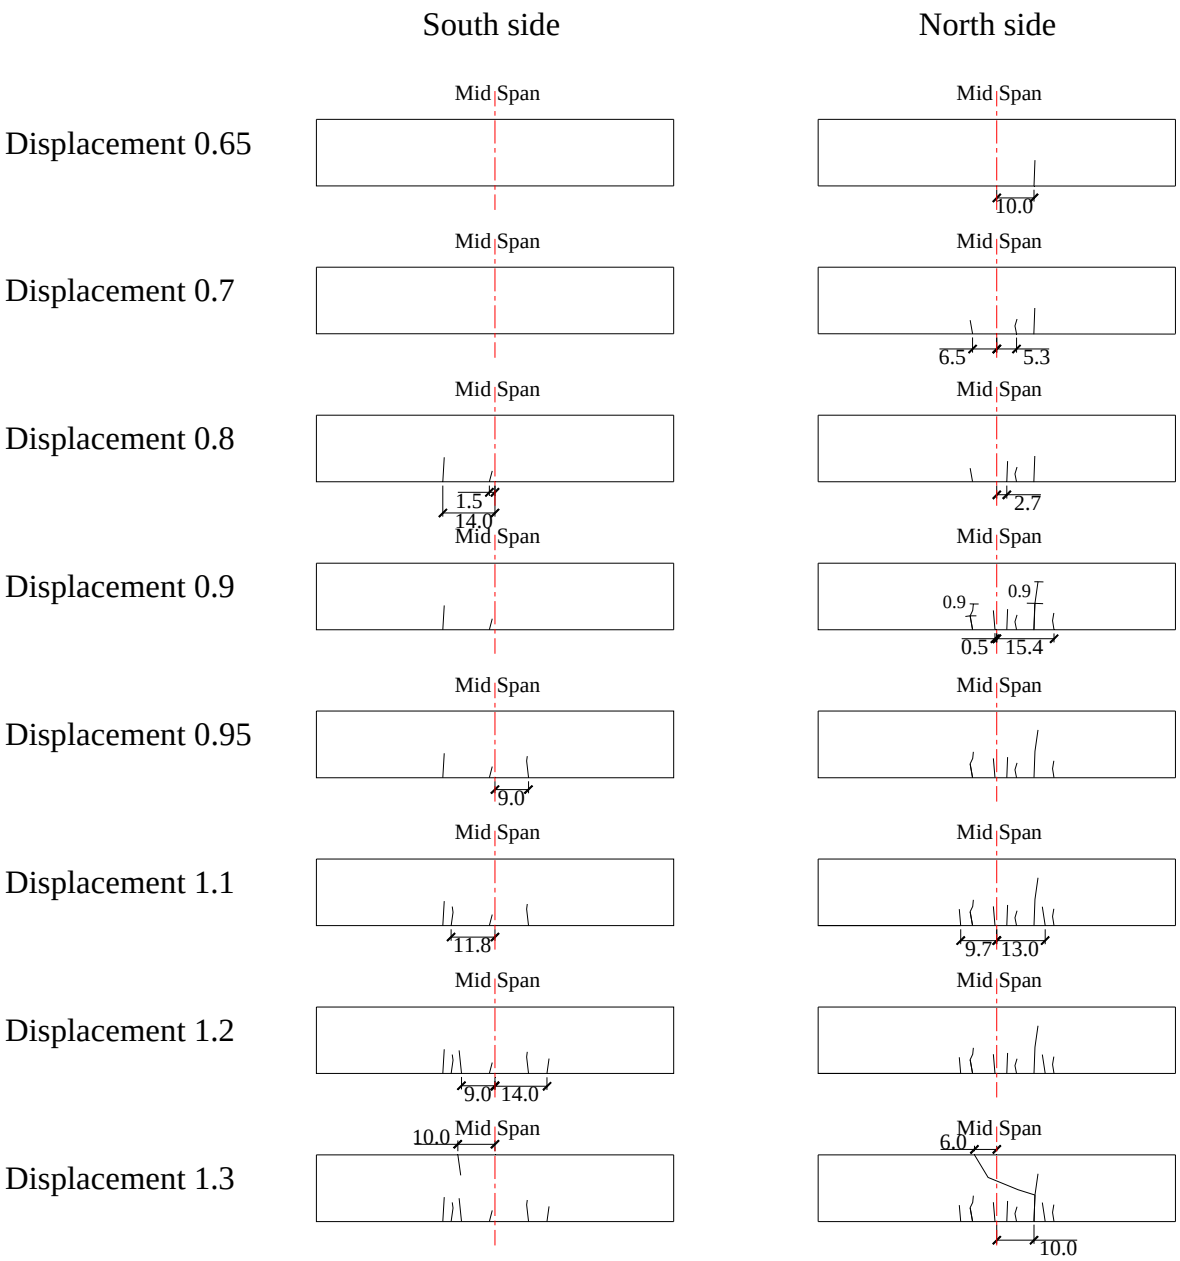
Figure C- 74 Flexural Failure at Midspan by Concrete Crushing of Panel ECST-NC-FL

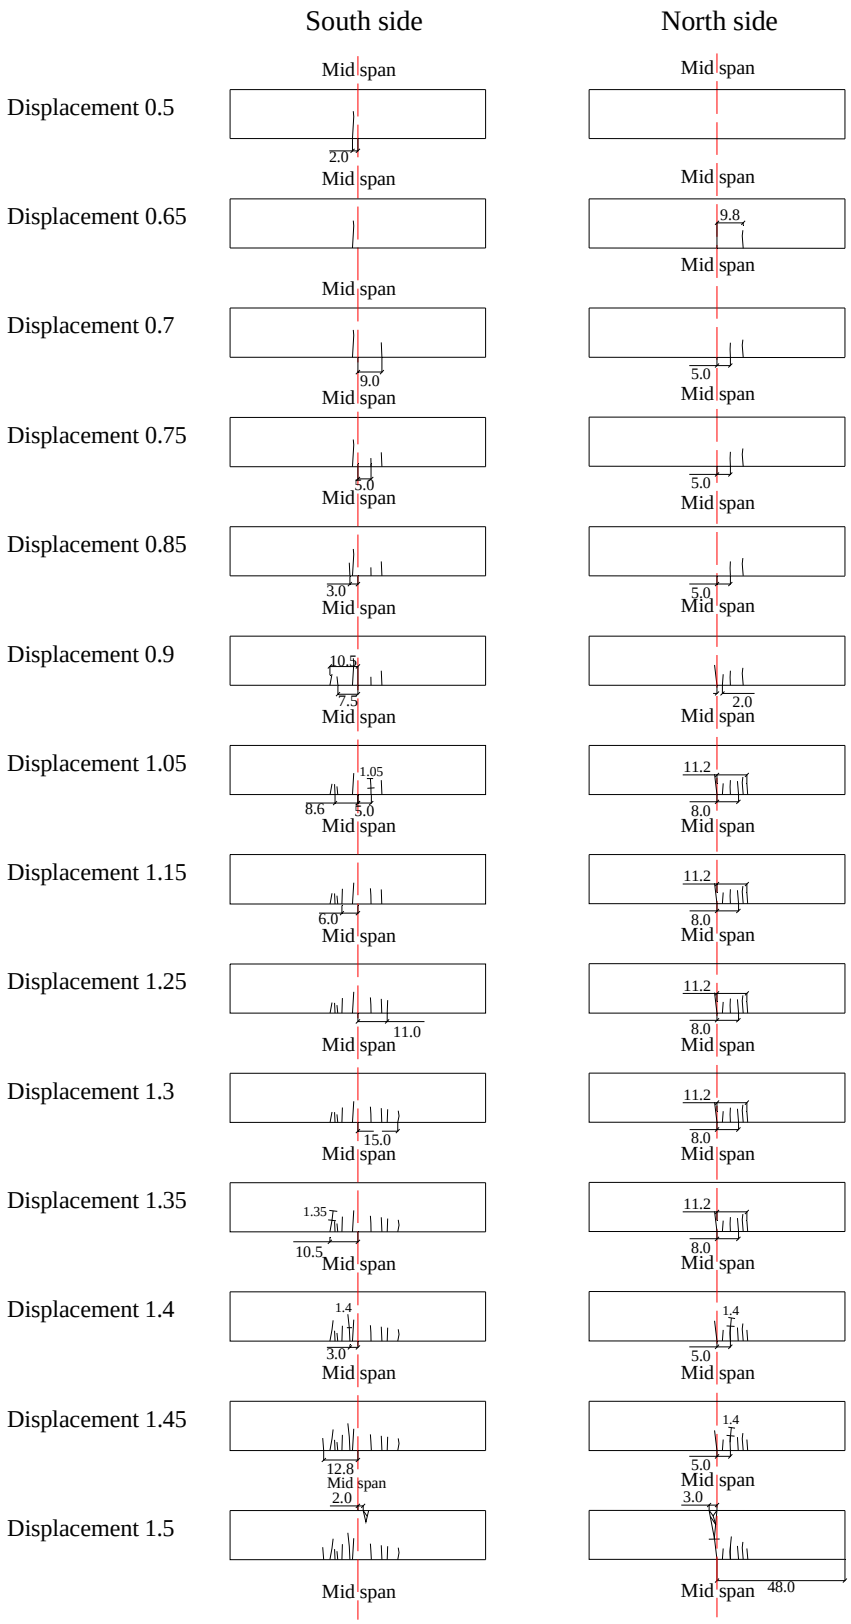
Figure C- 83 Flexural Failure at Midspan by Concrete Crushing of Panel ECST-FRC-FL
