APPENDIX A

QUESTIONNAIRE SURVEY AND RESULTS

SPALLING SOLUTION OF PRECAST-PRESTRESSED CONCRETE BRIDGE DECK PANELS

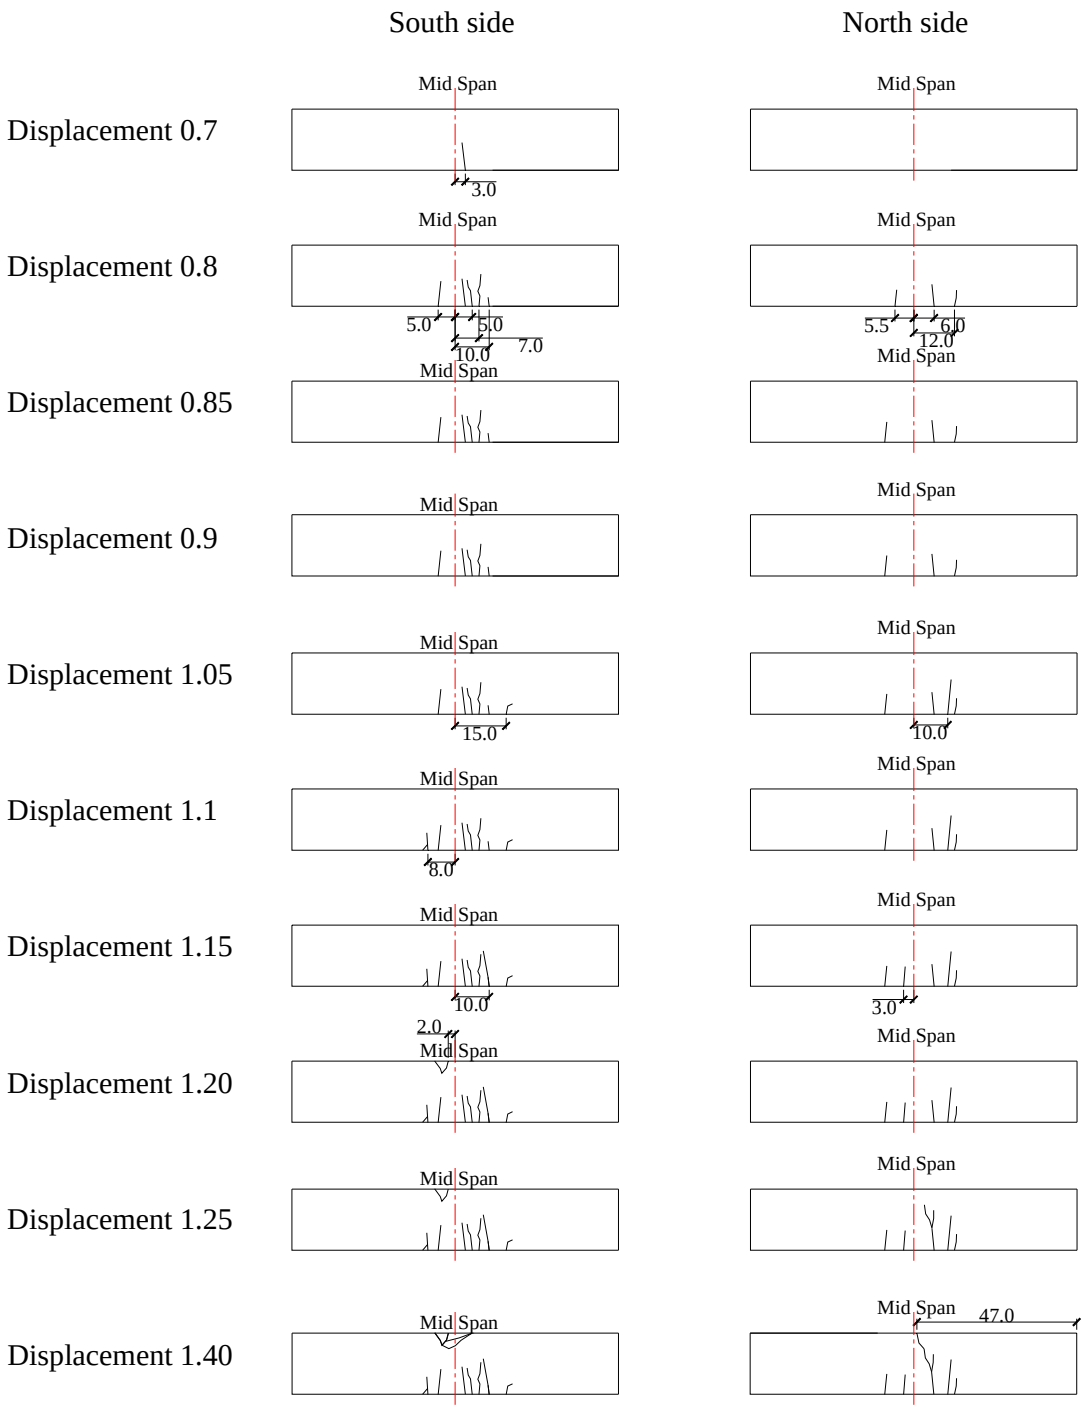
Figure C- 92 Flexural Failure at Midspan by Concrete Crushing of Panel CFRPT-NC-FL

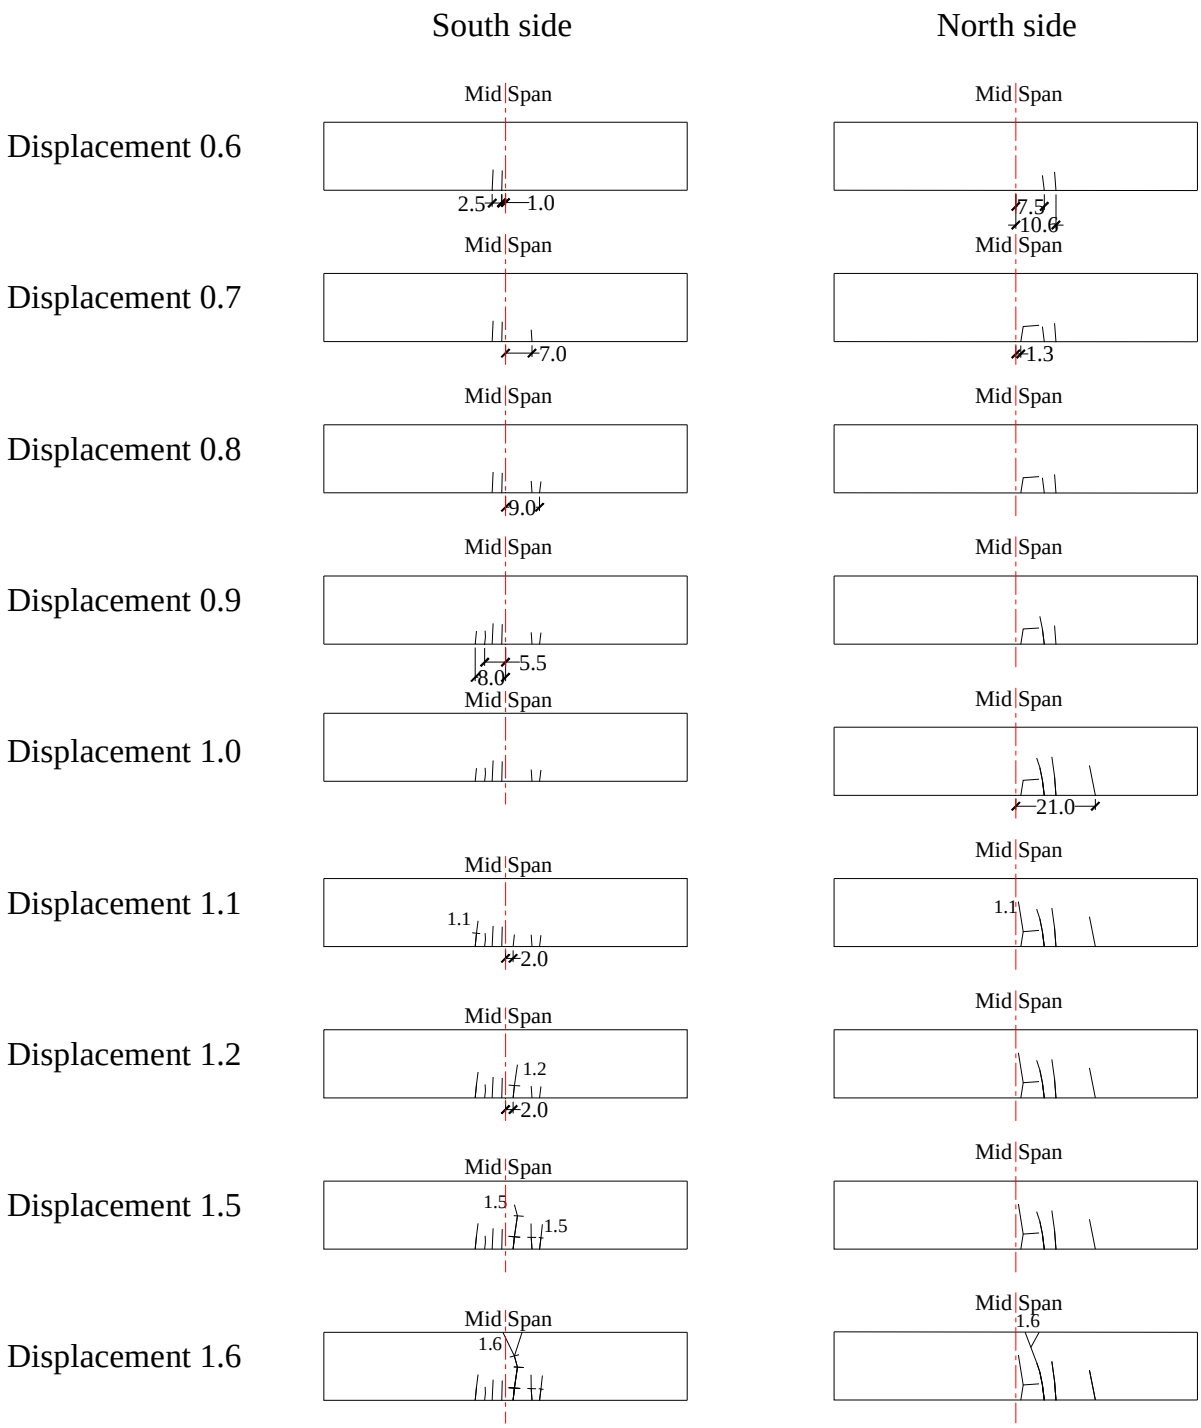
Figure C- 101 Flexural Failure at Midspan by Concrete Crushing of Panel CFRPT-FRC-FL
