Investigations of Failures of Epoxy Polymer Overlays in Missouri

Prepared by
Missouri Department
of Transportation

RI06-020

November 2007

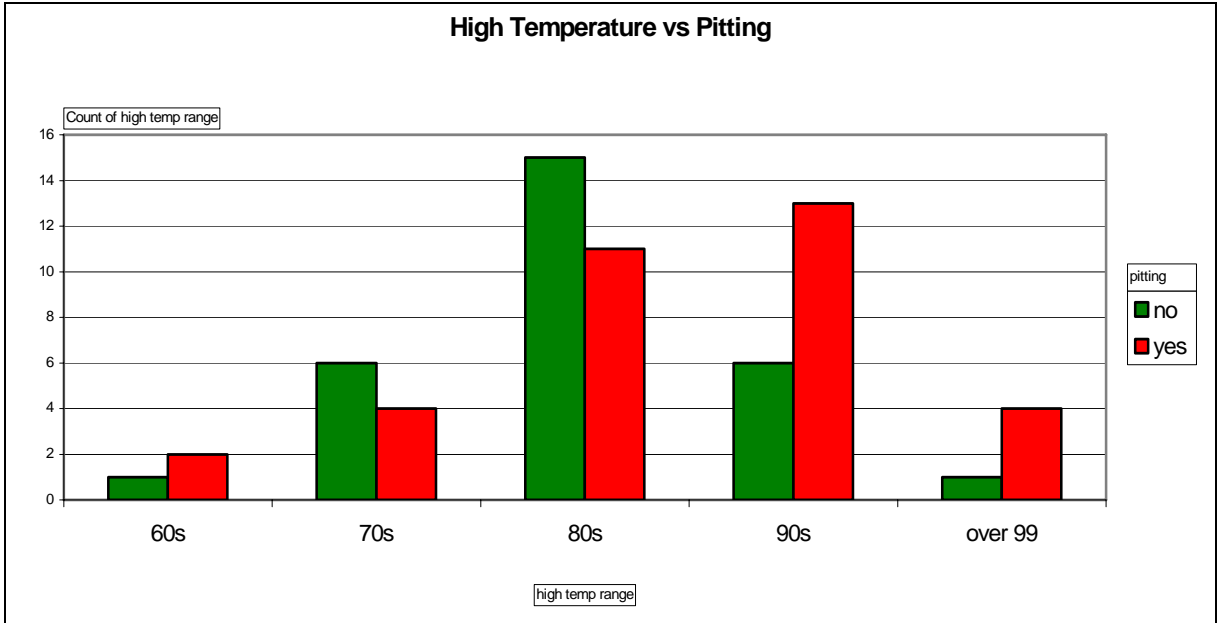
An unexpected observation during the study was the presence of pitting on a majority of the bridge decks. Sixty-two out of ninety eight bridges had pitting of some degree. (The epoxy polymer overlay on two of the bridge decks, K108 placed in 1990 and A1944 placed in 1984, had worn to the point that determining failure mechanisms was impossible.) The degree of pitting ranged from pinprick sized pits to quarter inch sized pits. Pitting has been noted in many literature reports; however most sources claim that the pits will never line up between the two layers of overlay and should not be of concern. In the course of the investigation we found areas where the pits DID line up which create a funnel for water and chlorides to enter the deck. We also found that once the pitting became larger the EPO began to show signs of cracking between the pits, which eventually became block cracking. One source of pitting is the presence of air bubbles in the epoxy component of the overlay. In discussions with epoxy suppliers it was noted that the use of certain types of paddles for mixing can lead to air bubbles within the epoxy. The proper type of paddle to be used is called a “jiffy paddle” or a “Sika paddle.” Most epoxies have a maximum speed for the paddle, mixing any quicker can introduce air. Inspectors should verify that the contractor is using the correct type of paddle for mixing the epoxy and that the correct speed is being used. It was also noted that an increase in temperature leads to an increased chance of pitting. See Figure 3. During higher temperatures, extra care should be given to working out any remaining air bubbles during placement. The likelihood of pitting also increased with the number of freeze/thaw cycles. See Figure 4.

Figure 3. High Temperature at Placement vs. Pitting

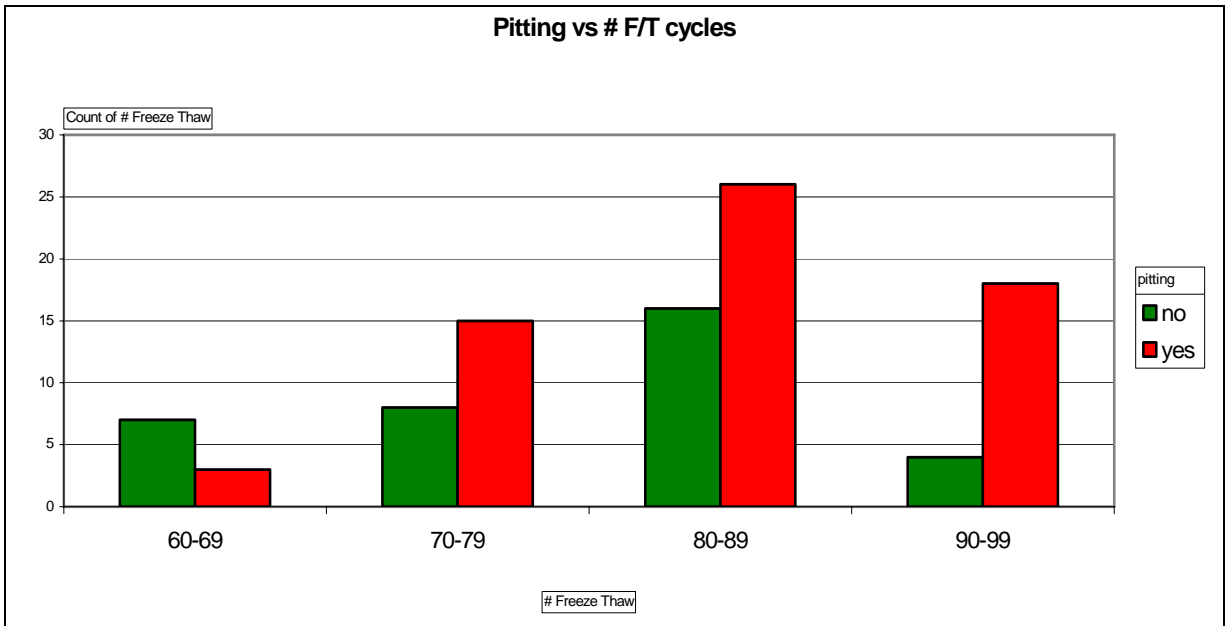
Figure 4. Freeze/Thaw Cycles vs. Pitting

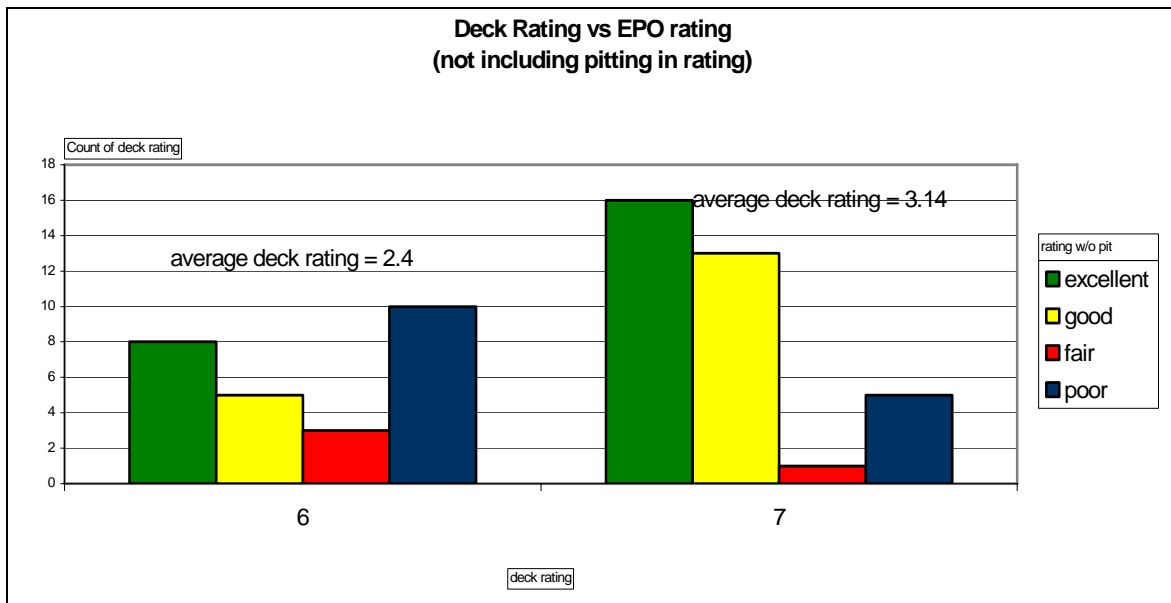
For those bridges that we were able to gather background information, we collected the previous deck survey prior to placement. Most bridges had either a rating of 6 or 7. There were a few decks that were previously rated an 8 however there were only five. Four out of the five had overlays that ranged in age from 12-14 years old so there is not enough data to draw any conclusions for those bridges. In order to quantify the EPO rating, each bridge was given a number of the EPO rating of 4 for excellent down to 1 for poor. The average rating for the overlay on the bridges with a previous deck rating of 6 was a 2.4 whereas the average rating for the overlay on the bridges with a previous deck rating of 7 was a 3.14. See Figure 5. The bridge decks with a higher deck rating prior to placement are more likely to have an excellent or good rated overlay.

Figure 5. Previous Deck Rating vs. EPO Rating

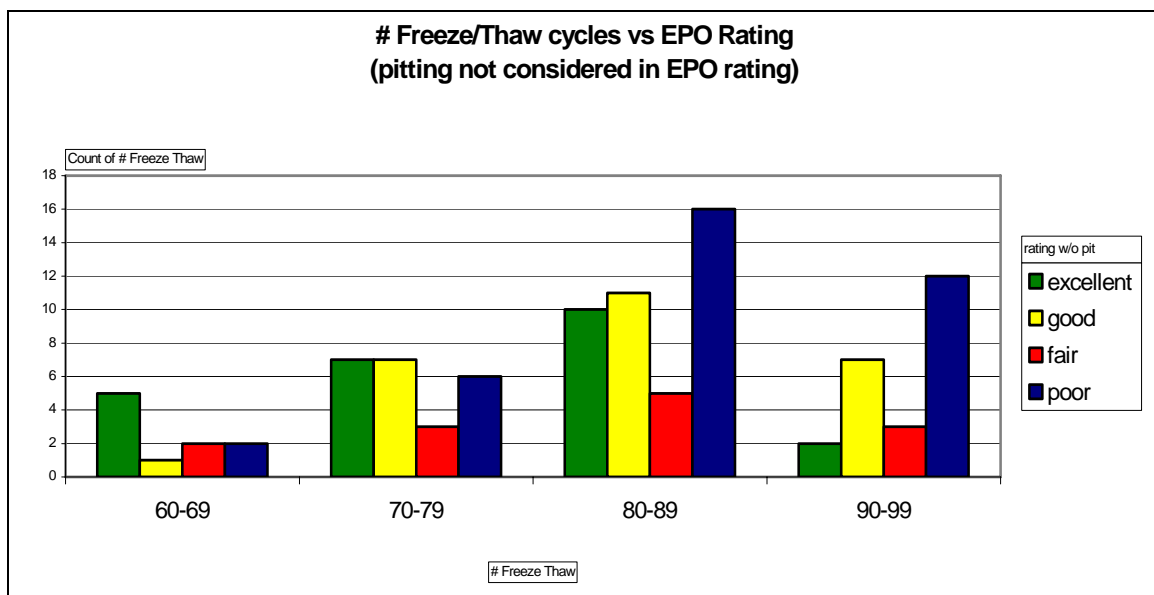
The number of freeze/thaw cycles greatly impacts a bridge deck. When water infiltrates the surface then freezes it can cause fractures in the concrete. The same can be said for epoxy polymer overlays, especially if the overlay has pitting. We gathered climatological data for each bridge deck. The Midwest Regional Climate Center provides the average values for temperatures from 1971 to 2000. By looking at the number of days below freezing and above freezing we estimated the number of freeze/thaw cycles at the nearest weather station to each bridge. As expected as the number of freeze/thaw cycles increases the average rating of the overlays decreased. See Figure 6.

Figure 6. Freeze/Thaw Cycles vs. EPO rating

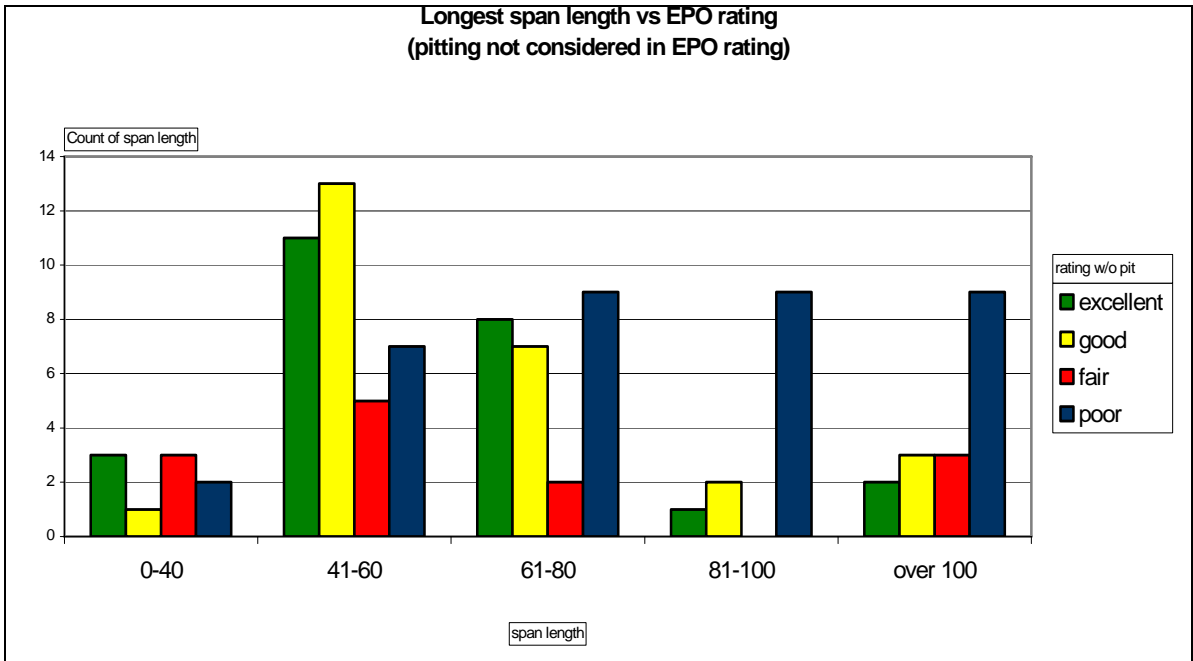
The span lengths of the bridge had an effect on the performance of the overlays. We compared the longest span length and overlay rating which indicated that the longer span bridges were more likely to have problems with their overlays. See Figure 7 and 8. This is not surprising since the longer spans will be more flexible, increasing the chance of the epoxy and/or deck cracking. Some of the newer epoxies are more flexible than the older epoxies, which should help with this problem. For bridges with long spans it would be more cost effective to look for an epoxy that is more flexible as opposed to going with the cheapest product. Transpo-T48 is a more flexible epoxy that might provide better protection on flexible decks. The girder type is related to the span length so the same pattern was found. Bridges with steel wide-flange sections and P/S I girders had higher EPO ratings than steel plate girders. See Figure 9.

Figure 7. Longest Span vs. EPO rating
