**Effectiveness of  
Metal and Concrete Pipe  
Currently Installed in  
Missouri  
(Phase 2)**

Prepared by  
Missouri Department of  
Transportation

**FINAL REPORT**

**January 2008**

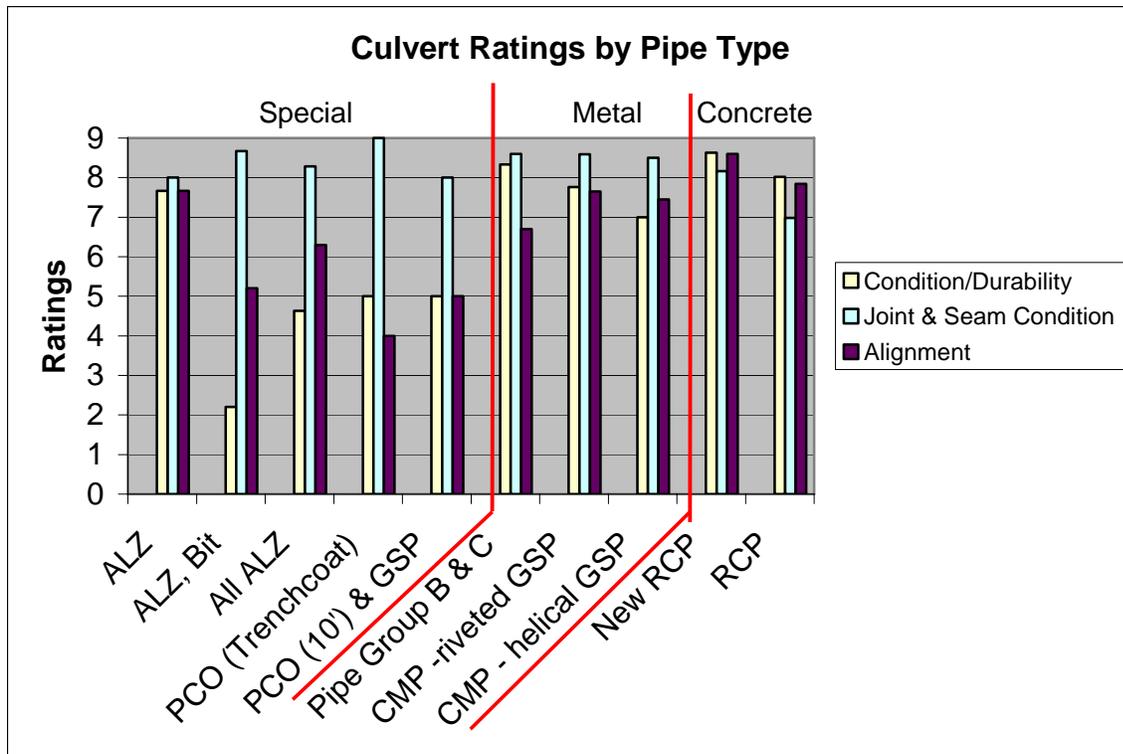
Figure 1:

Special metallic pipe are listed first. Aluminum Alloy pipes rate among the best of metallic pipe and it should be noted they are in the 33-45 years age group. Only three of these pipe were

inspected in this study and there is only a half dozen state wide because of the cost of solid aluminum alloy. Aluminized steel pipe was broken into two categories because the old bitumen coated aluminized pipes were in much worse condition than the uncoated aluminized which were rated high in all three criteria and overall with a 7.78 rating, next highest to Aluminum Alloy of the old in-place metal pipe. The bituminous coating was used in District 7 in known acidic areas, instead of just wearing off it must have trapped moisture and acid under it and caused a faster rate of corrosion. The next special material pipe is the polymer-coated steel, PCO. The first listed, located again in St. Clair County in District 7, is the only PCO entirely coated with Trenchcoat, a 3M coating used in 1997, when it was installed. This full-length polymer coated pipe was deteriorating at the outlet end where acid water runoff from this harsh area sat and damaged the pipe, thus it had a condition rating of 5. Another PCO pipe was installed in District 3 in 1990 but only experimentally using a 10 ft. section of the PCO pipe attached to a longer section of galvanized steel. The PCO part of this pipe, which was the inlet section, was rated 8, however, the galvanized steel CMP portion of the pipe had a condition rating of 5 because the invert was mostly covered with rust, this brought the overall rating to 6. These PCO pipe also have a problem of the outside coating deteriorating from ultra-violet light and the coating peeling off.

New galvanized steel CMP pipe are next and are listed as Group B & C pipe per the 2004 specifications. Even though these are new pipe installed after 2001 and have ratings above 8 for Durability and Joint and Seam Condition, they are rated below 7 on Alignment. These pipes are more flexible than concrete and need extra care taken when preparing the subgrade and backfilling, much like polyethylene (HDPE) pipe discussed in a previous report, Organizational Results Research Report OR08-002. The general CMP pipe, which are all galvanized steel pipe, are broken down into the older riveted corrugated plate sections and the newer helically wound corrugated types. The 18 CMP riveted were installed between 1993 to 2007 and had an overall rating of 8.0 slightly higher than the nine helical CMP installed between 1995 to 2002 with an overall inspection rating of 7.65. The ratings for Alignment were slightly less for the helical pipe. It was shown earlier that this pipe is flexible and can be damaged and punctured by rocks and the alignment changed if not backfilled properly.

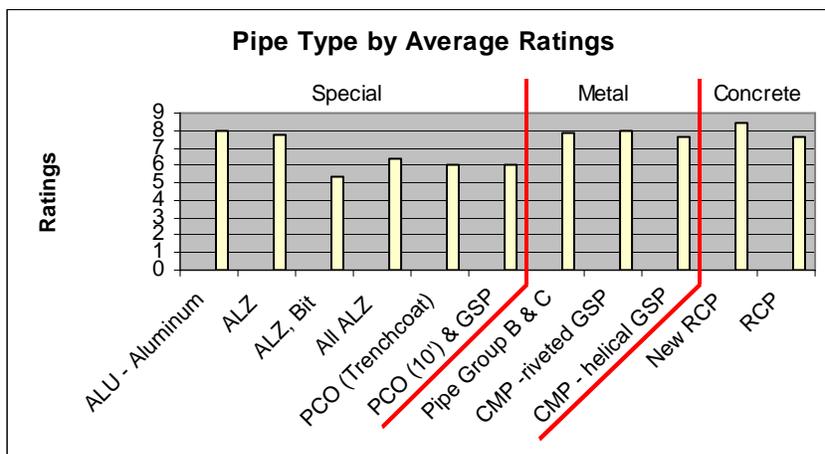
Figure 2:

That leaves only reinforced concrete pipe left (RCP), Group A in the 2004 specifications. The Condition and Alignment ratings are very high on these, over 8.5 for the new and near 8.0 for the older RCP pipe. The joints are the main problems and that rating was a little lower, 8.17 for the new and 6.98 for the older pipe. The overall rating for the 30 New RCP pipe installed 2002-2007 was 8.47 and for the 45 old RCP installed 1935-2001 was 7.61. Overall the Condition and Alignment ratings for concrete are better than metal but the Joint rating is more than one point less than metal pipe. It should be noted that the concrete pipe inspected in this study have been in service for as long as 72 years. Compare this to metal pipe inspected that have been in service only 5 to 14 years and one just installed in November 2007. If aluminized steel pipe are included in the metal category the oldest inspected was installed in 1952 and has been in service 55 years.
