DEVELOPMENT OF DESIGN CRITERIA  
FOR CUT SLOPES IN LOESS

**STUDY NO. 74-1**

**MISSOURI STATE HIGHWAY DEPARTMENT  
DIVISION OF MATERIALS AND RESEARCH**

**FINAL REPORT**

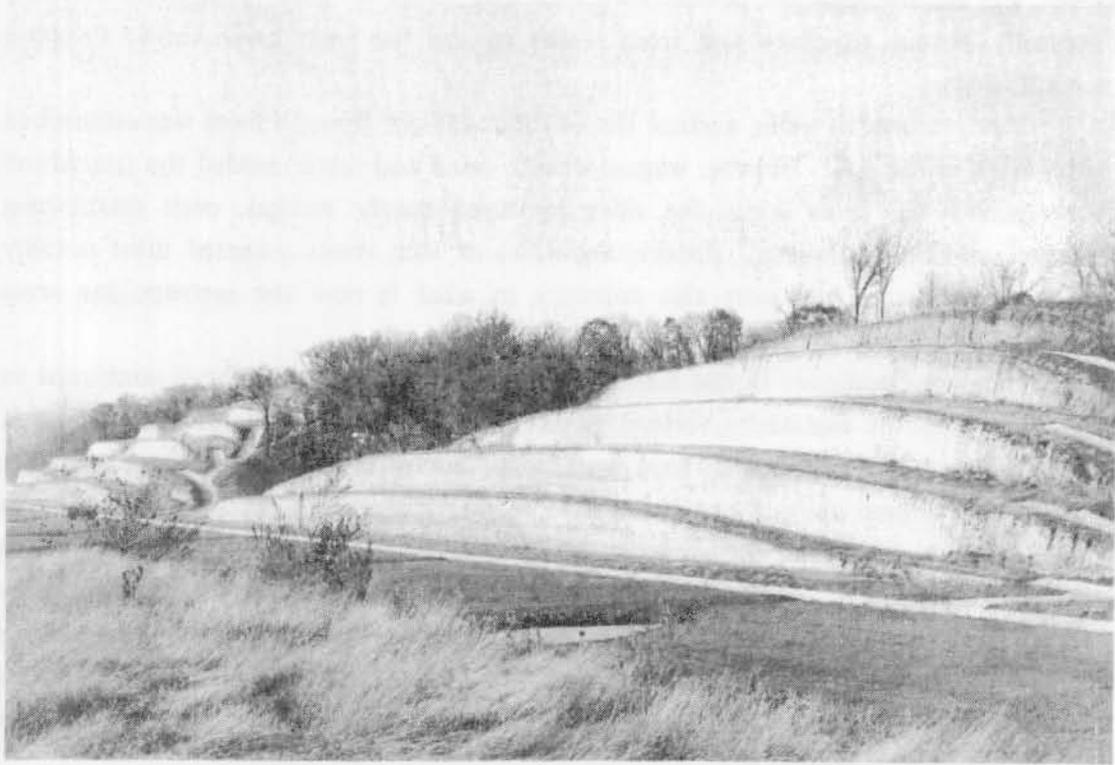
Figure 1. Example of successful use of near vertical rises with benches (stepped slope) (Buchanan County, I-229)

Three cuts with north-south orientation and up to 105 feet in depth were constructed through loess in a hill immediately east of the Missouri River and within the northwest urban limits of St. Joseph (see Figure 1)

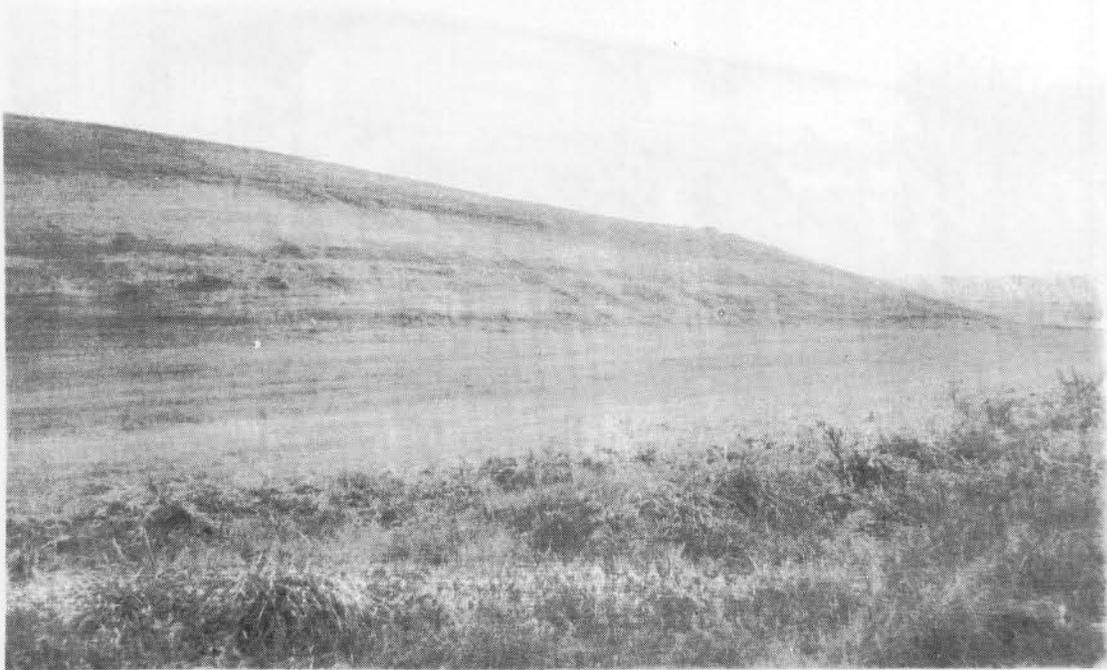
Figure 3. Example of a flattened slope ( $2\frac{1}{2}$  on 1) performing adequately in highly erosive loess. (Howard County, Route D(87))

Over a six year period, the 2 1/2 to 1 slope section has performed well (see Figure 3). The vegetative cover has prevented serious erosion and seems to have "healed" the initial erosion that occurred with exposure. The highest vertical rise, which was above the water table and where moisture contents now average 19 percent, is performing fairly well with only minor sloughing near the base of the rise. The lower two rises have deteriorated to the point of starting to undercut the upper rise. The benches are gone and the slope is approaching an effective 1 to 1. Erosion has been out of control for several years and continual ditch siltation is occurring.

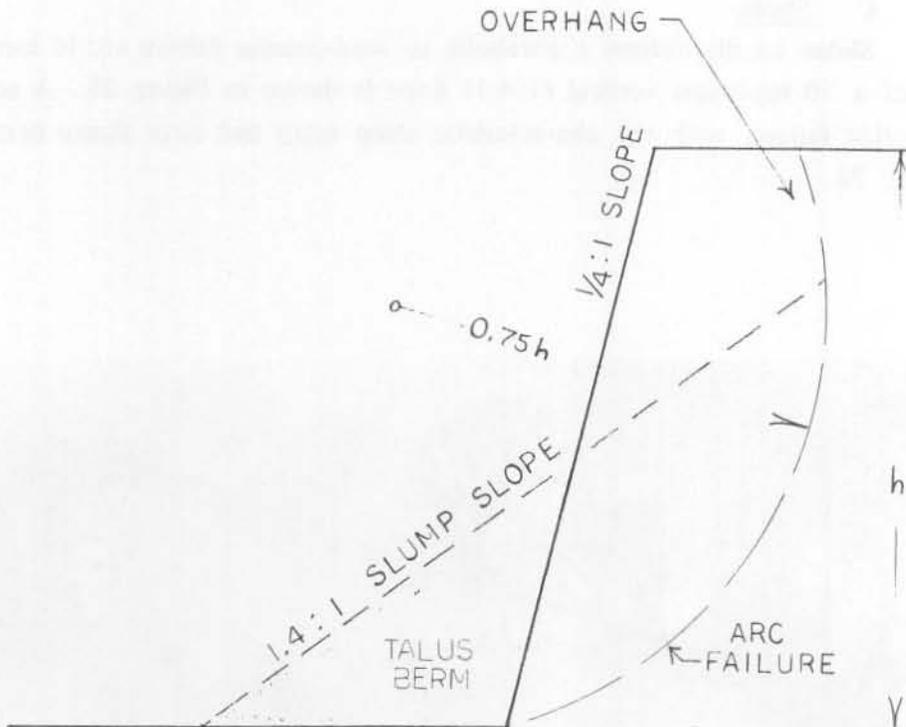
Slides usually follow a parabolic or semi-circular failure arc in loess. A slide failure of a 50 foot near vertical (1/4:1) slope is shown in Figure 25. A schematic of typical slide failure, with the characteristic steep scarp and large slump berm is shown as Figure 26

Figure 26. Schematic of a slide failure surface in a near vertical slope

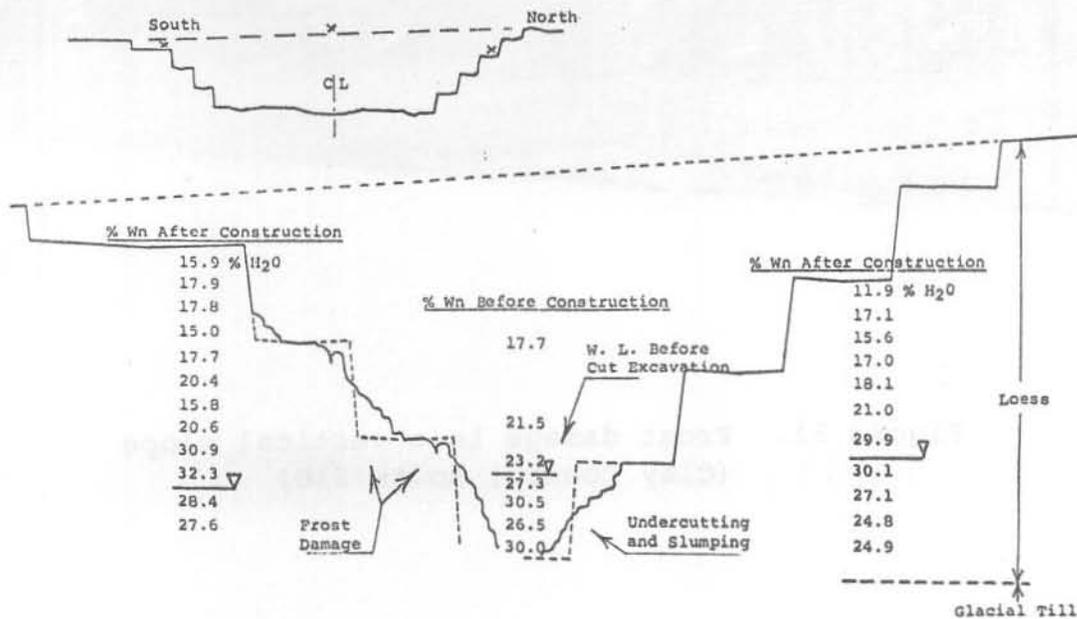
At this location, 86 feet of loess was found overlying glacial till with an original water table 20 feet above the till contact (see Figure 32). The loess strata intercepted are tentatively identified as Bignell, Peoria and Roxana with pockets of fine sand and silt with low cementation near the base of the cut (Loveland).

Figure 32. Comparison of moistures before and after construction at Station 1000, Holt County, Route I-29.

The roadway is oriented northwest to southeast with grade just above the till contact and about 18 feet below the original water table. Preconstruction moisture contents in the loess averaged about 17 percent above the water table and 28 percent below. The planned design for this area called for 20 foot wide, sodded V-shaped benches and nearly vertical rises (1/4:1) to a maximum of 20 foot height. Five rises were used on the southwest facing slope and four on the northeast facing slope. A basic design assumption was that pilot trenching of the cut would lower permanent water levels and reduce the high moisture content of the loess below the original water table.

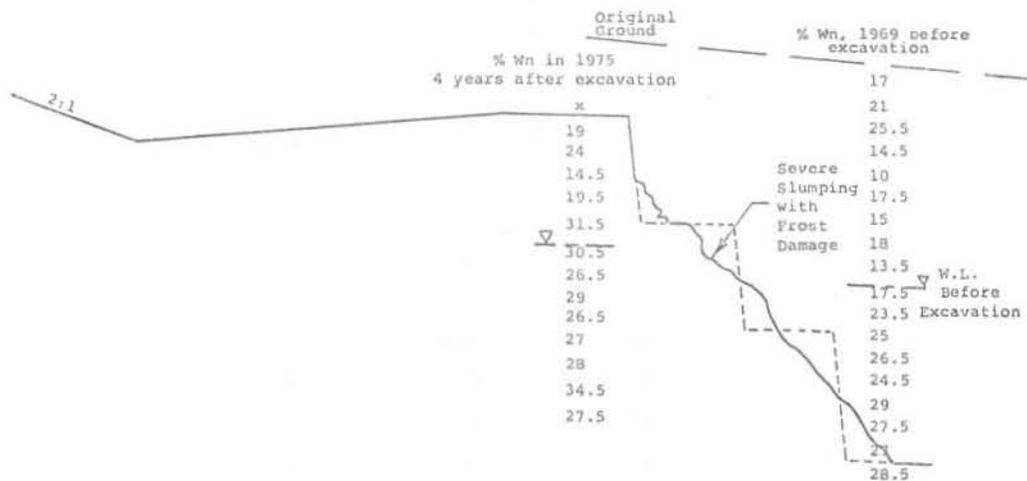
This north-south oriented, 90 foot deep cut is on the south bank of Greggs Creek immediately east of the Missouri River. Original sampling at this location revealed a high water table with moisture contents averaging slightly less than 17 percent above the water table and 26.2 below. The cut was designed with 5 near vertical rises of 1 on 10 to 20 foot height with 15 foot wide sodded benches. The original water table was found at an elevation corresponding to the first bench at the toe of the second 20 foot rise (see Figure 33).

Figure 33. Comparison of moistures before and after construction at Station 23, Howard County, Route D(87).

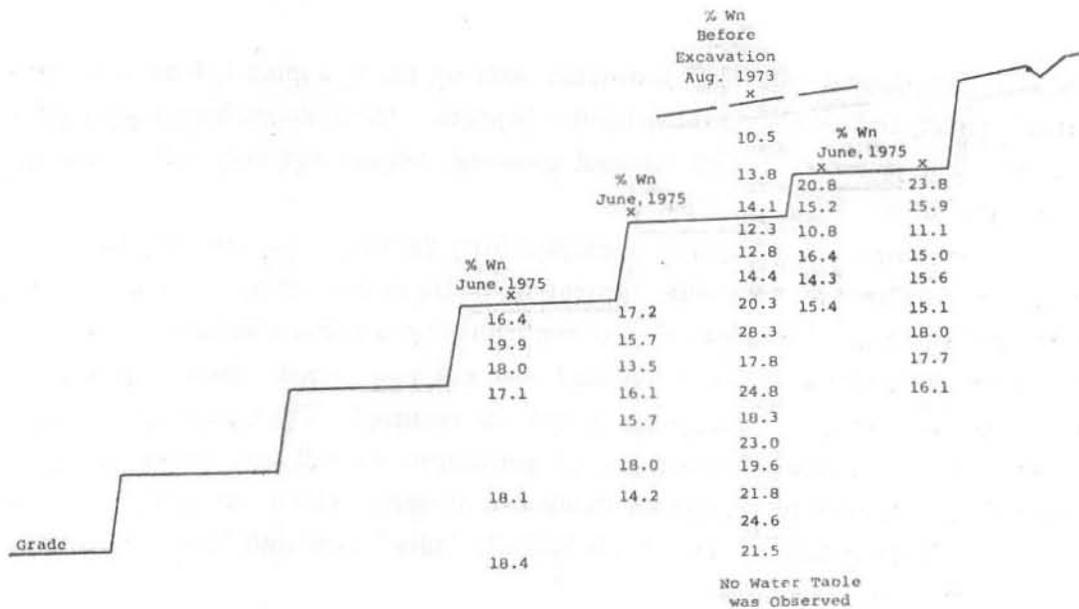
All of these cuts were sampled prior to excavation and no permanent water table was found. The results of all of the soundings were similar. Data from one of the cuts in the vicinity of station 131 is included as Table 16. Moisture contents averaged about 17 percent and the loess was found to overlie sand and gravel of glacial outwash origin (see Figure 34)

Figure 34. Comparison of moistures before and after construction at Station 131, Buchanan County, Route I-229.

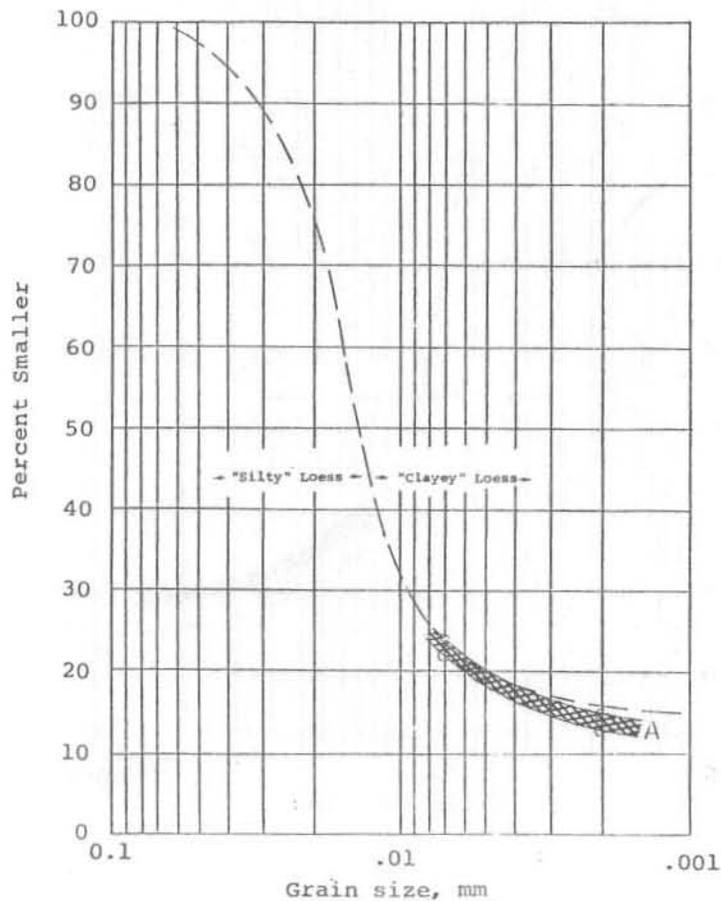
The five types of slope distress, as defined in the section entitled "Performance Survey", are related to the "silty" and "clayey" gradation bands in Figures 35 through 39. Figure 35 indicates the range of grain sizes found for samples obtained from slopes with erosion as a primary problem. The cross hatched area marked A indicates that, as would be expected, these curves fall in the "silty" loess range. These are mostly ML soils with an average liquid limit of 31.

Figure 35. Samples obtained from loesses having erosion problems have gradation curves which fall within the hatched area.

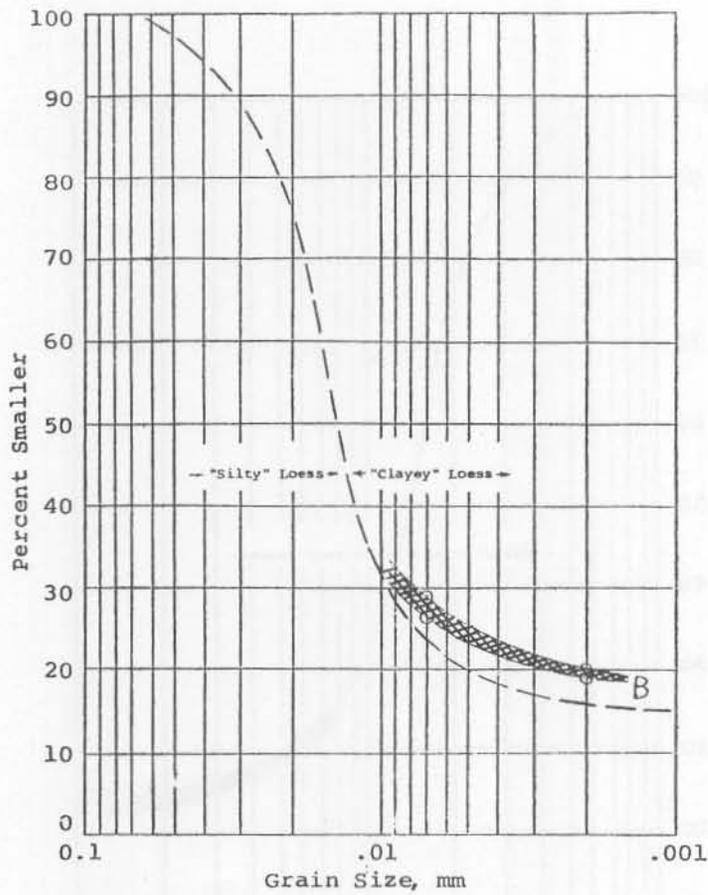
Figure 36 indicates the range of grain size distributions found for samples taken where volume change failures are occurring as sloughing and slabbing. The cross hatched area marked B indicates that these samples fall well in the "clayey" loess range with an average liquid limit of 35.

Figure 36. Samples obtained from loesses having volume change problems have gradation curves which fall within the hatched area.

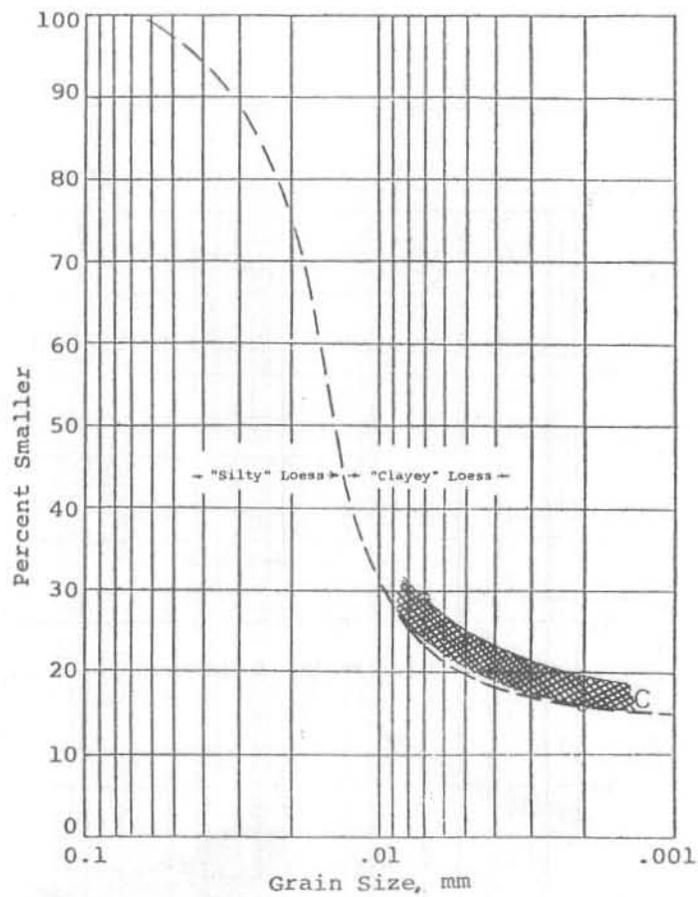
Figure 37 indicates the range of grain size curves for samples taken where slides were found. The cross hatched area marked C falls in the "clayey" range with an average liquid limit of 35.

Figure 37. Samples obtained from loesses in areas of slides have gradation curves which fall within the hatched area.

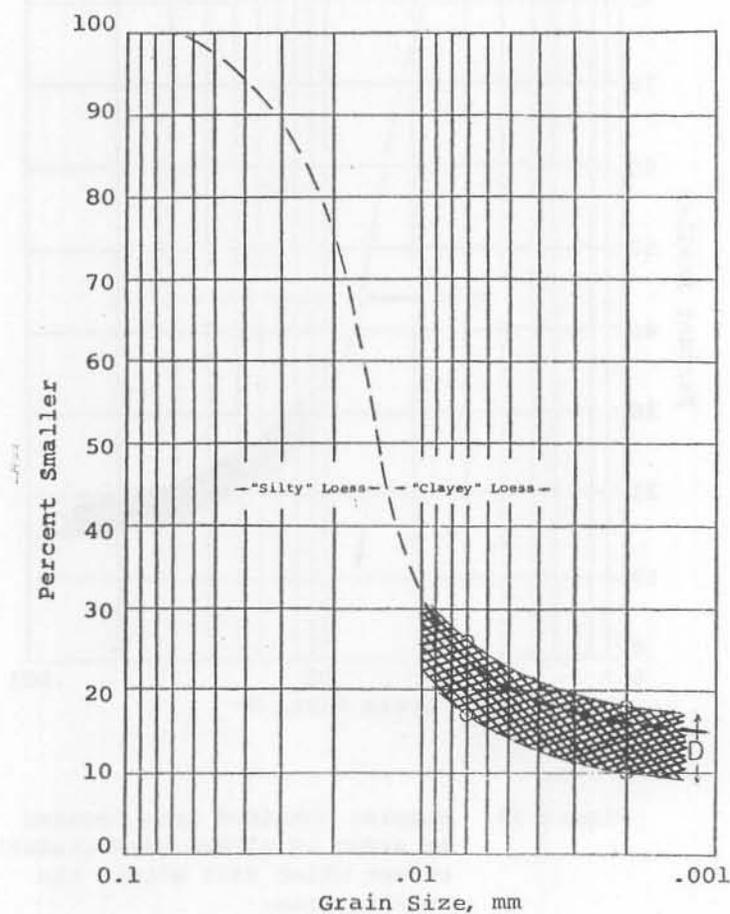
Figure 38 indicates the grain size range for samples taken where undercutting was occurring. The cross hatched area marked D indicates grain size curves to vary from "silty" to "clayey" in range. The corresponding liquid limit range is 31 to 34. This seems reasonable as the local failures which comprise this category are most often a consequence of high moisture contents, included truncated water tables, which cause problems in either category of loess when vertical slopes are used.

Figure 38. Samples obtained from loesses where undercutting is occurring have gradation curves which fall within the hatched area.

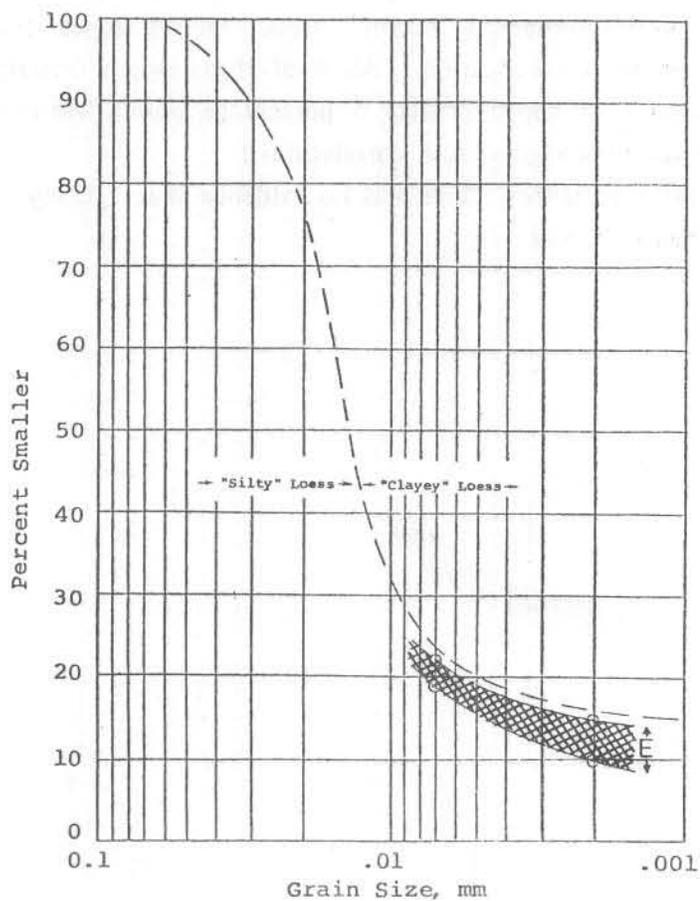
Figure 39 indicates the grain size range of samples secured in areas where frost damage was evident. The cross hatched area marked E indicates the "silty" loess soil normally identified with this type of failure.

Figure 39. Samples obtained from loesses where frost damage has occurred have gradation curves which fall within the hatched area.
