A STUDY OF DETERIORATION IN CONCRETE BRIDGE DECKS

Division of Materials and Research
Missouri State Highway Department

A Progress Report On
Investigation 59-2A
HPR 1(4)-30

Jefferson City, Missouri
October 1965

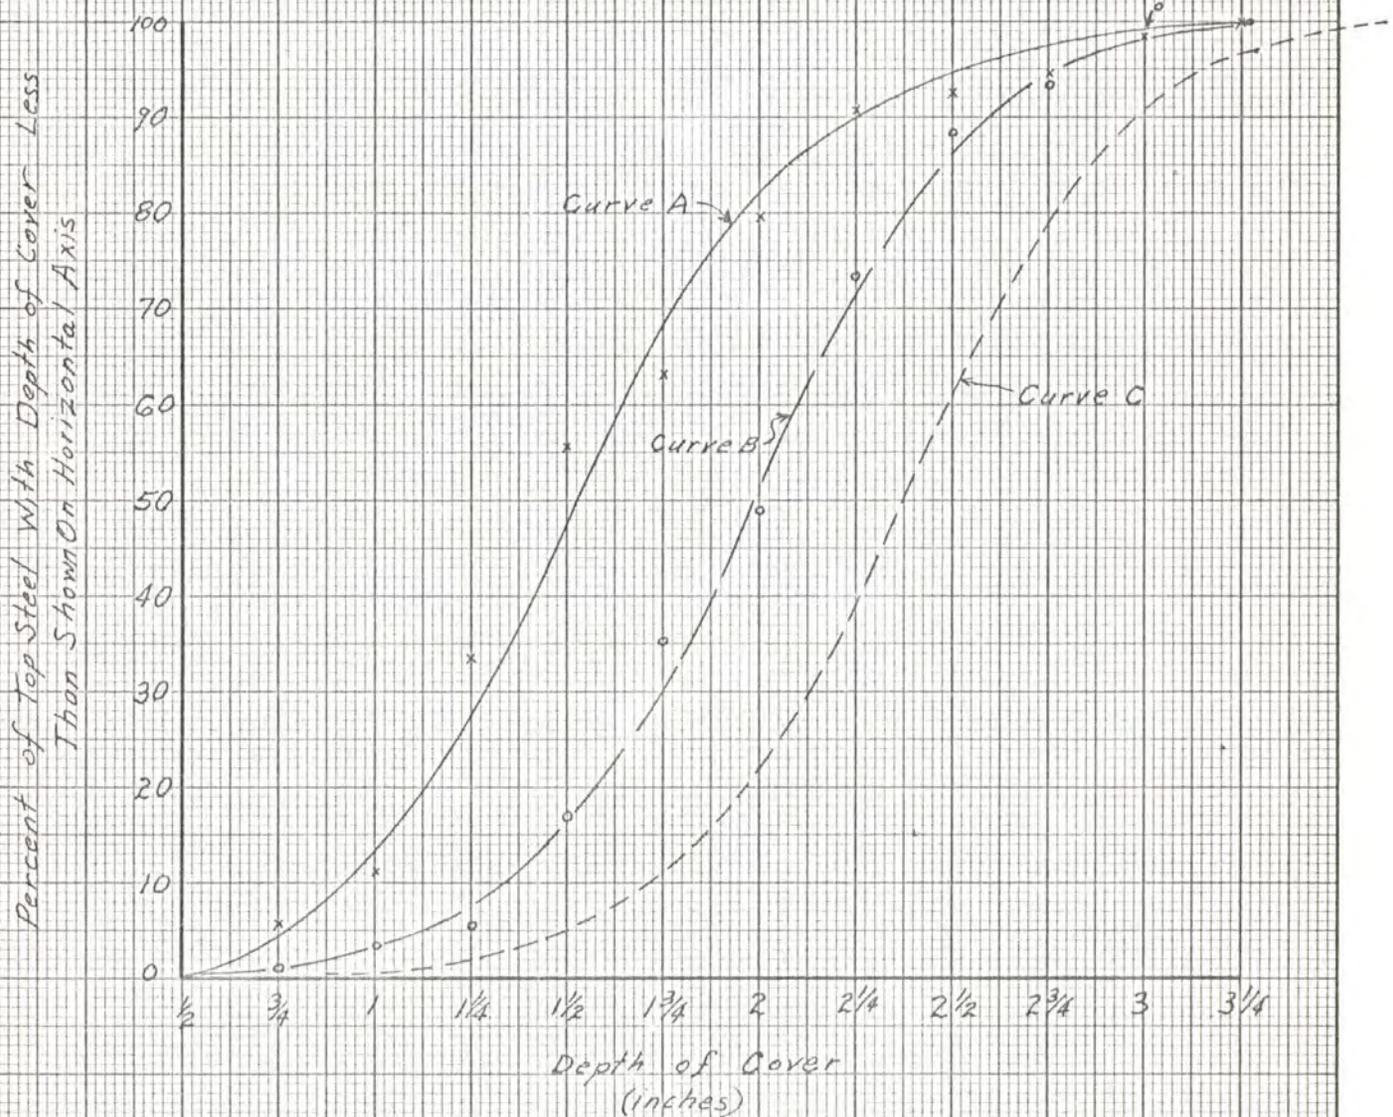
Cumulative Proportion Distributions For Depth of Cover Over the Top Reinforcing Steel In Areas of Bridge Deck With and Without Fracture Plane Deterioration

Curve A - Distribution in areas with fracture plane deterioration.

Curve B - Distribution in areas without fracture plane deterioration.

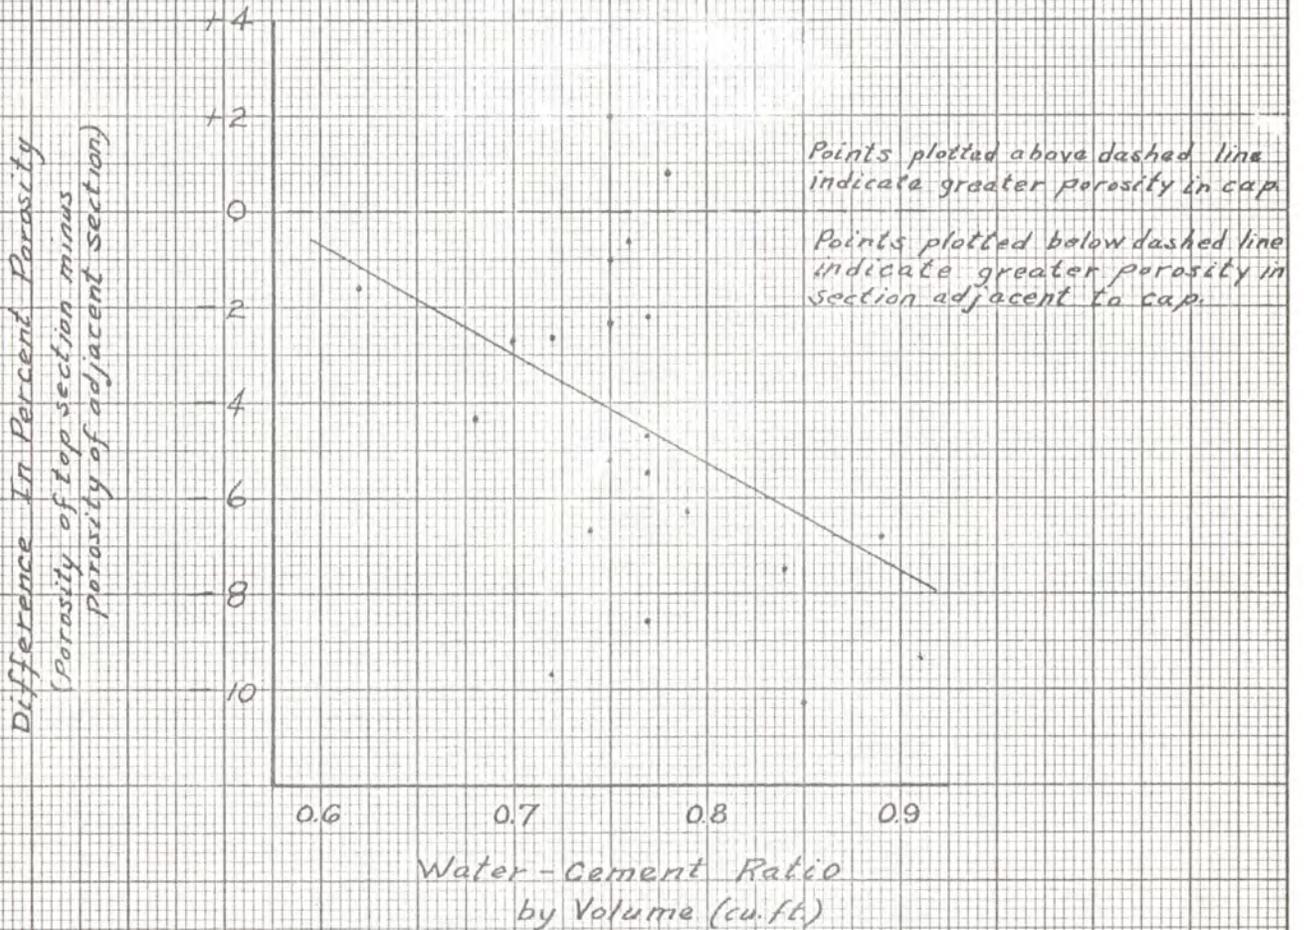
Figure 4

The relationship between water-cement ratio and difference in porosity of cement paste in concrete above and below a fracture plane for each core in Table D-1 is presented in Figure 4. The line of best fit indicates that this difference increases at the rate of 2.25 percent for each 0.10 cubic foot increase in water-cement ratio. The negative values on the ordinate (vertical axis) indicate that the porosity of the concrete below a fracture plane is greater than that above. The line of best fit intersects the line of zero difference at a water-cement ratio of 0.57 by volume (4.3 gallons per sack);

Difference In Porosity of Paste In Concrete Above and Below A Fracture Plane As A Function of the Water-Cement Ratio of the Core As A Whole.

this data indicates that there is a tendency for a greater occurrence of planes of weakness as the water-cement ratio increases above this amount.

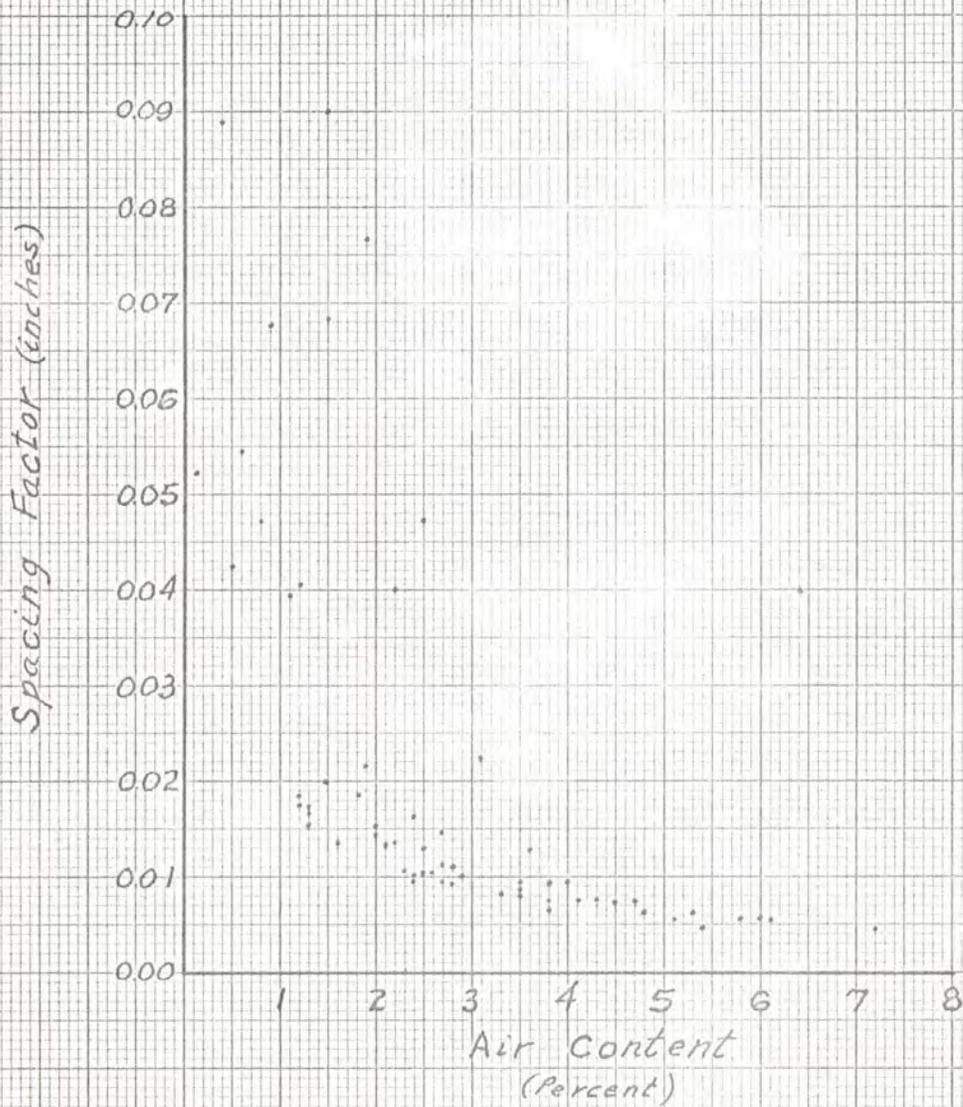
In Figure 5 is shown the relationship between percent air and spacing factor for each of the 61 cores tested. The data in this figure show that the spacing factor decreases as the percent of air increases. For those cores with air contents of 3 percent and above, the spacing factors are 0.01 inches or less — with two exceptions. Exceptions such as these usually indicate the presence of an excessive amount of entrapped air.

Bubble Spacing Factor As A Function of Air Content
