Research Development and Technology

Missouri
Department
of Transportation

Development of a Highway Rock Cut Rating System For Missouri Highways

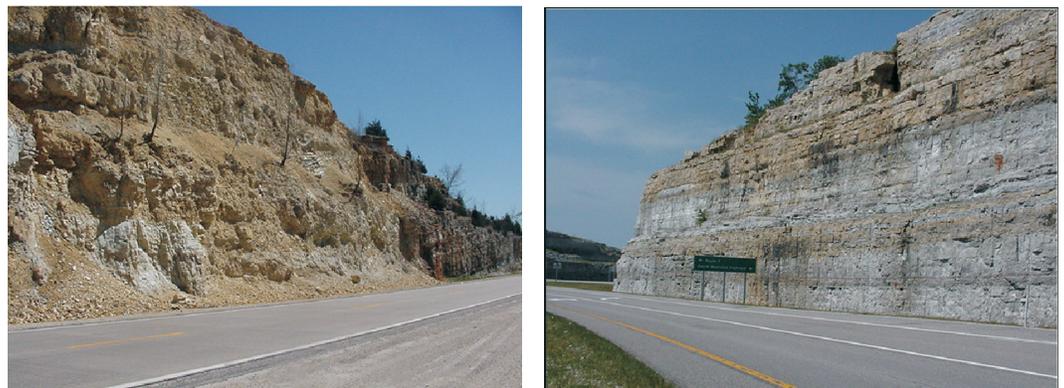
Figure 1: Missouri rock cuts with contrasting degrees of hazard (Left: Highway 63, Right: Highway 65)

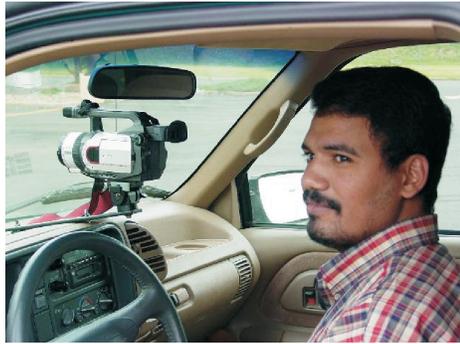
Figure 2: DV camcorder for video logging.

A simple, inexpensive digital video logging system (Figure 2) is used as a screening tool to identify problematic highway rock cuts. Alternatively the MoDOT ARAN system can be used to acquire digital images. A specific subset or the entire network of Missouri highways can be video logged. Trained geologists or geotechnical engineers can review the video footage at a computer workstation in their office to identify problematic cuts and then decide which sites warrant more detailed investigation.

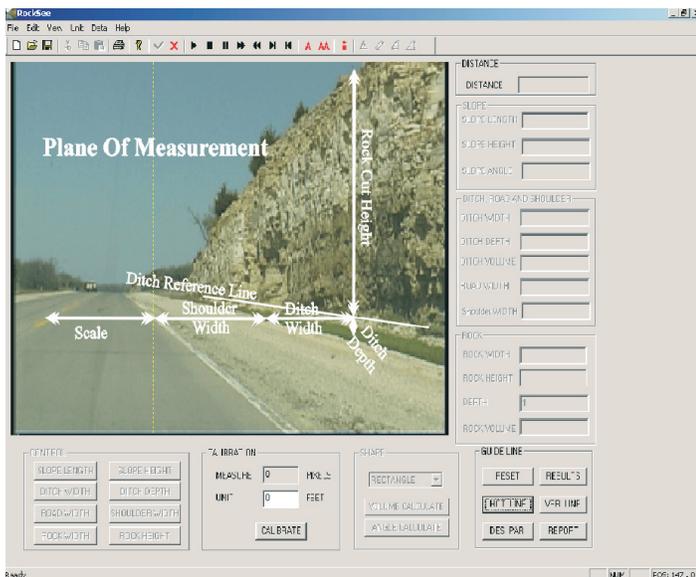
Figure 3: RockSee computer program to measure various parameters needed for the rating system.

The same images that are used for video logging can also be used to measure some of the parameters required for the rating system (Figure 3). Typical measurements include slope heights, lengths, and angles; ditch widths, depths, and volumes; mass volumes; and other linear measures.

Although not as accurate as manual measurements in the field, the measurements are sufficiently accurate to provide input data for a rock hazard rating system. Accuracy of the RockSee computer program was verified by calculating and comparing measurements from video images to manual measurements of road widths, ditch widths and depths, and slope heights and angles obtained using tape measures, measuring rods, and a range-finding clinometer. Errors on average were found to be less than 10%.

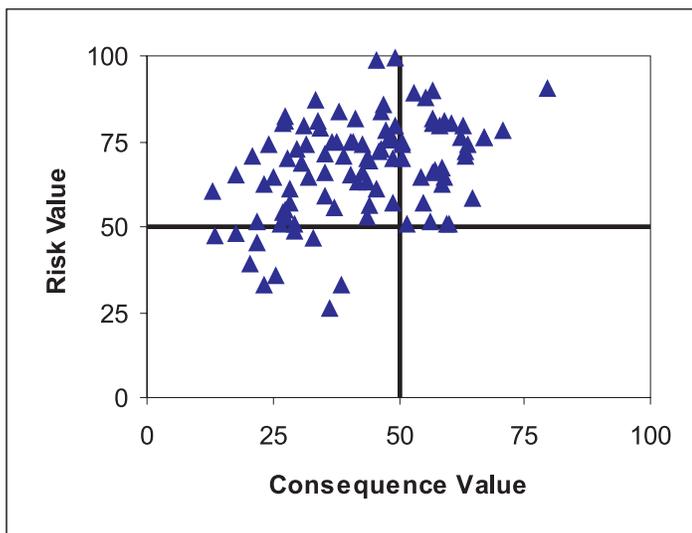
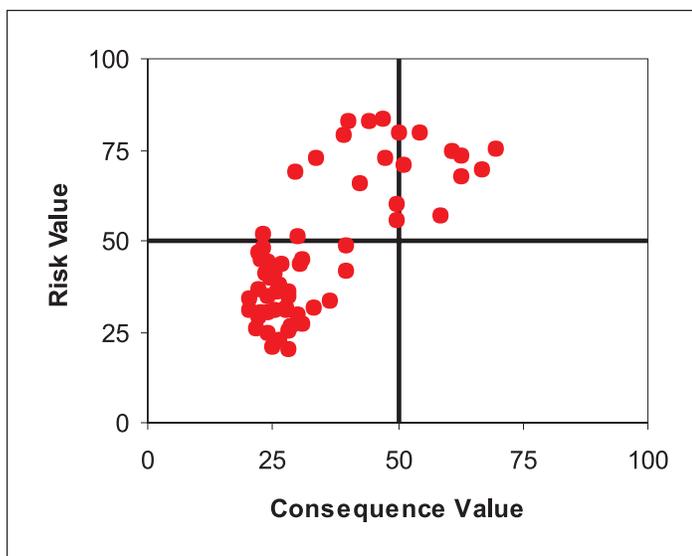
Figure 5: Ratings for sections of Highway 63 north of Rolla (top) and Highway 65 north of Branson (bottom).

The parameters are organized into a risk and a consequence rating on a scale of 1-100. Risk and consequence ratings are plotted against each other (Figure 4), and from this the relative priority of remediation can be determined (Figure 5).
