# Culvert Study Report

**CULVERT STUDY REPORT**

MISSOURI DEPARTMENT OF TRANSPORTATION  
RESEARCH, DEVELOPMENT AND TECHNOLOGY

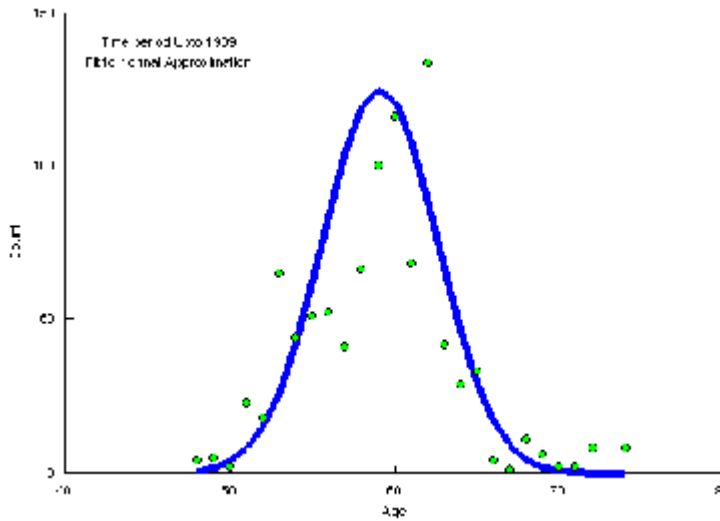
**Figure 1 - Useful Life of GSP from 1900 – 1939**

Figure 1 shows the normal distribution curve for GSP replaced from 1900 to 1939. The curve indicates that the average life is approximately 60 years.
