**RESEARCH INVESTIGATION 91-11**

**CULVERT STUDY REPORT**

MISSOURI DEPARTMENT OF TRANSPORTATION  
RESEARCH, DEVELOPMENT AND TECHNOLOGY

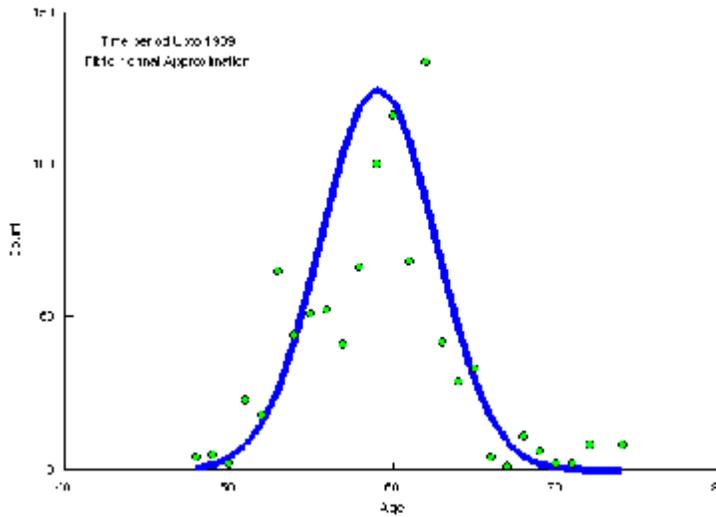
**Figure 1 - Useful Life of GSP from 1900 – 1939**

Figure 1 shows the normal distribution curve for GSP replaced from 1900 to 1939. The curve indicates that the average life is approximately 60 years.

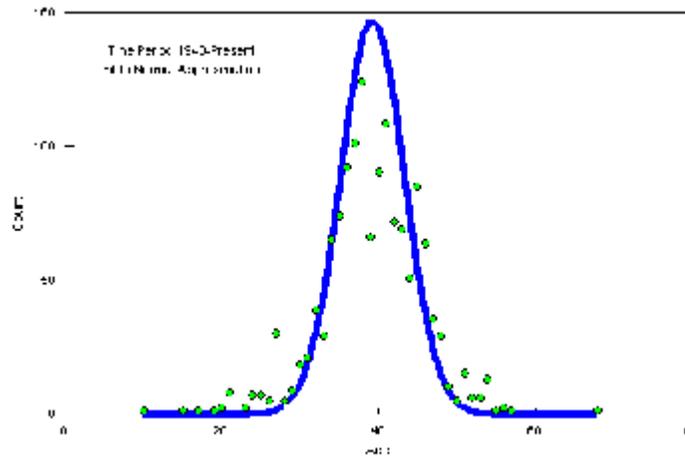
**Figure 2 - Useful Life for GSP from 1940 - 1998**

Figure 2 covers the time period of 1940 to the present. The useful life for this time interval is about 40 years.

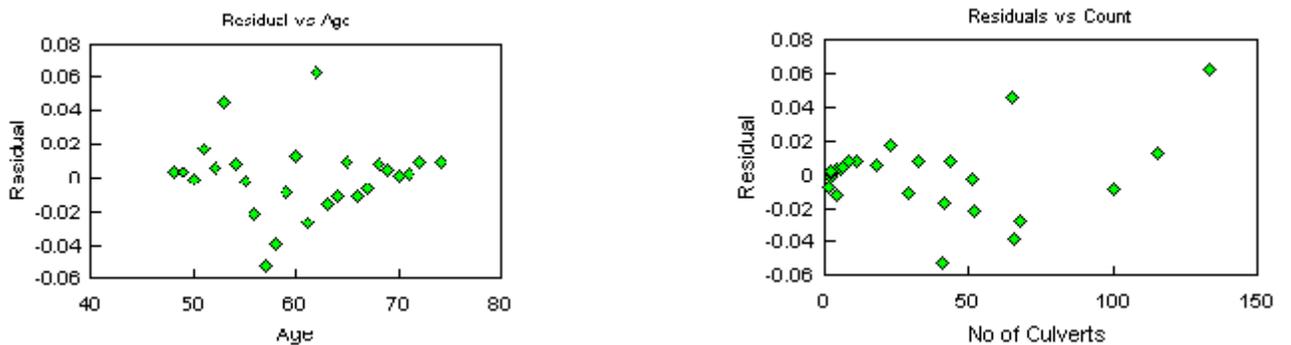
**Figure 3: Time period: Up to 1939**

Summary: There is no evidence the data does not fit the normal approximation because no patterns are evident in the residual plots for this time period.

The charts on the following pages show graphically how the separate distributions fit the data from their particular time period and how the time periods relate to each other. The purpose of the diagnostic plot analysis is to test the validity of the approximations. This is accomplished by plotting the residuals (the actual value minus the expected value) to check for any distinct patterns (see figures 3 and 4). Since there exist no contradicting evidence we will assume the data fits the normal approximation. The analysis will focus on the approximation for the time period from 1940 to the present because most of the culverts in place and those being installed will fall into this category.
