REPORT **MR 87-1**

**STUDY OF USE, DURABILITY, AND COST
OF CORRUGATED STEEL PIPE ON THE
MISSOURI HIGHWAY AND TRANSPORTATION
DEPARTMENTS HIGHWAY SYSTEM**

MISSOURI HIGHWAY AND TRANSPORTATION DEPARTMENT

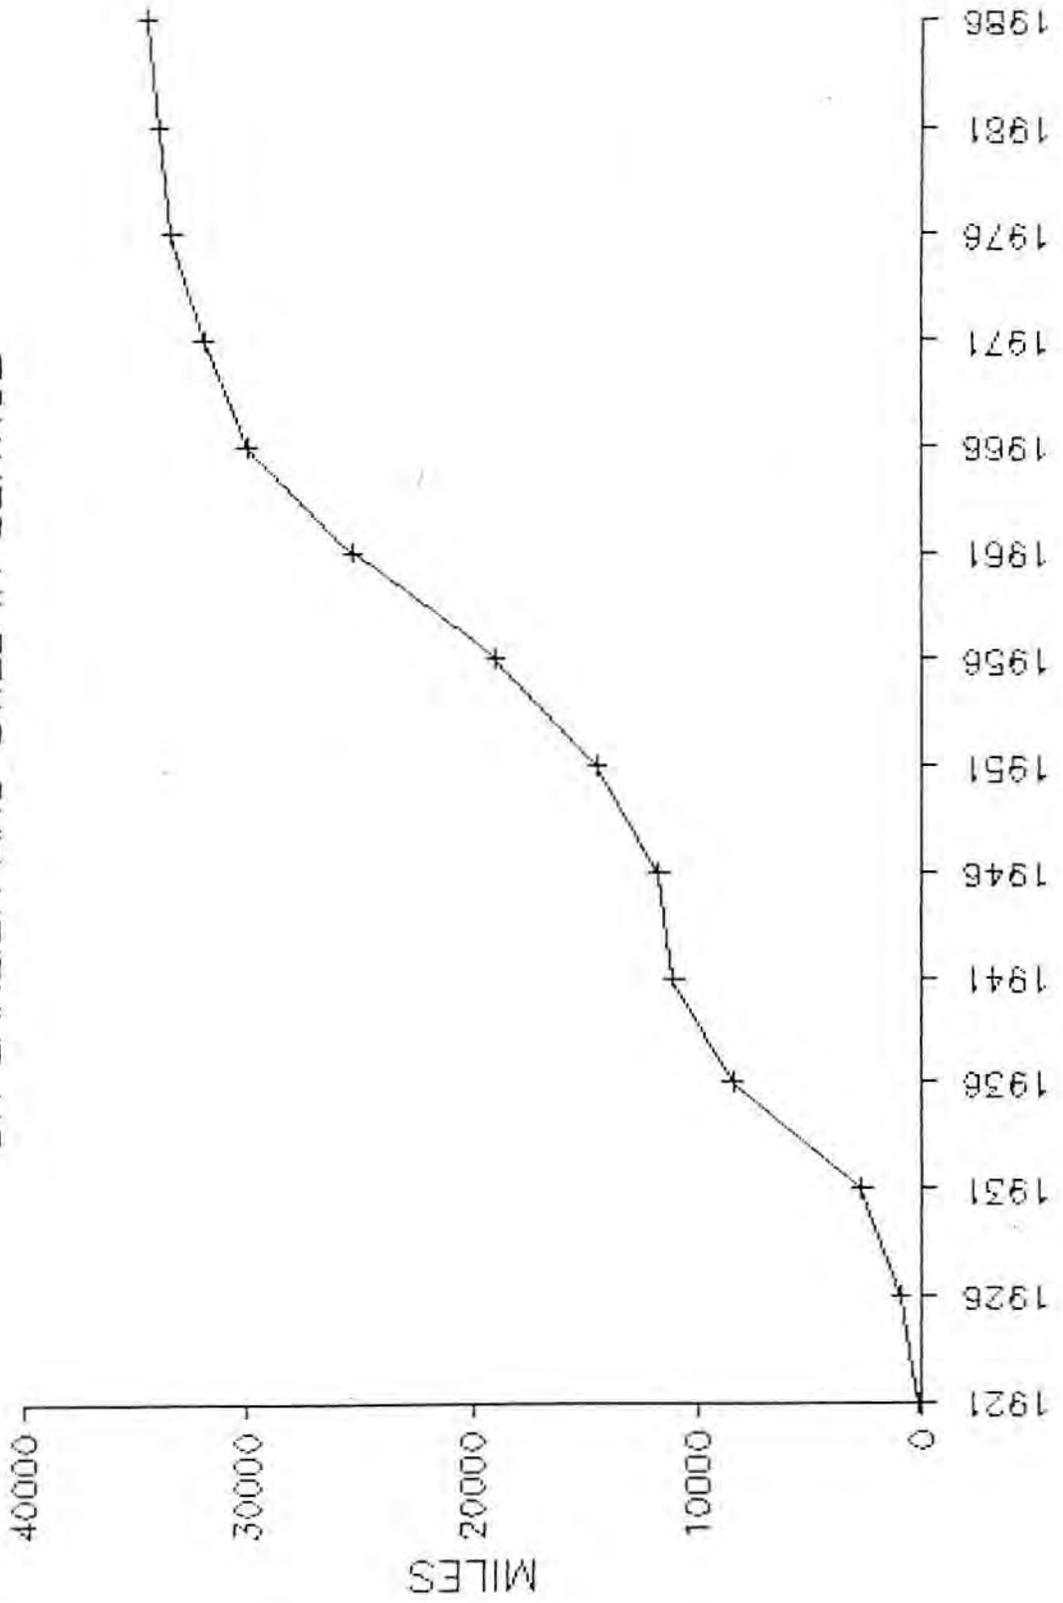
FIGURE 1

ROADBEDS CONSTRUCTED YEAR SHOWN
OR EARLIER AND STILL IN SERVICE

Table I shows the age - mileage distribution of the roadbeds in the Department's current highway system as obtained from the 1986 Service Ratings. Figures 1 and 2 graphically display the same data. Information was not available on roadbeds turned over to cities or counties for their continued use.

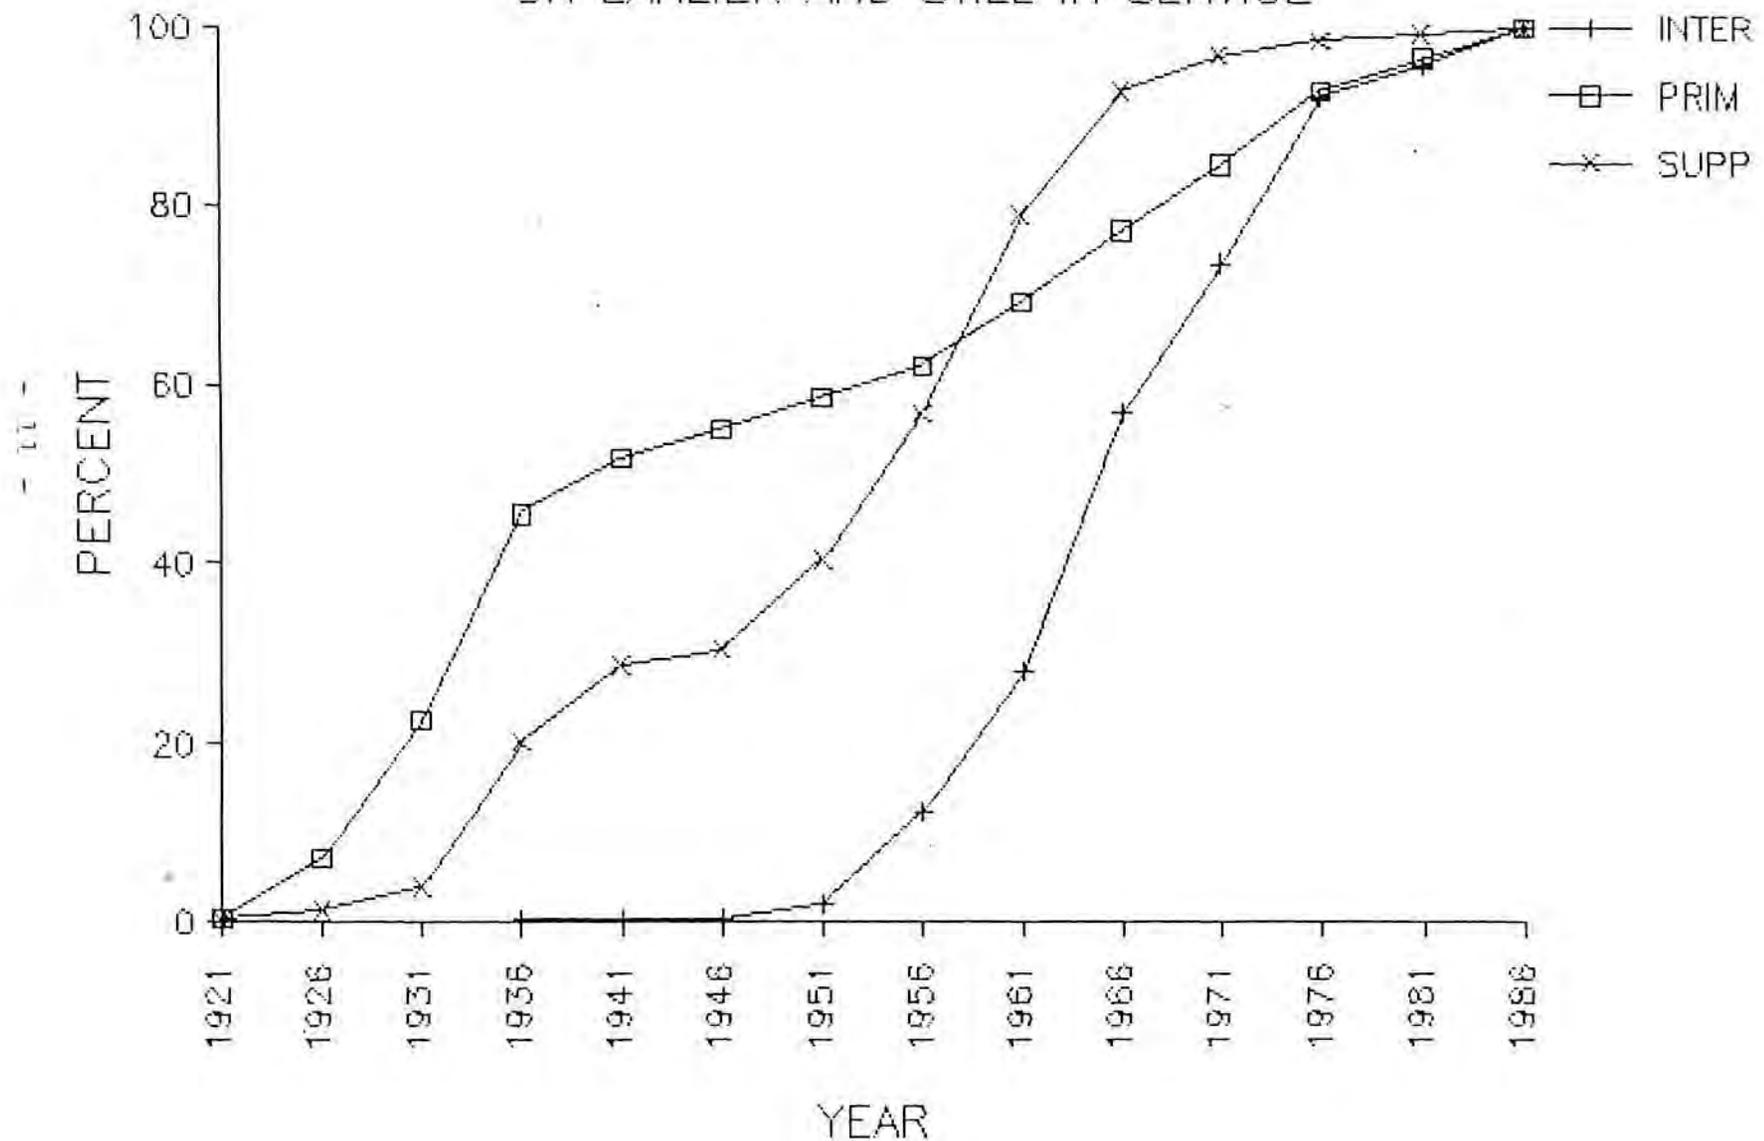
FIGURE 2

ROADBEDS CONSTRUCTED YEAR SHOWN OR EARLIER AND STILL IN SERVICE

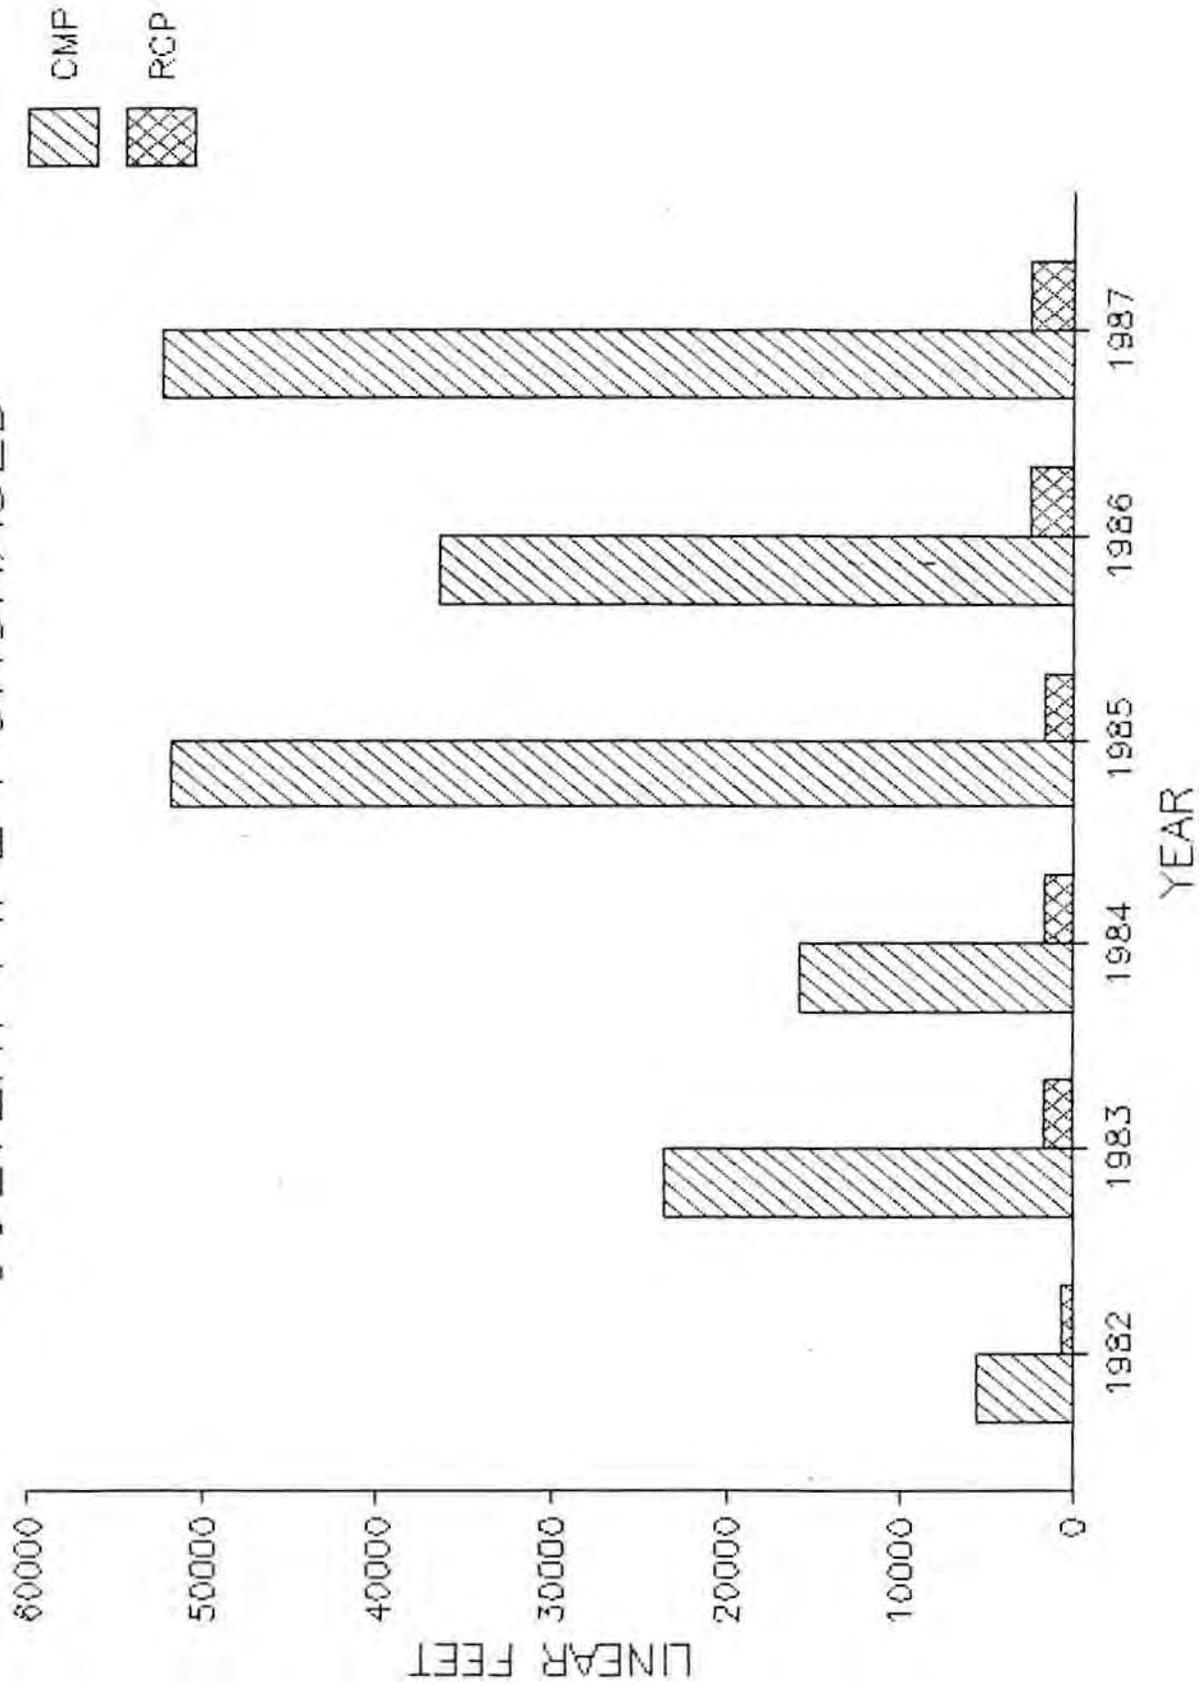
FIGURE 3

CULVERT PIPE PURCHASED

Actual usage figures were only available for the past three years, however, quantities purchased by the Department were available for the past five years and are shown in Figure 3. This figure also shows an increasing quantity of

CSP being purchased. A small, fairly constant quantity of RCP is purchased each year.
