White Paint Shouldn't Look Yellow

Technical Brief

Improve the Quality and Service Life of Water-based Pavement Marking Paints on Pavements with High-Iron Aggregates

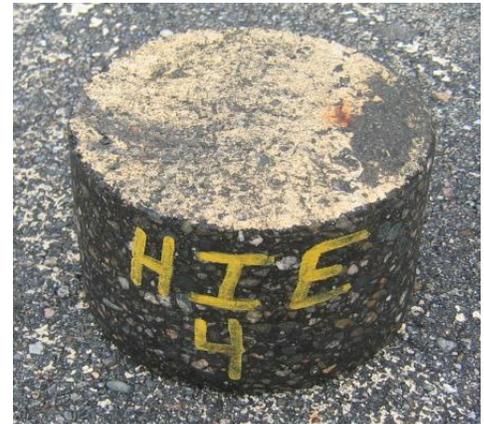
This paint should be white.

First, the study determined that the staining was caused by the rusting of iron compounds in the pavement aggregate. The study then considered different paint types (both solvent and water-based), various paint additives, and paint treatments (i.e., clear-coating). In addition, pavement treatments, such as sealers and grooves, were evaluated. Life-cycle cost evaluations determined the most cost-effective solution.
