Polyurethane Foam Infill for Fiber-Reinforced Polymer (FRP) Bridge Deck Panels

FINAL Report

TRyy1203

Missouri University of Science and Technology, Rolla, Missouri

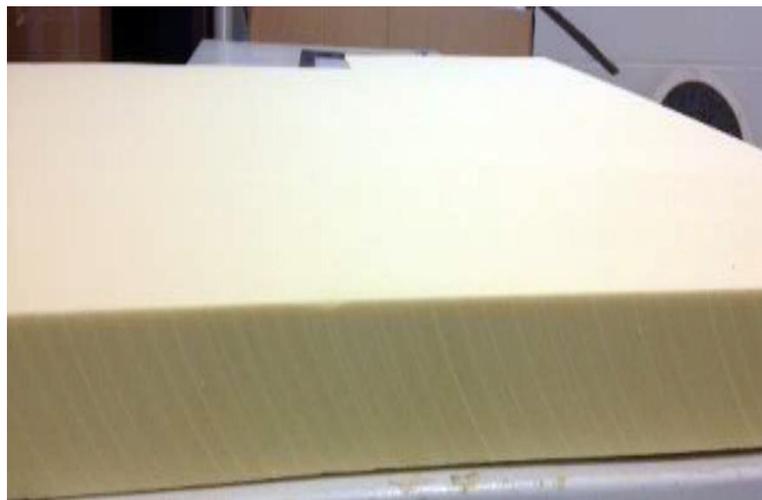
The Type 1 (PU RIGID), shown in Fig. 2.1, consists of a relatively high density polyurethane foam (6 pcf) without any special provisions or configuration. The advantage of the Type 1 material is that the manufacturing process is relatively simple as it only entails bonding of a top and bottom facesheet to the foam to form the sandwich panel. The disadvantage is that horizontal shear transfer between the facesheets relies solely on the shear strength and stiffness of the PU foam. The other disadvantage is that as the density of the PU foam increases, which increases horizontal shear transfer strength and stiffness, the cost increases.

Figure 2.1: Type 1 Polyurethane Foam (PU RIGID)

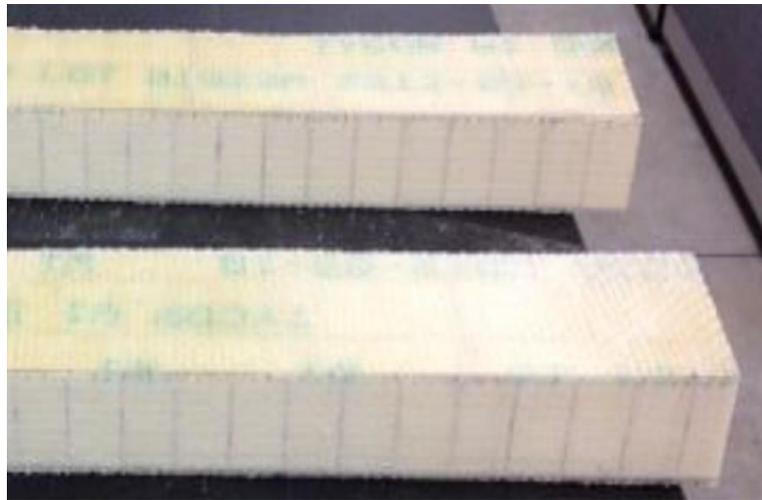
The Type 2 (WEB-CORE), shown in Fig. 2.2, consists of thin, interconnecting, glass mat/resin webs that form a bi-directional FRP gridwork that is infilled with a low density polyurethane foam (2 pcf). The advantage of the Type 2 material is that the FRP webs provide enhanced horizontal and vertical shear strength and stiffness, increasing the effectiveness of the sandwich panel. This type of panel is also relatively simple to manufacture, although the FRP webs require more care to ensure proper infusion of the resin. The disadvantage is that the FRP gridwork increases the cost of the foam compared to the Type 1.

Figure 2.2: Type 2 Polyurethane Foam (WEB-CORE)

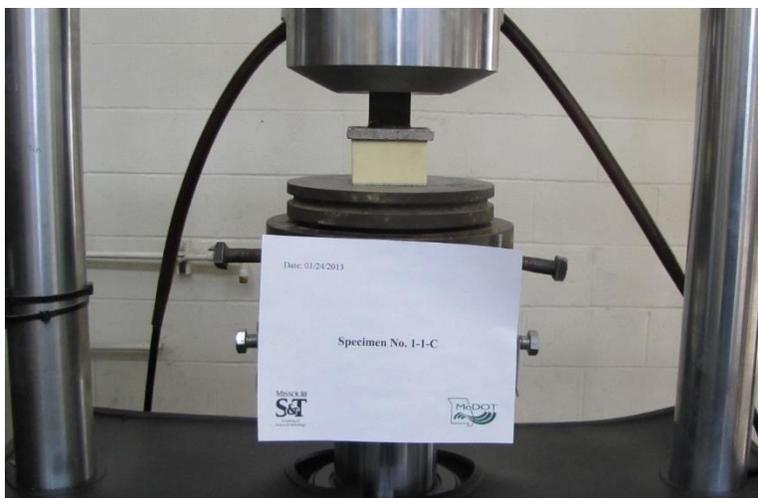
2.2.1.3. Test Procedure. Specimens were tested on multiple days at about the same time of day under similar temperature and humidity conditions. Before testing, the length, width, and depth of each specimen was measured using digital or dial calipers to the nearest 0.001 in. A minimum of three measurements were taken for each dimension and the average was recorded. The specimen was placed on the lower platen, and the platens were moved until there was a narrow gap above the specimen. The lower platen was locked into place and adjusted to be parallel with the top platen, and the load was zeroed. The specimen was centered using the concentric rings of the lower platen and the edges of the upper platen as a reference. For specimens with slight wrinkles in the facings, a thin ⅛-in.-thick rubber pad, Shore A hardness of 60, was placed between each platen to avoid any stress concentrations. The upper head was lowered until a small load was registered (10-50 lb.), then the displacement was zeroed. The test was displacement-controlled at a rate of 0.1 in./min. Displacement and load were recorded simultaneously at a rate of 10 Hz. The test was stopped once the displacement reached 50-80% of the depth of the specimen, which took 10-15 minutes, and the specimen was then unloaded.

Figure 2.5: Flatwise Compression Test Setup

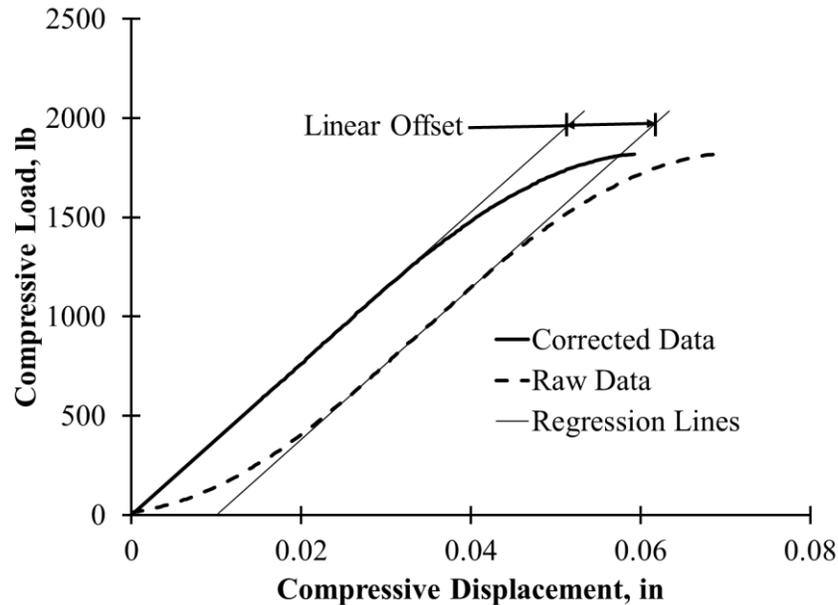
2.2.2. Test Results. The load and displacement were the primary results for this experiment, and before they could be normalized the data needed to be refined. The load versus displacement plots displayed Hookean (linear elastic) behavior before failure, but there were false nonlinearities and discrepancies in the initial readings. The nonlinearity was caused by small gaps in the system. Also, during testing the displacement was set to zero at a non-zero load. Both of these issues lead to a false offset in the displacement. In order to correct this issue, regression analysis of the linear region of the load versus displacement plot was used to correct this offset. Different ranges of the data were explored, and the range with the best correlation factor was chosen to be representative of the linear elastic region of the sample. Then, using the regression equation, the genuine part of the load versus displacement curve was offset by the x-axis intercept of the regression equation. Then, the false data at the beginning of the test was replaced by a projection of the linear region that intersected the origin. A graphical representation of this procedure is presented in Fig. 2.6.

Figure 2.6: Load vs. Displacement Correction using Linear Regression

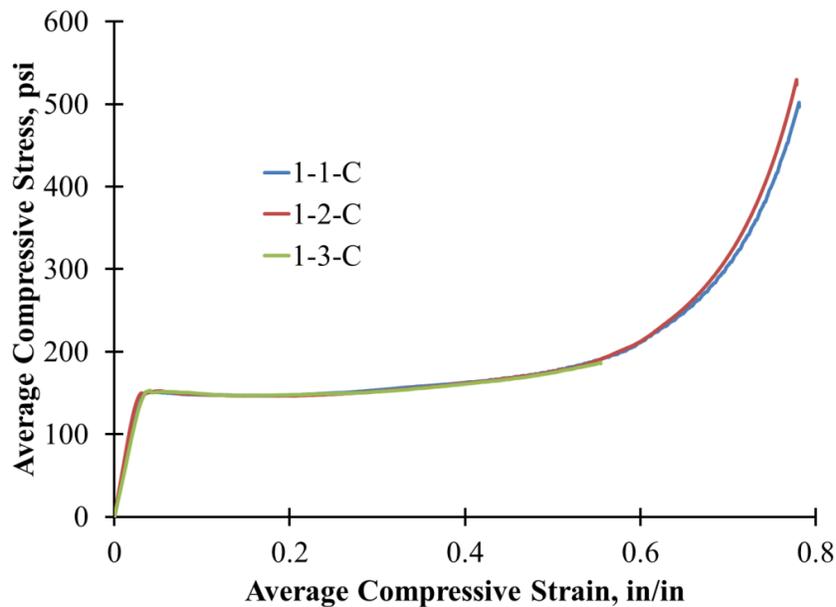
2.2.2.1. Results for Type 1. Three specimens were originally prepared and tested for the Type 1 core. However, during the testing of the original Specimen 1-1-C, the lower crosshead of the machine was not locked properly and the results were unusable. A fourth specimen was prepared and successfully tested, and the results of this test were used to replace the original 1-1-C data. Once the initial false nonlinearities and discrepancies in the load versus displacement response were corrected, the stress and strain were calculated for each specimen. The plot of stress and strain for each specimen is shown in Fig. 2.7. The stress versus strain response can be divided into three distinct regions, as shown in Fig. 2.8. The Type 1 core is constructed of rigid polyurethane foam that typically displays this type of response, and each region can be explained in physical terms.

Figure 2.7: Stress-Strain Results for Type 1 Flatwise Compression Test

In the second region, the specimen starts to fail as some of the cells collapse due to excessive buckling, yielding, and/or fracturing of the cell wall and struts. This begins at a critical location, which sets off a chain reaction that spreads throughout the cross-section, eventually encompassing the entire specimen. The material has an apparent yield point at the beginning of this region as stress temporarily peaks then fluctuates slightly as it remains nearly constant.

Finally, in the third region, the majority of the cells of the foam have begun to collapse and are permanently damaged. The damaged cell walls and struts deform to the point that their movement is impeded by the cells and struts near them. Eventually, through a process commonly referred to as densification, the foam becomes denser and more stable on the cellular scale as the voids close up. This response causes the stress to increase in a quasi-exponential manor as the foam becomes apparently stronger.

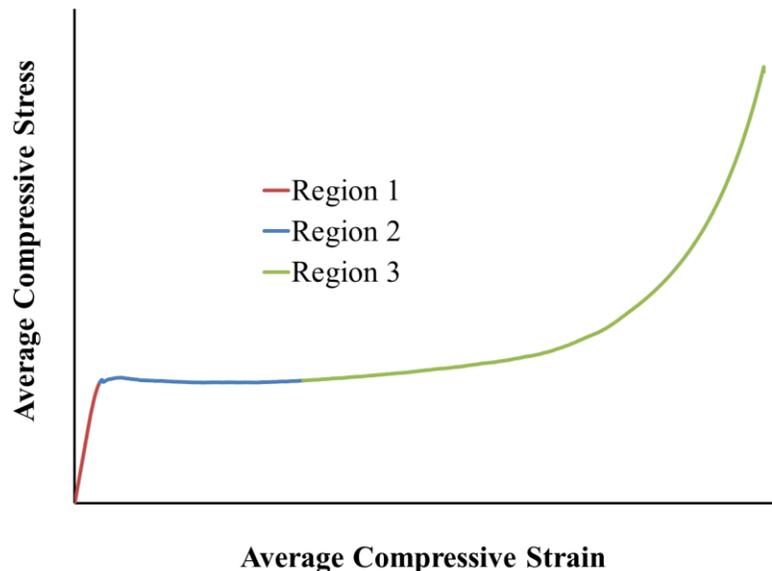
Figure 2.8: Generalized Stress-Strain Response for Type 1 Compression Test

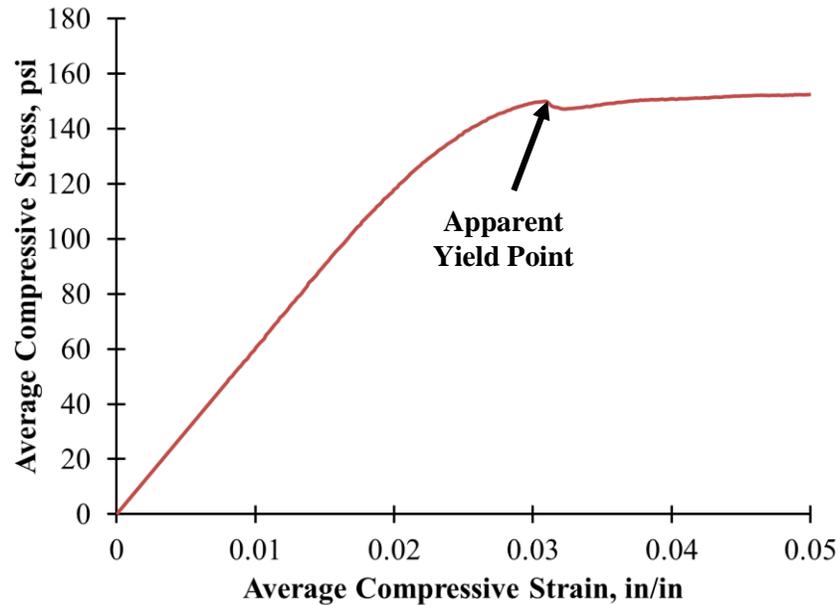
The plot of stress versus strain was then used to determine the strength and stiffness of the core material. The strength can be considered as the stress at failure, but first a failure point must be established. The failure occurs in the transition between the first two regions described previously and requires closer examination in order to define that point. Figure 2.9 shows a close up plot of stress versus strain for Specimen 1-2-C before and after failure.

In this plot, the transition between the regions is much more gradual, and the point of failure becomes difficult to define and somewhat subjective. However, there is an apparent yielding point that is located at the first small peak in stress where the specimen likely started to

fail. Also, this yield point is present on the stress versus strain curves for all three specimens, and it is easy to determine the stress and strain at this point. As a result, the flatwise compressive strength will be considered as the stress at this point. A visual representation of what the failure of the specimens actually looked like just after failure and at the end of the test is shown in Figs. 2.10 and 2.11, respectively.

Figure 2.9: Stress-Strain Response at Failure for Specimen 1-2-C Compression Test

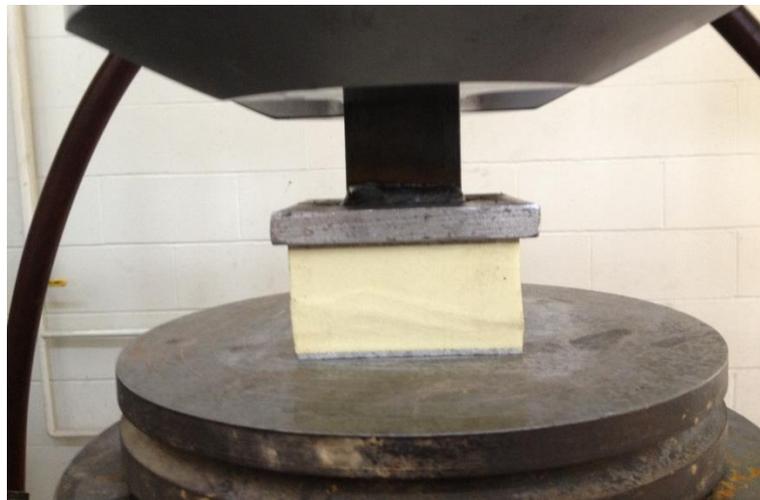
Figure 2.10: Damage at Failure for Flatwise Compression Testing of Type 1

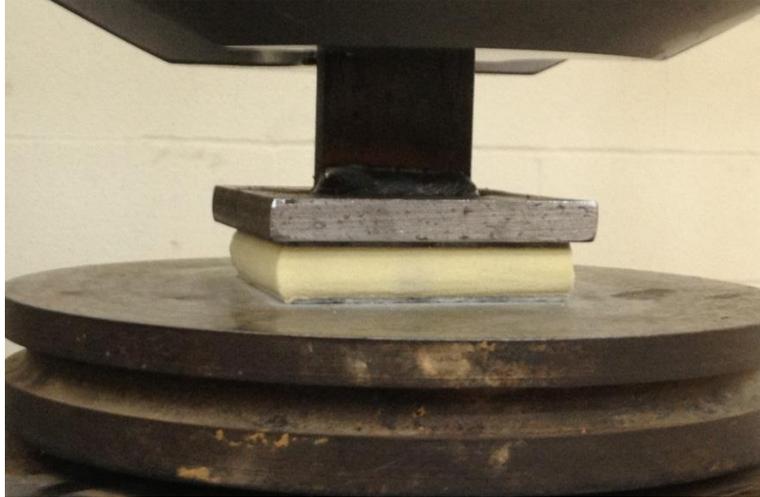
Figure 2.11: Damage at End of Test for Flatwise Compression Testing of Type 1

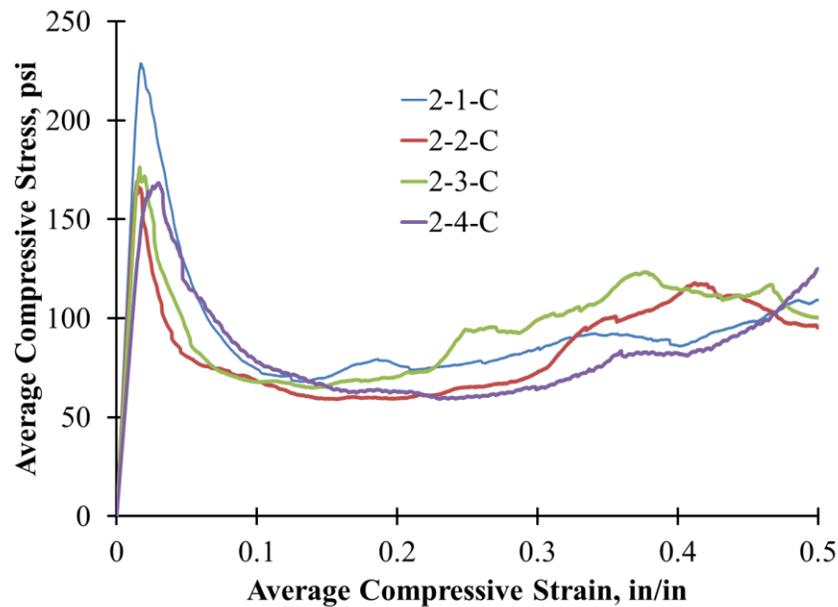
Moving forward with the analysis, the initial false nonlinearities and discrepancies in the load versus displacement response were corrected, and the stress and strain were calculated for each specimen. The plot of stress versus strain is presented in Fig. 2.12. The stress versus strain response has two distinct regions that are apparent in the figure, and each region can be explained based on the Type 2 core construction. The Type 2 core consists of thin, interconnecting, glass mat/resin webs that form a bi-directional FRP gridwork that is infilled with a low density polyurethane foam. This FRP gridwork plays an important role in the stress versus strain response.

Figure 2.12: Stress-Strain Results for Type 2 Flatwise Compression Test

In the first region, the web reinforcement has an apparent linear elastic behavior because the material consists of resin and fibers that display Hookean behavior to a point. The flexible foam contributes almost nothing to the response directly, but it does provide stability for the webs as they are very thin relative to their length. As a result, the global stress versus strain response in this region is linear, but as the load increases, minor defects in the webs or adjacent foam resulted in portions of the FRP gridwork beginning to buckle, and the behavior transitioned into the second region.

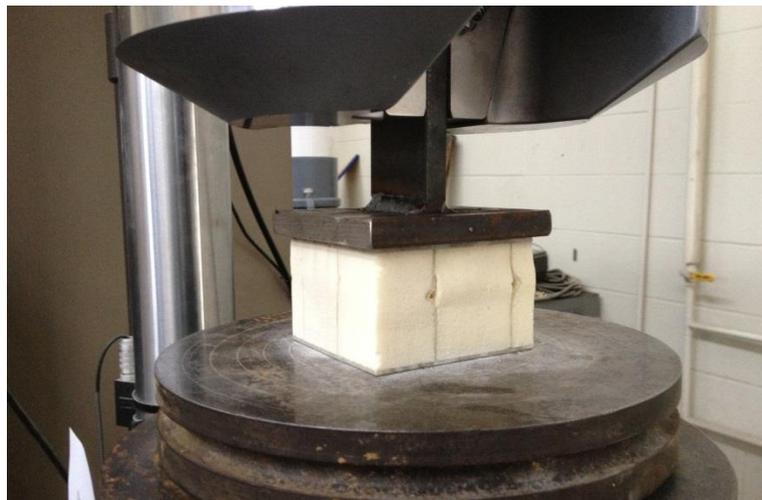
The compressive strength and stiffness were calculated using the stress versus strain plots. The flatwise compressive strength is more evident for the Type 2 core because failure occurred suddenly and was accompanied by a significant drop in load immediately after the peak value. Therefore, the stress at the maximum load was considered to be the flatwise compressive strength. A visual representation of what the failure of the specimens actually looked like just after failure and at the end of the test is shown in Figs. 2.13 and 2.14, respectively.

Figure 2.13: Damage at Failure for Flatwise Compression Testing of Type 2

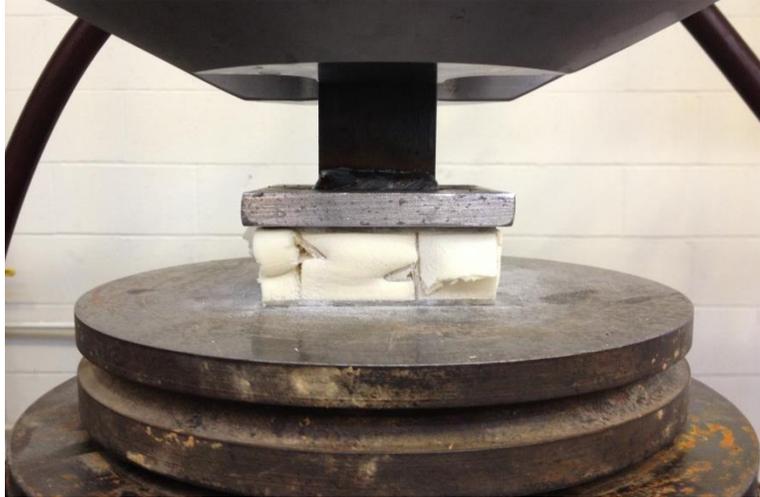
Figure 2.14: Damage at End of Test for Flatwise Compression Testing of Type 2

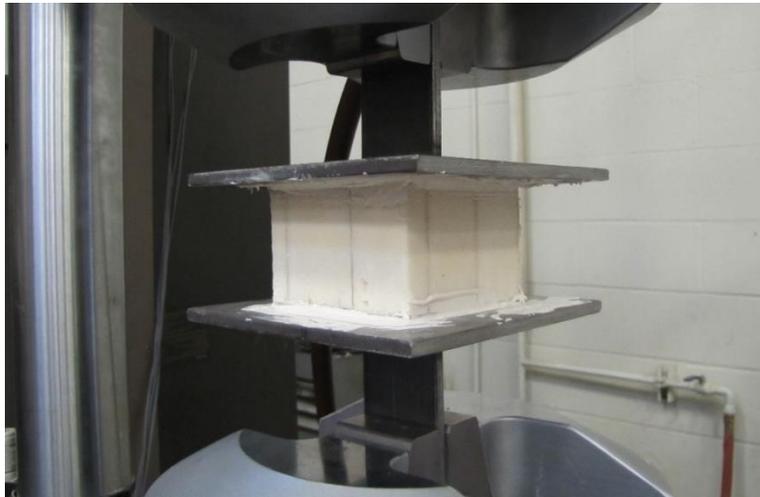
After the initial curing period, the assembly was marked to ensure it would be tested using the same orientation. It was removed and stored at standard room temperature and humidity conditions until testing was completed a few days later. The epoxy required a minimum 8 hour curing period to achieve full strength. Figure 2.15 shows a photograph of Specimen 2-1-T after it was adhered to the plates.

Figure 2.15: Prepared Specimen for Flatwise Tension Test

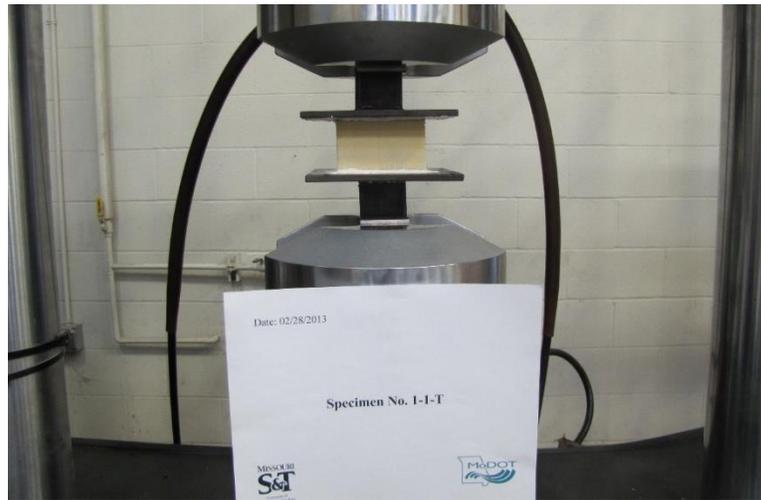
the alignment of the system was visually inspected before the grips were engaged. Once the grips were engaged, the displacement was zeroed and the load was allowed to float. Displacement was then added at a constant rate of 0.01-0.02 in./min., and the tensile load was recorded simultaneously. Load and displacement were recorded at a rate of 10 Hz. In general, the tension tests were characterized by a linear-elastic response followed by an abrupt decrease in load at failure, which took 5-20 minutes depending on the particular foam sample.

Figure 2.16: Flatwise Tension Test Setup

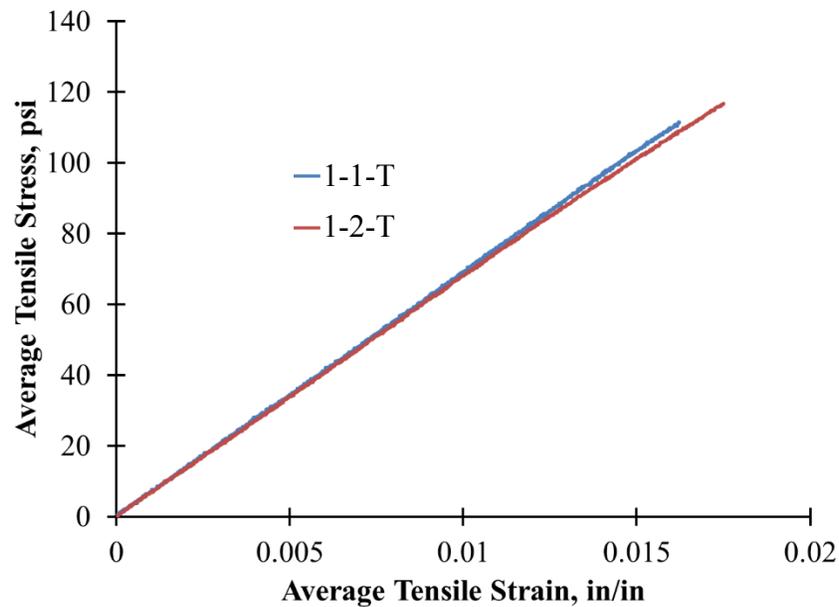
Figure 2.17: Stress-Strain Results for Type 1 Flatwise Tension Test

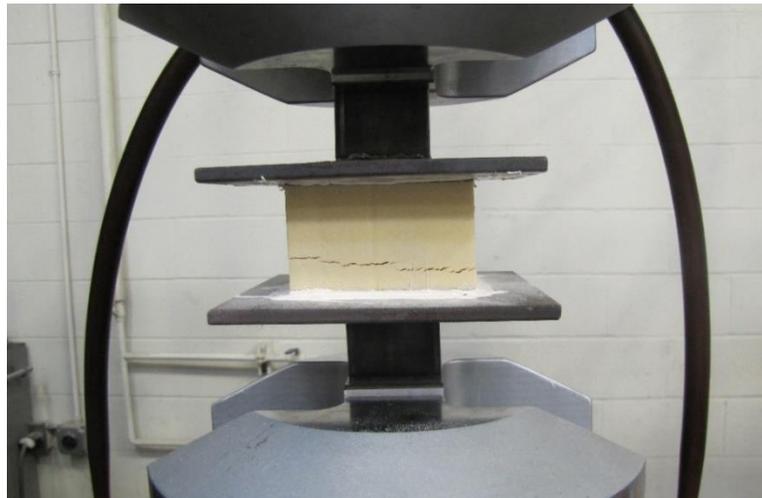
Figure 2.18: Damage at Failure for Flatwise Tension Testing of Type 1

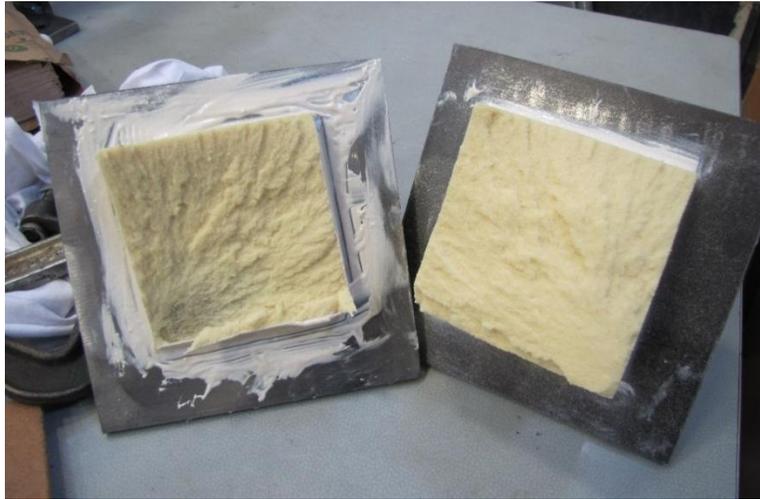
Figure 2.19: Fracture Surface for Flatwise Tension Testing of Type 1

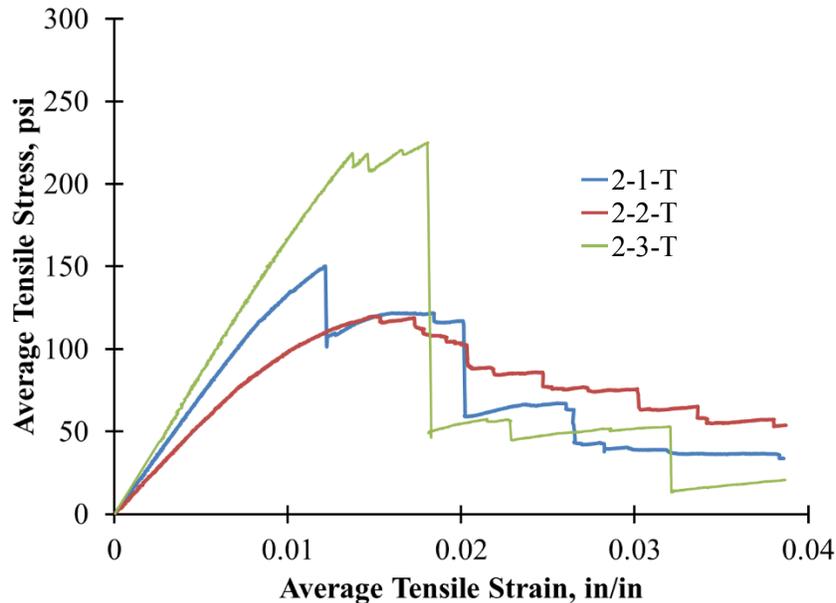
web reinforcing began to fracture or debond from the facing at the base and the foam started to crack, causing the load to decrease and redistribute to different parts of the core. Failure occurred in the bond between the core and facing for Specimens 2-1-T and 2-3-T, and for Specimen 2-2-T, failure occurred in the core material alone.

Figure 2.20: Stress-Strain Results for Type 2 Flatwise Tension Test

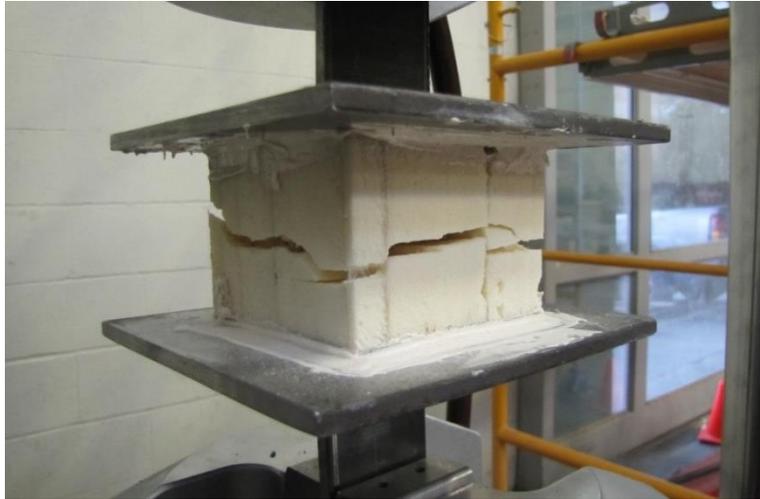
Figure 2.21: Type 2 Core Failure During Flatwise Tension Test

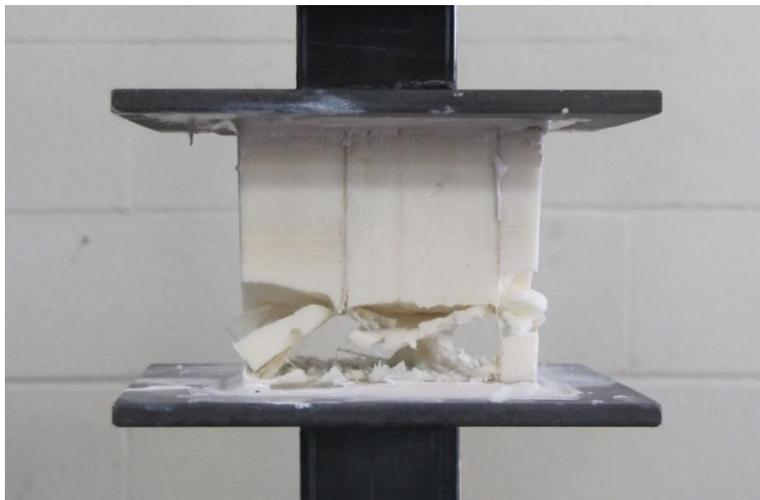
Figure 2.22: Type 2 Bond Failure During Flatwise Tension Test

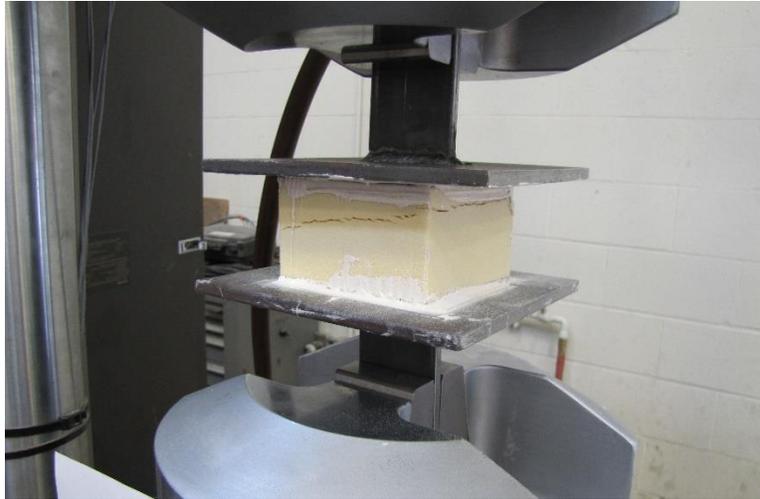
2.3.2.3. Results for Type 3. As with the flatwise compression testing, the flatwise tension testing for the Type 3 core consisted of testing the foam alone without any mat reinforcement. Representative square blocks of the Type 3 material were sectioned for testing, with three random samples chosen from the five available specimens. The stress-strain response of the Type 3 foam was essentially linear prior to failure, where an abrupt drop in stress occurred when the foam fractured, similar to the response shown in Fig. 2.17 for the Type 1 foam. Figure 2.23 is a photograph of the fracture that occurred at the peak load.

Figure 2.23: Damage at Failure for Flatwise Tension Testing of Type 3

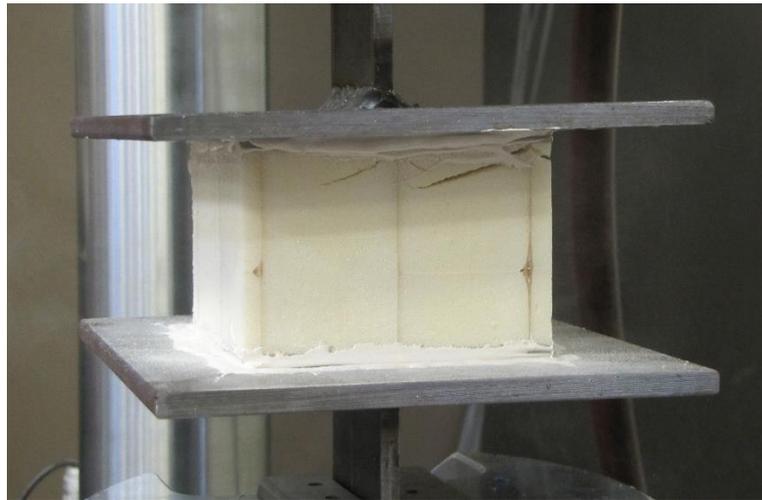
Once the stress in the stitches exceeded their capacity, there was an abrupt decrease in load as the all of the stitches fractured nearly simultaneously within the specimen. This behavior provided a very clear peak value, with the stress at the maximum load considered to be the flatwise tensile strength. Unlike the Type 2 material, the Type 4 core did not have as extensive a second region since the stitches failed fairly rapidly, although there was a slight degree of progressive failure prior to a complete loss in load carrying capacity. All of the Type 4 specimens experienced failure within the core material and not at the interface with the facesheets. Figure 2.24 is a photograph of the fracture that occurred at the peak load. The stiffness was again determined through the use of a linear regression analysis. A summary of the results for flatwise tensile strength and modulus for each specimen is presented in Table 2.8.

Figure 2.24: Damage at Failure for Flatwise Tension Testing of Type 4

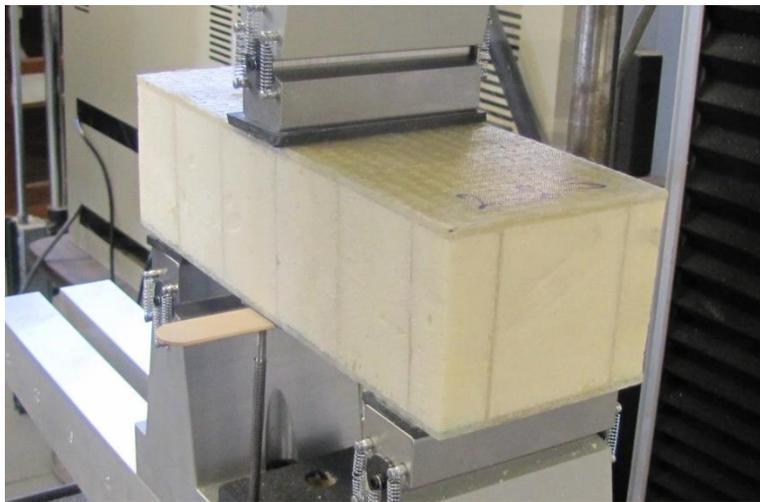
Figure 3.3: Type 2 (WEB-CORE) Sandwich Panel Specimen

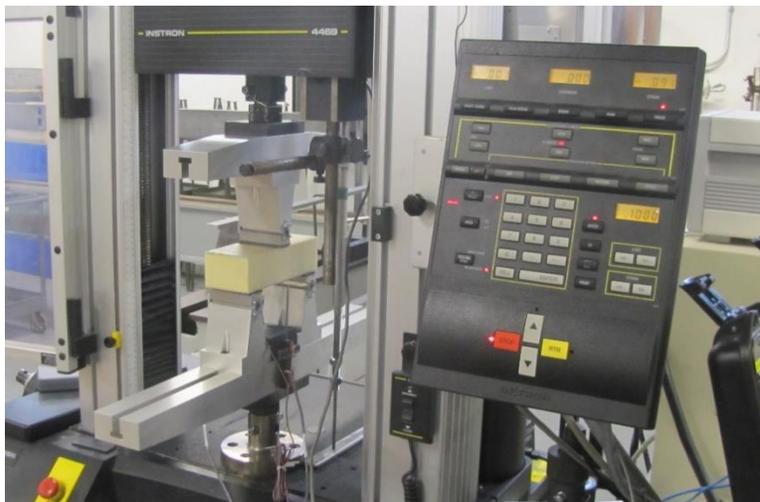
Figure 3.5: Three Point Flexural Test Setup

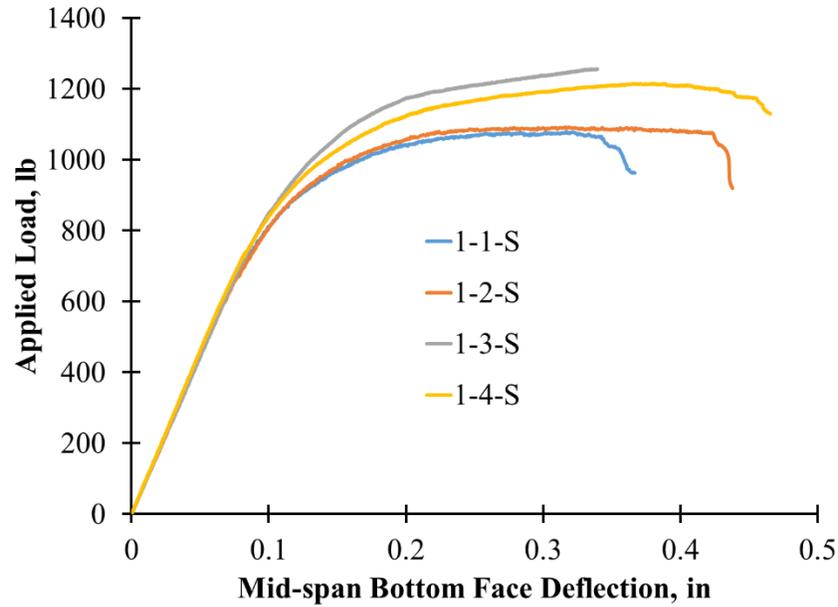
3.2.2.1. Results for Type 1. For the three point flexural tests, four specimens were prepared and successfully tested for the Type 1 sandwich construction. The false nonlinearities and offset were corrected for each of the data curves using the procedures mentioned previously. The bottom face deflection and the strain in the bottom facing at mid-span were then plotted as the dependent variable versus the load in Figs. 3.6 and 3.7, respectively. From these curves, several observations were made about the material behavior, and based on the observations made during the tests, a failure mode for the Type 1 specimens was determined.

Figure 3.6: Applied Load vs. Mid-Span Bottom Face Deflection for Type 1

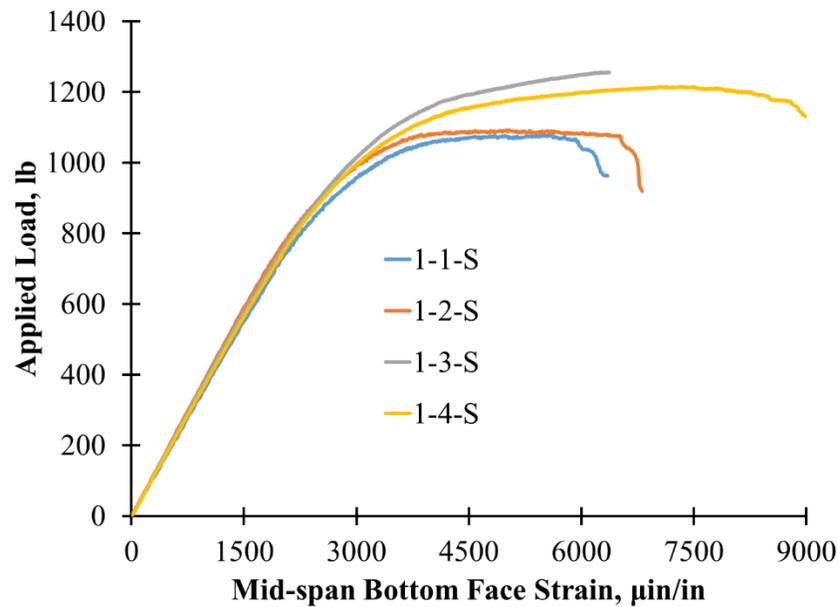
Figure 3.7: Applied Load vs. Mid-Span Bottom Face Strain for Type 1

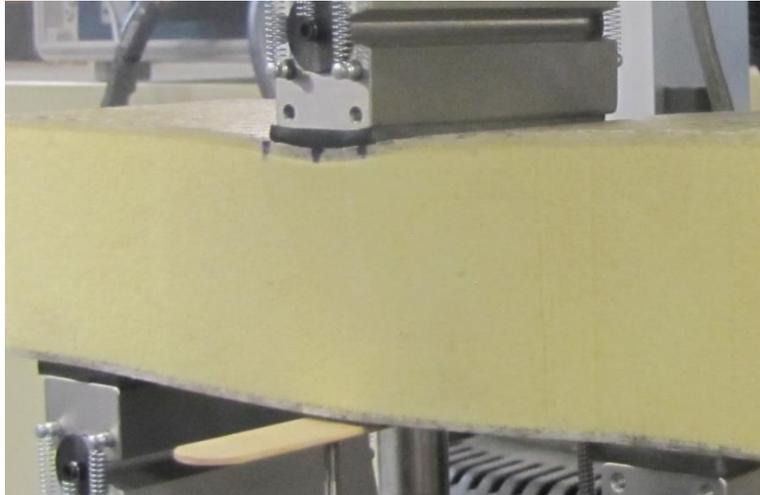
specimen ultimately failed due to shear stresses in the core. A photograph of the initial crushing of the foam where the response became nonlinear is shown in Fig. 3.8. Also, photographs of the ultimate failure due to excessive wrinkling of the facing, as well as shear failure in the foam, are shown in Figs. 3.9 and 3.10, respectively.

Figure 3.8: Initial Failure Due to Local Indentation for Type 1

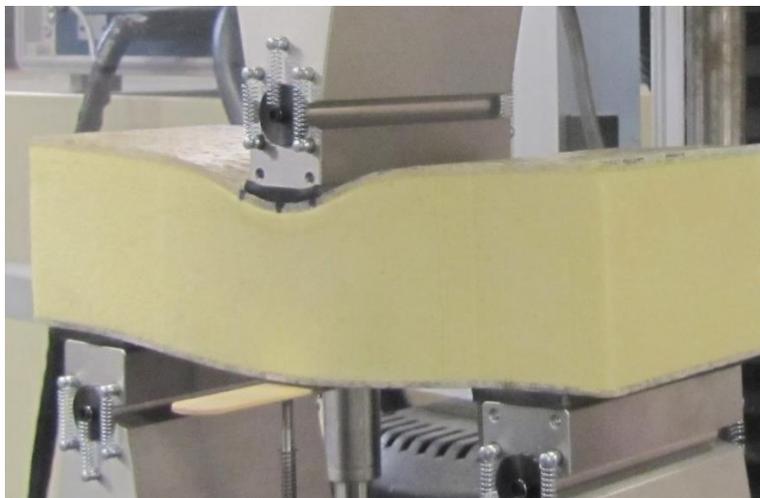
Figure 3.9: Ultimate Failure Due to Excessive Local Indentation for Type 1

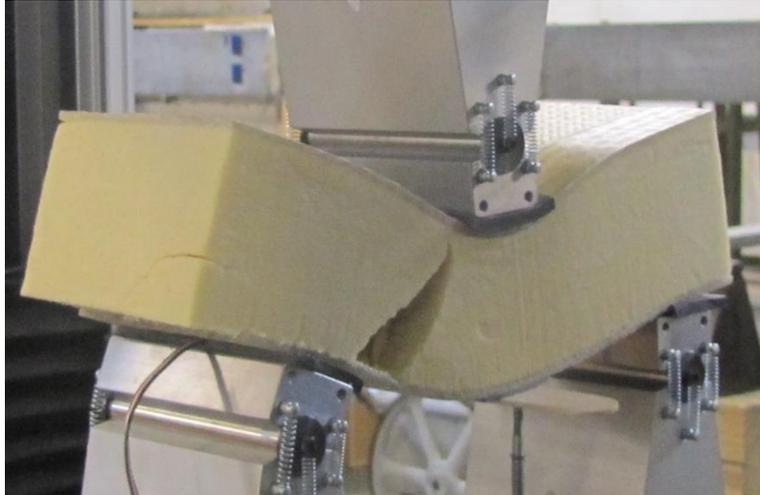
Figure 3.10: Ultimate Failure Due to Shear Failure of the Core Material for Type 1

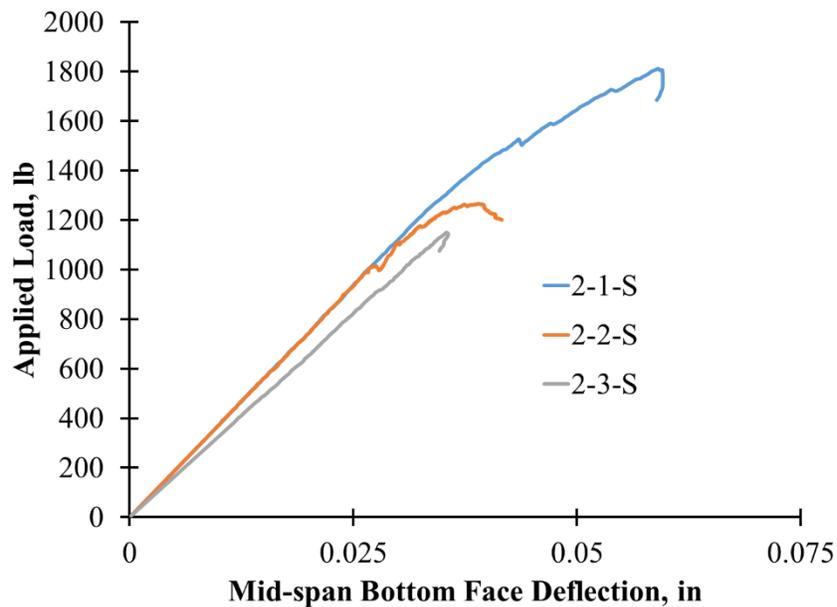
deflection and the strain in the bottom facing at mid-span were plotted as the dependent variable versus the load in Figs. 3.11 and 3.12, respectively. From these curves, several observations were made about the material behavior, and based on the observations made during the tests, a failure mode for the Type 2 specimens was determined.

Figure 3.11: Applied Load vs. Mid-Span Bottom Face Deflection for Type 2

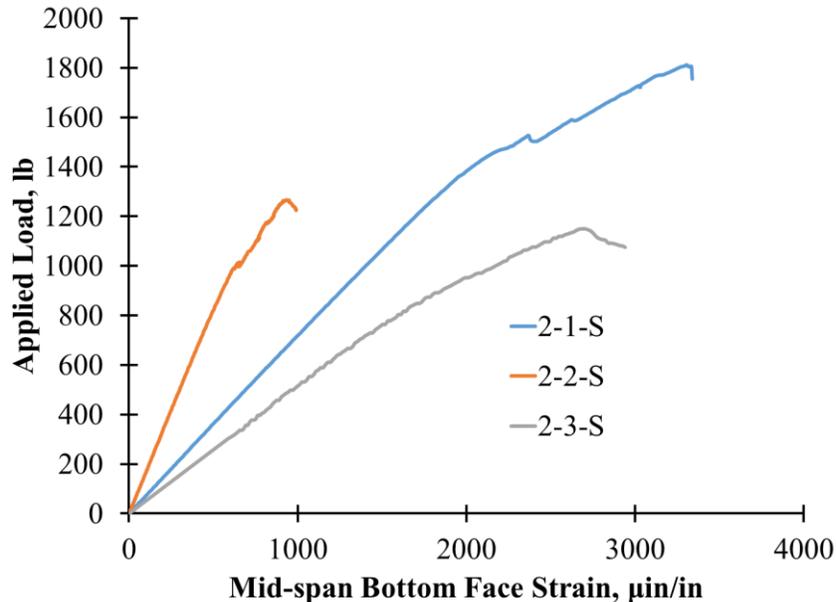
Figure 3.12: Applied Load vs. Mid-Span Bottom Face Strain for Type 2

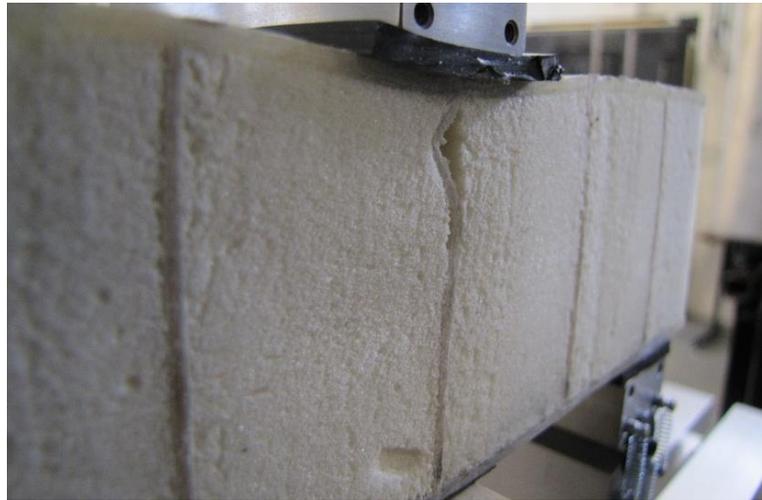
In conclusion, the initial failure mode for all three specimens was local indentation directly beneath the load initiated by buckling of the reinforcing webs. Then, the ultimate failure mode for each of the specimens was excessive local indentation caused by fracturing of the reinforcing webs. A photograph of the damage to the specimen when the response became nonlinear is presented in Fig. 3.13. A photograph of the damage at ultimate failure when the load reached its peak value is presented in Fig. 3.14.

Figure 3.13: Initial Failure Due to Buckling of the Reinforcing Webs and Local Indentation for Type 2

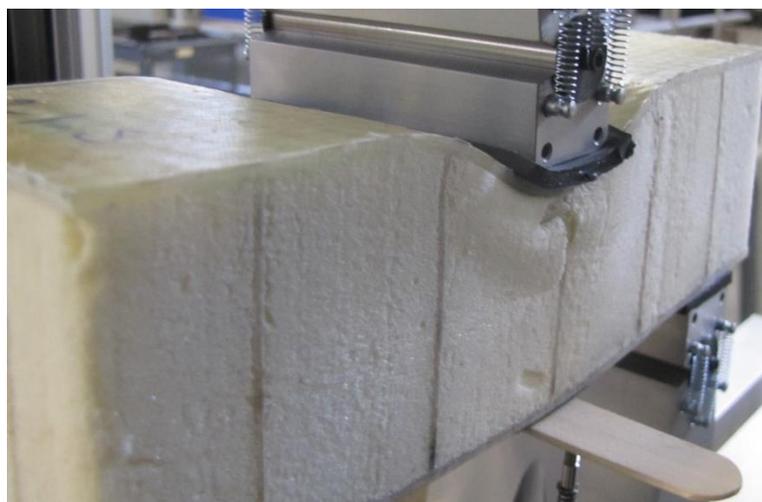
Figure 3.14: Ultimate Failure Due to Fracturing of Reinforcing Webs and Excessive Local Indentation for Type 2

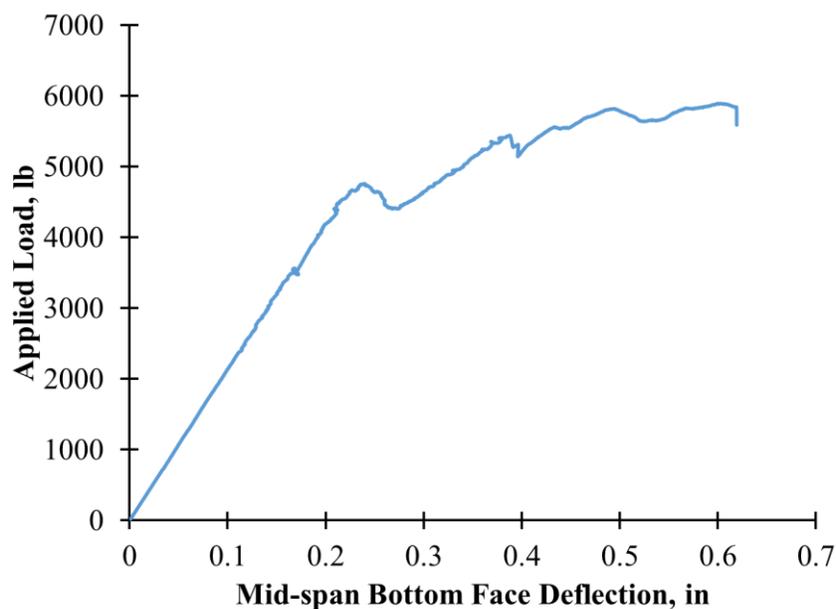
3.2.2.3. Results for Type 3. For the three point flexural tests, one specimen was prepared and successfully tested for the Type 3 sandwich construction. Unfortunately, the foam blocks needed to manufacture the Type 3 panel for the small scale flexural tests were difficult to obtain in the size that was needed, and only one representative small scale beam could be manufactured in the time allowed for this stage of the project. Therefore, very few specimens could be produced from the single beam. After the test, the initial false nonlinearities and offset were corrected for each of the data curves, and the corrected data was plotted. The bottom face deflection and the strain in the bottom facing at mid-span were plotted as the dependent variable versus the load in Figs. 3.15 and 3.16, respectively. From these curves, several observations were made about the material behavior, and based on the observations made during the tests, a failure mode for the Type 3 specimens was determined.

Figure 3.15: Applied Load vs. Mid-Span Bottom Face Deflection for Type 3

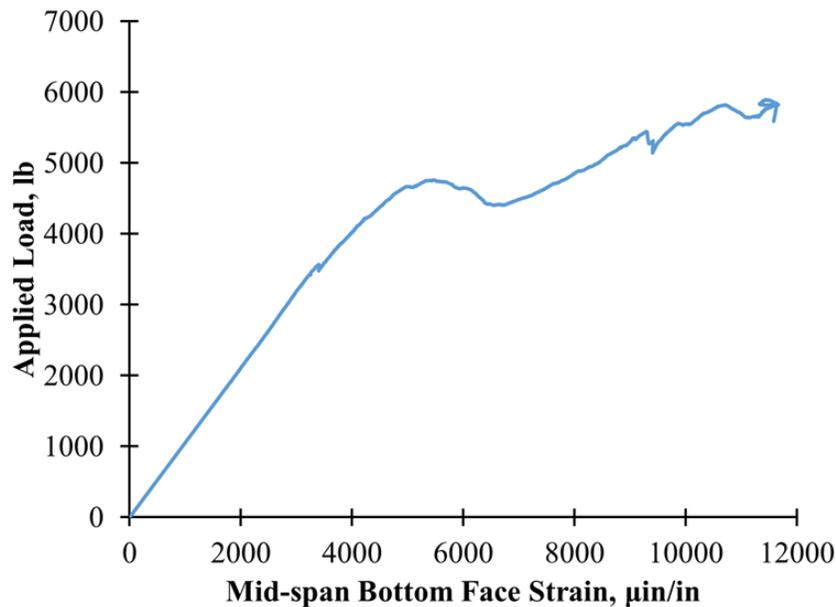
generally linear elastic. Therefore, the apparent linear elastic response at the beginning of the test was as expected.

Figure 3.16: Applied Load vs. Mid-Span Bottom Face Strain for Type 3

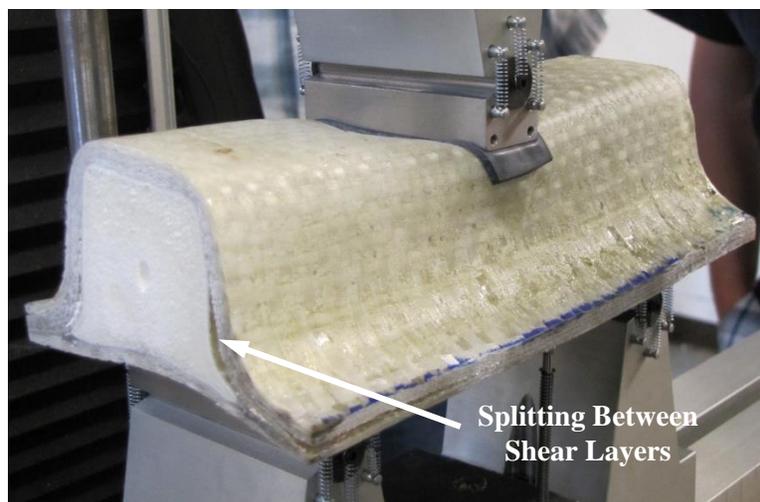
Summarizing the test, the initial failure mode involved splitting between the shear layers just above one of the supports, and the shear layer separation that formed became progressively larger throughout the remainder of the test, which likely had a significant effect on the response of the specimen. The ultimate failure mode was excessive local indentation, which led to crushing of the shear layers under the load point. A photograph of the splitting between shear layers at the beginning of the test that caused some nonlinearity in the response is shown in Fig. 3.17. The localized damage under the load point that caused erratic jumps in the applied load at the end of the test is shown in Fig. 3.18. Also, the severity of the unsymmetrical deformation caused by splitting of the shear layers by the end of the test is shown in Fig. 3.19.

Figure 3.17: Initial Failure Due to Splitting Between Shear Layers for Type 3

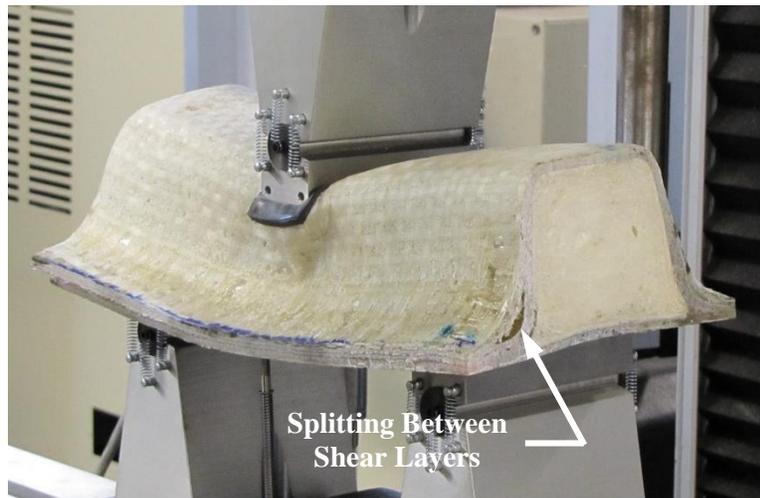
Figure 3.18: Ultimate Failure Due to Excessive Local Indentation and Splitting Between Shear Layers for Type 3

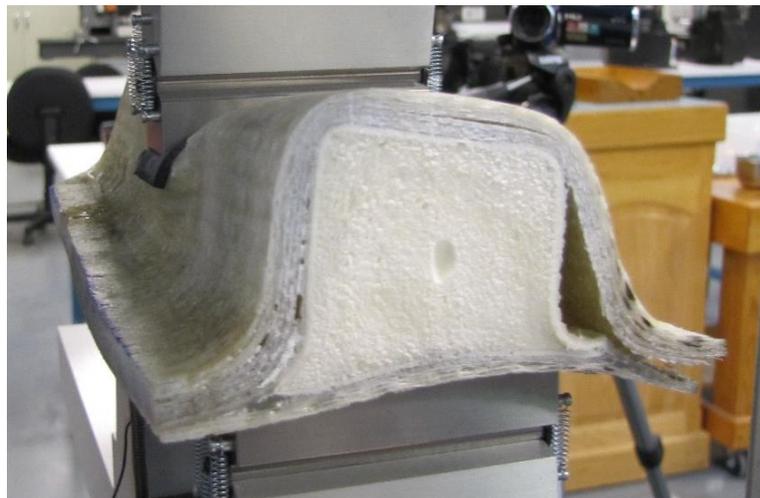
Figure 3.19: Unsymmetrical Deformation Caused by Splitting Between Shear Layers for Type 3

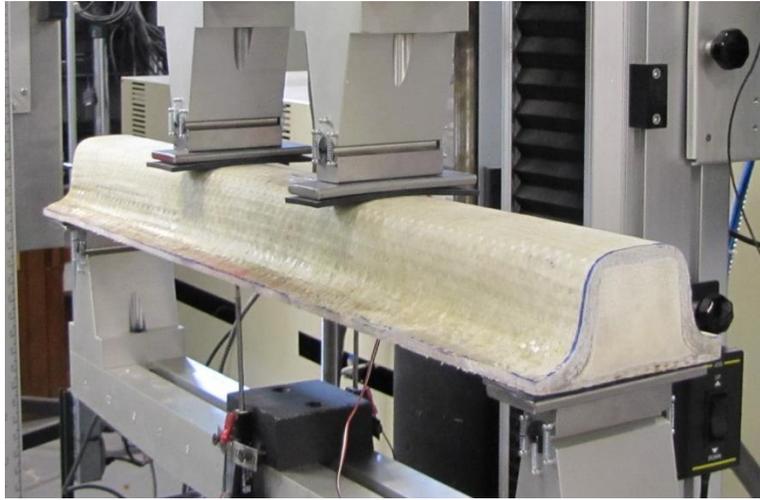
Figure 3.22: Type 3 (PRISMA FOAM) Sandwich Panel Specimen

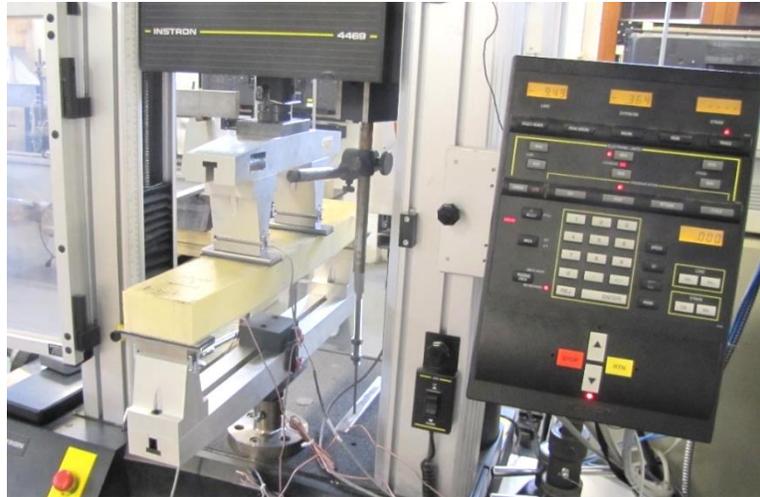
Figure 3.23: Four Point Flexural Test Setup

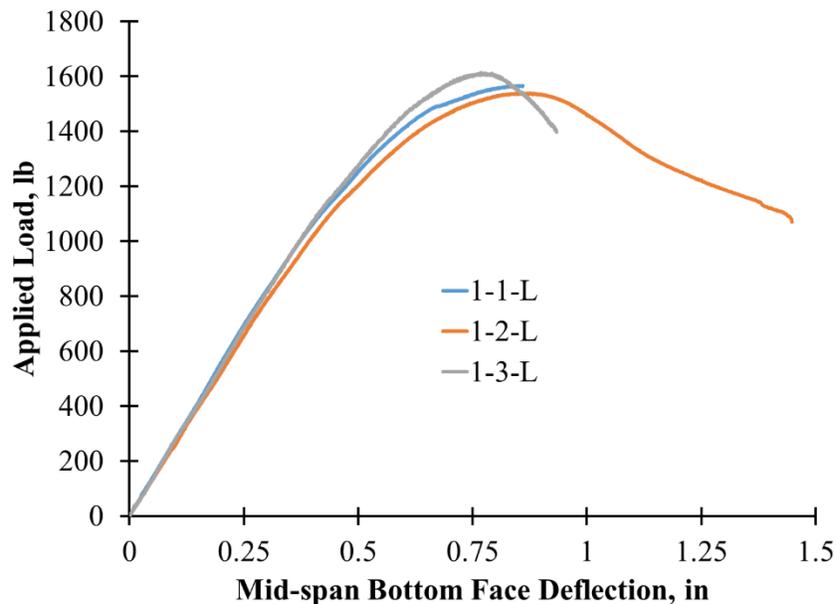
Figure 3.24: Applied Load vs. Mid-Span Bottom Face Deflection for Type 1
