Polyurethane Foam Infill for Fiber-Reinforced Polymer (FRP) Bridge Deck Panels

FINAL Report

TRyy1203

Missouri University of Science and Technology, Rolla, Missouri

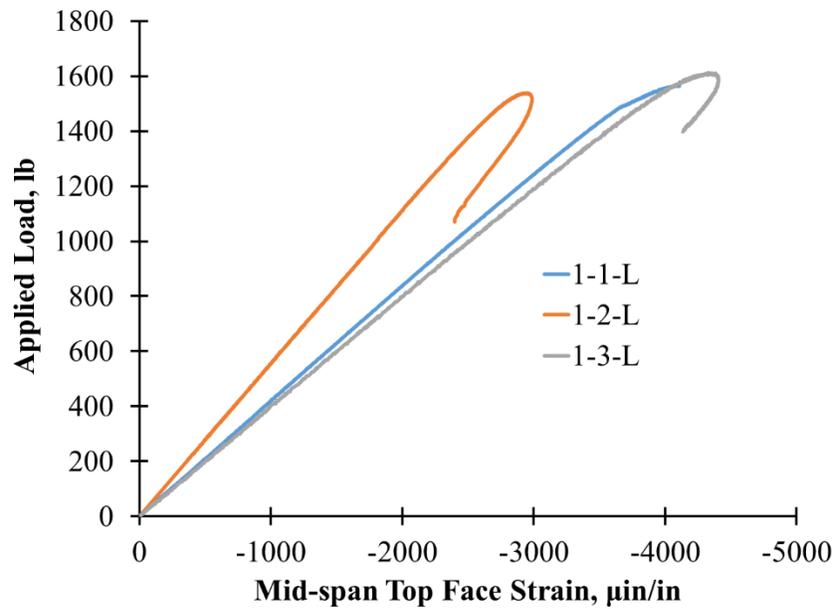
Figure 3.25: Applied Load vs. Mid-Span Top Face Strain for Type 1

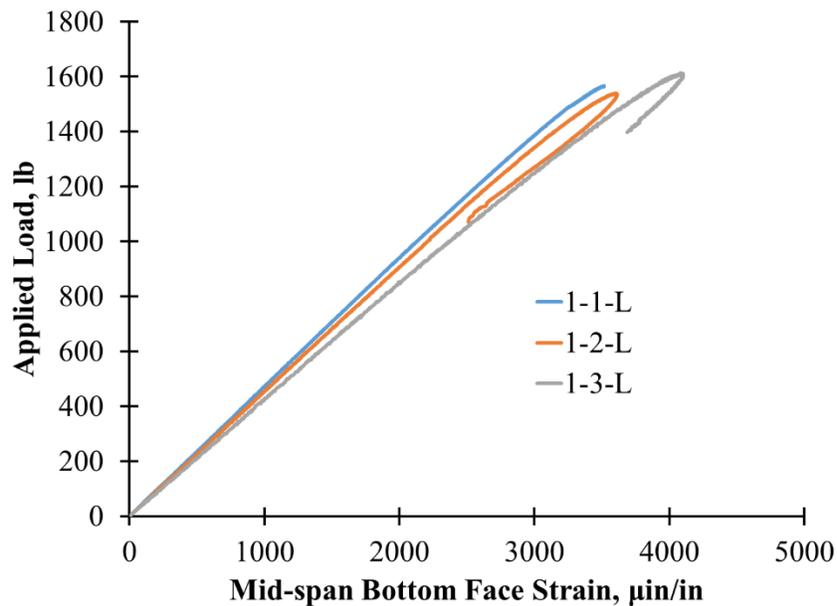
Figure 3.26: Applied Load vs. Mid-Span Bottom Face Strain for Type 1

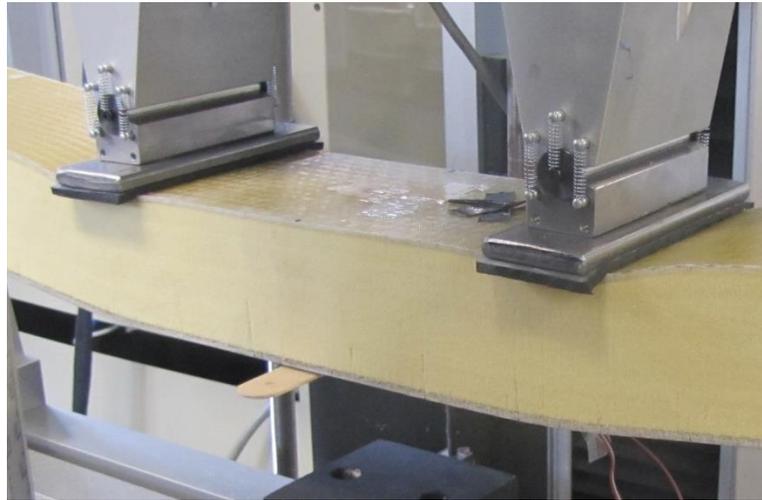
Figure 3.27: Initial Failure Due to Local Indentation for Type 1

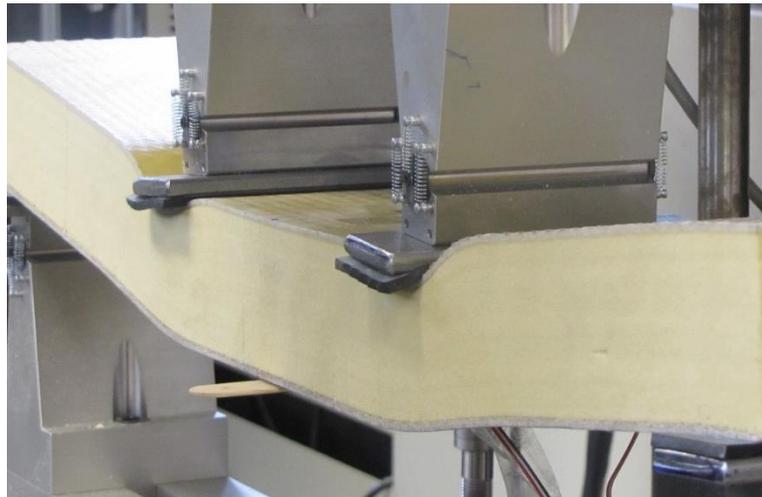
Figure 3.28: Ultimate Failure Due to Excessive Local Indentation for Type 1

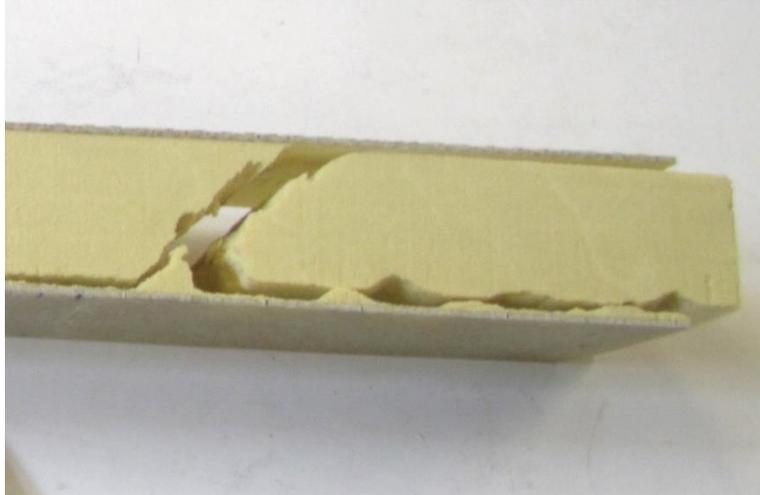
Figure 3.29: Ultimate Failure Due to Shear Failure of the Core Material for Type 1

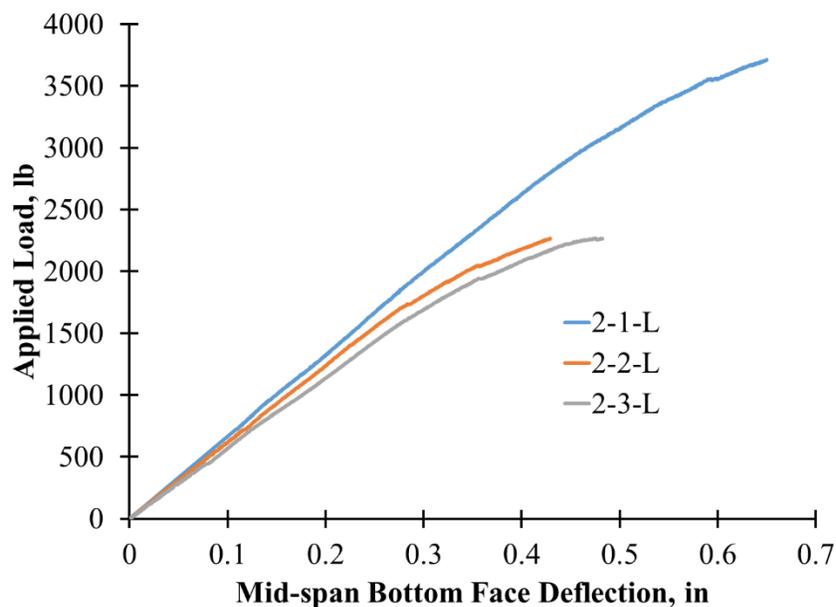
Figure 3.30: Applied Load vs. Mid-Span Bottom Face Deflection for Type 2

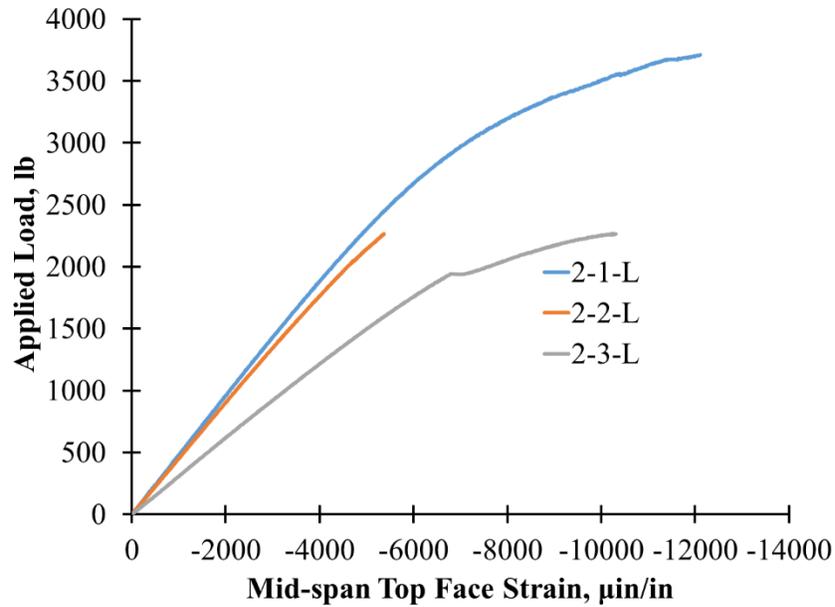
Figure 3.31: Applied Load vs. Mid-Span Top Face Strain for Type 2

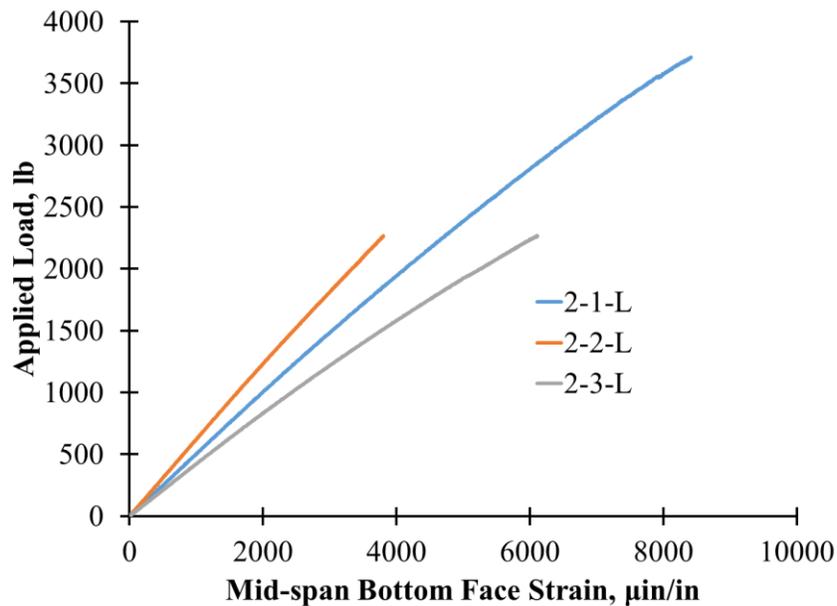
Figure 3.32: Applied Load vs. Mid-Span Bottom Face Strain for Type 2

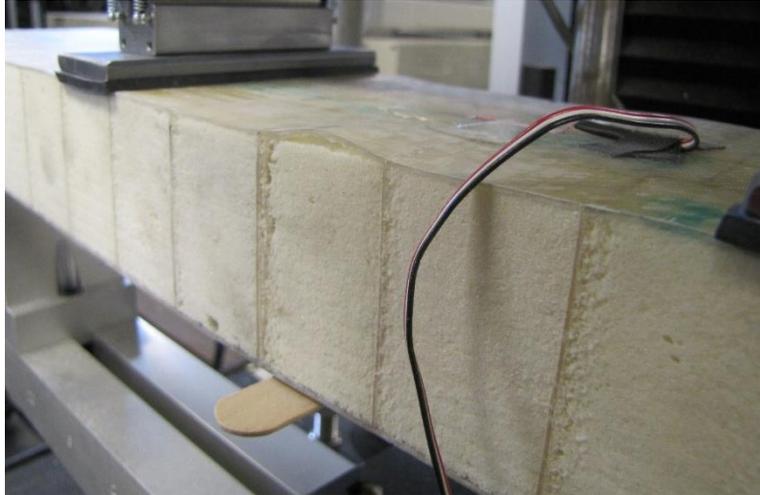
Figure 3.33: Initial Failure Due to Inter-cellular Buckling of the Top Facing for Type 2

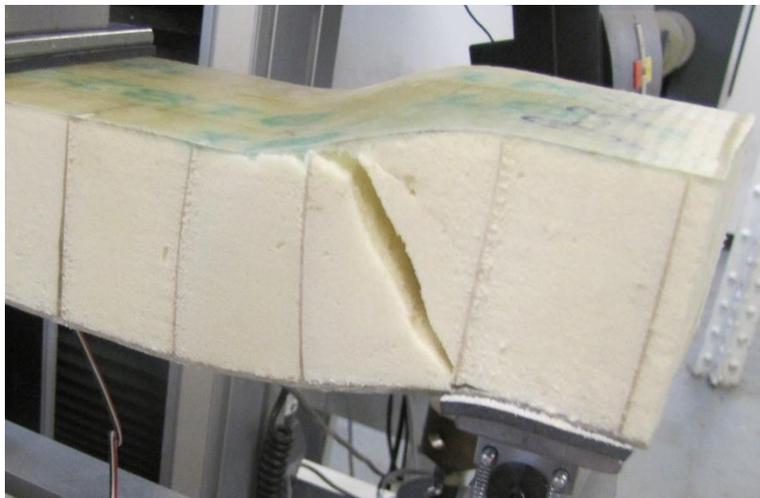
Figure 3.34: Ultimate Failure Due to Shear Failure of the Core Material for Type 2

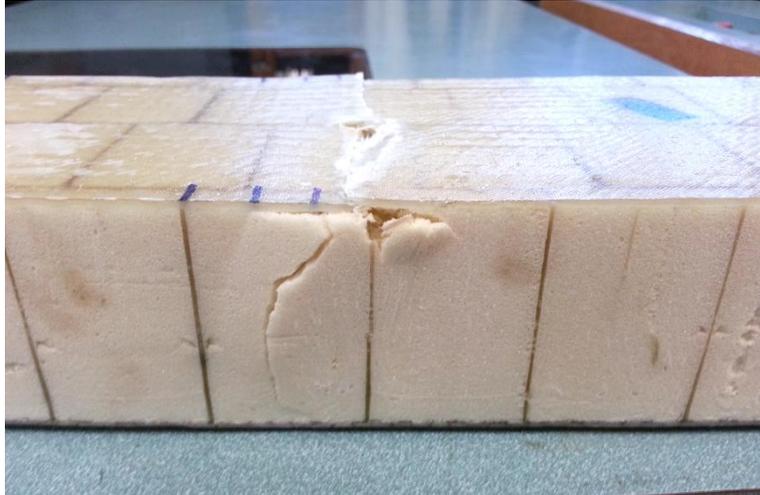
Figure 3.35: Ultimate Failure Due to Compressive Failure of the Top Facing for Type 2

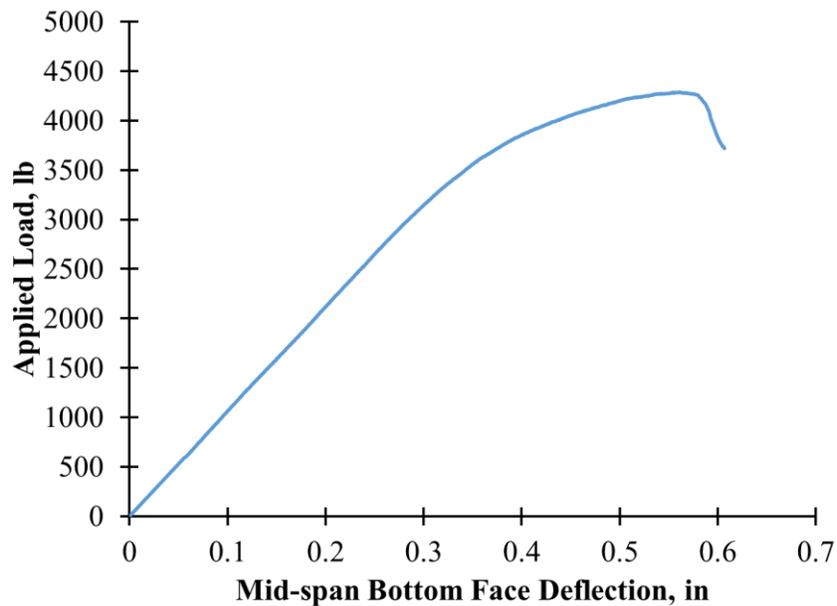
Figure 3.36: Applied Load vs. Mid-Span Bottom Face Deflection for Type 3

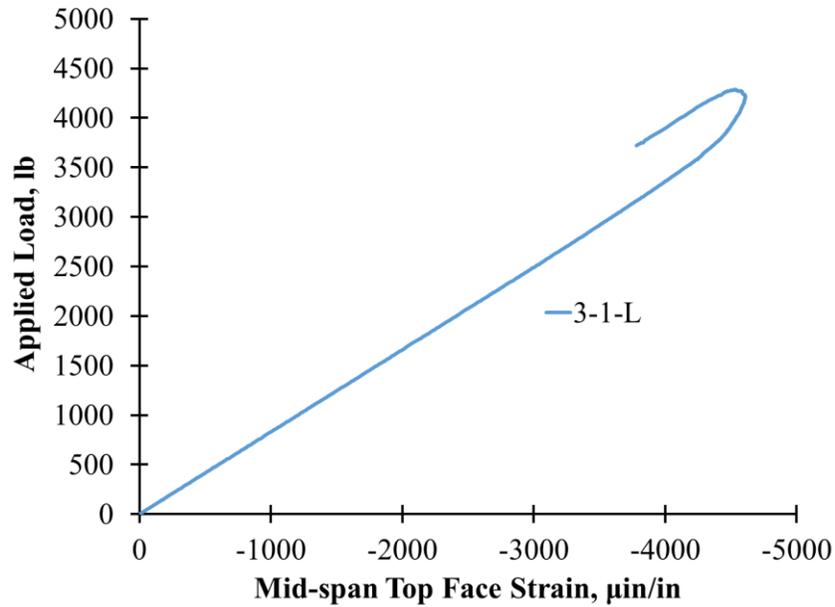
Figure 3.37: Applied Load vs. Mid-Span Top Face Strain for Type 3

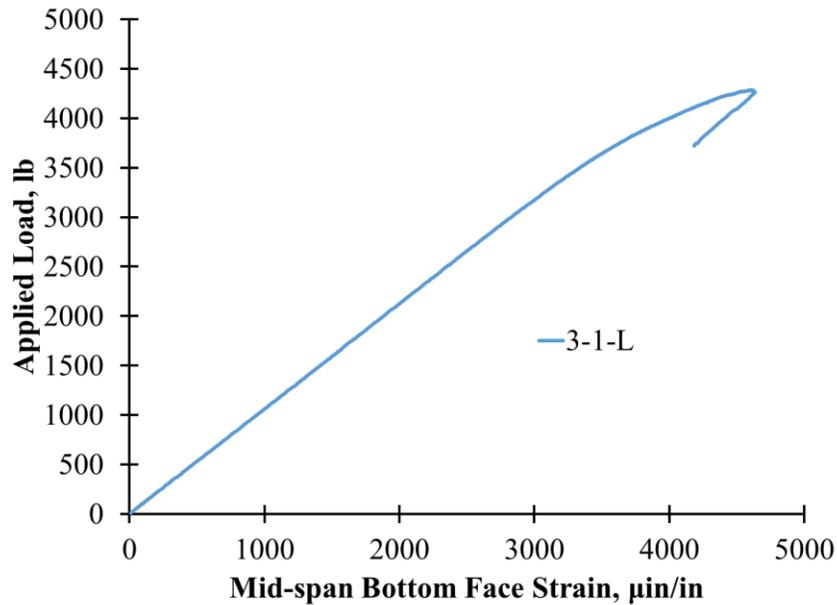
Figure 3.38: Applied Load vs. Mid-Span Bottom Face Strain for Type 3

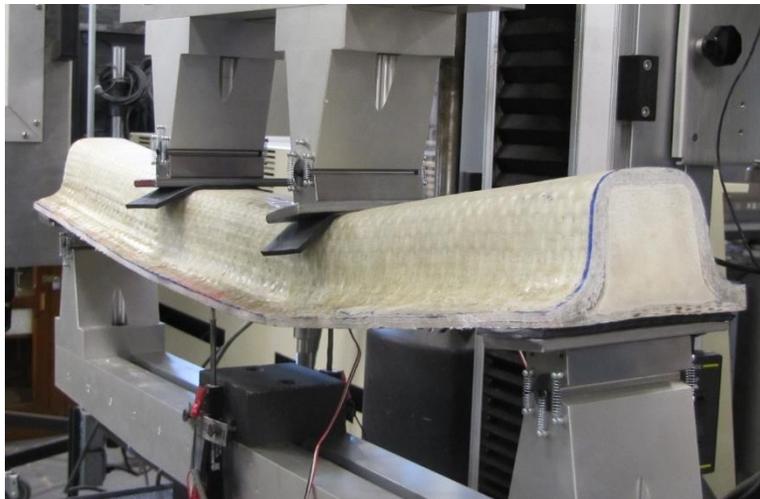
Figure 3.39: Ultimate Failure Due to Compressive Failure of the Top Facing for Type 3

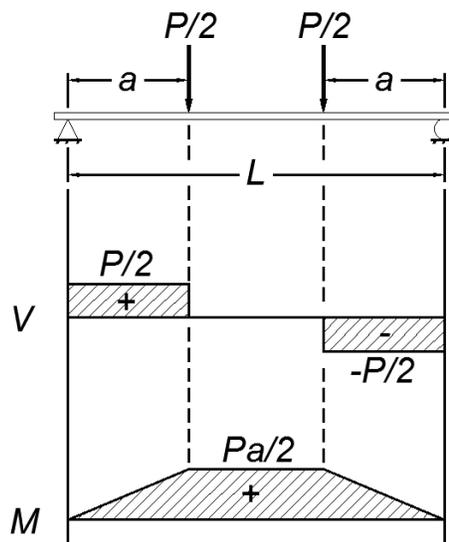
Figure 4.1: Idealized Support and Loading Conditions for Small-Scale Panel Tests

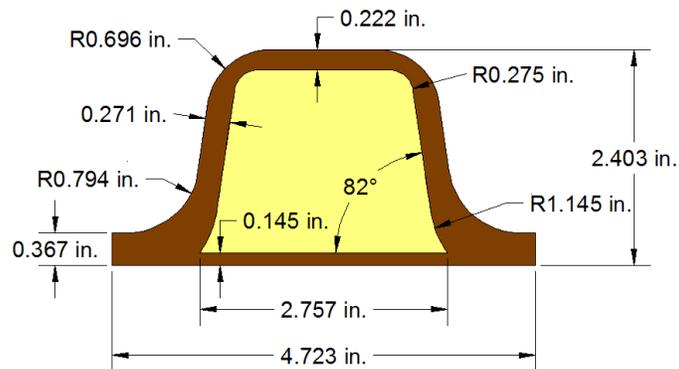
Figure 4.3: Measured Dimensions of the Type 3 Cross Section

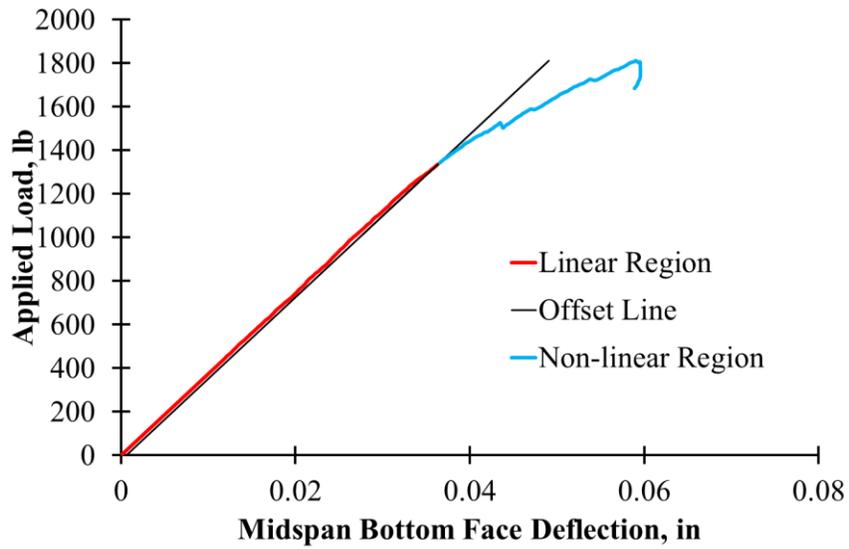
Figure 4.5: Estimate of Initial Failure Load Using Offset Method

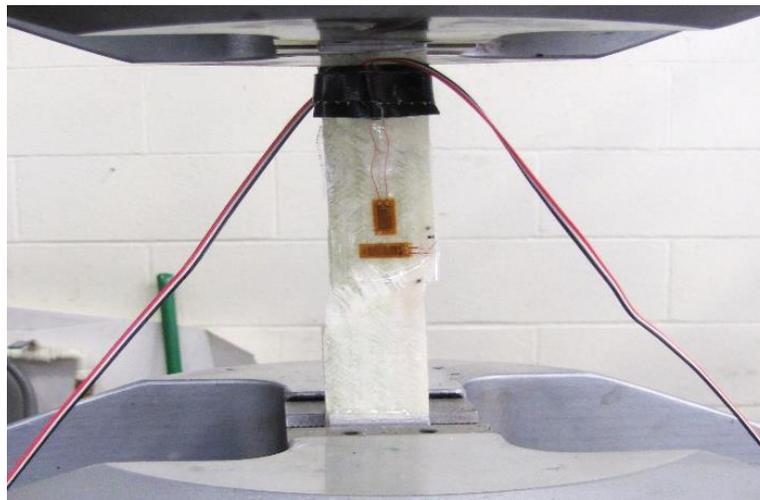
Figure 5.4: Facing Coupon Failure During Tension Test

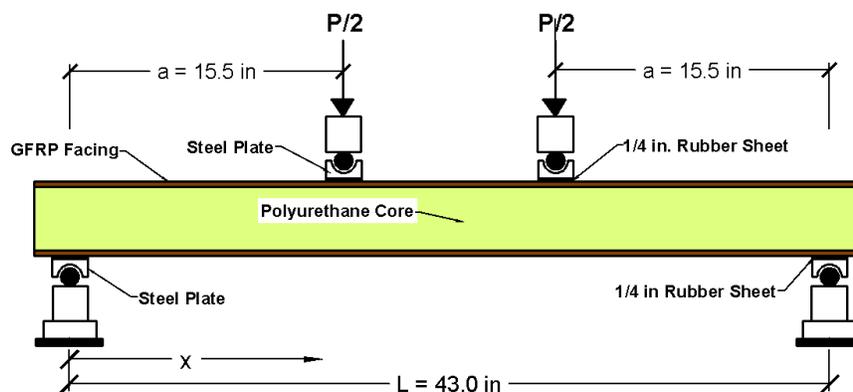
Figure 5.5: Schematic of Mid-Scale Panel Test Setup

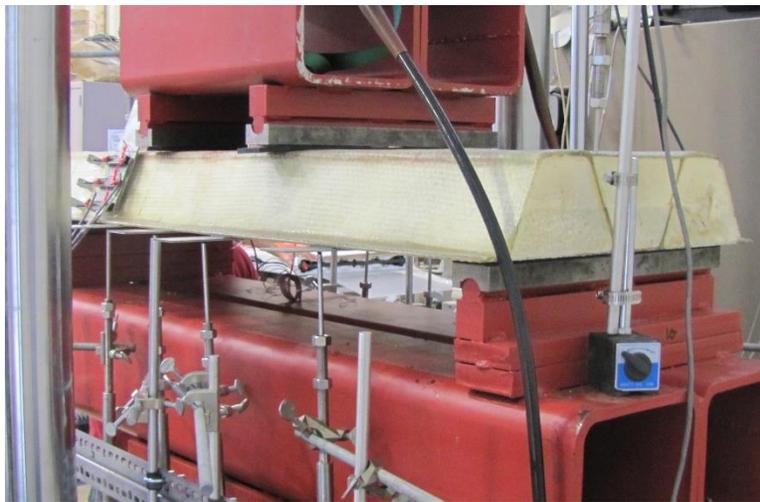
Figure 5.7: Mid-Scale Panel Test Setup

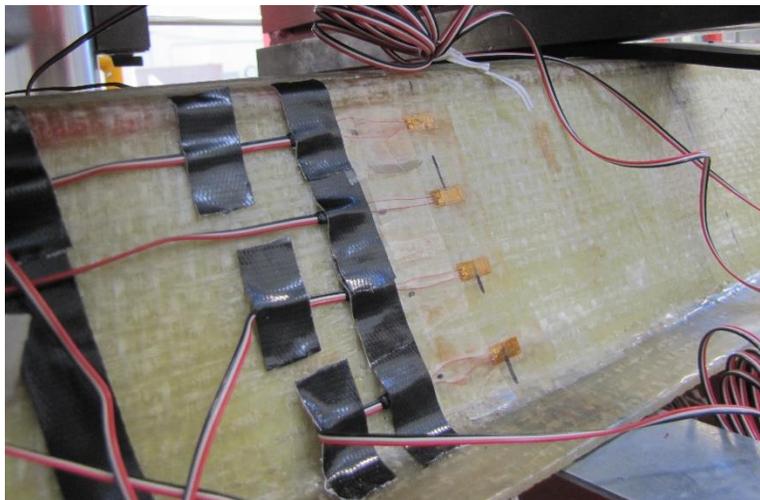
Figure 5.9: Strain Gauges Installed Along Diagonal Web at Mid-Span

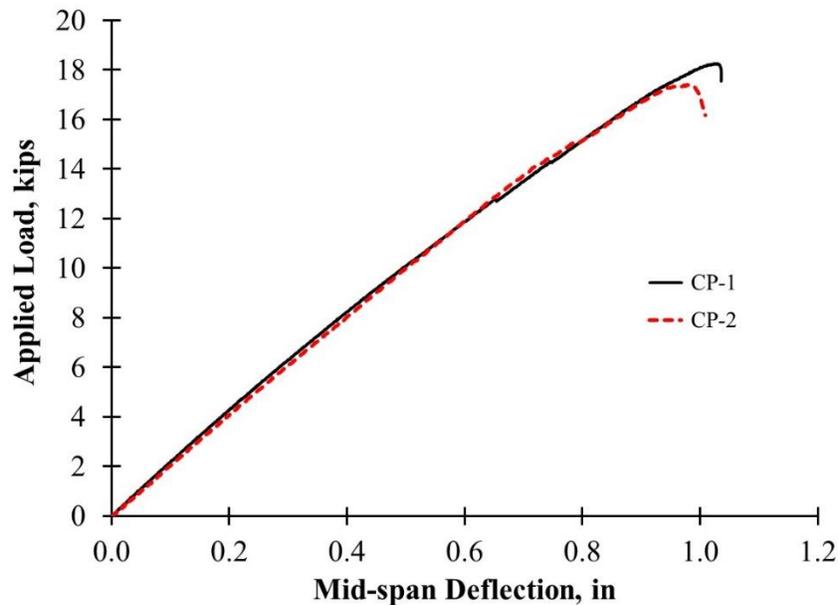
Figure 5.10: Applied Load vs. Mid-Span Deflection for Type 3

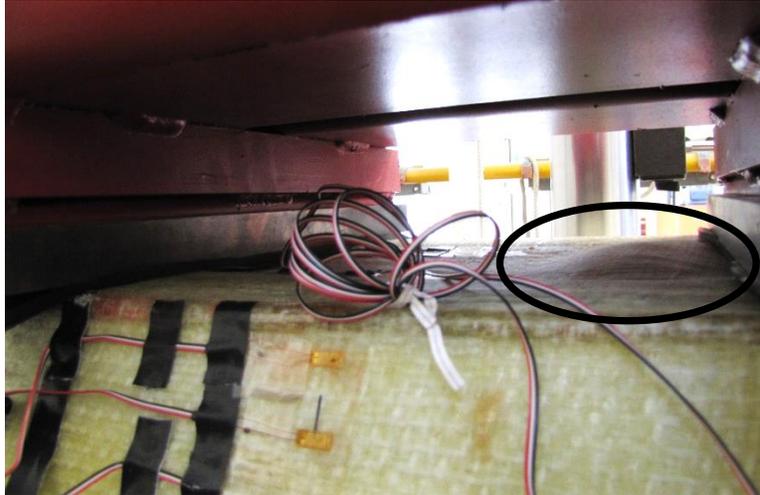
Figure 5.11: Top Facesheet Buckling (Dimpling) During Testing

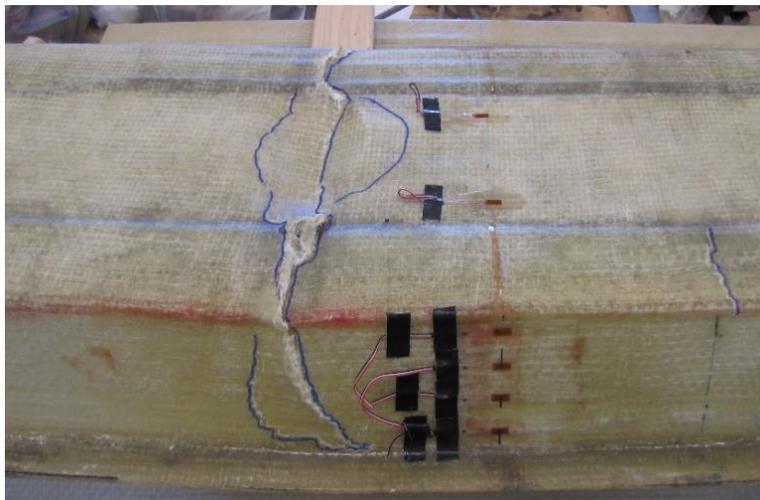
Figure 5.12: Compression Failure of Top Facesheet

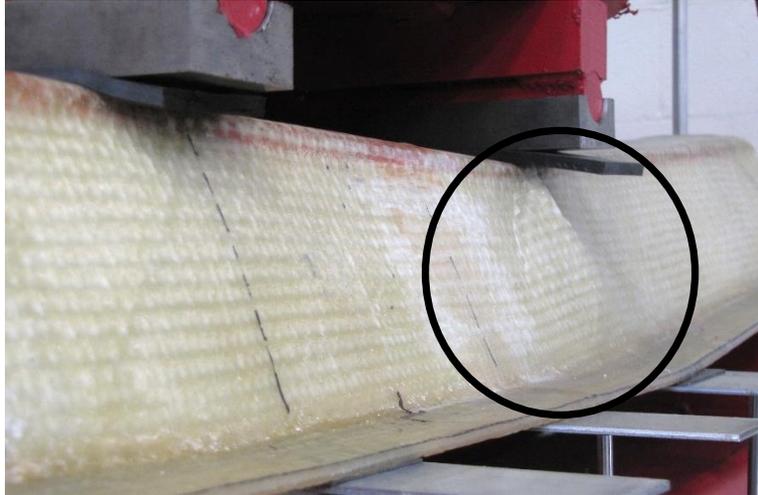
Figure 5.13: Buckling of Diagonal Web at Failure

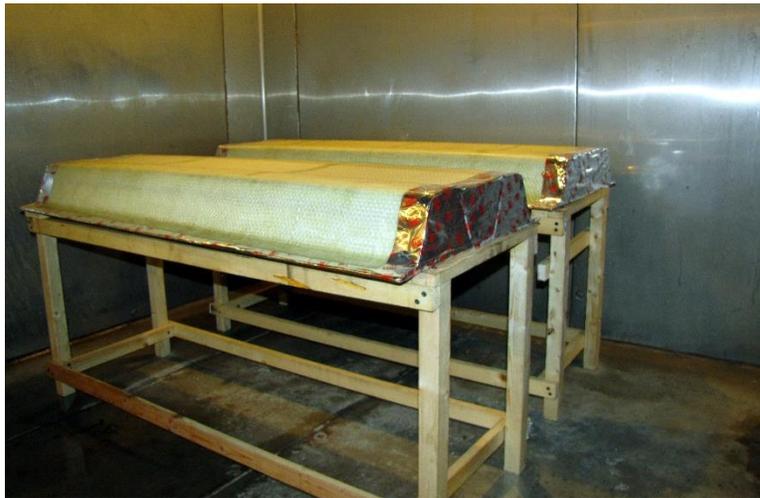
Figure 5.14: Durability Specimens within Environmental Chamber
