SALT-SCALE FREEZE
AND THAW TESTS OF
LOW SLUMP CONCRETE

REPORT ON
INVESTIGATION 74-31

Materials and Research Division
Missouri State Highway Department

May 20, 1975

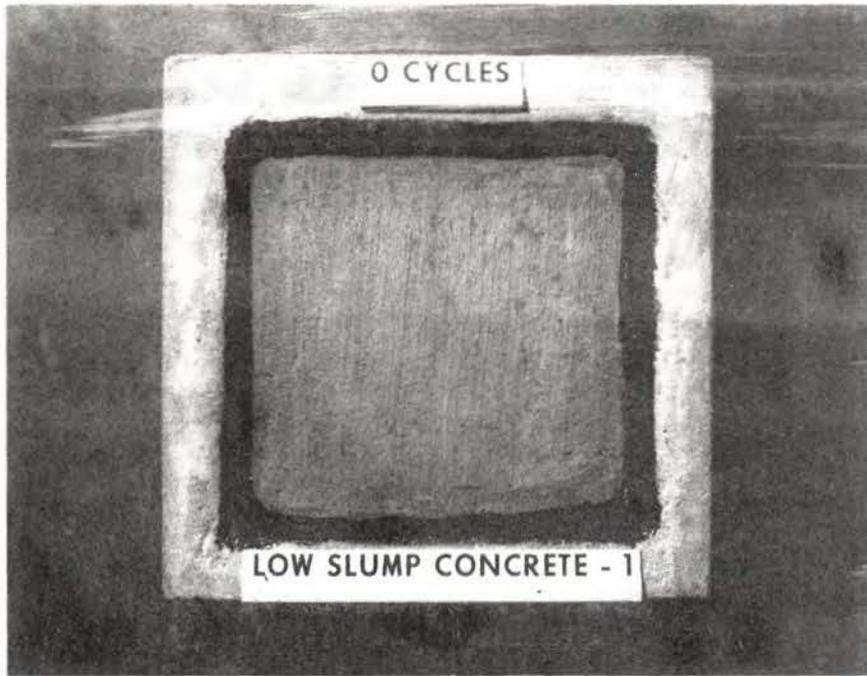
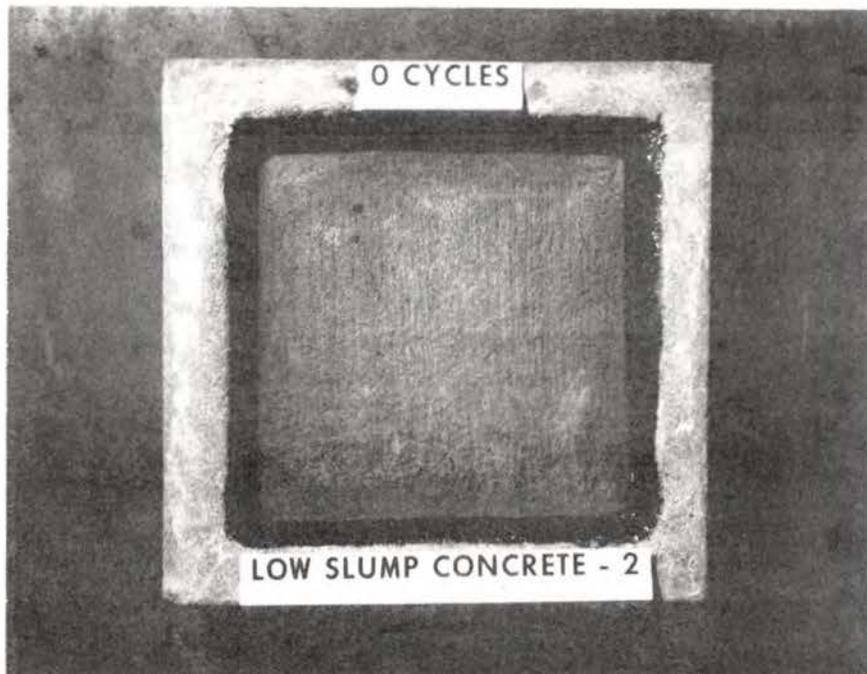
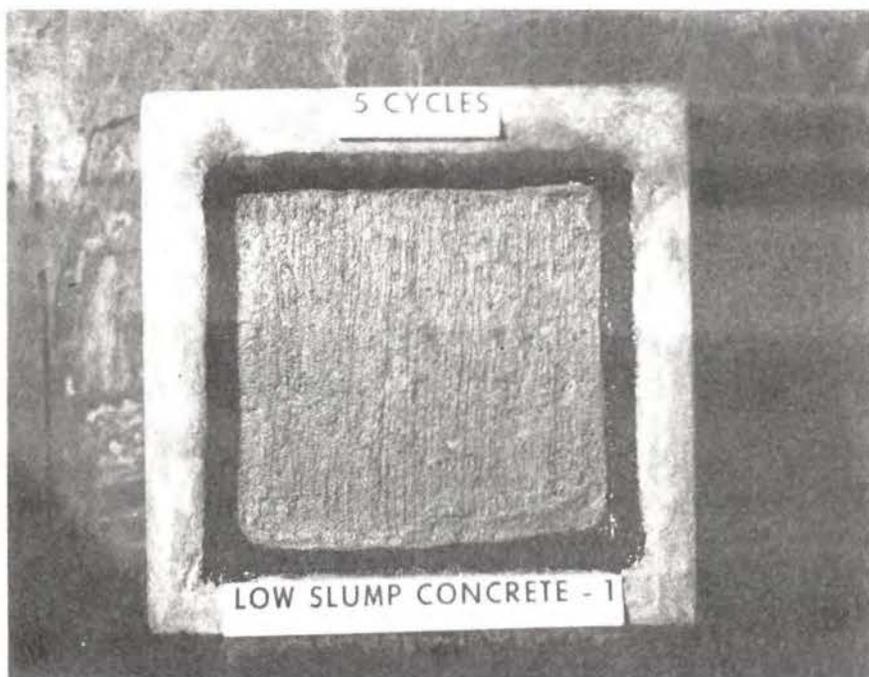
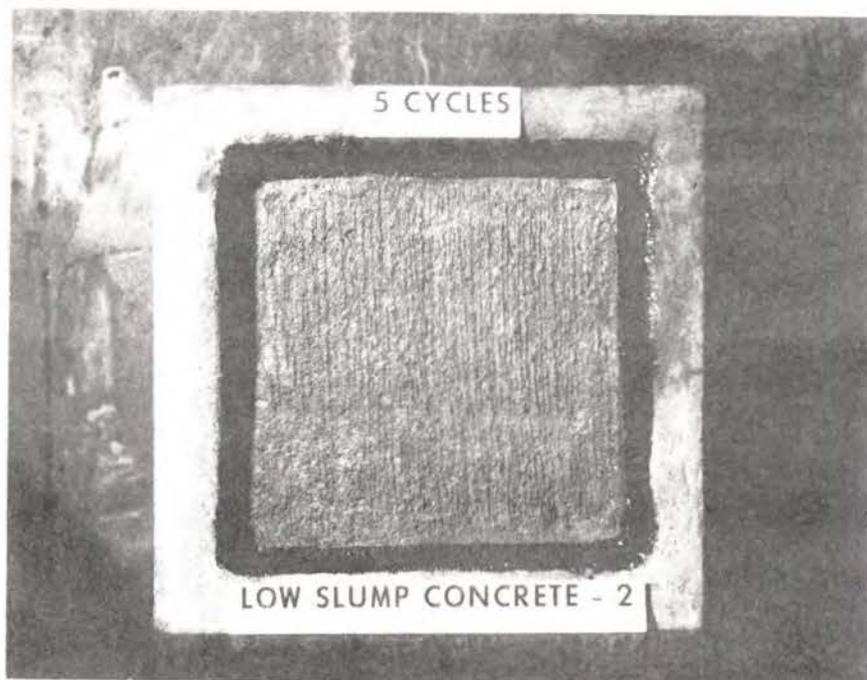
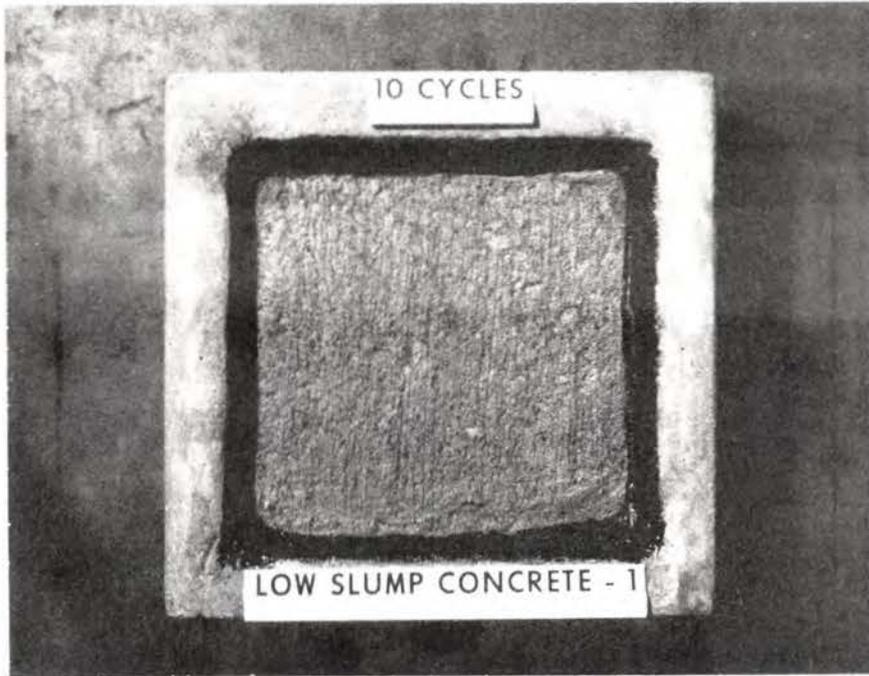
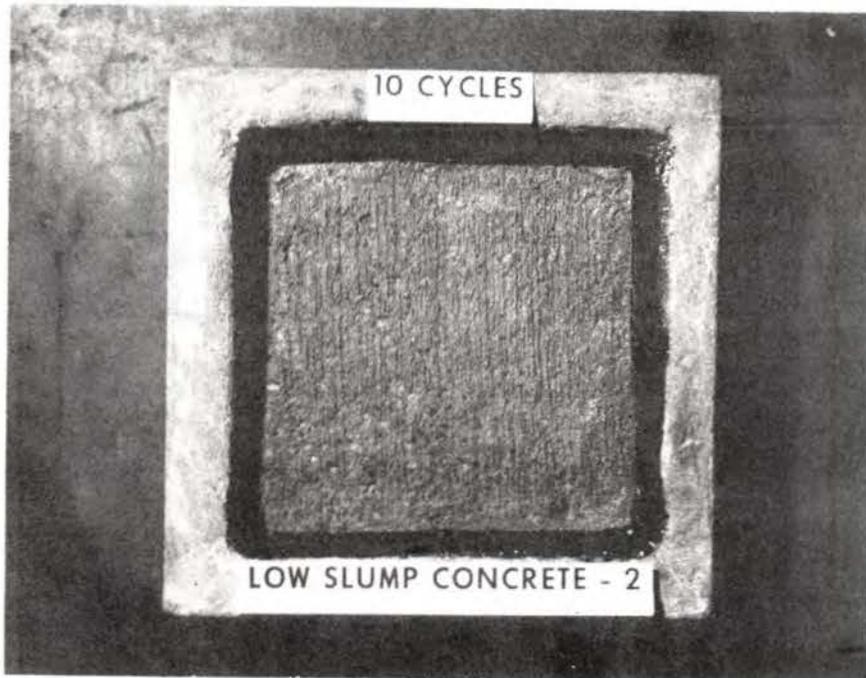
APPENDIX E

The ratings given to the panels are shown in Appendix D and the photographs showing their progressive deterioration are given in Appendix E. The ratings are shown for every 10 cycles although the panels were rated every five cycles. As the photographs illustrate, the deterioration was of a general nature, scaling of the surface mortar and pitting over and around the coarse aggregate particles. The areas affected by scaling and pitting were not localized but rather uniformly distributed over the entire surface area. The deterioration of the panels took the form of the amount of surface area affected by scaling and pitting increasing, and the depth of pitting increasing. The deterioration occurred at a fairly uniform rate with no rapid acceleration of deterioration. The panels were taken out of test at the end of 100 cycles.

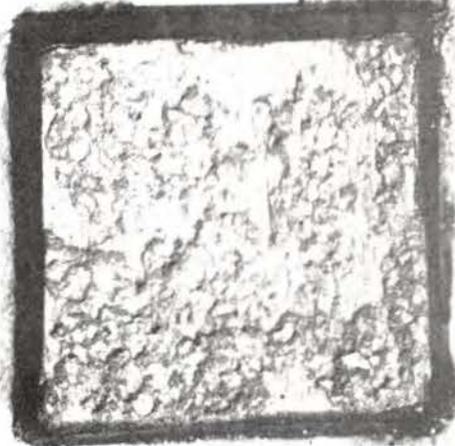
LOW SLUMP CONCRETE - 2

10 CYCLES

Based on the results of the salt-scale freeze and thaw tests, which indicated that low slump concrete was not resistant to surface mortar deterioration, it is recommended that low slump concrete not be used for bridge deck patching or overlay without a sealer or protective system being applied.
