# Longitudinal Useful Life Analysis and Replacement Strategies for LED Traffic Indicators

Final Report Prepared for Missouri Department of Transportation  
2014 May

Project TRyy1310

Report cmr14-012

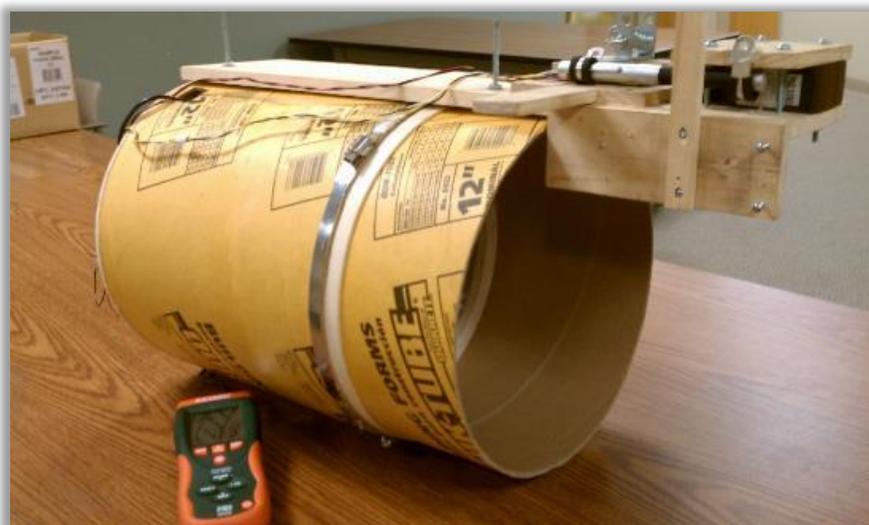
The data collection device described in the previous study was used again in this study. The device consists of a 12" tubular form, a 100x focusing Fresnel lens, and an attached illuminance meter. A separate device was used to record the distance between the data collection instrument and the traffic signal indication. A picture of the device is included in Figure 2.1 below.

Figure 2.1- Data Collection Device

An original field testing instrument was developed for collecting illuminance readings from the intersections across the state of Missouri by Missouri University of Science and Technology in the study provided to MoDOT in 2010 [11]. Illuminance is defined as the density of light falling into an particular area. Illuminance is measured in lux. The instrument consisted of a commercial light meter, distance meter, laser pen, and the custom made Fresnel lens. The instrument works on the technology of the Fresnel lens. The Fresnel lens was mounted inside a cylindrical casing and this blocked any ambient light [11]. The Fresnel lens filtered the light emitted from the LED traffic indicators into a concentrated beam. The light meter used is HD450 Data logging light meter. It is placed behind the Fresnel lens at its focal length so that it effectively captures all the light emitted into the opening of the cylindrical casing. The light meter by itself would be incapable of measuring the illuminance of a LED traffic indicator from far out distances because the ambient light would impact the measured light output from the LED. The device also has a laser pointer to properly point at the maximum intensity capturing position of the LED traffic indicators. The distance was measured by a commercial distance meter. The output of the light meter is ported to the data recorder through a USB port. The interface software is provided by the light meter manufacturer.

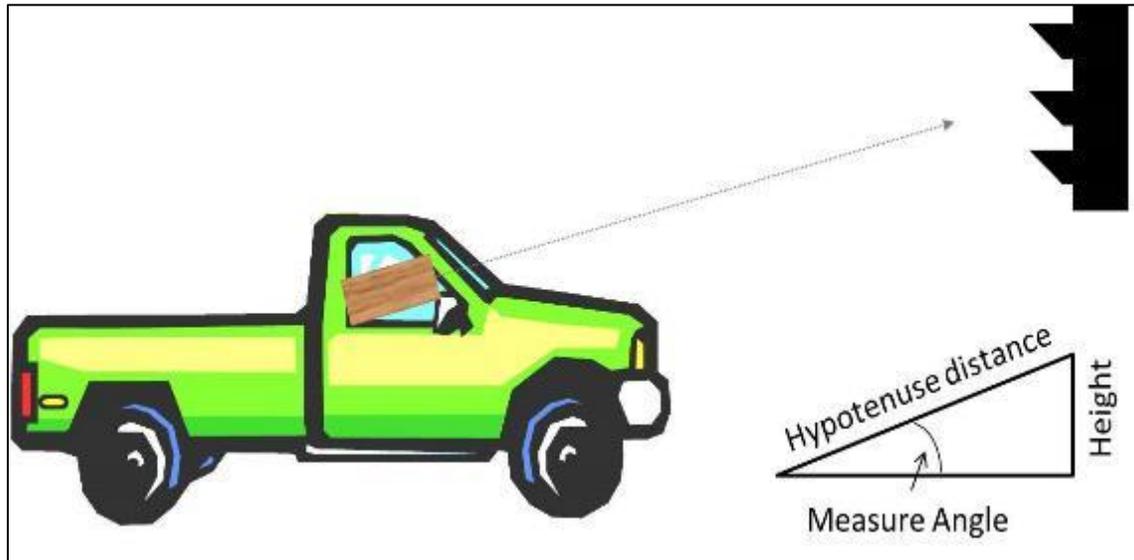
During data collection, an operator in the passenger seat of a vehicle, points the device at the traffic signal and locates the maximum reading for each indication. Using a distance meter, the driver then reads and records the hypotenuse distance between the traffic signal and the device. Data from the illuminance meter is then recorded, into an attached computer, for the duration of one traffic signal cycle. This process is completed five times for each traffic signal at each intersection at varying distances. Figure 2.2, below, depicts the relative locations between the vehicle and the traffic signal.

Figure 2.2 - Data Collection Image

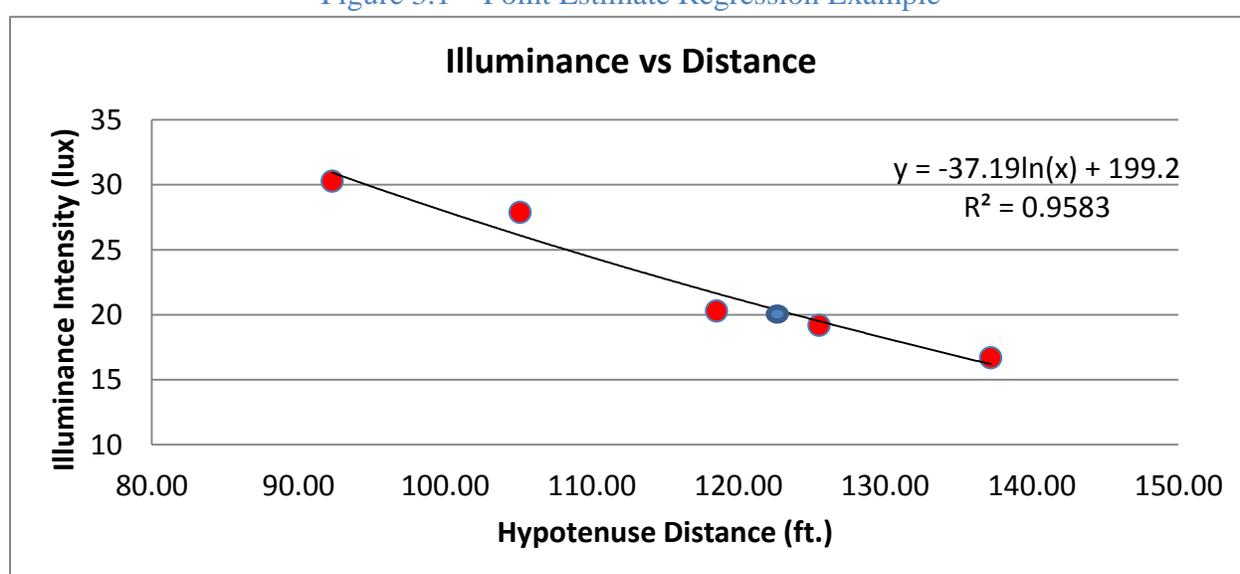
For example, in Figure 3.1, seen below, five measurements were completed in the winter set for a circular red traffic signal indication. After the angle correction factor was applied, a regression analysis was performed on each observation set. This allowed for a calculation of an illuminance point estimate, seen in blue, at 124.15 feet. The five observations in Table 2.2 were used in the Point Estimate regression analysis, which outputs  $\beta_0$  and  $\beta_1$  for these five observations. The  $\beta_0$  (199.2) and  $\beta_1$  (-37.19) were then used to calculate a point estimate at 124.15 feet. This same process was then applied to each traffic signal indication within each observational set. This process calculated an illuminance point estimate at 124.15 feet for all traffic signal indications.

Figure 3.1 – Point Estimate Regression Example

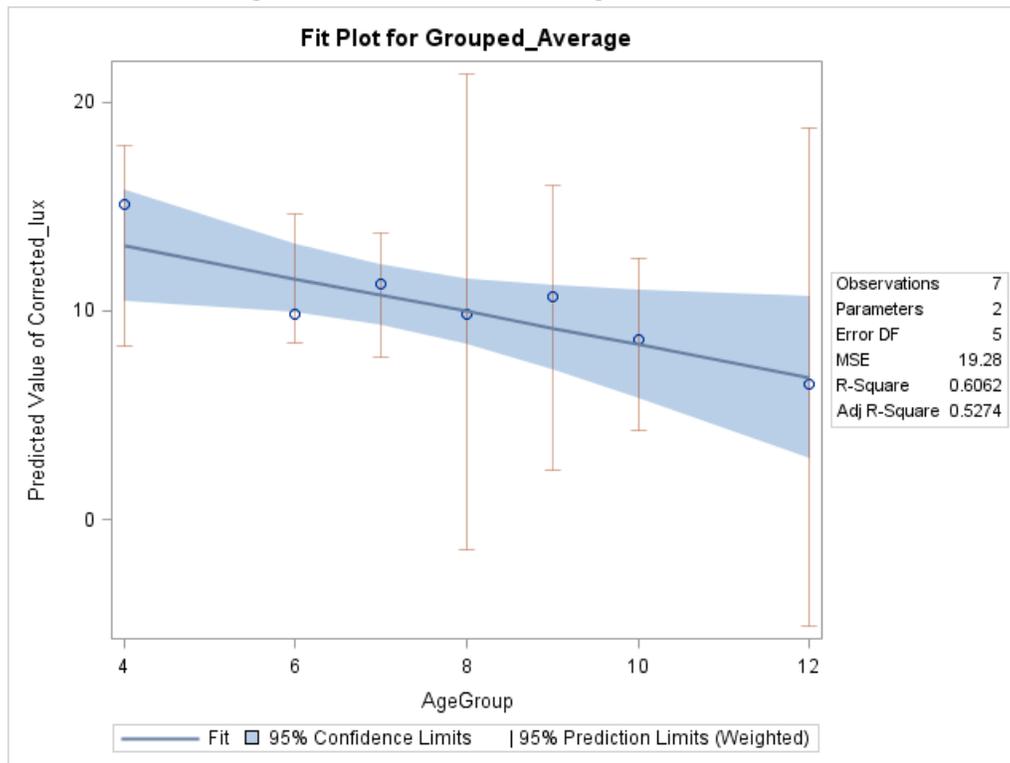
The degradation rate for the Dialight Green Arrow shows a strong decreasing trend. The  $R^2$  value of 0.6062 for this indication has a moderately strong correlation between the age and weighted average point estimate illuminance value. The area within the confidence limit, shown in light blue in Figure 3.2, is shown to be close to the trend line. In addition, the area enclosed by the 95% confidence limits is relatively small, which supports the accuracy of the degradation regression model for this indication.

Figure 3.2 - Fit Plot for Dialight Green Arrow

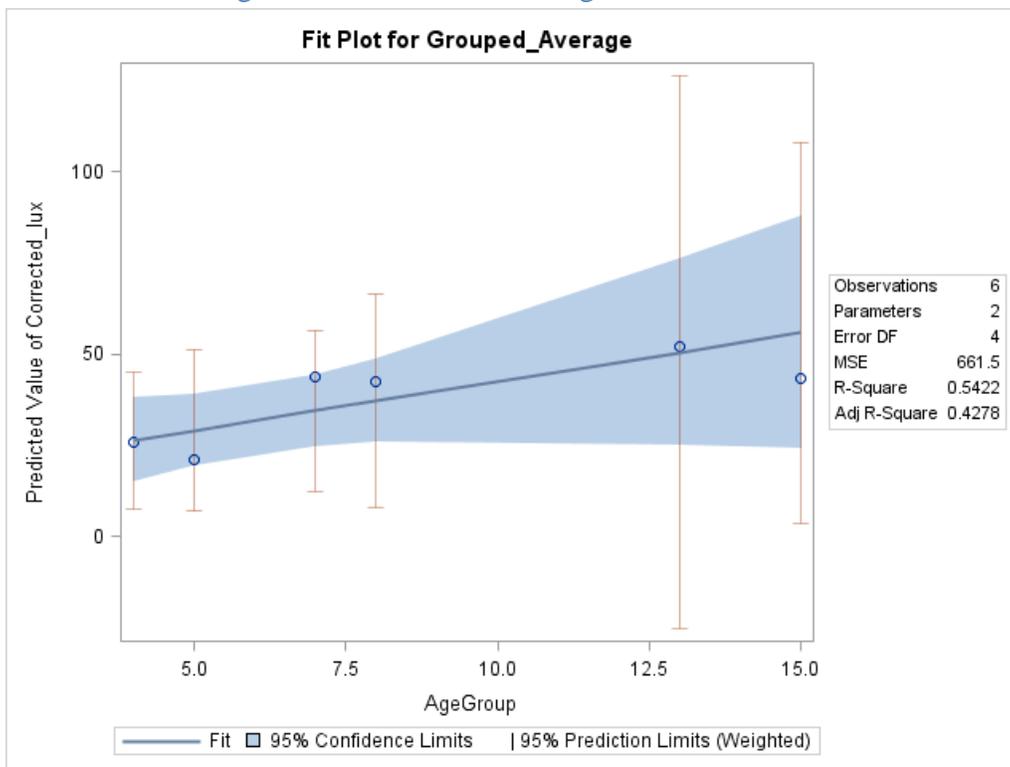
The degradation rate for the Dialight Circular Green shows a strong increasing trend. The  $R^2$  value of 0.5422 for this indication has a moderately strong correlation between the age and weighted average point estimate illuminance value. The area within the confidence limit, shown in light blue in Figure 3.3, varies in width across ages. The higher age group values have larger confidence limits, which indicate imprecision for indications within the 13 and 15 year age groups. Based on the increasing trend line, which is inconsistent with degradation models, the Dialight Circular Green indication is excluded from the Lifetime Estimate Analysis.

Figure 3.3 - Fit Plot for Dialight Circular Green

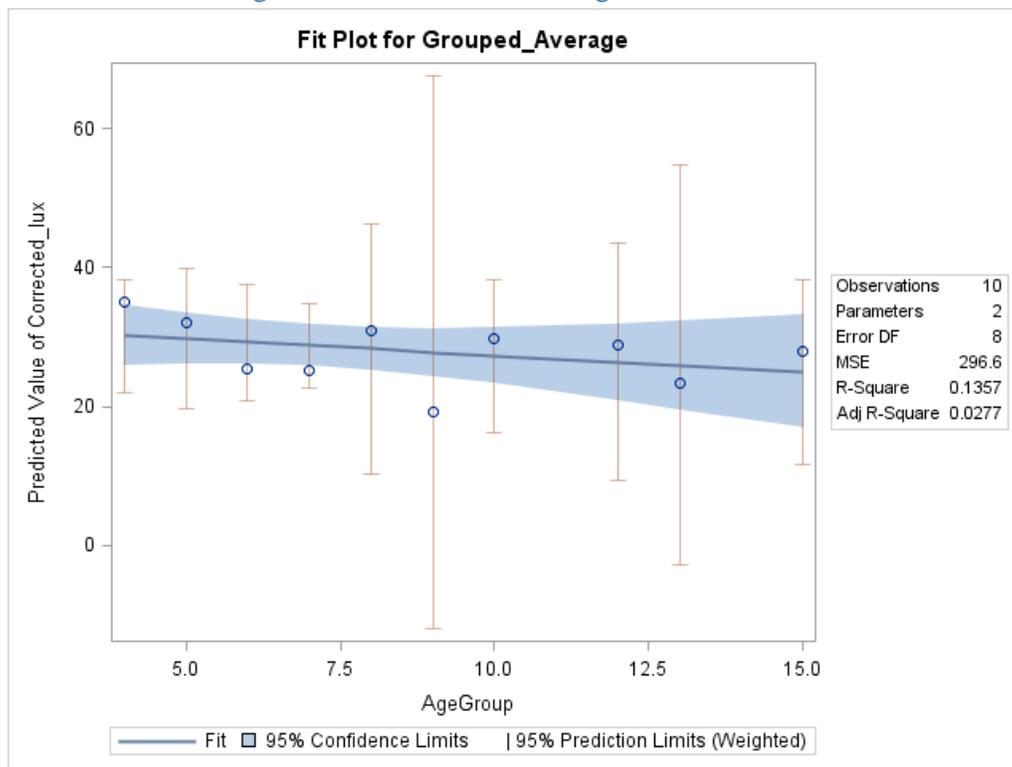
The degradation rate for the Dialight Circular Red shows a small decreasing trend. The  $R^2$  value of 0.1357 for this indication has a weak correlation between the age and weighted average point estimate illuminance value. However, the area within the confidence limit, shown in light blue in Figure 3.4, remains tightly bound around the trend line, which indicates a small variance around the predicted trend line. The small negative slope value also indicates a small degradation value over time. The slight annual degradation value and the large intercept value provide a high estimated lifetime value for the Dialight Circular Red indication.

Figure 3.4 - Fit Plot for Dialight Circular Red

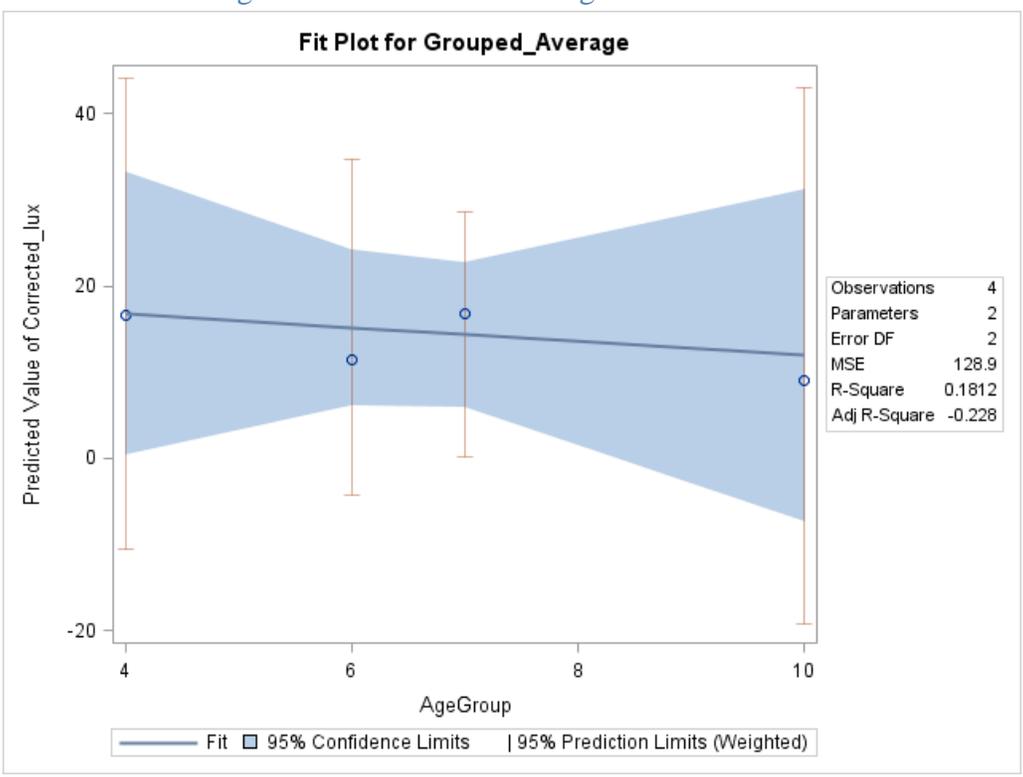
The degradation rate for the Dialight Yellow Arrow shows a small decreasing trend. The  $R^2$  value of 0.1812 for this indication has a weak correlation between the age and weighted average point estimate illuminance value. In addition, the area enclosed by the confidence limits, shown in light blue in the Figure 3.5, is quite large and varies greatly from point to point. The large confidence interval and the weak  $R^2$  value indicate there is uncertainty within the predicted trend line. However, a large portion of this uncertainty is due to the relatively few number of observations collected for this indication. The small negative slope value also indicates a small degradation value over time. The slight annual degradation value and low ITE threshold provide a high estimated lifetime value for the Dialight Yellow Arrow indication.

Figure 3.5 - Fit Plot for Dialight Yellow Arrow

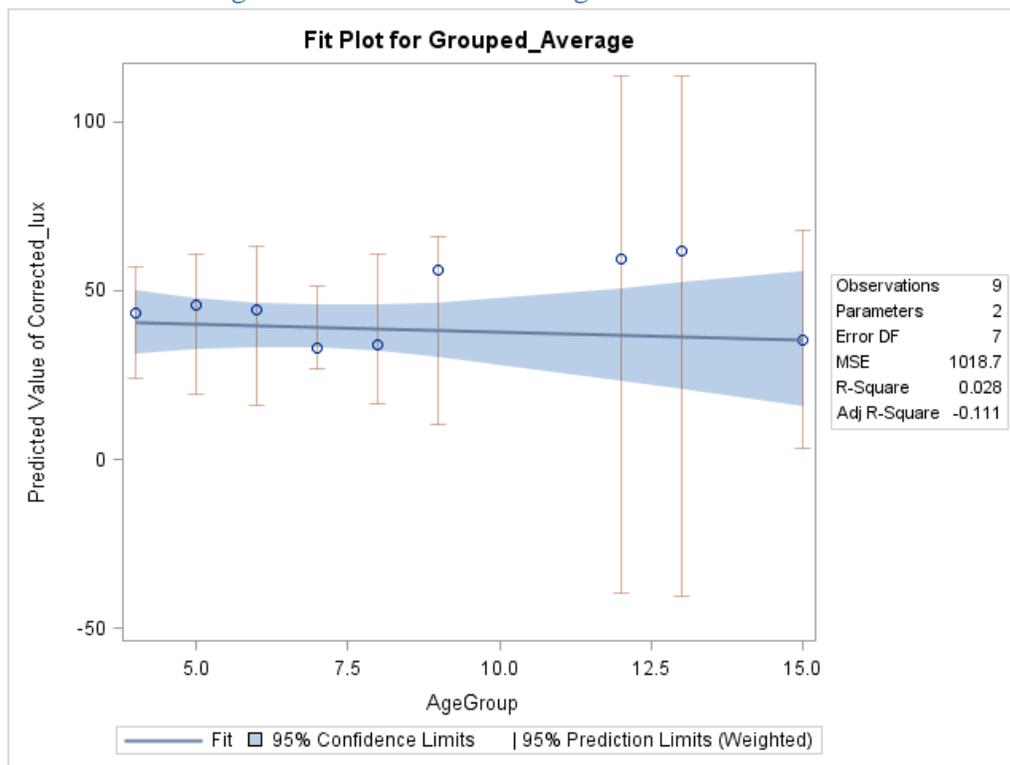
The degradation rate for the Dialight Circular Yellow shows a negligibly small decreasing trend. The  $R^2$  value of 0.028 for this indication has an extremely weak correlation between the age and weighted average point estimate illuminance value. In addition, the area enclosed by the confidence limits, shown in light blue Figure 3.6, is quite large and varies greatly from point to point. The large confidence interval and the weak  $R^2$  value indicate there is uncertainty within the predicted trend line. In addition, the intercept calculated in this regression model is lower than the ITE Threshold for yellow circular indications. Because the apparent uncertainty in the degradation regression model and the intercept is less than the ITE threshold for circular yellow indications, the Dialight Circular Yellow indication was excluded from the estimated lifetime analysis.

Figure 3.6 - Fit Plot for Dialight Circular Yellow

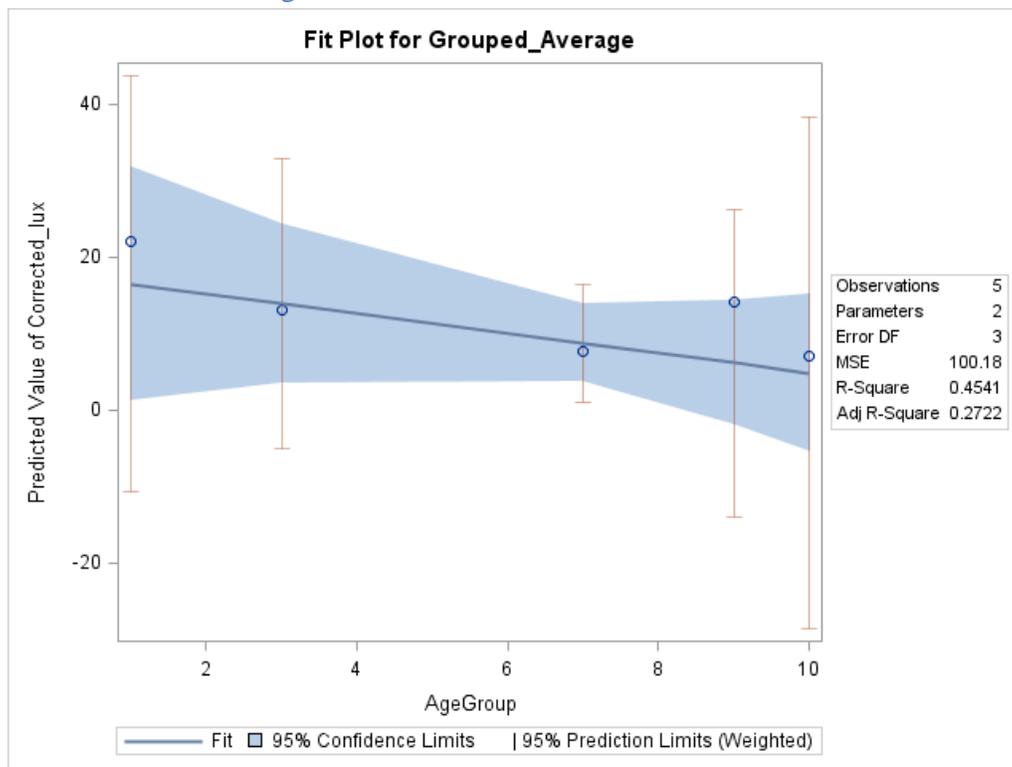
The degradation rate for the GE Green Arrow shows a strong decreasing trend. The  $R^2$  value of 0.4541 for this indication has a moderate correlation between the age and weighted average point estimate illuminance value. The area within the confidence limit, shown in light blue in Figure 3.7, is shown to vary widely in relation to the trend line. However, the predicted trend line shows a distinctly negative slope, which supports a small degradation over time. The high intercept value, small annual degradation value, and lower ITE Threshold for arrow indications will provide a moderate lifetime estimate for GE Green Arrows.

Figure 3.7 - Fit Plot for GE Green Arrow

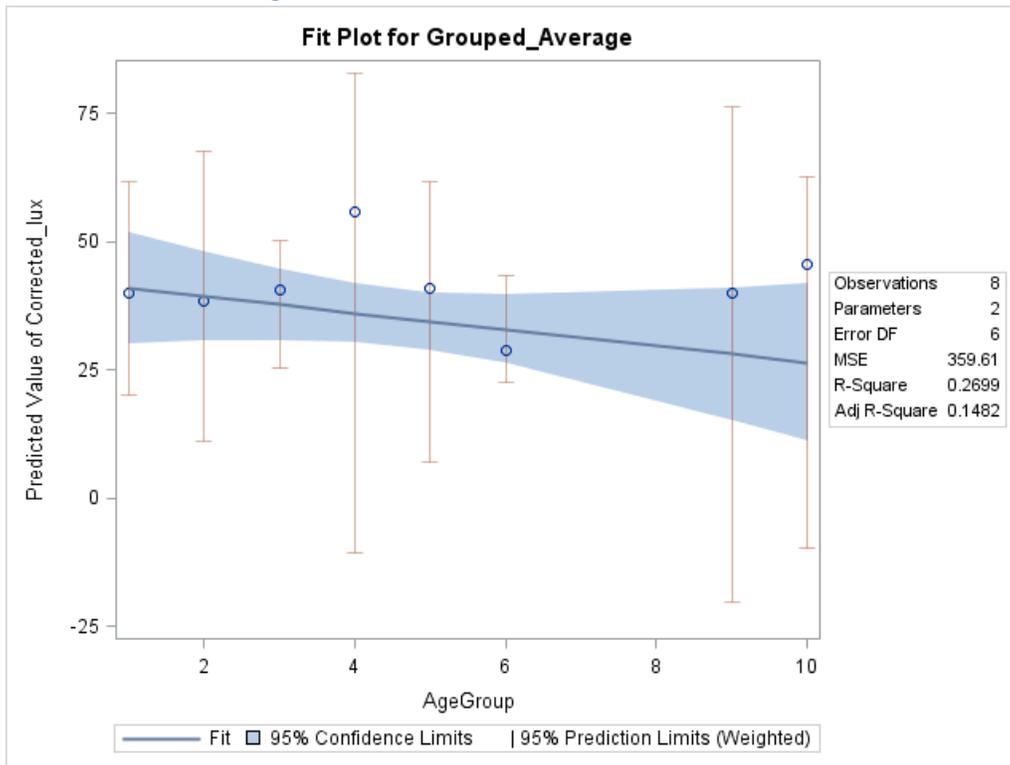
The degradation rate for the GE Circular Green shows a strong decreasing trend. The  $R^2$  value of 0.2699 for this indication has a weak correlation between the age and weighted average point estimate illuminance value. The area within the confidence limit, shown in light blue in Figure 3.8, is shown to tightly follow the trend line. Despite the weak  $R^2$  value, the trend line shows a distinctly negative slope, which supports a small degradation over time.

Figure 3.8 - Fit Plot for GE Circular Green

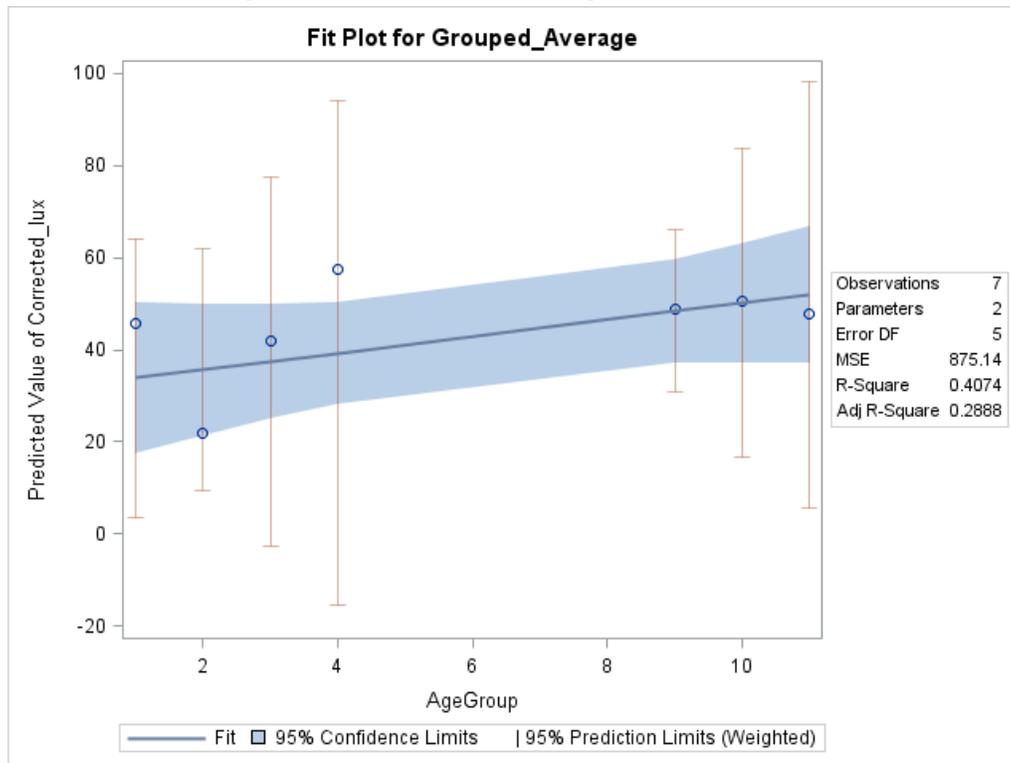
The degradation regression model rate for the Dialight Yellow Arrow has an increasing trend line. Based on the increasing trend line, which is inconsistent with degradation models, the Dialight Yellow Arrow indication is excluded from the Lifetime Estimate Analysis.

Figure 3.9 - Fit Plot for Dialight Yellow Arrow

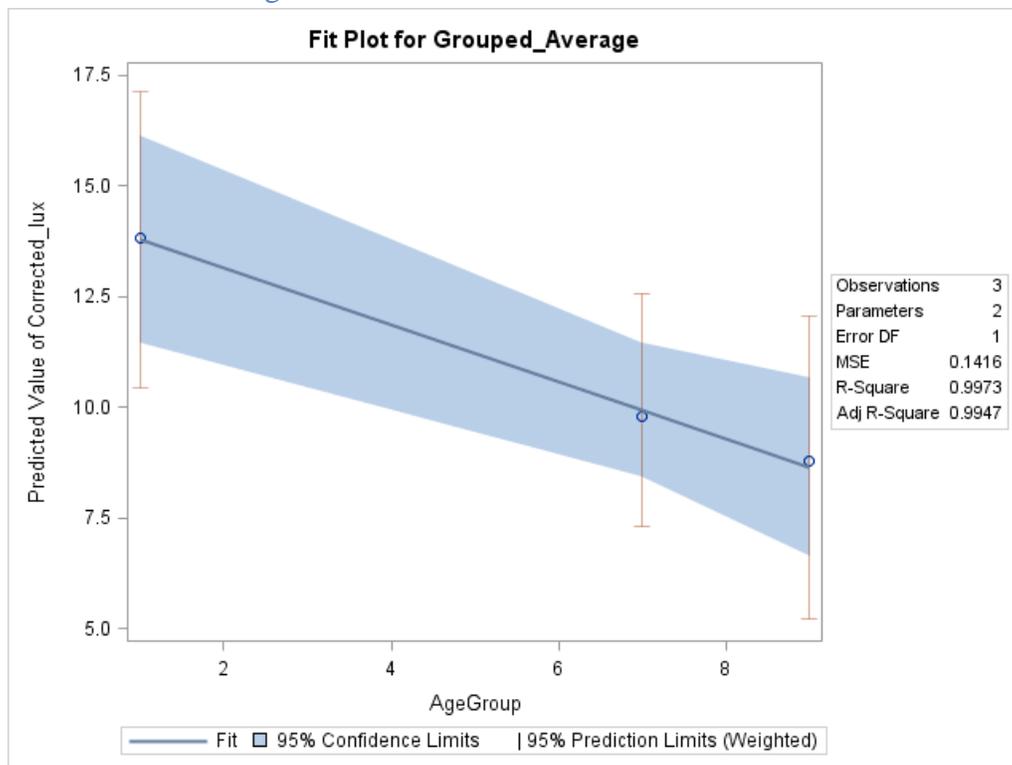
The degradation rate for the GE Yellow Arrow shows a strong decreasing trend. The  $R^2$  value of 0.9973 for this indication has an extremely strong correlation between the age and weighted average point estimate illuminance value. The area within the confidence limit, shown in light blue in Figure 3.10, is shown to vary consistently across all age groups in relation to the trend line. However, the predicted trend line shows a distinctly negative slope, which supports a small degradation over time. The high intercept value, small annual degradation value, and lower ITE Threshold for arrow indications will provide a moderate lifetime estimate for GE Yellow Arrows.

Figure 3.10 - Fit Plot for GE Yellow Arrow

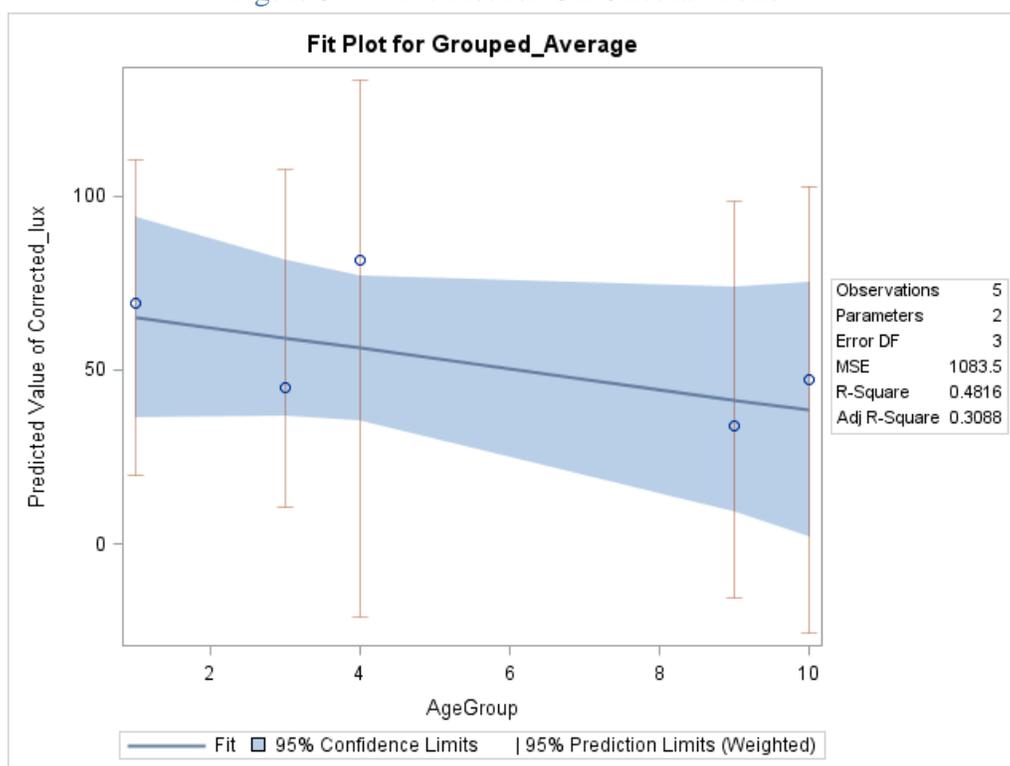
The degradation rate for the GE Circular Yellow shows a strong decreasing trend. The  $R^2$  value of 0.4816 for this indication has a moderate correlation between the age and weighted average point estimate illuminance value. The area within the confidence limit, shown in light blue in Figure 3.11, is shown to vary greatly across all age groups in relation to the trend line. However, the predicted trend line shows a distinctly negative slope, which supports degradation over time. The  $R^2$  value and the distinctly negative slope do not rule the GE Circular Yellow indication from exclusion in the Lifetime Estimate Analysis.

Figure 3.11 - Fit Plot for GE Circular Yellow

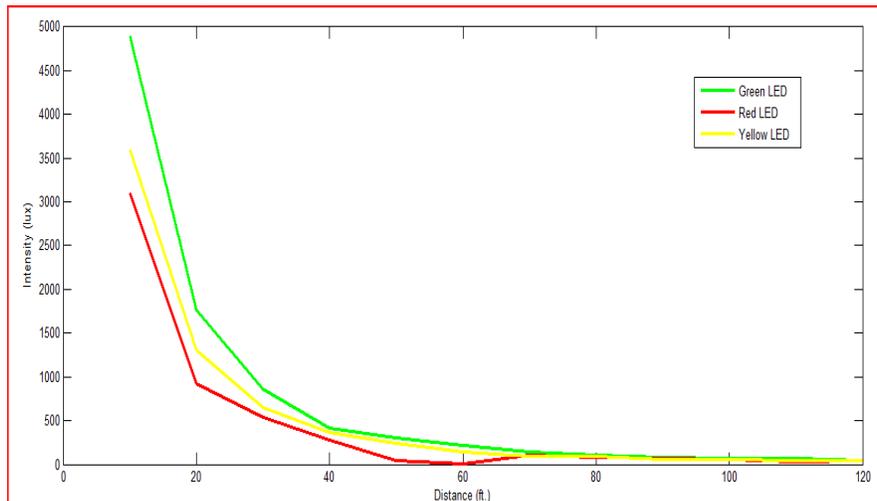
Figure 5.3 and 5.4 presents the overview of the intensity readings obtained for red, green, and yellow LED traffic indicators. Performance in comparison with manufacturer provided data shows that the readings collected with the study device is at a statistically significant confidence level.

Figure 5.3- Average Intensity in Lux versus Distance in ft. for Lab Analysis

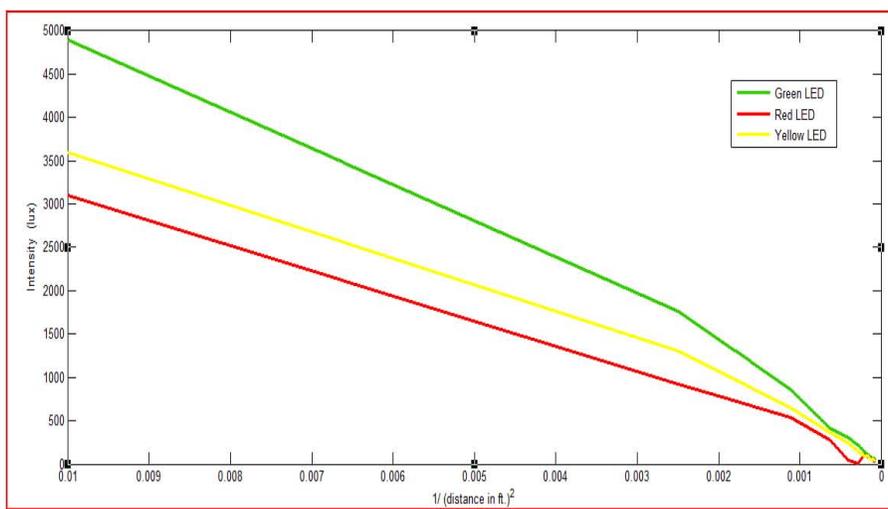
Figure 5.4 - Inverse Square Law Curve for Lab Analysis

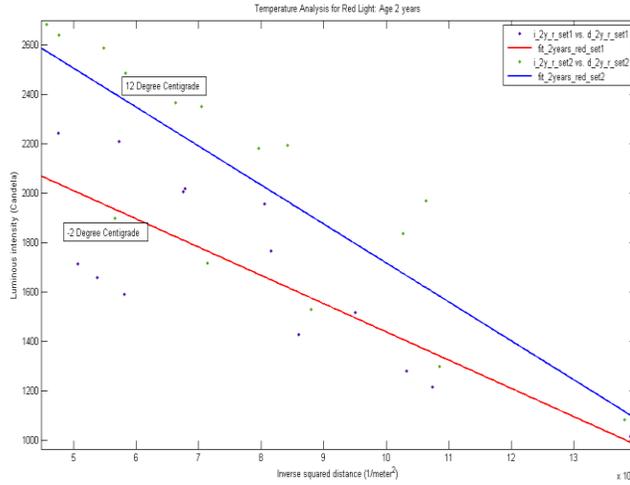
Figure A.1 - Temperature Analysis for Red Indication: Age 2 years

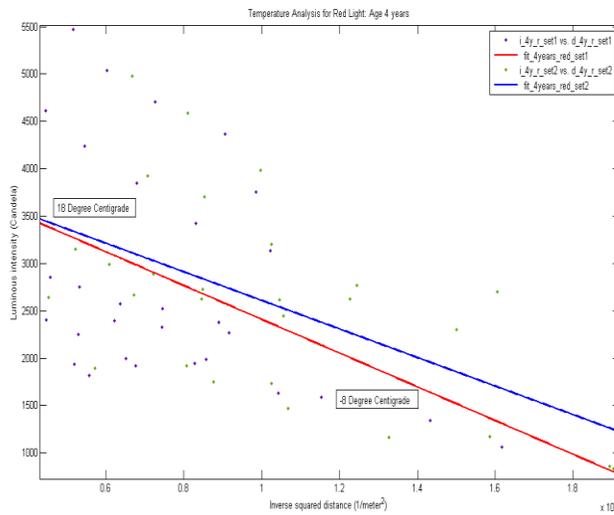
Figure A.2 Temperature Analysis for Red Indication: Age 4 years

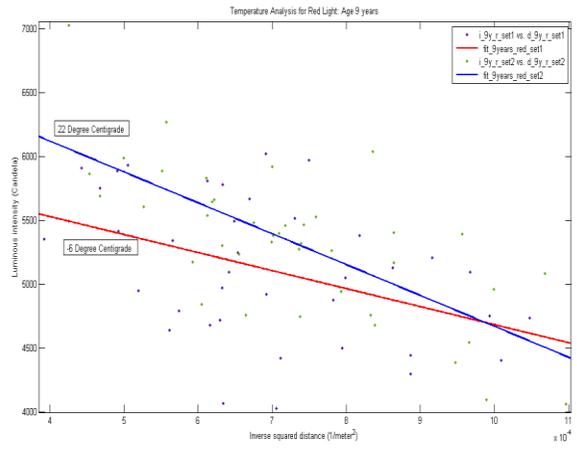
Figure A.3 Temperature Analysis for Red Indication: Age 9 years

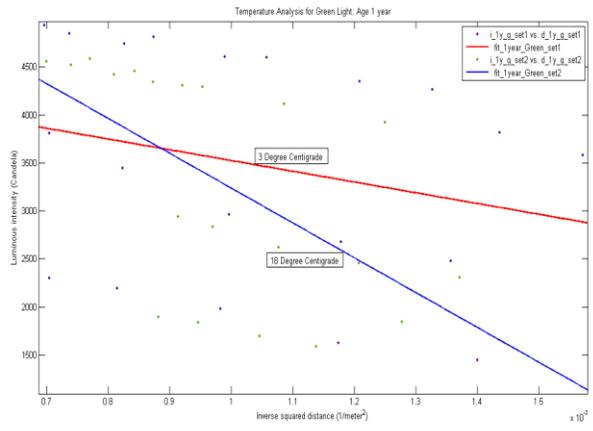
Figure A.4 - Temperature Analysis for Green Indication: Age 1 year

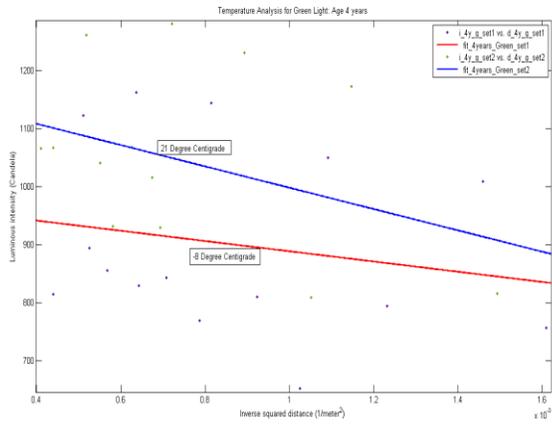
Figure A.5 Temperature Analysis for Green Indication: Age 4 years

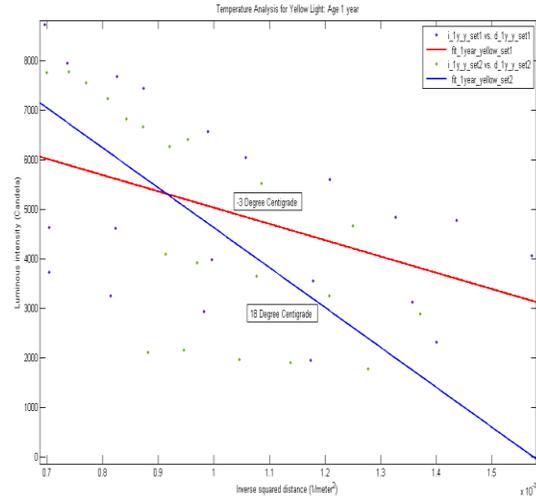
Figure A.6 - Temperature Analysis for Yellow Indication: Age 1 year

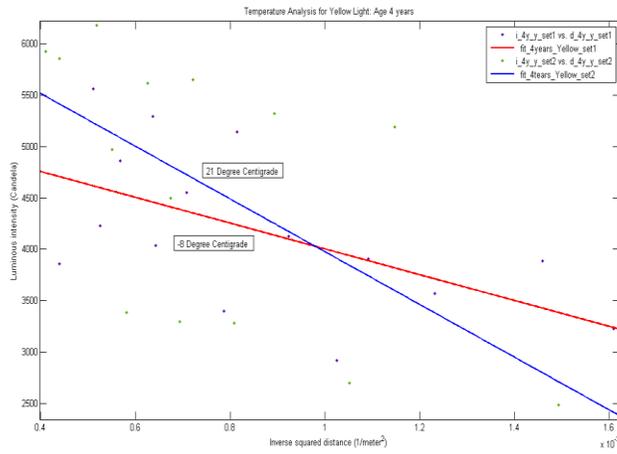
Figure A.7 Temperature Analysis for Yellow Indication: Age 4 years

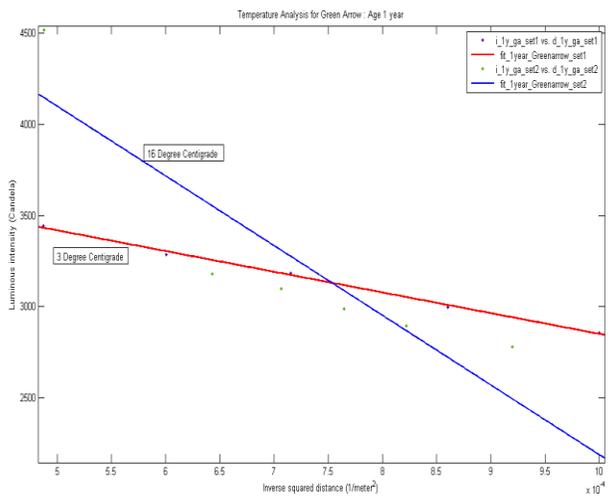
Figure A.8 Temperature Analysis for Green Arrow: Age 1 year

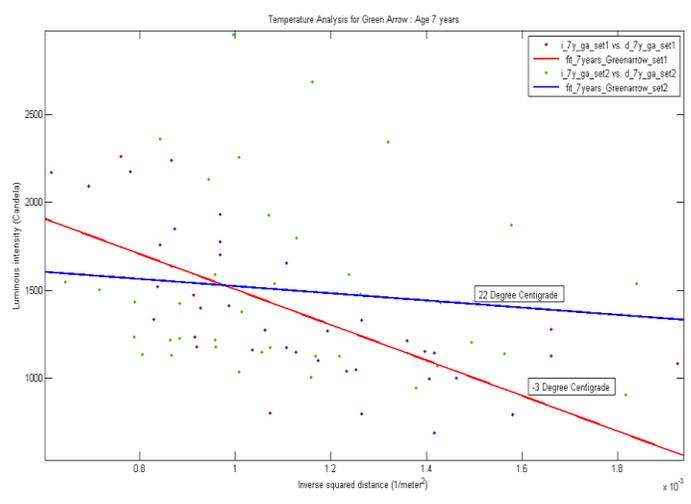
Figure A.9 Temperature Analysis for Green Arrow: Age 7 years

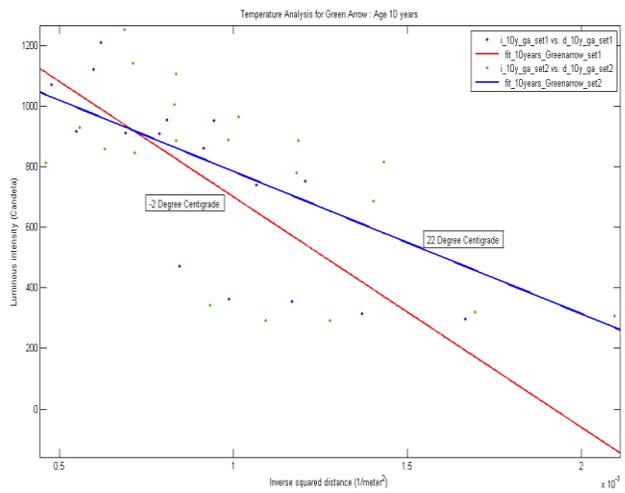
Figure A.10 Temperature Analysis for Green Arrow: Age 10 years

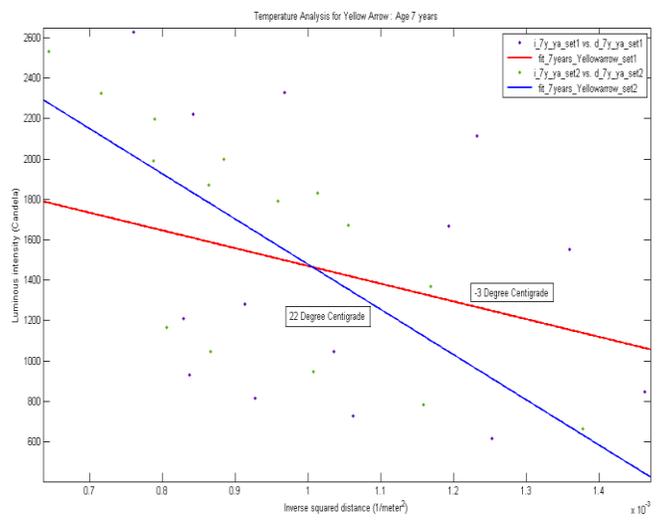
Figure A.11 Temperature Analysis for Yellow Arrow: Age 7 years
