Macon and Adair County, Route 63, Job J2P0485

Route 63, Howell Co., project J9P0497, HDPE double wall storm sewer, W. Side Rt.63

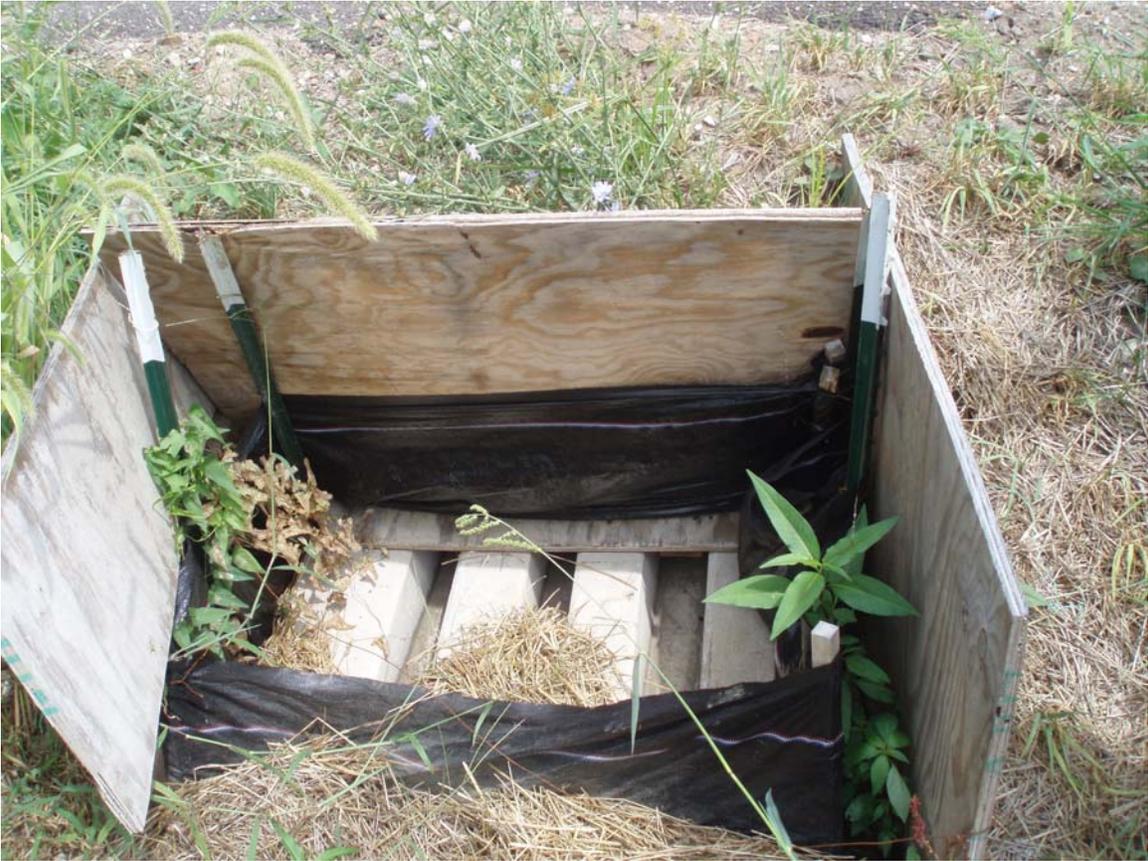
7-30-07, s-227, 24", 2105+00,

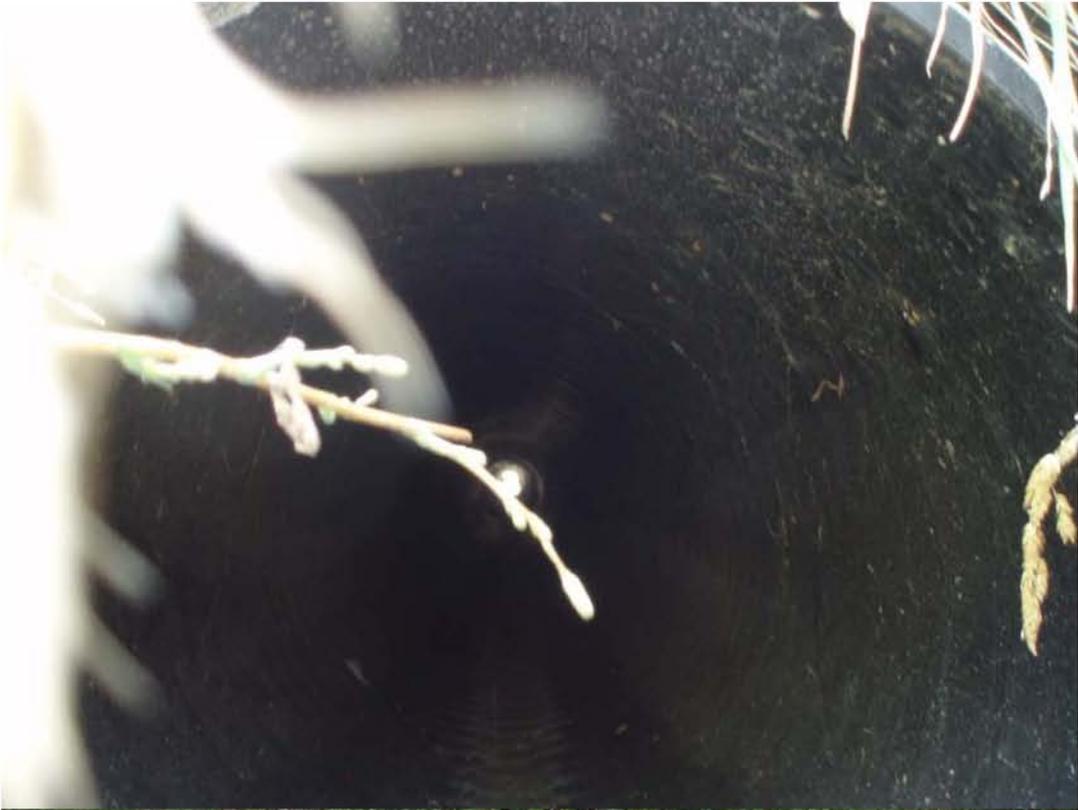
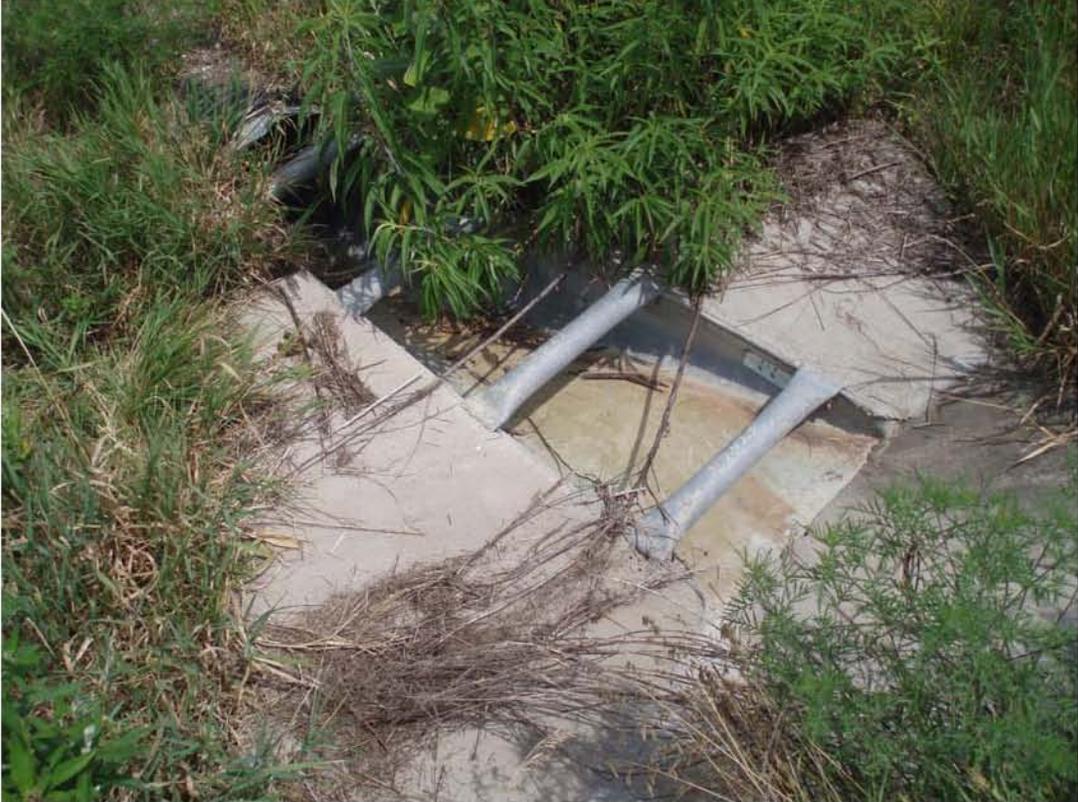
7-30-07, s-226, 24", 2098+37,

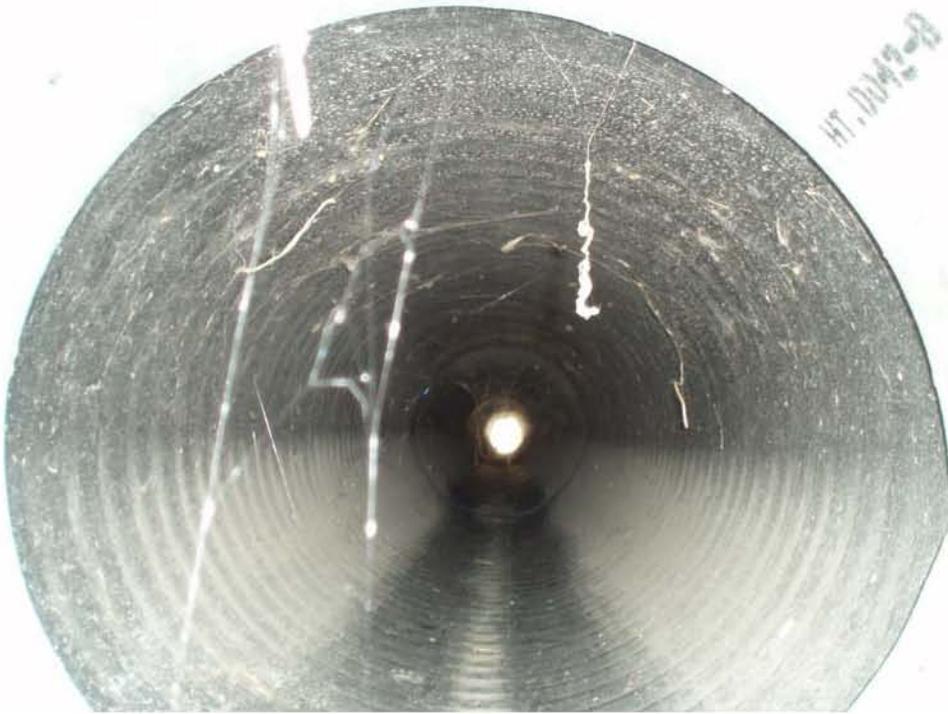
30-07, s-225, 24", 2097+00,

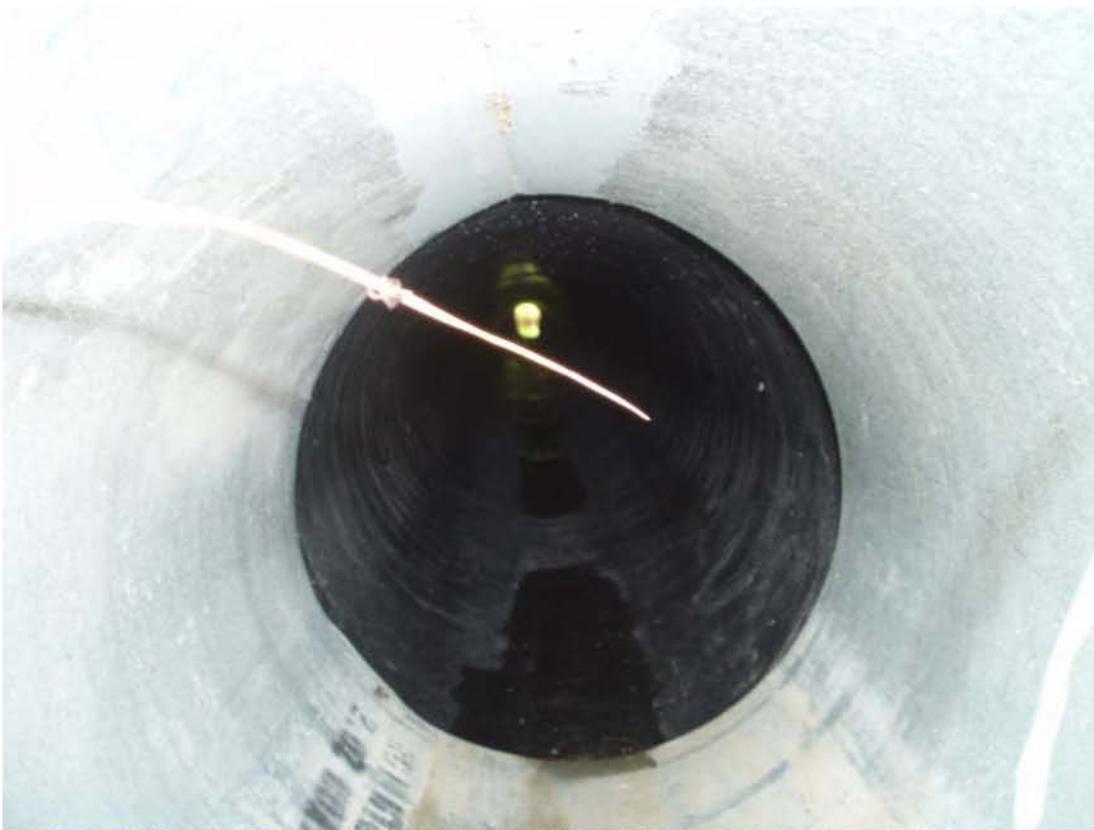
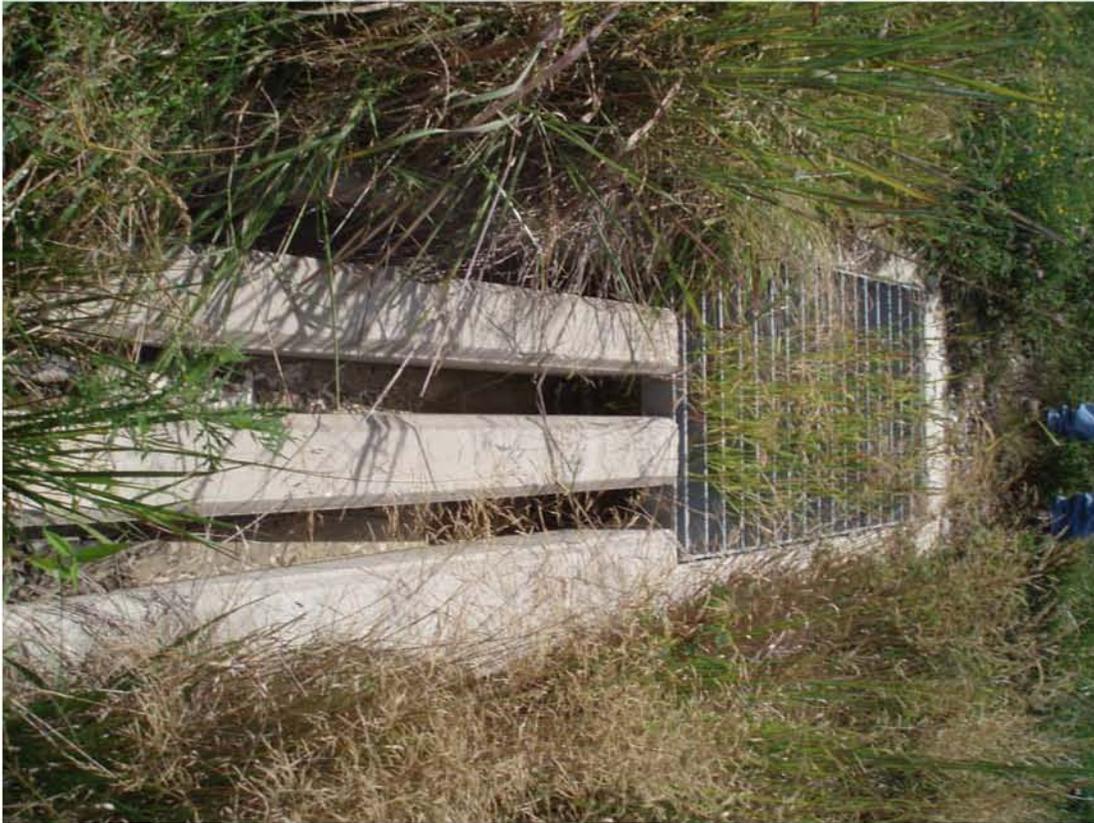
7-30-07, s-223, 15", 2092+00, ran camera

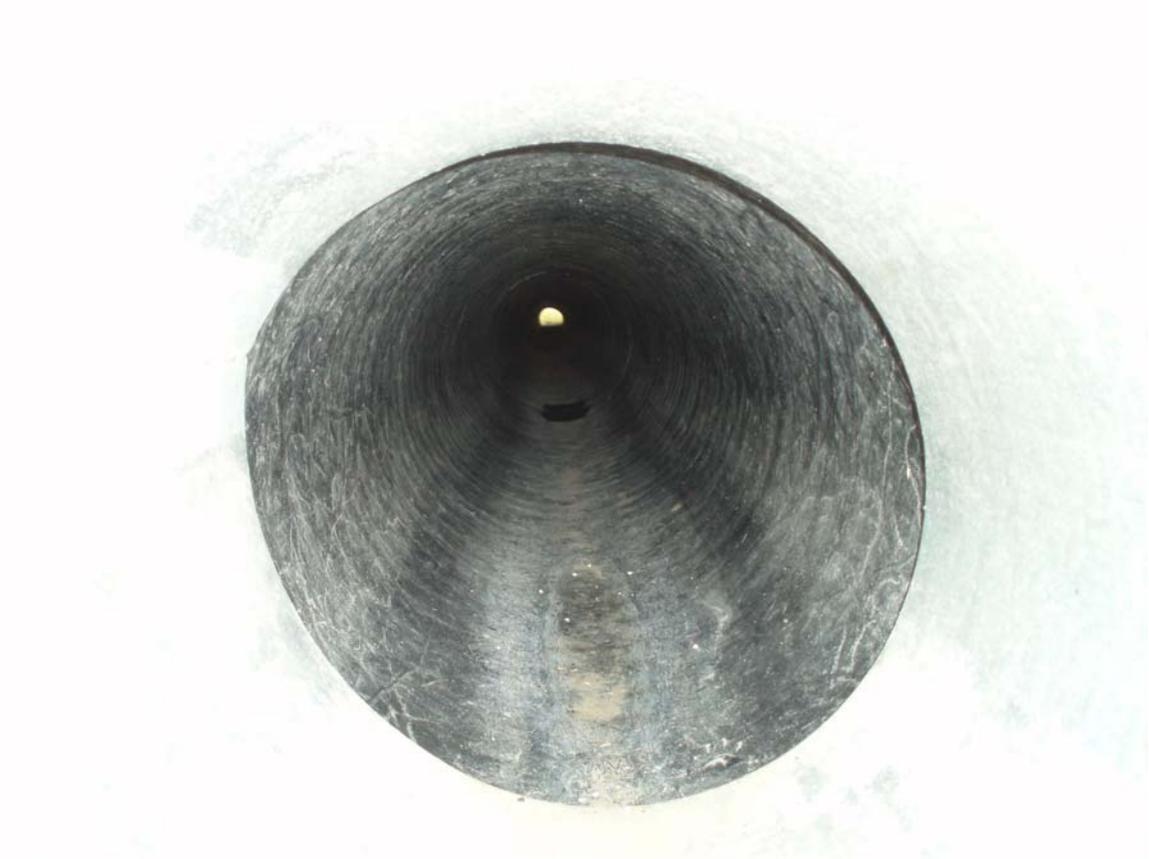
7-30-07, s-222, 15", 2087+00,

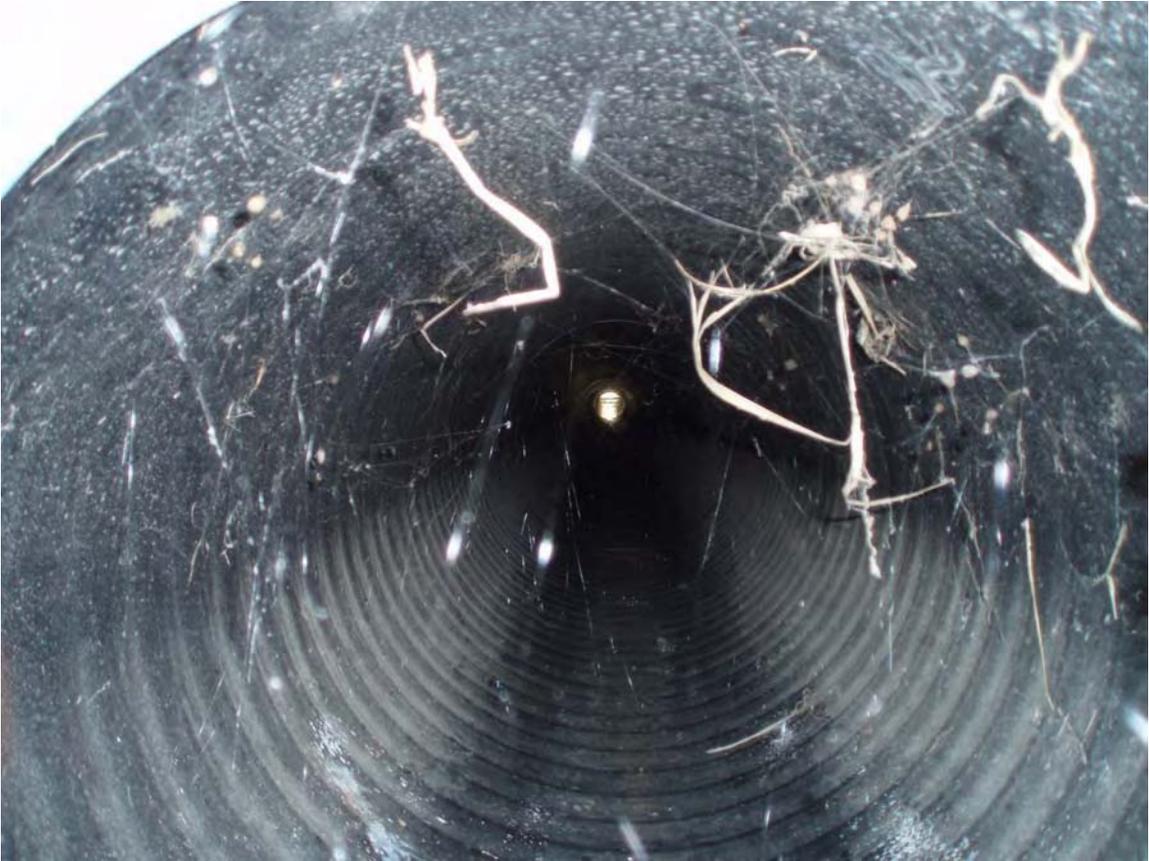
7-30-07, s-221, 24", 2081+00,

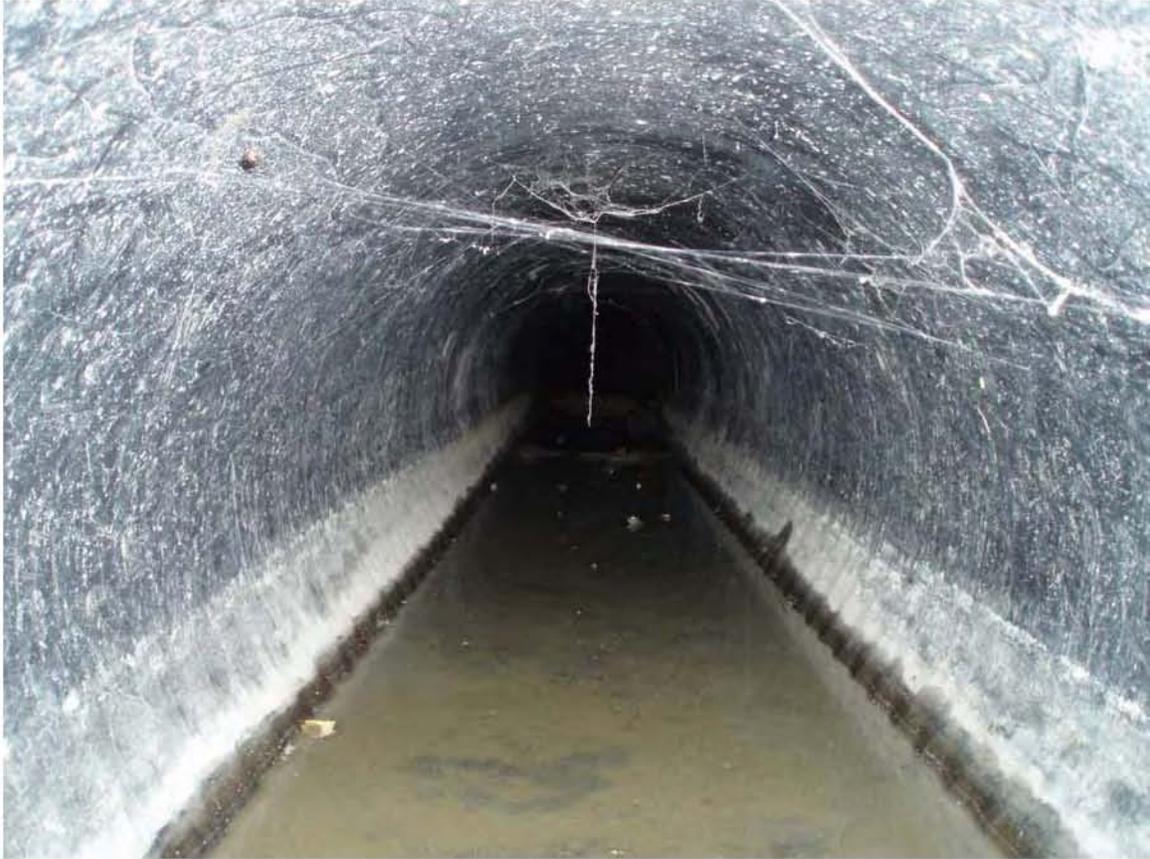
7-30-07, s-219, 24", 2077+70

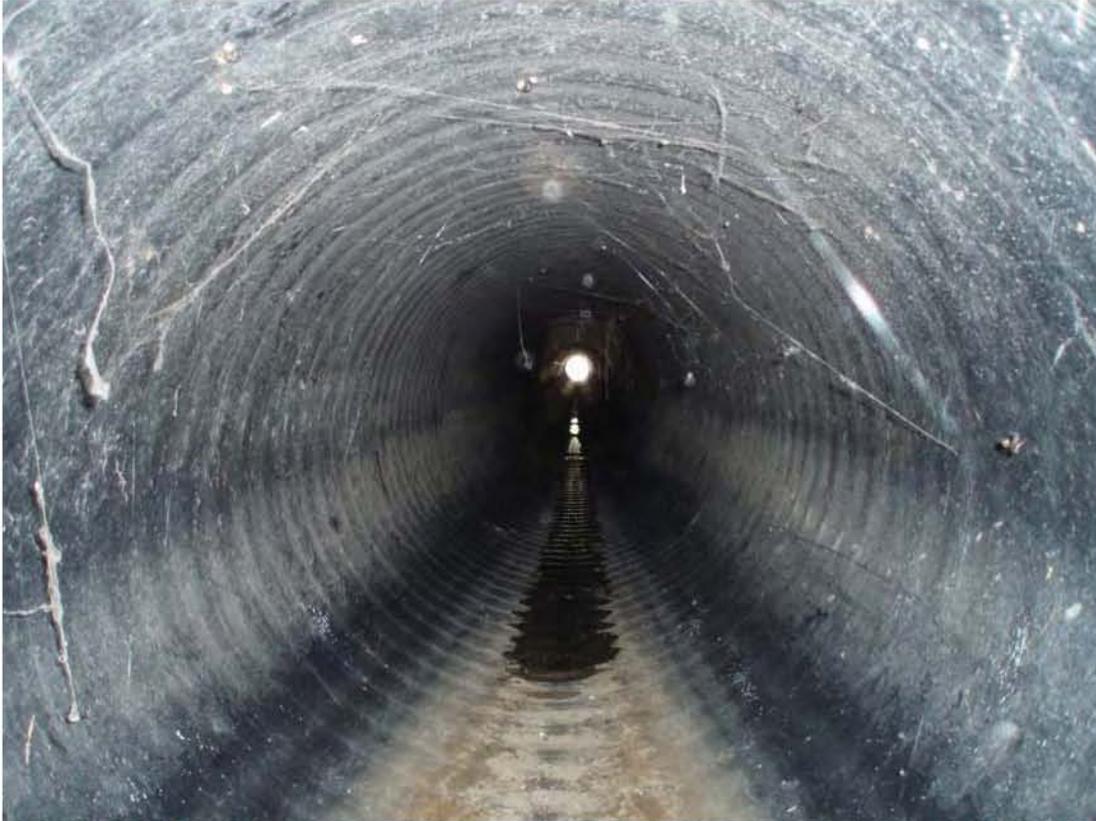
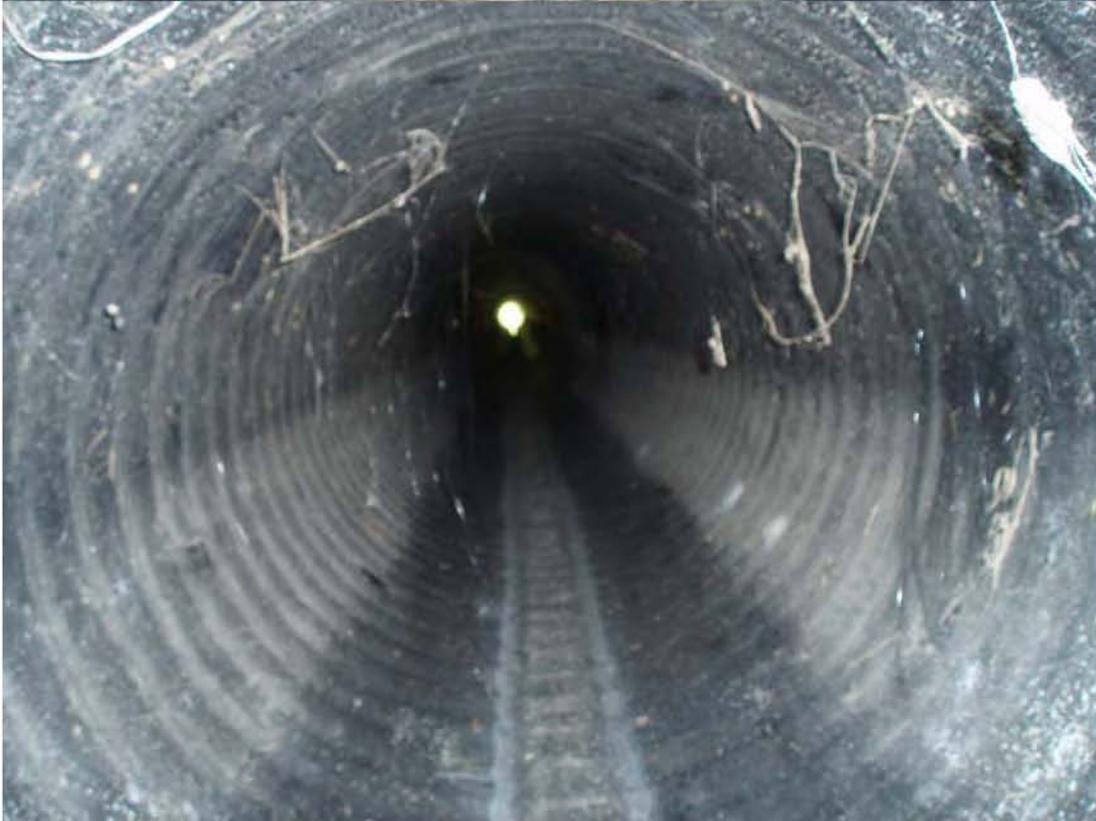
30-07, s-218, 30", 2069+86, 8'-10' of cover.

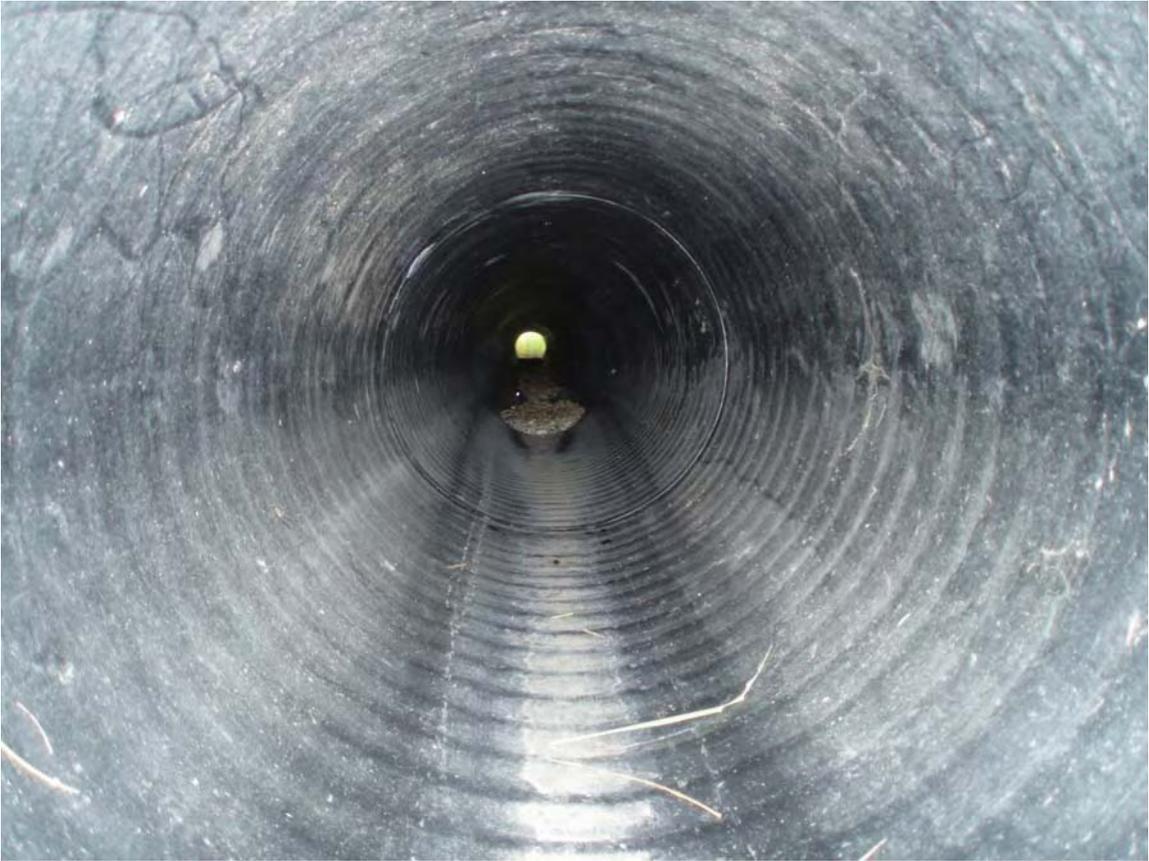
7-30-07, s-217, 18", 2060+00,

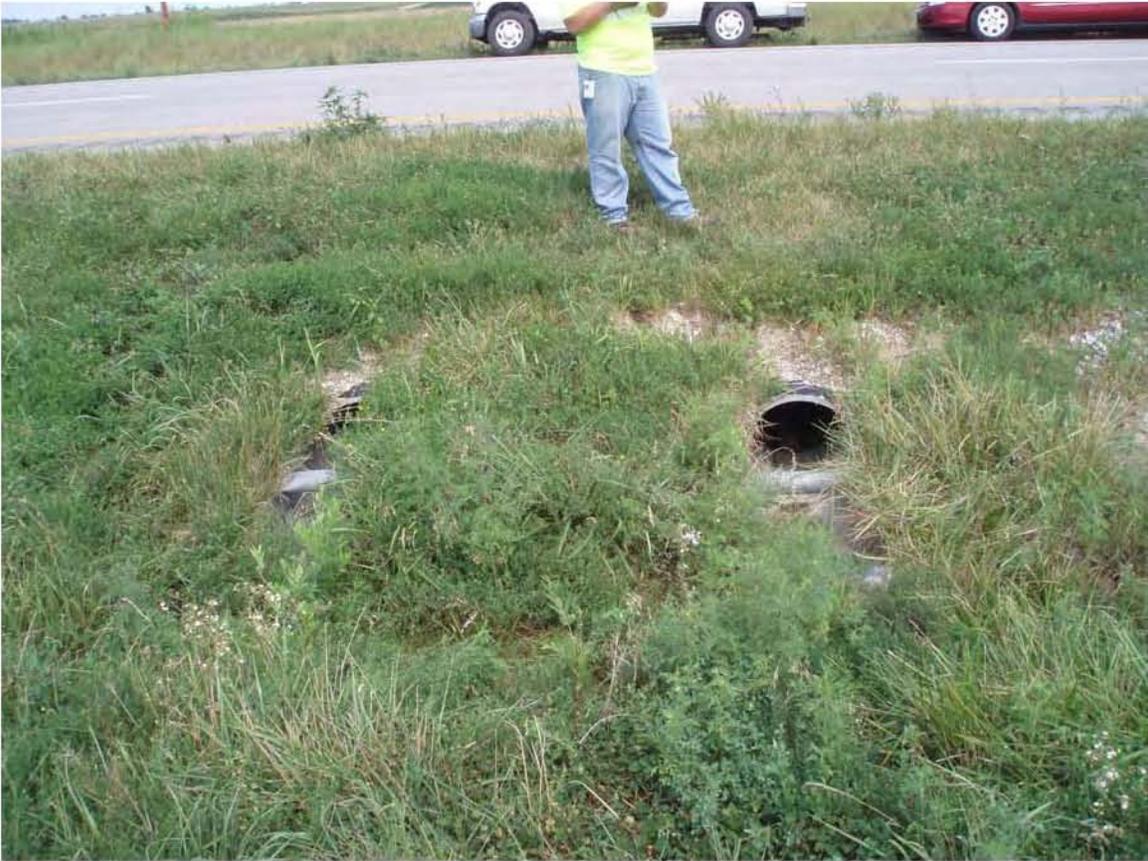
7-30-07, s-216A&B, 2057+00

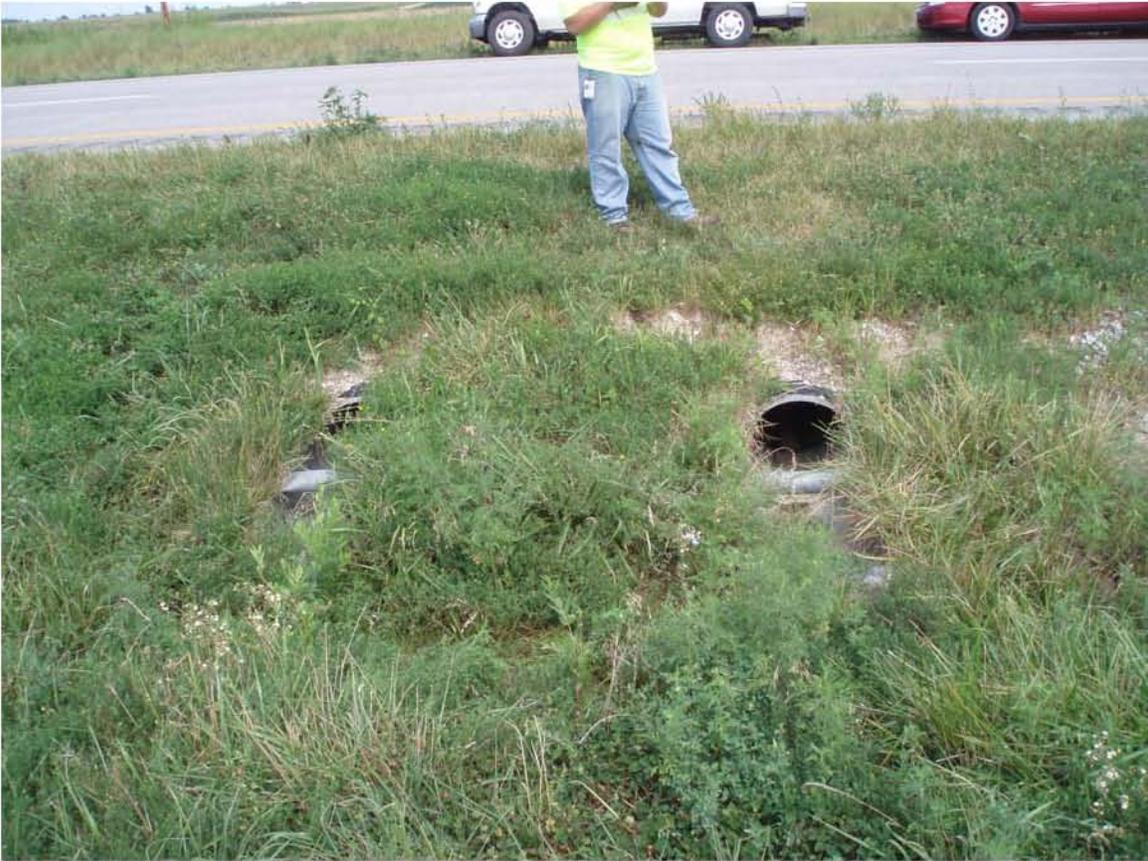
7-30-07, s-216A&B, 2057+00

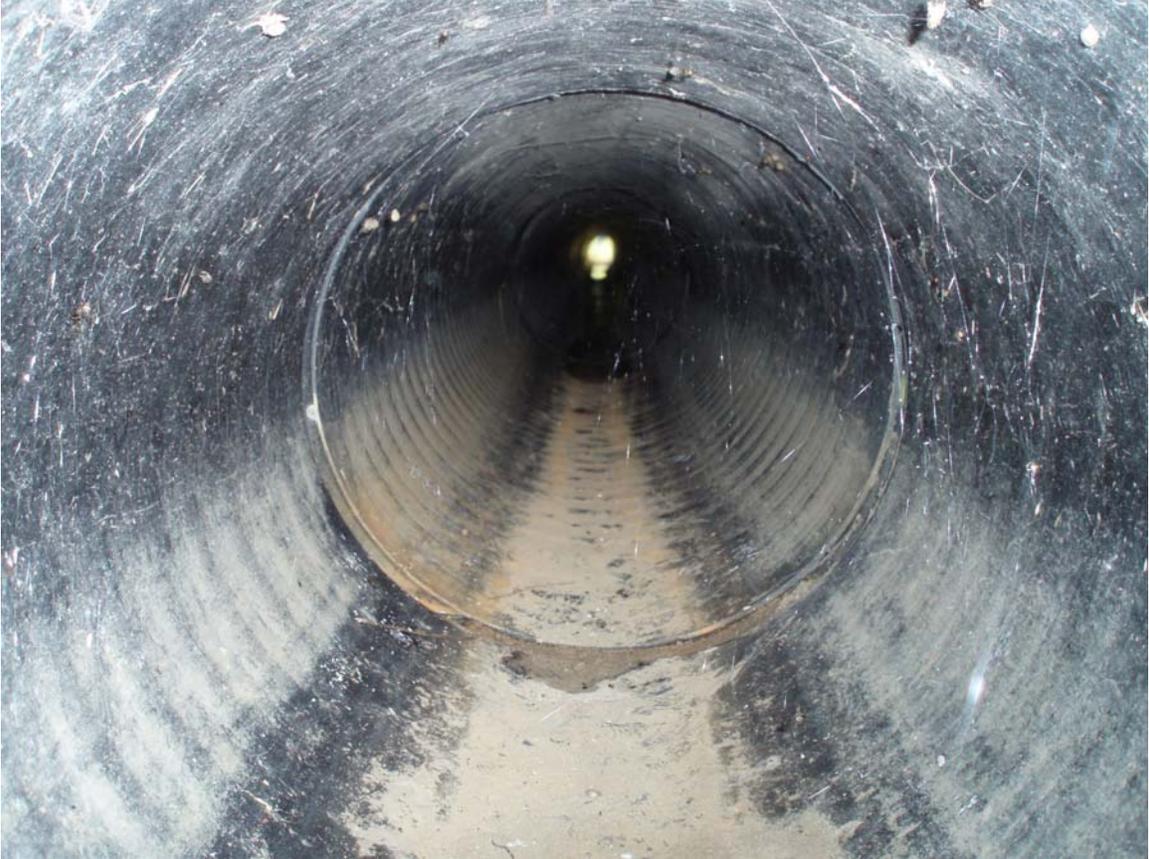
7-30-07, s-215, 18"

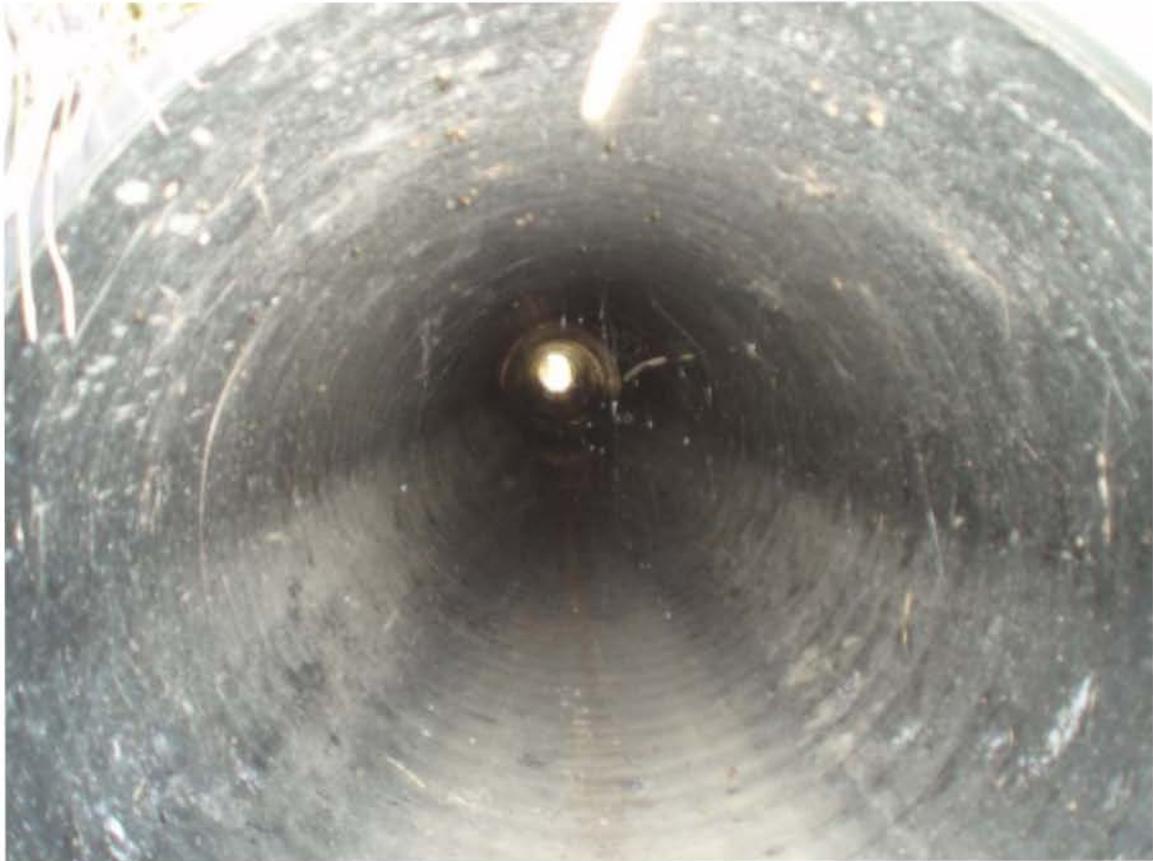
7-30-07, s-213, 24", 2047+00

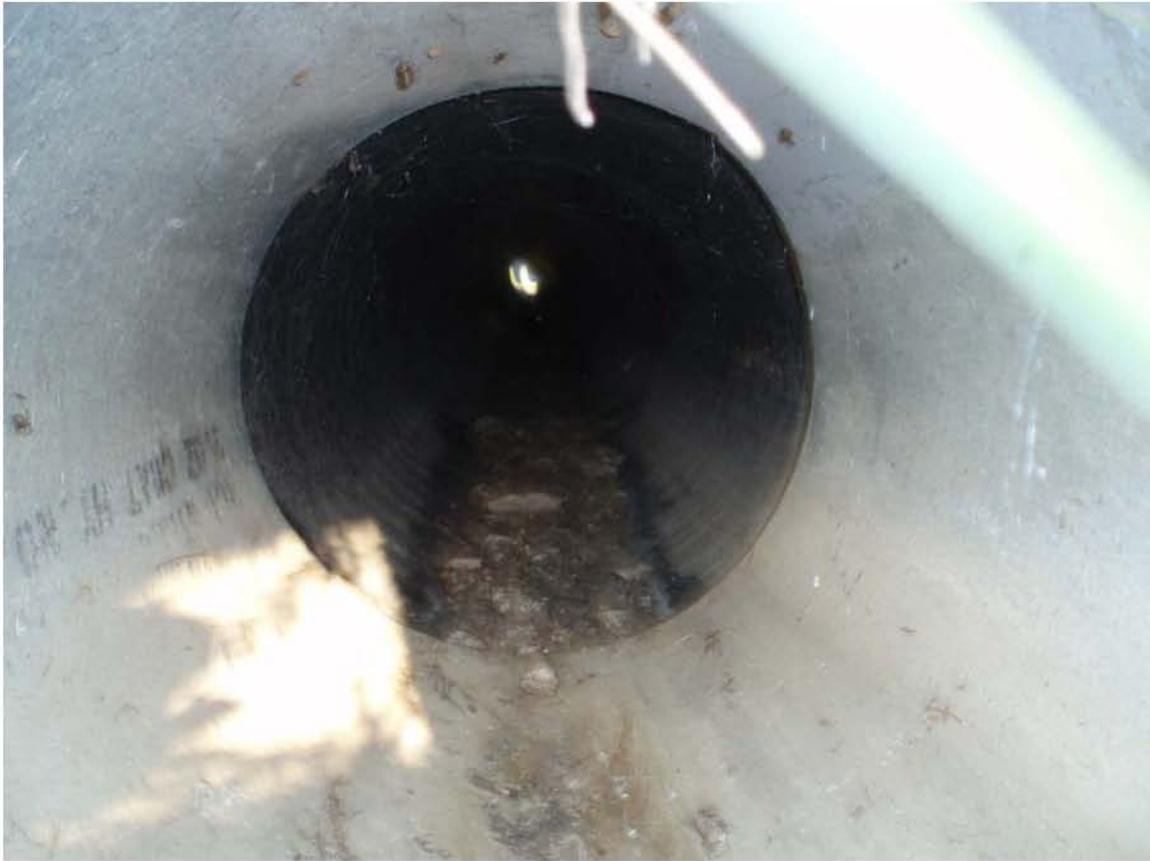
7-30-07, s-211, 15", 2042+00

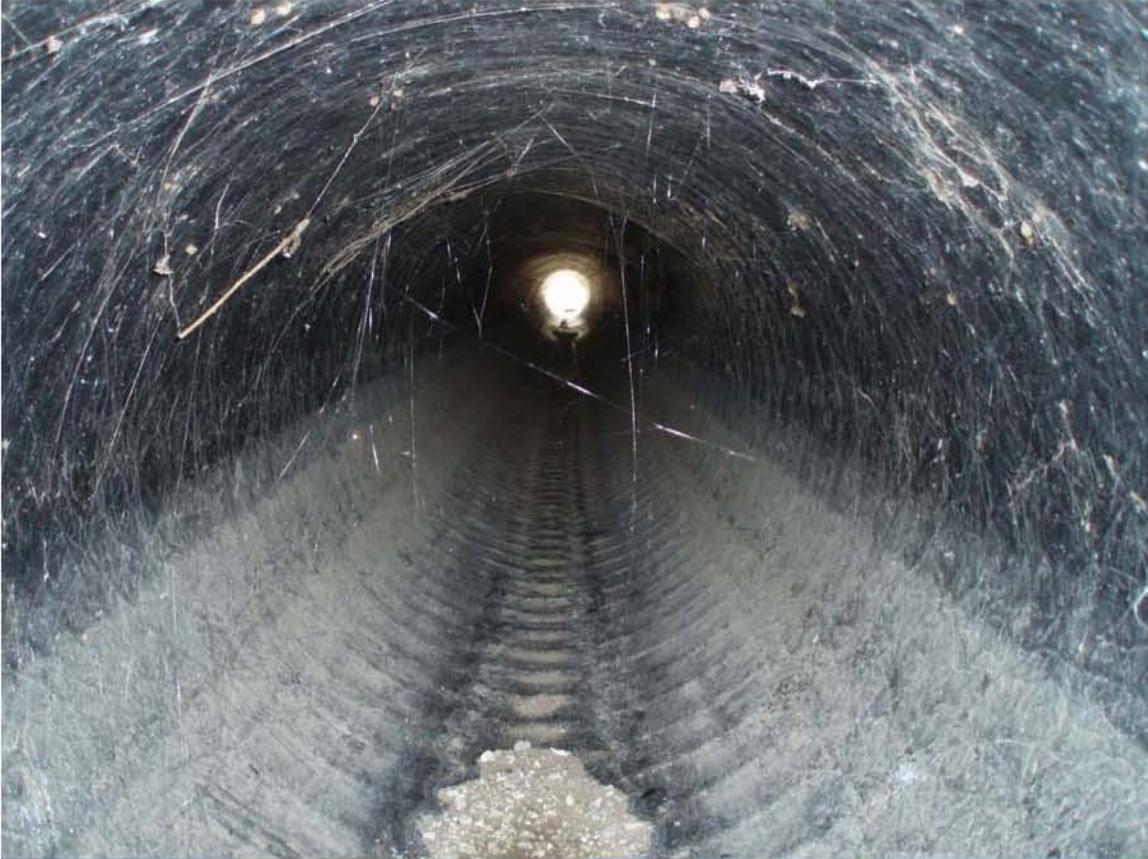
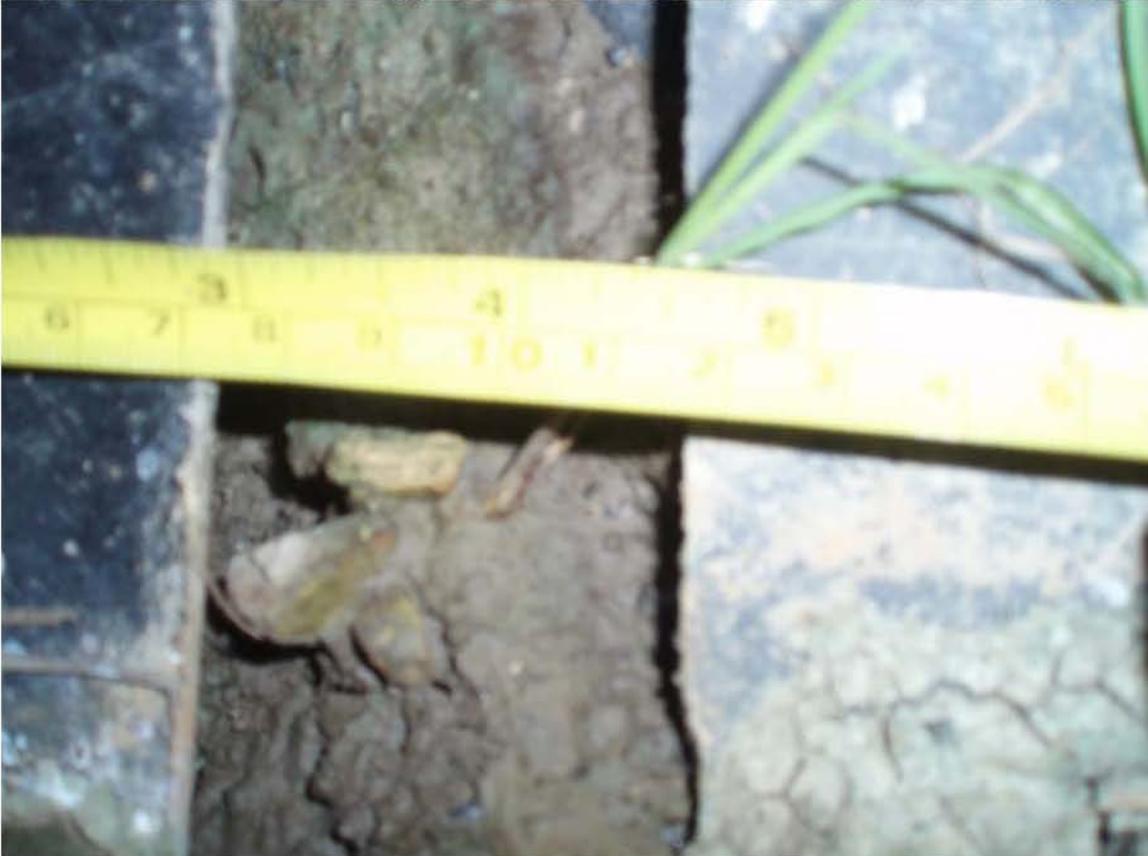
7-30-07, s-210, 30", 2038+00, OF FLE Separation 1.5" at bottom!

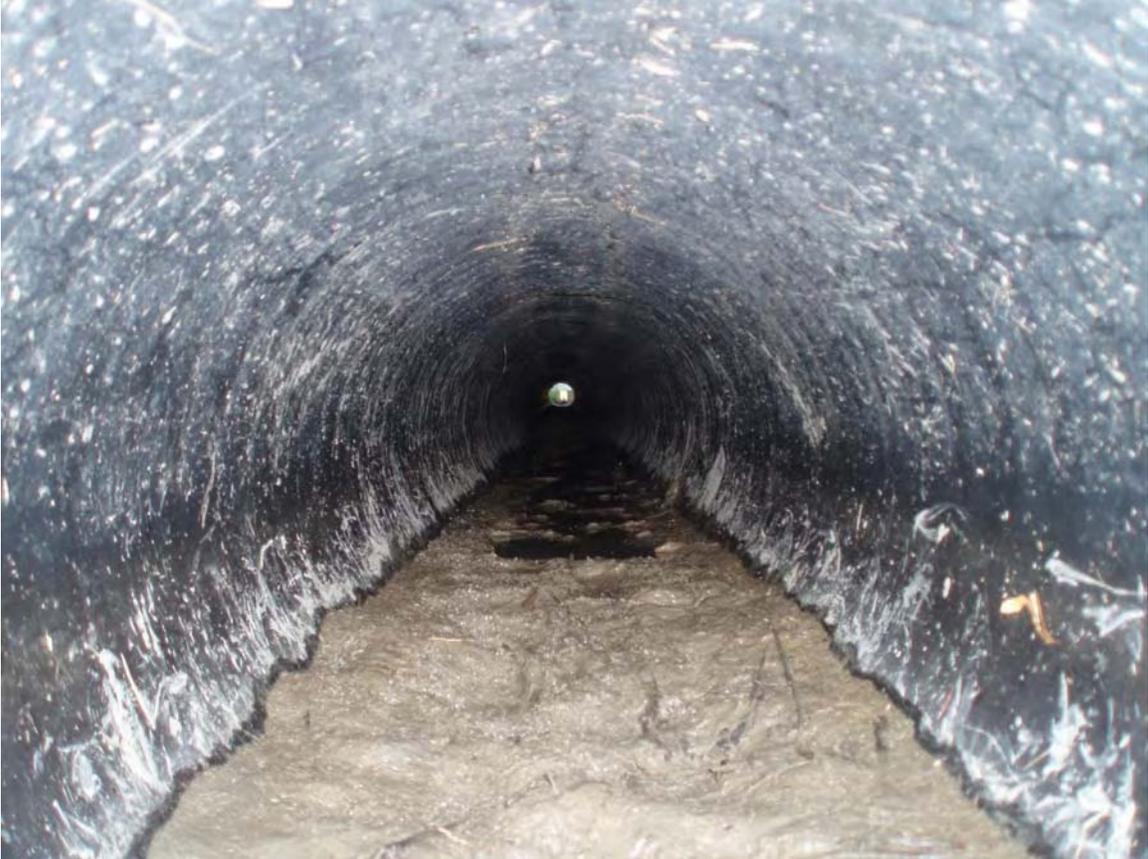
7-31-07, 15"

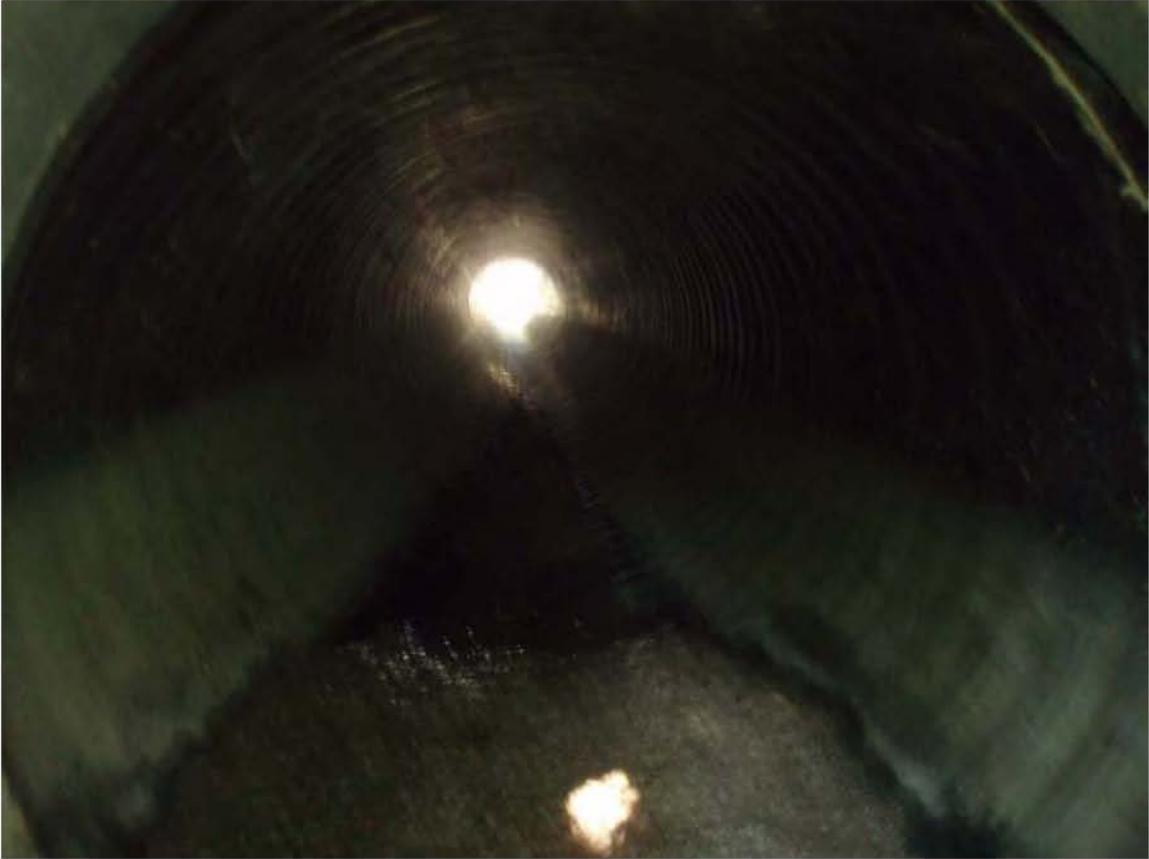
7-31-07, s-204, 18", 2011+00

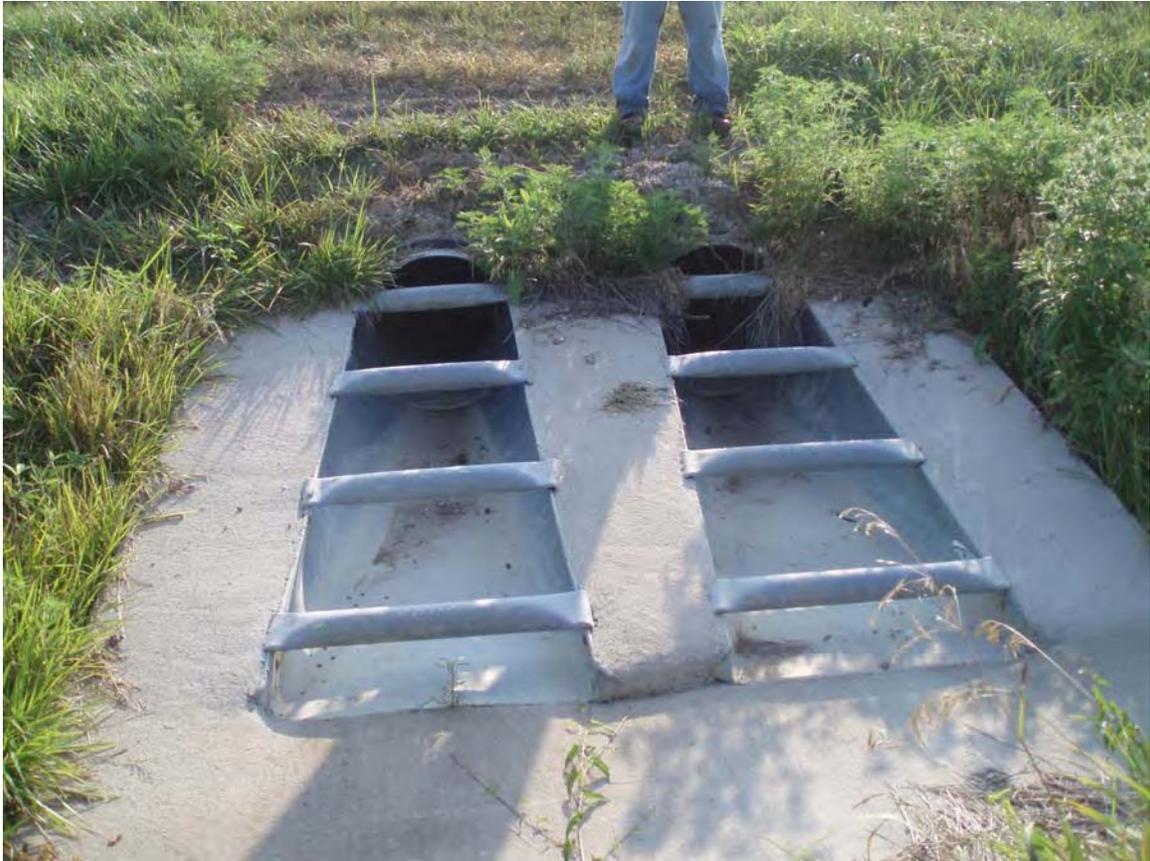
7-31-07, s-203 south 24", north 24",

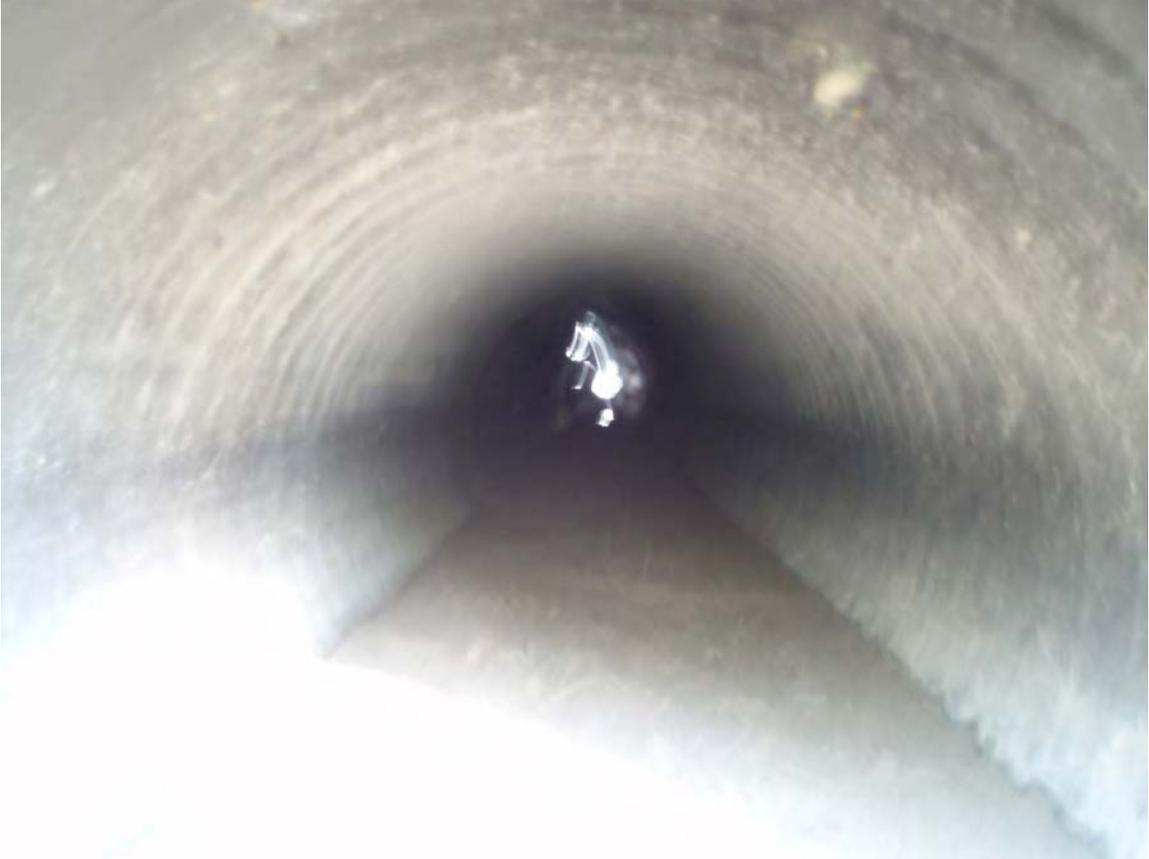
7-31-07, s-202, 24", 1998+91, 4" of dirt all the way,

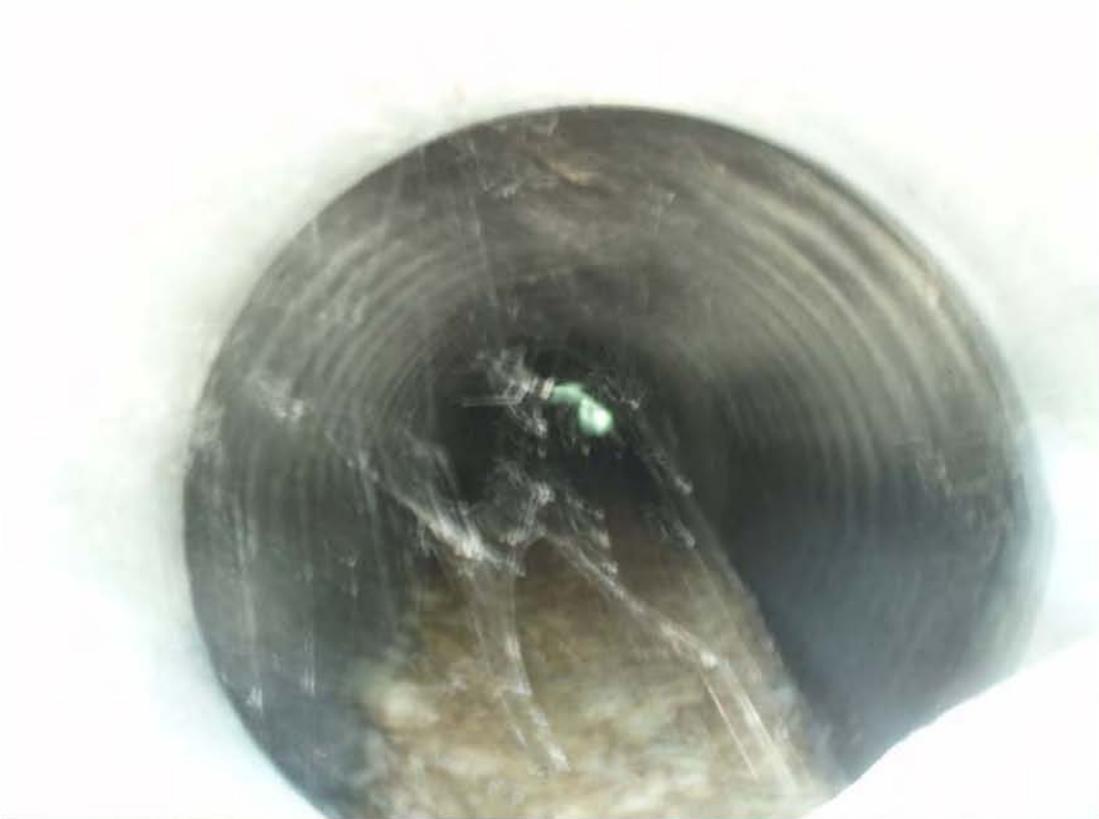
31-07, p-201, 15", 1994+18, 1" of gravel all the way.
