Macon and Adair County, Route 63, Job J2P0485

Route 63, Howell Co., project J9P0497, HDPE double wall storm sewer, W. Side Rt.63

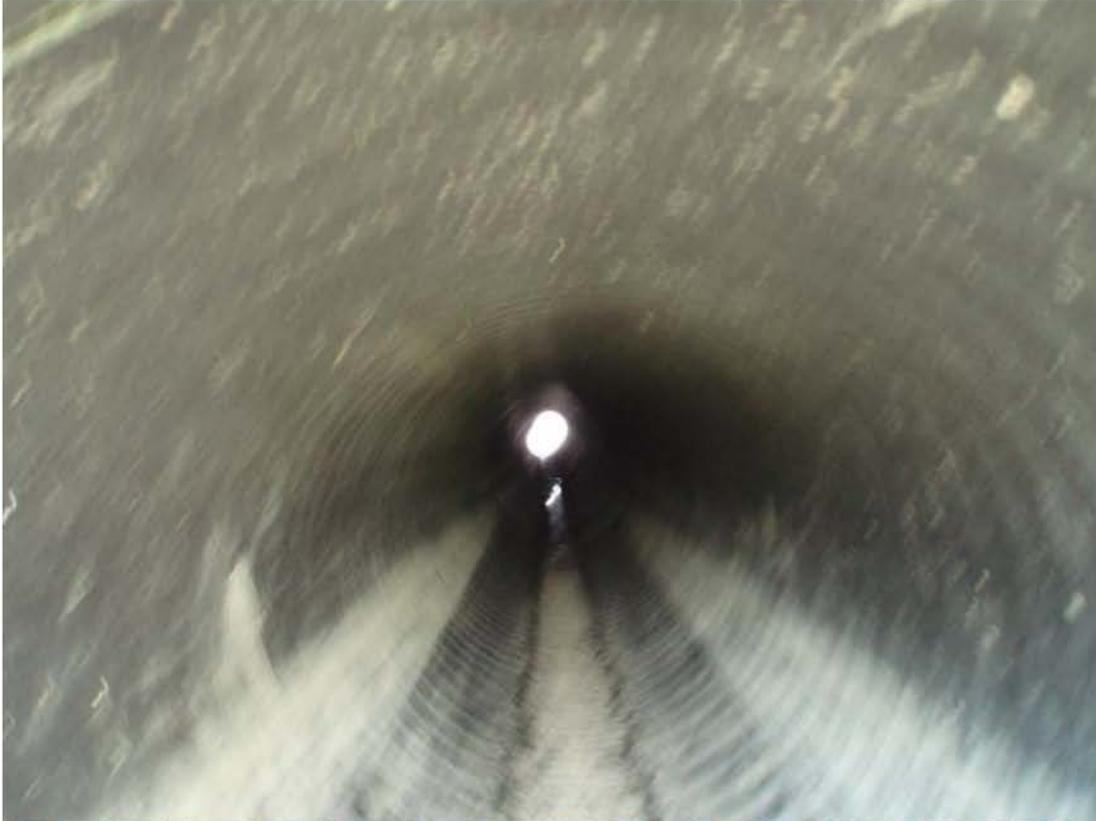
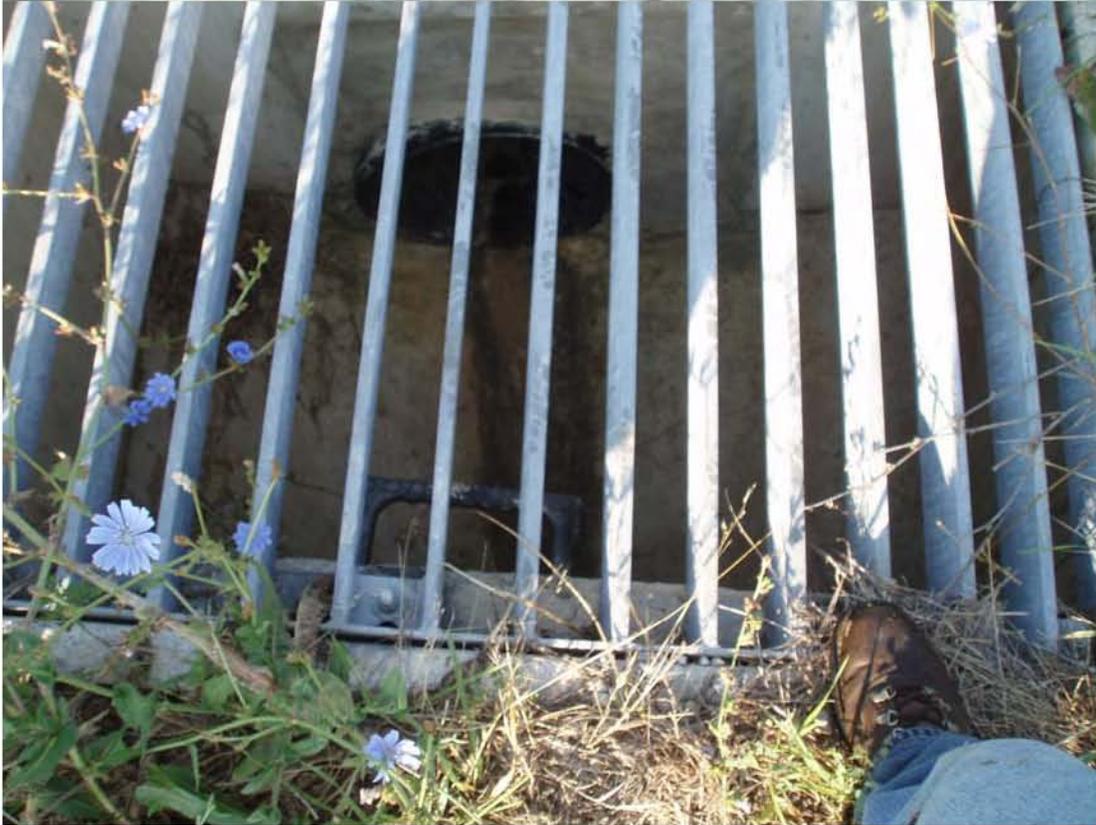
7-31-07, s-200, 30", 1988+00, 18" in median Box Culvert,

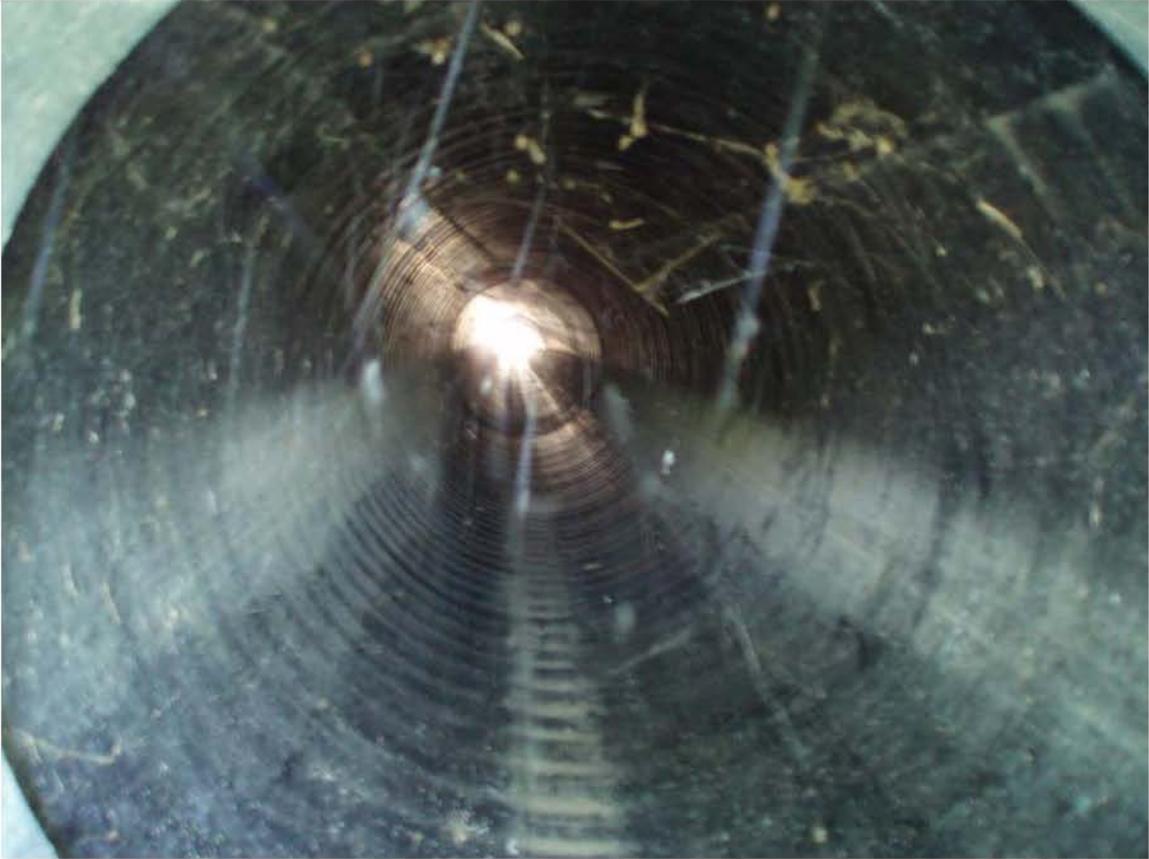
7-31-07, p-198,15", 1978+00

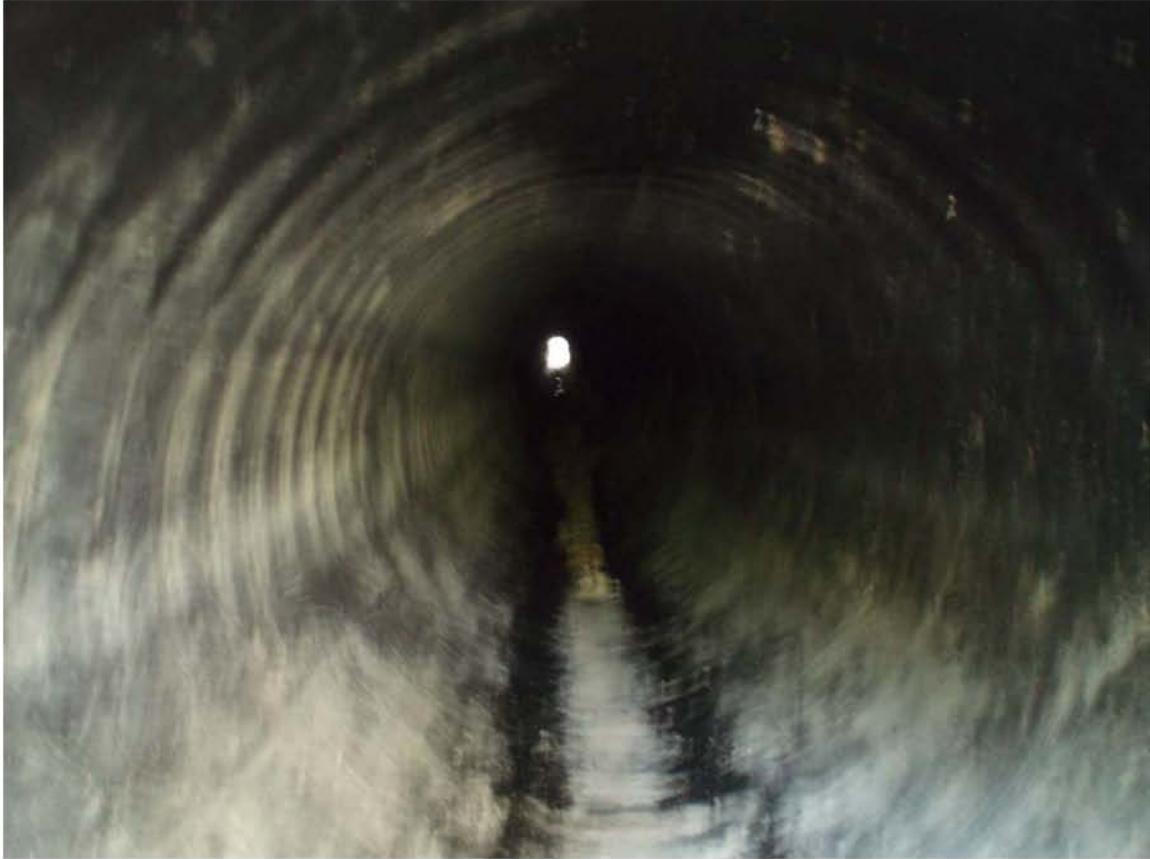
7-31-07, p-197, 15", 1967+48

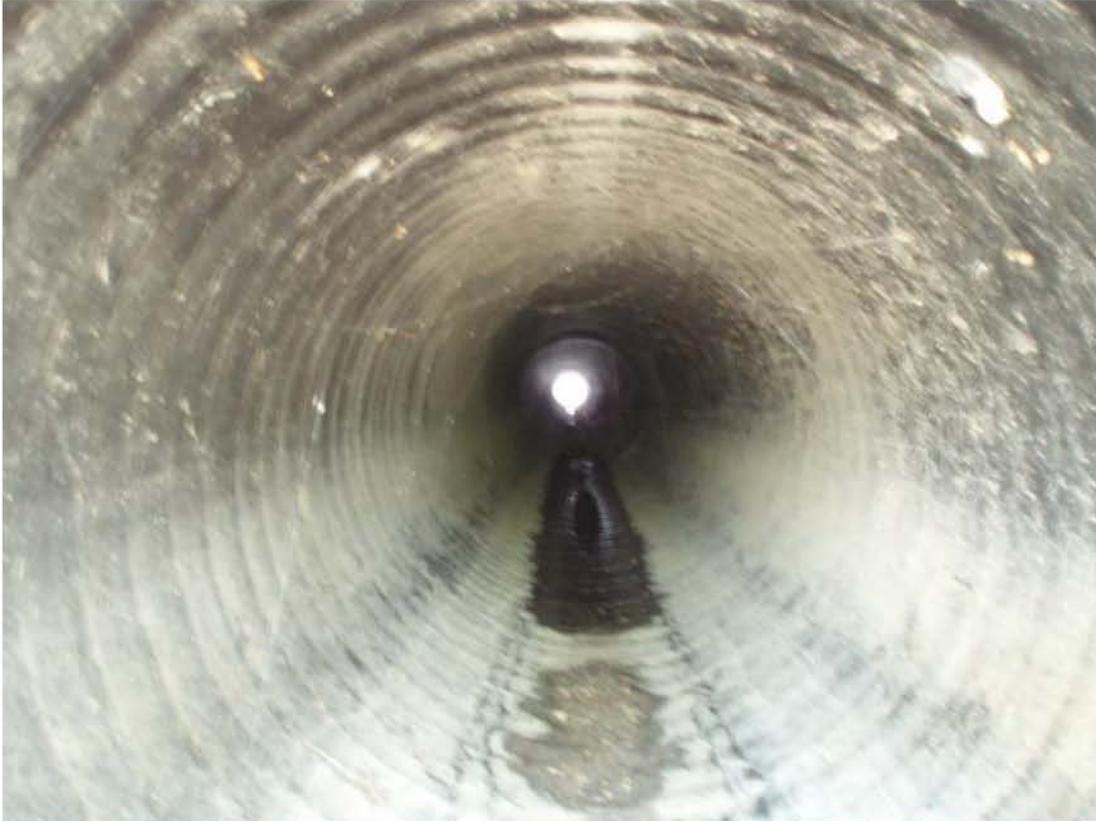
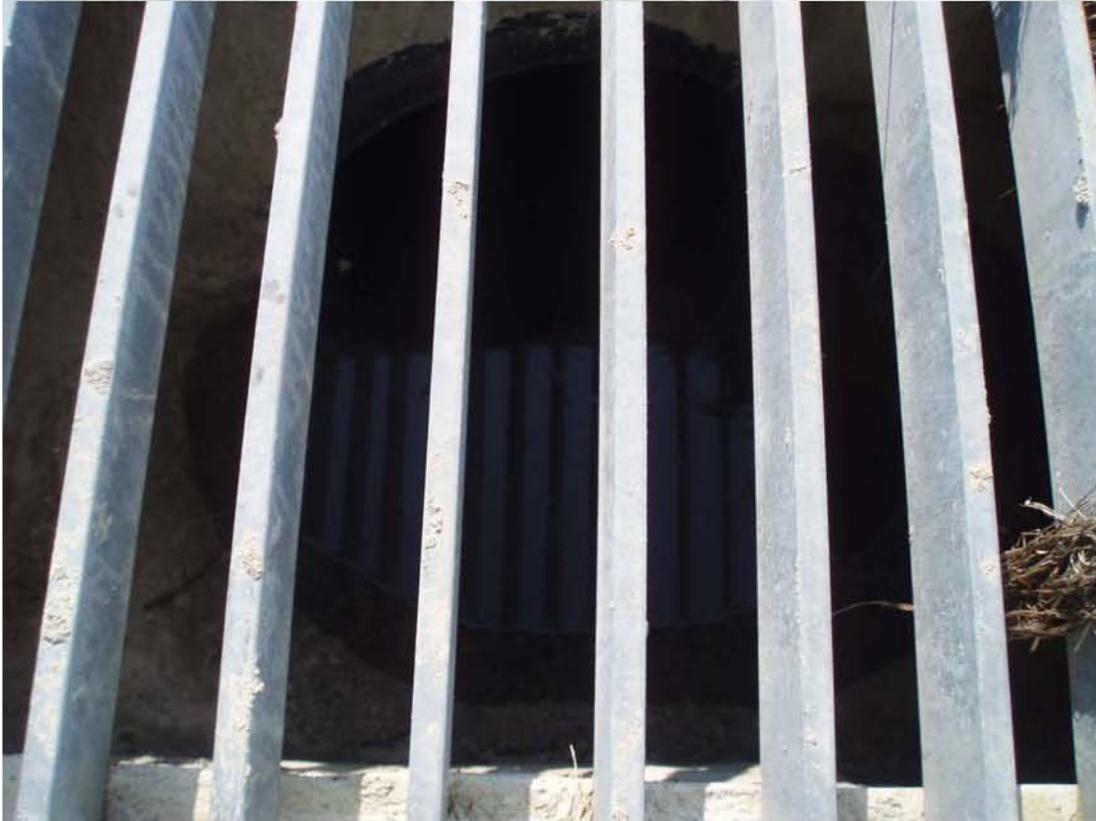
31-07, s-196, 24", 1967+48

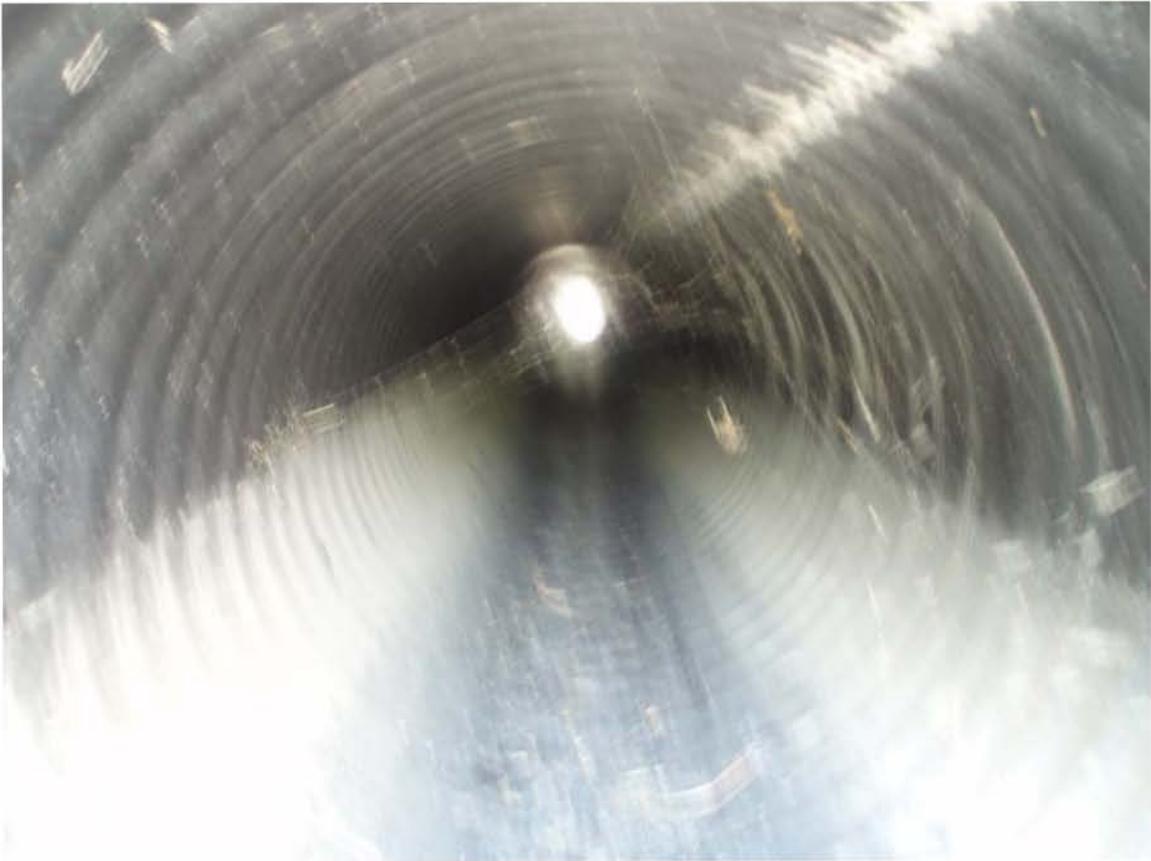
7-31-07, p-194, 24", 1949+54

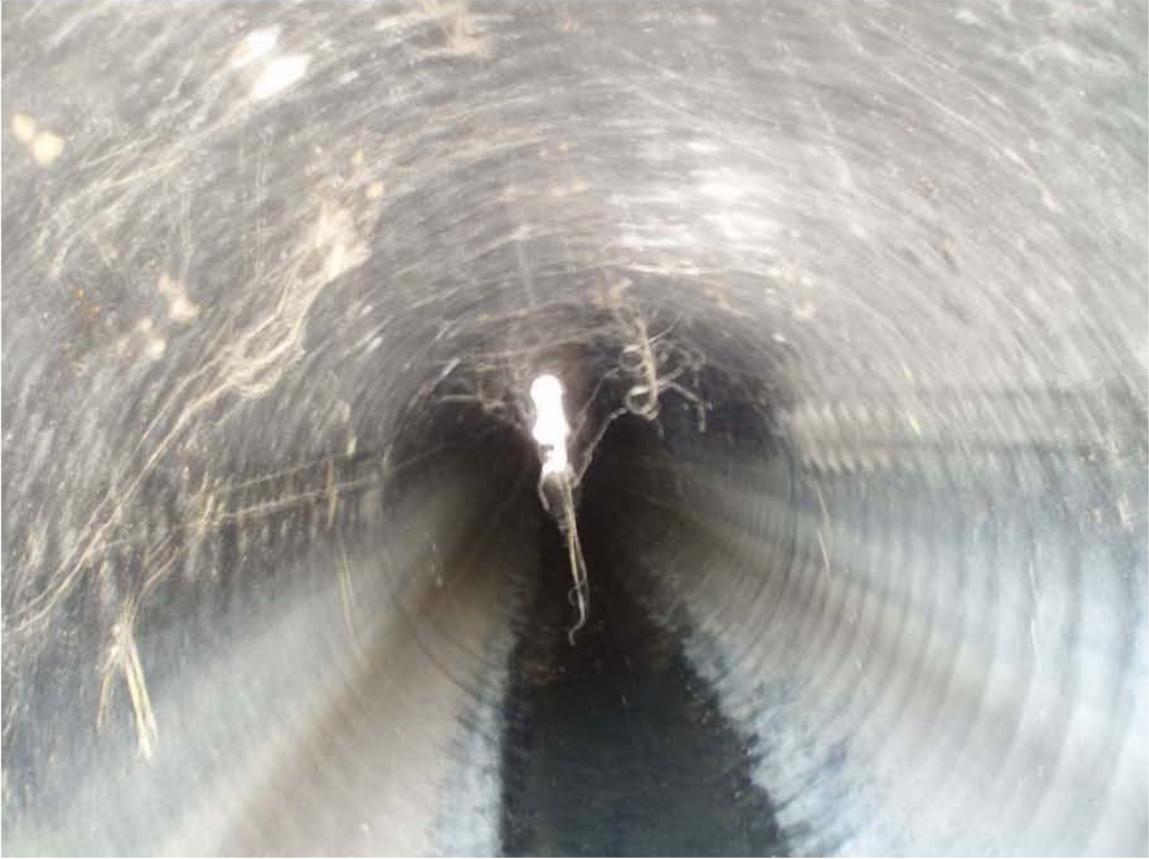
7-31-07, s-192, 24", 1993+45

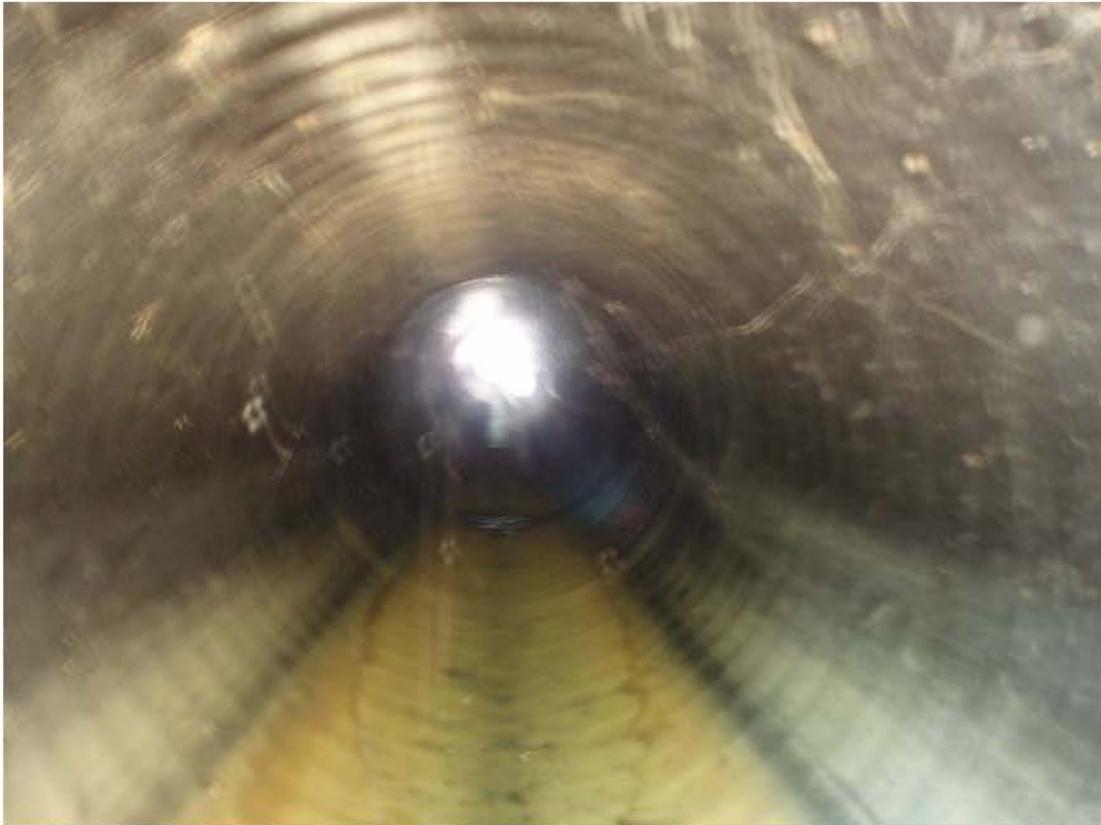
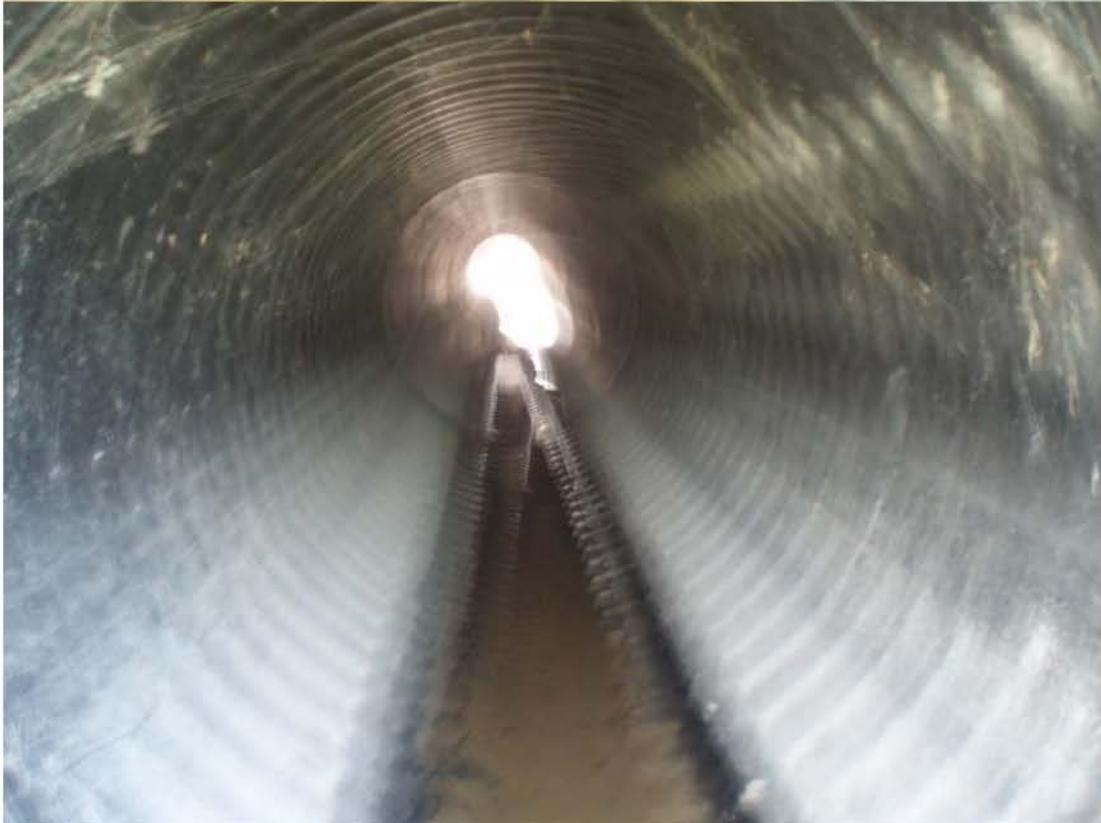
7-31-07, s-191, 42", 1929+15,

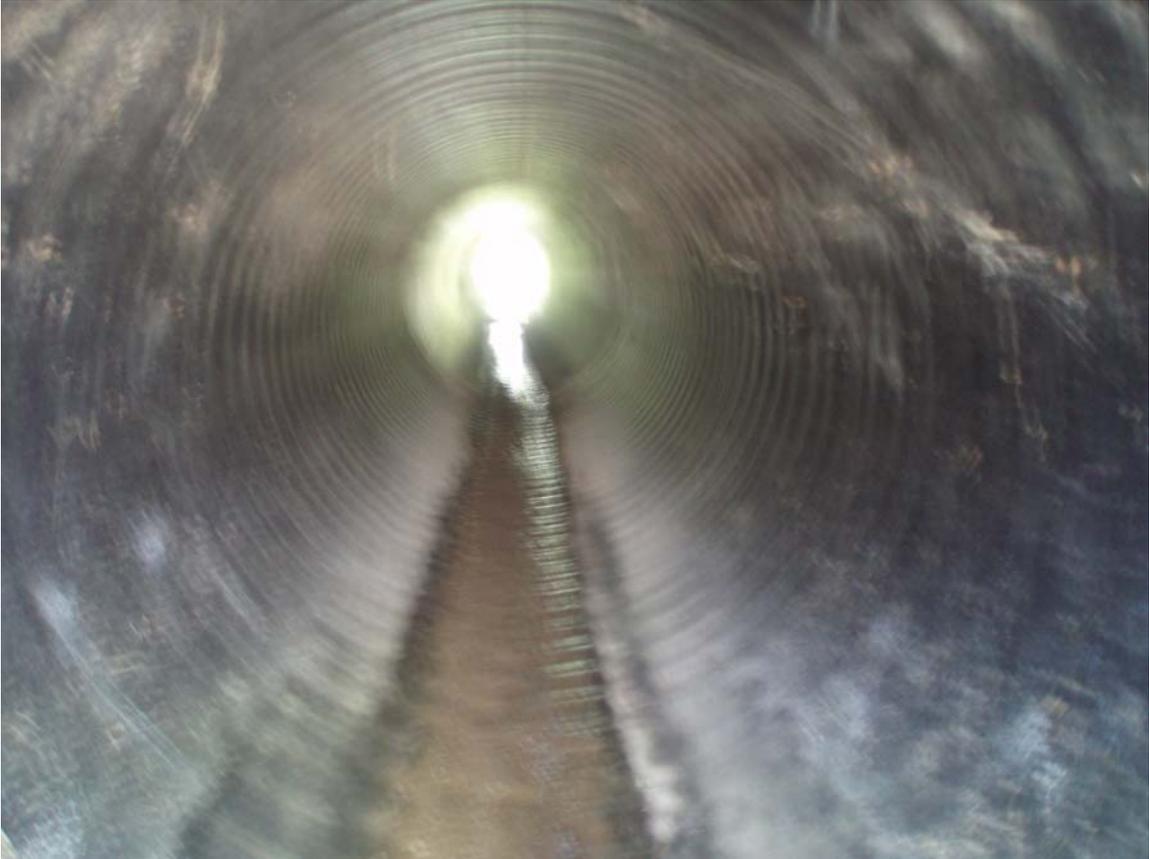
7-31-07-, p-190, 24", 1919+00

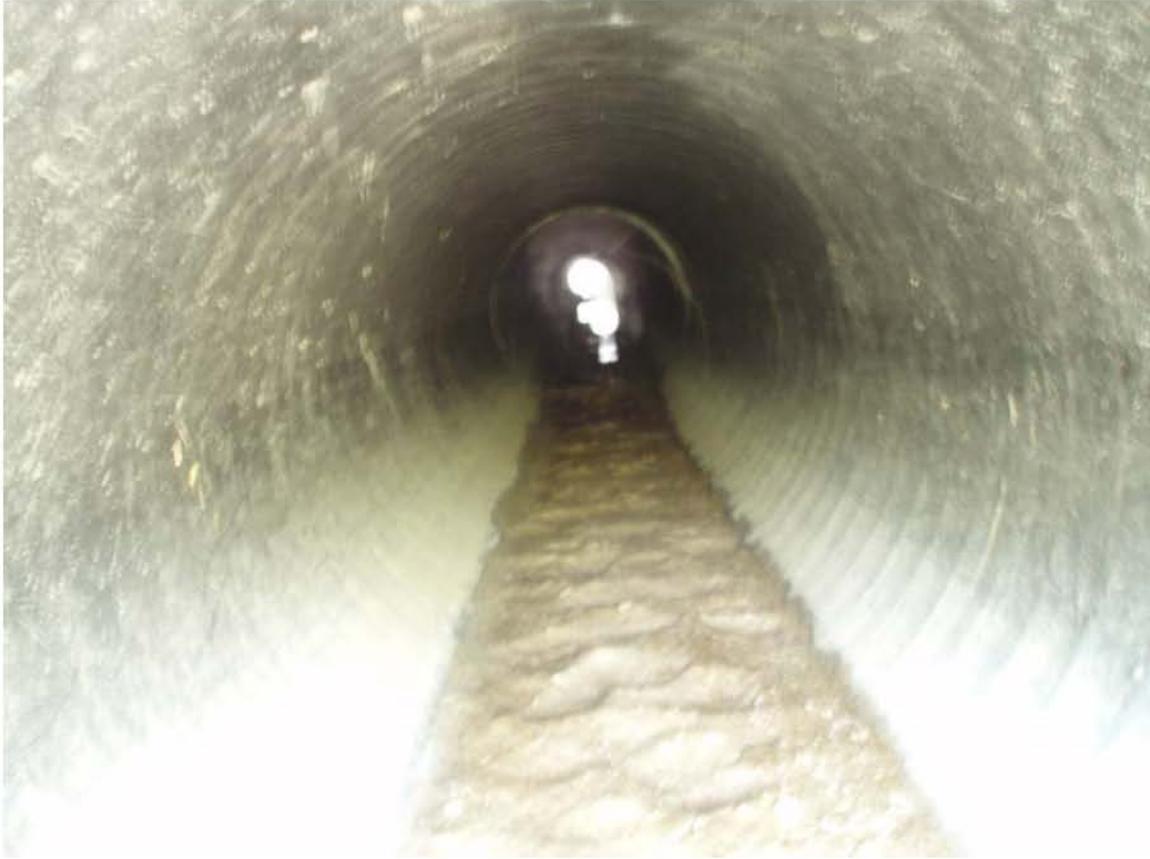
7-31-07, p-189, 24", 1899+00

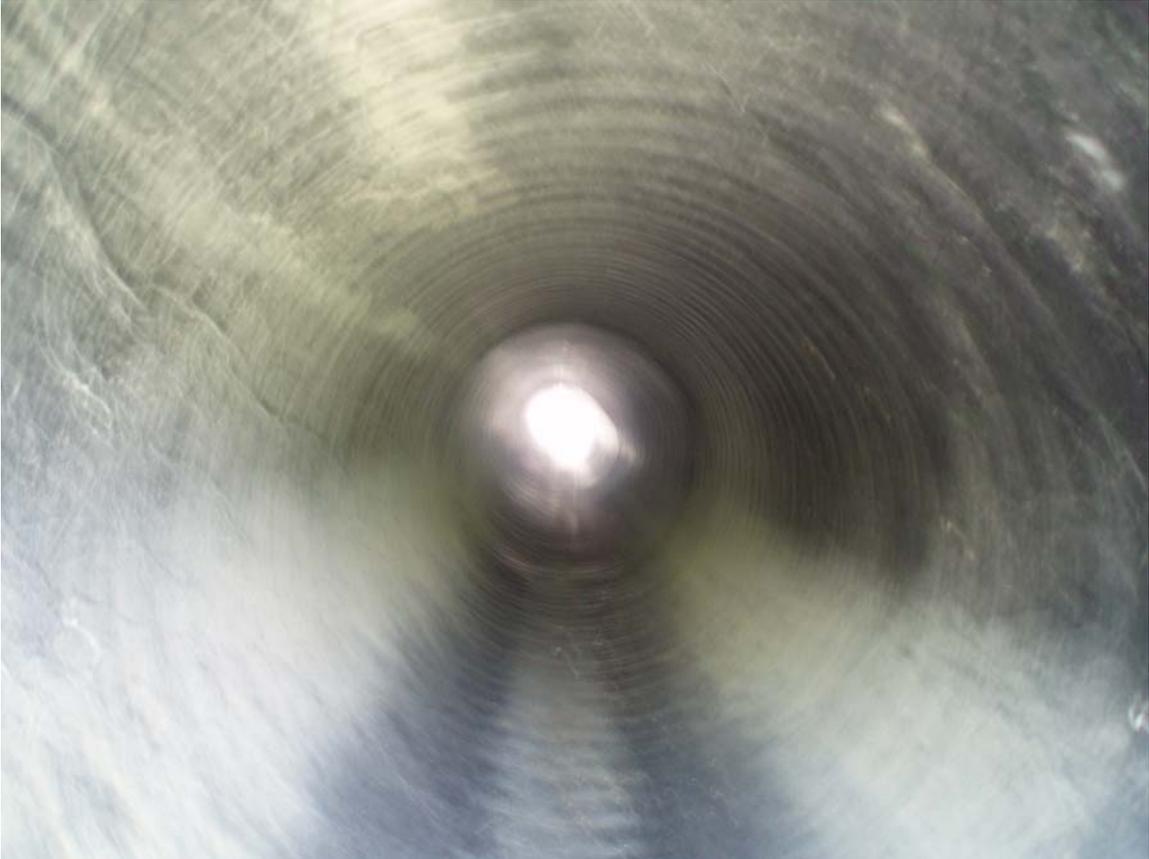
7-31-07, p-188, 30", 1890+38,

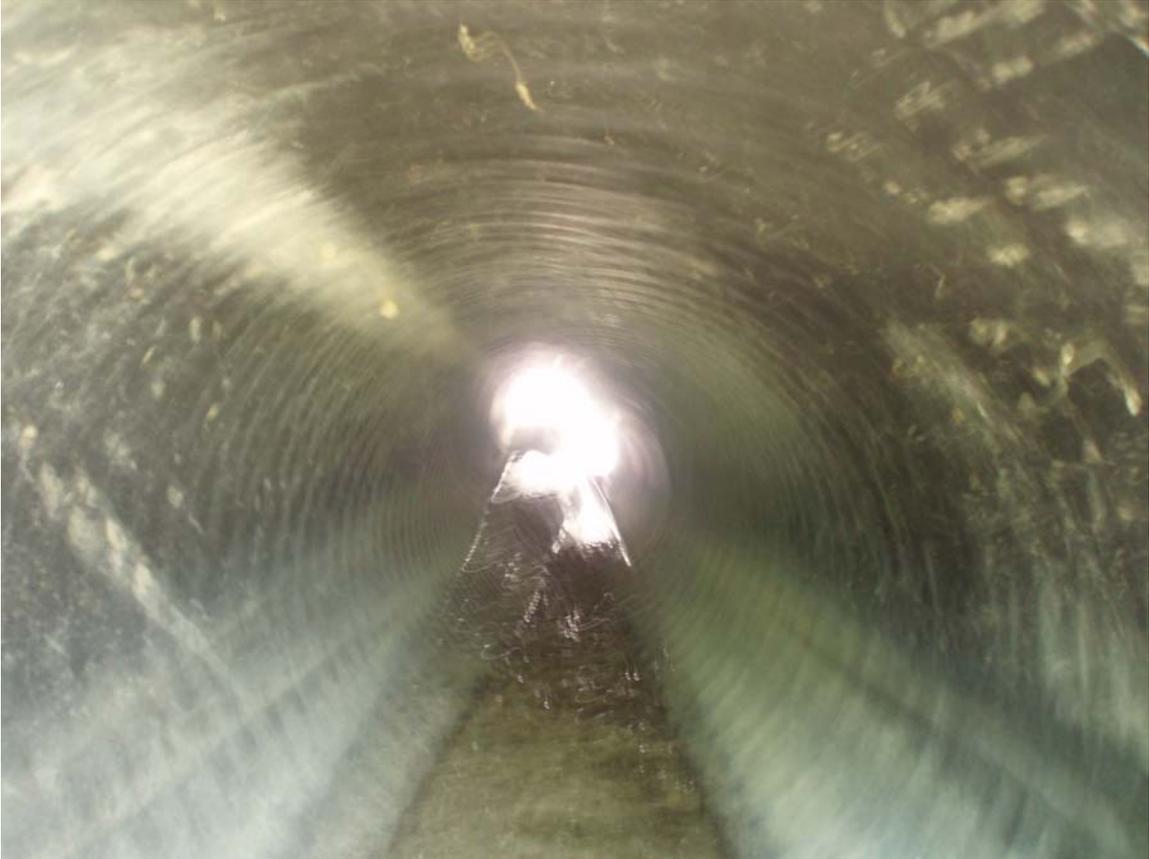
7-31-07, s-187, 24", 1886+79, appears deflected but too much debris for video camera or mandrel

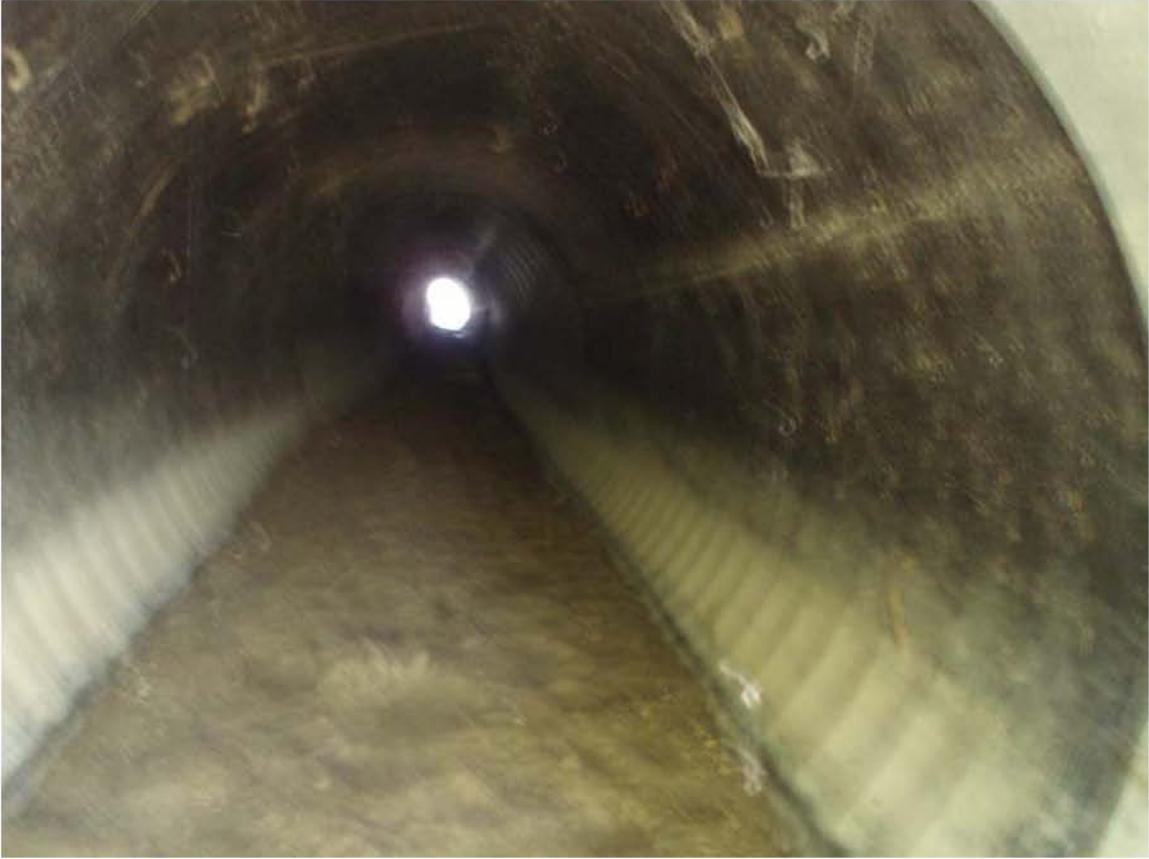
7-31-07, s-186, 24", 1884+00

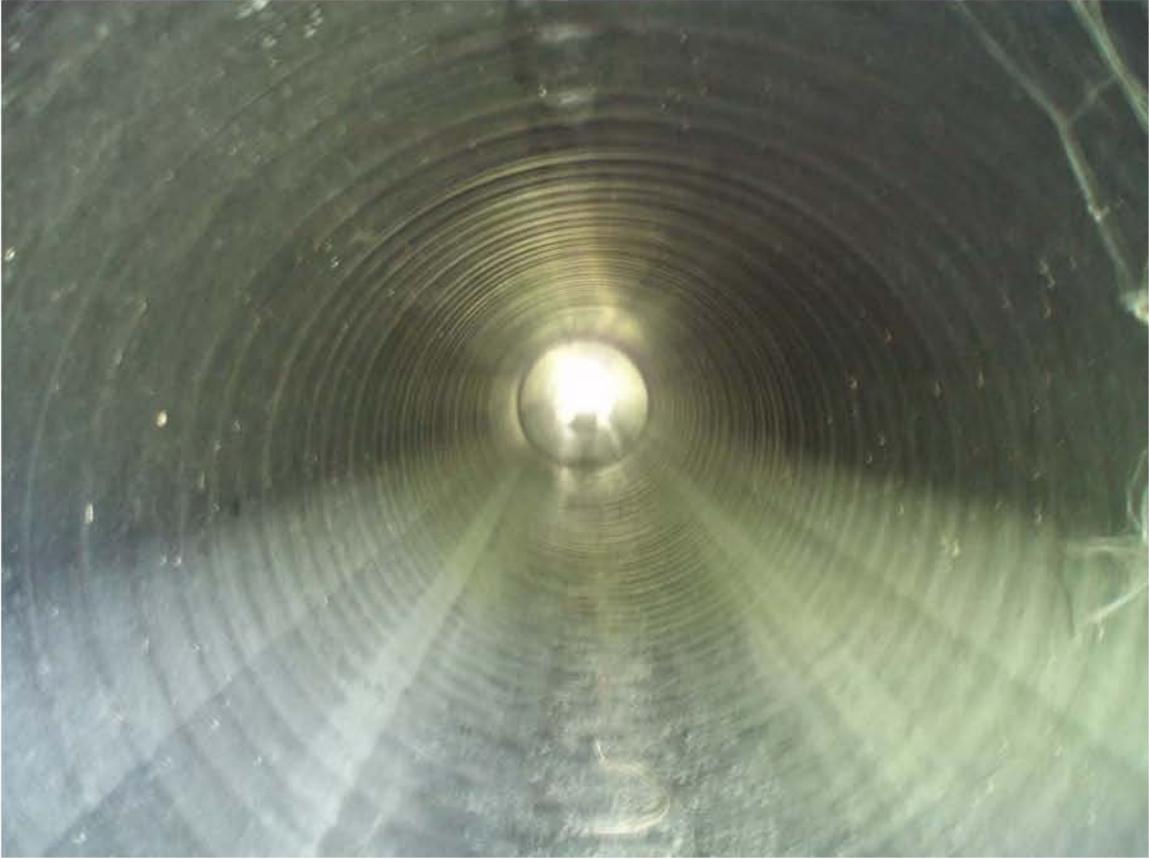
7-31-07, s-184, 30", 1869+37

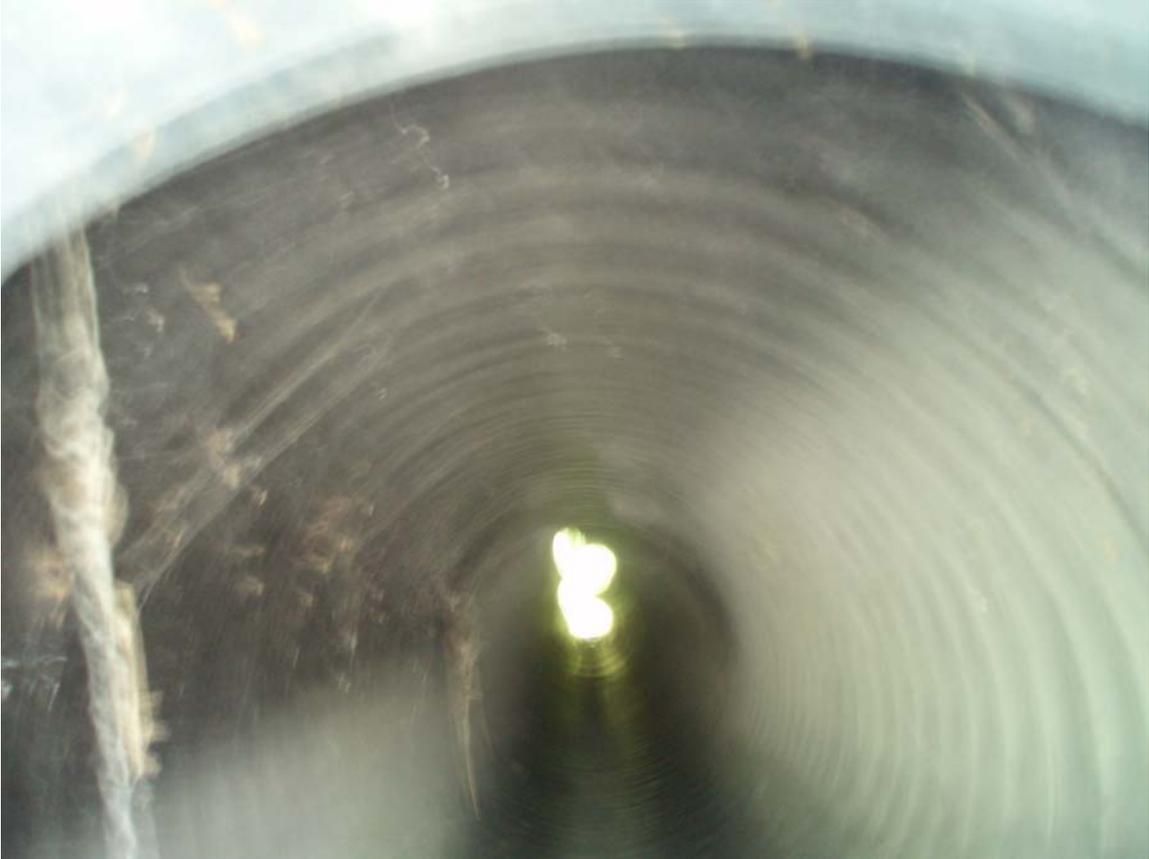
7-31-07, s-183, 24", 1863+31, Type S Grate

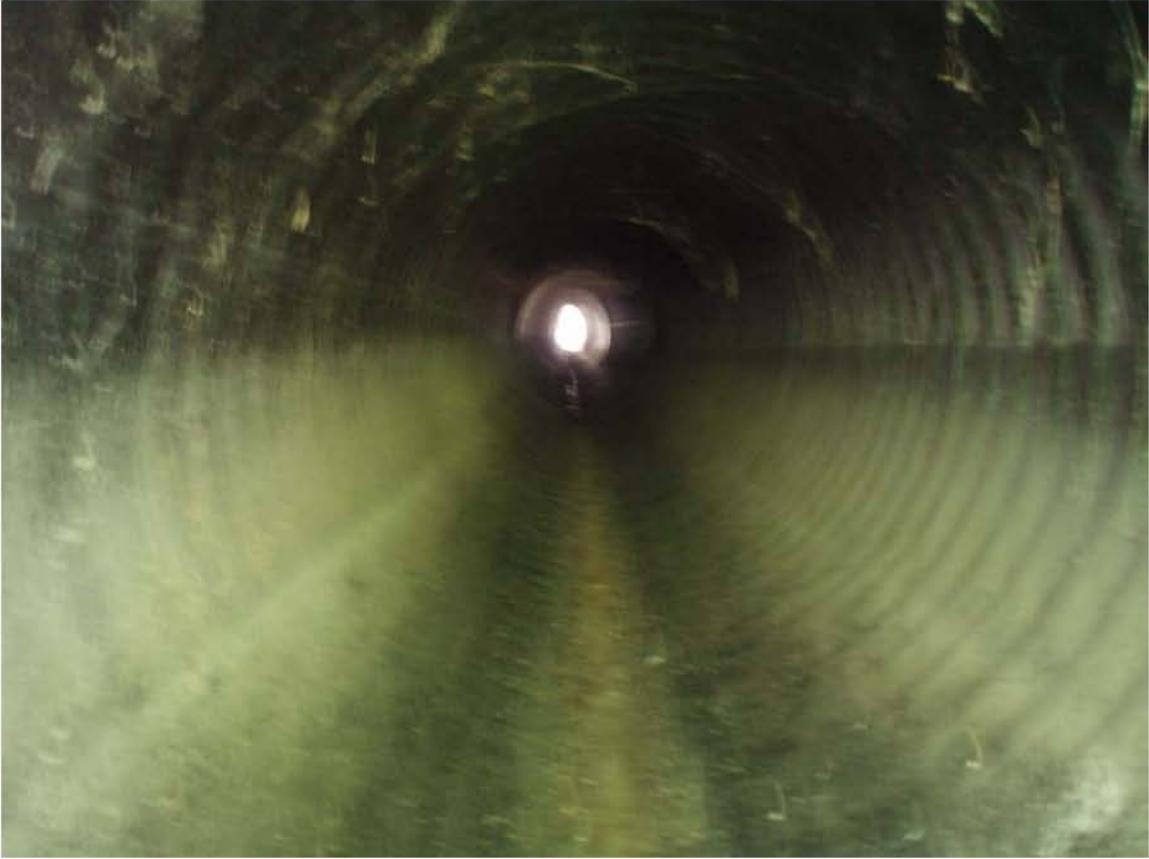
7-31-07, s-181, 15", 1855+00

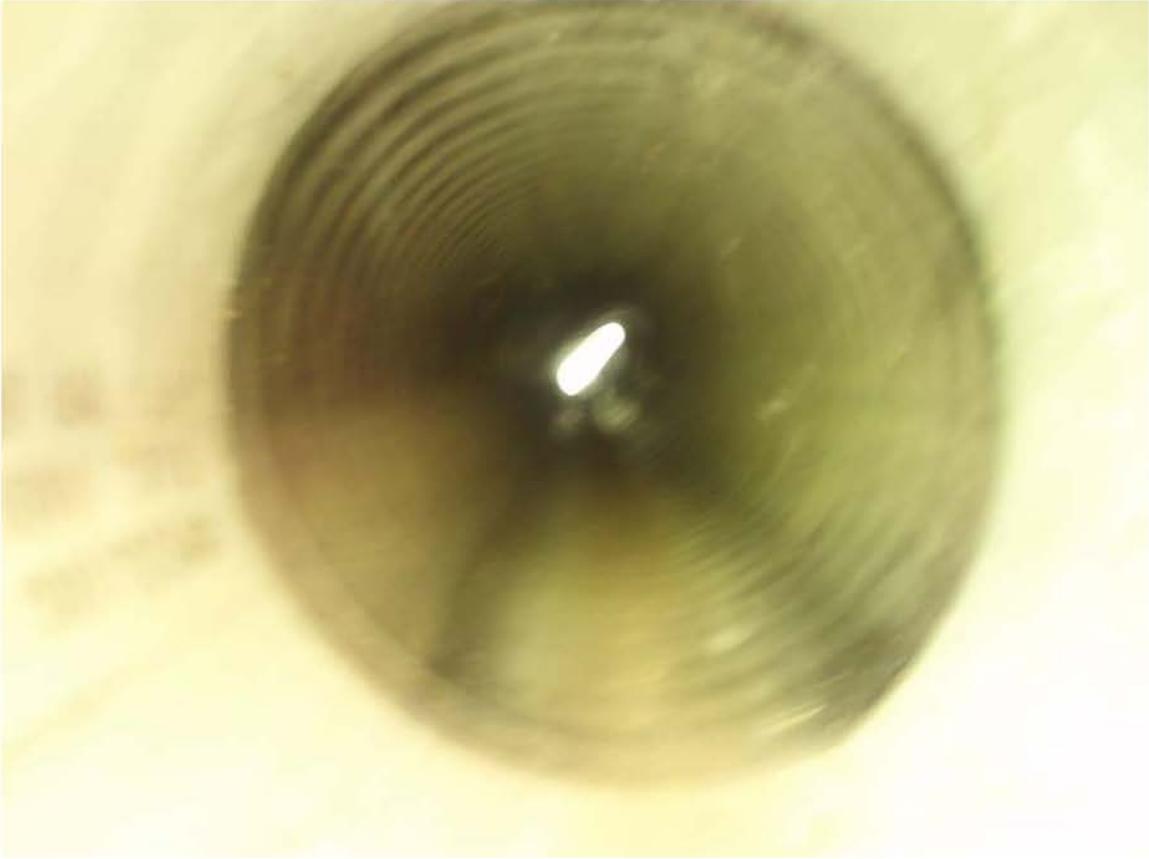
7-31-07, s-180, 18", 1849+00

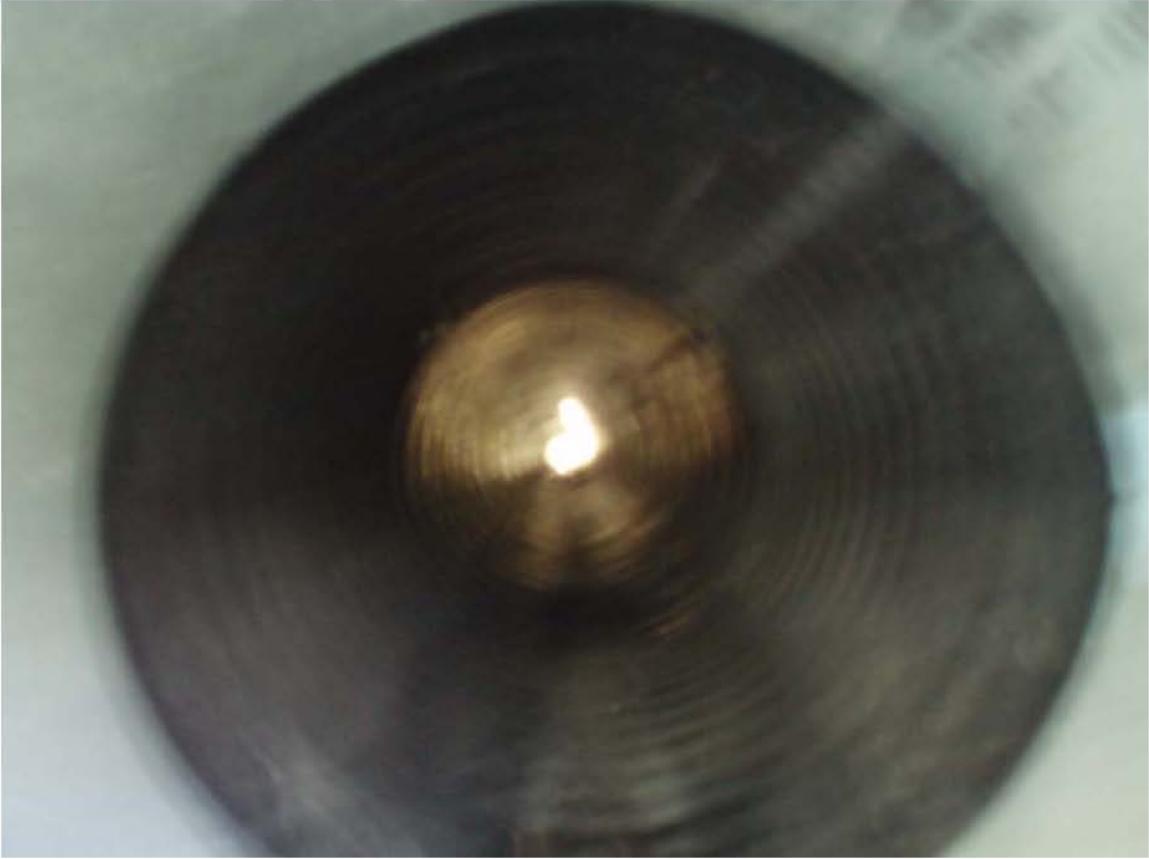
7-31-07, s-179, 15", 1836+00

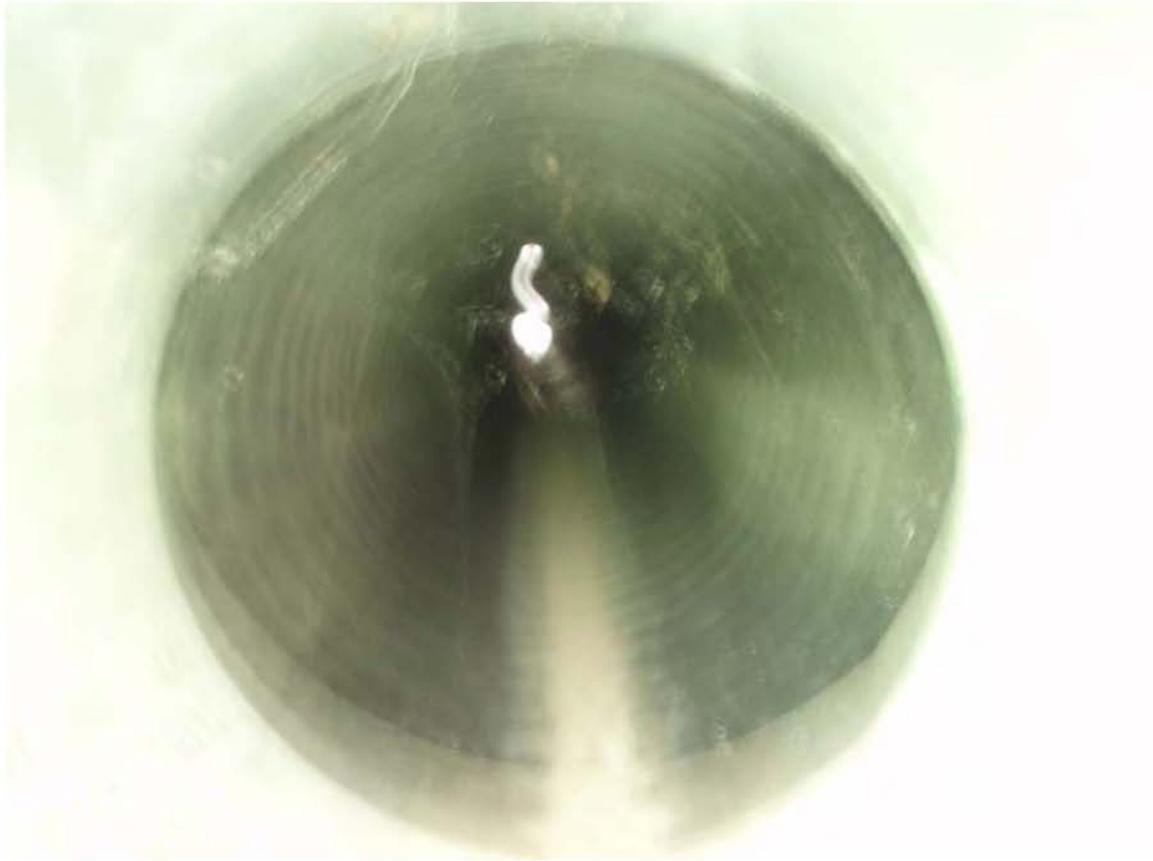
7-31-07, s-178, 18", 1833+00

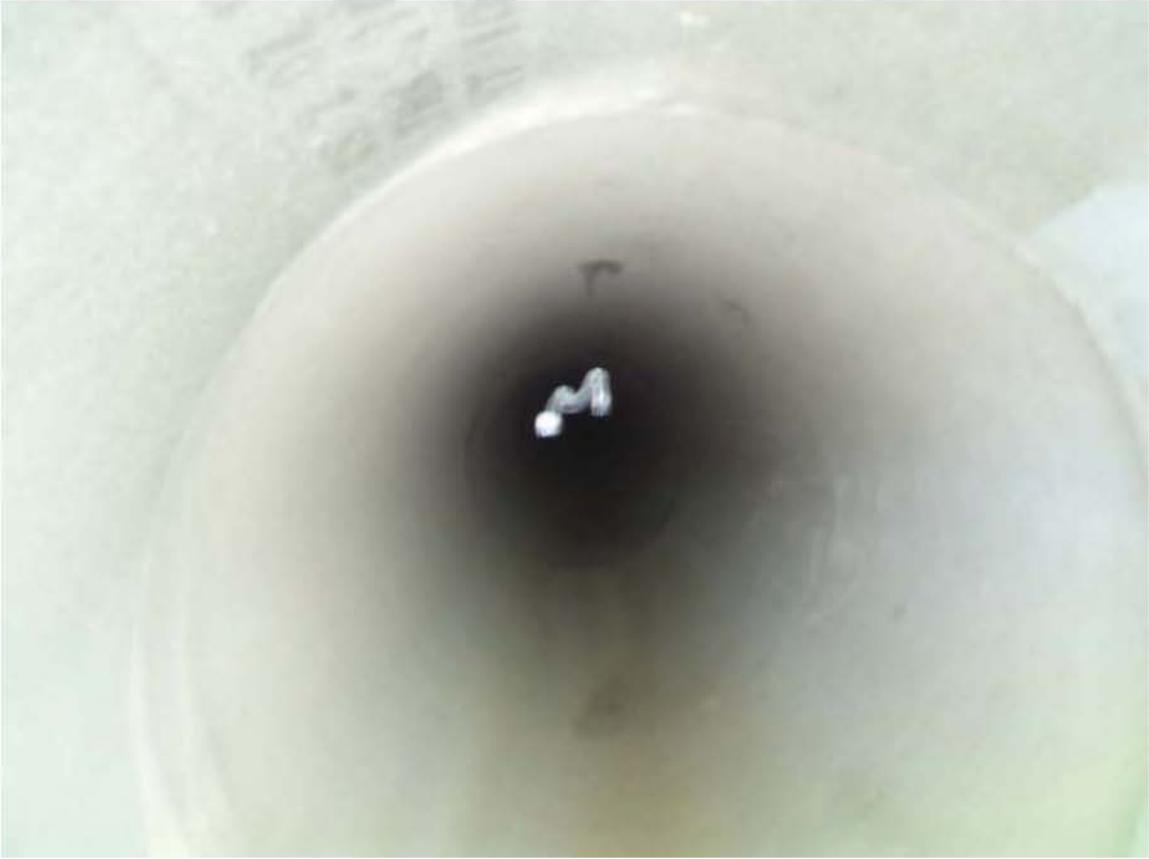
7-31-07, s-176, 24", 1824+79

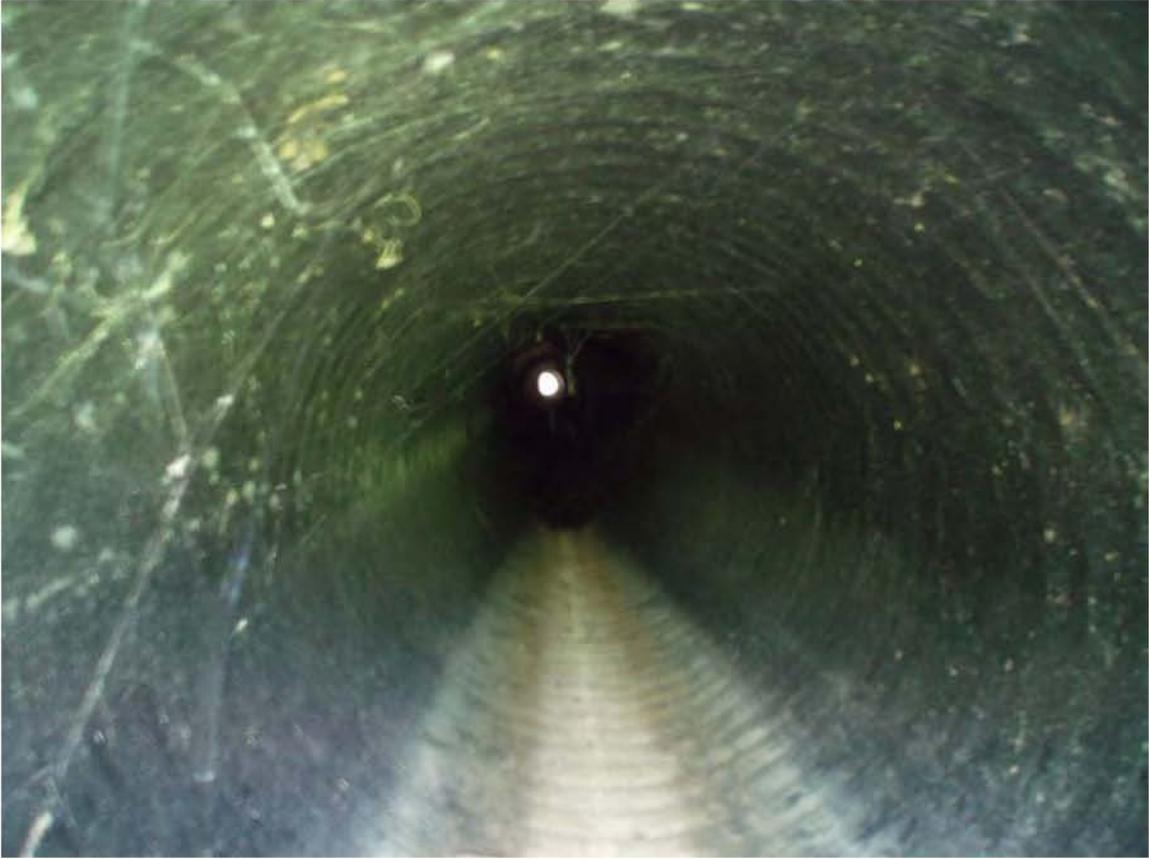
7-31-07, s-174, 30", 1819+80

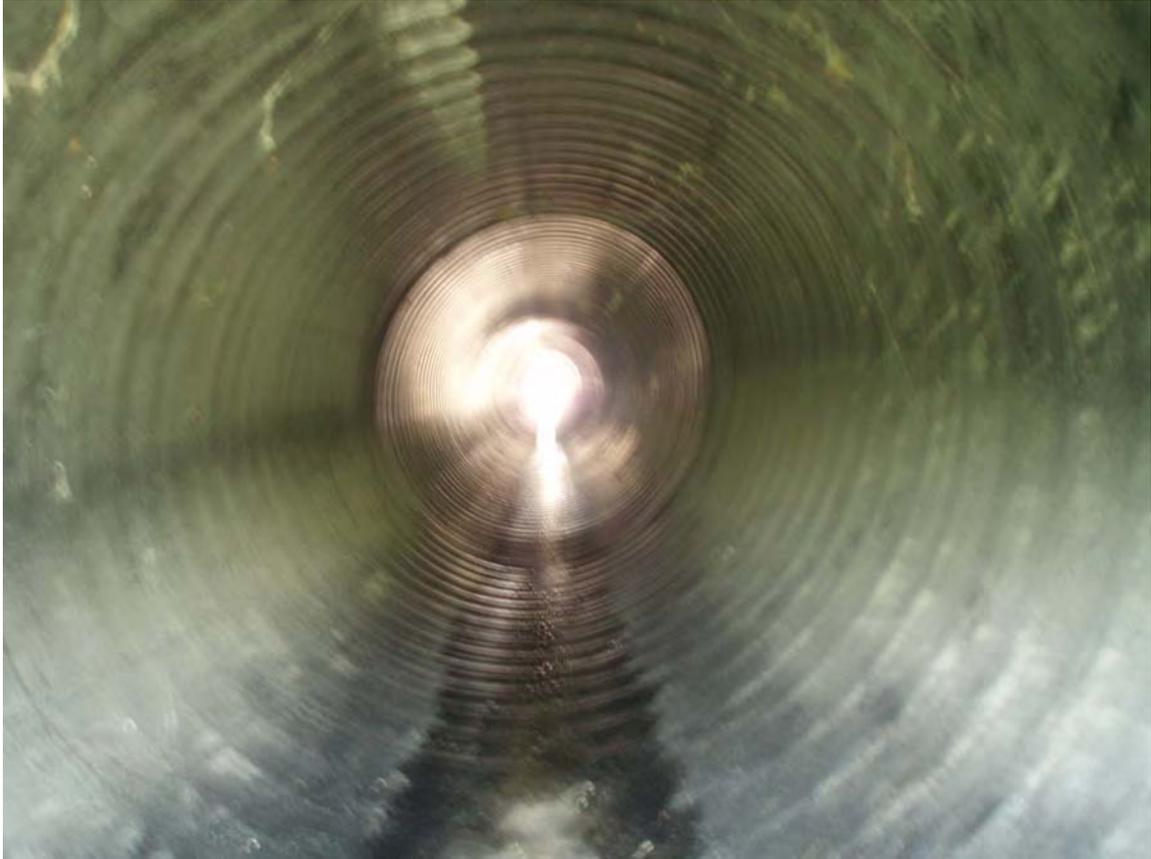
7-31-07, s-173,
